LOAD RATING AND FRP RETROFITTING OF BRIDGE ABUTMENT TIMBER PILES

Research Report No. FHWA-ICT-16-011

**Strengthening of Bridge Wood Piling
Retrofits for Moment Resistance, Phase II**

Illinois Center for Transportation

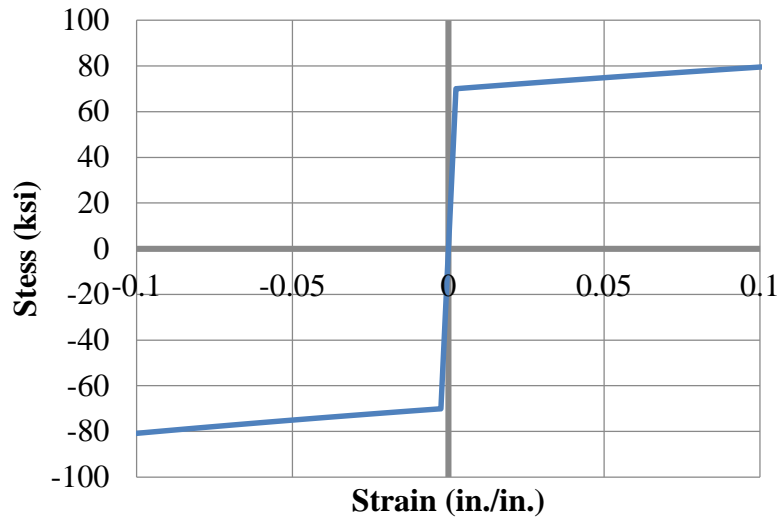
Figure 2-6. Weld material behavior.

All welds between the steel components were 1/4 in. fillet welds all around the joined members. A bilinear material behavior was assumed for the welds with a yield stress of 70 ksi with linear hardening, as shown in Figure 2-6. Tie constraints were used to fuse the weld geometry to the joined steel members.

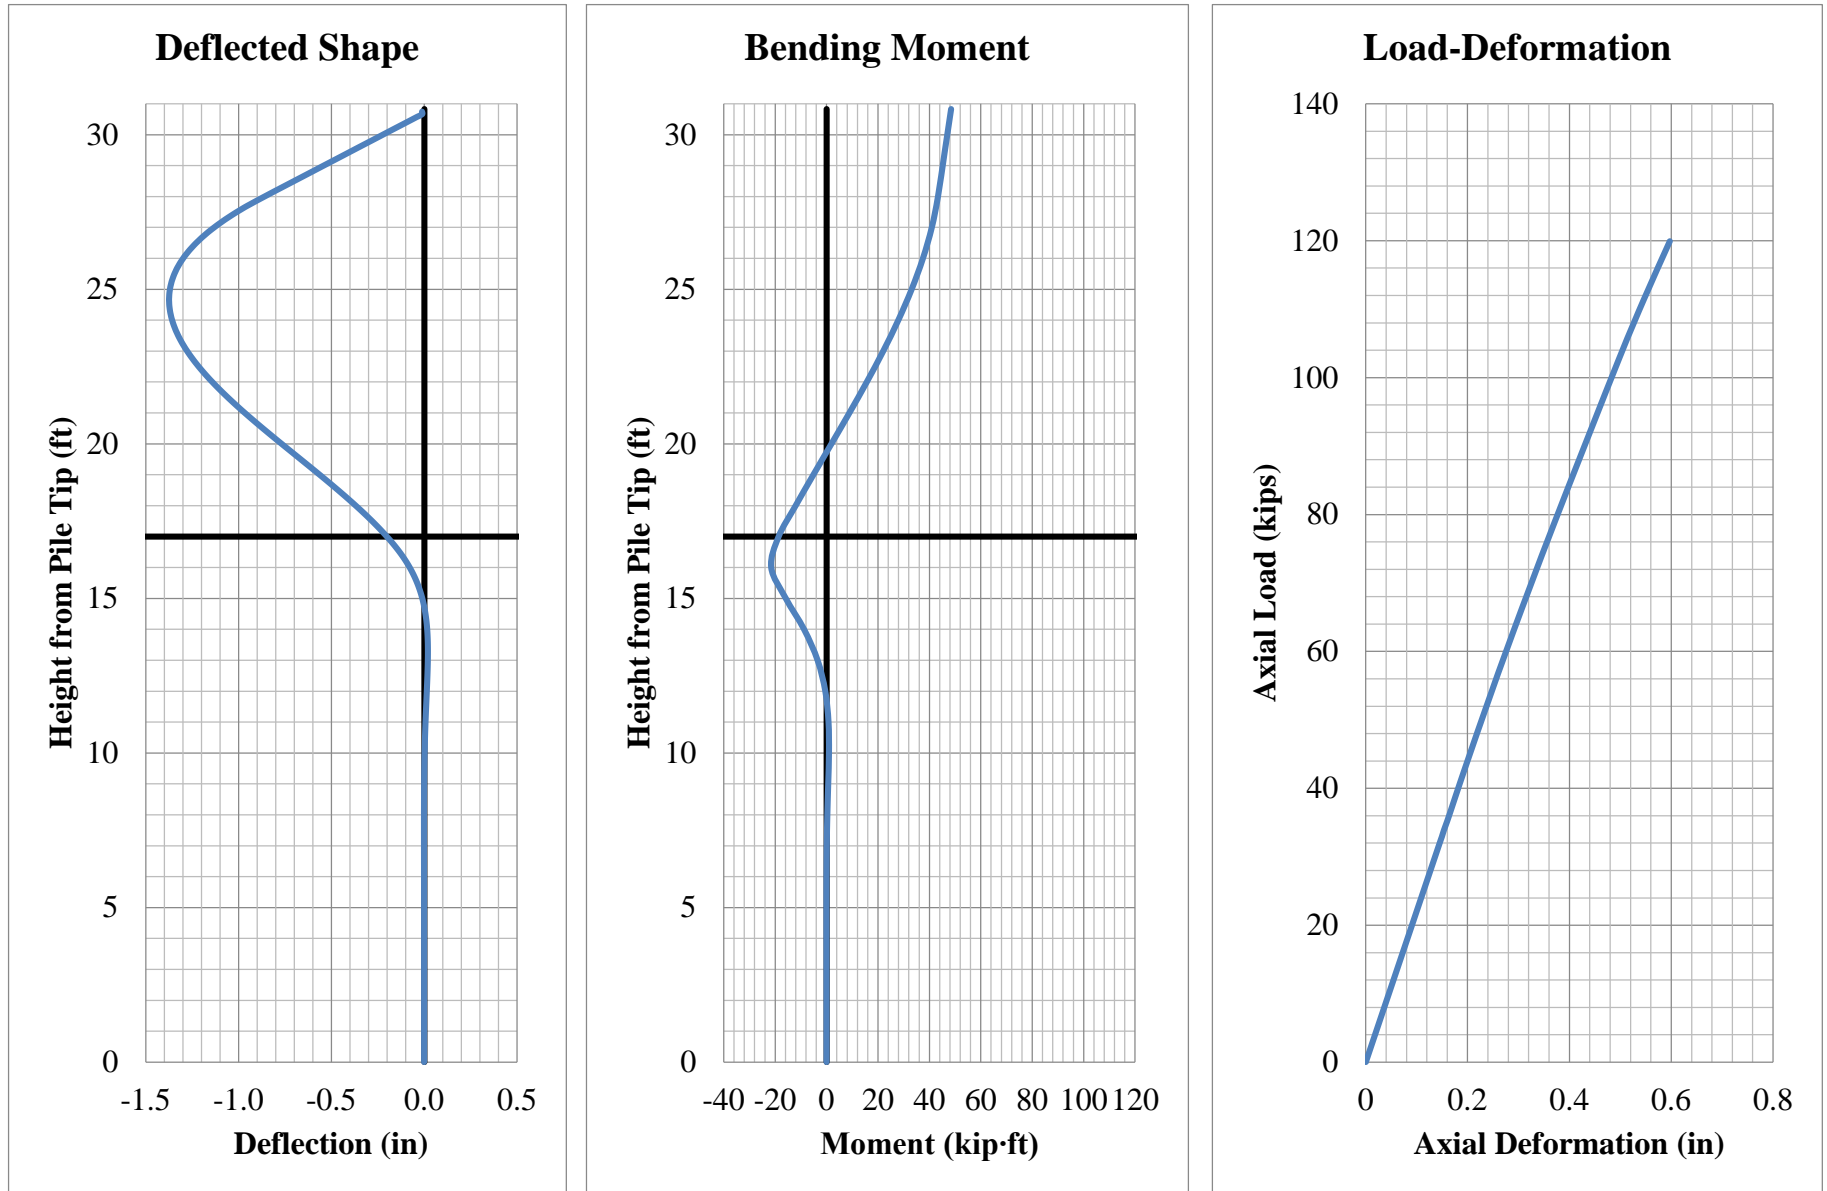
Figure 2-9. Timber pile analysis results.

Most of the deformation occurs above the riverbed, with the maximum deflection of 1.38 in. occurring at approximately 3 ft below the pile cap. Failure of the tensile fibers initiates at this location. The bending moment is maximum at the top of the pile cap and gradually reduces until the inflection point at approximately 2 ft above the river bed. This implies that the geometric nonlinearity arising from the deflection of the pile does not significantly increase the moment in the pile. The ultimate stress distribution in the cross-section at the pile tip and locations of maximum deflection above and below the riverbed are shown in Figure 2-10. In Figure 2-10(a), it is clear that the tensile extreme fiber has reached the ultimate stress but the compressive fiber has not. Below the riverbed, the pile is almost under pure compression.

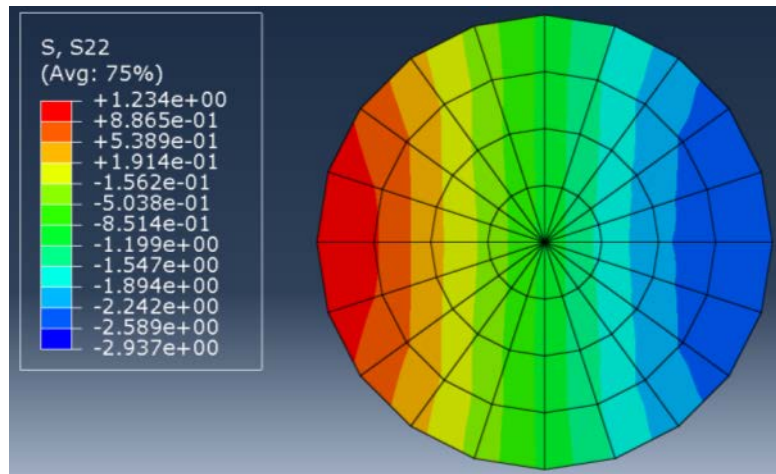
Figure 2-10. Cross-section stress at (a) maximum deflection above the riverbed; (b) maximum deflection below the riverbed; (c) pile tip.

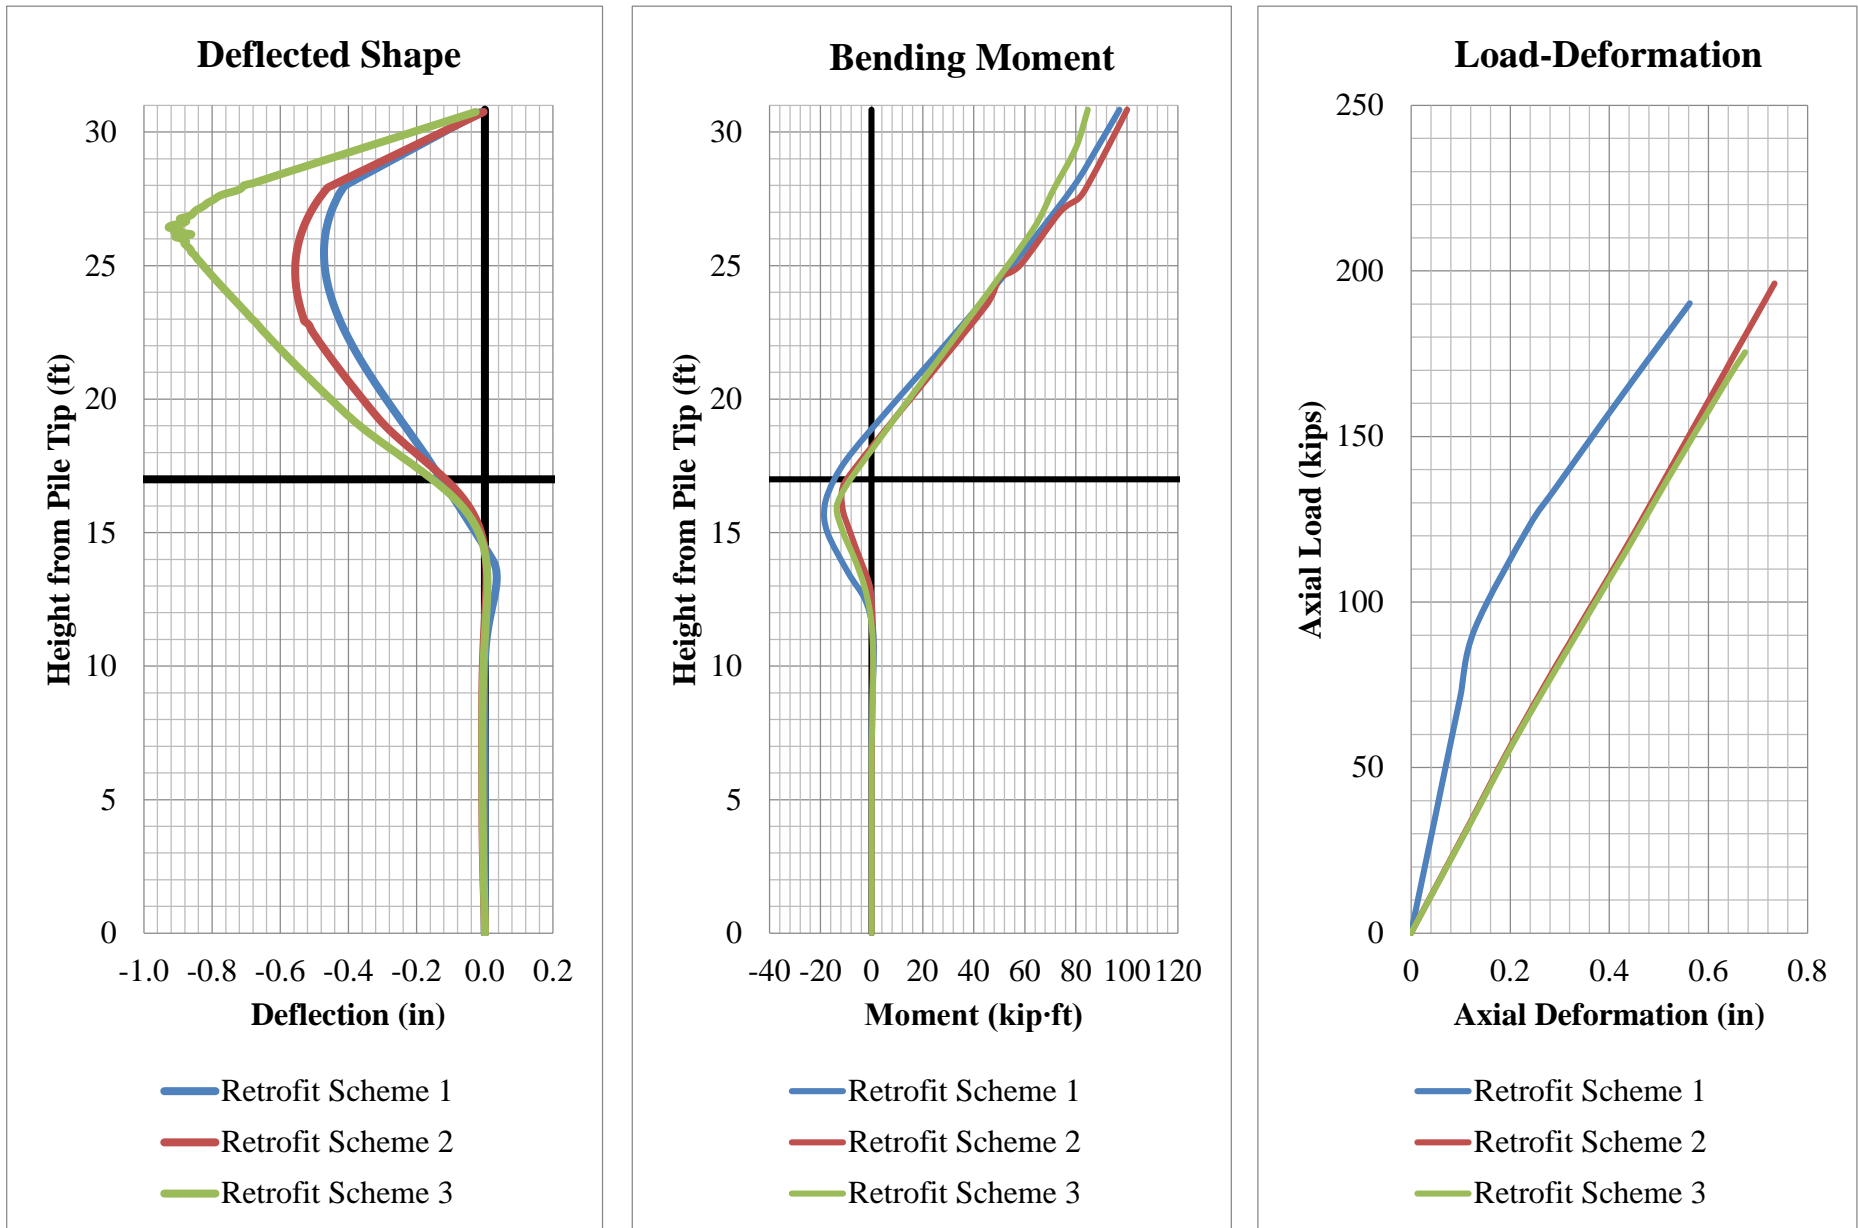
Figure 2-11. Retrofitted pile analysis results.

As shown in Figure 2-11, all three retrofit schemes significantly improved the load capacity and stiffness of the piles. Because the entire exposed length is replaced with a steel section, Retrofit Scheme 1 had the lowest deflection, while Retrofit Scheme 2 achieved the highest ultimate load.

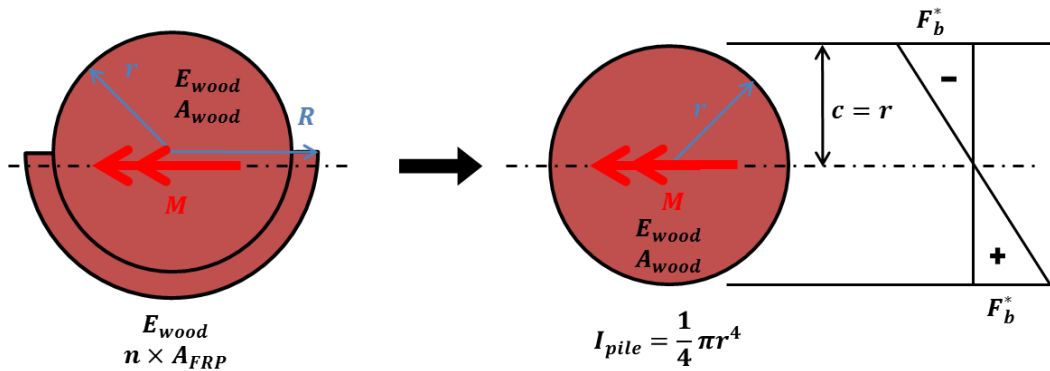
Figure 3-8. Projection of the bending moment obtained from transformed section analysis onto an unretrofitted timber pile section.

where M is the bending moment capacity of the retrofitted section, E_{wood} is the timber pile elastic modulus, I_{eff} is the transformed section moment of inertia, and ϕ is the section curvature. ε_{comp} is the strain at the extreme compression fiber, c_{eff} is the depth to the neutral axis measured from the compressive fiber, and F_b is the design allowable bending stress obtained from the NDS. This FRP retrofitting method is expected to improve the bending moment capacity of the timber piles but will not offer significant contributions in the axial direction. To account for the improved moment capacity provided by the FRP, the moment calculated using Equation 3-9 is then projected onto an unretrofitted timber pile section to obtain a modified allowable bending stress, as shown in Figure 3-8.

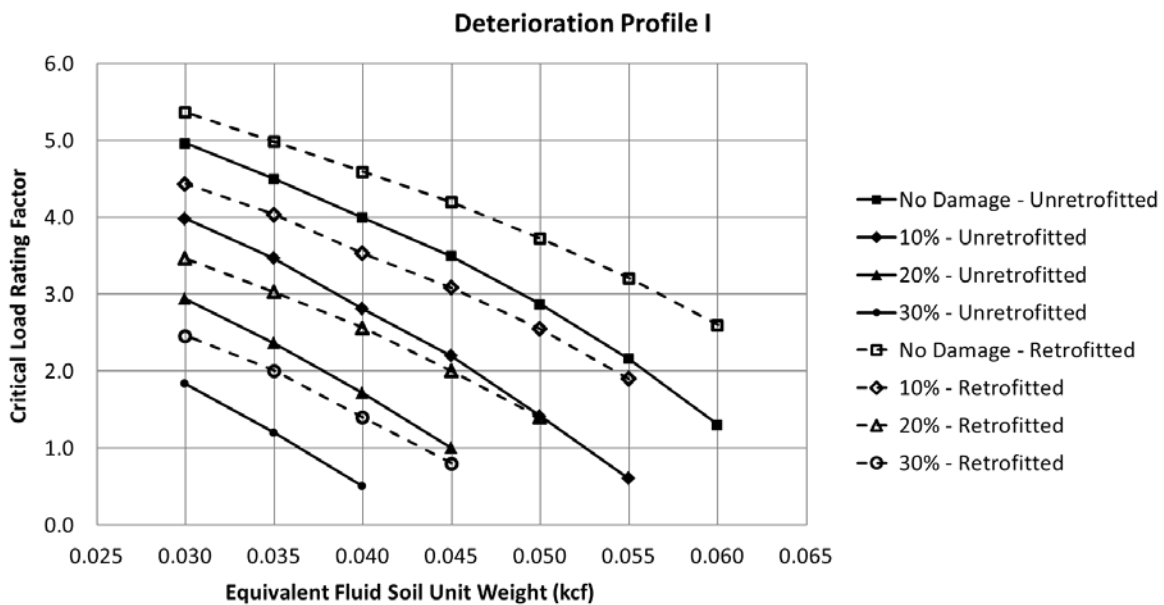
Figure 3-9. Comparison of critical load ratings for unretrofitted and retrofitted timber piles with deterioration Profile I.

The modified allowable bending stresses in Table 3-5 were taken as the reference bending stress in computing the allowable bending stress under earth pressure and live load surcharge using Equation 3-9. The critical load rating for the FRP-retrofitted timber piles is compared with unretrofitted timber piles in Figure 3-9 for various soil conditions.

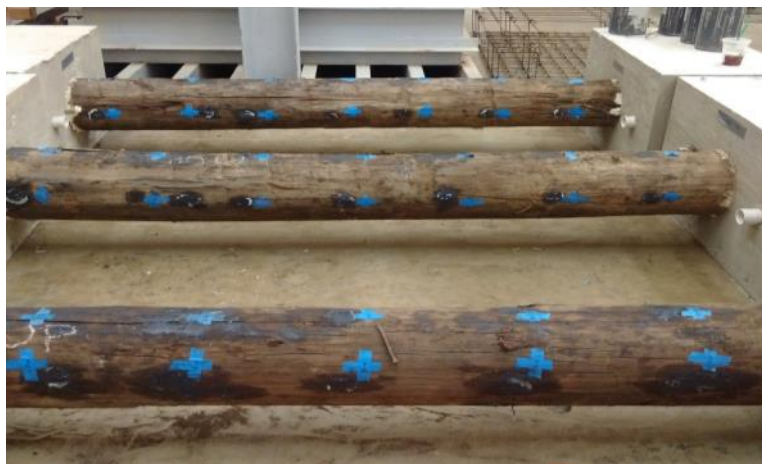
Figure 4-1. Timber pile specimens used in experimental testing of FRP retrofits.

Three red oak piles removed from service were used in the study. The NDS reference design values for red oak can be found in Table 3-5. It was unclear how long these piles were in service for and what the service conditions were. Visual inspection of the piles found no signs of decay or damage to the exterior of the specimens. Minor splitting was common across all three specimens. The timber pile specimens are shown in Figure 4-1.

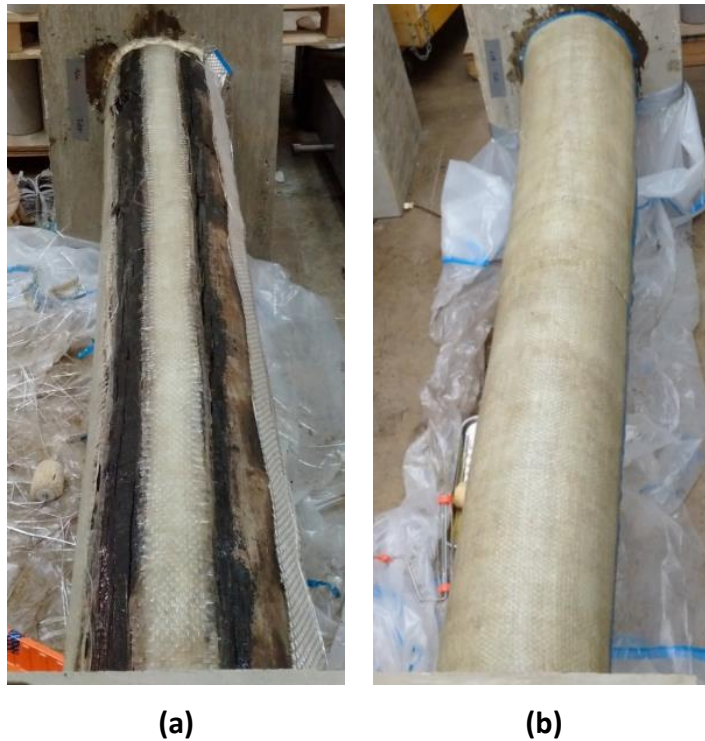
Figure 4-8. FRP-retrofitted timber pile specimens: (a) SP1; (b) SP2.

Currently there are no guidelines available on designing FRP retrofits for timber piles. In the Phase I study conducted by Caiza et al. (2012), a simplified elastic method was used to derive the thickness of FRP needed in a full FRP shell to restore the flexural stiffness of timber piles. Based on providing full FRP wraps, it was shown that the timber pile specimens used in that study required between 6 and 10 layers of FRP. In the current study, 10 layers (0.25 in.) of FRP was used in both retrofitting schemes shown in Figure 4-6. Prior to applying the FRP composite to the piles, the surfaces of the timber piles were cleaned with a wire brush to remove any dirt and debris. The fabric was cut to size and saturated with resin using rollers. Once applied, the FRP was allowed to cure for at least 72 hours before testing. The retrofitted specimens are shown in Figure 4-8.

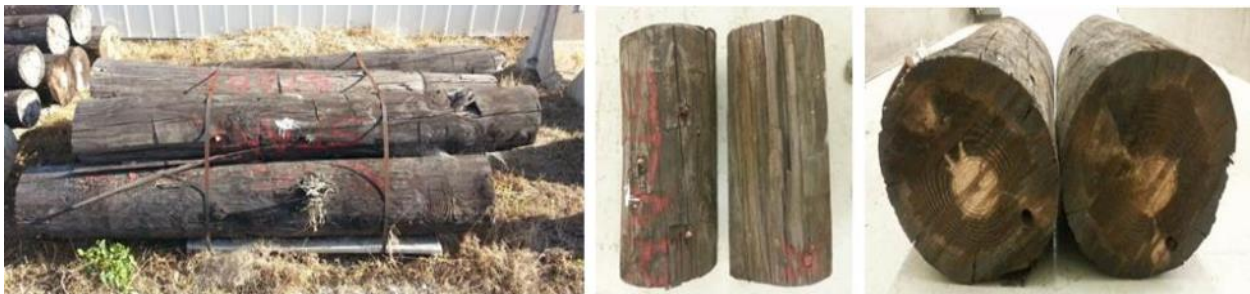
Figure 5-1. Typical red oak pile specimens used in the study.

Because this study was aimed at investigating existing timber piles that are in need of rehabilitation, it was essential to use specimens from piles that have been in service for a considerable amount of time. The specimens used in this study were cut from eight field-extracted red oak piles. The piles used in this study ranged in diameter from 8.7 in. to 12.5 in. While the exact age of the piles was not known, it was indicated that they were treated with creosote in 1993. Ports drilled for creosote injection were clearly visible and had been properly plugged. The piles were cut into specimens 24 in. in height. In total, 24 specimens were prepared. Figure 5-1 shows typical timber specimens used in this study.

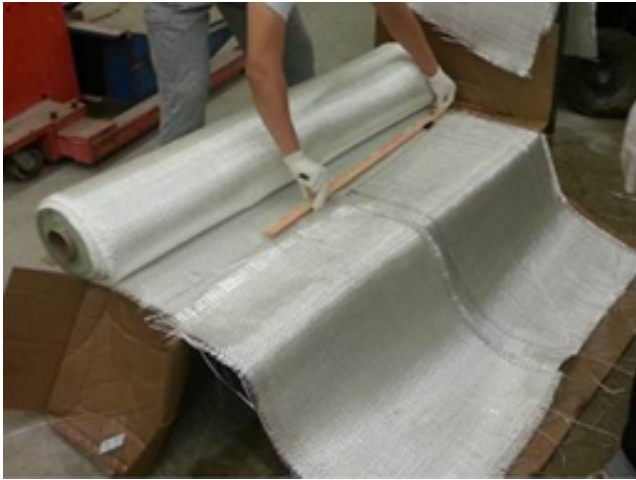
(a)

Prior to applying the FRP, the surfaces of the timber piles were cleaned with wire brushes to remove any dirt and debris. The fabric was cut into sheets tailored to each specimen then wrapped around the timber and saturated with resin using rollers. Each layer was overlapped 3 in. at the ends, with each subsequent layer being offset by 90 degrees to ensure that the seams did not coincide. The saturated FRP was smoothed out to remove any air pockets. The FRP was allowed to cure for at least 48 hr before testing. The FRP wet layup process is illustrated in Figure 5-2.

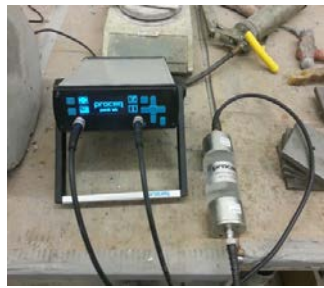
Figure 5-3. Stress wave timing parallel to grain: (a) UPV instrument; (b) schematic of test setup.

To better assess the condition of the timber pile samples before testing and determine how the initial condition of the timber affects the overall performance of the FRP retrofit, a nondestructive stress wave timing method was used. The same equipment described in Chapter 4 was used. In this case, measurements were taken in the longitudinal direction of the specimens parallel to the grain. The ultrasonic pulse velocity (UPV) equipment used in this study is shown in Figure 5-3(a). Measurements were taken at five equally spaced points across the cross-section in the direction parallel to the grain, as shown in Figure 5-3(b).

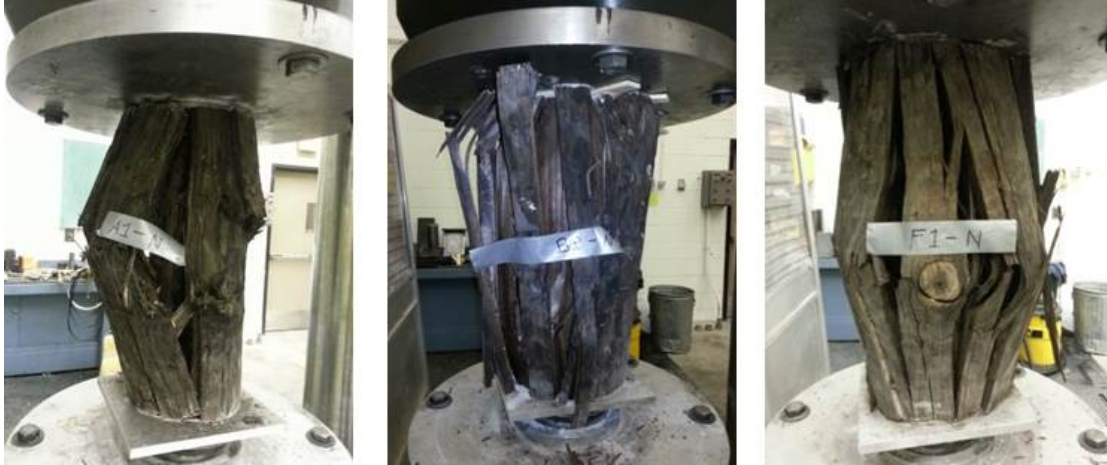
Figure 5-5. Failure of unretrofitted timber specimens.
