# **Creating Multi-Use Highway Structures with Retrofitted Fencing to Reduce Collisions with Elk on Interstate 17**

**SPR-689**

**July 2016**

Jeffrey W. Gagnon, Chad D. Loberger,  
Scott C. Sprague, Susan R. Boe,  
Kari S. Ogren, and Raymond E. Schweinsburg  
Arizona Game and Fish Department  
5000 West Carefree Highway  
Phoenix, AZ 85068

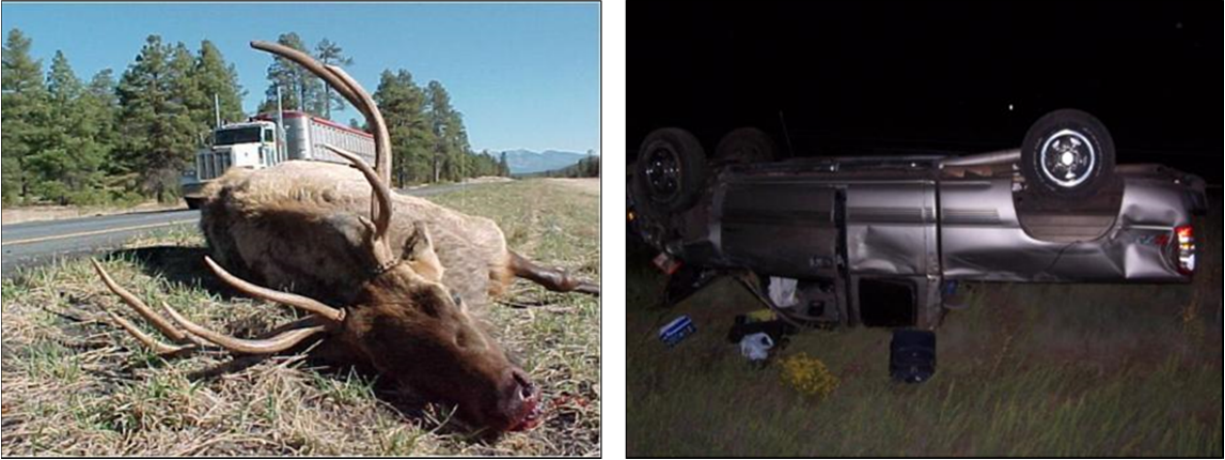
**Figure 3. On Interstate 17, Bull Elk Killed by a Vehicle Near Munds Park (Left), and Vehicle Wreckage Resulting in Human Injuries Caused by an Elk-Vehicle Collision (Right)**

The initial DCR for ADOT included a WVC assessment that reported that more than 20 percent of all crashes in the segment involved wildlife (Stanley Consultants 2011). This is substantially higher than the national average, which is an estimated 4.6 percent of WVC among all types of collisions (Huijser et al. 2008); see Figure 2 for a comparison. Elk can weigh close to 1,000 lb, increasing the risk of injury or death to motorists when compared to collisions with smaller mammals (Figure 3).

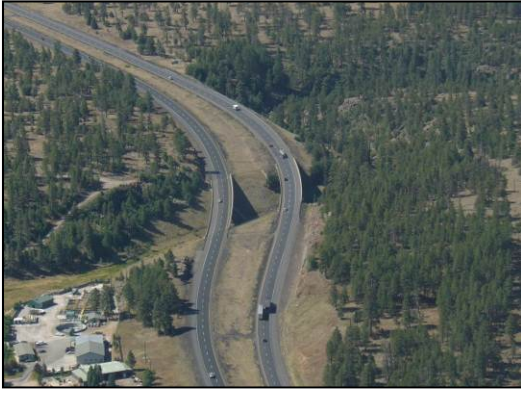
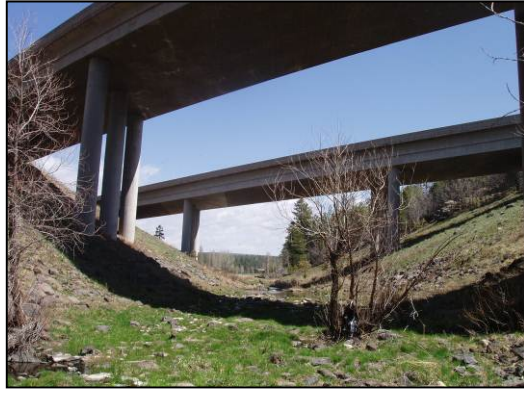
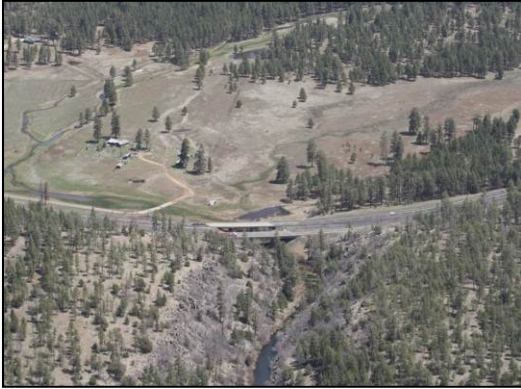
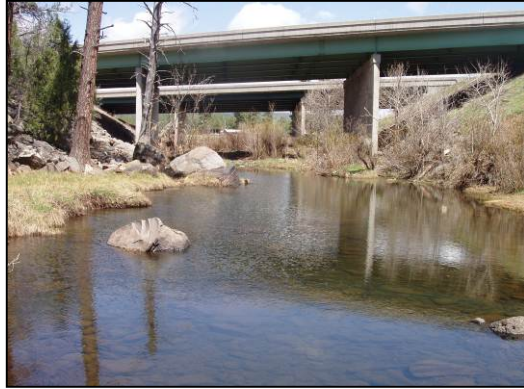
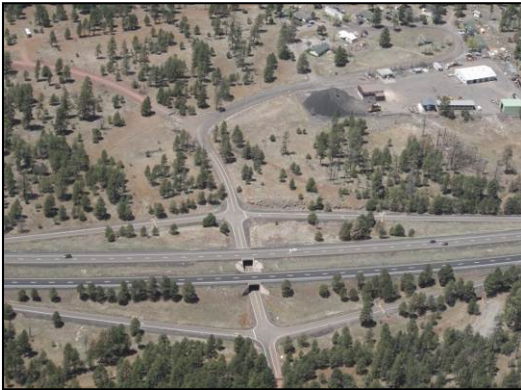
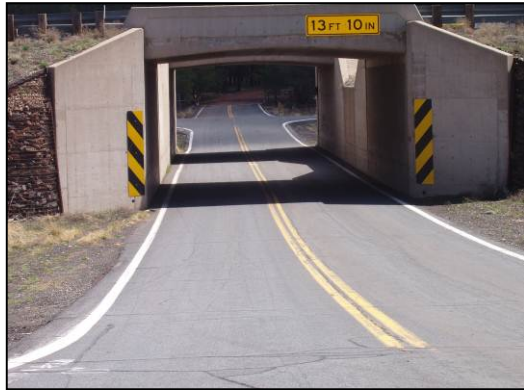
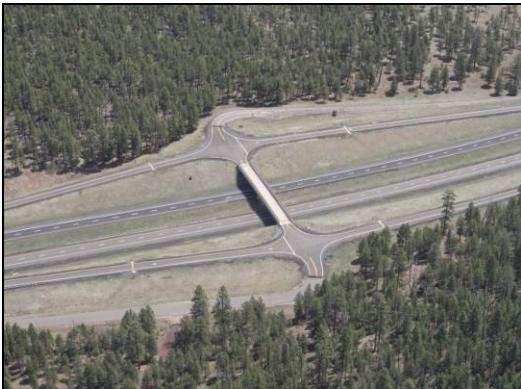
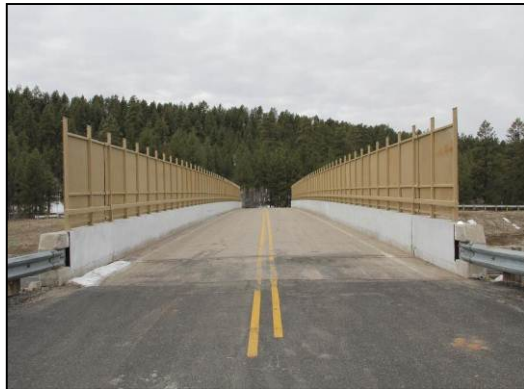
5a. Views of Munds Canyon Bridge

5b. Views of Woods Canyon Bridge

5c. Views of Schnebly Hill Road Traffic Interchange

5d. Views of Fox Ranch Road Traffic Interchange

**Figure 5. Four Selected Highway Structures along the Study Area**

The 5.9 mi along I-17 included four existing highway structures with the potential to function as WCS. These highway structures are detailed in Table 1 below and pictured in Figure 5.

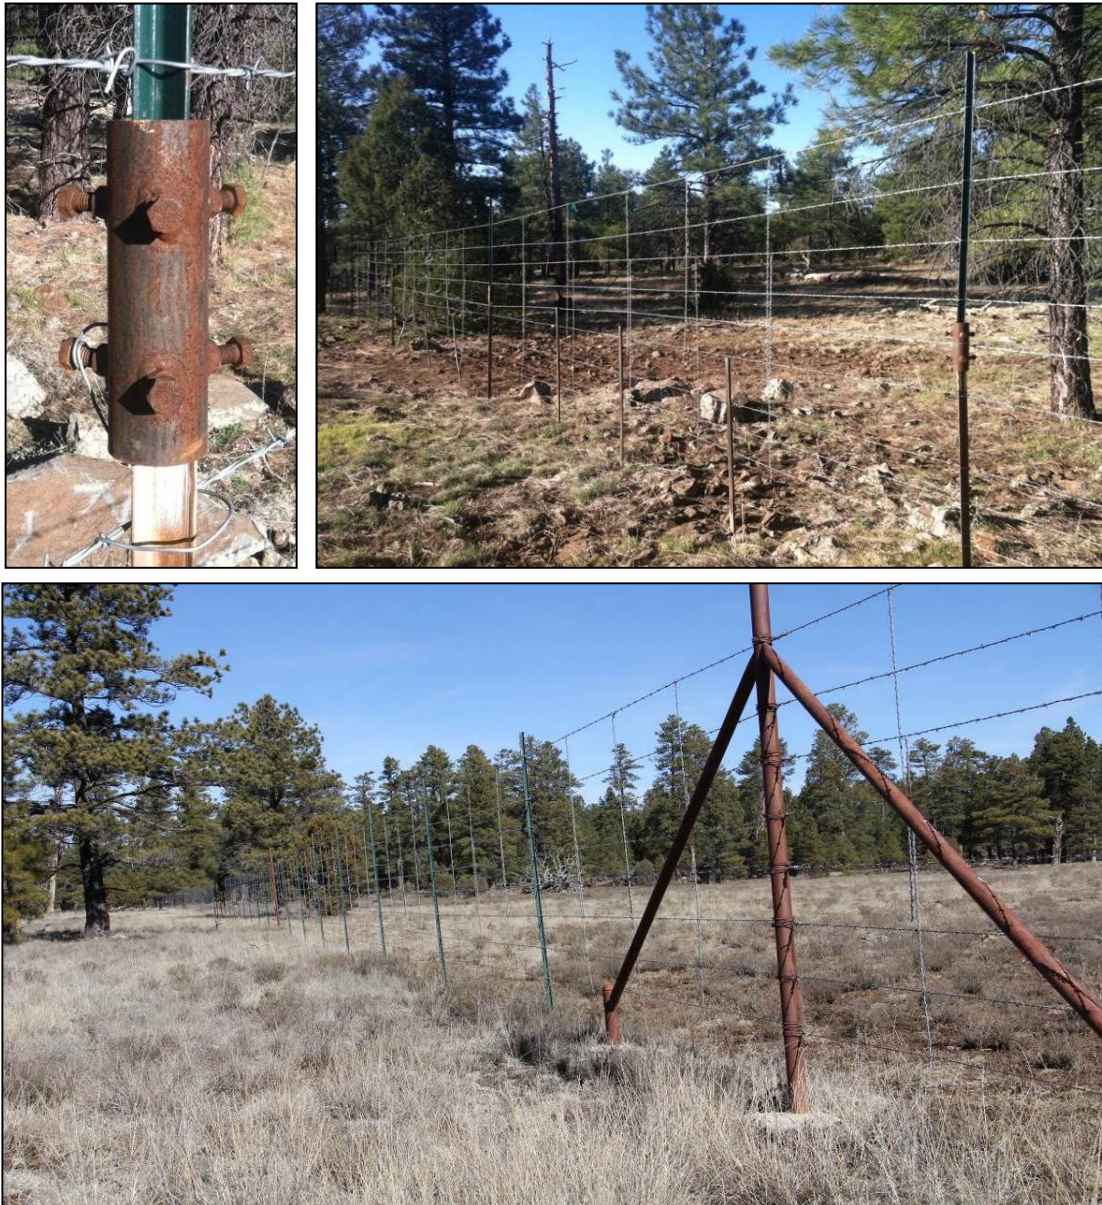
**Figure 8. Heightened Fencing along the Study Area: Metal Couplers Attached Extensions to Existing T-Posts (Top Panel); New 8-Ft-High Fencing Replaced Fencing that Was Too Degraded to Heighten (Bottom Panel)**

In 2011, the 4-ft-high, four-strand barbed wire ROW fence along the study area was extended to a height of 7 to 8 ft by coupling new T-posts to the old T-posts with metal extension sleeves (Figure 8). To provide additional support, new steel corner posts, brace posts, and line posts were installed along with additional stays that connected the top wires to the bottom ROW fence. New T-posts and barbed-wire fencing were installed where the ROW fencing was too degraded to retrofit. The type of heightened fencing used had, in previous testing, reduced EVC by 97 percent (Gagnon et al. 2010) and was less expensive than woven wire.

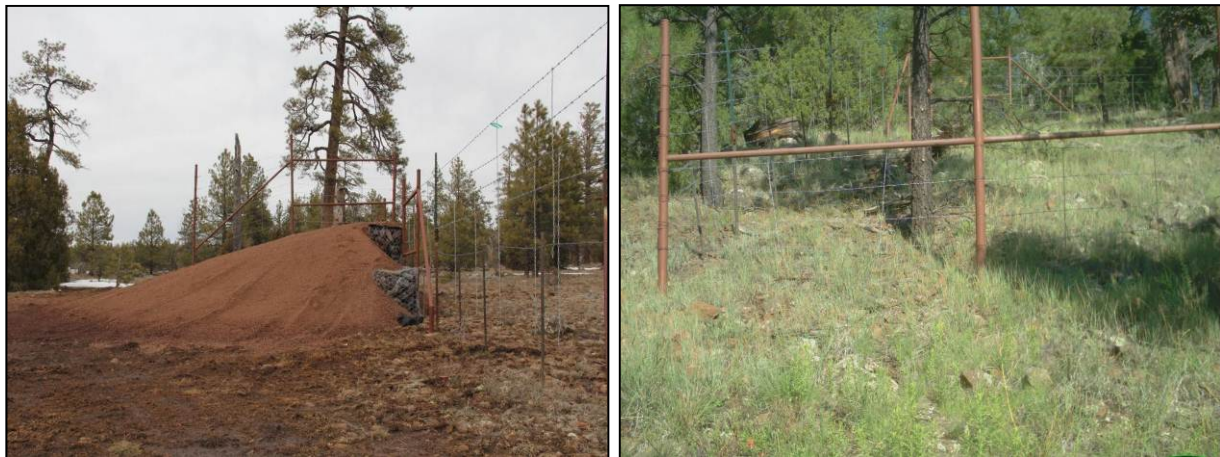
**Figure 9. Examples of Jump-out (Left) and Slope-jump (Right)**

To help elk escape being trapped in the ROW, ADOT installed jump-outs and slope-jumps (Figure 9) at various locations. Jump-outs (also referred to as escape ramps) are the most common method of allowing ungulates to exit the ROW and have shown some success with elk when properly designed and installed (Bissonette and Hammer 2000). Jump-outs consist of gradually sloping ramps made of natural materials that allow ungulates to jump down and out of the ROW while prohibiting them from jumping back in. Slope-jumps are a section of lowered fence positioned where the terrain slopes downward. The concept relies on elk's physical inability to jump uphill over the fence and into the fenced corridor; instead, elk jump more easily downslope. Slope-jump effectiveness, which has not yet been proven, is based on the concept of functional fence barrier height increasing with the slope steepness (Payne and Bryant 1994). Less expensive than jump-outs, this method requires the slope to be gradual enough that the animal is able to land without dropping too far, and steep enough that elk cannot easily jump up from the bottom.

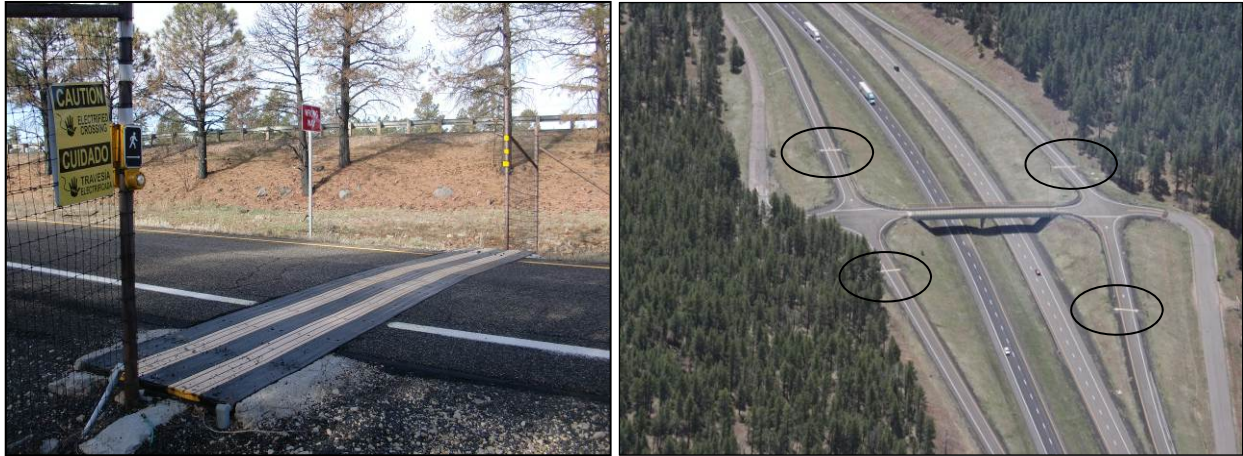
**Figure 10. Electrified Cattle Guards Installed at Schnebly Hill Road TI (Left) and at Fox Ranch Road TI (Right; Guards Circled)**

To block entry into the ROW and guide elk to the TI, ADOT installed electrified cattle guards at the on- and off-ramps of the Schnebly Hill Road TI and Fox Ranch Road TI (Figure 10). These electrified cattle guards give an elk a shock when stepped on, thereby deterring crossing. The cattle guard's electric current shuts off during daylight hours and a flashing LED (daytime only) indicates functionality. Although the cattle guard is safe for pedestrians wearing shoes, a deactivation button was installed to assure safe pedestrian crossing if needed. A similar electrified cattle guard installed along SR 260 in 2010 continues to show positive results in deterring access to the ROW, although further testing is needed (Gagnon et al. 2010, Huijser et al. 2015). To eliminate wildlife jumping off the Fox Ranch Road TI, ADOT erected a fence on the parapet, already shown in Figure 5d.

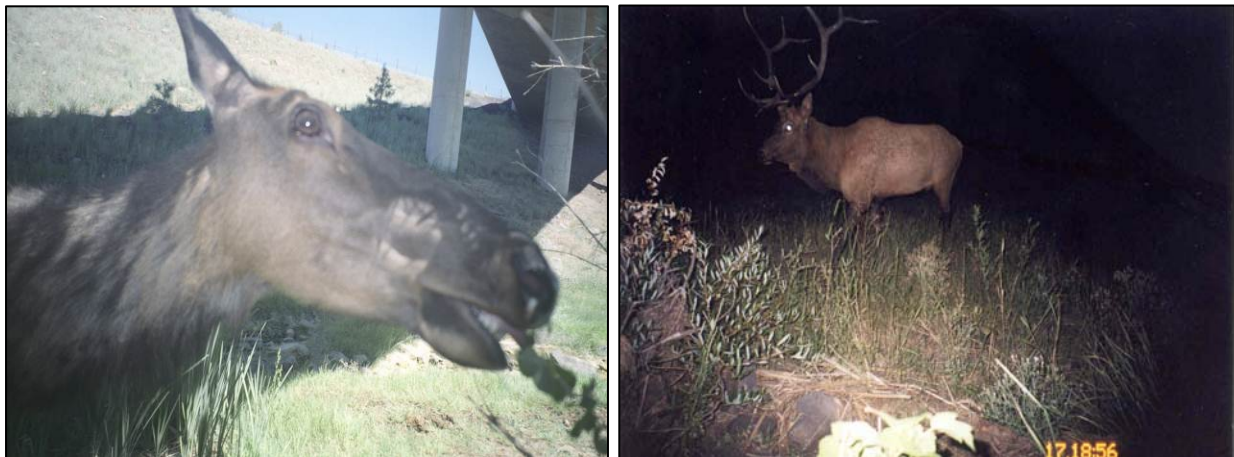
**Figure 11. Elk Using Munds Canyon Bridge in 2004**

Preliminary camera data collected by ADOT in 2004 showed that elk and deer used Munds Canyon bridge (Figure 11), but there were no data on elk using either of the TIs or the Woods Canyon Bridge. To minimize the potential of “end runs” of the fence termini by elk, the northern terminus ended just beyond Munds Canyon Bridge, at a lighted TI, and the southern terminus was located just beyond Woods Canyon Bridge at large cliffs. This selection of termini allowed elk to encounter a suitable crossing structure prior to reaching the fence ends that were located in areas that hinder elk movements (Gulsby et al. 2011).

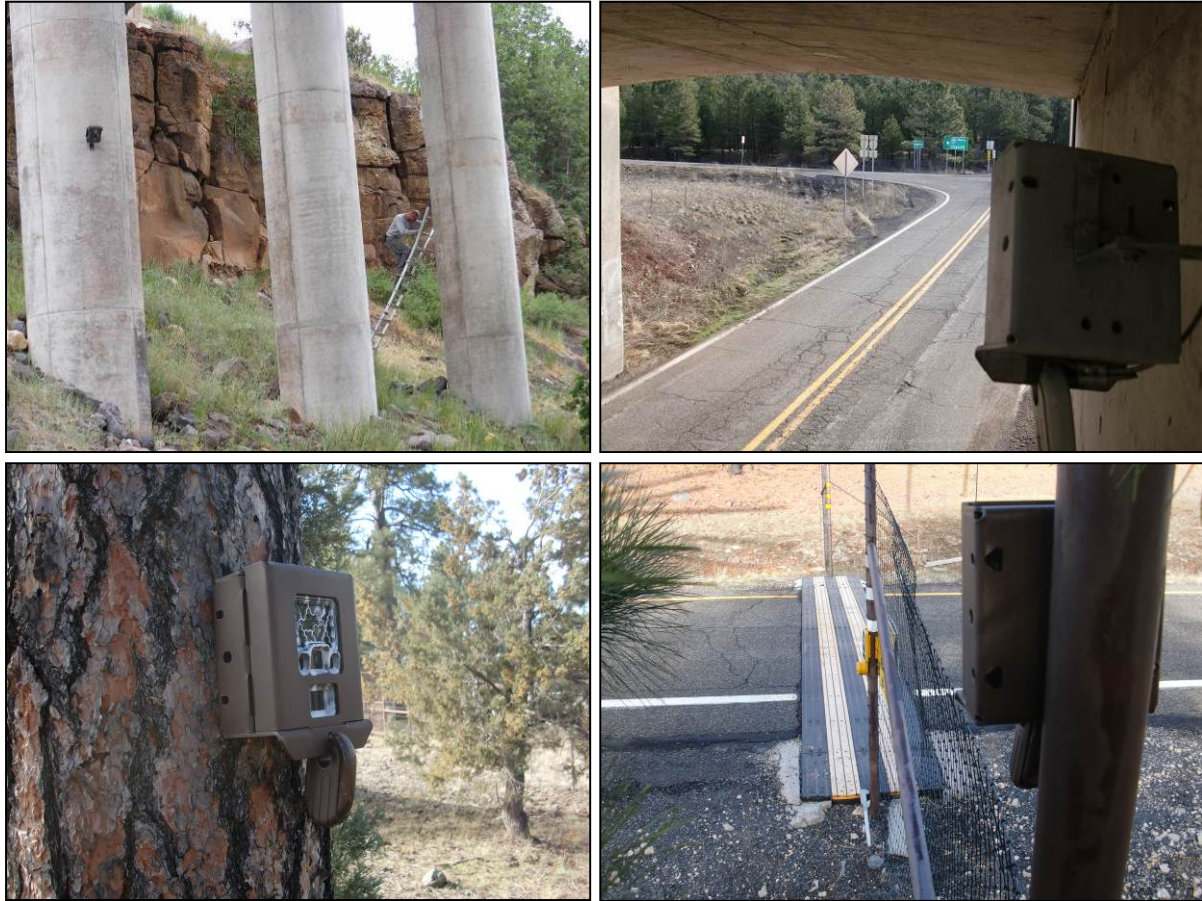
**Figure 12. Examples of Camera Orientations at Munds Canyon Bridge (Upper Left); Schnebly Hill Road TI (Upper Right); Jump-out Near MP 320 (Lower Left); Electrified Cattle Guard at Schnebly Hill Road TI (Lower Right)**

evaluate wildlife interaction at jump-outs, slope-jumps, and electrified cattle guards, the research team installed cameras at three jump-outs, three slope-jumps, and four electrified cattle guards (Figure 12).

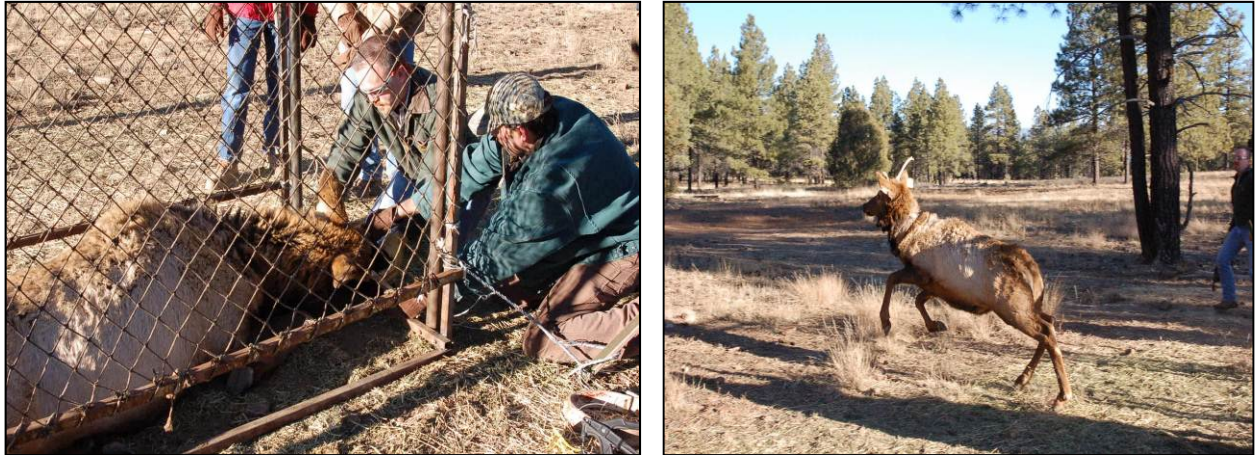
**Figure 13. Capture of Elk along Interstate 17: Processing an Elk in a Clover Trap (Left) and Release of Collared Elk to Begin Data Collection (Right)**

To determine whether elk movements or highway permeability changed, the research team compared pre-retrofit (2008 to 2010) and post-retrofit (2012 to 2013) GPS telemetry data. The team captured elk using modified Clover traps (Clover 1954) baited with salt and alfalfa hay within the study area and 1.0 mi beyond the termini. The team physically restrained and fitted elk with a combination of Telonics, Inc., Model TG3 and Model TG4 store-on-board and Model SST-TG3 Spread Spectrum GPS collars programmed to receive eight relocations per day at 2-hr intervals—between 17:00 and 07:00, when elk were most active—for approximately two years (Figure 13). After two years, a pre-programmed release mechanism allowed the collars to fall to the ground, and they were located and retrieved using VHF telemetry. Following download of the data from the collars, the researchers used ArcGIS Version 10

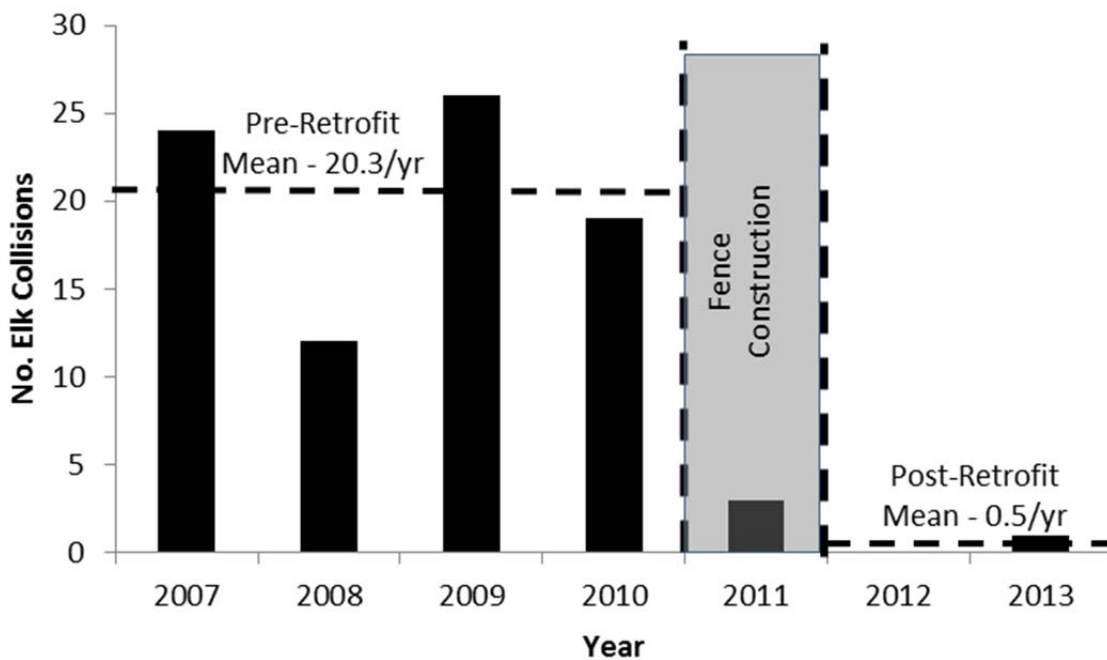
**Figure 15. Number of Elk-Vehicle Collisions by Year Before, During, and After Fencing Retrofit Along Study Area of Interstate 17 (2007 to 2013)**

Note: Bars indicate total number of elk-vehicle collisions, horizontal dashed lines indicate mean number of collisions, vertical dashed lines show construction timeline.

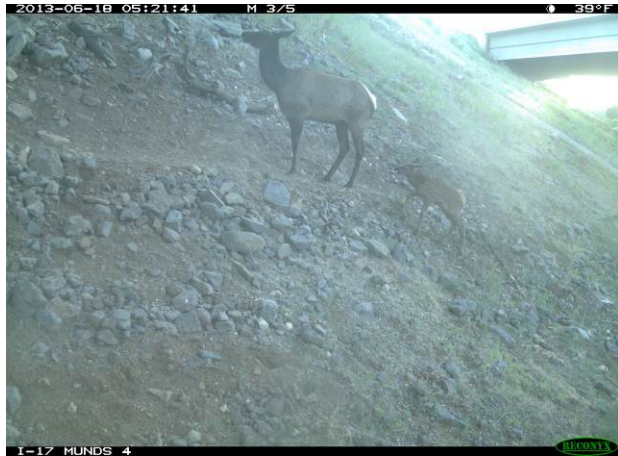
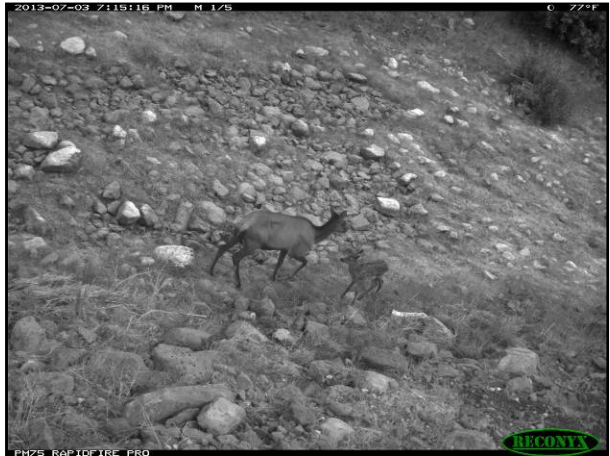
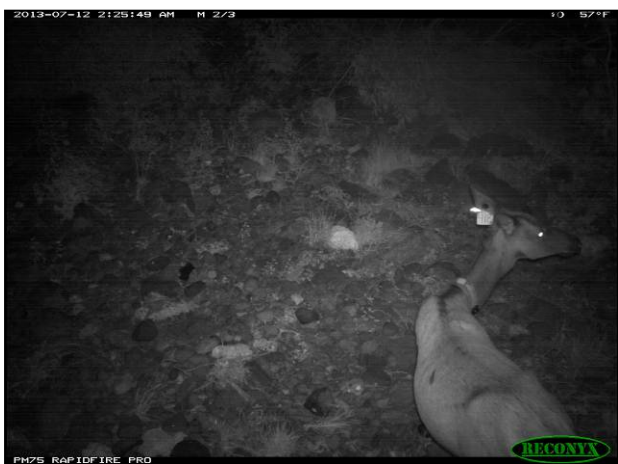
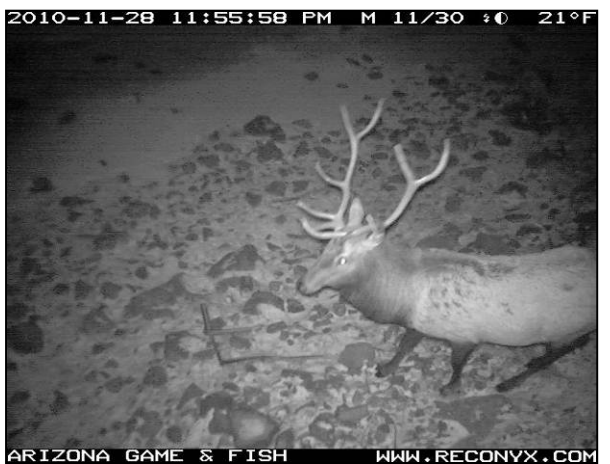
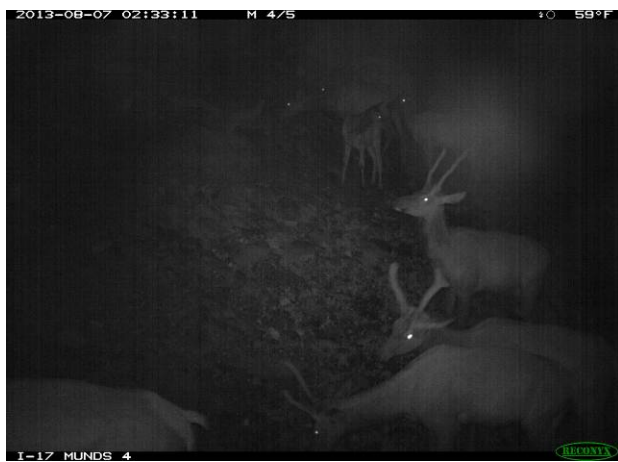
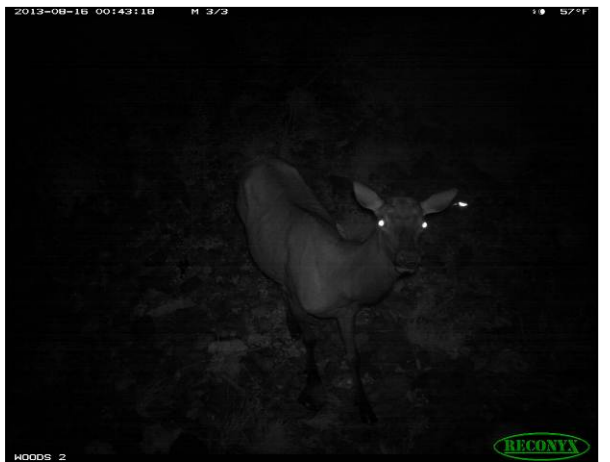
Figure 16. Elk Using Munds Canyon and Woods Canyon Bridges

At the Munds Canyon and Woods Canyon bridges, the research team documented an increase in elk crossings following installation of the retrofit fencing (Figure 19). At Munds Canyon Bridge, the larger of the two, researchers documented 545 elk crossings pre-retrofit and 1,725 elk crossings post-retrofit, a 217 percent increase. At Woods Canyon Bridge, the team documented 26 elk crossings pre-retrofit and 44 crossings post-retrofit, a 54 percent increase.

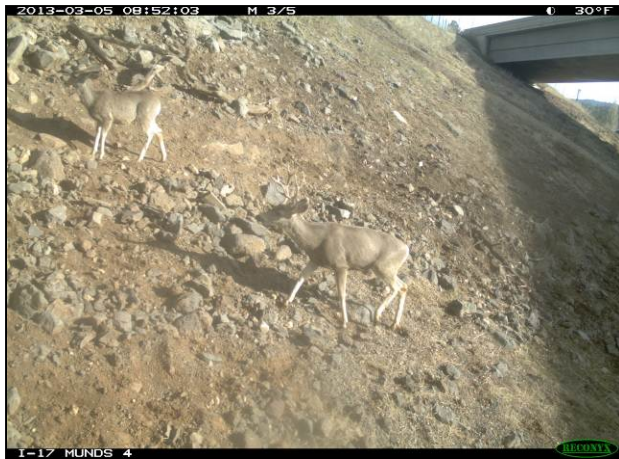
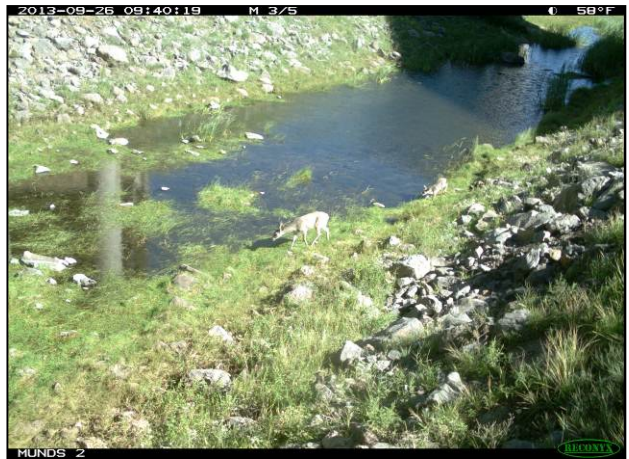
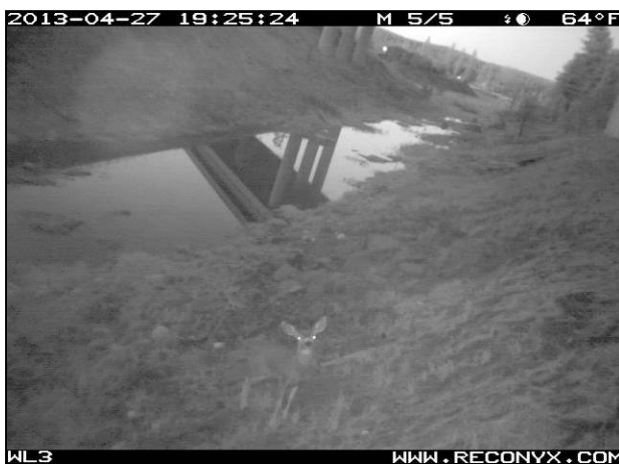
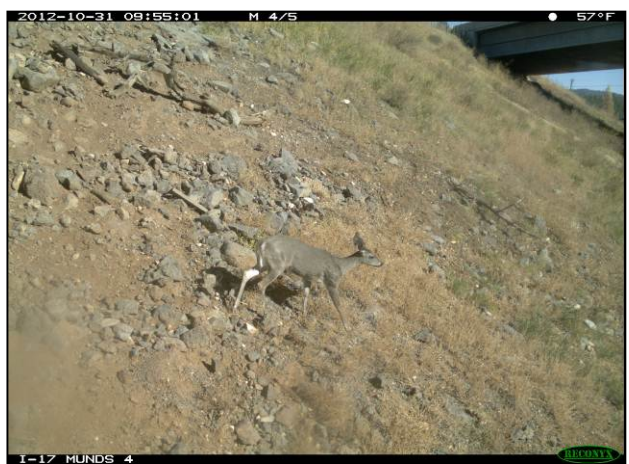
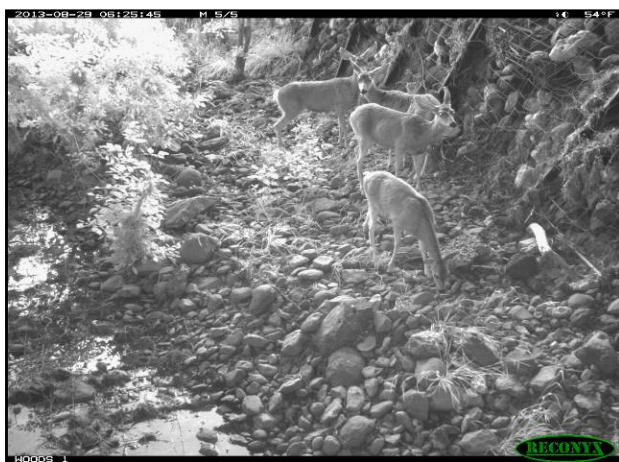
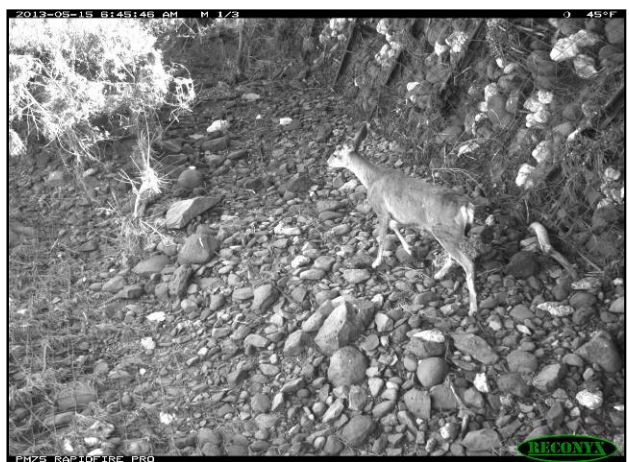
Figure 17. Deer Using Munds Canyon and Woods Canyon Bridges

Incidentally, although deer were not the study’s focal species, the research team documented a 69 percent (n = 358 and 350 percent (n = 77) increase in deer use of Munds Canyon and Woods Canyon bridges, respectively, following the retrofit. During the 24 months following retrofit completion, the research team documented no ungulates crossing the TI structures, although one raccoon and one coyote crossed.

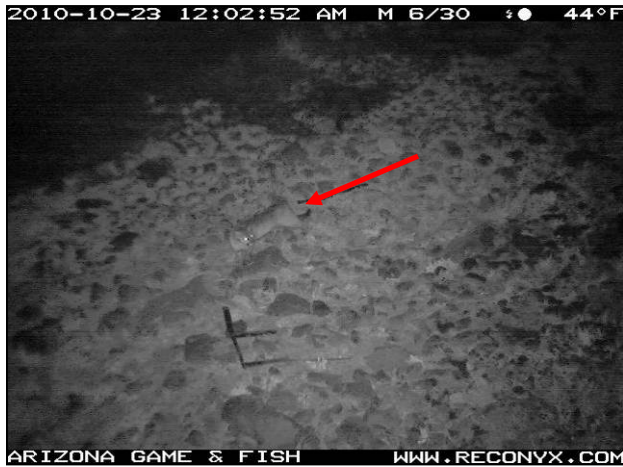
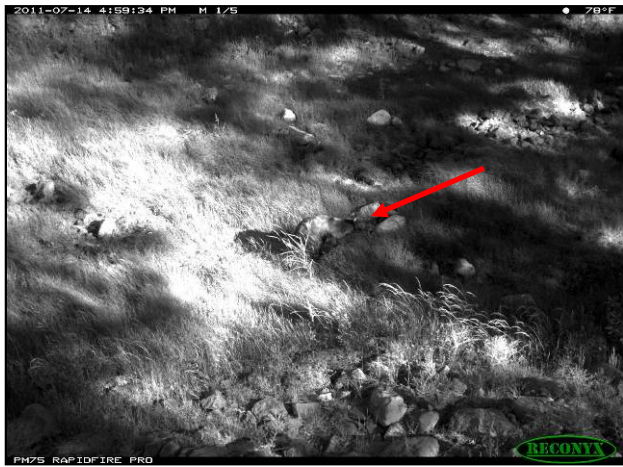
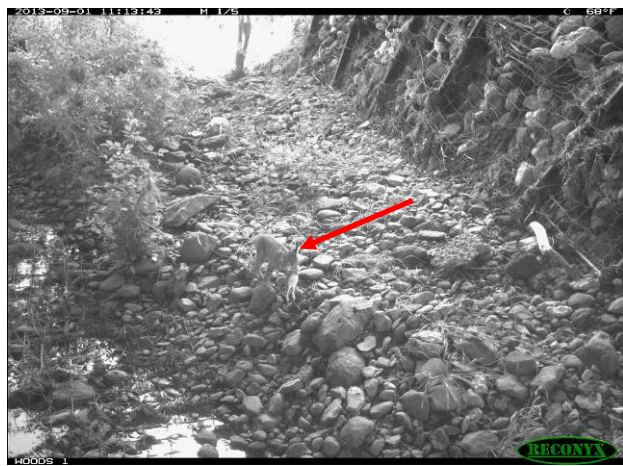
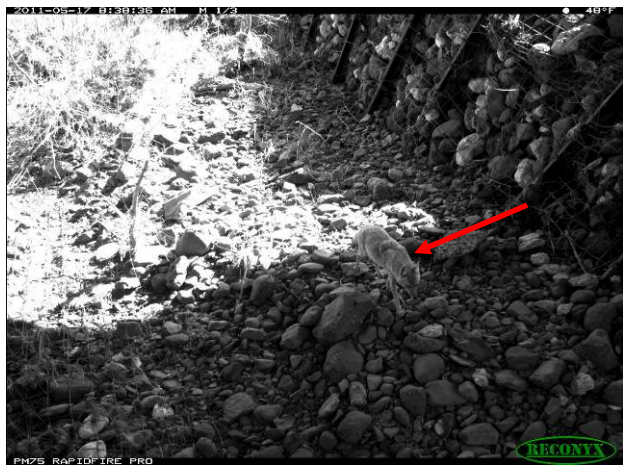
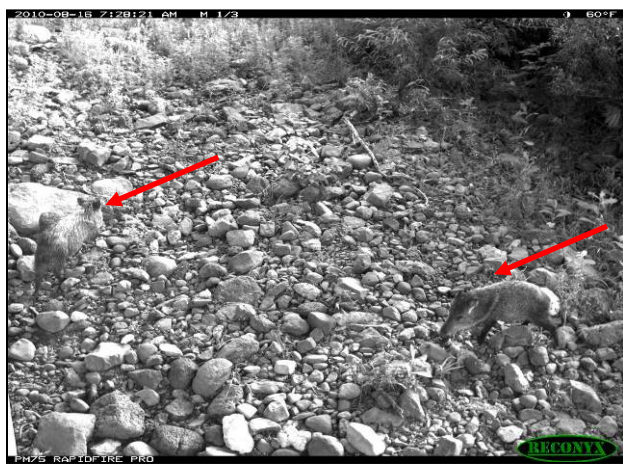
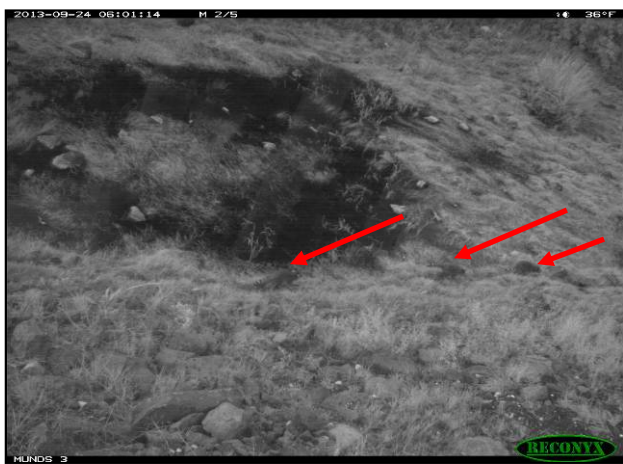
**Figure 18. Wildlife Using Munds Canyon and Woods Canyon Bridges (Red Arrows), Clockwise from Top Left: Cougar, Black Bear, Coyote, Raccoon, Javelina, Bobcat (with Rabbit in Mouth)**

fencing retrofit. During the 38 months, the cameras detected a total of 3,150 bridge crossings by 14 species (Table 3); 2,340 of these bridge crossings were by elk . Bridge use by non-target species included 435 crossings by deer (416 mule deer, 19 white-tailed deer), 269 crossings by mesocarnivores (20 bobcats, 12 coyotes, 42 gray foxes, 188 raccoons, six skunks, and one ringtail cat), and four crossings by large carnivores (three mountain lions and one black bear), as highlighted in Figures 16 through 18. Other wildlife species crossings recorded included two javelinas, 94 rock squirrels, five mallard ducks, and one great blue heron. Non-wildlife crossings included 79 cattle, 34 dogs, eight house cats, six unidentified animals, and multiple pedestrians.

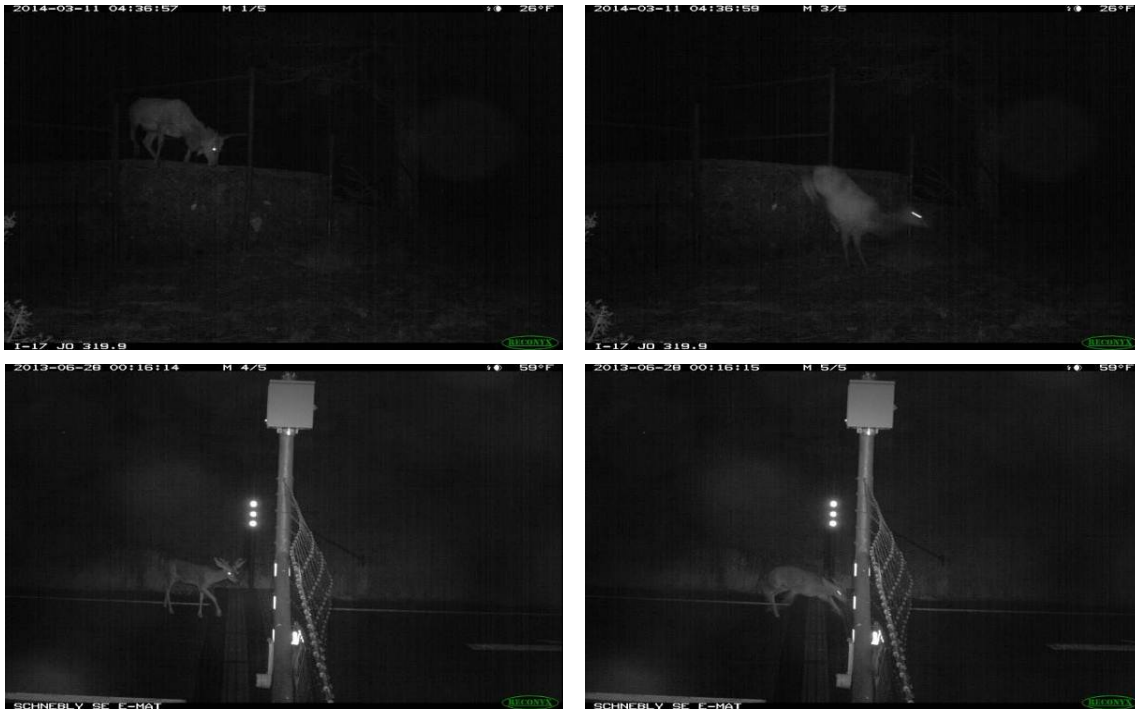
**Figure 20. Along Study Area: Elk Using Jump-out to Escape Right-of-Way (Top); Mule Deer Experiencing Shock from Electrified Cattle Guard (Bottom)**

The research team's monitoring of jump-outs and electrified cattle guards provided minimal information on their effectiveness. Overall, few animals interacted with jump-outs and electrified cattle guards (Figure 20). The data being collected from jump-outs and cattle guards along I-17 (combined with data from SR 260, U.S. Route 93, and a test site near Payson, Arizona) will provide information for the "Gaps in Knowledge" identified in the NCHRP 25-25, Task 84 *Construction Guidelines for Wildlife Fencing and Associated Escape and Lateral Access Control Measures* (Huijser et al. 2015).

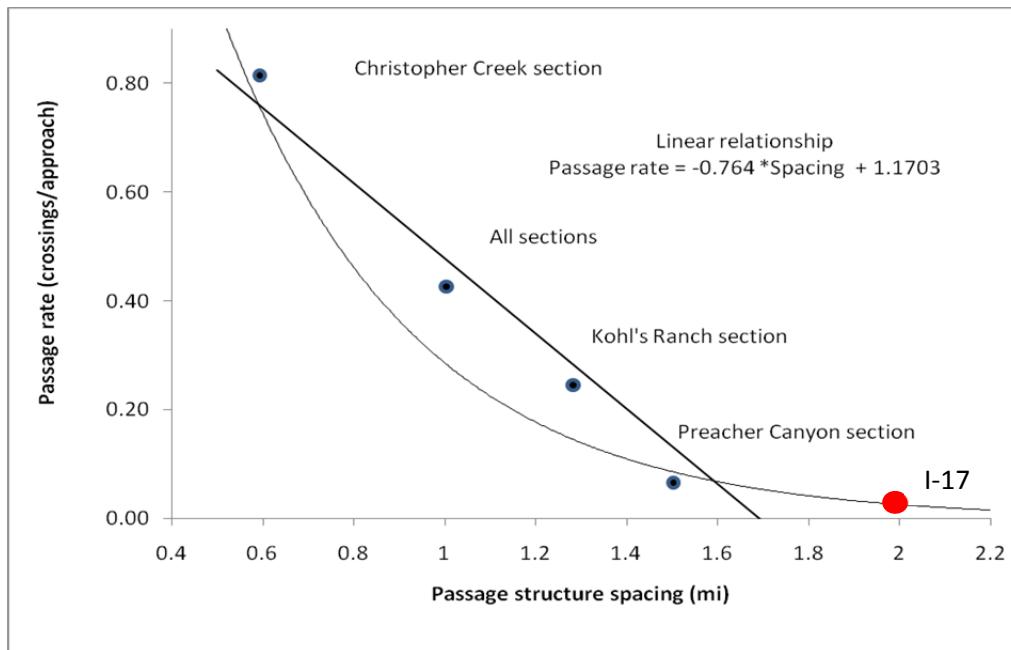
**Figure 23. Elk Passage Rate on State Route 260 after Wildlife Crossing Spacing (from Dodd, Gagnon, Boe, et al. 2012, Gagnon et al. 2013)**

Note: Red dot represents recommended maximum structure spacing for future upgrade of Interstate 17.

Along the study area on I-17, effective structures (the Munds Canyon and Woods Canyon bridges) were located almost 5 mi apart, thus resulting in a 0.03 percent passage rate. Future planning should include efforts to space WCS approximately 2 mi apart as outlined by Gagnon et al. (2013), shown in Figure 23, and consistent with Bissonette and Adair (2008).

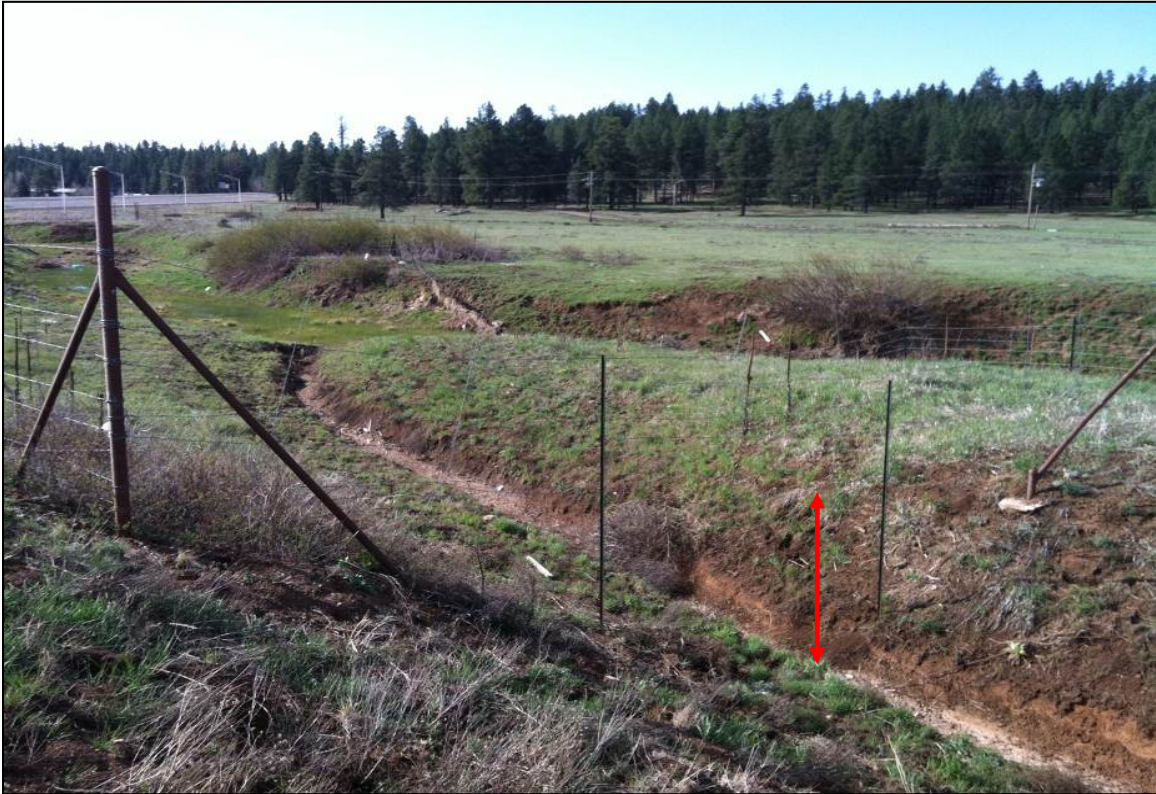
**Figure 24. Example of Wash-out (Red Arrow) Near Site of an Elk-Vehicle Collision in 2014**

concentrated collision zones where animals will follow the fence to the first opening they encounter (Figure 24).

The research team recommends annual inspection and repair of the wildlife fence ahead of spring migration. In addition to thorough spring maintenance and repairs, Flagstaff District maintenance personnel should watch for signs of fence issues throughout the year. Aside from typical ROW fence repairs associated with fallen trees, wash-outs, cuts in the fence, etc., maintenance personnel should inspect fences in the areas of elk roadkill or excessive elk tracks to determine the point-of-entry, and repair the location(s) immediately. In the long term, the research team recommends replacing the heightened barbed wire fence with the standard, stronger 8-ft woven-wire fence used elsewhere in Arizona to exclude elk from I-17 (Figure 25). This replacement should occur either during the upgrade of I-17 as initially described in the 2011 environmental assessment (ADOT 2011), or sooner if the fencing becomes too degraded to exclude elk or be properly maintained. Brace and line posts that were added to support the heightened ROW fence would also support the replacement woven-wire fence.

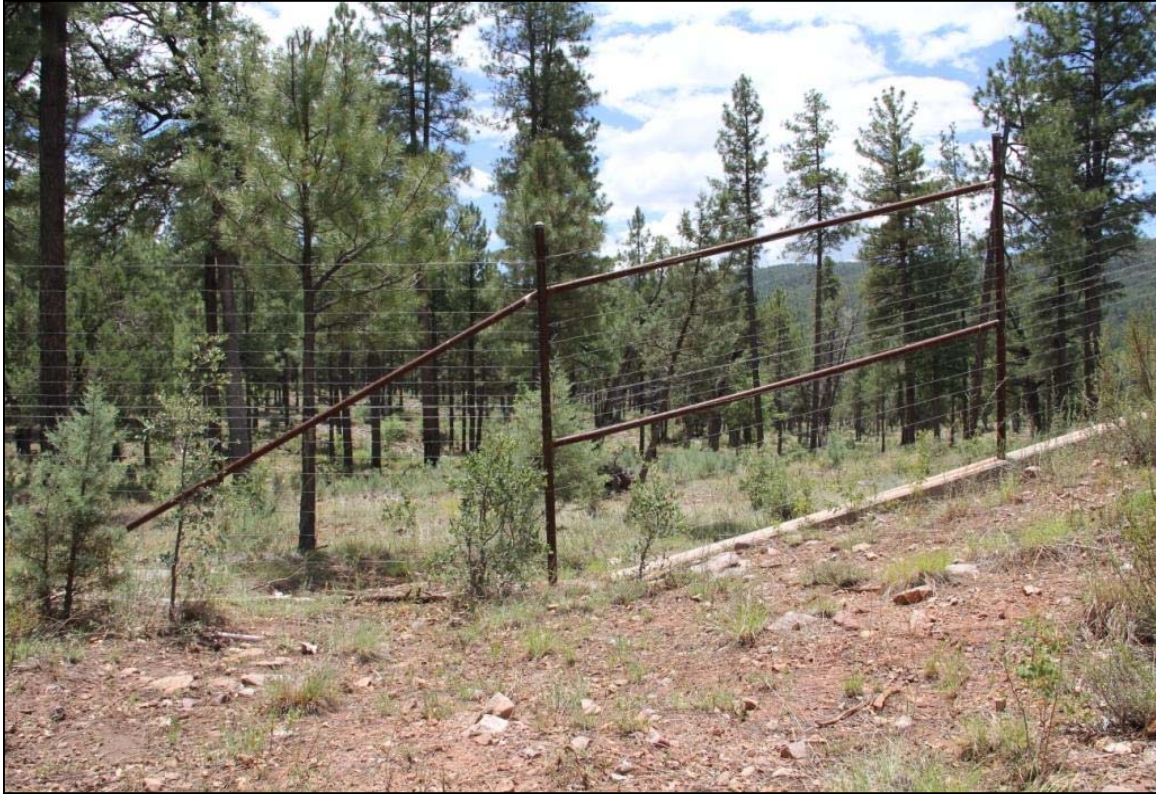
**Figure 25. Example of Standard Woven Wire Ungulate-Proof Fence Recommended for Interstate 17**

- In the long term, the research team recommends replacing the heightened barbed wire fence with the standard, stronger 8-ft woven-wire fence used elsewhere in Arizona to exclude elk from I-17.

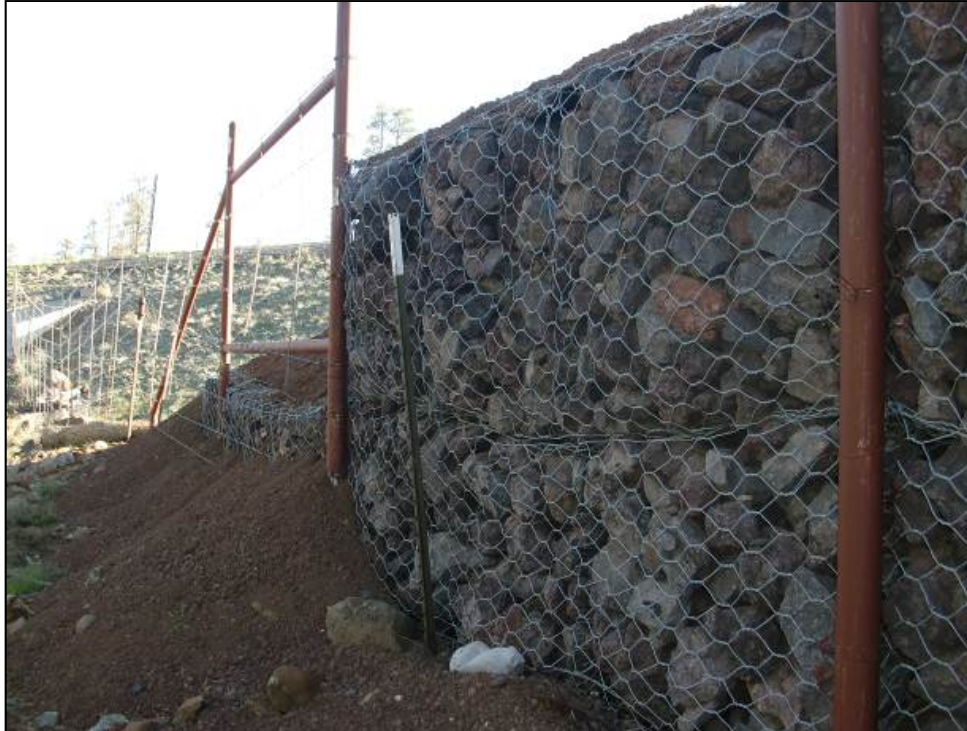
Figure 26. Photograph of Erosion of Interstate 17 Jump-outs

The research team noted cinders sloughing off the face of the jump-outs, or escape ramps, thereby reducing the potential for proper use and creating mounds that could allow elk easier access to the ROW. Repair and maintenance of the jump-outs will be required to ensure proper functionality.

The research team noted additional maintenance concerns associated with jump-outs. Cinders used for backfill at the jump-outs began sloughing off the face of the gabion baskets, creating piles at the base of the jump-outs. In these instances, not only were gabion basket tops exposed, which deterred elk use in the proper direction, but the piles also provided an elevation that allowed elk easier access to the top of the ramp and entrance to the ROW. After noting a couple of instances where elk accessed the ROW through the jump-outs via these mounds, the research team removed the mounds and elk ceased using the jump-outs in the wrong direction. Future maintenance will need to address these issues more permanently (see Chapter 6: Conclusions and Recommendations).

Jump-outs provide elk with an opportunity to escape the ROW when needed. The gabion basket-style jump-outs, while much less expensive than the original jump-out designs used along SR 260, will require additional repair and maintenance to function properly over the long term. This is because the cinders used to backfill the jump-outs can slough off of the leading edge of the jump-outs, exposing gabion basket wire and forming mounds of cinders at the base (Figure 26). This erosion can lead to elk being reluctant to use the escape ramp. Instead, elk can return to the ROW seeking another means of escape, and sometimes elk use the mounds of eroded cinders to gain entry into the ROW (Figure 27).

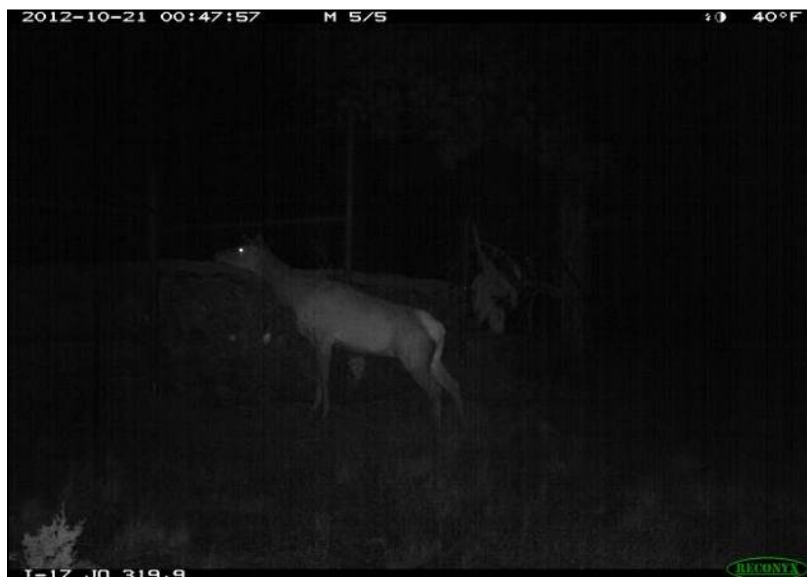
Figure 27. Elk using Mound Created by Erosion to Use Jump-out in the Improper Direction

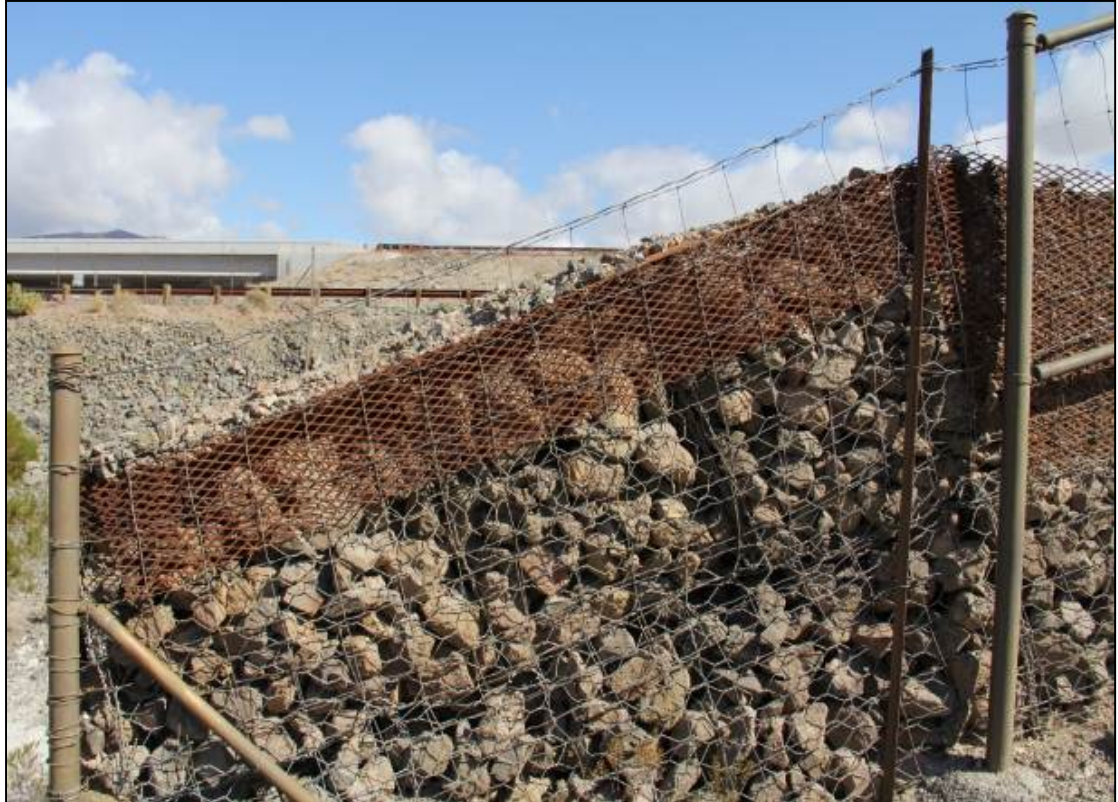
**Figure 28. Example of Expanded Metal Mesh to Retain Soil**

- The research team recommends repairing jump-outs by adding metal mesh to the leading edge of the features to prevent erosion of cinders.
- Future ADOT jump-out projects should include a design that addresses soil retention. The final jump-out height should be 6 ft at the face. Jump-outs should be inspected during annual fence inspections to determine additional maintenance needs.

The research team recommends repairing the jump-outs by adding metal mesh to the leading edge of the features to contain the cinders, and replacing the cinders with those from the mounds formed at the base (Figure 28).
