# **Creating Multi-Use Highway Structures with Retrofitted Fencing to Reduce Collisions with Elk on Interstate 17**

**SPR-689**

**July 2016**

Jeffrey W. Gagnon, Chad D. Loberger,  
Scott C. Sprague, Susan R. Boe,  
Kari S. Ogren, and Raymond E. Schweinsburg  
Arizona Game and Fish Department  
5000 West Carefree Highway  
Phoenix, AZ 85068

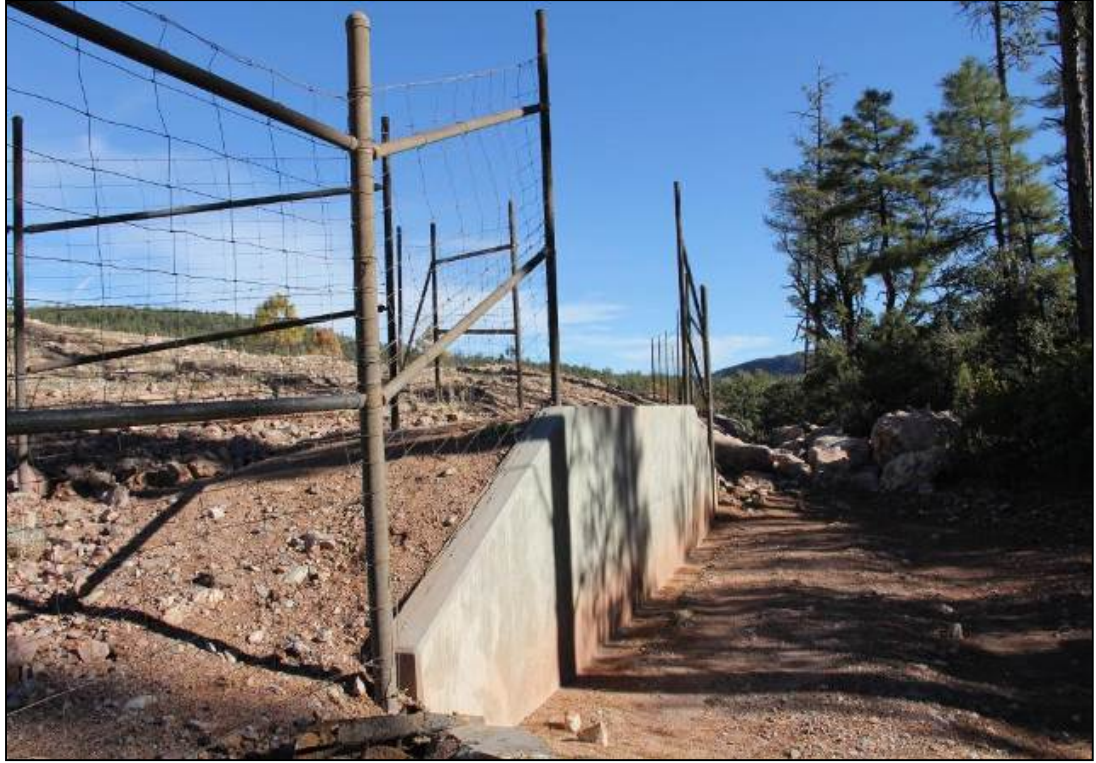
**Figure 29. Example of Optimal Style of Jump-out**

Future ADOT projects should include a design that better addresses soil retention (Figure 29). The final jump-out height should be 6 ft at the face. Jump-outs should be inspected during annual fence inspections to determine additional maintenance needs.
