**Federal Railroad
Administration**

Status of the Transportation Technology Center - 2015

1. AGENCY USE ONLY (Leave blank)		2. REPORT DATE March 2016	3. REPORT TYPE AND DATES COVERED Technical Report – December 2015	
4. TITLE AND SUBTITLE Status of the Transportation Technology Center - 2015			5. FUNDING NUMBERS

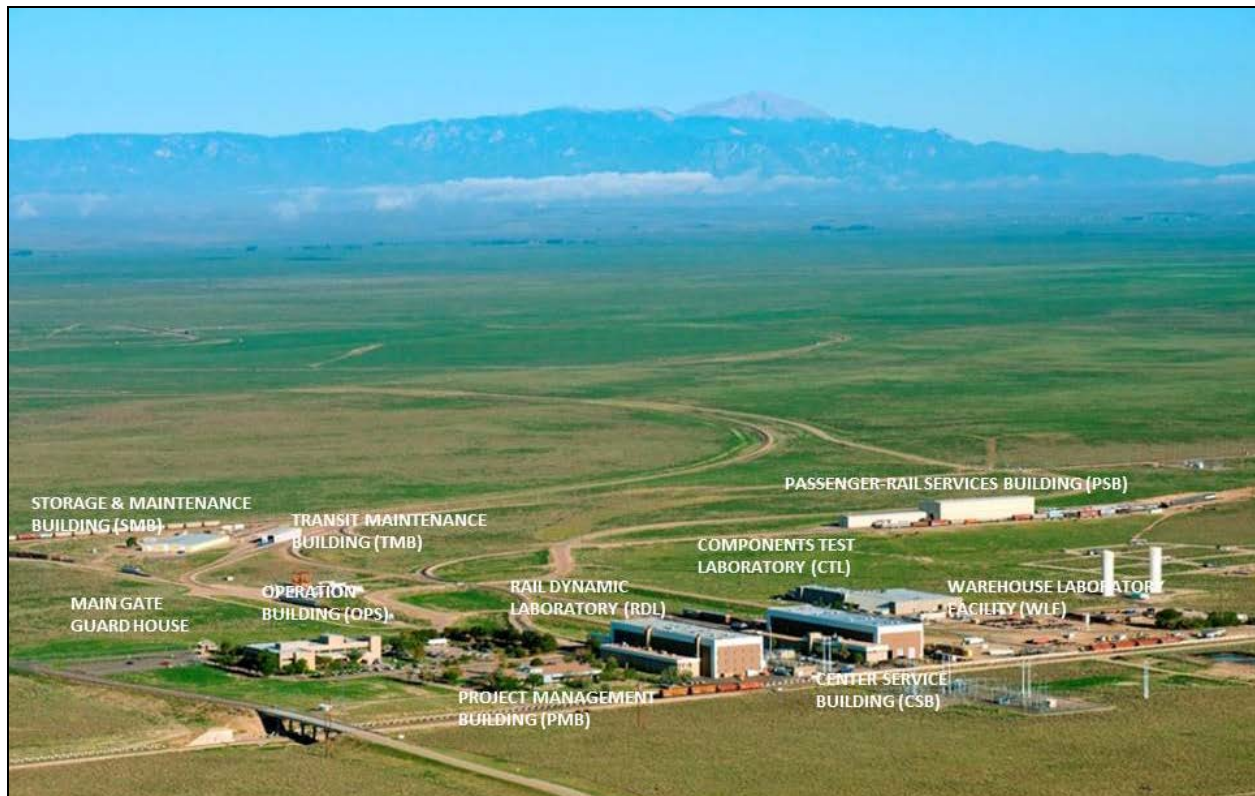
Figure 3. Core Area at the Transportation Technology Center

There are eighteen buildings at TTC that each has a floor area greater than 2,000 square feet (186 m²). These buildings house offices, laboratories, test equipment, storage, maintenance services and support facilities for ongoing research work at TTC. Figure 3 shows the core area where several of the principal buildings are located.

Yard and service tracks for the core area are shown in Figure 3. Tracks were constructed using recycled materials with predominately wood ties. Tracks are maintained to FRA Class 2 safety standards. Maximum track curvature is 12 degrees.

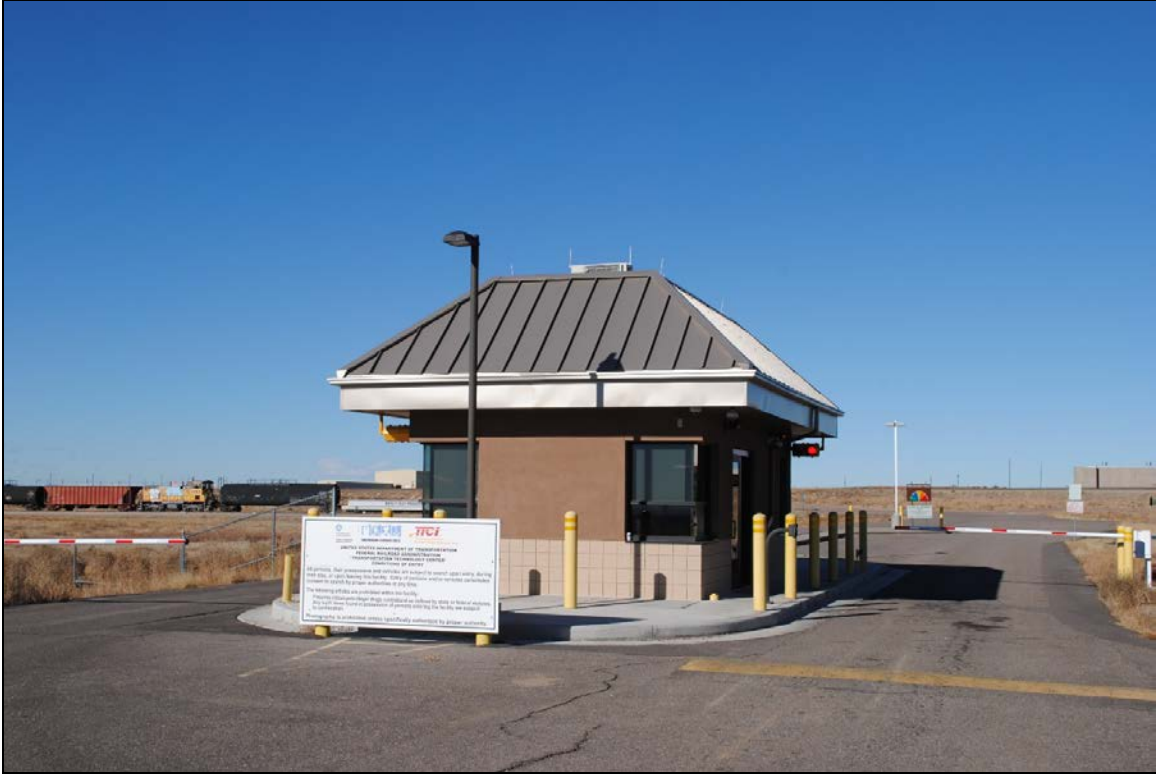
Figure 4. Main Gate Guard House

The Main Gate Guard House, shown in Figure 4, is located directly west of the Operations Building (OPS) on the main entrance road to the facility. The original structure, which was constructed with the OPS in 1975, was replaced in 2013. It now has many of the improvements recommended in a Physical Security Assessment that was conducted in April, 2012. Such items include bullet resistant glass and exterior wall construction, surveillance monitoring capability, panic alarm to local emergency response station, secured storage for firearms not allowed into the facility, badge reader system for employee entrance and exit, and improved vehicle barrier protection.

The central fire alarm station and a satellite water system monitoring station are located in the Main Gate Guard House.

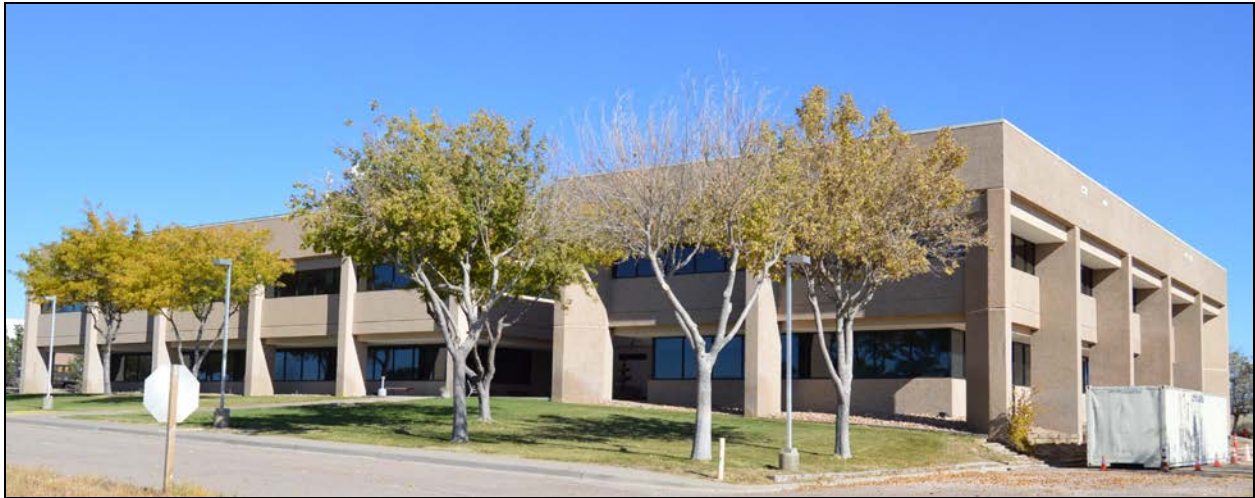
Figure 5. Front View of the Operations Building (OPS)

The Operations Building (OPS) (see Figure 5) is the main office building on site. The primary structure was constructed in precast concrete in 1976, followed by a southern addition in 1980. The combined building contains 54,487 square feet (5,062 m²) of floor area. It includes a 42 by 24 feet (12.7 m by 7.3 m) conference room called Harris Hall. A data processing area and the Operations and Control Center (OCC) share a raised floor 75 by 55 feet (22.8 m by 16.8 m). In

The general interior and exterior condition and appearance of the OPS Building is good.

Building sustainability improvements to the OPS started in 2011, and are still in progress. To-date, the windows, exterior wall and roof insulation, boiler, air handlers and condensing units of the heating, ventilating and air conditioning (HVAC) system, fire suppression system, water efficient faucets, LED office lighting, LED parking lighting, Energy Management System (EMS) have been replaced with high energy efficient components. To bring the building to LEED Silver standard would require refurbishment of the kitchen and restrooms, as well as landscaping around the building.

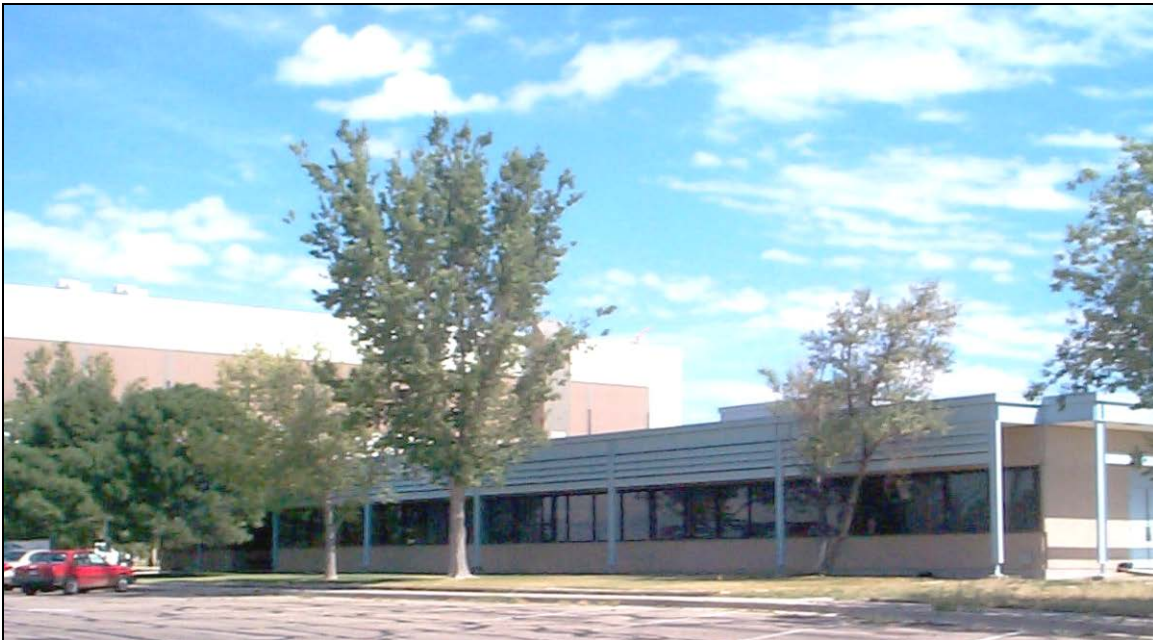
Figure 6. The Project Management Building (PMB)

The Project Management Building (PMB) (see Figure 6) was constructed of pre-cast concrete panels supplemented with steel and aluminum trim work in 1972. This one-story building is 180 feet (49 m) long and 100 feet (33.5 m) wide, providing 17,400 square feet (1,616 m²) of office space.

The PMB has not been used since 2007. The exterior is in good condition. The ceilings in the interior contain asbestos, which needs to be mitigated before the building can be reoccupied. A preliminary design was performed in 2011 to refurbish the PMB and convert it into a multiple use training and conference center. All lighting fixtures, heating and air cooling systems are original to the building.

The structure of the PMB is in good condition, but the interior finishes are showing normal wear for a 44 year old building.

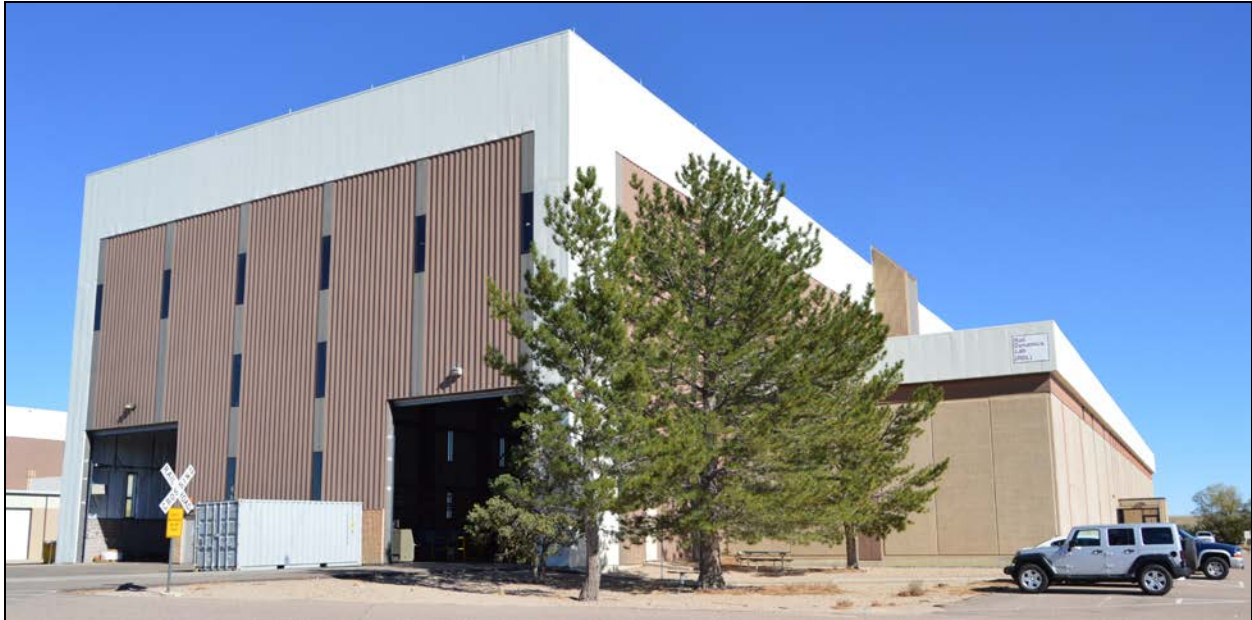
Figure 7. The Rail Dynamics Laboratory (RDL)

The Rail Dynamics Laboratory (RDL) (see Figure 7) houses three major rail vehicle simulators, several smaller test stands and facilities to support laboratory testing. Construction began in June 1972 and occupation started in April 1974. The high-bay area of the building is constructed of structural steel and has exterior walls covered with fabricated metal panels. The walls of the low-bay area are constructed of concrete masonry units and pre-cast concrete panels. The floors of both sections of the building are of cast-in-place concrete. Built-in provisions to reduce noise and vibration permit most activities in the low-bay area to continue while testing is being conducted in the high bay. The high-bay area is served by two 100 ton (91 tonne) rated overhead cranes with hook heights of 42 feet (11.2 m). The cranes with support rigging are capable of lifting fully loaded freight cars, locomotives, or passenger vehicles and setting them on the simulators.

The structure of the RDL is in good condition, but finishes are showing normal wear for a 40 year old building except in some office areas that have been recently refurbished. The roof of the building was replaced in 2014. Installation of LED light fixtures, high efficiency windows and wall insulation in the high bay was completed in 2015.

The mechanical heating and ventilating systems are original to the building. The air conditioning systems have R-22 Freon, and will need replacement in the near future.

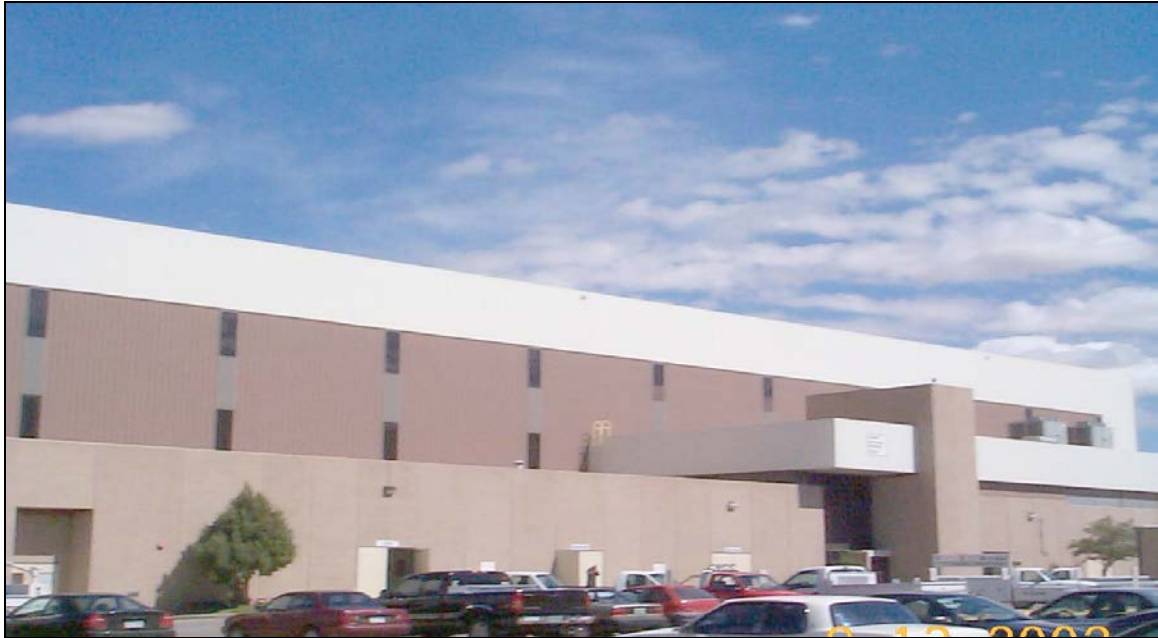
Figure 8. The Center Service Building (CSB)

The Center Service Building (CSB) (see Figure 8) is located in the core area. It is the primary maintenance facility for TTC, providing for minor overhauling, repair, maintenance and test preparation in the high bay. The facility also provides office space, motor pool area, parts storage, and craft shop areas for vehicle and building maintenance. Located outside the CSB are a loading dock, a rail car squeeze fixture, yard tracks, vehicle fueling stations, and a locomotive servicing facility.

The structure of the CSB is in good condition, but finishes are showing normal wear for a 40 year old building. The mechanical heating and ventilating systems were replaced with modern, energy efficient propane boilers in 2015. The air conditioning systems have R-22 Freon, and will need replacement in the near future.

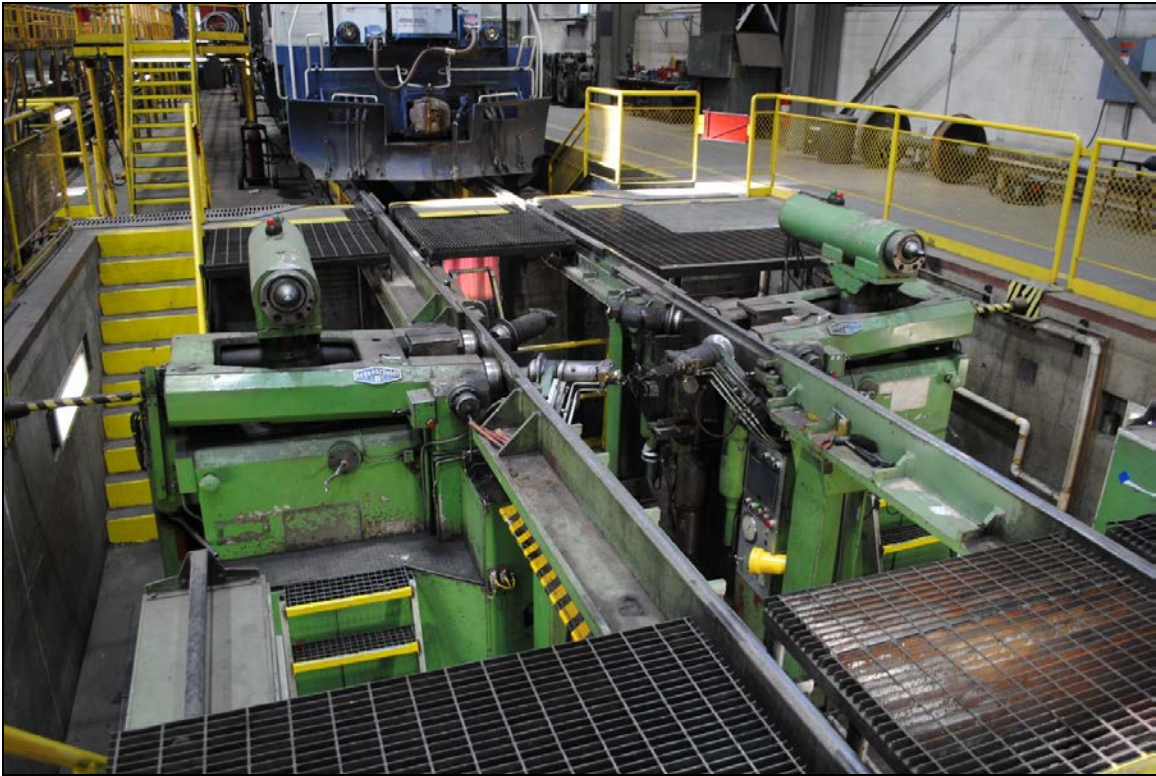
Figure 9. Wheel Truing Machine in the CSB

Four tracks enter the high-bay area from the west. The most northern track (Track #4) continues through the building, to a concrete slab on grade east of the building. This features a repair pit with air, water, and power at convenient locations. A drive-on, wheel-truing machine is located at the center of the building on this track (see Figure 9). Installed in 1975, it is an under-floor, tracer lathe fabricated by Hegenscheidt MFD Corporation. The lathe was refurbished in the late 1980's for hydraulic lines and components, and in 1990 for a control system upgrade. A review

of costs to refurbish the main hydraulic cylinders showed them to be economically cost prohibitive. Wear in this area will degrade tolerance control over time, limiting use to freight wheels where tolerances are not as critical as higher speed passenger applications.

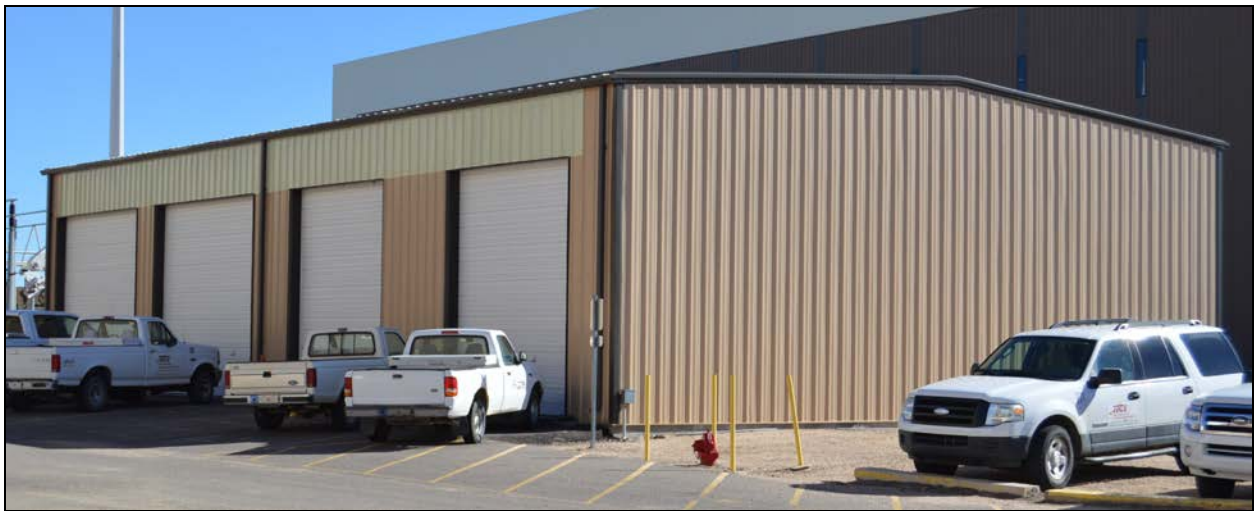
Figure 10. The CSB Storage Building (aka the TTX building)

The TTX Building (see Figure 10) was constructed in 2007 under a joint funding agreement between TTCI and TTX. The building is FRA real property, with TTX receiving long term use under an agreement with TTCI.

The TTX Building is in very good condition.

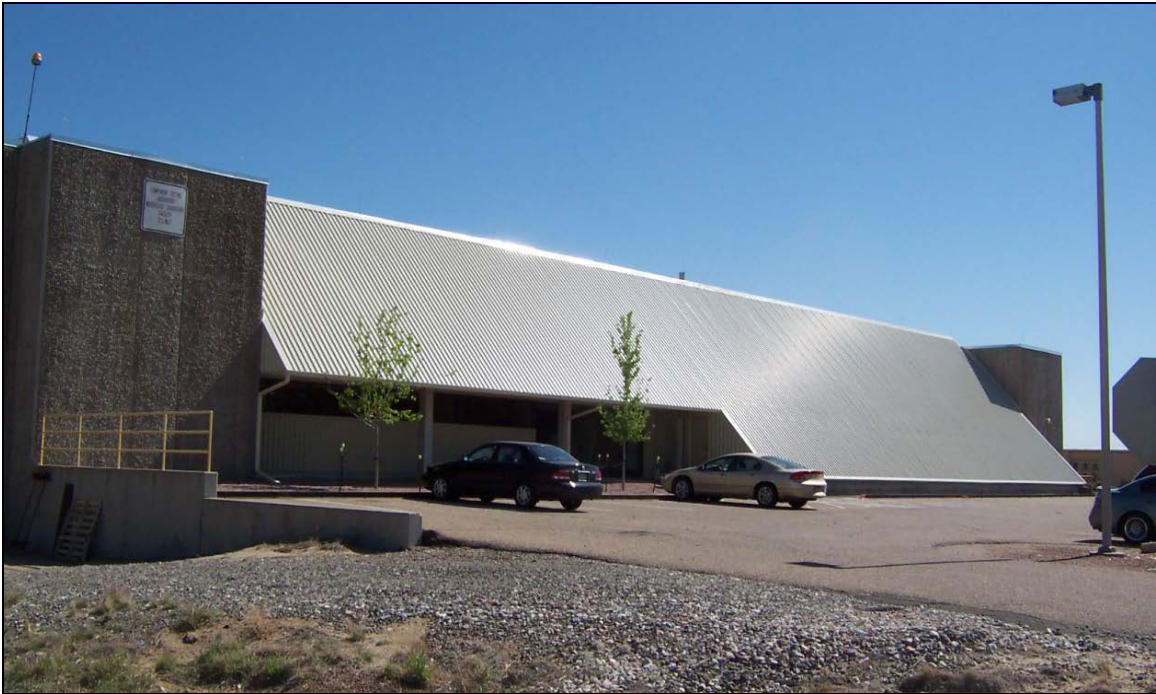
Figure 11. Warehouse Laboratory Facility (WLF) and Components Test Laboratory (CTL)

The building shown in Figure 11 was constructed in two phases, with the initial phase currently called the Warehouse Laboratory Facility (WLF) and the second phase called the Components Test Laboratory (CTL). Both phases were constructed in between 1979 and 1980. The completed building is a pre-cast, pre-stressed concrete structure. The total floor space is 53,428 square feet (4,964 m²).

The structure of the WLF/CTL building is in good condition, but finishes are showing normal wear for a 35 year old building. The mechanical heating and ventilating systems are original to the building. The current diesel fired boiler was designed to handle half of the design load, with a second boiler planned, but never installed. The air conditioning systems have R-22 Freon, and will need replacement in the near future.

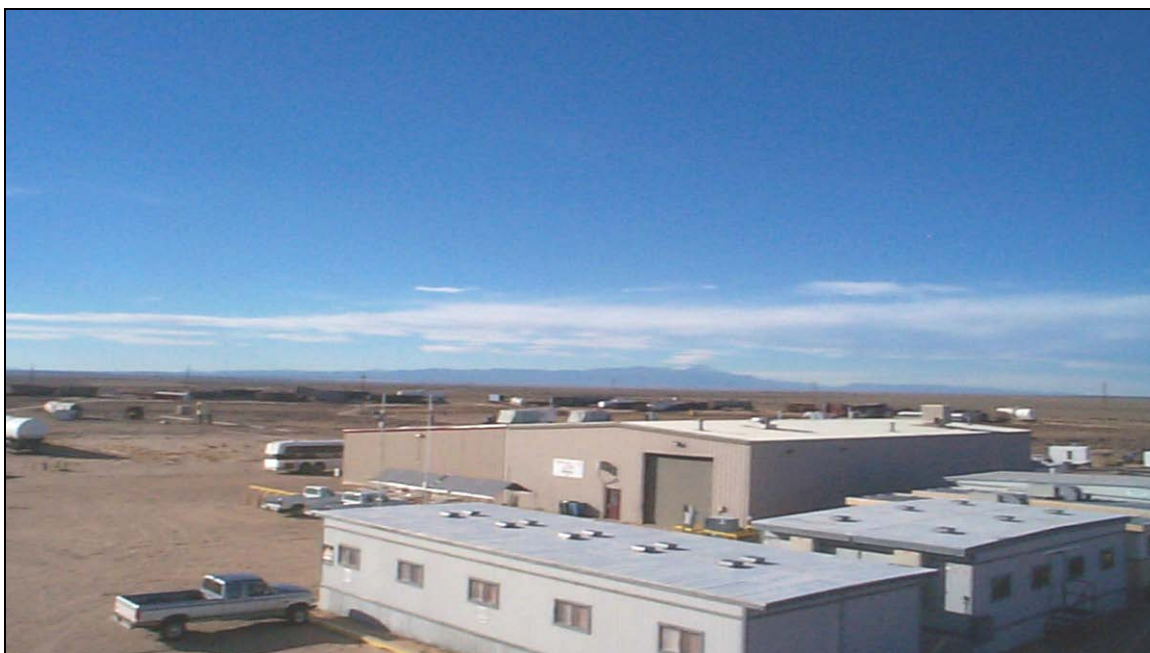
Figure 12. Security and Emergency Response Training Center (SERTC)

The Security and Emergency Response Training Center (SERTC) (see Figure 12) provides classroom and full-scale simulation training for emergency responders to rail and highway incidents. The initial building was constructed in 1973 to house and maintain the Prototype Tracked Air Cushion Vehicle (PTACV). The main structure is a pre-engineered metal building, 60 feet (18.3 m) wide by 120 feet (36.6 m) long. The PTACV program was completed in 1974, with the building modified in 1978 for testing of insulated tank car test assemblies.

The main SERTC building interior is maintained in a like new condition. The exterior finish is in good condition, but showing some oxidation of the paint coating. The five modular units used for personnel offices are in poor condition and require a lot of maintenance.

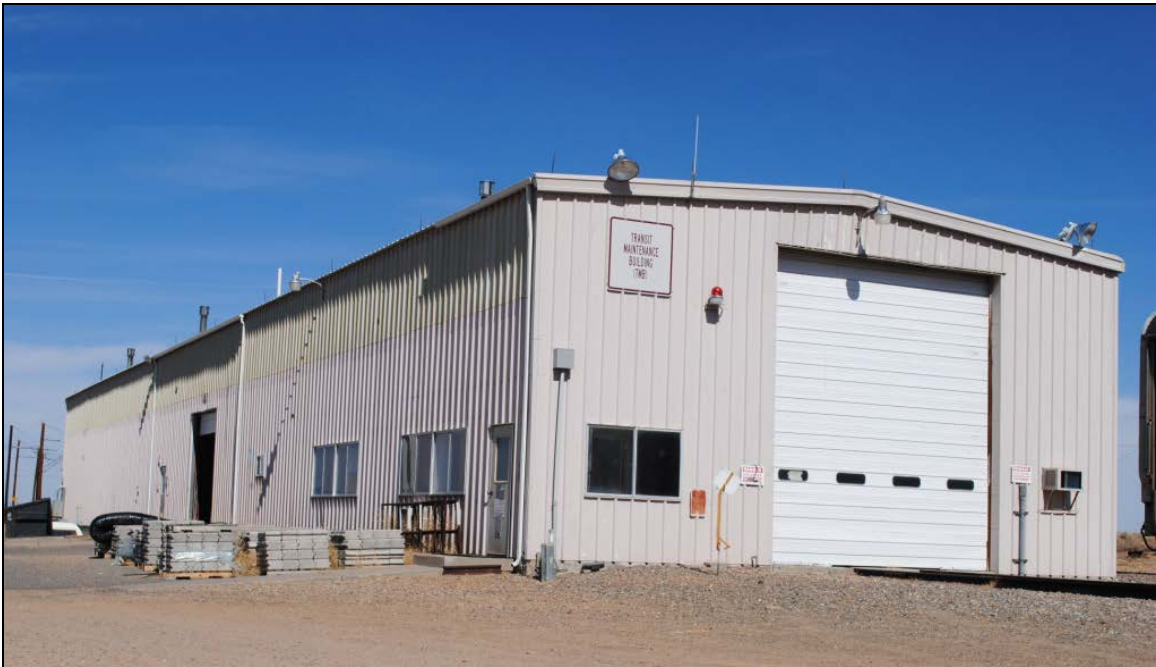
Figure 13. The Transit Maintenance Building (TMB)

The Transit Maintenance Building (TMB) (see Figure 13) was constructed in 1973 as a temporary facility for mass transit vehicle testing. It is currently used as a project maintenance facility. The building is pre-engineered metal construction, insulated and heated, 40 feet (12.2 m) wide by 192 feet (58.5 m) long, with a single through track. The building has a 100 feet (30.5 m) long service pit between the rails with flat track for the remainder of the building.

The building structure is in good condition, but both exterior and interior finishes are in fair condition. The fiberglass light panels on the exterior walls, although intact, are oxidized with excessive weathering.

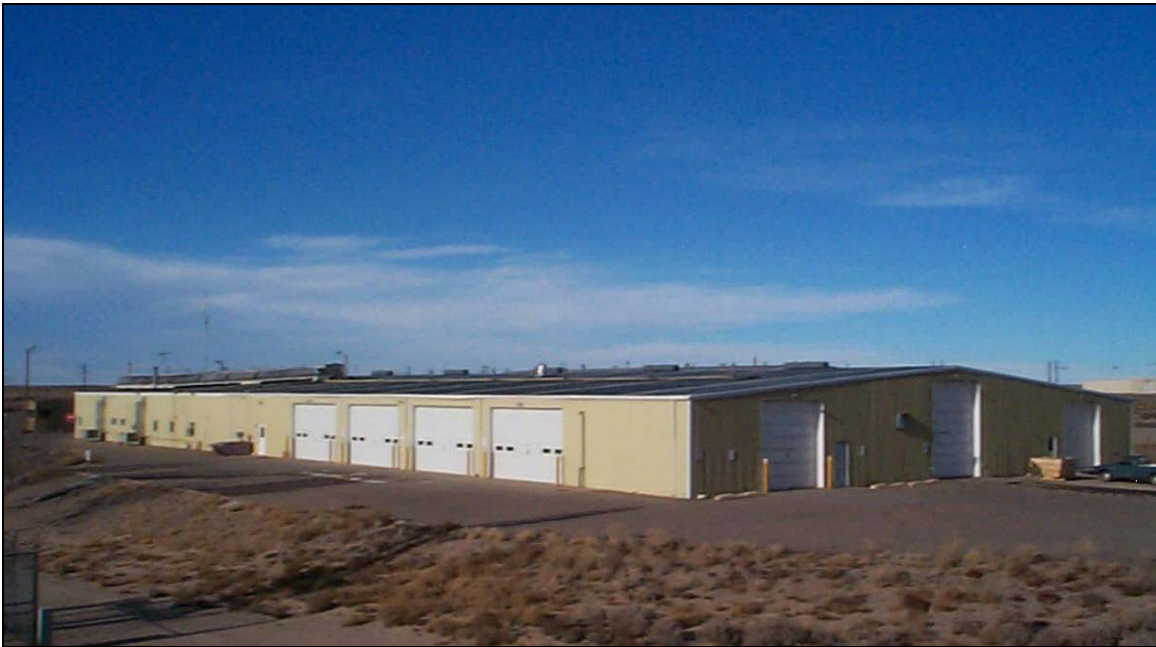
Figure 14. The Site Storage and Maintenance Building (SMB)

The large one-story Site Storage and Maintenance Building (SMB) (see Figure 14) with track access was constructed in 1973 as interim warehousing and offices. The building is pre-engineered metal construction with a non-insulated and un-heated high bay, 130 feet (39.6 m) wide by 277 feet (84.4 m) long. A single track runs through the building. This building serves several purposes, including; craft material storage, lading and damage material staging, and emergency response vehicle staging. Areas available for project use, include ballasted track through the building for staging (no jacking), limited inside secured and un-secured storage, outside secured storage, large office space area (4,000 square feet (372 m²)), which includes separate offices, conference rooms, a break room with kitchen, and restrooms with showers.

The structural frame and exterior walls are in good condition. Half of the roof decking was replaced to remove excess penetrations in 2010. The other half over the storage area will need replacing when the fiberglass light panels degrade and weather seals on screw fasteners fail. The existing deck panel is an obsolete rib design that buckles under personnel traffic causing cracks

at the top of the rib. Exterior and interior finishes are worn, but in an acceptable condition for the type of building use.

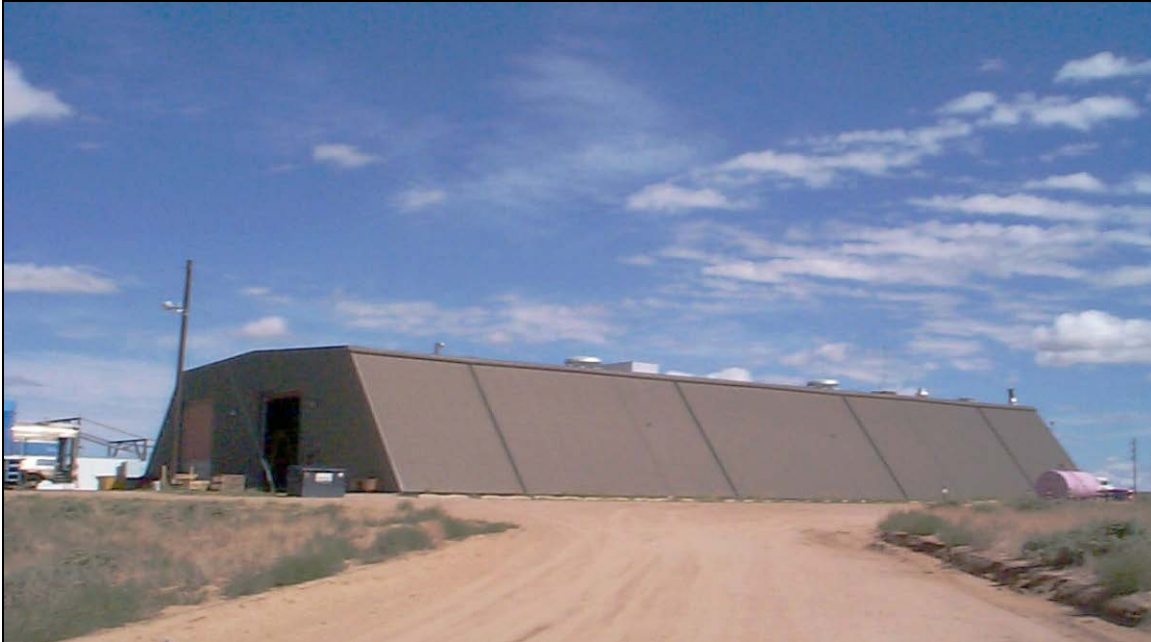
Figure 15. The Urban Rail Building (URB)

The Urban Rail Building (URB) (see Figure 15) and adjacent yard tracks were constructed in 1980 as a permanent maintenance facility for vehicles using the Transit Test Track (TTT). A Wye track extends to the building from the TTT to allow turning of vehicles without leaving the TTT test area. Third rail power is extended along the Wye track into the building, with the power source controlled from the building. A portable stinger system can move rail cars from the end of the 3rd rail into the building. The DC power supply is separate from the TTT, allowing isolation of the URB facility from TTT testing. Each of the two rectifiers in the URB can provide up to 1,000 volts DC, with 1,000 amps.

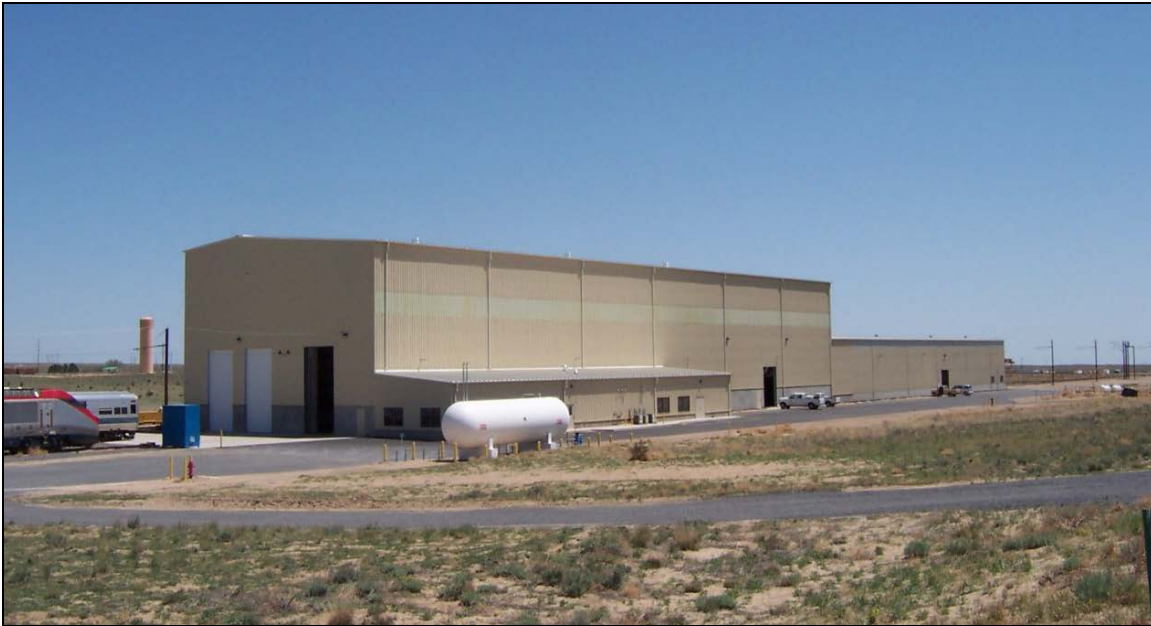
Figure 16. The Passenger-Rail Services Building (PSB)

preparation for the unit. A wheel truing pit was also installed in Track #3 for a future in-floor, CNC wheel truing machine (see the yellow panels in Figure 16). In addition to the tracks that extend through the building, Track #4 runs parallel and to the east side of the building. All four tracks extend approximately 300 feet (91.4 m) north of the building.

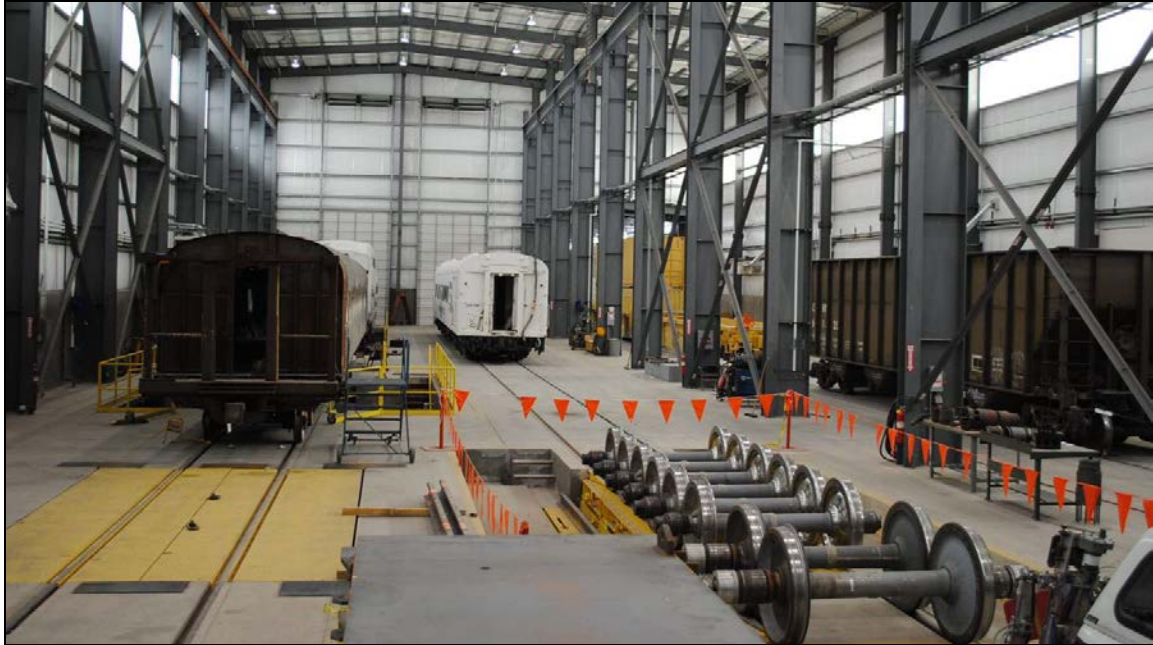
Figure 17. PSB High Bay, Facing South

The PSB is in very good condition. The HVAC systems are modern and in good working order.

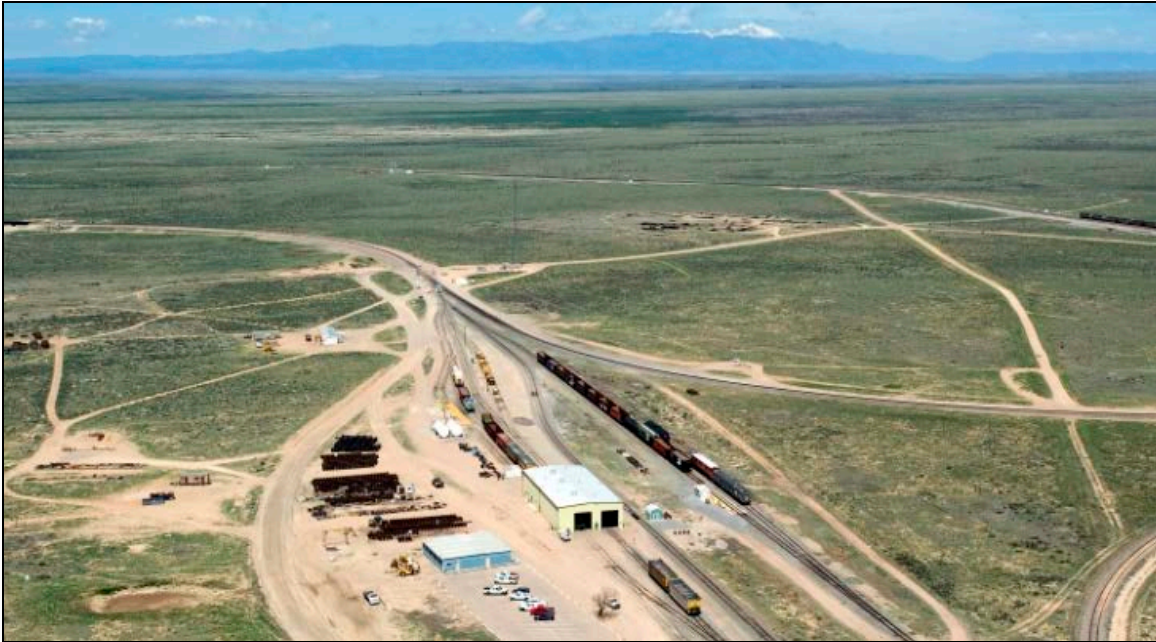
Figure 18. The FAST Modular Building (left) and the FAST Maintenance Building (right)

The FAST Facility contains two primary structures to house project personnel and to perform routine maintenance on equipment and vehicles associated with the program – a maintenance building and a modular unit (see Figure 17). The FAST maintenance building is pre-engineered metal construction, 60 feet by 140 feet (18.3 m by 42.7 m) in size, insulated, and heated. It has two service tracks extending through the building, with a service pit under one of the tracks. The FAST modular unit is 3,600 square feet (334 m²) in size, containing offices, restrooms, and a break room.

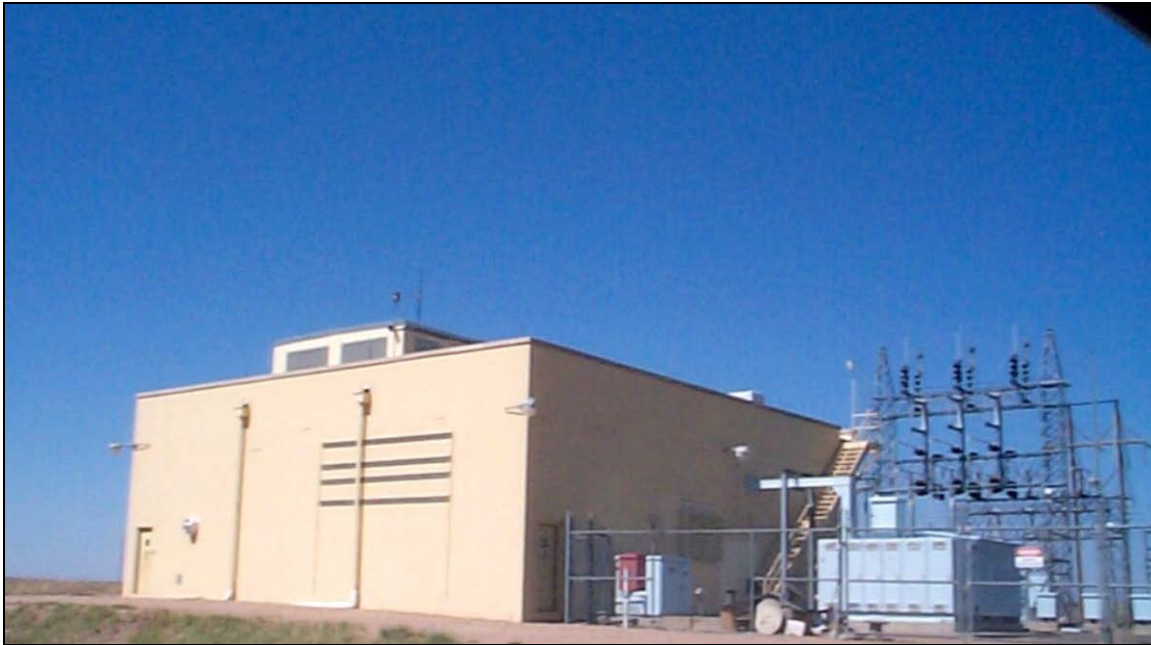
Figure 19. DC Rectifier Substation #1

Figure 18 shows one of the two substation buildings that were constructed in 1976 to house the DC Rectifiers and associated controls for the Transit Test Track (TTT) loop. The units are a mirror image of each other, with DC Rectifier Substation #1 located on the east side of the TTT near the Post 85 road crossing, and DC Rectifier Substation #2 near the west side of TTT. Each building is 62 feet by 65 feet (18.9 m by 19.8 m), masonry wall and steel roof deck construction.

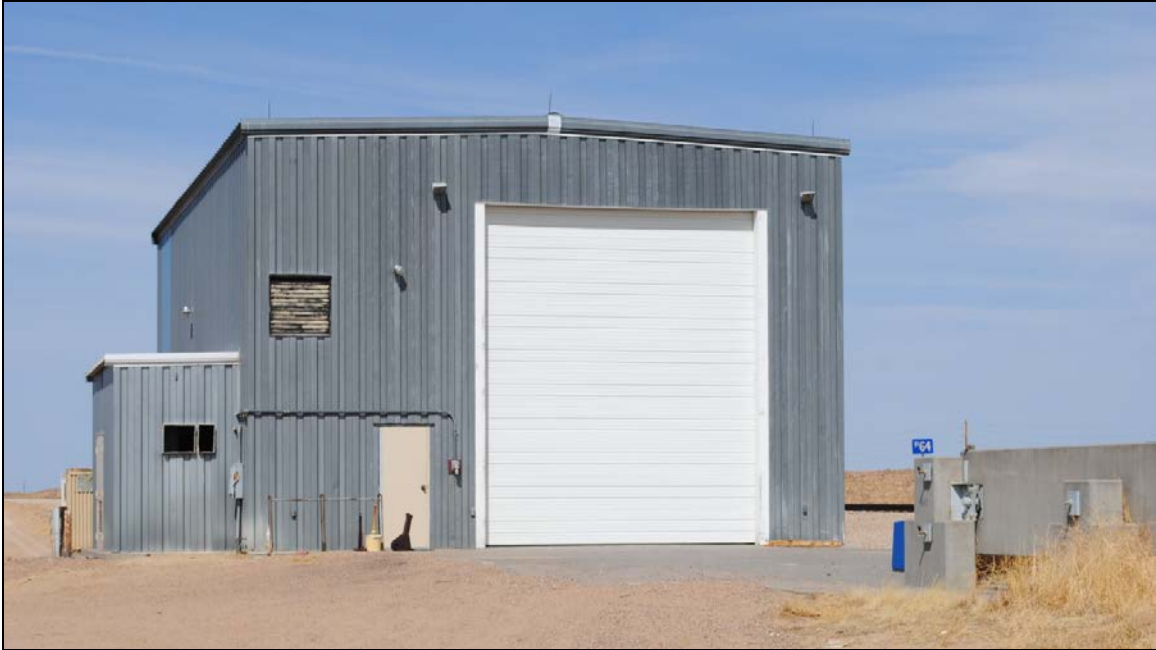
Figure 20. The TLRV Maintenance Building

The building shown in Figure 19 was constructed in 1973 to house and maintain the Tracked Levitated Air Cushion Vehicle (TLRV). It is located at the north end of the concrete “U” Channel (TLRV) Guideway. The building is pre-engineered metal construction, 40 feet (12.2 m) wide by 62 feet (18.9 m) long, with a concrete floor. The building is currently used for storage of site materials and equipment.

The interior of the TLRV maintenance building was insulated in 2014. The exterior walls, although intact, are oxidized with severe weathering.

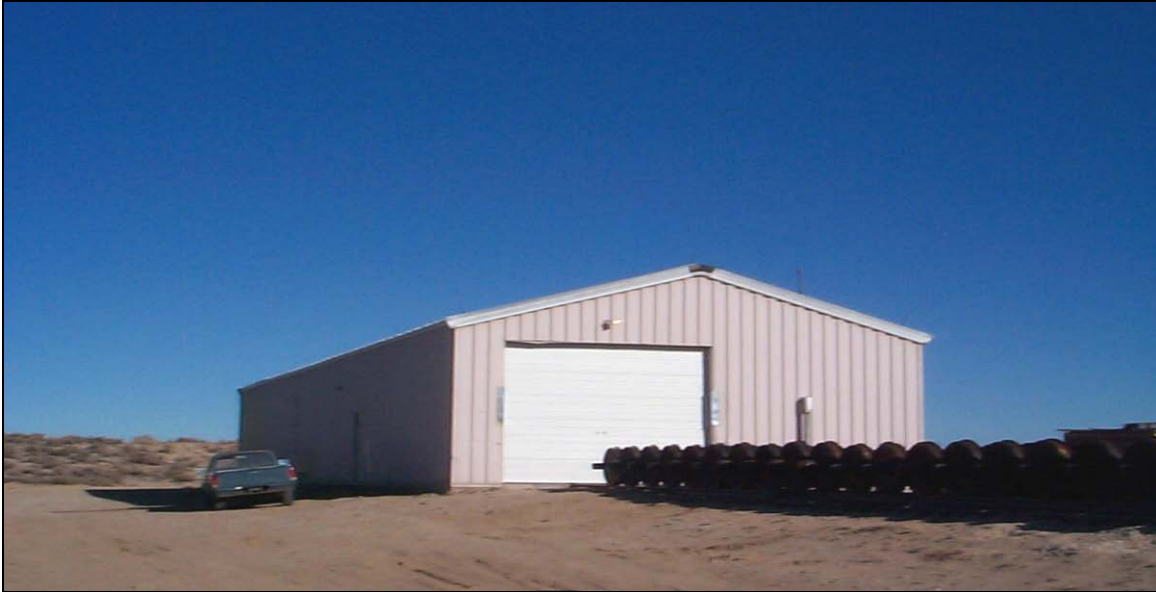
Figure 21. The LIMRV Maintenance Building

The building shown in Figure 20 was constructed in 1971 to house and maintain the Linear Induction Motor Research Vehicle (LIMRV). The building is pre-engineered metal construction, 32 feet (9.75 m) wide by 100 feet (30.5 m) long, insulated, electrical heat, with the track extended inside the building. The building is located at the north end of the LIMRV Test Track, now called the Precision Test Track (PTT). The LIMRV maintenance building is in fair condition and is used for storage of materials and equipment, as well as project space for test programs.

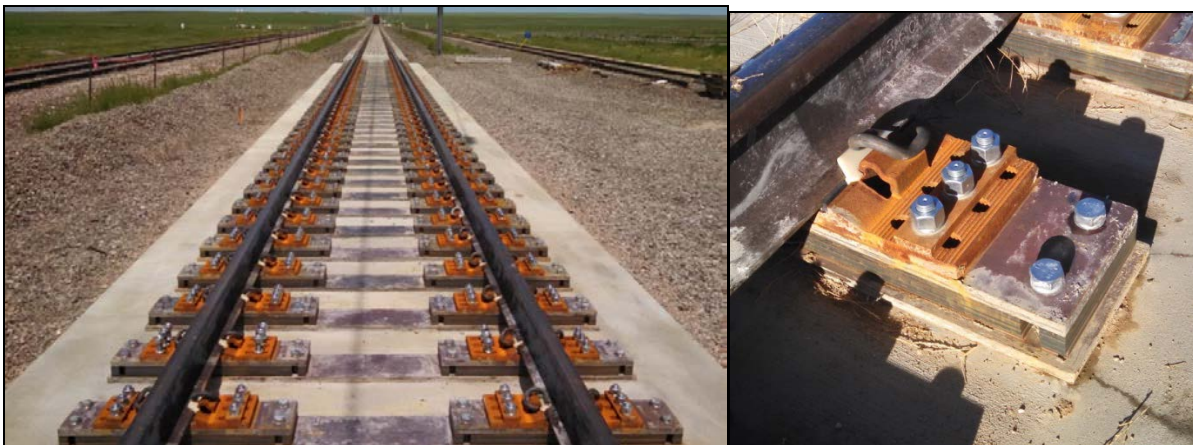
Figure 23. RTT Precision Geometry Slab Track and Adjustable Fastener

Figure 22 shows a Precision Geometry Slab Track section installed on the RTT in 2014. The section is 500 feet (152 m) long located on the tangent in section R16 where the maximum speed for testing in this section is at 165 mph (265 km/h).

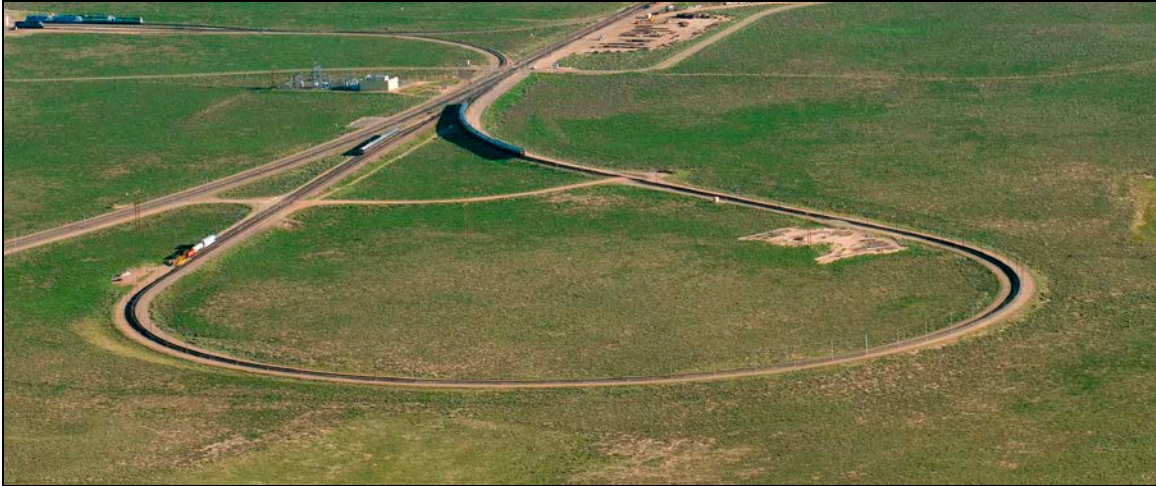
Figure 30. Balloon Loop Looking Northwest

Overhead catenary for the Balloon Loop transitions from compound style on the RTT, to a simple style catenary. The catenary around the loop can be isolated from the RTT to remove clearance restrictions when working on the track.

The Balloon Loop has also been modified to install the Rail Defect Test Facility (RDTF) (see Section 4.13). Rail defects have been added to the track on a set of parallel rails installed on the same set of cross ties. Movable switch points are used at each end of the parallel rails for access to the defect set of rails.

The ties on the Balloon Loop are in poor condition. All wood ties on the RDTF portion of the loop need to be replaced with 10 foot wood ties equipped with an elastic rail fastening system.

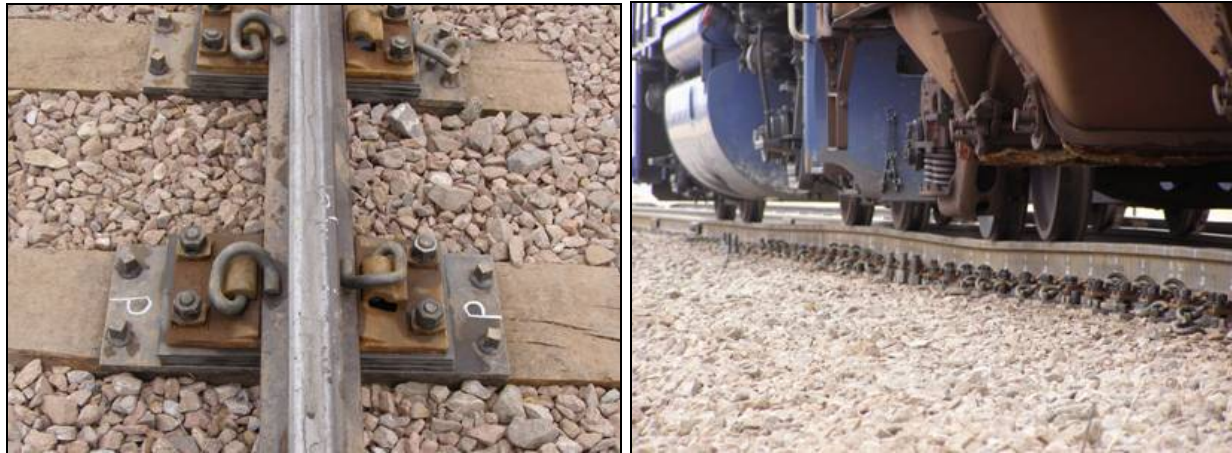
Figure 33. Adjustable Tie Plates for Vertical and Lateral Track Geometry Perturbations

The curvature on the siding on the east of the WRM is approximately 10 degrees and is used for dynamic curve track perturbation testing to meet the requirements of Chapter 11, Paragraphs 11.7.3, 11.7.4 and 11.8.5. In 2011 this perturbation section was reconstructed using a prototype system of adjustable tie plates (Figure 32). These are intended to reduce maintenance and adjustment costs for the perturbations, and allow alteration of the perturbations to different amplitudes.

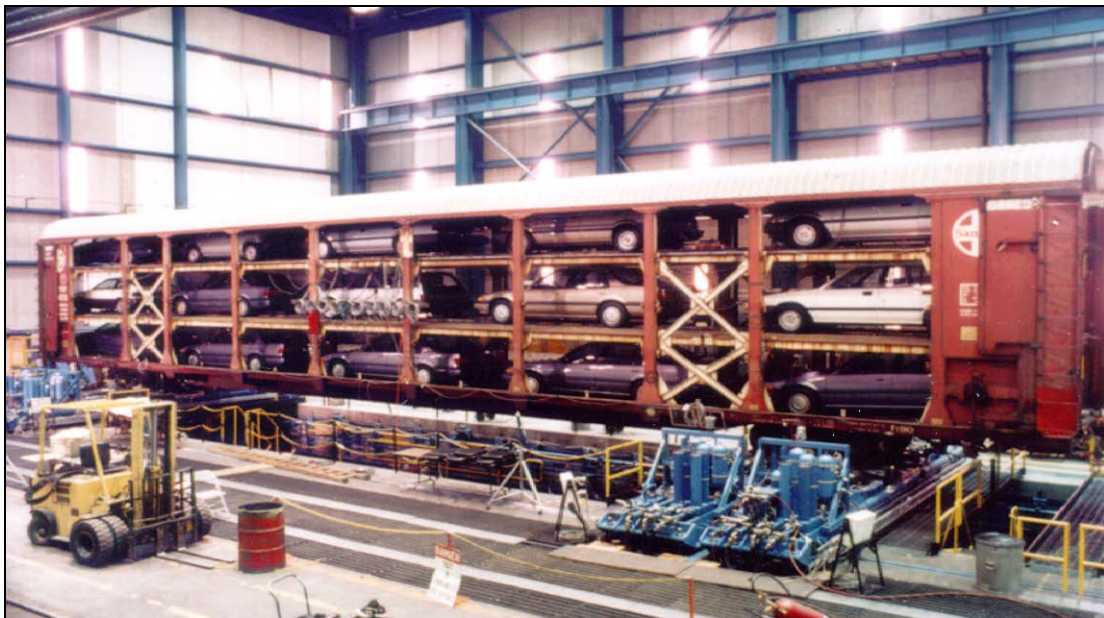
Figure 36. Vibration Test Unit, With Autorack Car in Test Mode

The VTU can induce vibrations in the frequency range of 0.2 to 30 Hz to the test car. It can be modified to accommodate a 4-axle rail vehicle up to 90 feet (27.4 m) long and 160 tons (145 tonne) weight, and up to a 66-inch (1,676 mm) wheel gage. It can also be used to test non-rail vehicles such as buses and off-road construction equipment.

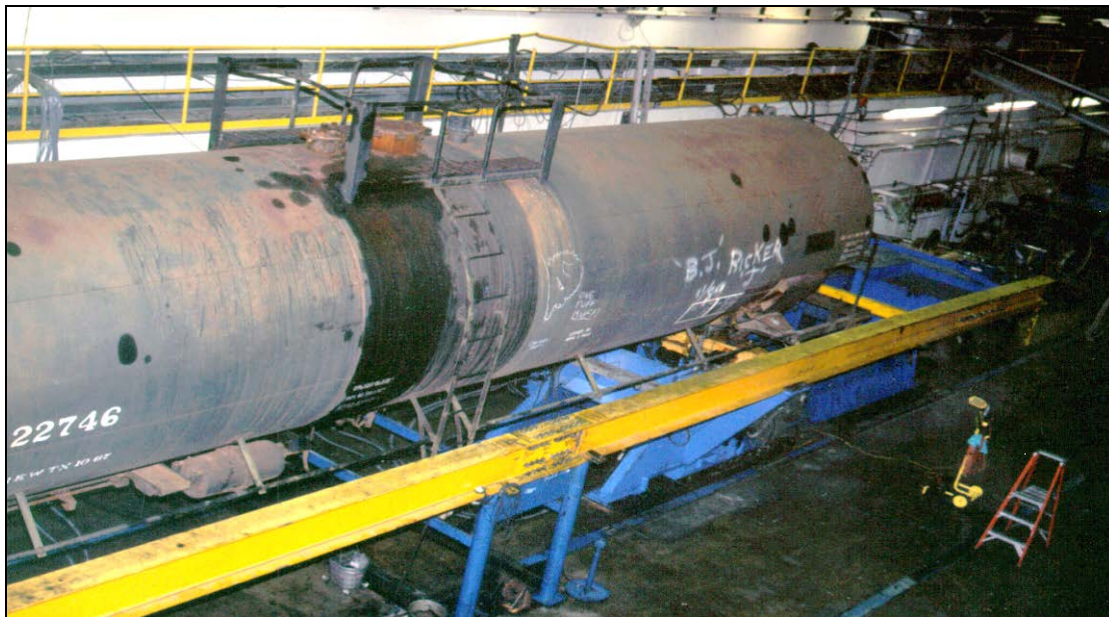
Figure 37. Simuloader (SMU)

The SMU is in the final stages of a general overhaul and upgrade of the control system, actuators, and modifications to the foundation anchor system.
