**Federal Railroad
Administration**

Status of the Transportation Technology Center - 2015

1. AGENCY USE ONLY (Leave blank)		2. REPORT DATE March 2016	3. REPORT TYPE AND DATES COVERED Technical Report – December 2015	
4. TITLE AND SUBTITLE Status of the Transportation Technology Center - 2015			5. FUNDING NUMBERS

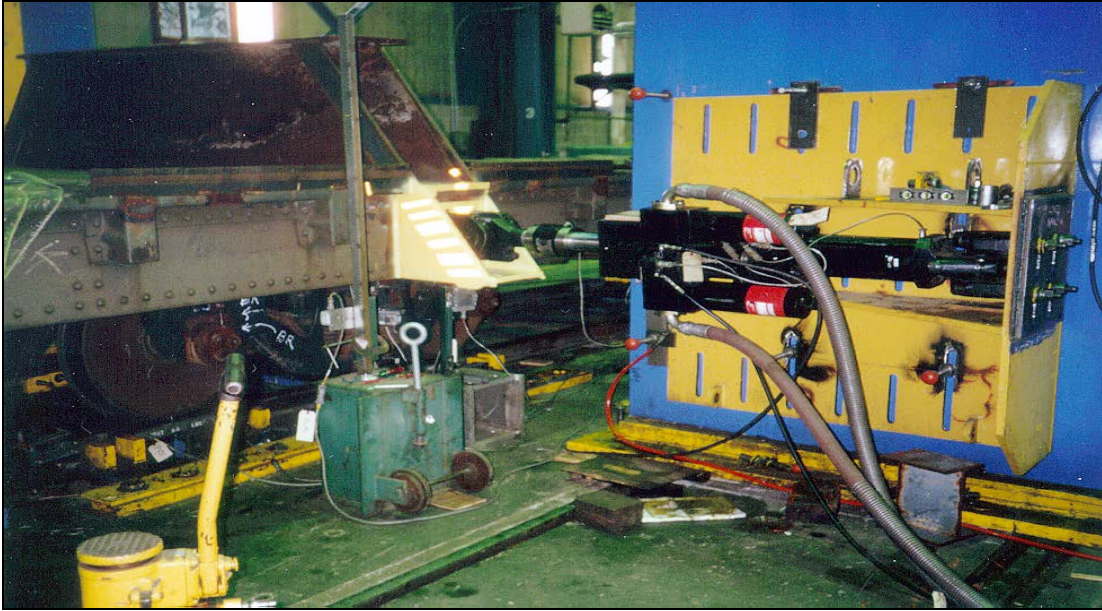
Figure 38. Mini-Shaker Unit Attached to Flat Car

The test vehicle can experience up to 210 kips (934 kN) through its suspension during a full stroke. The MSU is equipped with special instrumented rail sections to measure wheel-rail forces. Airbag assisted bearing tables under the wheels of the test vehicle allow for inter-axle shear and yaw stiffness measurements.

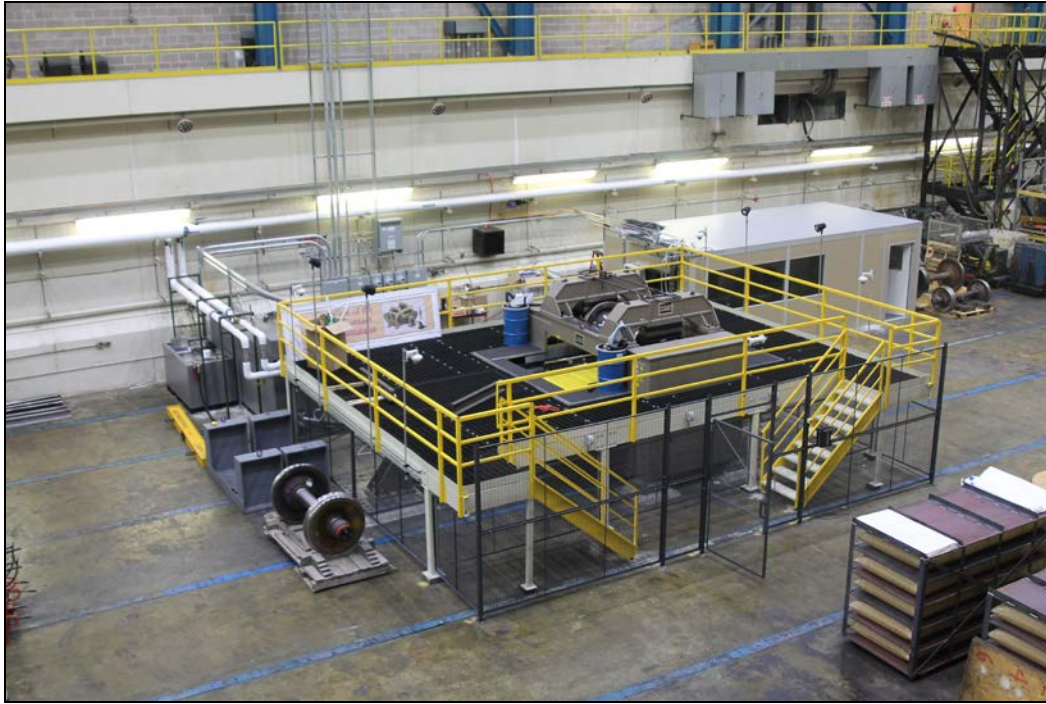
Figure 41. Rolling Contact Fatigue Simulator (RCFS)

A laboratory test rig for investigation of rolling contact fatigue (RCF) was installed in the RDL low bay in March 2015. The rig, called the Rolling Contact Fatigue Simulator (RCFS), can

generate RCF on wheels and rails. It was manufactured and installed by MTS Corporation (see Figure 40).

The RCFS uses a fully controllable table with the wheelset firmly clamped to a rigid reaction frame. Loads and motions are imparted via a moving rail support carriage. The carriage is supported and controlled with large hydrostatic bearings. These bearings have no moving parts and no mechanical contact other than seals. They also act as actuators to apply vertical and lateral force.

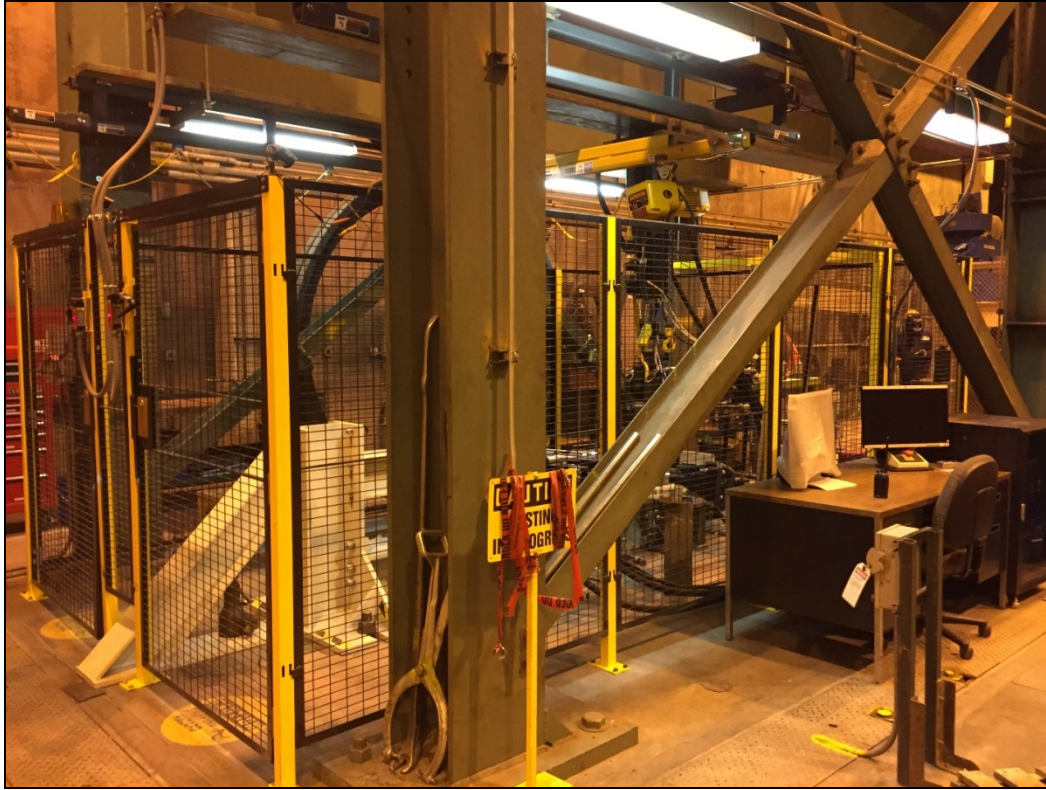
Figure 43. New Tie Wear Machine in the CTL

The new tie wear machine consists of a load frame with two servo-controlled dual action hydraulic actuators (see Figure 42). Vertical and lateral actuators are joined by a steel block that is attached to the rail head at the approximate location where a train wheel would make contact. The tie is restrained from movement and a combined vertical and lateral load is applied. The load is cycled at 3 Hz in a sine wave. A typical test is run for 3 million cycles.

There are currently two test load configurations. The first simulates an axle load of 50,000 pounds (222 kN). The loads applied through the actuators are 25,000 pounds (111 kN) vertical and 13,000 pounds (58 kN) lateral (L/V ratio=0.52). The second configuration simulates an axle load of 65,000 pounds (289 kN). The loads applied through the actuators are 32,500 pounds (145 kN) vertical and 16,900 pounds (75 kN) lateral (L/V ratio=0.52). A 1,000 pound (4.4 kN) return force mechanism is attached to the rail base to maximize repeated rail base travel and simulate actual field conditions.

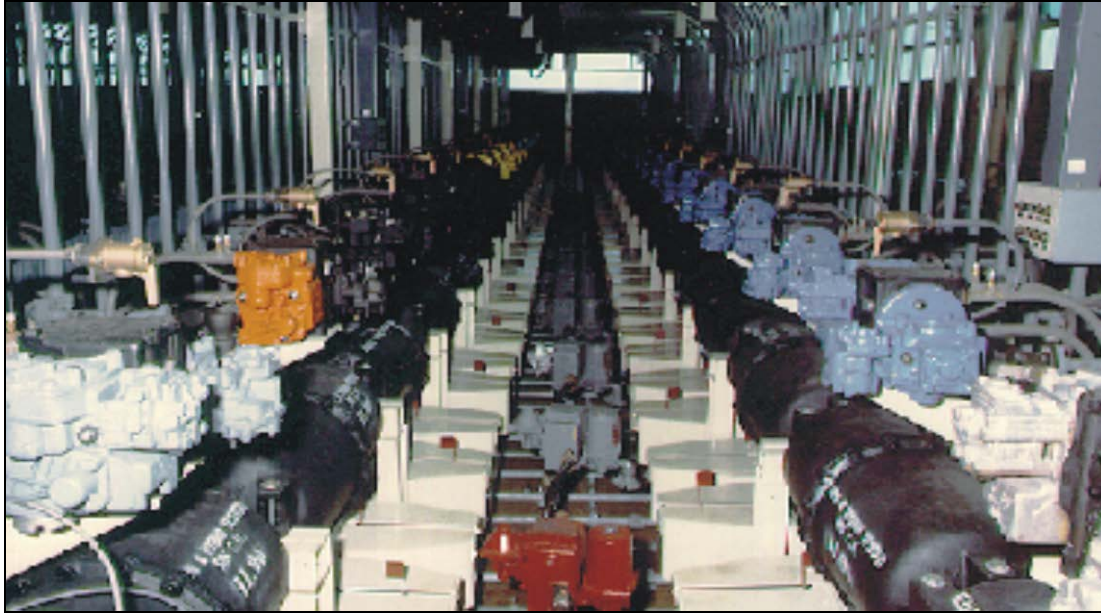
Figure 44. Air Brake Lab

The Train Air Brake Research Facility consists of 150 complete car sets of air brake equipment as shown in Figure 43. The facility is used to evaluate the performance of different air and electric valve systems. Independently operated from the air brake manufacturers, the air brake rack can be used for performance research. A broad range of train types and lengths can be simulated to analyze ways of improving current air brake systems. The air brake facility can be a key in developing new and advanced braking systems as well as a live demonstration tool for proper use of single line air brake systems.

The air brake lab is owned by the AAR. It has not been used since 2000.

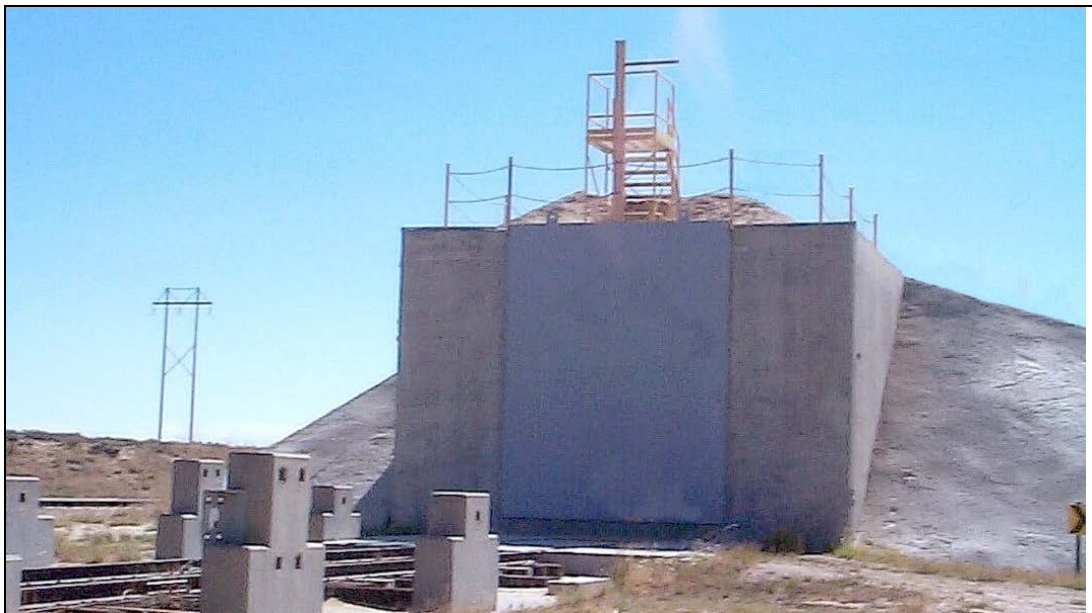
Figure 45. Vehicle Impact Wall

The vehicle impact wall shown in Figure 44 was constructed at TTC in October 2008. An inclined railway track leads to the rigid barrier, which is constructed from structural steel and reinforced concrete and backed by an earth embankment. The wall is capable of taking an impact load of approximately 3,000,000 pounds (13.4 MN).

The wall is faced with a 3-inch (76 mm) steel plate. Anti-climb bars or vehicle body ends can be mounted on the front of the wall if such a test is required. It is also possible to mount a target wall separated by load cells from the main barrier if a direct measurement of force is required.

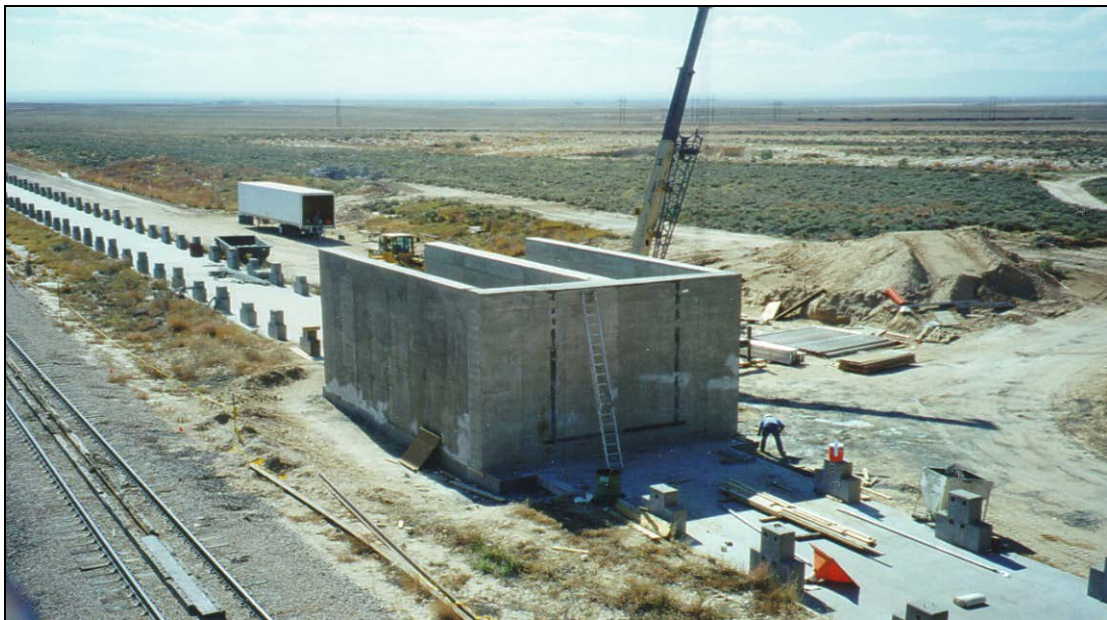
Figure 46. Vehicle Impact Wall Under Construction

The front wall is 2 feet (610 mm) thick reinforced concrete, 25 feet (7.62 m) wide by 18 feet (5.49 m) high. This wall is supported by three longitudinal walls (see Figure 45) each 2 feet (610 mm) thick by 36 feet (10.97 m) deep and 18 feet (5.49 m) high. In between these three walls there are another two vertical support walls 18 inches (457 mm) thick by 20 feet (6.10 m) deep and 8 feet (2.44 m) high, designed to adsorb high impact loads associated with side sills on railcars. Native soil was compacted into the gaps between these walls and piled up against the two side walls and the rear. Over 1,000 tons of earth was used in the construction.

Further additions have been made to the Vehicle Impact Wall since its original construction. A concrete pad with the rails built-in has been constructed immediately in front of the wall. This allows easier access to the wall and fixes the rails rigidly in front of the barrier. This concrete pad has a pit to allow a camera and lights to look up at the impact zone. Extra power outlets have been provided either side of the wall and at the top of the wall for cameras and lights.

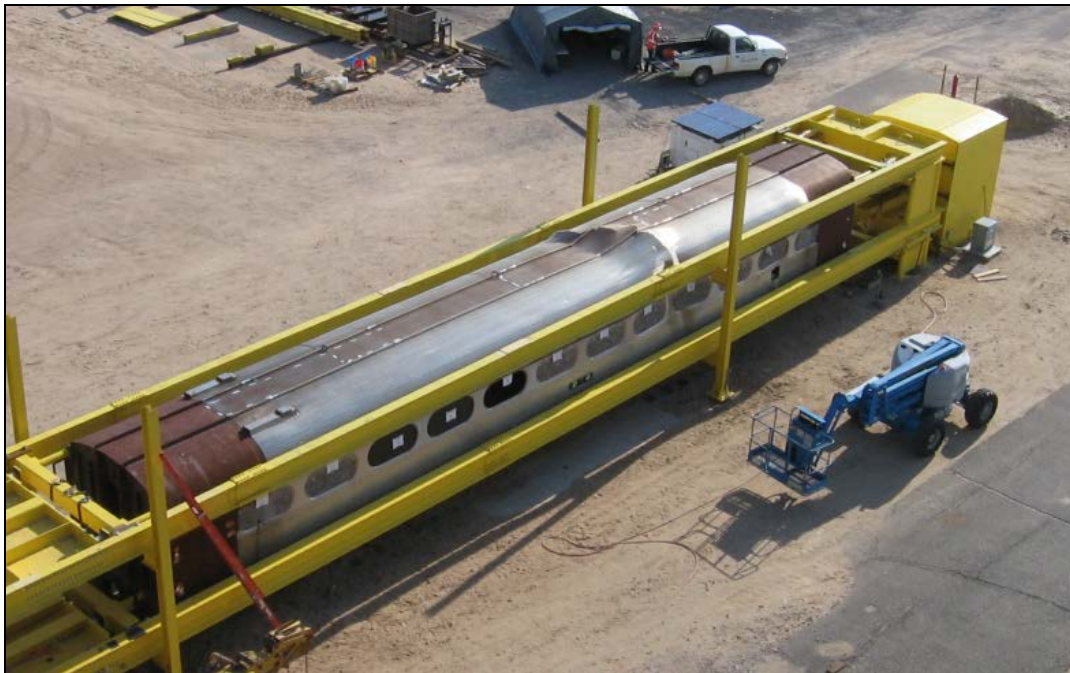
Figure 47. Squeeze Test Fixture

The Squeeze Test Fixture is in good condition.

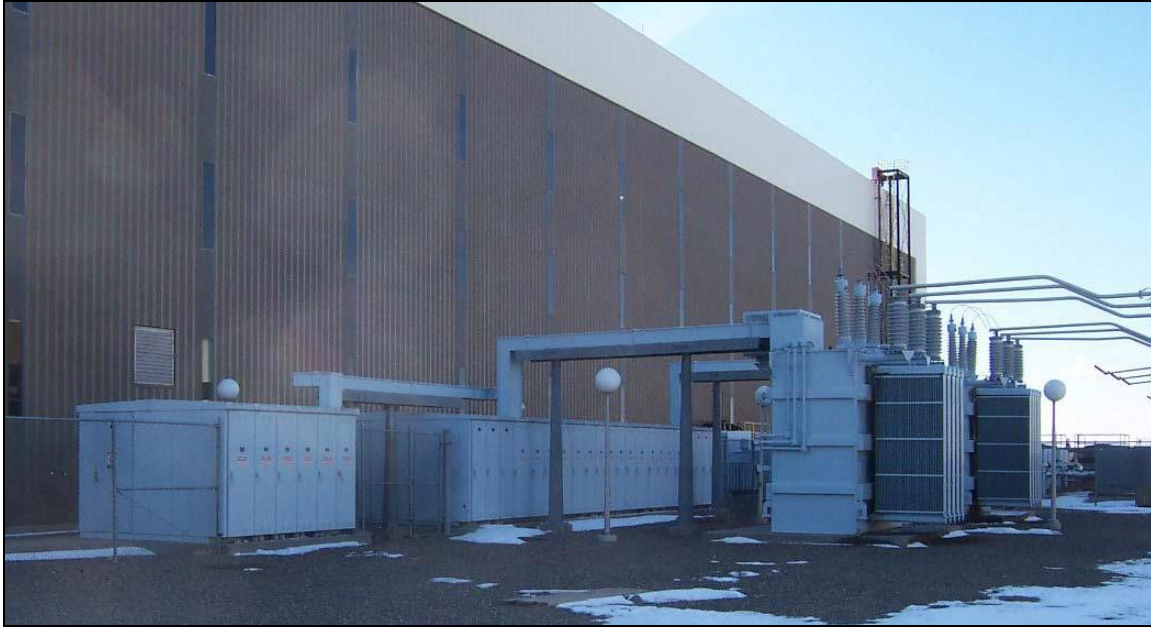
Figure 49. Main Core Area Substation

The Main Core Area Substation (see Figure 48) is located between the CSB and RDL Buildings. The two primary transformers feed a common switch gear bus system that has 17 air circuit breakers (six spares) divided into three sections for metering and control. The switch gear can be configured to feed the system with either primary transformer for redundancy, or zoned to feed separate sections. Individual circuit breakers feed secondary building or facility transformers that further reduce the voltage to 480 volts, 3-phase. Common building power voltage is 480 / 208 / 120 volts. Power demand for 220 volt supply is available in some locations.

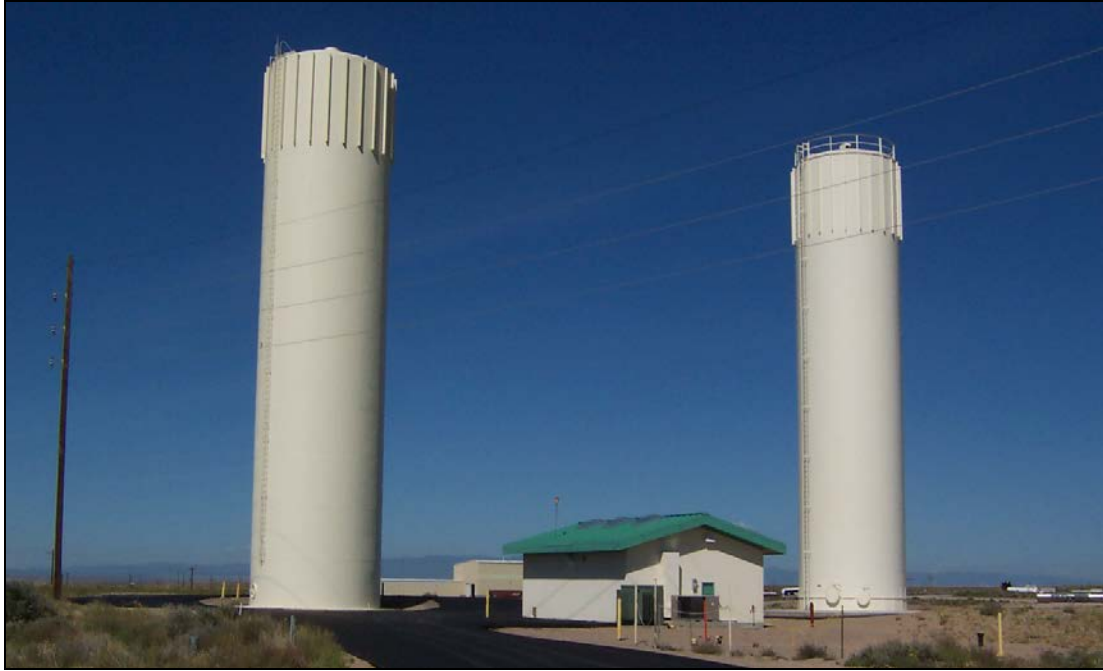
Figure 50. Water Reservoir and Distribution Pump House.

The water transmission line is a 6 inch (152 mm) diameter PVC line installed in 1972. There are several buildings that tap into the transmission line for water supply, including the URB, DC Substation #1, SMB, TMB, and FAST Facility. The FAST Facility service line extends from the Main Well Pump House north by north west approximately 1 mile (1.6 km). The line is a 2.5 inch (63.5 mm) diameter PVC line installed in 1977. Water pressure for the buildings

serviced from the transmission lines varies from 40 to 50 psi (276 to 345 kPa) when there are normal operating levels in the water towers.
