**INSPECTION GUIDE FOR COLUMN SPLICE REGIONS AFFECTED BY
PREMATURE CONCRETE DETERIORATION**

Report 0-5722-P2

Project Title: Lap Splice and Development Length Performance in ASR and/or DEF Damaged
Concrete Elements

Published: July 2016

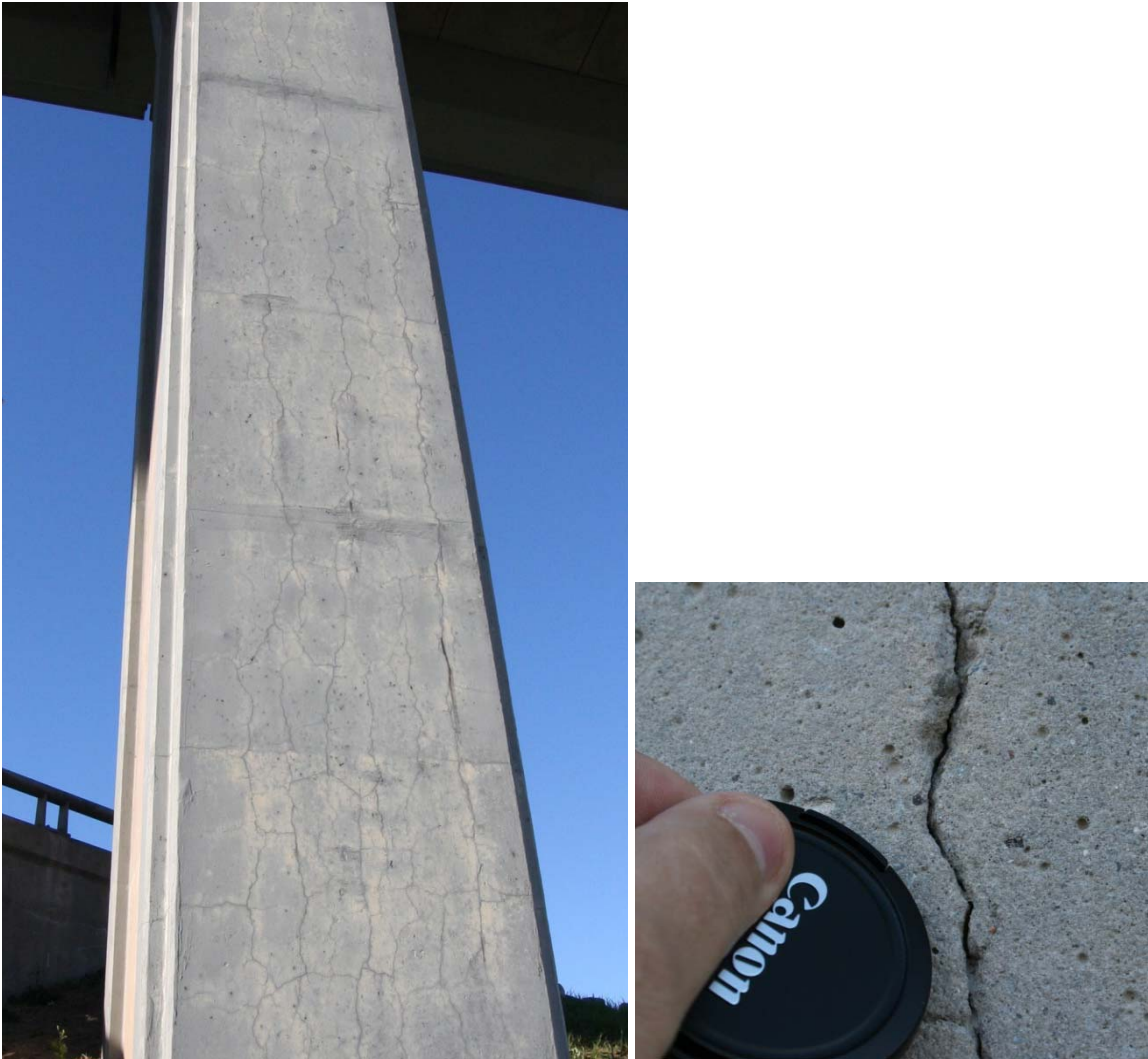
Figure 2-1. Cracking in Column under Axial Compression Loads (Houston, TX).

However, in both cases, as ASR/DEF effects continue, cracks can also develop in other directions from the initial cracks that formed in the tension field (see Figures 2-1 and 2-2a). Shear cracking in the D-regions (bent cap-column joint regions) are also evident. Figure 2-3 shows an example of a bridge bent cap with mapped cracking predominantly influenced by ASR under minor levels of gravity loading (minimum tension field).

(a) Column Elevation View

(b) Close-up View of a Typical Crack

Figures 3-7, 3-8, and 3-9 show sample cracking that developed throughout the exposure phase for LSC Specimens #1, #8, and #12, with about 2.3, 3.0, and 5.8 years of exposure, respectively. The figures show that substantial cracking resulted and the cracking pattern was similar between the specimens, even though the exposure periods of the specimens varied. LSC Specimens #1 and #8 had similar crack widths; however, Specimen #12 had some much larger crack widths (about two times those of Specimens #1 and #8, as reported in Table 3-4). The specimen cracking, as shown in Figures 3-7, 3-8, and 3-9, is comparable to the cracking in actual field structures affected by ASR (see Figure 2-1).

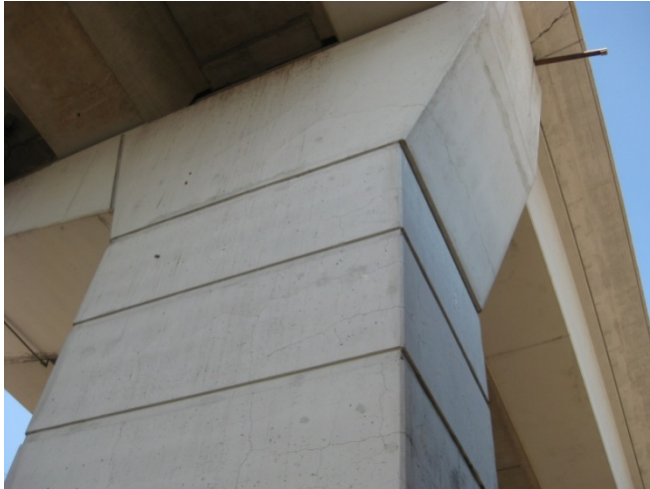
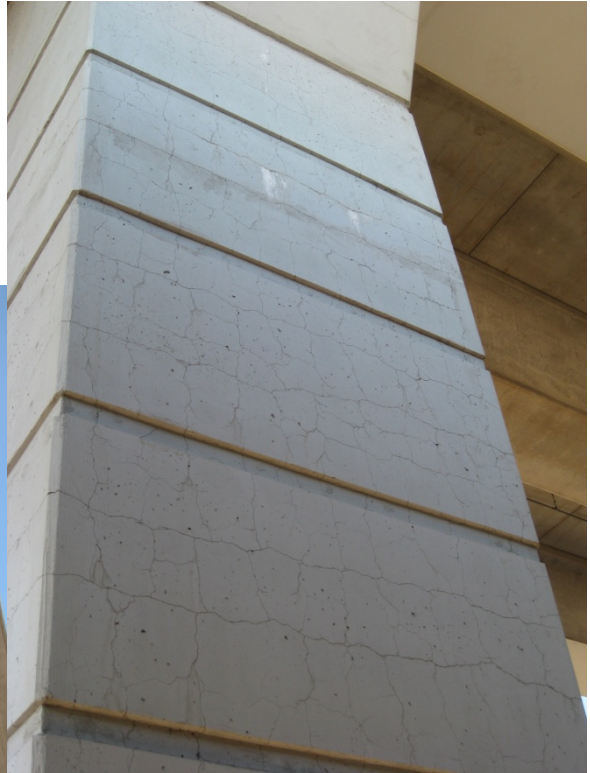
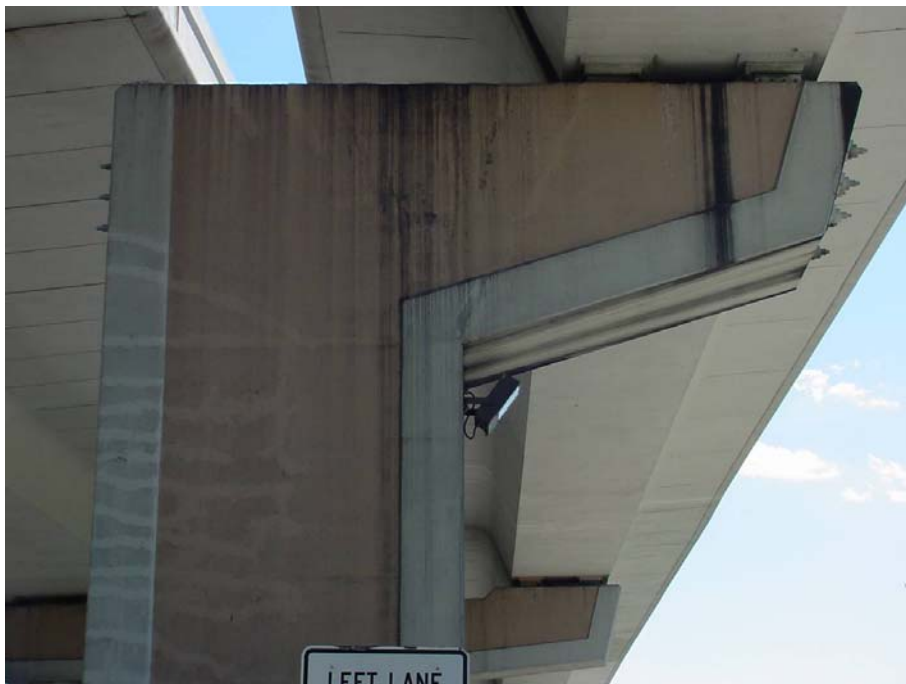
Figure 2-2. Cracking in Cantilevered Bents under Axial and Overturning Moments.

Both ASR and DEF can lead to volumetric expansion of concrete; therefore, initial cracking from these mechanisms typically develops in the tension field of the concrete member under gravity loading. This research program investigated the structural performance of column specimens, with particular focus on the lap splice region, with varying levels of ASR and DEF. Figure 2-1 shows an example bridge column in Texas under predominantly concentric axial service loading where cracks have developed in the splice region (directly above the foundation), and these cracks were reported to be primarily due to ASR (Folliard et al. 2009). The figure shows that cracks propagate vertically along the column length in the direction of the tension field caused by Poisson's effect from the compressive axial service loads on the structure. For columns of cantilevered bents with applied overturning moments (see Figure 2-2), predominant cracking first develops in the tension field due to the overturning moment (Bracci et al. 2012).

(a) Elevation View and Typical Cracking on Tension Face (Houston, TX).

(b) Elevation View (San Antonio, TX)

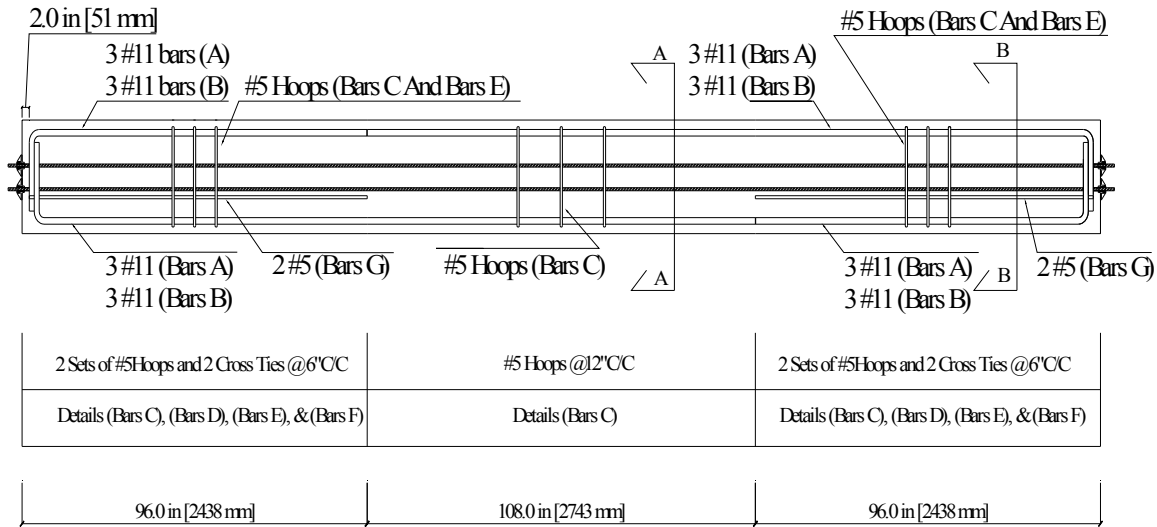
Figure 3-1. Reinforcement Layout.

Figure 3-1 and Figure 3-2 show the dimensions and rebar layout of the LSC specimens.

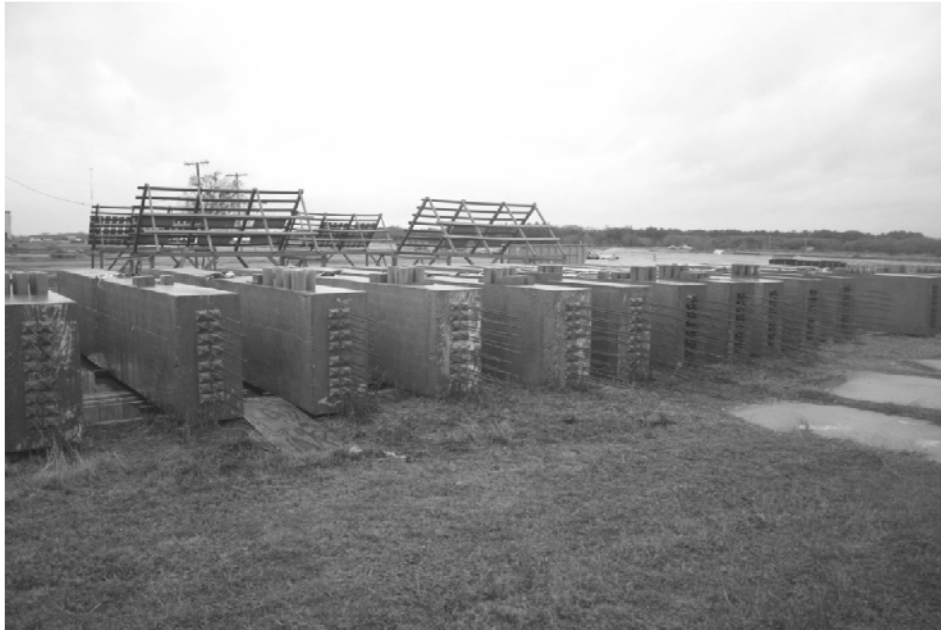
Figure 3-4. LSC Specimens Exposed to the Environment at the Riverside Campus.

Shortly after the construction of LSC specimens and application of the preload to simulate gravity loading from in-service conditions, the specimens were placed outside at the Texas A&M University Riverside Campus in Bryan, Texas, where they were exposed to the environmental weather conditions of the area and supplemental water to accelerate the ASR and DEF

deterioration mechanisms (see Figures 3-4 and 3-5). A sprinkler system activated four times a day and for 15 minutes each time supplied the supplemental water.

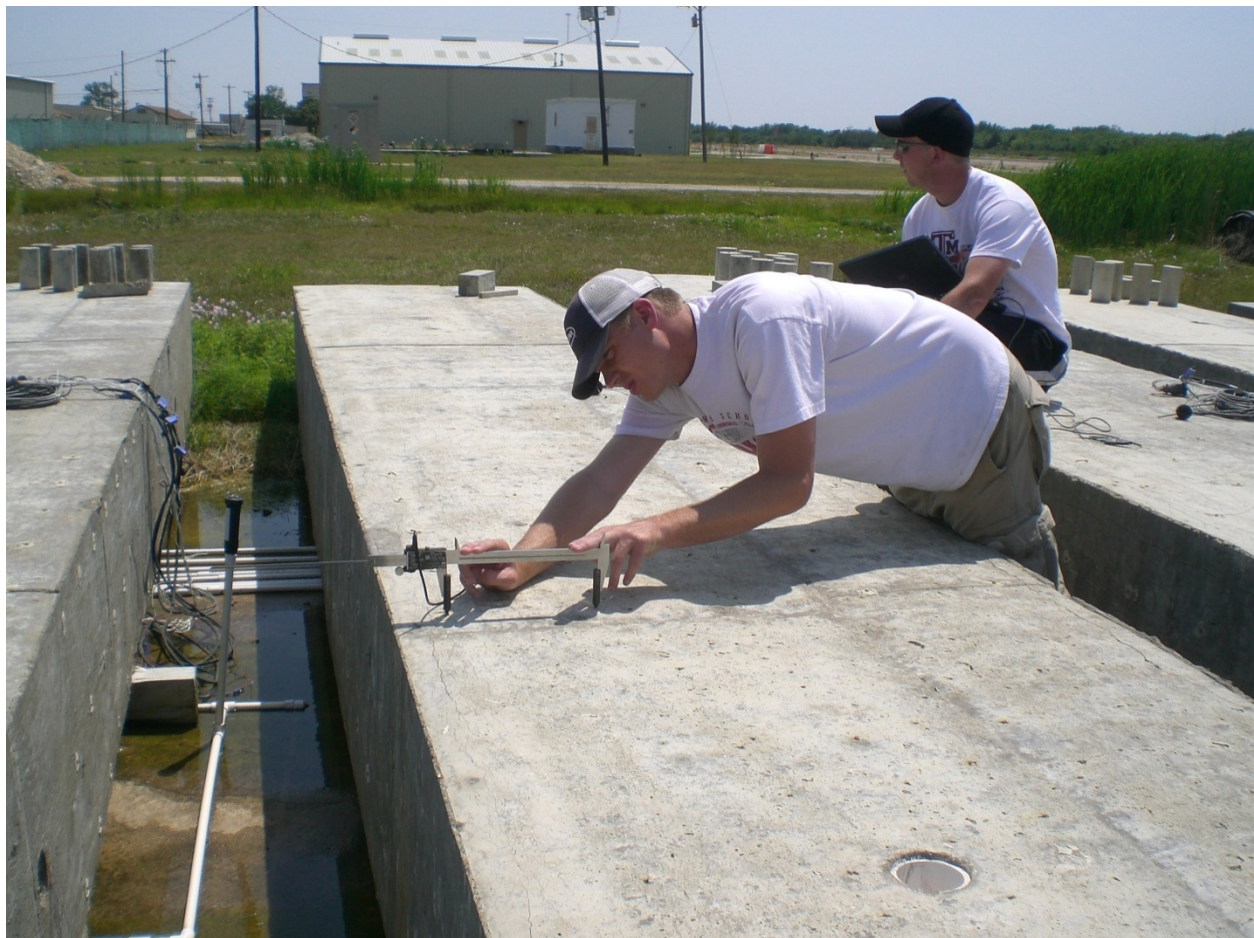
Figure 3-6. DEMEC Surface Strain Measurements.

The behavior of the LSC specimens during the environmental exposure conditions was monitored with external and internal measuring devices. Demountable mechanical (DEMEC) points were mounted on the surface of the specimens and provided a way to measure the external surface deformations using a caliper during the exposure phase (see Figure 3-6). Electronic strain gages were placed on the reinforcing steel, and concrete embedment gages were placed within the concrete specimen to measure the internal deformations during the exposure phase. Tables 3-3 and 3-4 summarize specimen age at structural testing, measured surface expansions and concrete crack widths on the different faces of the specimens, and estimated degrees of ASR and DEF at the time of structural testing, which were determined based on the surface strains and cracking, measured internal strains, and petrography analysis of concrete cores taken from the specimens after they were structurally tested.

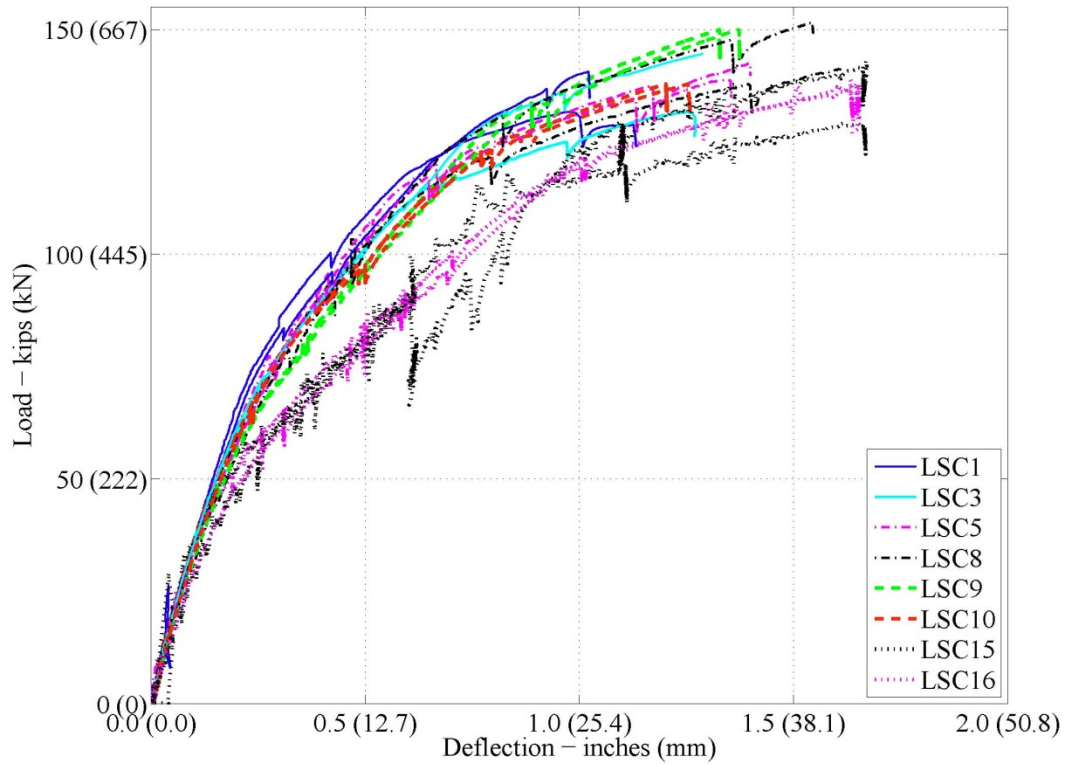
Figure 3-12. Experimental Load vs. Deflection during Four-Point Test: Specimen Behavior at the Actuator Load Point (Splice End) (Bracci et al. 2012)

Figure 3-12 shows the measured force-deformation behavior of the control specimens (LSC15 and LSC16) and those with varying degrees of primarily ASR (and minimal DEF), as identified in Tables 3-3 and 3-4, during the four-point test setup prior to the project extension phase (originally reported by Bracci et al. 2012). Figures 3-13 and 3-14 show the measured force-deformation behavior of LSC Specimens #12 and #4 tested during the project extension phase with increasing levels of concrete expansion and cracking due to primarily ASR (and minimal DEF), as identified in Tables 3-3 and 3-4, during the four-point test setup. The figures show that the structural behaviors of Specimens #12 and #4 are comparable to those specimens tested early in the research project that were influenced by ASR. In particular, the structural testing of Specimen #4 was taken to significantly larger deformations (terminated close to when the researchers deemed structural failure was eminent) in order to get an indication of structural ductility capability of the spliced region. Also, the structural response of the specimen at around 1 inch displacement seemed to have unloaded at one actuator point and further loaded at the other actuator point. This response developed due to a slight shift in the physical supports at the

As seen by comparing Figures 3-12, 3-13, and 3-14, the specimens with varying degrees of ASR showed no evidence of bond deterioration within the splice, had similar initial stiffness and behavior up to the first cracking, had a 25 to 35 percent increase in post-cracking stiffness up to yielding, had a 5 to 15 percent increase in yield strength, and showed no overall detrimental effects on the structural response when compared to control specimens without ASR deterioration. This improved behavior can be explained by the resulting volumetric expansion of the concrete due to ASR that engaged the longitudinal and transverse reinforcement, which is believed to have resulted in increased axial loading and better confinement of the core concrete.
