**Federal Railroad
Administration**

Improved Quality Truck Castings

1. AGENCY USE ONLY (Leave blank)		2. REPORT DATE June 2016		3. REPORT TYPE AND DATES COVERED Technical Report – June 2014
4. TITLE AND SUBTITLE Improved Quality Truck Castings			5. FUNDING NUMBERS DTFR53-00-C-00012 FRA Task Order 254

9. SPONSORING/MONITORING AGENCY NAME(S) AND ADDRESS(ES) U.S. Department of Transportation Federal Railroad Administration Office of Railroad Policy and Development Office of Research, Development, and Technology Washington, DC 20590			10. SPONSORING/MONITORING AGENCY REPORT NUMBER DOT/FRA/ORD-16/18

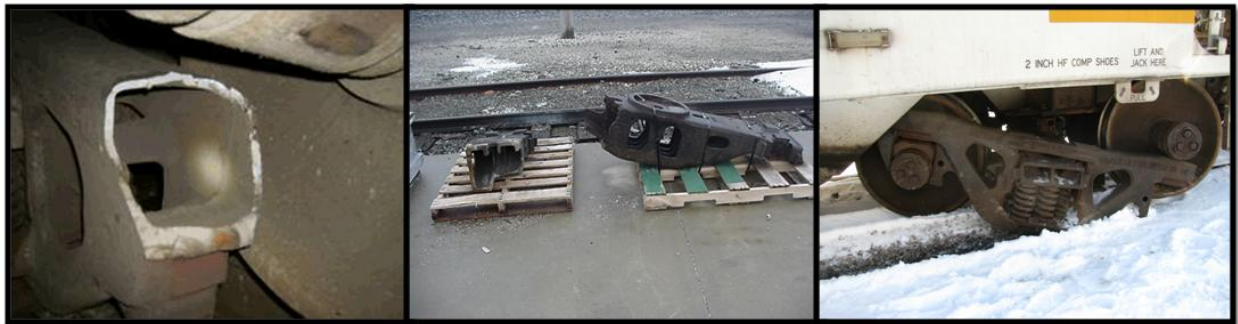
Figure 1. Examples of Brittle and Fatigue Failure in Truck Castings

Brittle failures can be attributed to marginal strength and poor impact resistance of the cast steel material. This failure mode is dangerous because it occurs instantaneously and under stresses that can be below the yield strength of the material. Figure 1 shows several examples of brittle and fatigue failures.

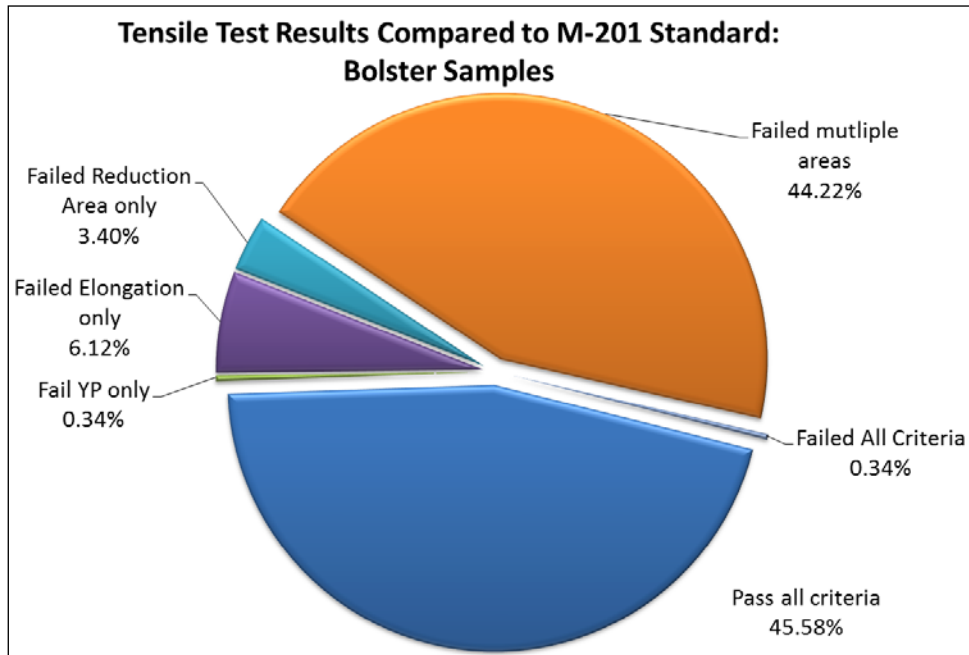
Figure 3. Tensile Tests Results from All Bolster Samples [4]

Fourteen tensile specimens were tested from each bolster; for the foundries that provided keel blocks, four additional specimens were tested. A total of 313 tensile tests were performed. Ultimate tensile strength, 0.2 percent offset yield strength, elongation, and reduction of area were measured in each test. Figures 3 and 4 show summaries of the results.

As seen in Figures 3 and 4, a large number of specimens from the bolsters did not meet the minimum requirements. Of these, most were low on both elongation and reduction of area. The keel block specimens performed somewhat better, but there were still some that tested below the requirements. For the keel block samples, 25 percent of them did not pass the yield strength requirement. Some of the low performing samples were examined with low power optical microscopy; the fracture surfaces indicated very rough surfaces and porosity.

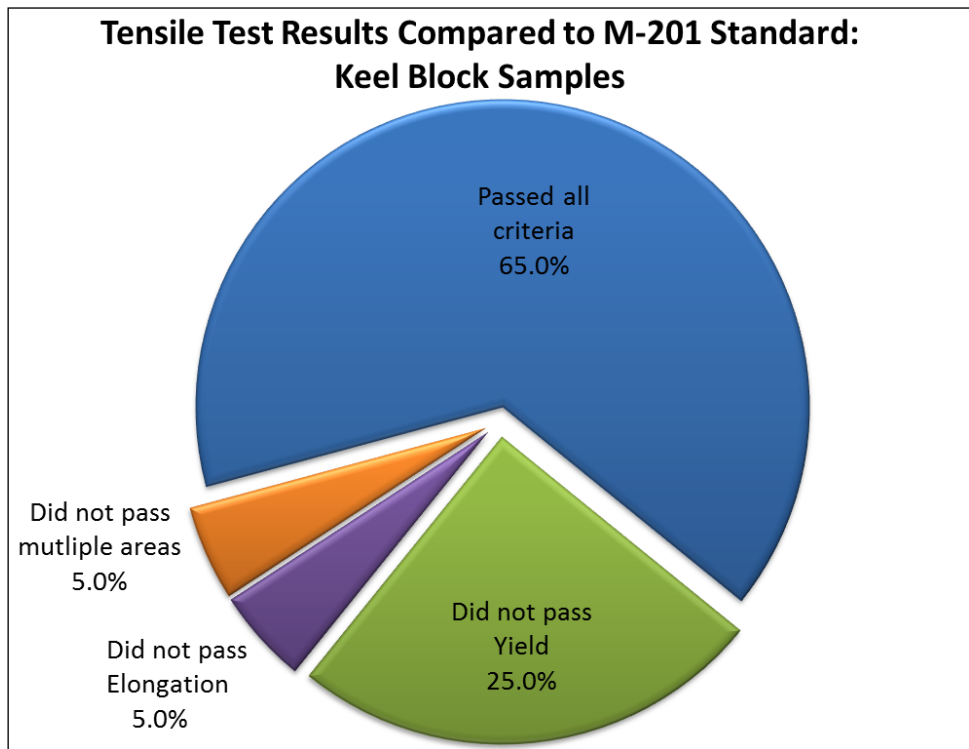
Figure 4. Tensile Test Results from Keel Block Samples [4]

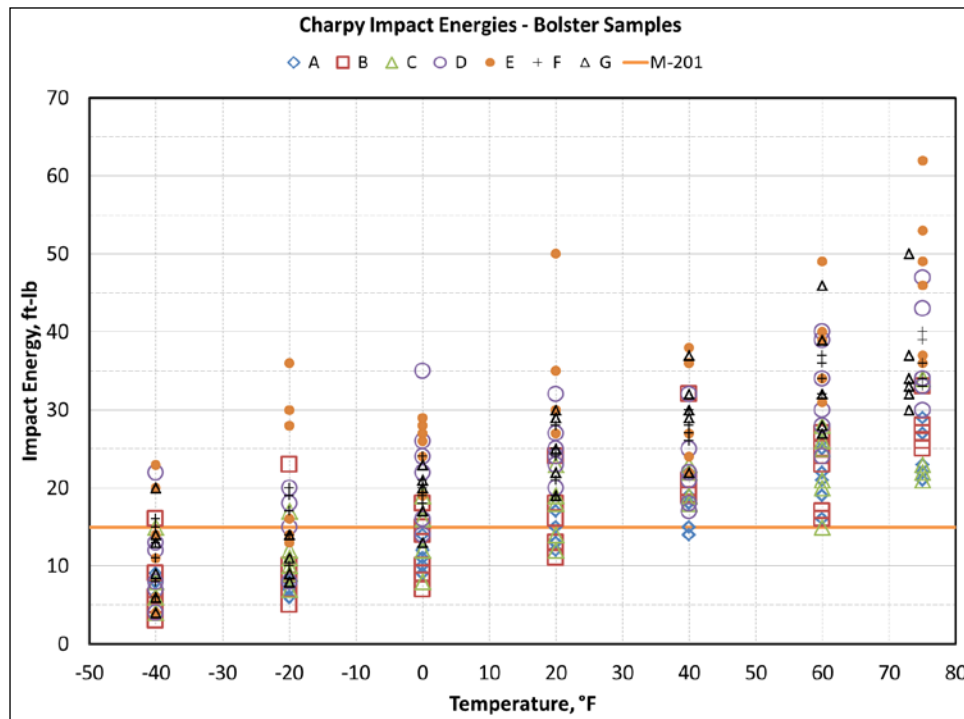
Figure 5. Charpy Impact Test Results from All Bolster Samples

Fourteen Charpy impact samples were tested from each bolster. There were seven test temperatures, and two samples per test temperature per bolster were tested. For the foundries that supplied keel blocks, four additional Charpy samples were tested. The keel block data is not presented here due to the small sample size. Figures 5 and 6 show the test results for the bolster samples.

The testing was conducted over a wide range of temperatures, but the critical test temperature per the AAR M-201 standard is 20 °F (-7 °C). Foundries A and B had samples that did not meet the minimum requirement of 15 ft-lbs (20 N-m) at the critical temperature [5]. These two suppliers also had the largest number of tensile samples that did not meet the elongation and reduction of area requirements.

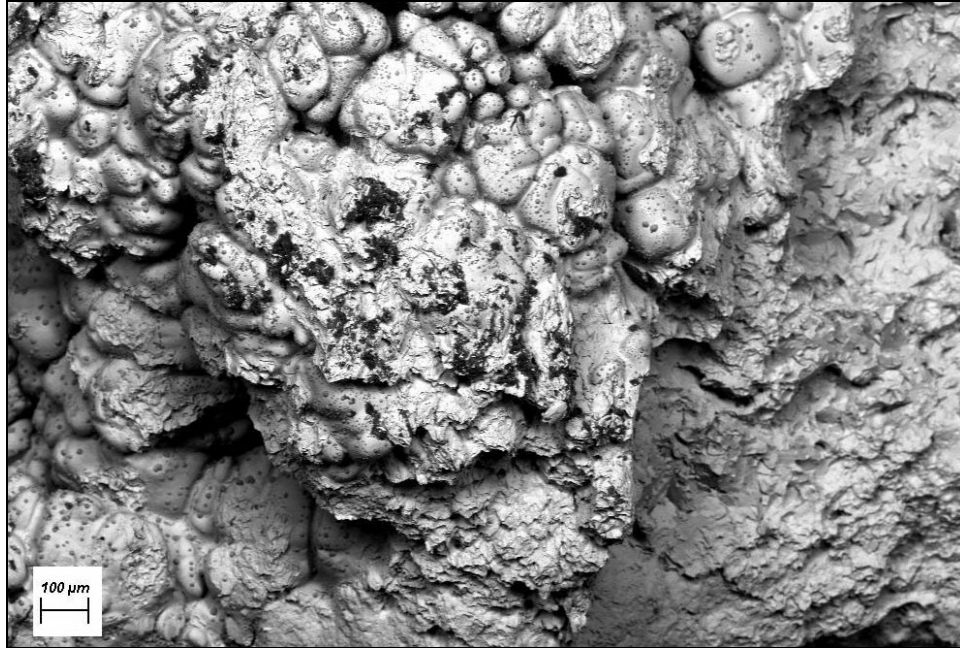
Figure 7. Gas Porosity in a Low Performing Charpy Impact Specimen

To further investigate the causes of the low impact energies, the fracture surfaces of 11 of the lowest performing Charpy impact samples were analyzed with a scanning electron microscope (SEM) [6]. All of the samples in this group showed some degree of shrinkage porosity on the fracture surface. As expected, most of the samples tested at relatively warm temperatures exhibited at least partially ductile fracture surfaces, while the samples tested below 0 °F (-18 °C) were entirely brittle. Figure 7 shows a SEM of the sample with the lowest absorbed energy of the 11 samples [6]. This feature is inside a large pore. The black oxide material on the dendrites indicates this porosity was likely caused by gas; the large pore was likely a major reason for the low absorbed energy of this sample. Shrinkage porosity can be controlled by modifying the gating and risering system, and by monitoring the melt temperature. Gas porosity has two sources: core gases and dissolved gases in the metal.

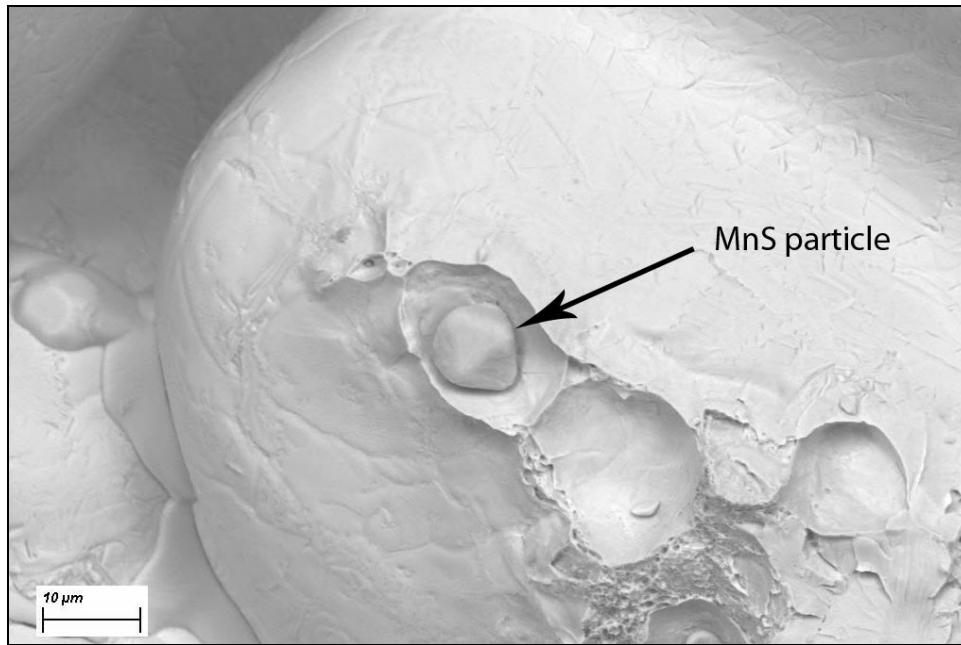
Figure 8. Manganese Sulfide Particle in Charpy Specimen

Also, inclusions can greatly reduce the strength or impact energy; these are frequently present as oxides or sulfides. The oxygen and sulfur atoms typically combine with a metal atom, forming a hard inclusion. These inclusions form discontinuities in the material and cause lower mechanical properties. Figure 8 shows an inclusion that energy dispersive spectroscopy revealed to be a manganese sulfide (MnS) particle in a pore of a Charpy impact fracture surface [6]. Inclusions occur because of residual elements in the scrap steel used for melt material, oxygen entrained during melting and pouring, or sand from the mold. Control of scrap sources, gate modification, and improved molding techniques can reduce these inclusions.

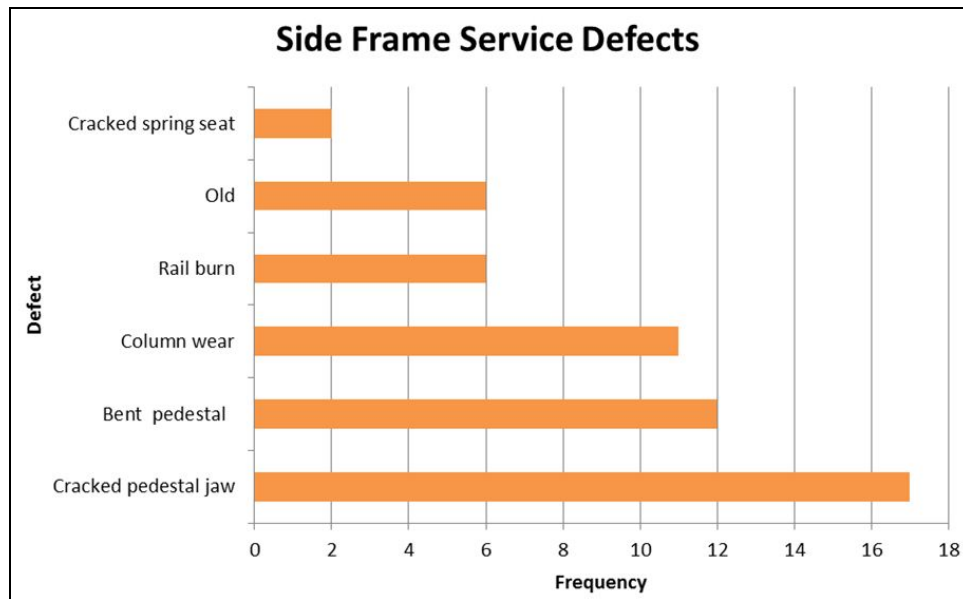
Figure 22. Common Side Frame Defects Seen during Survey [9]

Figure 22 shows the top six side frame defects, which represent 93 percent of the defective side frames examined.

The remaining defects were cracks below the wear plate, bent spring seats, and cracks on lightening holes.

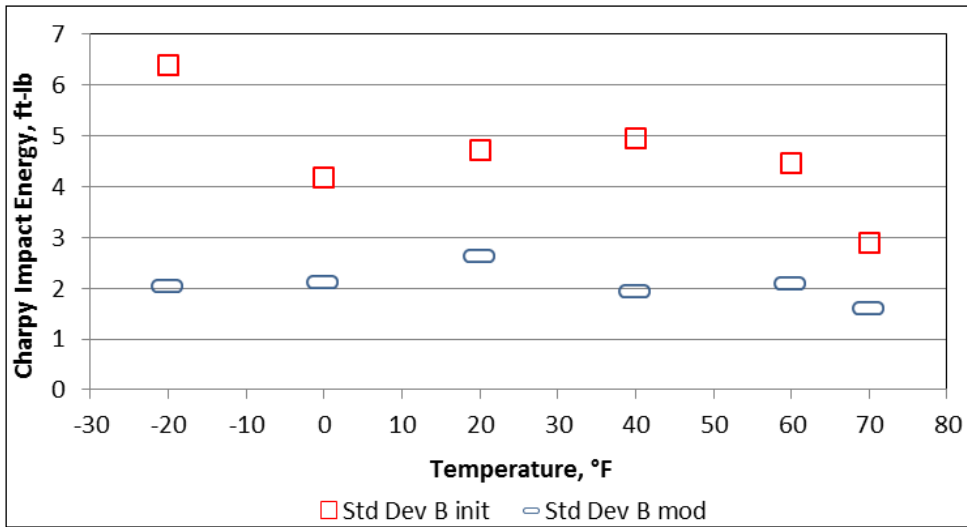
Figure 28. Standard Deviation of Foundry B Charpy Impact Samples

Figures 27–29 show different representations of the Charpy impact test results for both sets of Foundry B tests. Samples tested at 75 °F (24 °C) in the initial round were tested at 70 °F (21 °C) during the second round of testing. Though there was little, if any, statistical difference in the impact energies, the mean impact energies decreased for the modified samples. This was not expected. However, the ranges and standard deviations showed definite decreases.

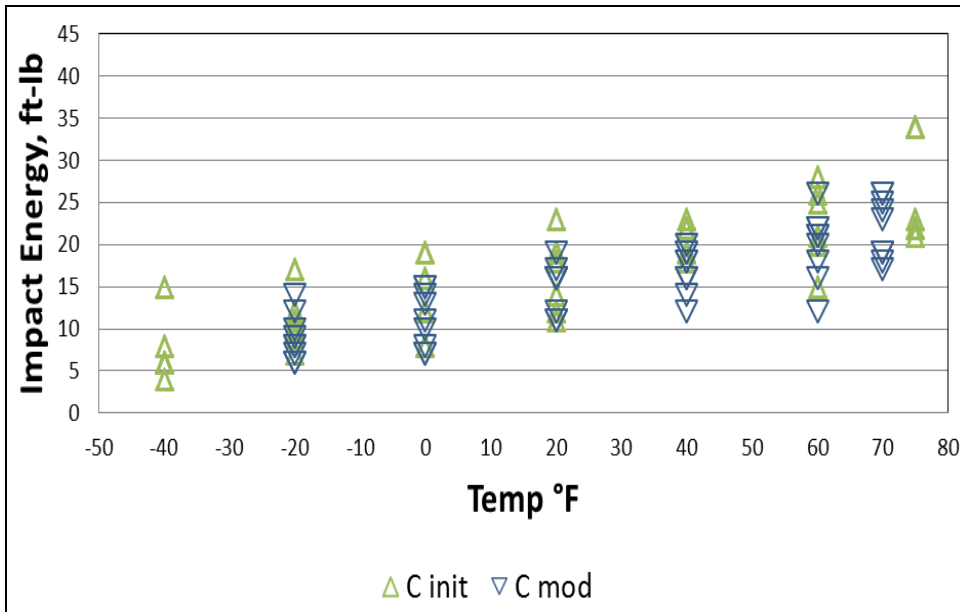
Figure 30. Charpy Impact Test Results from Standard and Alternate Parameters for Foundry C

Figures 30–32 show different representations of the Charpy impact test results for both sets of Foundry C tests. Samples tested at 75 °F (24 °C) in the initial round were tested at 70 °F (21 °C) during the second round of testing. As with the results from Foundry B, there was little statistical difference in the impact energies; again, the mean impact energies decreased for the modified samples. The ranges and standard deviations decreased as most test temperatures decreased.

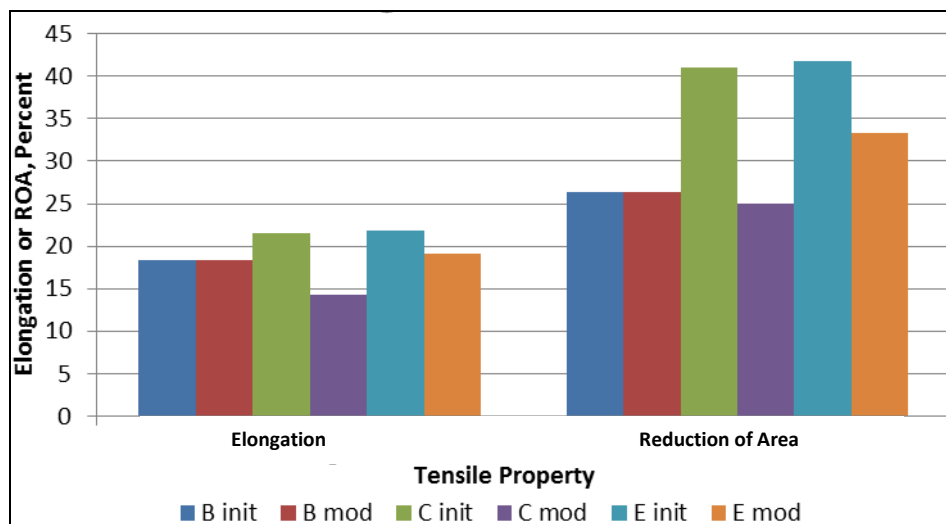
Figure 36. Mean Elongation and Reduction of Area Changes for Foundries B, C, and E

Figure 36 shows the elongation and reduction of area values for the three foundries; both of these properties are measures of ductility. All of the foundries had mean elongation values below the required 24 percent, though some were well above this. Two suppliers had reduction of area values above the required 36 percent for the initial set of tests. For the second set of tests, the mean value for all foundries was below the requirement. The results for each supplier are detailed in the following sections. In Figure 36, the “init” designation stands for initial and or “mod” stands for modified.
