**Federal Railroad  
Administration**

## **Geothermal Switch Heater Installation, Testing and Monitoring – Phases 1 & 2**

| 1. AGENCY USE ONLY (Leave blank) | 2. REPORT DATE<br>July 2016 | 3. REPORT TYPE AND DATES COVERED<br>Technical Report | |

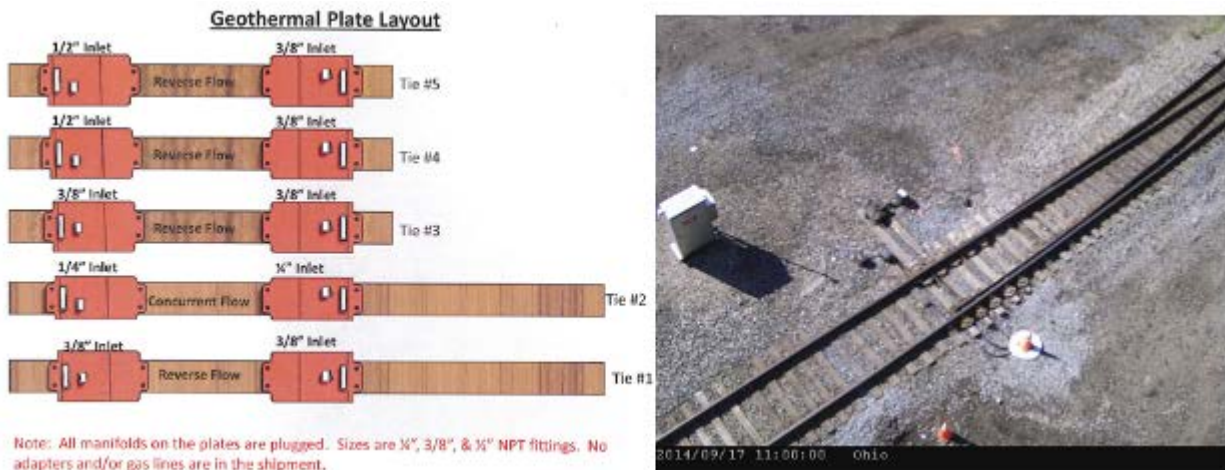
Figure 4. Switch Configuration and Tie Plate Layout

Voestalpine Nortrak tie plates were installed in the switch during the week of August 31–September 6, 2014. The old switch plates were removed and 10 specially designed tie plates were installed before initiation of other system installations. The tie plates were designed for a left hand turnout that switches from the right side, which was the configuration at a previous location choice. The 55<sup>th</sup> Street location has a left hand turnout with switch stand on the left side, whose different layout was successfully accommodated by the switch plate installation gang during preliminary site activities. However, there were some problems matching the tubing to the switch plates as a result of the different head block configurations. Figure 4 shows the switch configuration and tie plate layout. The left graphic is Nortrac's left hand turnout design showing the switch head blocks on the right and the right graphic shows the left hand turnout installed at the test site.

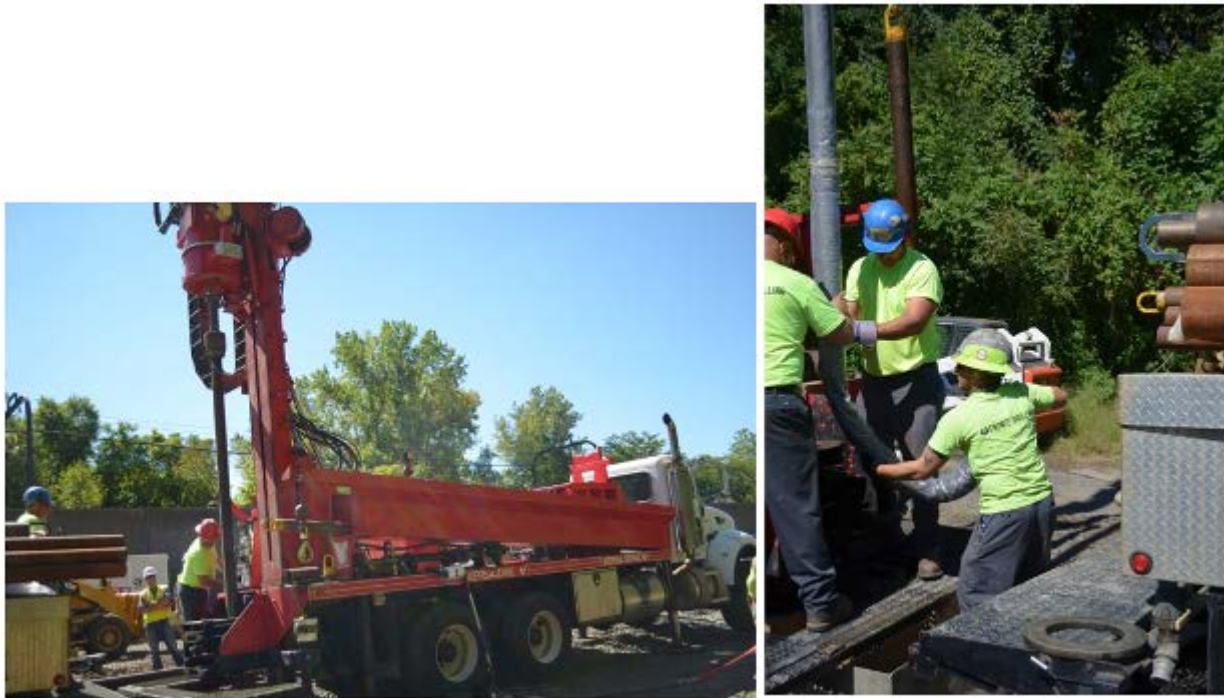
**Figure 5. Drilling and Sampling Well 1**

Fronz Drilling drilled two boreholes to 175 feet according to the work plan, using a sonic drill rig. Continuous coring methods were used, producing a 4-inch diameter core in unconsolidated soils to 150 feet below ground level, and a 2-inch core in consolidated sediments from 150 to 175 feet below ground level. Golder Associates logged the boreholes and produced a drilling log of the results. Geothermal wells were drilled in predetermined locations; one on either side of the track. Figure 5 shows the sonic drill rig in operation and a 4-inch diameter sample extraction of soil.

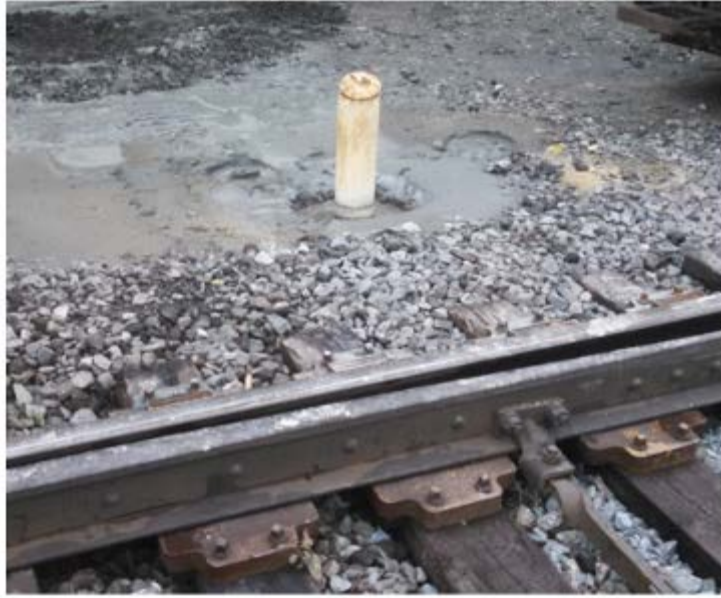
**Figure 7. Bore Hole 1 Completed  
(casing riser was cut off before tubing installed)**

Well 2 was drilled with similar methods, except that it was not required to produce any soil samples. Consequently, Well 2 was drilled with the 8-inch diameter bit to the total depth, and completed in a similar manner as Well 1. Well 2 took approximately two days to drill and complete, compared to four and a half days for the first well.

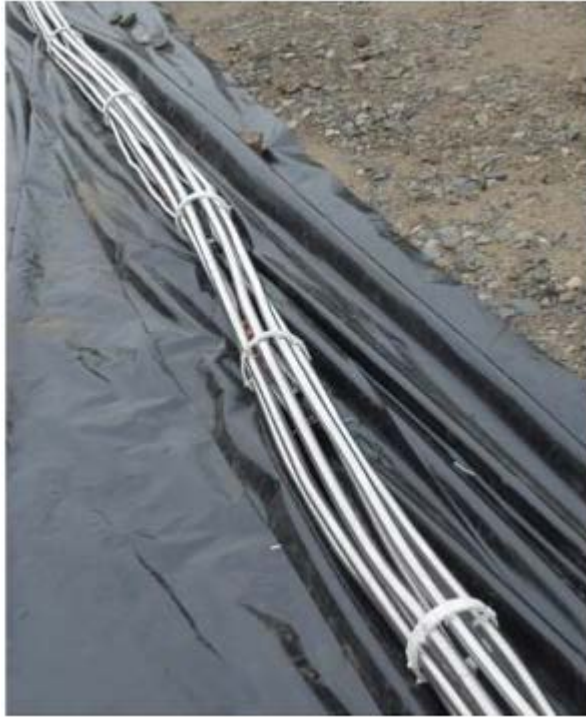
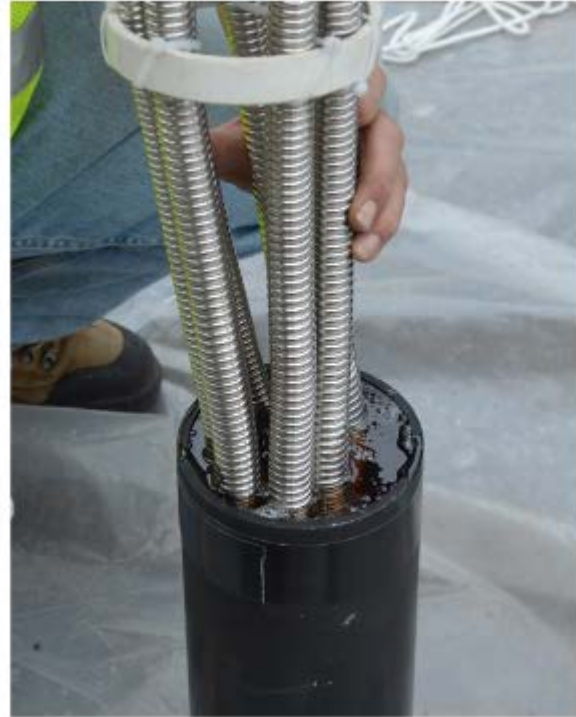
**Figure 9. Tubing Preparation**  
(left) tubing with spacers (right) epoxying the tubing

Spacers and zip ties were initially used to hold tubing apart down-hole, maximize tubing contact with groundwater. The cluster was to be 5-inch diameter, and the 6-inch PVC inside diameter was 5.5 inches, resulting in a clearance of  $\frac{1}{2}$  inch between the tubing cluster and the well inner diameter. It was found during tubing insertion that this did not allow enough room for sidewall frictional forces, buoyancy effects, and zip tie thickness. Figure 9 shows the tubing with the spacers attached and epoxying the tubing into the 85-pound steel ballast weight.

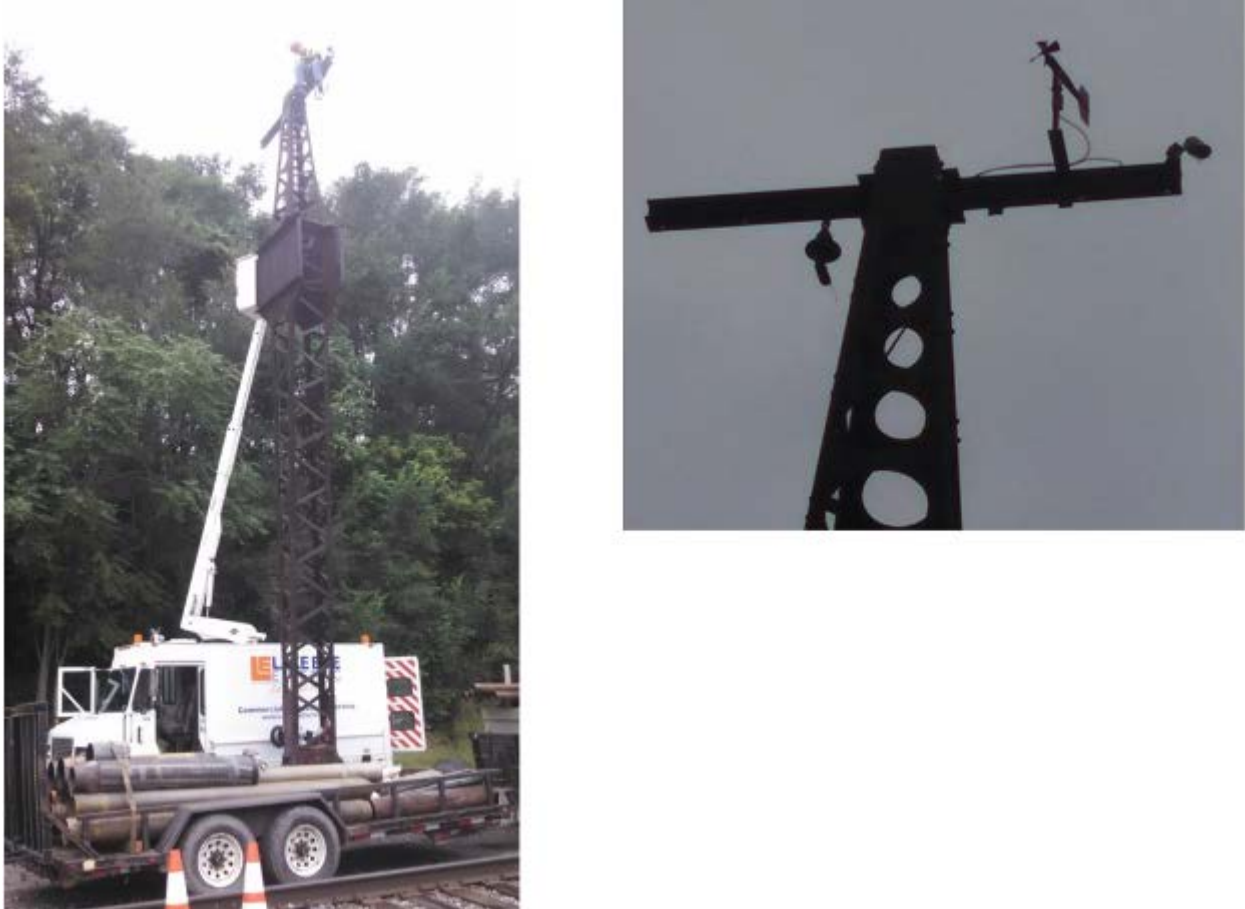
**Figure 17. Anemometer and Camera System**

The metal tower located near the switch was used to mount the camera and anemometer for the system (Figure 17).

The camera and anemometer logged photos of the switch heater from above every 10 minutes, and provided wind speed information.

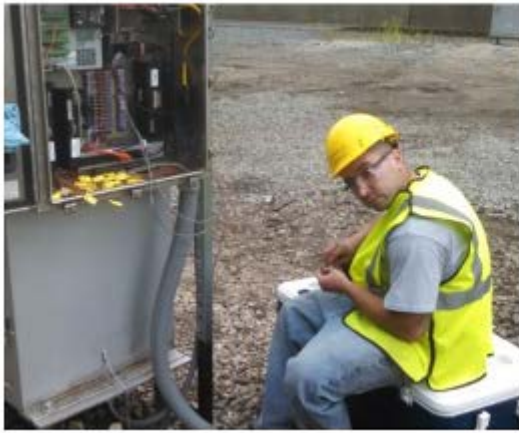
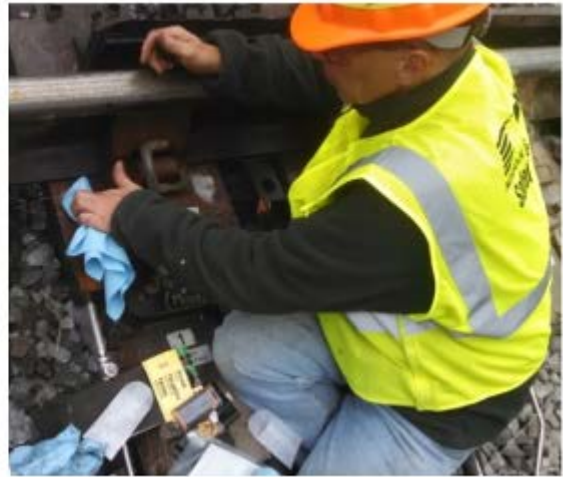
**Figure 18. Preparation of Signal Wire and Installation of Switch Plate Thermocouples**

Signal wiring was used to connect down-hole, track, switch plate, and ambient thermocouples to the instrumentation logging box (Figure 18). Trenches were dug and 2-inch diameter flexible conduit was placed in the trenches at a depth of at least 12 inches to minimize the potential for cable damage during the testing and logging of the systems.

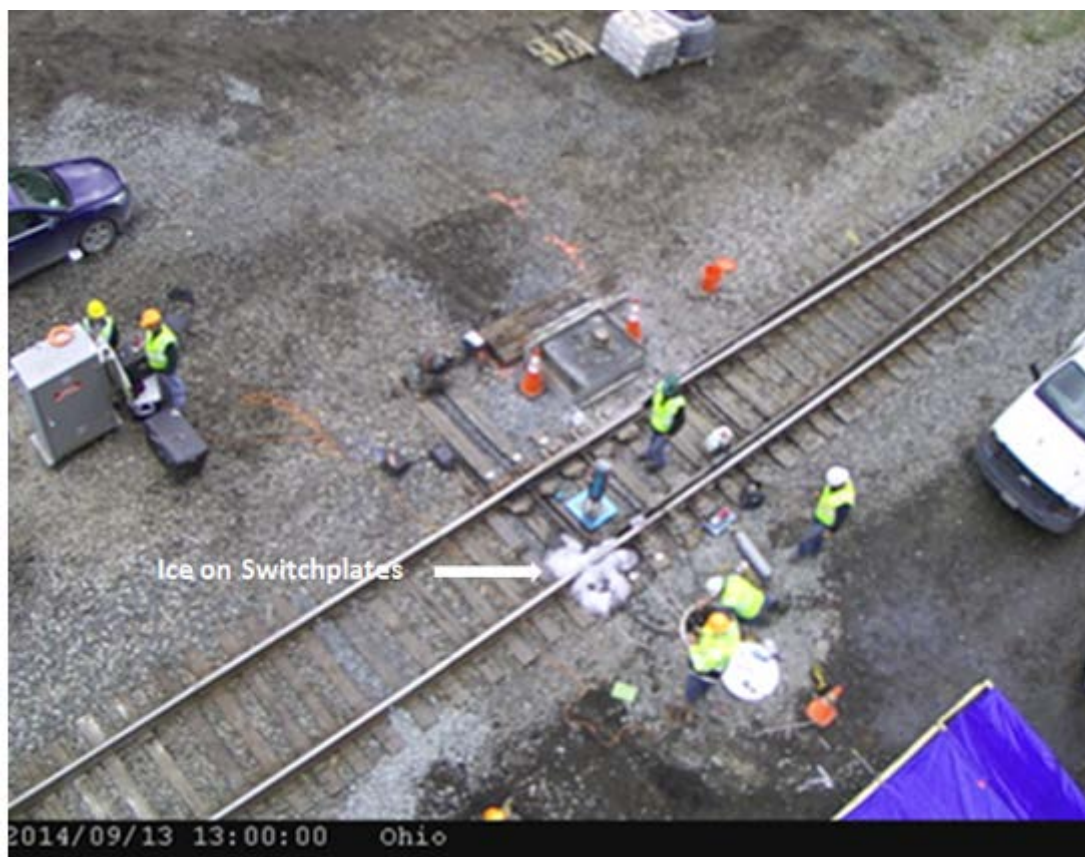
**Figure 19. Overhead View of Initial Ice Melt Test**

The refrigeration contractor charged two of the down-hole refrigeration systems successfully, corresponding to Switch plate 1 (right side “R”) and Switch plate 2 (right side “R”). The tubing associated with the left sides of the two switch plates, “L”, did not hold pressure, so were “dead” and not charged with gas. As soon as they were pressurized, an ice test was immediately performed on the two charged systems, using approximately 240 pounds of ice which had been ordered for system testing. The ice was placed directly on Switch plates 1 and 2. It was observed that within 30 seconds of placing the ice on the two switch plates, the associated “R” crossover tubing was noticeably cold, which meant that liquid ammonia was passing through the down-hole tubing as it condensed and released heat into the switch plates. The “L” side tubings were at ambient temperature, with no condensate passing through them. The test continued for approximately 1 ½ hours, after which the ice was melted.

The ice melt test produced visual and instrumentation results, which indicated that the conceptual principles of the technology are sound, but additional work needs to be accomplished to complete the working system. Figure 19 and Figure 20 show the ice test and results.

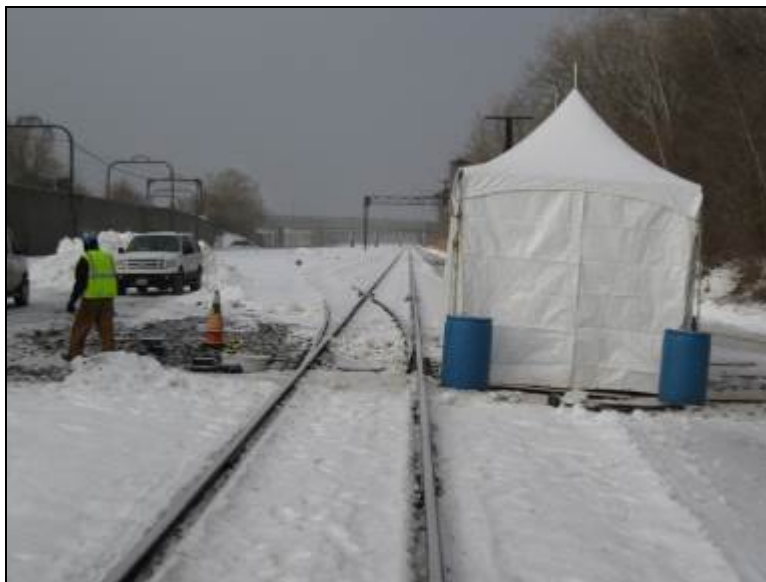
**Figure 21. Phase 2 Installation of Geothermal Switch Heater**

The final installation of the geothermal switch heater system was completed in February 2015 (Figure 21). Geothermal Wells 1 and 2 had already been completed and were ready to receive the refrigerant tubing. A local refrigerant contractor had removed damaged wellhead fittings from the refrigerant tubing cluster and replaced them with higher quality fittings. In addition, the crossover tubing connection to the switch plates were redesigned to receive a 2-foot-long flexible connector to provide dynamic damping and fatigue reducing properties to the wellhead tubing pieces.

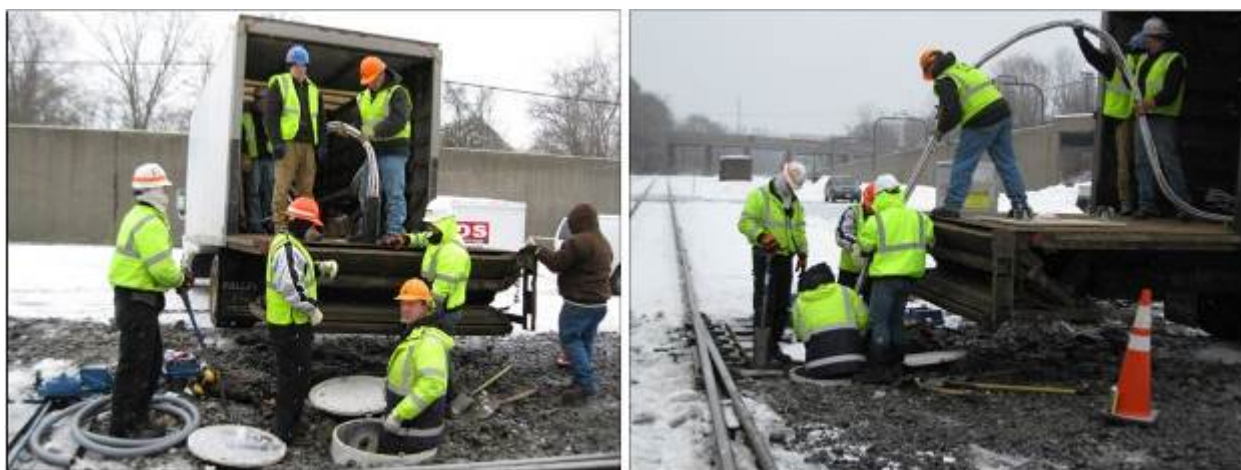
**Figure 22. Installing Refrigerant Tubing into Well 2**

Snow was cleared away from the work area at the site, and the refrigeration contractor backed up a delivery truck to Well 2, which had been prepared with an instrumentation vault at ground level, identical to the vault that had been positioned over Well 1. The tubing was coiled up in a large roll for transport from the shop, and the ballast weight was positioned to go down the well first (Figure 22). The tubing was uncoiled down into the well by hand, and the tubing insertion process took less than 10 minutes. The insertion proceeded smoothly and the well cap was tightened into place. The total process was streamlined using lessons learned from Phase 1 work.

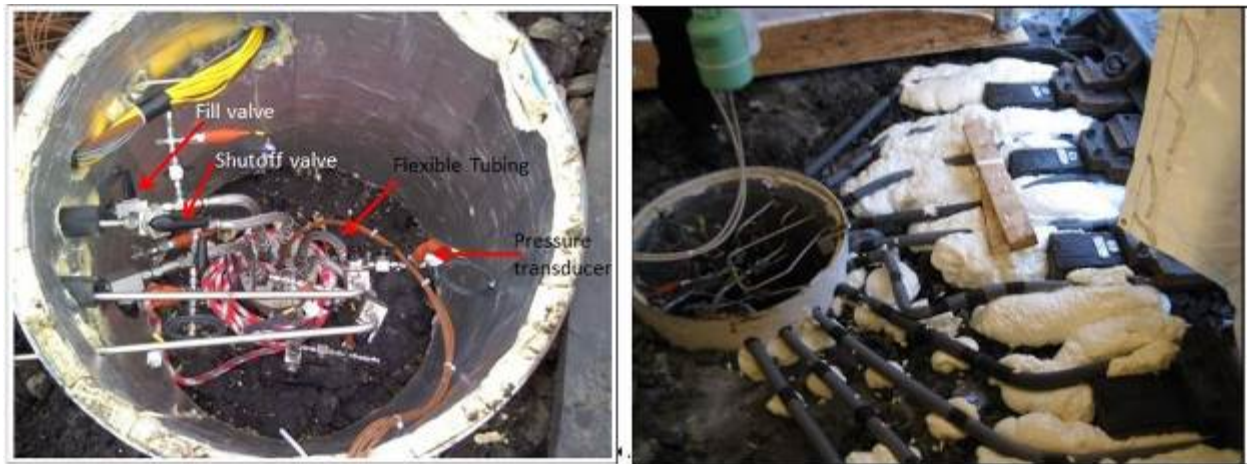
**Figure 23. (left) Vault Interior Details (right) Tubing Support Insulation**

1. Vault wall insulation – Rigid 1-inch insulation on the inside walls of the instrumentation vault.
2. Pipe insulation on the crossover tubes.
3. Spray foam insulation between the crossover tubing also served as a flexible support during dynamic track movement when trains are passing (Figure 23 right).
4. Polyurethane peanuts were used to fill the vaults after the system was complete. The peanuts can be vacuumed out for servicing the systems.

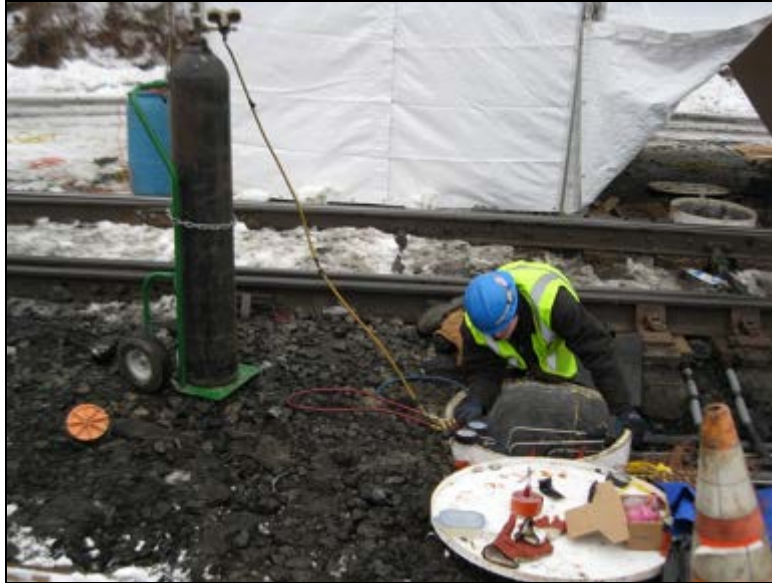
**Figure 26. Purging the Systems with Nitrogen**

After the tubing was in place, each system was pressure and vacuum tested with nitrogen overnight before filling with ammonia (Figure 26 and Figure 27). The nitrogen also served to capture and displace any air and water vapor that might be present before the systems were charged with ammonia. Nitrogen purging was performed three times, then ammonia was introduced to the evacuated system.

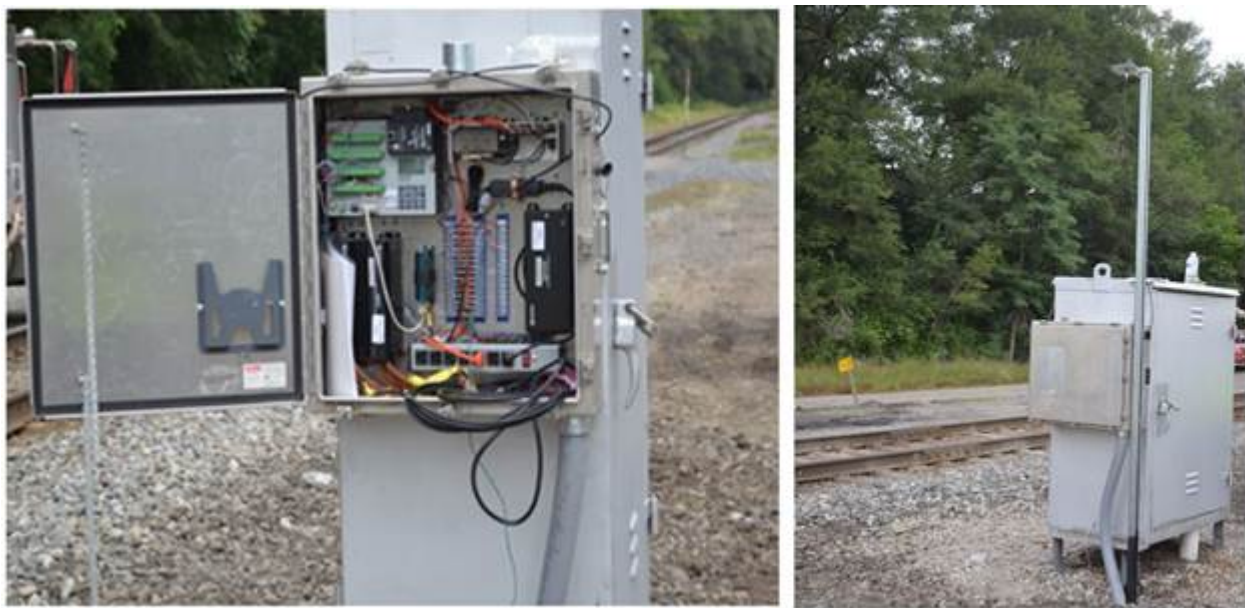
**Figure 28. Instrumentation Logging and Remote Telemetry Box**

Thermocouple cable and signal wiring were used to connect down-hole, track, switch plate, and ambient temperature thermocouples and pressure transducers to the instrumentation logging box (Figure 28). Of 29 thermocouples originally placed in the wells and above ground, 23 are still recording data.

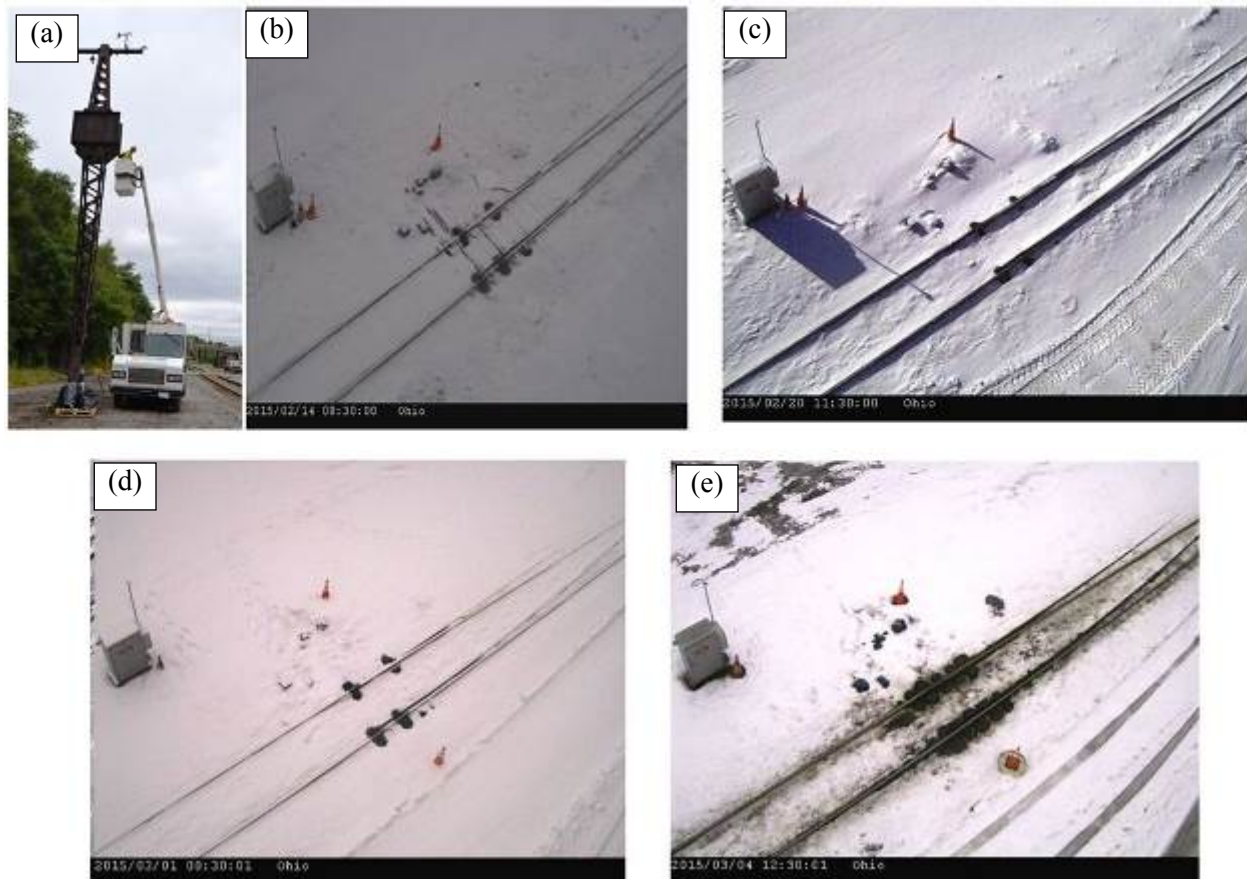
**Figure 30. (a) Overhead Camera and Anemometer Setup on Old Catenary Tower  
(b) Feb. 14, Initial Overhead Photos show five Switch Plate Heating Systems Working  
(c) Feb. 20 after heavier snow (d) Mar. 1 system still working  
(e) Mar. 4, switch plates are clear**

A video camera was mounted on a nearby abandoned catenary support tower with a full view of the switch. The camera was configured to communicate with the data logger over a serial communications link, and an external SD card was provided for image storage. Remote access to the data logger was provided by a wireless 4G modem. The video camera showed that four of the switch plates worked well during the entire test period of approximately 3 months; one switch plate appeared to have one side working and one side working marginally. Figure 30 shows photographs of the overhead camera setup and several overhead photographs taken during the test.
