Evaluation of High Performance Pavement and Bridge Deck Wearing Surface Repair Materials

Prepared by:
Norbert Delatte, Richard Miller, Mohammad Asghar, Alice Sommerville,
Andrew Lesak, Kamran Amini, Larisa Susinskas, and Jennifer Woods

Prepared for:
The Ohio Department of Transportation,
Office of Statewide Planning & Research

Final Report

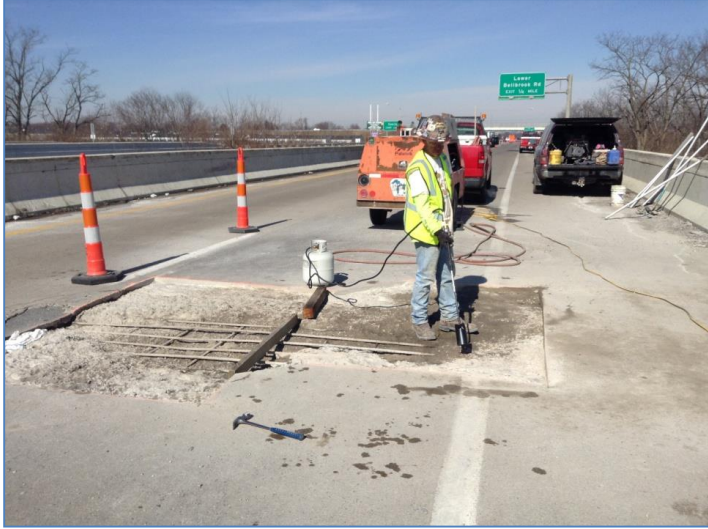
Figure 2: Bridge deck patch installation (Lesak 2014)

The bulk of the work in March 2014 was carried out at the bridge deck at location A in figure 1, west of Xenia, Ohio. The patch extended for a full lane width of the bridge deck and nearly half of the deck thickness. It took considerable time to jackhammer out the hole and then to dry out all of the water, and it took several dozen batches of material to fill the patch. This patch is shown in Figure 2. The board separates the two materials used in this patch, FlexSet to the left and MG Krete to the right. During the installation, it was observed that the bridge deck at this location was in poor condition, to the point that there was concern about punching completely through the deck during concrete removal.

The other exception was a failure of the bridge deck patch that was installed on the right side of figure 2, using MG Krete. The UC researchers were scheduled to perform a final pre-winter site visit on December 17, 2015. Just prior to the site visit the research team was informed by ODOT that part of the bridge deck patch placed in March 2014 had failed. Looking back at the photos from the June 2015 inspection it is clear that this particular patch was already showing distress at that time. In the center of figure 7, that part of the patch can already be seen to be severely cracked and there are signs of a punching failure.

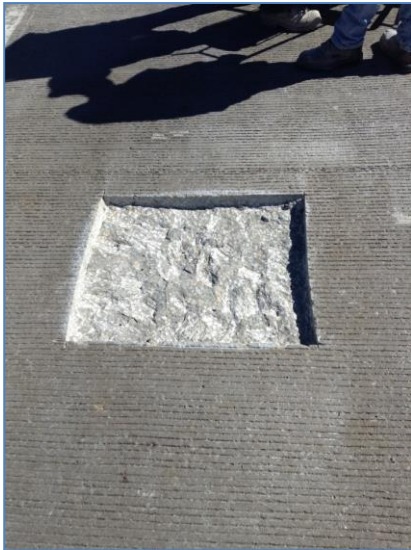
Figure 3: An example of a clean, smooth-cut hole, where patch #14 was installed (Lesak 2014)

The work in June 2014 installed the other approximately 80 % of patches at locations B through E, south and east of Xenia, Ohio. These were all concrete pavement locations. The same tests and monitoring were carried out as in March 2014. A typical patch repair hole is shown in Figure 3.

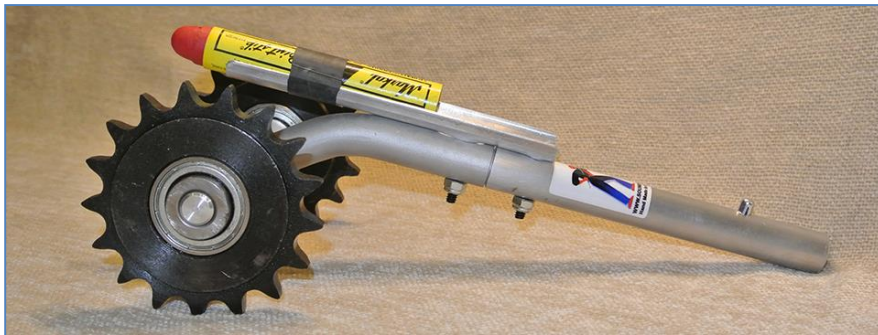
Figure 5: Delam 2000 rotary percussion tool for detecting shallow delaminations

The Delam 2000 tool for detecting and mapping shallow delaminations is shown in figure 5. The figure does not show the extension handle, which allows an operator to roll it along a pavement or bridge deck while standing straight up. This tool was used for monitoring patch performance after installation, but it also proved to be very useful for defining patch limits during installation, making sure that there were no shallow delaminations adjacent to the patch that would cause damage to spread. The research team also used a piece of reinforcing steel to tap to identify delaminated areas, but the Delam 2000 proved to be much more reliable. It is a relatively inexpensive tool, only a few hundred dollars, and would be useful for repair crews to carry and use during patching operations. It is easy to operate while standing up, and it is very easy to hear the difference between the low pitched dull sound of intact concrete and the high pitched ring of a shallow delamination.

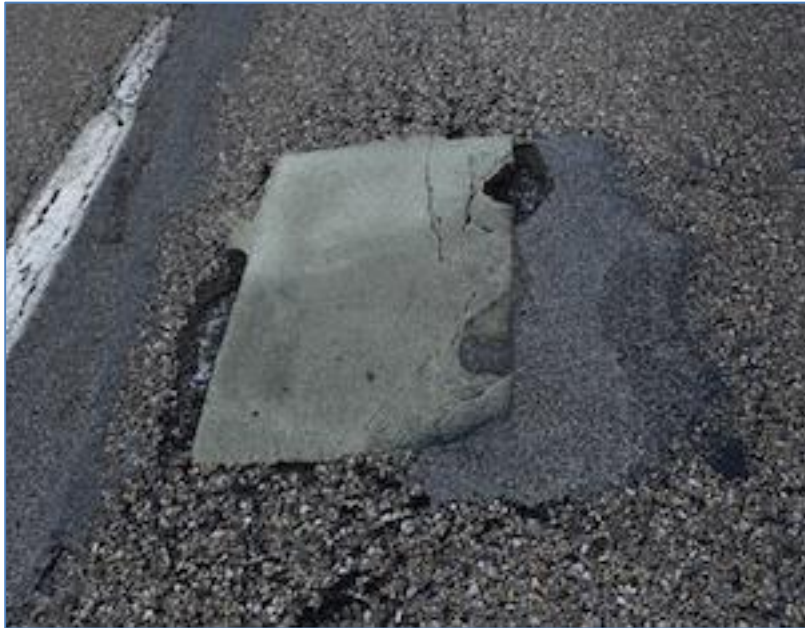
Figure 6: Example of failing patch in asphalt

Although the patches, in general, performed well, there were three important exceptions. The first was the small number of patches in asphalt pavement repaired using the flexible materials FlexSet and SR-2000. There was considerable cracking of the material, especially around the edges. Over several visual observations, it appeared that failure was mostly caused by failure of surrounding material as opposed to failure of the patch itself. This is shown in figure 6. It also appeared that the problem was an extremely stiff patch in a very flexible material. The patch probably attracted most of the stress leading to failure. Therefore, the materials investigated in this study should not be used to repair asphalt pavements, since other solutions are available at lower cost.

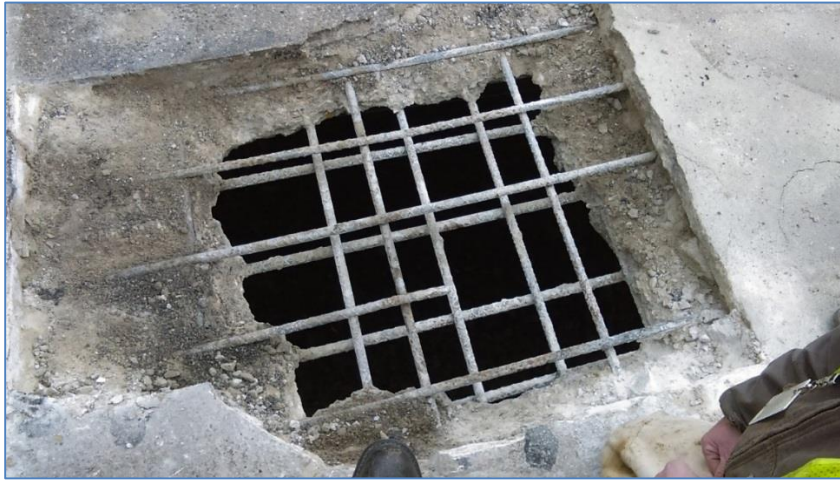
Figure 8: Bridge deck patch failure (Photo provided by Brandon Collett, ODOT District 8)

Examination of the photos provided by ODOT of the failed surface, one of which is shown in figure 8, plus the December 17 examination, suggested that the lower part of the bridge deck failed and fell out from under the patch. This would make it more of a substrate failure than a patch material failure. It is interesting that the rebar seems to be clean and in good condition, so rebar corrosion does not appear to be a factor.

From the beginning there were concerns about the soundness of the bridge deck substrate. When the project team installed these patches in the bridge deck, there was some concern about jackhammering too deep into the bridge deck. This makes it surprising that the patch held together for close to two years. In retrospect, this should probably have been a full depth patch rather than a partial depth patch; pointing out the need to properly assess the substrate conditions for any repair.

This hole has since been repaired with fresh concrete, and the entire bridge deck is scheduled for extensive renovation. This patch is the MG Krete material, which otherwise performed well in both the field and the laboratory, so it will be important to review the other patches made with this material to rule out material performance as a failure mechanism.

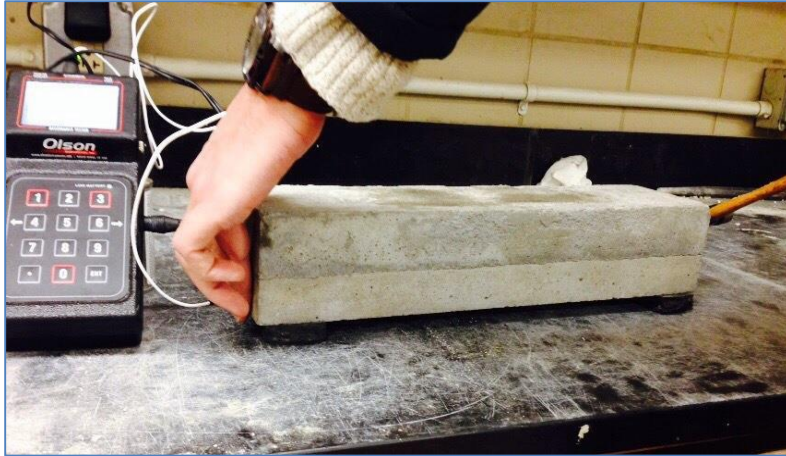
Figure 9: Two layer bonded specimen and ASTM C215 resonance testing (Amini 2015)

The research team also developed a new test using composite freeze-thaw beams of ODOT Class S base concrete and bonded repair material. A typical specimen is shown in figure 9. This test evaluates the overall performance of the repair system, rather than just the material. This is important because a patch can fail in the existing patch concrete, in the new repair material, or in the bond between the two materials. The specimens were tested through 300 freeze-thaw cycles over about 2 months, following AASHTO T161 (ASTM C666), with resonant frequency testing by ASTM C215 (no comparable AASHTO specification) approximately every 30 cycles.

The purpose of the resonant frequency test is to determine whether freeze-thaw damage has occurred within a specimen. The concrete specimen is struck with a small hammer and vibrates at a specific frequency, which is a function of the geometry of the specimen, its mass, and its modulus of elasticity. As concrete is damaged by freezing and thawing, the compressive strength and modulus of elasticity both decrease. As a result, the concrete becomes weaker and less stiff and vibrates more slowly. The vibration frequency is measured before the specimen is subject to freezing and thawing, and then measured again after every 30 or so cycles of freezing and thawing, until 300 cycles are reached, generally at about 10 weeks of testing. The relative dynamic modulus (P_c), or durability factor, is the frequency after exposure divided by the original frequency squared, expressed as a percent (ASTM C 215):

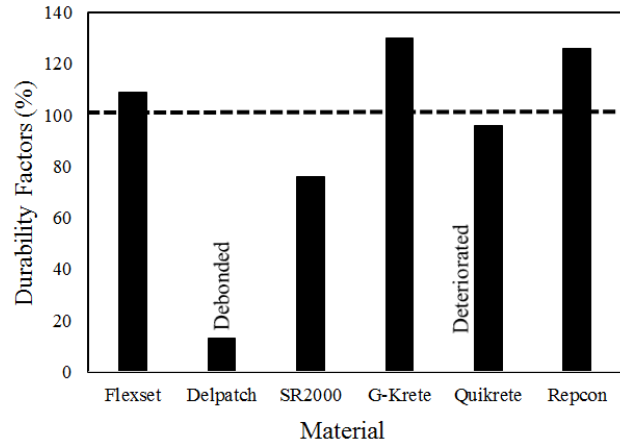
Figure 10: Durability factor of the repair materials after 300 cycles (Amini 2015)

The material is considered to fail the test if P_c falls below 60 % within 300 cycles. It is well known that AASHTO T161 (ASTM C666) is a harsh test method, and it is not uncommon for materials to fail the test in the laboratory but to have satisfactory field performance. Figure 10 shows the results of this testing. Three of the materials, FlexSet, MG Krete, and RepCon, showed excellent performance. Two others, the SR-2000 and the Quickcrete, showed some minor deterioration. This has not yet been observed in the field after two years of exposure, but the AASHTO T161 (ASTM C666) test is designed to predict long term performance.

One material, the Delpatch, showed a separation between the base material and the repair. This, however, contradicts the field observations, because this material remains well bonded and actually has continued to show some of the best visual appearance in the field. Delpatch requires the use of a bonding agent. It is possible that the bonding agent used in the lab was either contaminated or not applied correctly. Therefore, this result should be considered inconclusive, but the field performance of Delpatch should continue to be observed to see if this separation occurs in the future. Lesak (2014) provided the specific locations of all patches including those installed with Delpatch.

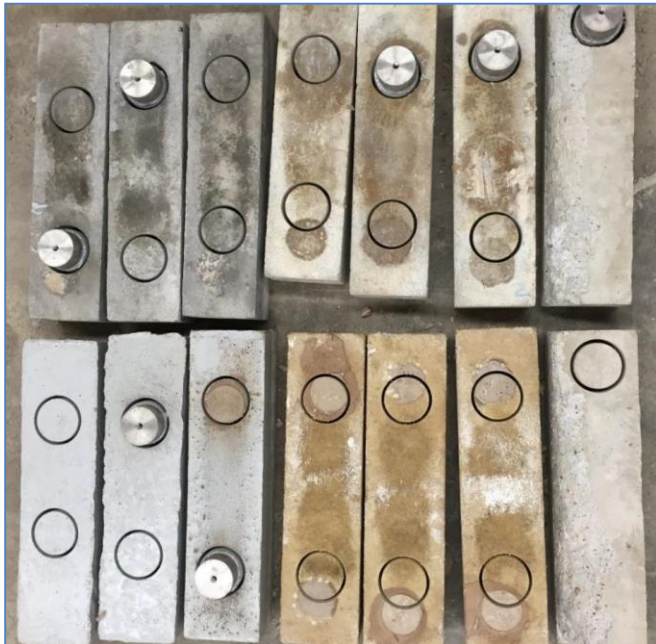
Figure 11: Bond testing of two layer specimens following freeze thaw testing (Amini 2015)

Once the materials had completed 300 cycles of freeze-thaw testing, pull-off testing was used to determine if the bond between the two materials was still intact. A 2 inch (50 mm) diameter coring drill was used to core down through the overlay into the substrate material, and then a steel pull off disk was bonded to the overlay material using epoxy. Specimens are shown in figure 11. Generally the materials remained well bonded following the freeze-thaw cycles.

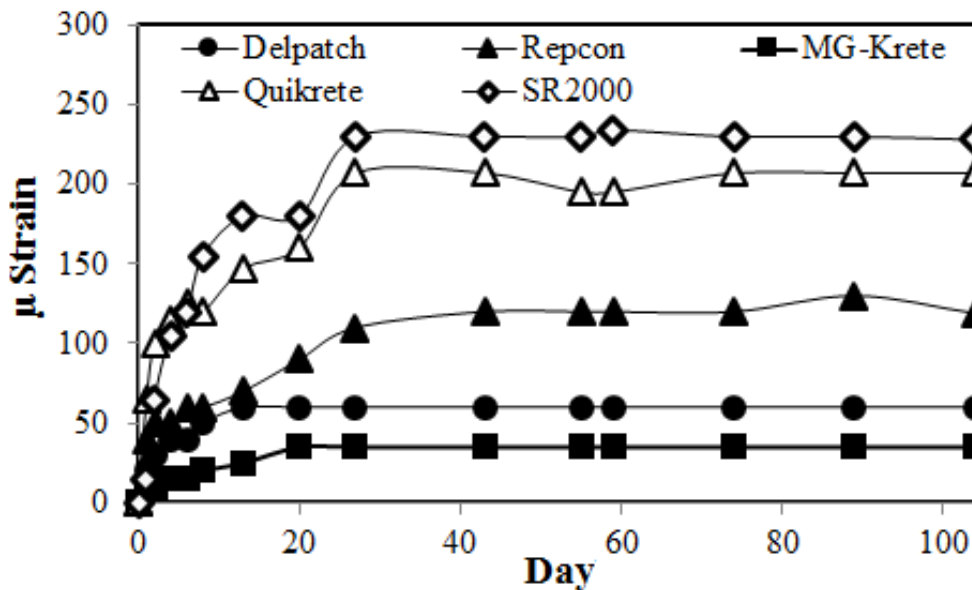
Figure 12: Shrinkage evolution of the repair materials (a) FlexSet, (b) Other repair materials (Amini 2015)

Shrinkage prisms were also made in 3 by 3 by 11 inch (75 by 75 by 275 mm) molds, with embedded metal inserts (AASHTO T160/ASTM C157). Results are shown in figure 12. Five of the six materials showed shrinkage less than 250 microstrain ($\mu\epsilon$), within limits in typical repair material specifications. The FlexSet had much greater shrinkage, approximately 5,000 microstrain ($\mu\epsilon$) or millionths. This would normally suggest a material likely to crack and debond, due to high shrinkage stress development.

However, the FlexSet material has continued to perform well in the field. The compression test on this material shown in figure 13 suggests why. Whereas conventional concrete shatters in compression, the FlexSet is very flexible, deforms considerably and really does not fail in compression.
