CORROSION OF POST-TENSIONED TENDONS WITH DEFICIENT GROUT

FINAL REPORT
Project BDV29-977-04
(800002803)

October 2016

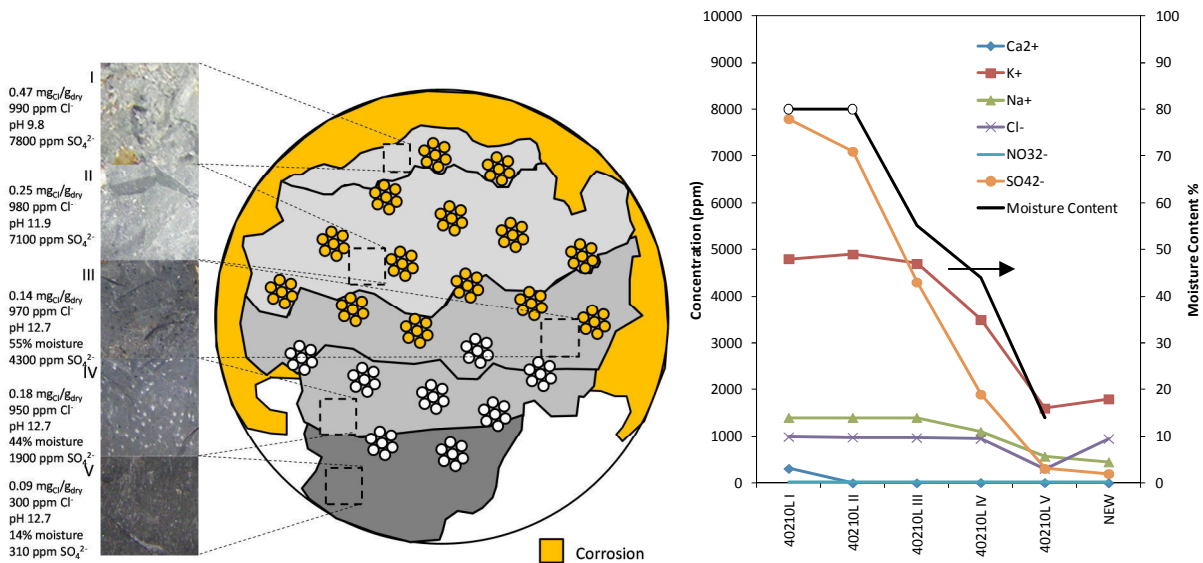
Figure 2.7. Chemical characteristics of segregated grout.

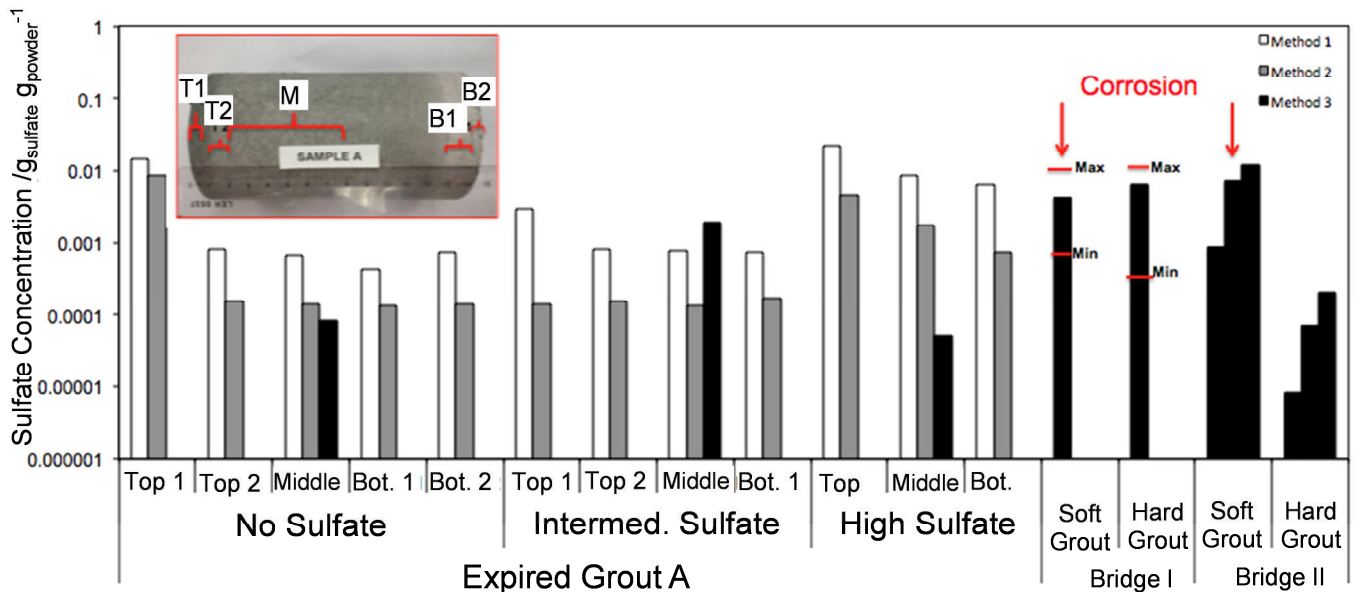
Figure 3.6. Sulfate content for expired grout and field samples.

behavior in deficient grout. Further research to address the importance of cement chemistry on the availability of soluble sulfates is needed.

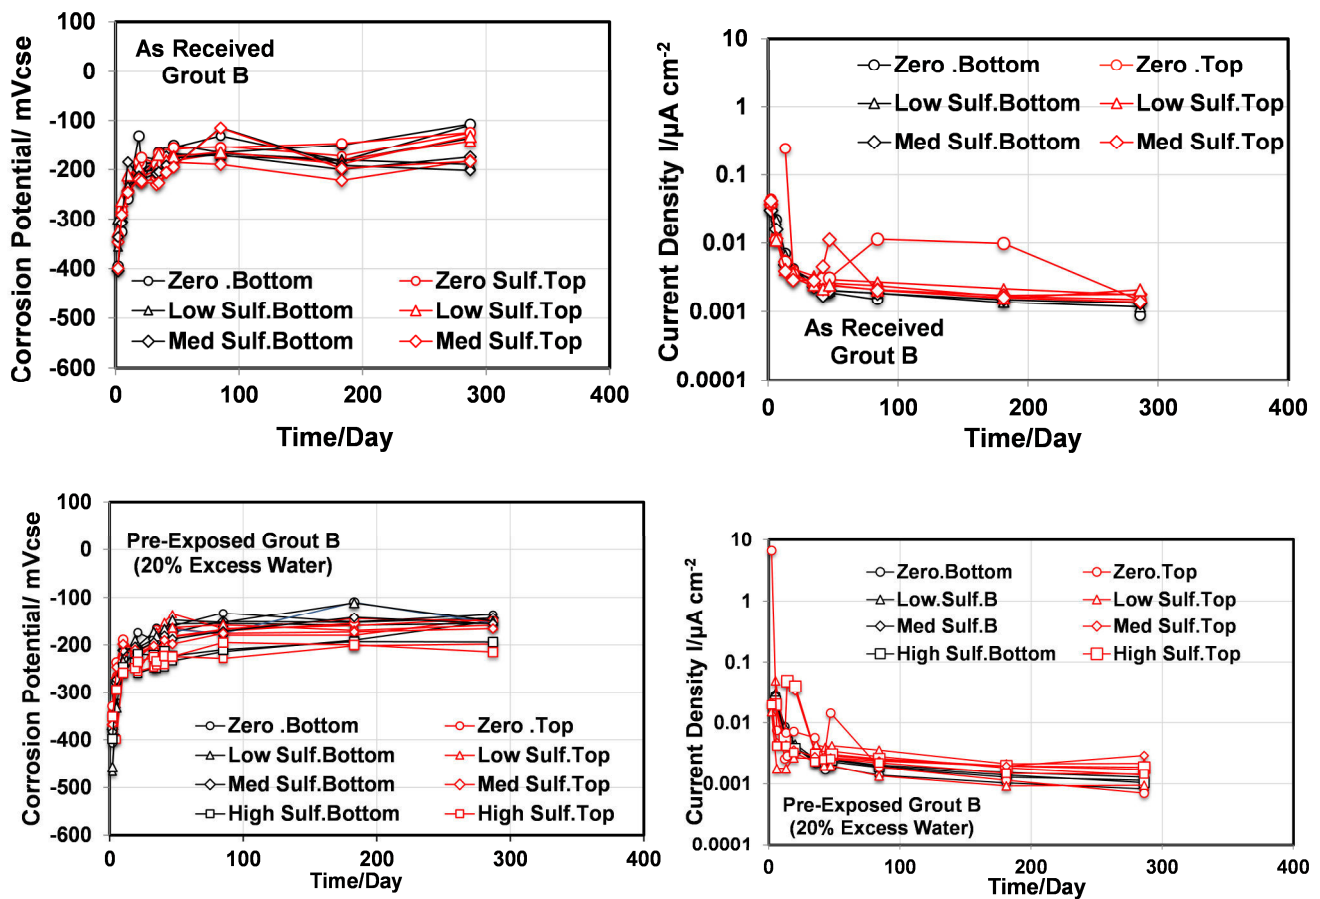
Figure 5.6. Corrosion potential and current density for INT testcases: B.A.1-3, B.P.1-4. (Low Sulf: 2,000ppm. Med Sulf: 20,000ppm. High Sulf: 100,000 ppm)

As shown in Figure 5.6, Grout B had passive like corrosion behavior for all of the grout test conditions. The corrosion potential was in the range of $-200 > E_{corr} > -100$ mV_{cse} and current density was 0.001-0.01 $\mu\text{A}/\text{cm}^2$ for the as-received and pre-exposed conditions. There was no indication of active corrosion even in the top portion of the samples with segregated grout.

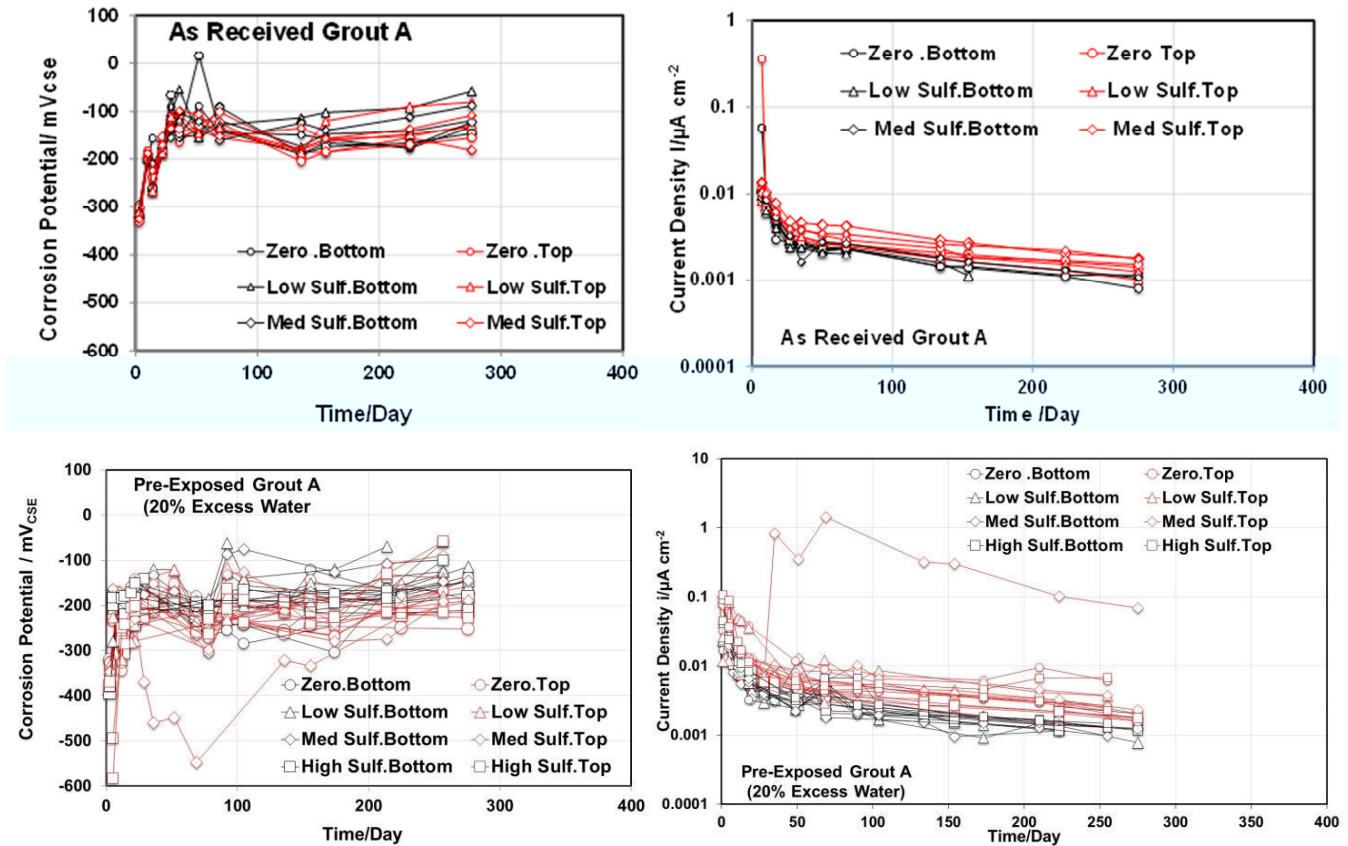
Figure 5.7. Corrosion potential and current density for INT test cases A.A.1-3 and A.P.1-4.
(Low Sulf: 2,000ppm. Med Sulf: 20,000ppm. High Sulf: 100,000 ppm)

As shown in Figure 5.7, INT test samples made with Grout A in the as-received condition (A.A.1-3) did not show active corrosion behavior for both tee header and tee body section regardless of the amount of admixed sodium sulfate. However for cases where sodium sulfate was admixed to the pre-exposed Grout A (cases A.P.1-4), there was differentiation in OCP and i_{corr} for steel embedded in the tee header and tee body. The general trend of enhanced corrosion activity in deficient grout was consistent with observations in the MIT test samples and in the field. However the conditions here appeared less adverse. The corrosion potential of steel in the tee body and tee header was $\sim -150 \text{ mV}_{CSE}$ and -250 mV_{CSE} , respectively. In comparison corrosion potentials in deficient and hardened grout in the MIT test and in the field were less than -350 mV_{CSE} and greater than -200 mV_{CSE} , respectively. In the INT tests here, one sample with 20,000 ppm sodium sulfate addition (A.P.3) exhibited severe active corrosion conditions where i_{corr} exceeded $1 \mu\text{A}/\text{cm}^2$.

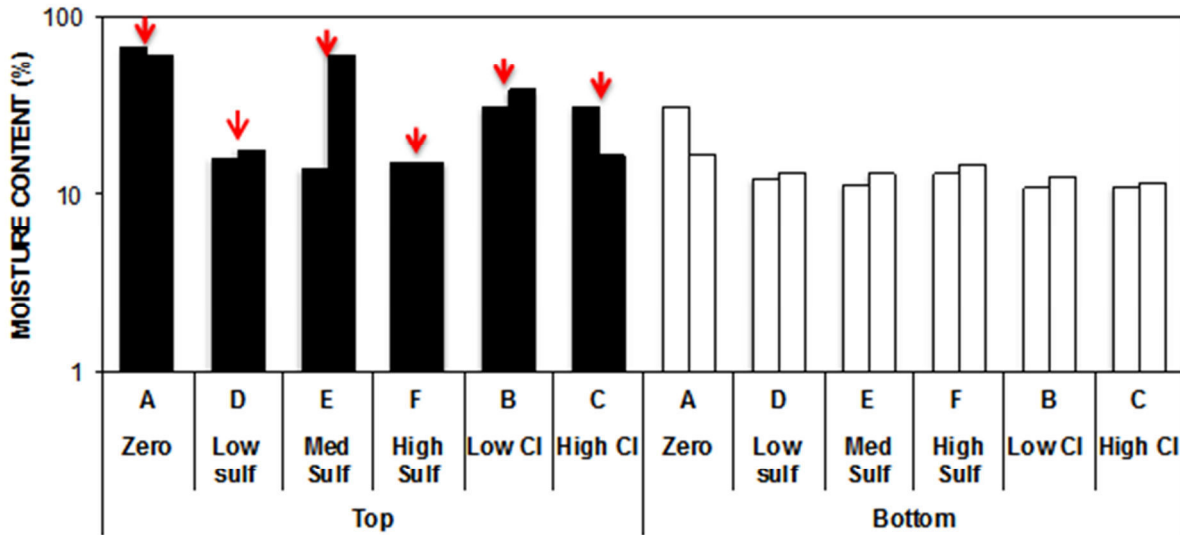
Figure 7.17. Moisture content of grout from MIT test samples.
(Red arrows show case where corrosion occurred)

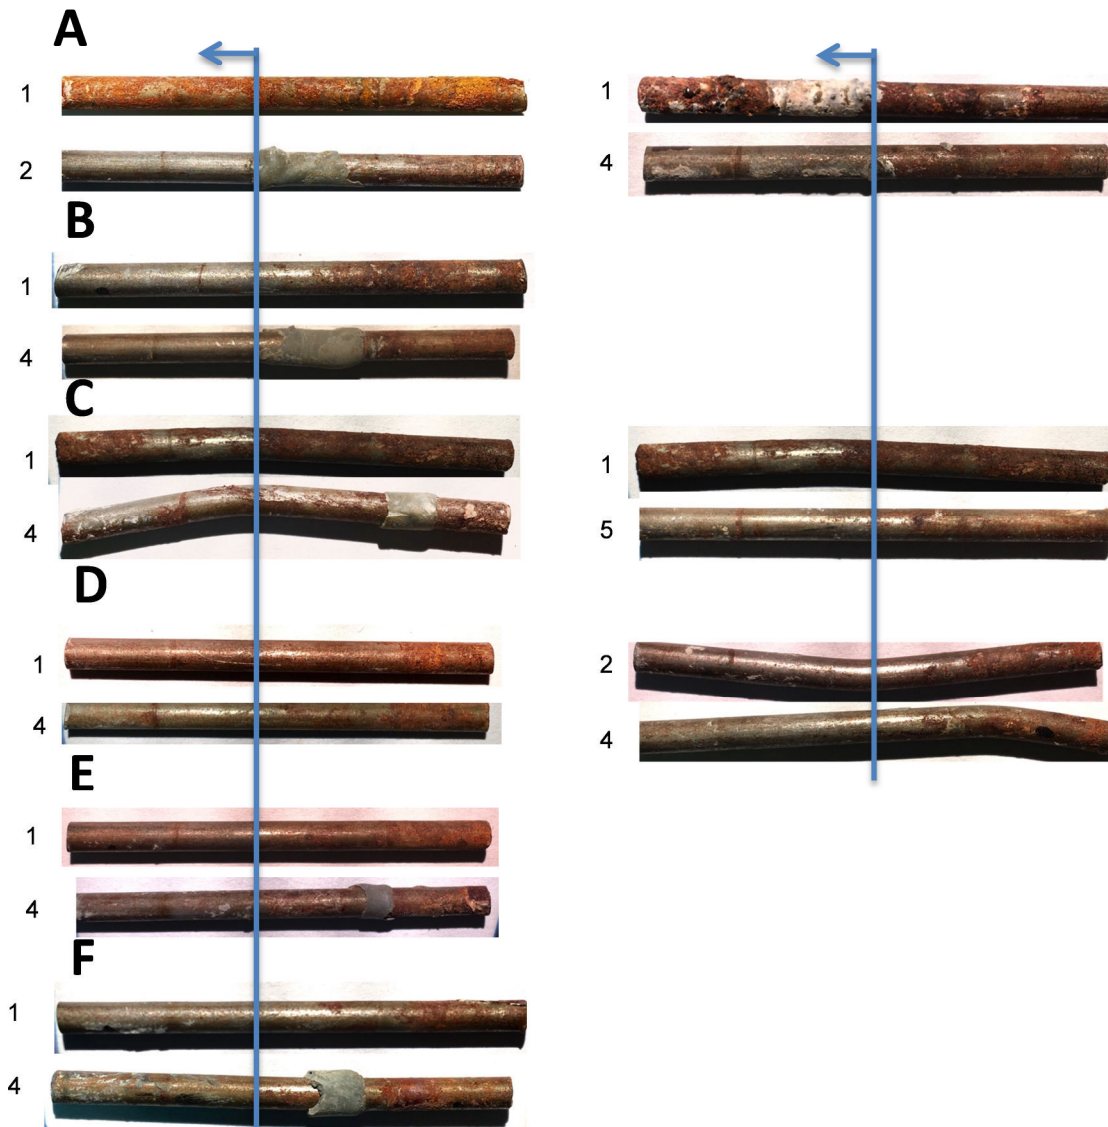
Figure 8.3. Photos of corrosion steel probes in MIT test (crevice condition).
