**Reviewing the Testing Protocol for Density Cores Collected
from CTDOT during the 2012 and 2013 Construction Seasons**

Report Number: CT-2281-F-15-8

Final Report

Connecticut Advanced Pavement Laboratory
Connecticut Transportation Institute
School of Engineering
University of Connecticut

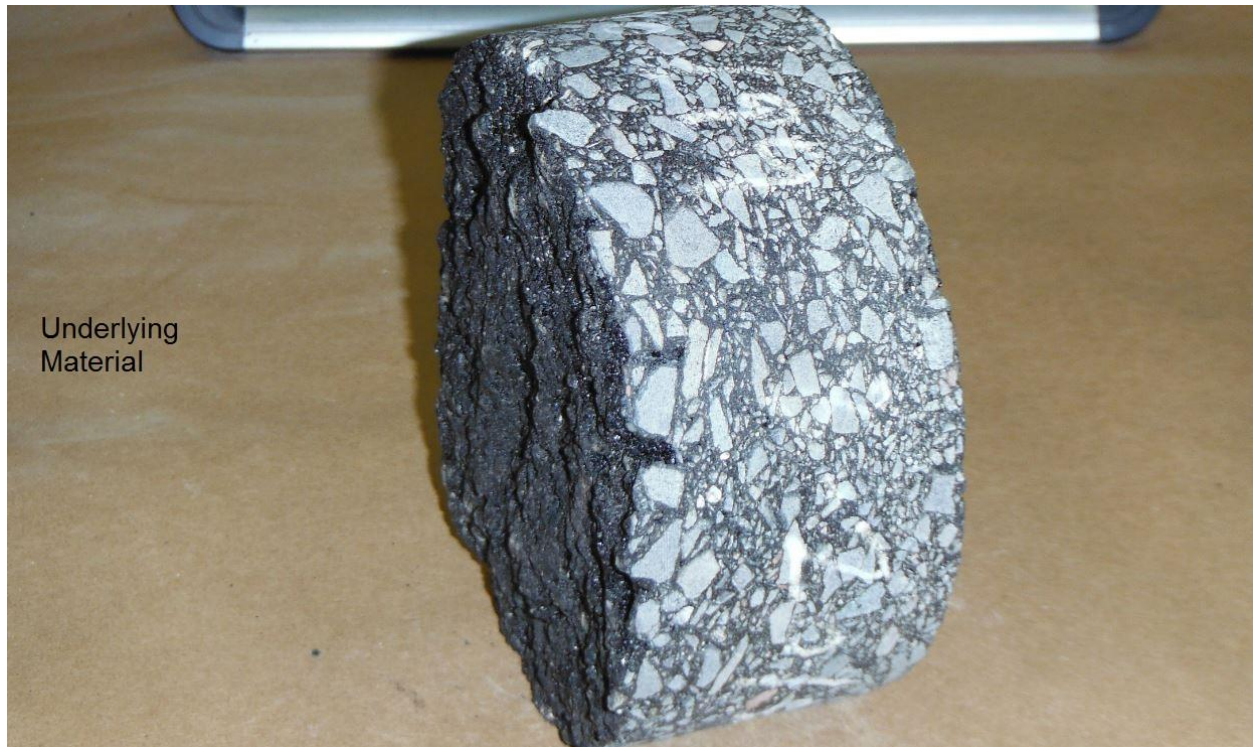
Figure 1. Core with Partial Underlying Layer Attached

It was observed that there were several cores retaining underlying material (base course or binder course), which was not removed. The amount of material ranged from an entire layer to a partial layer attached to the bottom side of the cores. An example of such a core is shown in Figure 1.

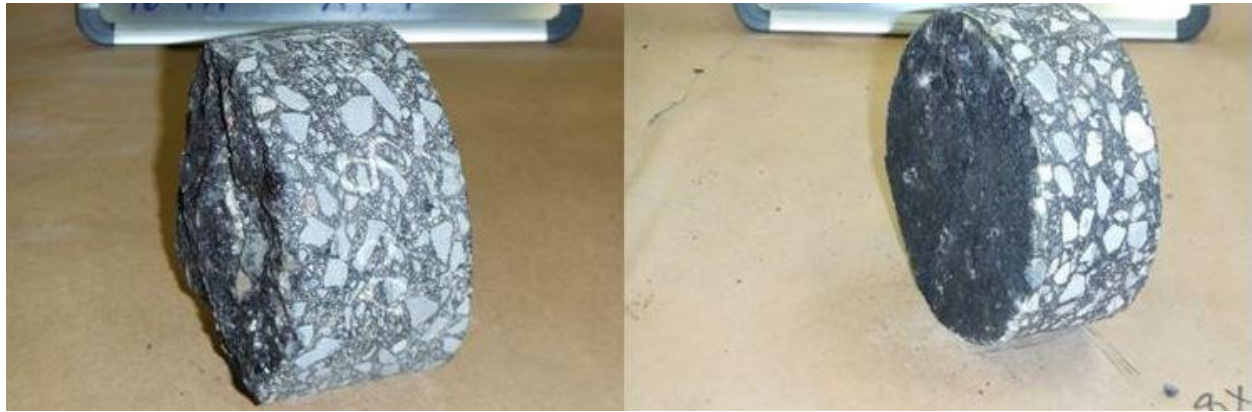
Figure 2. Different Levels of Unclean Separation on Cores

CAP Lab personnel with assistance from CTDOT acceptance testing personnel collected an additional 426 cores on random days over the course of the 2013 construction season. All of the necessary testing data and information was provided by CTDOT with the 2013 cores, as well. Random checks were made to verify the accuracy of the initial reported bulk densities from which there were no discrepancies. A negligible number of the cores collected during the 2013 season contained any observable underlying material. In addition, there were 190 (of the 426) cores collected from the 2013 season that did not separate cleanly. It should be noted that the research team was calling a separation unclean if there was any sign of irregular

surface relief, noticed through simple observation. This means that there are (were) varying degrees of unclean separation of the pavement layers as it was unknown at that point in time what an acceptable amount of surface relief was. Figure 2 provides examples of two different levels of unclean separation, as they were termed for purposes of this research.

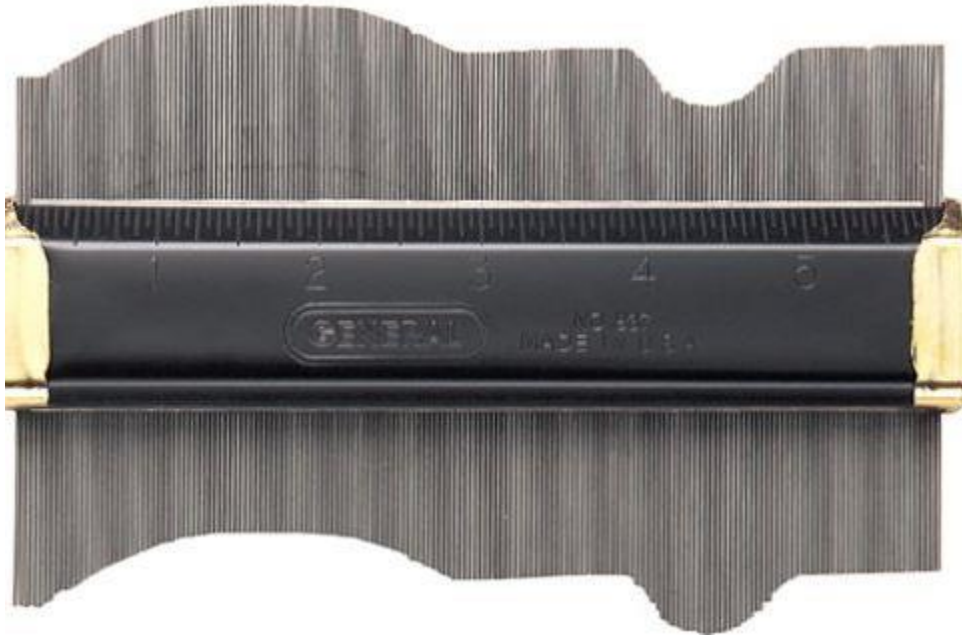
Figure 3. Contour Duplication Gauge

The next attempt involved using a contour duplication gauge as shown in Figure 3.

This method involved pressing the gauge down evenly to match the contour of the irregular surface plane for three locations on the core bottom surface. The locations of lines for measurement were selected by first using a diameter that crossed the highest peak on the surface. The other two lines of measurement were then selected to be at 60° and then 120° from the first measurement line as shown in Figure 4.

There were problems associated with this method, as well. First, the operator had to be sure that contour gauge was being lowered onto the core in a manner that was parallel to the top of the core, which proved difficult. The contour gauges also did not fair very

well with all of the measurements that were made resulting in damage to the gauge itself. These measurements took an unreasonable amount of time to obtain. Finally it was found that this method was not repeatable or consistent as the amount of relief on the core was quite variable, and measurement on three lines may not have been enough to enumerate the relief.

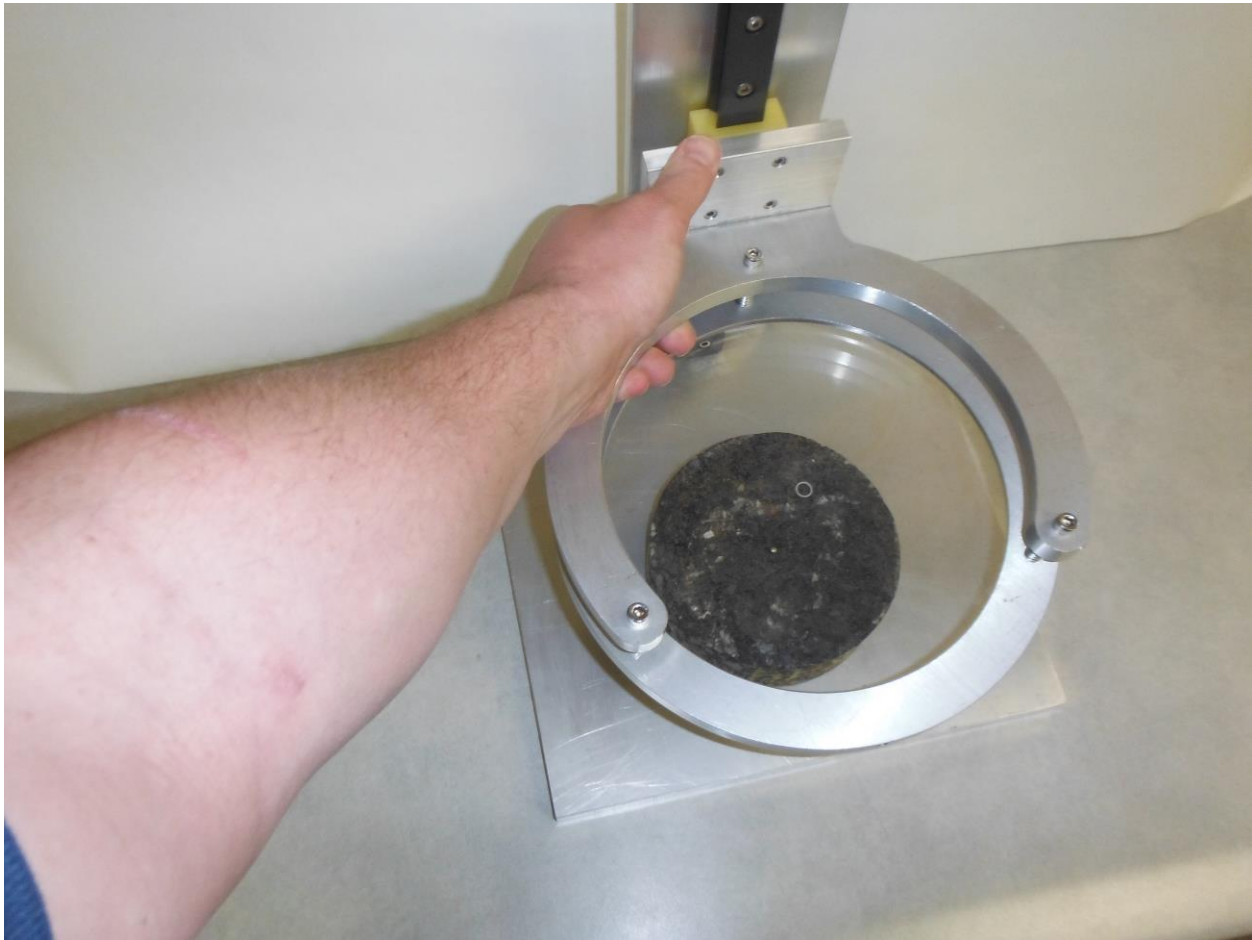
Figure 7. Texture Gauge Glass Plate Lowered onto Core via Slide

The glass plate is then lowered down the slide until it comes into contact with either the core or the ball bearing as shown in Figure 7 and Figure 8.

UCONN has available drawings and sketches of the gauge. There are springs that expand underneath the frame to the glass plate that allow for a small amount of vertical movement. It may be desired that the neck of the gauge be fitted with a pivoting head to accommodate cores that are not parallel from top to bottom.

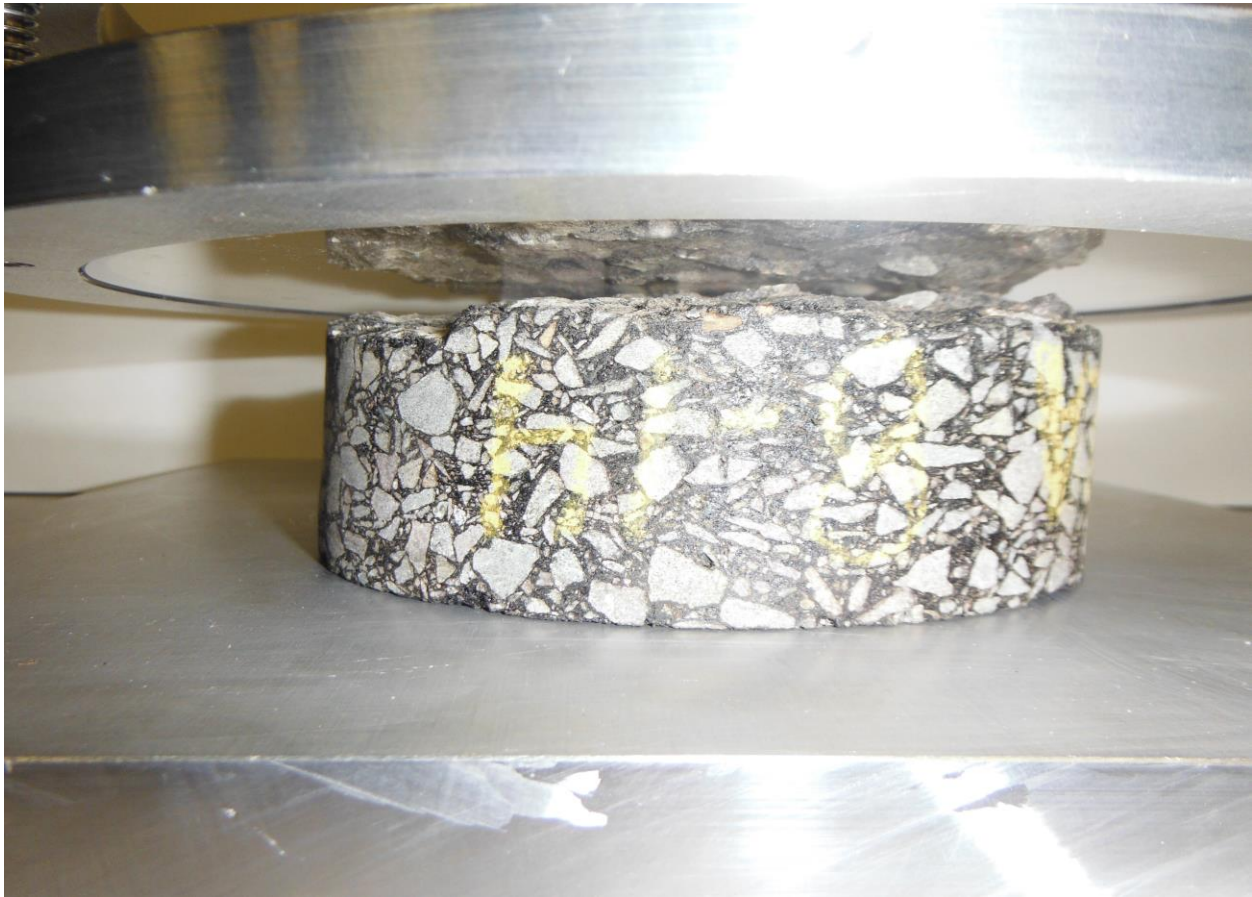
Figure 8. Texture Gauge Glass Plate in Contact With Core

If the glass plate comes into contact with the ball bearing and not the core, then the amount of surface relief on the core is less than 4.5 mm. In that case the core would not need to be saw cut. If the glass plate contacts the core without contacting the ball bearing then the relief is in excess of 4.5 mm and the core should be saw cut. If it cannot be visually determined what the glass plate is contacting, a piece of very thin gauged metal or feeler stock or even a piece of paper can be slid between the glass and core until it stops. The point of contact can then be observed through the glass plate. This is shown in Figure 9.
