1. Report No. FHWA/TX-04/0-1405-7		2. Government Accession No.		3. Recipient's Catalog No.	
4. Title and Subtitle Long-Term Post-Tensioned Beam Exposure Test Specimens: Final Evaluation				5. Report Date August 2003

# **LONG-TERM POST-TENSIONED BEAM EXPOSURE TEST SPECIMENS: FINAL EVALUATION**

**Research Report 1405-7**

*DURABILITY DESIGN OF POST-TENSIONED  
BRIDGE SUBSTRUCTURE ELEMENTS*

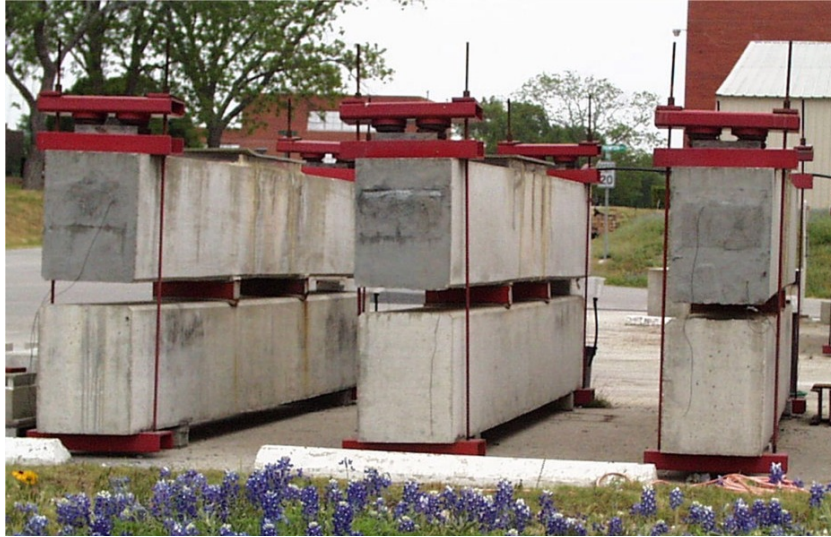
Figure 2.1 Linear Rectangular Beam Specimens (on Top of Reaction Beams)<sup>7</sup>

The specimens used in this experimental program are not patterned after a prototype structure. Linear rectangular flexural elements, as shown in Figure 2.1, were chosen for the following reasons:

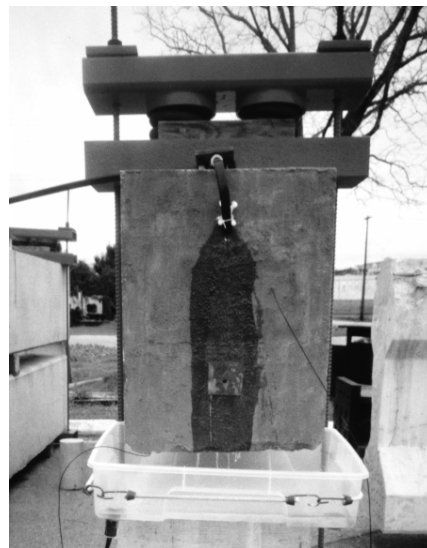
**Figure 2.18 Beam End Dripper System<sup>3</sup>**

Three specimens were selected to evaluate the effect of saltwater dripping in the anchorage area, at the top of the nonshrink grout: Specimen 2.7 (epoxy-coated strand), Specimen 2.9 (poorly grouted) and Specimen 2.12 (encapsulated system / plastic duct). The trickle saltwater system is shown in Figure 2.18.

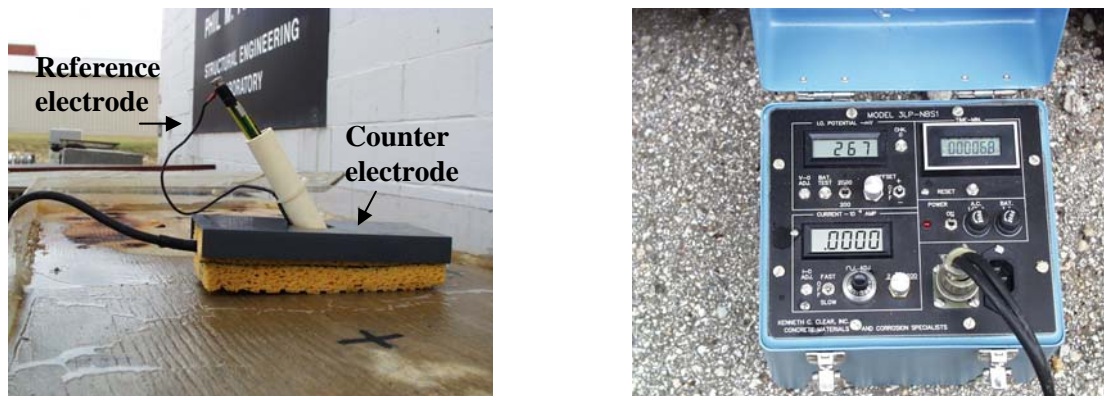
Figure 3.4 3LP Equipment and Setup<sup>6</sup>

The 3LP Equipment was developed by Kenneth C. Clear, Inc., USA. A photograph of the equipment and setup is shown in Figure 3.4. The 3LP device is manually operated, and polarization scan data are recorded by hand. The counter electrode is rectangular and current confinement is not provided. The equipment measures the half-cell potential of the reinforcement (working electrode) and the applied polarization current. The polarization scan uses three steps of 4 mV, starting at the free corrosion potential and ending at +12 mV. The concrete resistance is not measured by the 3LP device. The linear regression analysis on the polarization scan data must be performed using a hand calculator or computer to determine the total resistance,  $R_{tot}$ , as the slope of  $\Delta E$  versus  $\Delta I_{applied}$ . No correction is made for the concrete resistance, and the polarization resistance,  $R_p$ , is simply taken as equal to the total resistance.

The manufacturer recommends a proportionality constant, B, of 40.76 mV for calculating corrosion current. The manufacturer also provides guidance for relating corrosion current densities to expected corrosion damage. The SHRP Procedure Manual for Condition Evaluation of Bridges<sup>25</sup> indicates a proportionality constant, B, of 26 mV can be used with the 3LP device. The interpretation guidelines listed in Table 3.3 are appropriate for the 3LP device if B = 26 mV is used.<sup>25</sup>

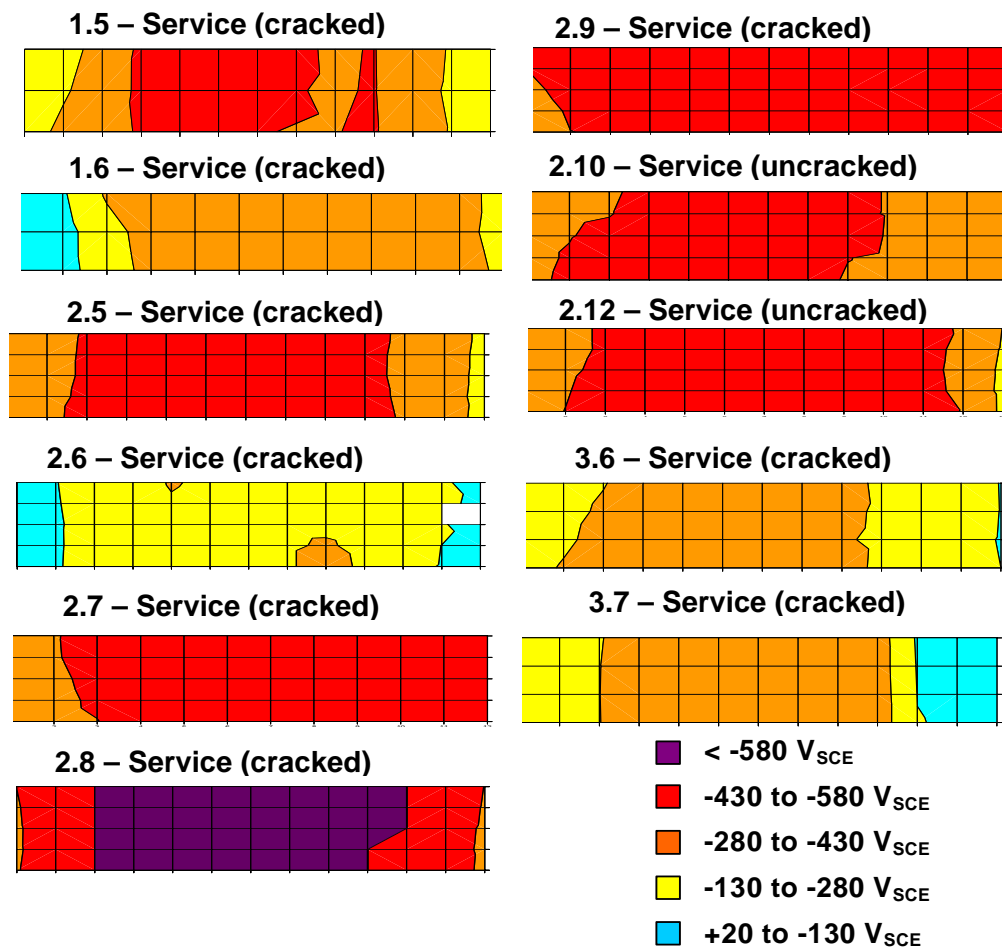
**Figure 4.24 Half-Cell Potential Contour Maps at 1235 Days for All Phase II Beams**

Figure 4.24 shows the half-cell potential contours maps for all Phase II specimens after 1235 days of exposure testing. Contour maps at 139 days of testing are shown in Reference 12.

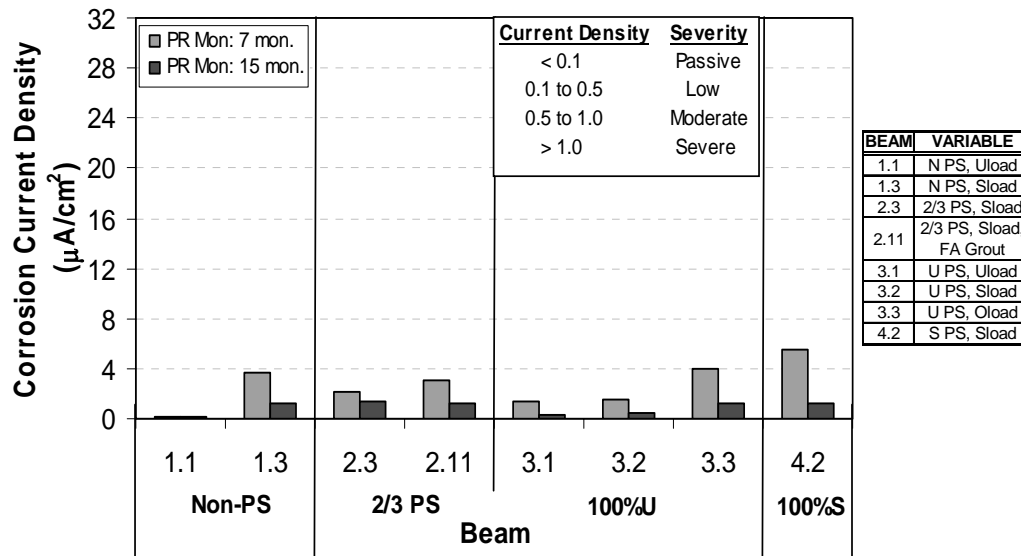
Figure 4.25 Maximum Corrosion Rate Readings Using PR Monitor for Phase I Autopsy Beams<sup>6</sup>

Figure 4.25 is a graph of the maximum corrosion rate readings taken of the Phase I autopsy beams using the PR Monitor equipment. The graph shows a consistent trend that the corrosion rate decreased over time. This does not make practical sense. Therefore, further investigation of the corrosion rate readings will be made after the forensic examination to determine the reliability of the use of the PR Monitor equipment as a means of assessing corrosion rate. Through comparison of the three 100%U PS beams, both sets of readings show that the corrosion rate increases as the applied load, which corresponds to crack width increases.

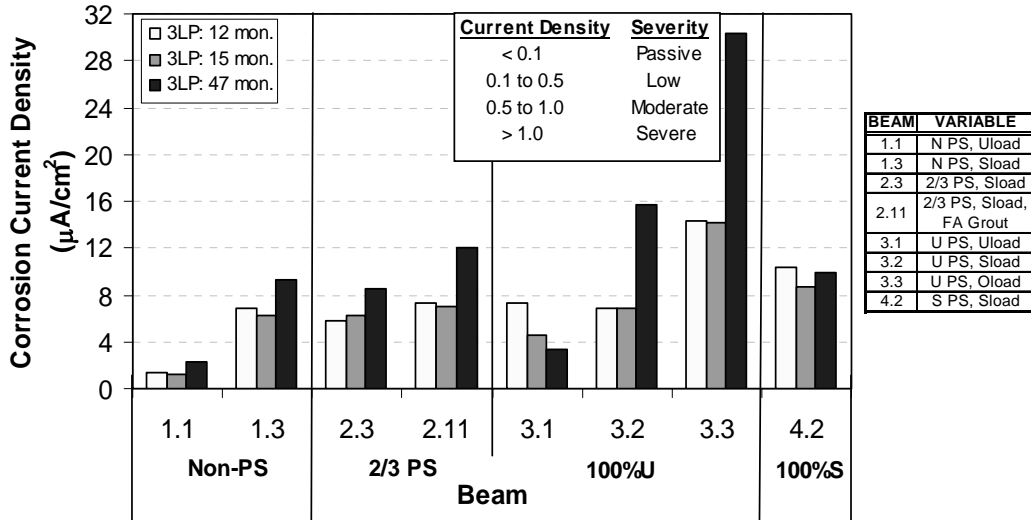
Figure 4.26 Maximum Corrosion Rate Readings Using 3LP for Phase I Autopsy Beams<sup>6</sup>

Figure 4.26 is a graph of all the maximum corrosion rate readings taken of the Phase I autopsy beams using the 3LP equipment. The graph shows a consistent trend that the corrosion rate increased over time, with the exception of Specimen 3.1. Again, comparison of the 100%U PS sections show increasing corrosion rates with increasing applied load. There is a significant increase from Specimen 3.2 (uncracked) to Specimen 3.3 (cracked).

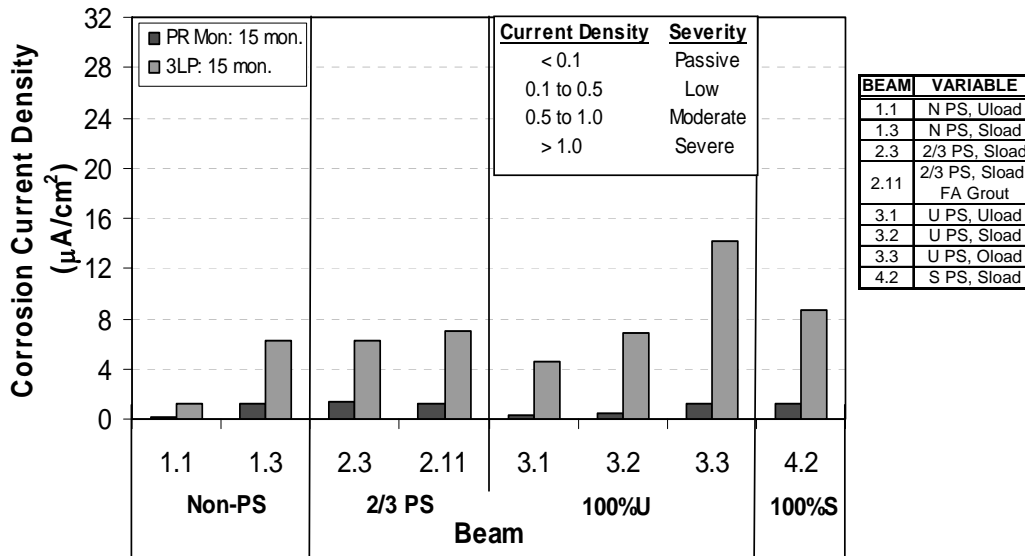
Figure 4.27 Comparison of Corrosion Rate Measurement Equipment<sup>6</sup>

Figure 4.27 is a graph of maximum corrosion rate readings taken after 15 months of exposure. The purpose of this graph is to compare the two types of equipment used for taking the readings over the duration of this experimental program. The 3LP corrosion rates measured after fifteen months of testing are significantly higher than the PR Monitor corrosion rates. Other research and field experience with various devices for corrosion rate measurement have consistently shown that the 3LP equipment indicates higher corrosion rates than other devices.<sup>2</sup> Although there is a large difference in the readings from the two types of equipment, the trends in corrosion activity are similar. This suggests that the large discrepancy in magnitude is likely due to inherent differences between the two devices. Although the magnitude measured by the 3LP equipment may not be reliable, it appears to be a good method for determining corrosion trends of individual specimens and comparing these trends among multiple specimens.

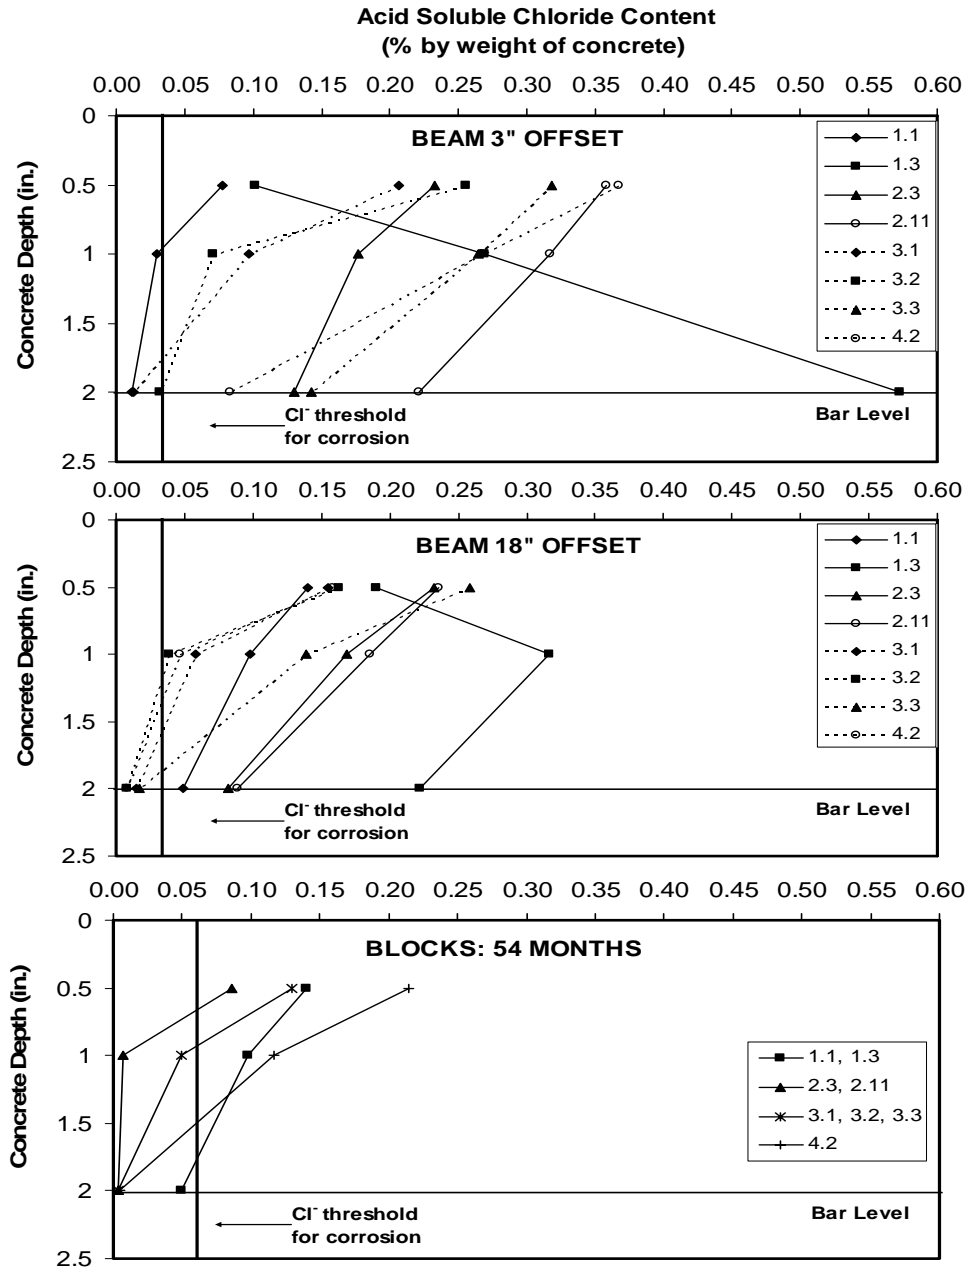
- Chloride content in the ponded region is consistently higher at the bar level than outside the ponded region.
- Unloaded and uncracked specimens (1.3 and 3.1) show very low chloride contents at all locations.
- Measurements taken at crack locations give significantly larger chloride content values, as in the case of Specimens 1.3 and 2.3 at the three-inch offset.
- An increase in the level of prestress results in lower chloride contents due to fewer cracks and higher compressive stresses in the concrete.
- Minimal difference is observed in the performance of the 100%S and 100%U PS beams. The larger value from the 100%U PS beam at the three-inch offset location is due to the small crack at the sample locations.

**Figure 4.31 Beam and Block Chloride Penetration at 1594 Days  
for Phase I – Ponded Region on Beams<sup>6</sup>**

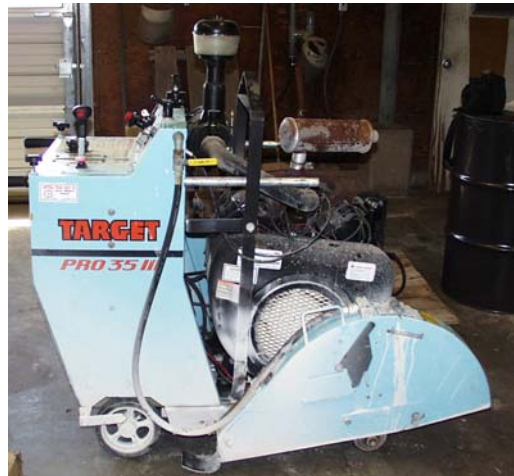
**Figure 5.3 Concrete Saw used in Autopsy<sup>6</sup>**

The concrete saw with a 27-inch circular blade shown in Figure 5.3 was used to make all the cuts in the specimens. Two eight-inch deep vertical cuts were made on the top of the beam, and a horizontal cut was made on each side of the beam, below the duct line. These cuts separated the portion of the beam to be analyzed from the rest of the specimen, allowing the area of interest to be removed with a forklift.

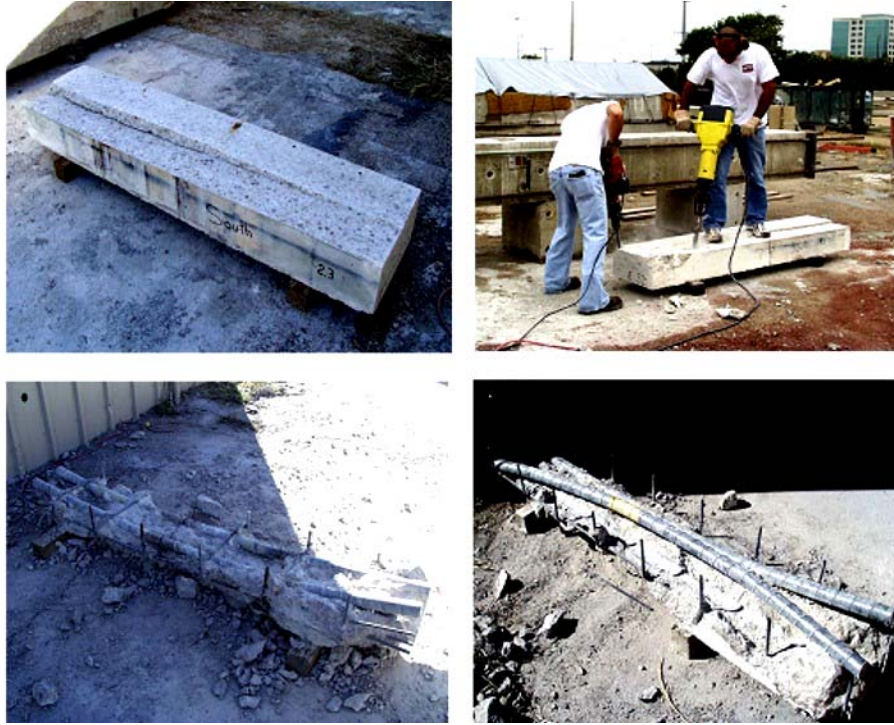
**Figure 5.4 Concrete Removal to Expose Duct and Mild Steel<sup>7</sup>**

Jack hammers and chipping hammers were used to carefully remove all existing concrete around post-tensioning ducts and mild steel reinforcement, as illustrated in Figure 5.4.

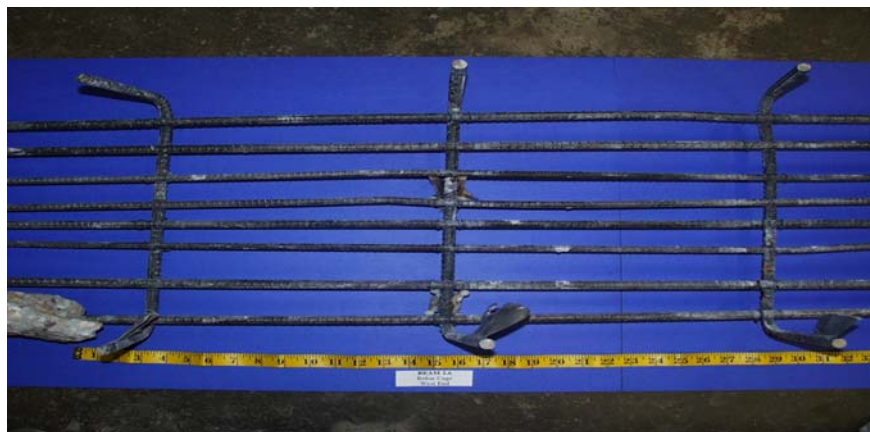
**Figure 5.6 Mild Steel Reinforcement Cage**

The mild steel bars and stirrups were removed after ducts had been removed, using the jackhammers and chipping hammers. Analysis of longitudinal steel was limited to 72 in. corresponding to the same analysis length used for the post-tensioning ducts and strands. Stirrups were analyzed only in the top portion and two 3 in. legs at each side, as shown in Figure 5.7.

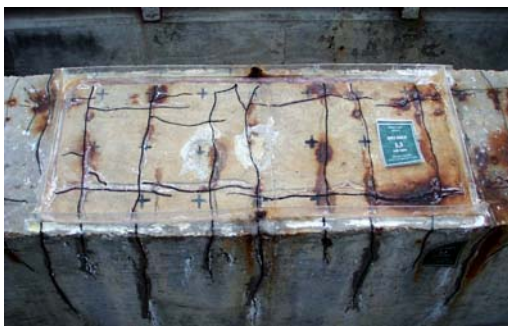
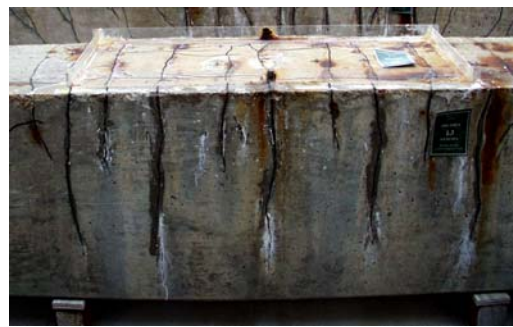
Figure 5.12 Specimen 1.3 – Condition Prior to Autopsy<sup>6,7</sup>

Specimen condition after testing included nine transverse cracks in the constant moment region (seven in the ponded region), with a maximum transverse crack width of 0.020 inches. Longitudinal cracks were also visible at 4.5 inches from the sides of the beam, with a maximum crack width of 0.050 in. Heavy rust stains and salt deposits were visible in the top of the cracks in localized areas, as shown in Figure 5.12.

*Lateral (South) view*

*Top view (from South side)*

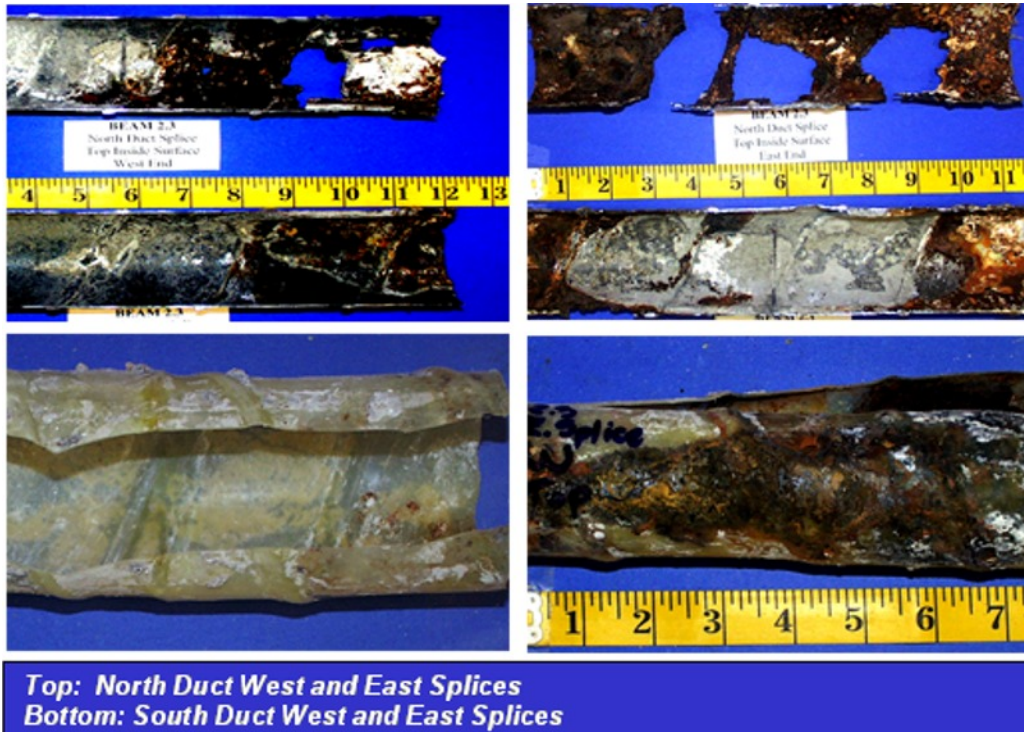
**Top: North Duct West and East Splices  
Bottom: South Duct West and East Splices**

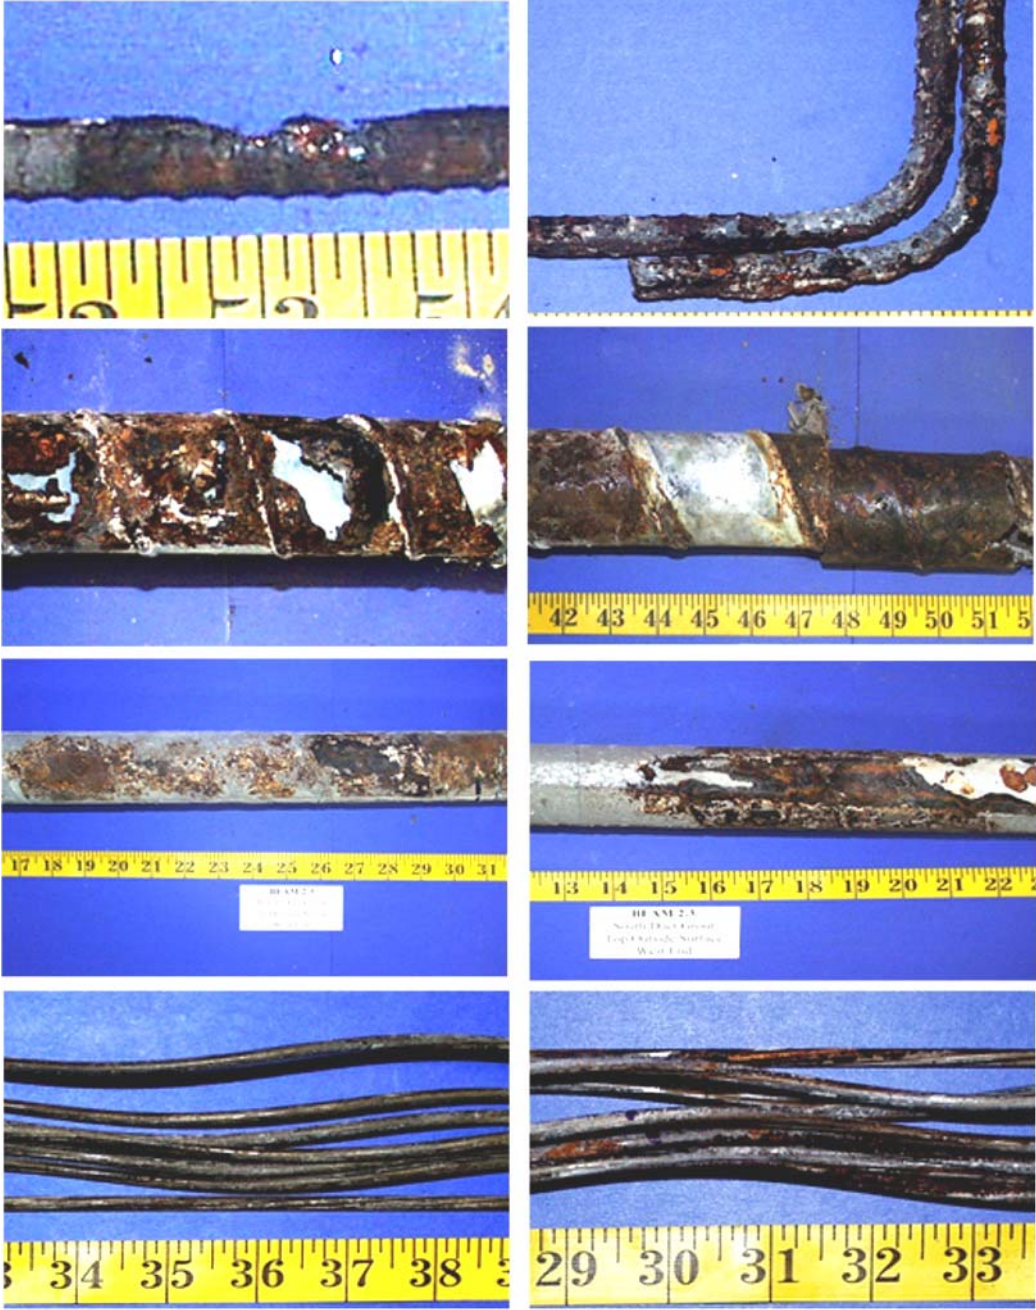
Moderate localized corrosion and pitting in a few wires was found on the south strands. The north strands show only moderate to light uniform corrosion. As with the mild steel bars, stirrups and ducts, localized corrosion in the strands corresponded to crack locations in the ponded region.

Figure 5.17 Specimen 2.3 – Reinforcing Elements<sup>6,7</sup>

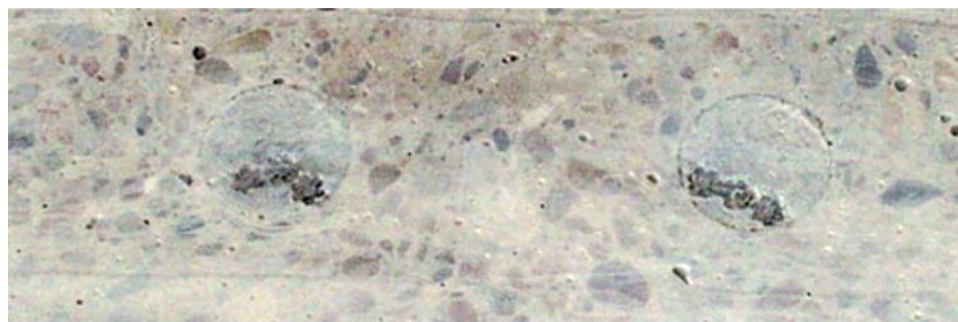
**Figure 5.28 Specimen 3.2 – Grouted Duct<sup>6,7</sup>**

The grout in the north duct showed multiple small voids over the entire length. The south duct grout had three large voids. A 14-inch long void was located at the centerline, as shown in Figure 5.30. Two six-inch long voids were found 24 inches to the east and to the west of the centerline. Figure 5.28 was included to illustrate the good grouting quality of both ducts in Specimen 3.2. The acid soluble chloride content in the north and south duct grout was negligible. Chloride samples were taken at 6-inch intervals within the forensic analysis length and chloride content plots were obtained, as shown in Figure 5.31.

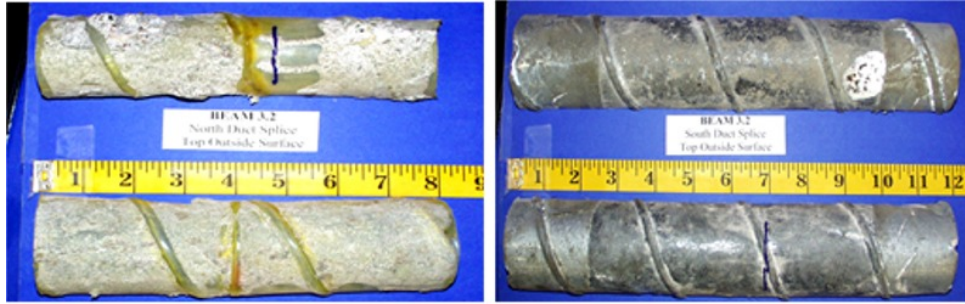
**Figure 5.29 Specimen 3.2 – Duct Splices<sup>6,7</sup>**

Specimen 3.2 had two duct splices. The south duct had an industry standard splice and the north duct had a heat-shrink splice. Both splices were located at the centerline of the beam. Figure 5.29 shows the condition of the duct splices at the end of exposure. Both splices showed no signs of corrosion, with only a minor salt stain on the industry standard splice.

*North Duct Splice*

*South Duct Splice*

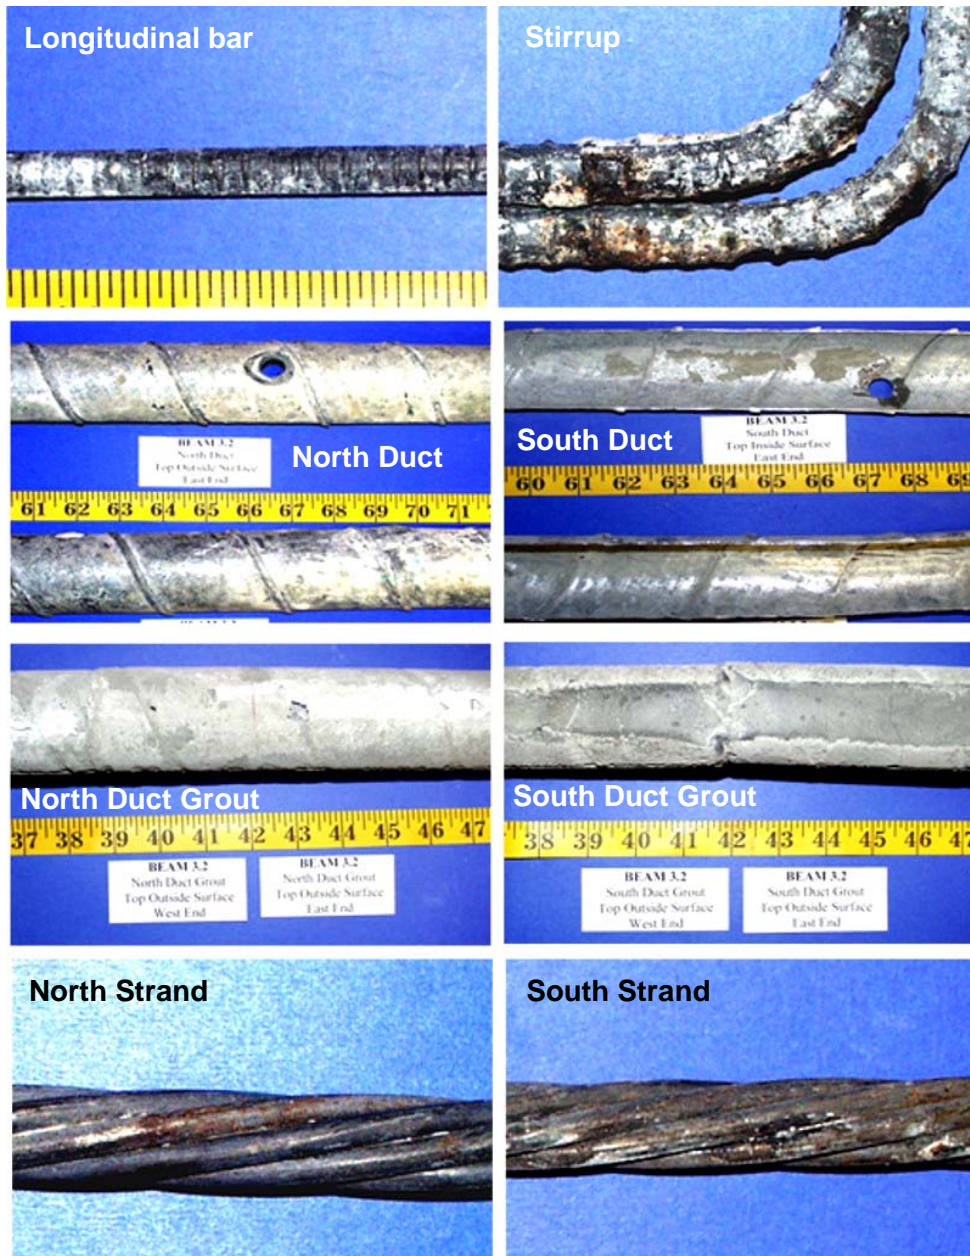
**Figure 5.30 Specimen 3.2 – Reinforcing Elements<sup>6,7</sup>**

A full autopsy of Specimen 3.2 was performed, providing a total length of 72 inches of the longitudinal bars, ducts, grout and strands and six stirrups to be analyzed (see Figure 5.30). Forty-two inches of the analysis length extended to the west of the centerline of the beam and the remaining 30 inches extended to the east.

The only corrosion found on the north duct was located under the heat-shrink splice at the centerline of the beam. It showed two very light spots of corrosion. The south duct showed no signs of corrosion (see Figure 5.30).

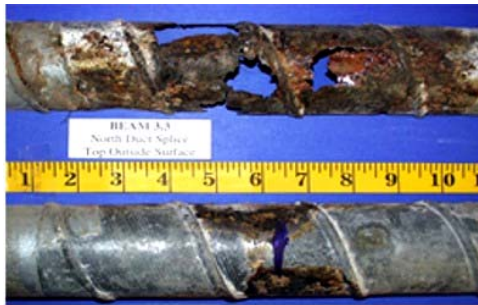
Figure 5.33 Specimen 3.3 – North Duct Splice<sup>6,7</sup>

Specimen 3.3 had one duct splice. It was an industry standard splice located on the north duct at the centerline. Figure 5.33 shows the condition of the duct splice at the end of exposure testing. The top of the north duct splice was found to be severely corroded with significant section loss.

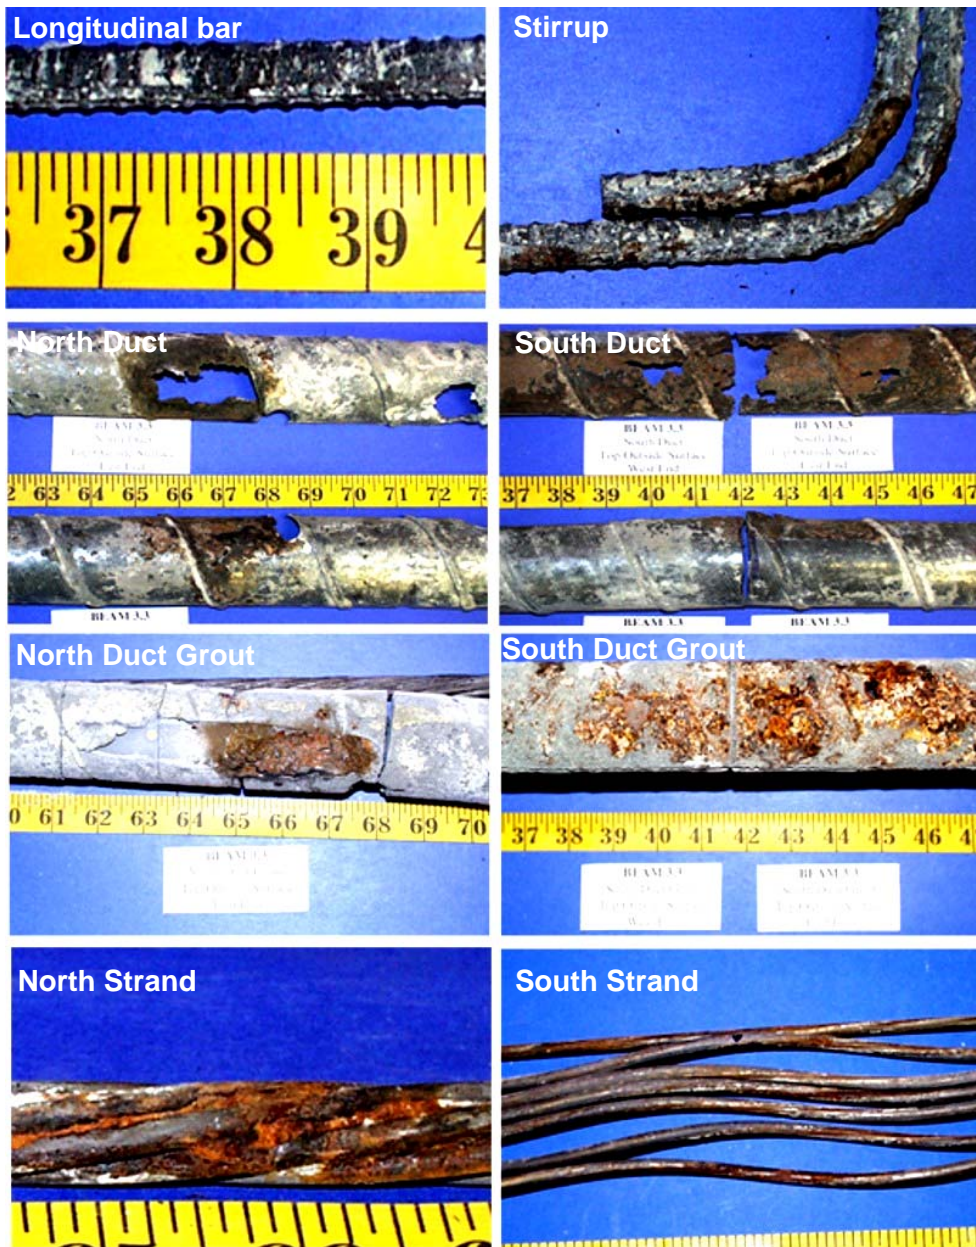
Figure 5.34 Specimen 3.3 – Reinforcing Elements<sup>6,7</sup>

Severe corrosion and area loss corresponding to the three crack locations was found on the north duct. The south duct also showed signs of severe corrosion and area loss at the centerline, and moderate corrosion under the other two cracks (see Figure 5.34). The remainder of the ducts showed no signs of corrosion.

Moderate to severe uniform corrosion was found on all three prestressing strands in the north duct. As shown in Figure 5.34, severe localized corrosion was found 24 inches to the west of the centerline, which again coincides with a crack location. Moderate to severe uniform corrosion was also found on all three prestressing strands in the south duct.

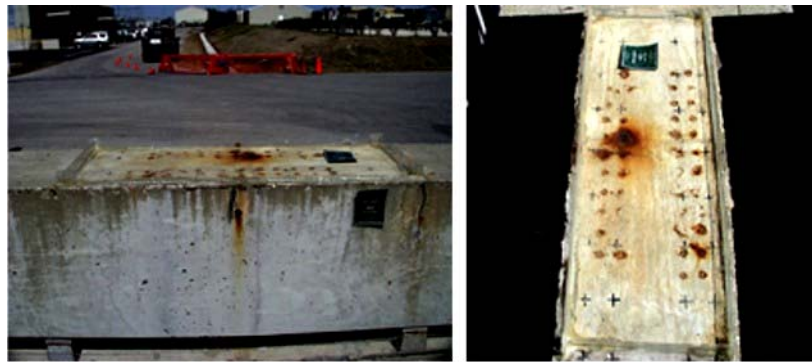
*Lateral (South) View*      *Top View (from East Side)*  
**Figure 5.36 Specimen 4.2 – Condition Prior to Autopsy<sup>6,7</sup>**

As shown in Figure 5.36, a visual inspection found that Specimen 4.2 had two transverse cracks across the top of the beam at the end of exposure. This specimen was designed to remain uncracked. The first crack had a maximum width of 0.013 inches and was located one inch to the west of the centerline of the beam. This location was directly above a stirrup. The second crack had a maximum width of 0.01 inches.

It was located 22 inches to the east of the centerline, also above a stirrup. As seen in Figure 5.36, there was no rust staining around the cracks. Any rust spots were again from the bolster strips.

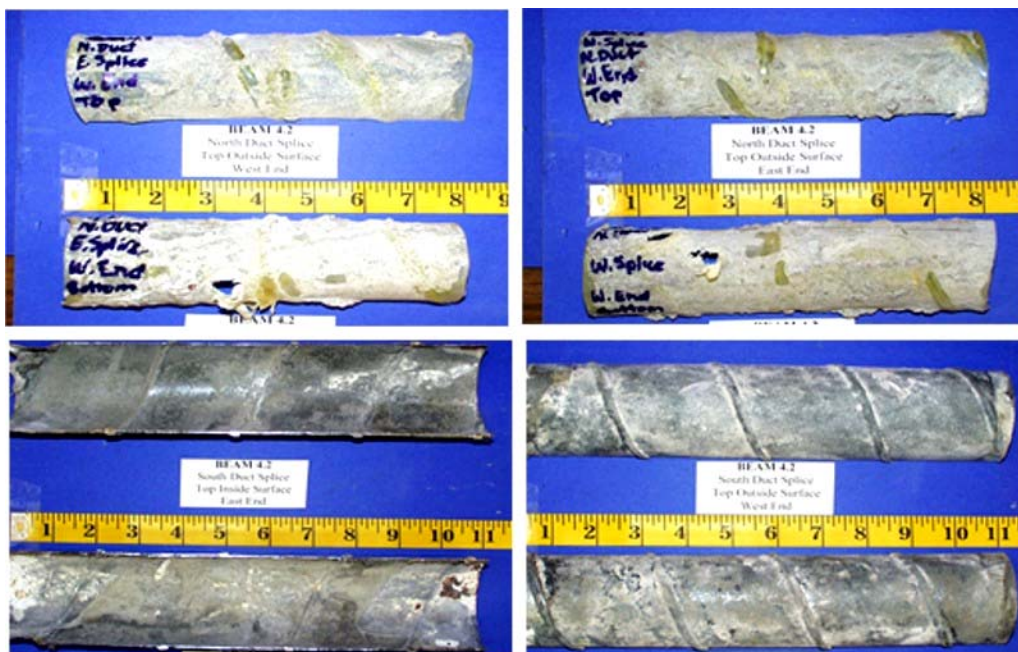
**Figure 5.37 Specimen 4.2 – Duct Splices<sup>6,7</sup>**

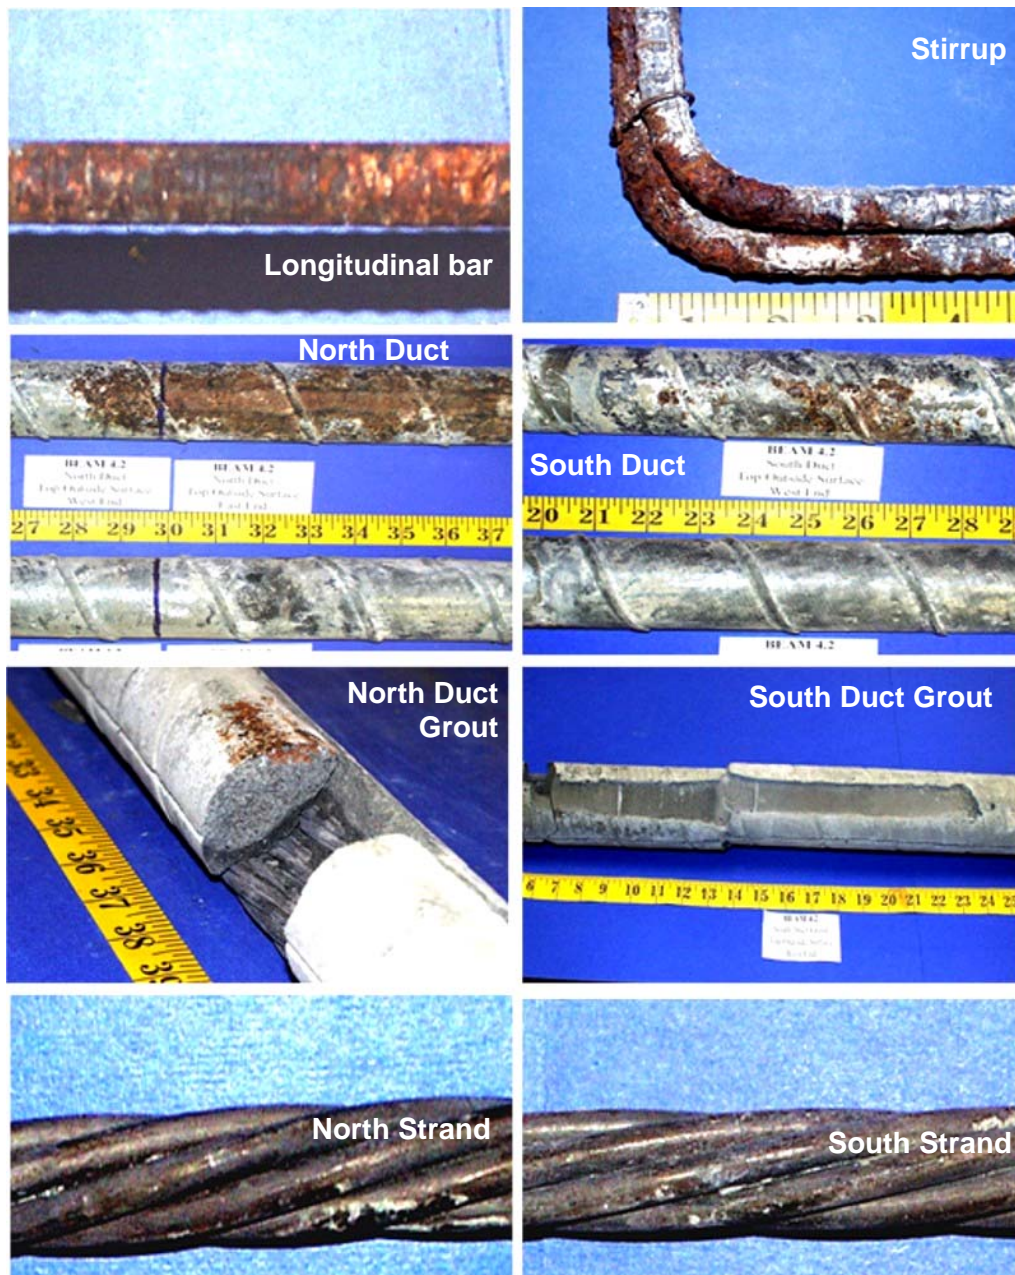
**Figure 5.38 Specimen 4.2 – Reinforcing Elements<sup>6,7</sup>**

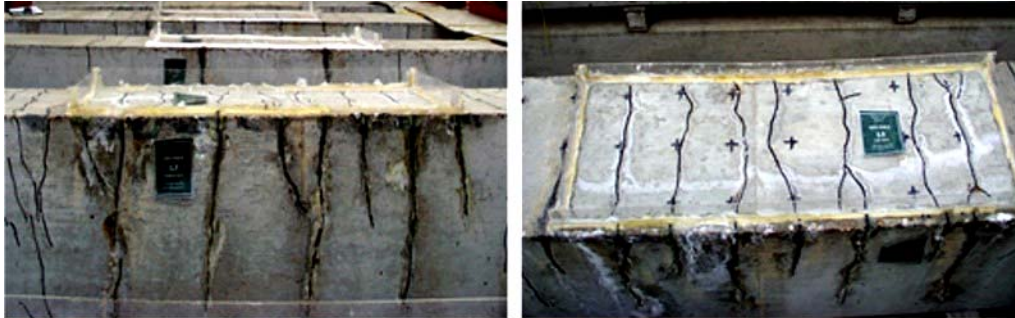
**Figure 5.40 Specimen 1.5 – Condition Prior to Autopsy<sup>6,7</sup>**

At the end of exposure, Specimen 1.5 had a large number of cracks on the top face and both sides (see Figure 5.40). A majority of the cracks were confined to the constant maximum moment region. There was a large amount of rust staining, corresponding to the cracks, on both sides of the specimen. Rust stains did not surround the cracks located outside the ponded region. Specimen 1.5 had a maximum crack width of 0.02 inches located 14 inches to the west and 11 inches to the east of the centerline.

*Lateral (North) View*

*Top View (from South Side)*

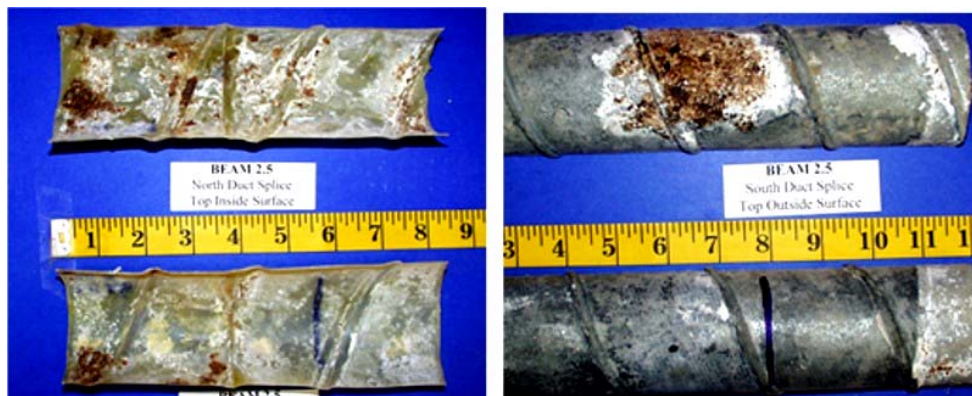
**Figure 5.47 Specimen 2.5 – Duct Splices<sup>6,7</sup>**

Specimen 2.5 had two duct splices. The south duct had an industry standard splice, and the north duct had a heat-shrink splice. Both splices were located at the centerline of the beam. Figure 5.47 shows the

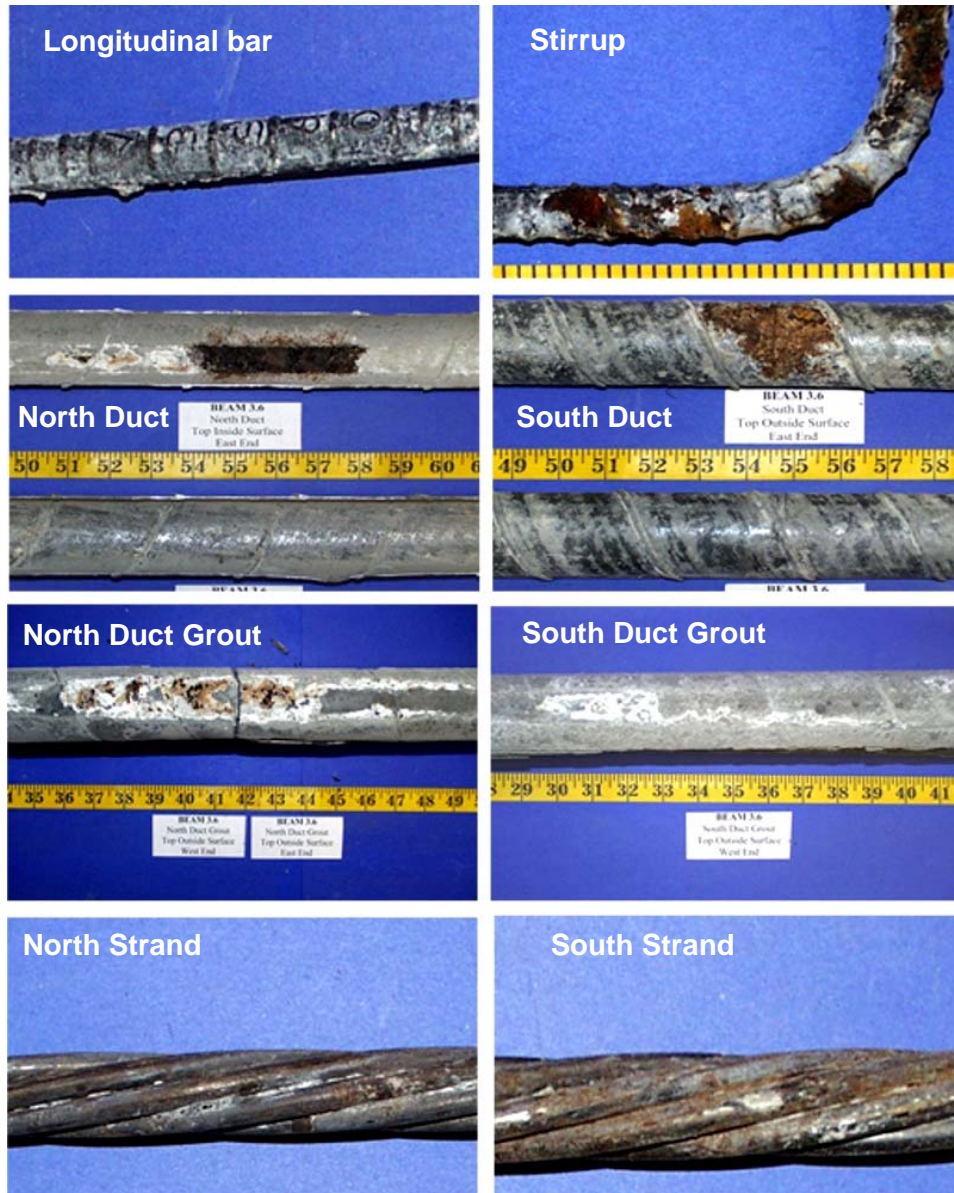
Figure 5.56 Specimen 3.6 – Reinforcing Elements<sup>6,7</sup>

A full autopsy of Specimen 3.6 was performed, providing a total length of 72 inches of the longitudinal bars, duct, grout and strands, and six stirrups for analysis. (See Figure 5.56) Forty-two inches of the

Corrosion in the north duct was found at the centerline and directly under the larger crack. The centerline corrosion was a result of the industry standard splice on the outside and the large void in the grout on the inside. There was minor area loss at the location, which was due to the alignment with the larger crack and the void in the grout. The only corrosion found on the south duct was moderate to severe corrosion with no area loss, located under the larger crack (see Figure 5.56).

The grout in the north duct showed a large void in the top due to bleed water. The void extended from the centerline across the entire east side. The effect of the void in the corrosion of the duct is apparent in Figure 5.56. The corrosion on the north duct and the corrosion products on the north grout are confined to the area above the void. A few small voids were present on the south duct grout, with the most significant one located 13 inches to the east of the centerline. This location is again directly under the larger crack. The acid soluble chloride content in the north duct grout reached a maximum value of 0.0022% by weight of grout at the location under the larger crack. The grout in the south duct reached 0.0021%. These values are much lower than the critical chloride threshold value of 0.033% by weight of grout. Chloride samples

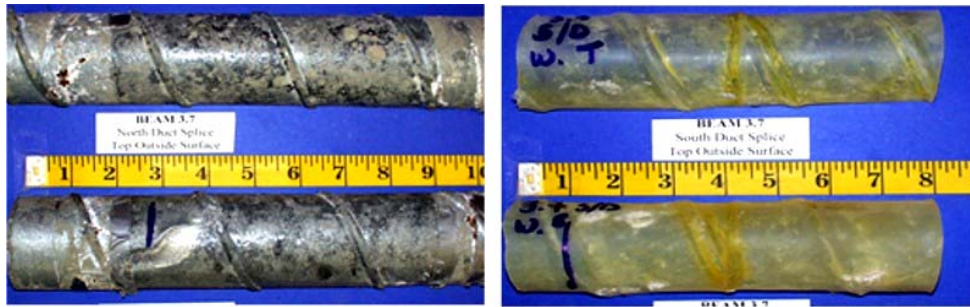
Figure 5.59 Specimen 3.7 – Duct Splices<sup>6,7</sup>

Specimen 3.7 had two duct splices. The north duct had an industry standard splice, and the south duct had a heat-shrink splice. Both splices were located at the centerline of the beam. Figure 5.59 shows the condition of the duct splices at the end of exposure. The only corrosion found on the industry standard splice was located under the duct tape. The heat-shrink splice showed no signs of rust staining or corrosion.

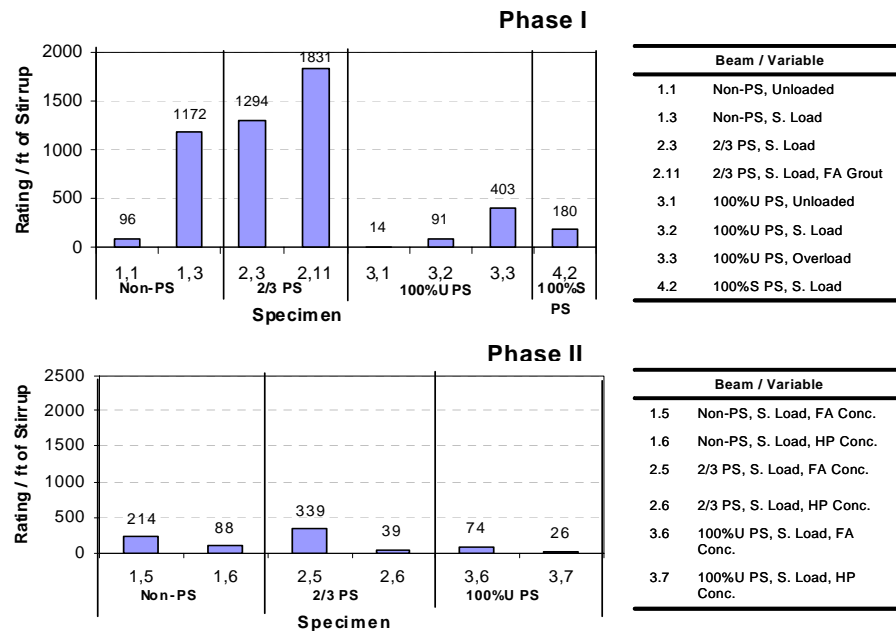
Figure 5.62 Generalized Stirrup Corrosion Ratings<sup>6,7</sup>

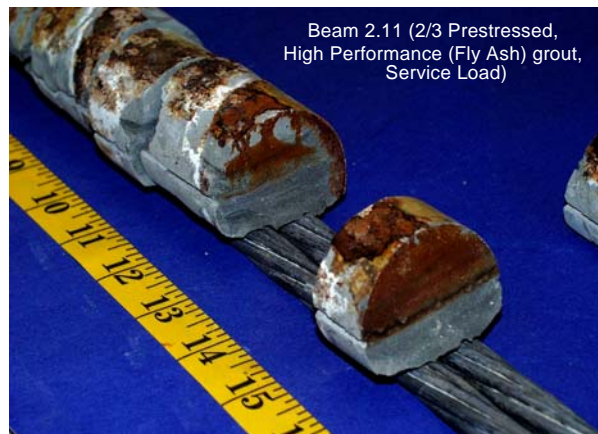
Figure 6.16 Effect of Grout Cracking<sup>7</sup>

Figure 6.16 shows the grout condition found during forensic examination for Specimen 2.11. As shown in this figure, moisture and corrosion stains coming from the galvanized duct were present in many grout transverse slices. At the time of forensic examination, it appeared that only a short time more would have been required for the moisture to get to the strand level. Similar findings were also reported before by Hamilton.<sup>9</sup> However, this aspect in the multilayer strand corrosion protection concept has not received enough attention to date.

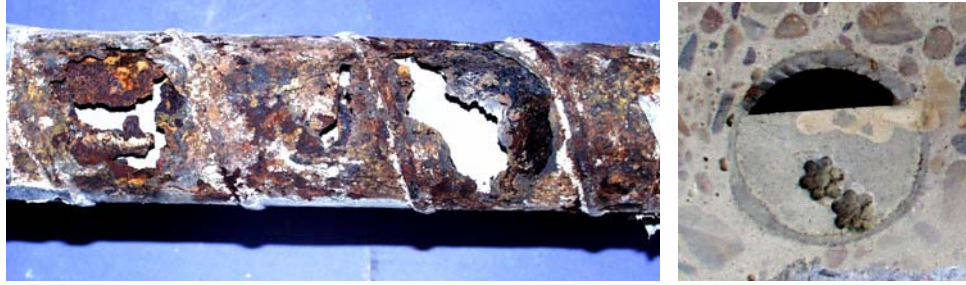
Figure 6.17 Bleed Water Void and Duct Corrosion<sup>7</sup>

Bleed water voids were also found inside the ducts on a few specimens, even when they were supposed to have been grouted following correct procedures. Figure 6.17 shows the negative effects of a bleed water void. It was found that grout voids do not only affect the corrosion protection of the strands, but they also appear to be detrimental to the duct.

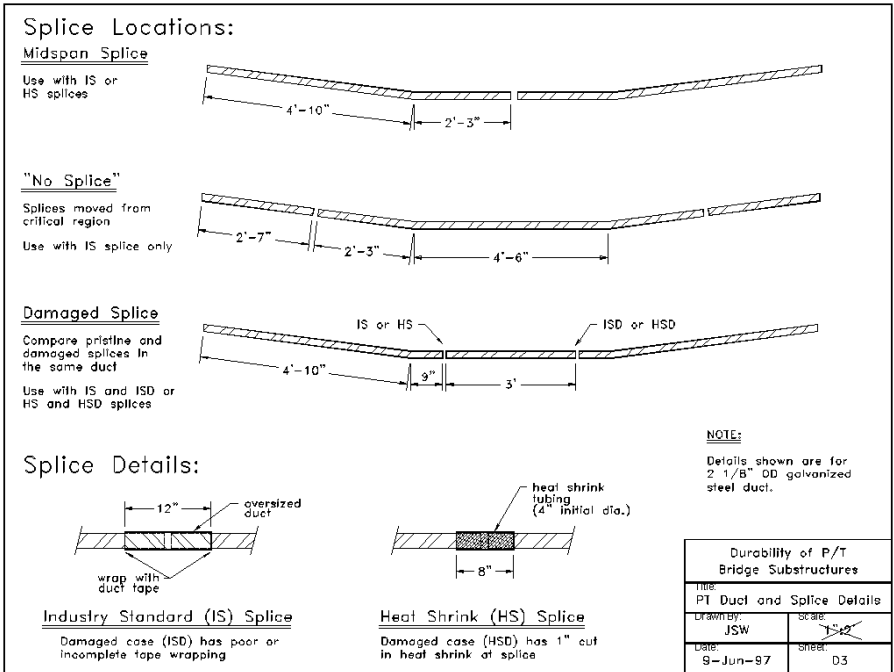
**Figure A.20 Sheet D3: Post-Tensioning Duct and Splice Details<sup>2</sup>**
