Polyurethane Foam for Roadway Stabilization
NH Route 129, Loudon, NH

Final Report

EVALUATION REPORT, OCTOBER 2011 TO JUNE 2014
POLYURETHANE FOAM
FOR ROADWAY STABILIZATION
NH ROUTE 129, LOUDON, NH

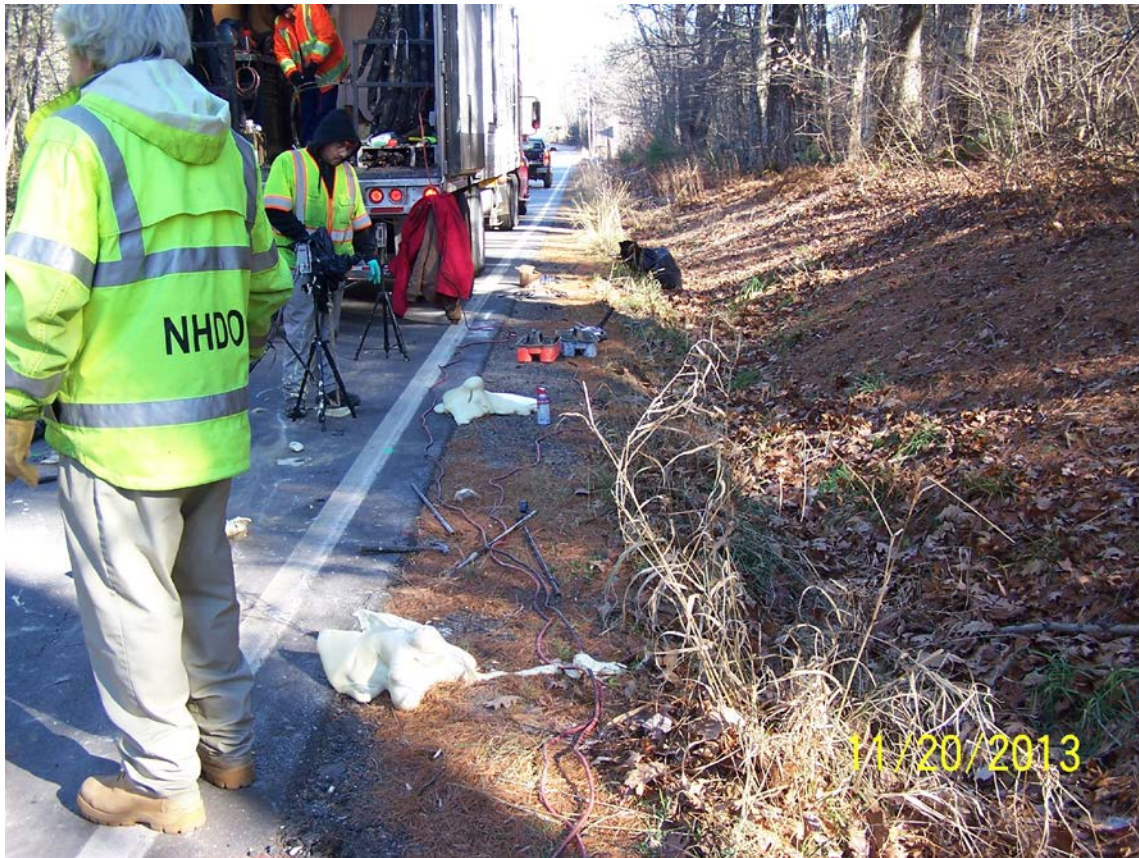
Expanding foam breaking through shoulder adjacent to injection points

Phase II injections were located from Station 6+55 to Station 7+55 inclusively. Two-level injections on a four-foot grid were again implemented; this time at 24 inches and 15 inches deep. Polymer was again injected until a pavement rise of 1 mm was indicated by laser level. Occasionally, foam broke out through the shoulder, indicating that it sometimes expanded to the pavement surface. The shallower depth allowed for the steel piping to be easily withdrawn to perform the shallow injection. Both injection depths were completed in the same drill hole. The piping was fully withdrawn after the shallow injection. Frost heaving measured during the 2013-14 winter season indicated a 31.7% reduction when compared to the control area.

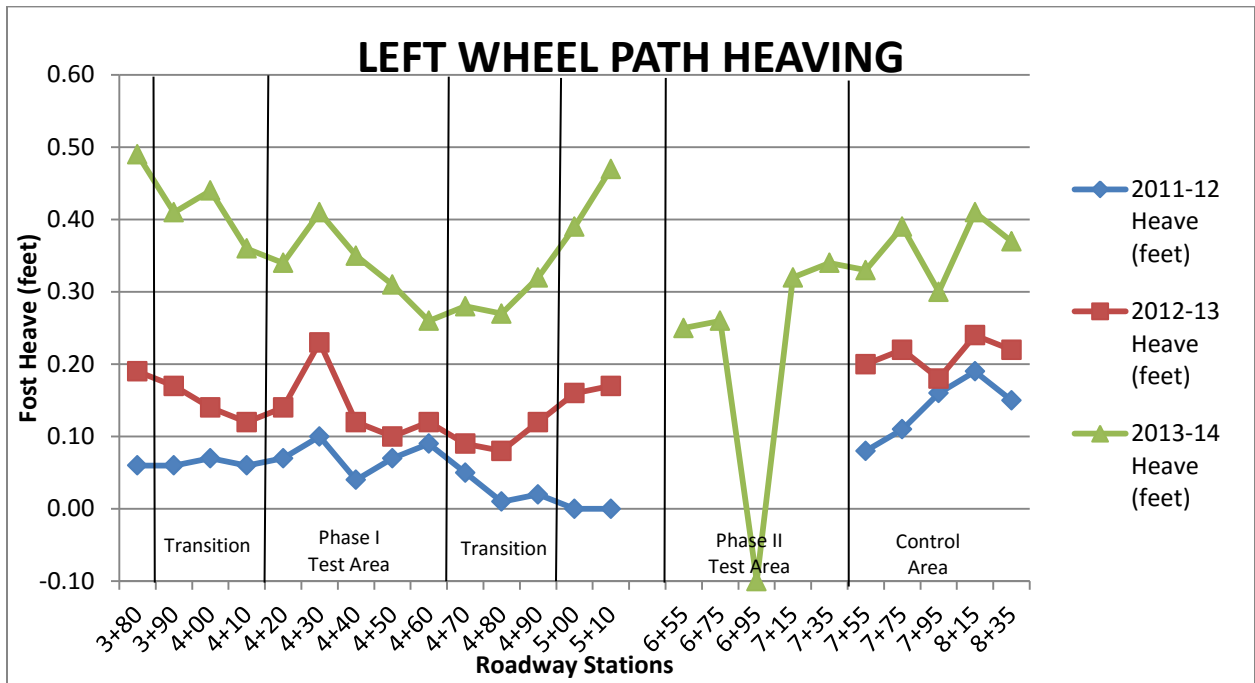
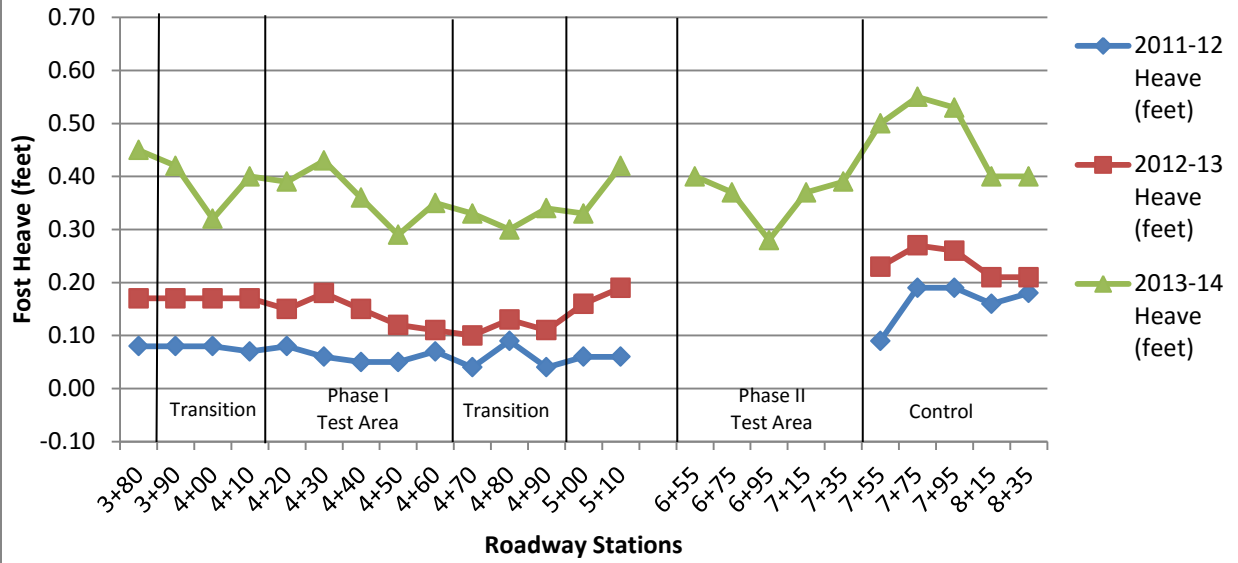
PHASE I and II FROST HEAVE DATA PLOTS BY AMOUNT OF HEAVE

RIGHT WHEEL PATH HEAVING

Unfortunately, the winter of 2011-12 was mild, with unusually little snow and below-average temperatures for November through March. Elevation survey data was collected on February 24 and June 21, 2012. In spite of the mild conditions, there was still a significant comparison of the treated and control areas. Elevation data showed that the fully treated area reduced heaving by 60% when compared with the control area in the first winter.

The second winter of observation (2012-13) experienced normal temperatures and snowfall, but resulted in a very brief frost heave season, leaving little opportunity for comparison of the most extreme and differential heaving period. Elevation data indicated a 41% reduction in heaving when compared with the control area.

Heaving in the treated transition areas was reduced by 67% in the first winter and 46% in the second. These values are similar to the values of the fully treated area, indicating that the deepest injections (48 inches, located only in the full treatment area) provided no heaving reduction benefit. Pavement elevations measured in the summers of 2012 and 2013 indicated that the surface had essentially returned to its baseline elevation. Visual observations of the surface show a subtle, but improved pavement condition in the treated area, indicated by fewer cracks.
