**Continuous Long-Term Health Monitoring using
Ultrasonic Wave Propagation**

December 2016

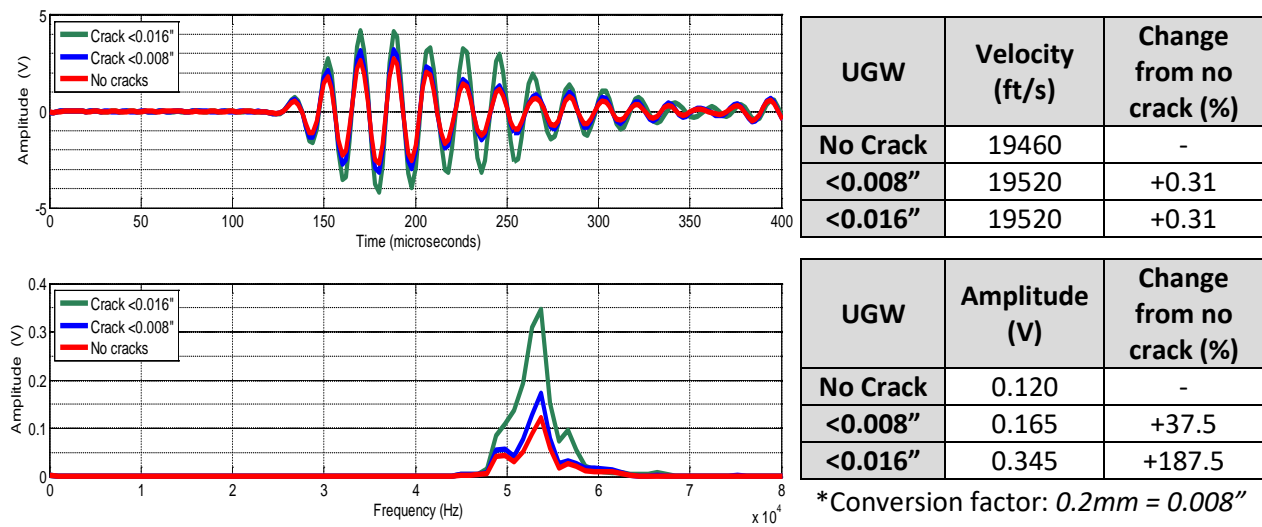
Figure 15. UGW (Figure 5a): Transducers located at ends of rebar

Figures 15 to 17 present sample time and frequency domain plots using UGW, UPV direct and UPV indirect, test arrangements that have been either previously used in research or have been standardized for practice. Time domain plots relate to velocity measurements and the frequency domain allows amplitude measurements.

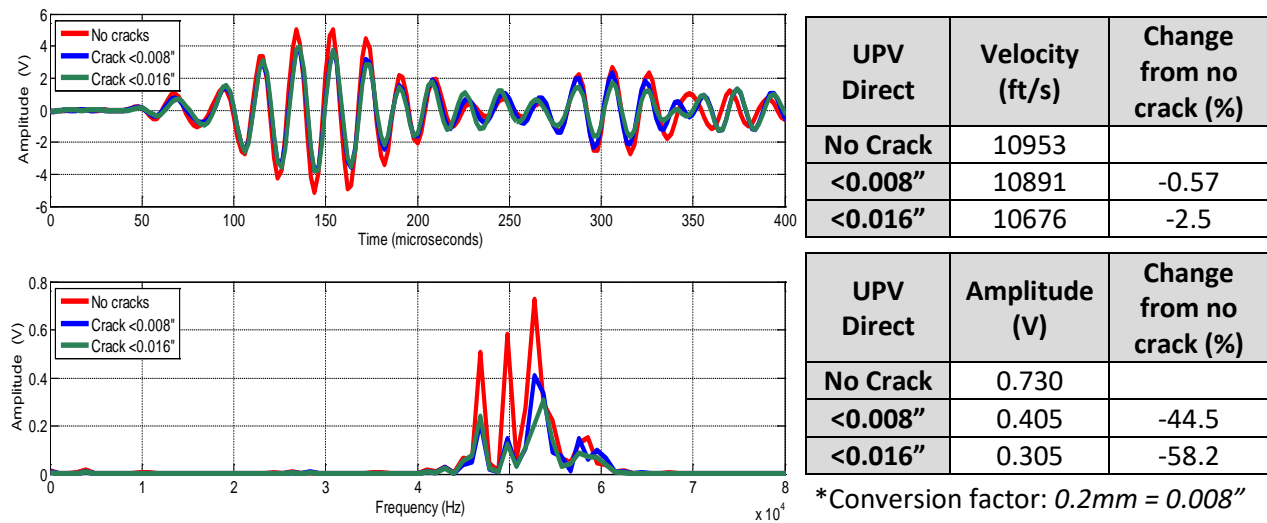
Figure 16. UPV (Figure 5b): Direct (Gain 10)

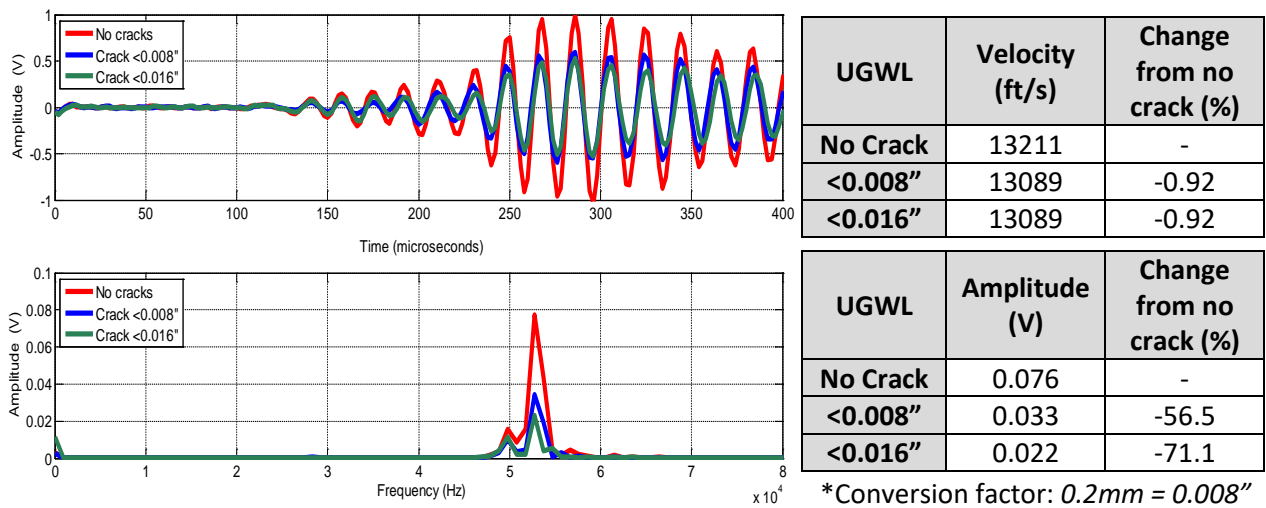
Figure 19. UGWL (Figure 5d and 18a): Delamination in path of leakage – Transducer (Gain 10)

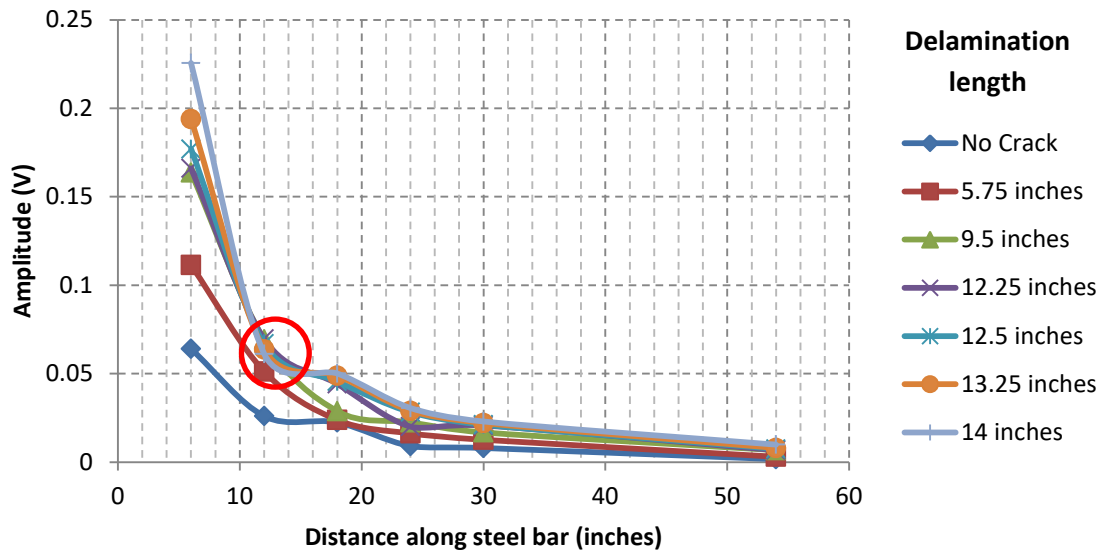
Figure 30. Amplitude with respect to delamination length monitored by the array 3 inches away from steel bar.

and 31 show how the amplitudes of signals monitored by arrays 3 and 15 inches away from steel bar, respectively, changed as delamination grew. In Figure 31, the array of sensors located on the parallel edge 15 inches away from the steel bar consistently saw increases in amplitude throughout the array as the delamination grew wider and longer. However, the array of sensors located 3 inches away did not. The sensor monitoring the 12 inch location along the steel bar saw decreases once the delamination reached 12.25 inches long, shown circled in Figure 30. The specimen was opened up along the delamination after testing and at the 12 inch point along the steel bar it was found that the side facing toward the array 3 inches away from the steel bar had delaminated from the concrete, as shown in Figure 32.

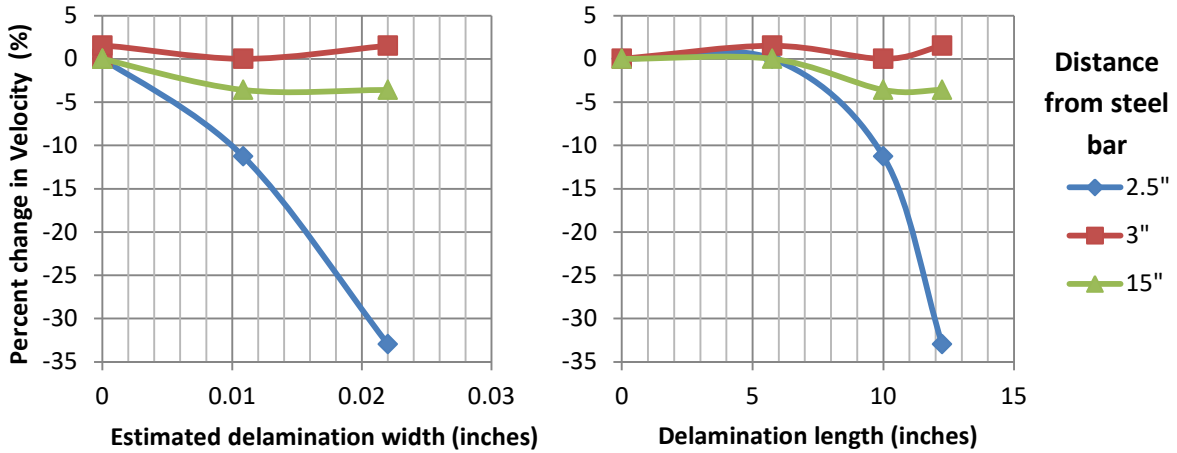
Figure 47. Percent change of velocity with respect to delamination width and length for sensors located to monitor the 6 inch point along steel bar.

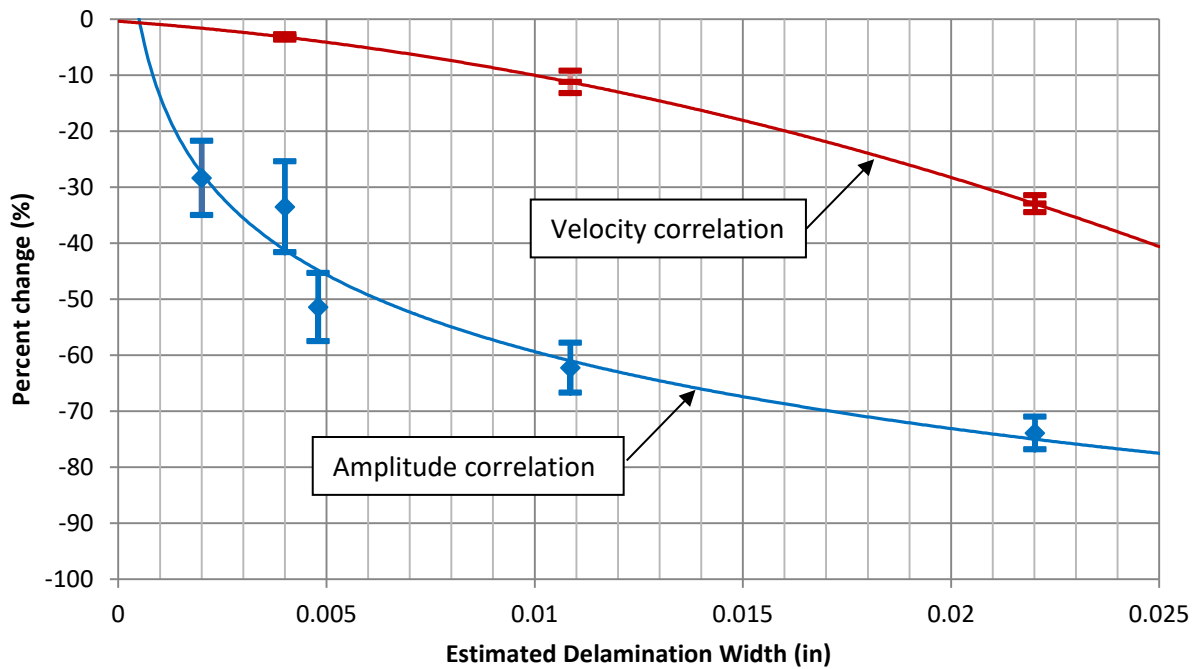
Figure 51. Percent change of amplitude and velocity against estimated delamination width in path of leakage.
