### **Technical Report 17- 4**

*Experimental Evaluation and Design of  
Unfilled and Concrete-Filled FRP  
Composite Piles*

*Task 7 – Final Report - Thesis*

**EXPERIMENTAL EVALUATION OF FIBER REINFORCED POLYMER  
PILES IN LOAD-BEARING APPLICATIONS**

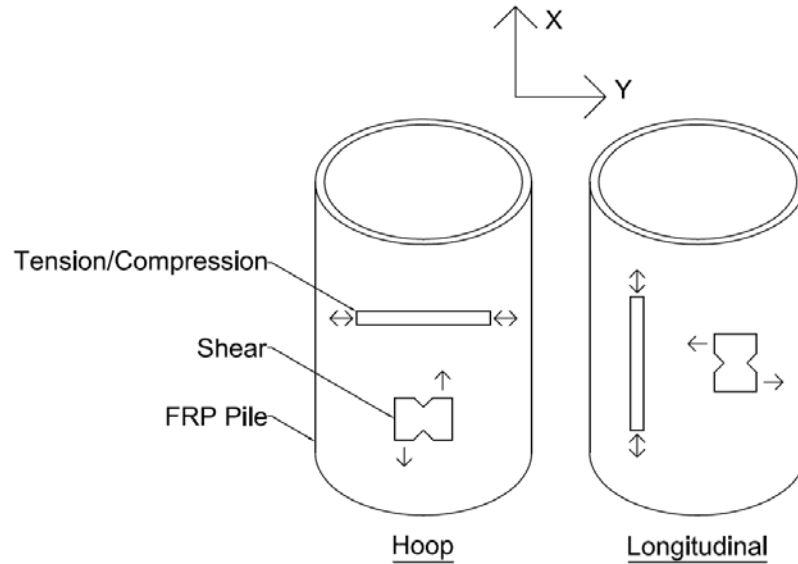
piles. This is presented graphically in Figure 2.1. Glass transition temperature testing was only conducted in the hoop direction due to the high modulus of the material.

Figure 2.1 Orientation of Coupons for Mechanical Testing

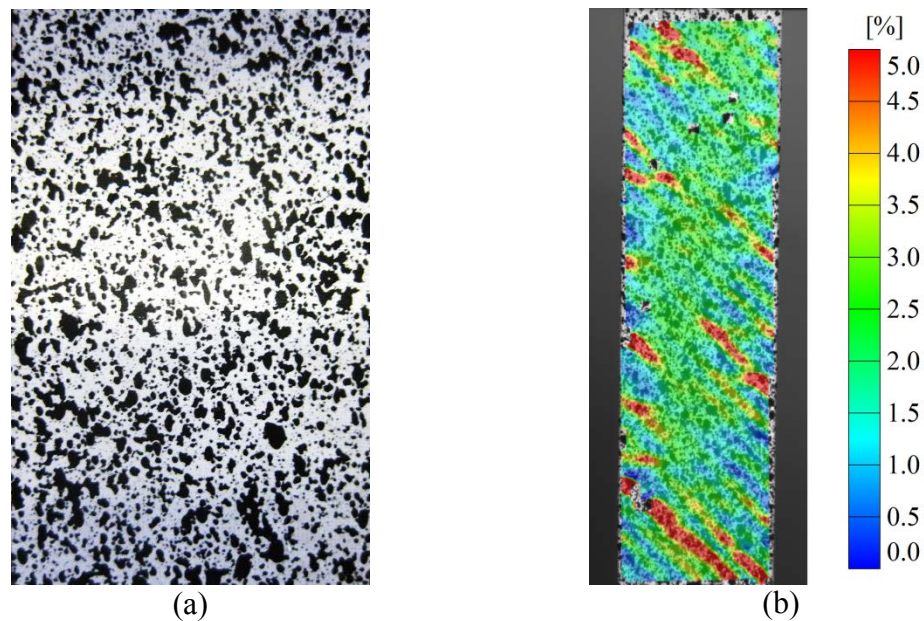
over the entire gage length of the samples by tracking the movement of dots in a black and white, painted speckle pattern. The data was then trimmed to eliminate strain concentrations at the edges of the sample and near the grips. The strains presented are the average value over the area of interest. An example of the speckle pattern and strain field created by ARAMIS software can be seen in Figure 2.2.

Figure 2.2 ARAMIS Speckle Pattern (a) and Strain Field (b)

The ARAMIS system is sensitive to vibrations created by nearby laboratory activity, hydraulic systems, and temperature and humidity control systems. This can create an error in strain measurement of approximately +/- 500 microstrain. The error is relatively small in the direction of loading, but it will be larger when measuring strains perpendicular to loading.

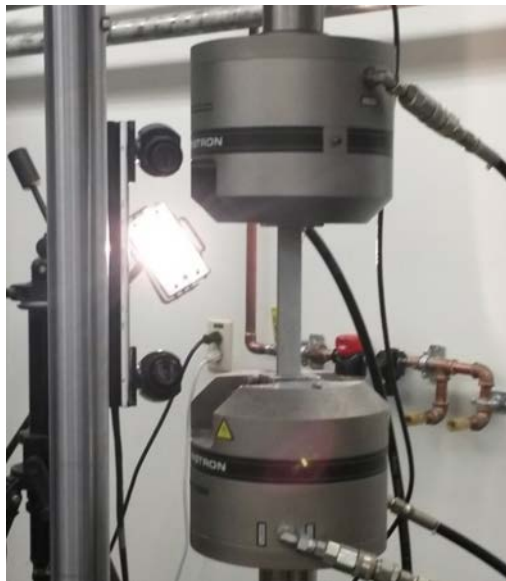
Some longitudinal tension samples slipped in the grips during testing with a maximum available gripping pressure of approximately 17.3 MPa (2.5 ksi). Grit paper was added to the grips of the Instron testing machine to limit slipping of the sample during tests. Several longitudinal tension samples were discounted due to slipping in the grips. The test fixture can be seen in Figure 2.3.

Figure 2.3 Tension Test (ASTM D3039)

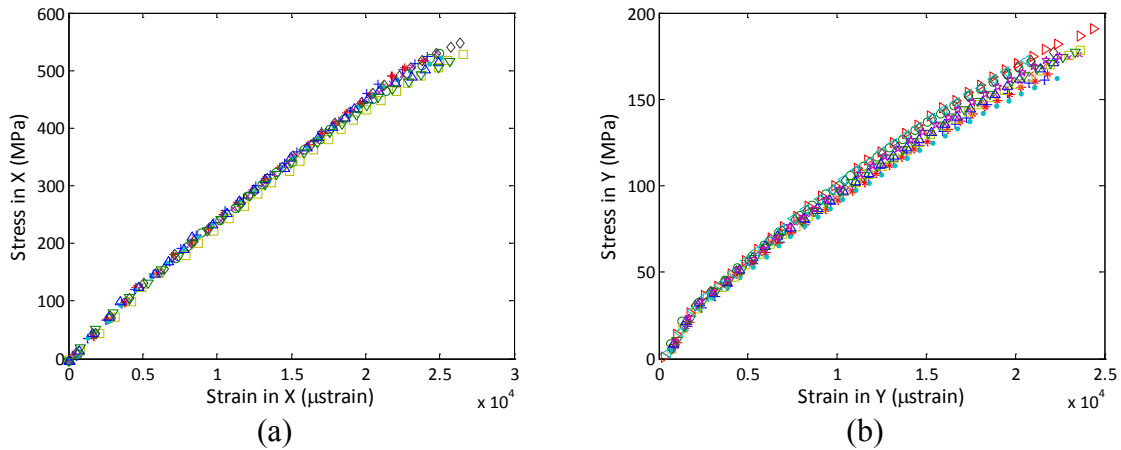
Stress-strain plots of longitudinal and hoop tension tests can be seen in Figure 2.4.

Figure 2.4 Longitudinal (a) and Hoop (b) Tension Stress-Strain Curves

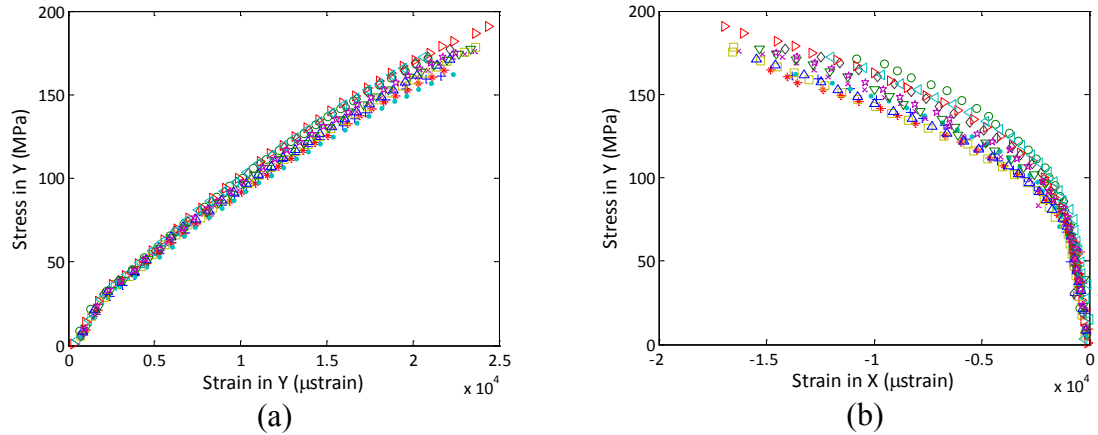
strain ranges used in calculating properties for longitudinal and hoop tests may also induce error. The bilinear trend in hoop tension tests can be seen in Figure 2.5.

Figure 2.5 Strain Parallel (a) and Perpendicular (b) to Loading in Hoop Tension

This indicates that the material does not behave linear-elastically. Hoop tension tests show a bilinear trend, which is a likely cause of this difference. The difference in

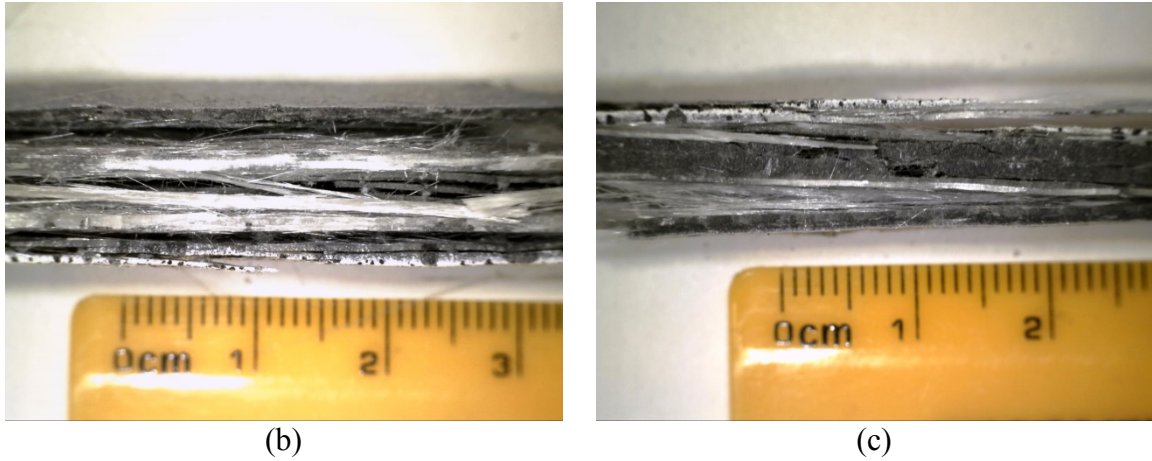
Typical failure modes of tension coupons were classified using ASTM D3039 [8]. Longitudinal tension samples were characterized as having an “explosive gage middle” (XGM) failure, while hoop tension samples had an “angled gage middle” (AGM) failure. The failure modes can be seen in Figure 2.6.

Figure 2.6 Image Location (a) of Failure in Longitudinal (b) and Hoop (c) Tension Samples

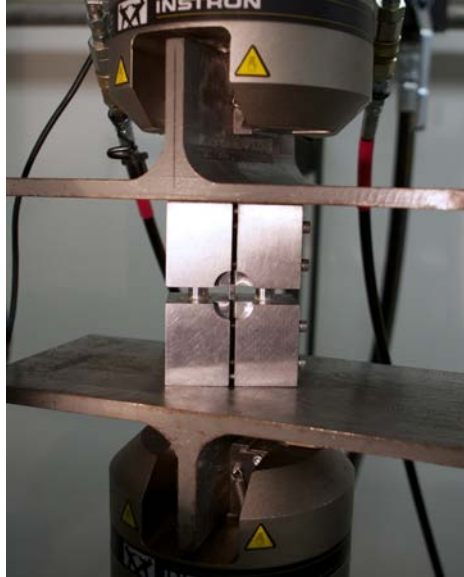
Figure 2.7 Compression Test (ASTM D6641)

The ASTM standard for this test suggests a bolt torque of 2.5 to 3.0 N-m (20 to 25 in-lbs). The bolt torque was increased to 5.6 N-m (50 in-lbs) to prevent samples from slipping in the test fixture. The test fixture can be seen in Figure 2.7.

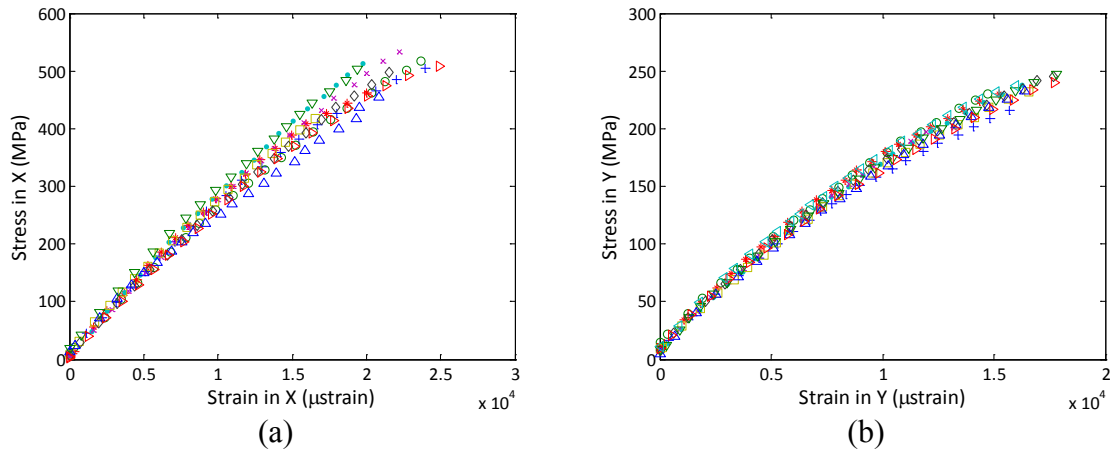
Stress-strain plots of longitudinal and hoop compression tests can be seen in Figure 2.8.

Figure 2.8 Longitudinal (a) and Hoop (b) Compression Stress-Strain Curves

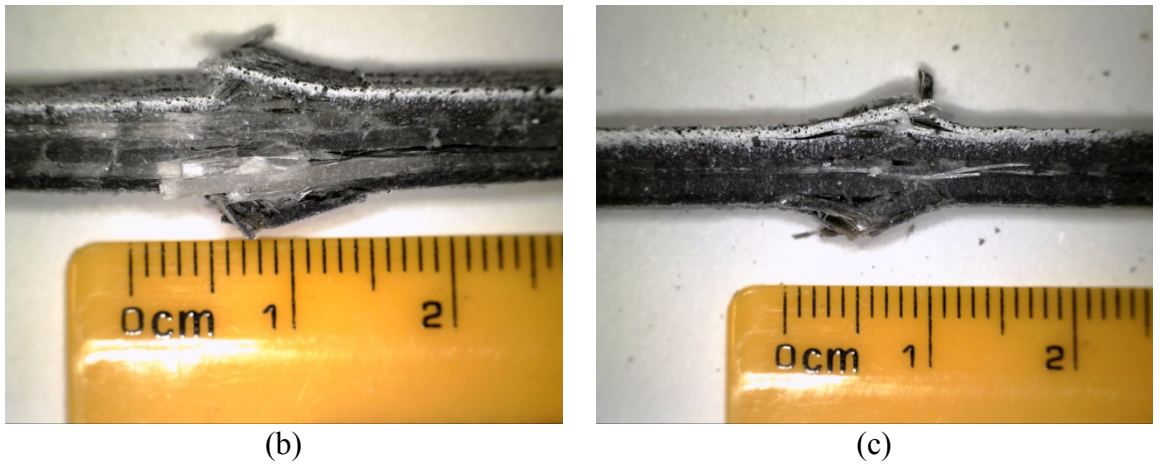
Typical failure modes of compression coupons were classified using ASTM D6641[9]. Longitudinal and hoop compression samples were characterized as having a “brooming gage middle” (BGM) failure. The failure modes can be seen in Figure 2.9

Figure 2.9 Image Location (a) of Failure in Longitudinal (b) and Hoop (c) Compression Samples

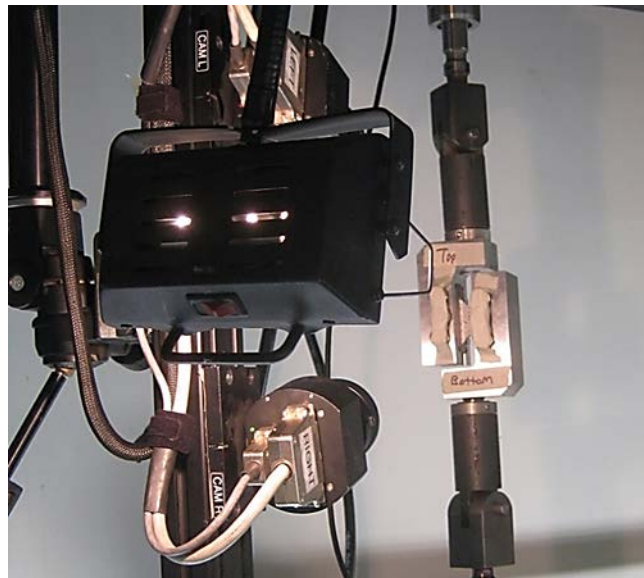
All shear testing was conducted in accordance with ASTM D7078 [10]. Twelve shear coupons were tested in the longitudinal orientation and another twelve coupons were tested in the hoop orientation. The ASTM standard used for this test was designed for samples with reinforcing only in the 0 and 90 degree directions. This material has reinforcing in the 0, 90, and +/- 45 degree directions which gives the material a higher shear strength. The suggested bolt torque of 55 N-m (40 ft-lbs) allowed samples to slip in the test fixture before failure, so the bolt torque was increased to 75 N-m (55 ft-lbs). The test fixture can be seen in Figure 2.10.

Figure 2.10 Shear Test (ASTM D7078) with ARAMIS System

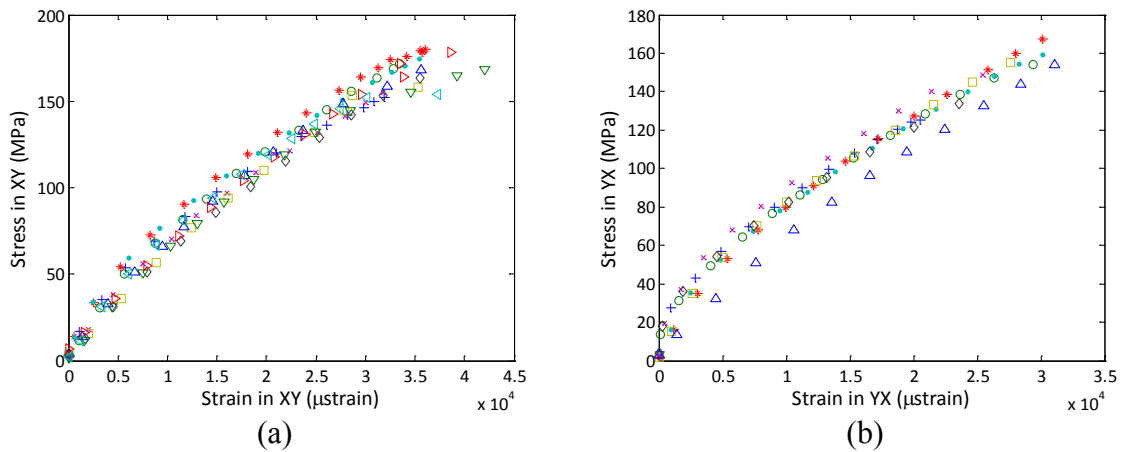
Stress-strain plots of longitudinal and hoop shear tests can be seen in Figure 2.11.

Figure 2.11 Longitudinal (a) and Hoop (b) Shear Stress-Strain Curves

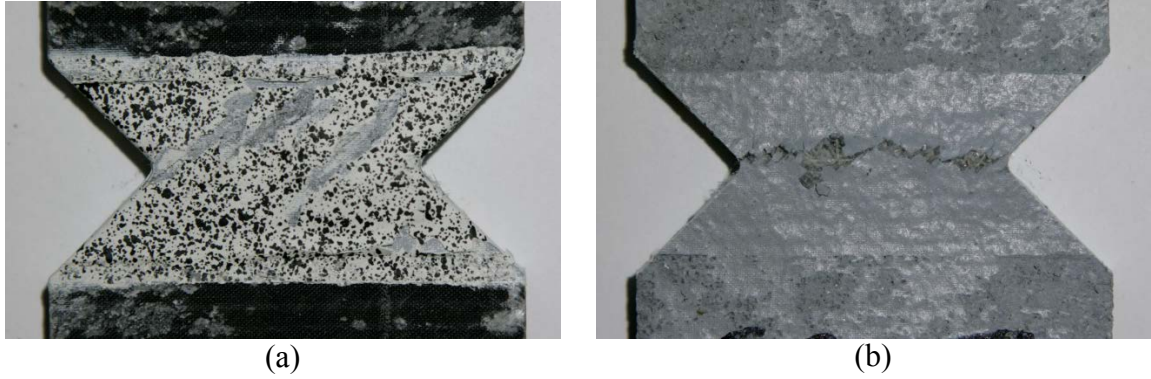
Longitudinal and hoop shear samples were characterized as having an “angled gage section between notches” (AGN) failure on one face and a “vertical cracking gage section between notches” (VGN) failure on the other face. The failure modes can be seen in Figure 2.12.

Figure 2.12 Typical AGN Failure (a) and VGN Failure (b) of Shear Samples

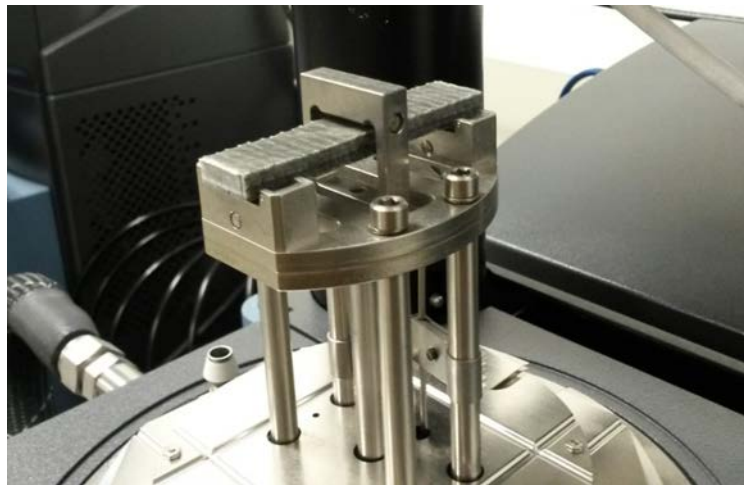
Figure 2.13 Glass Transition Temperature Test (ASTM E1640)

Glass transition testing was conducted in accordance with ASTM E1640 [11]. A Thermal Analysis Instruments DMA Q800 dynamic mechanical analyzer was used to test samples. The 3 point bend test configuration was used to accommodate the thickness and modulus of the samples. The test set up can be seen in Figure 2.13.

Tests were conducted with a pre-load of 2 N, frequency of 1 Hz, temperature ramp of 3 °C per minute, and amplitude of 10 micrometers. The temperature range was 30 to 140 °C.

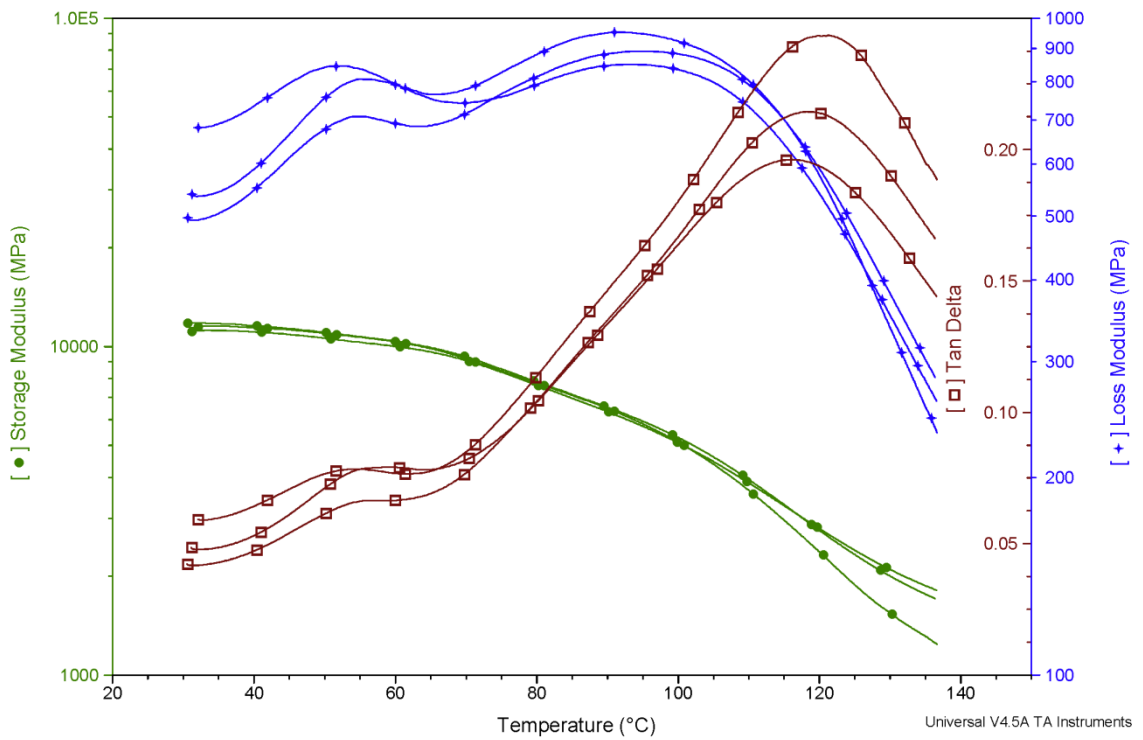
For the purpose of this research, the onset of the change in slope of the storage modulus will be used as the glass transition temperature in accordance with ASTM E1640 [11], but the peak of the loss modulus and tan delta curve will be presented for comparison. A plot of glass transition temperature test results can be seen in Figure 2.14.

Figure 2.14 Glass Transition Temperature Results

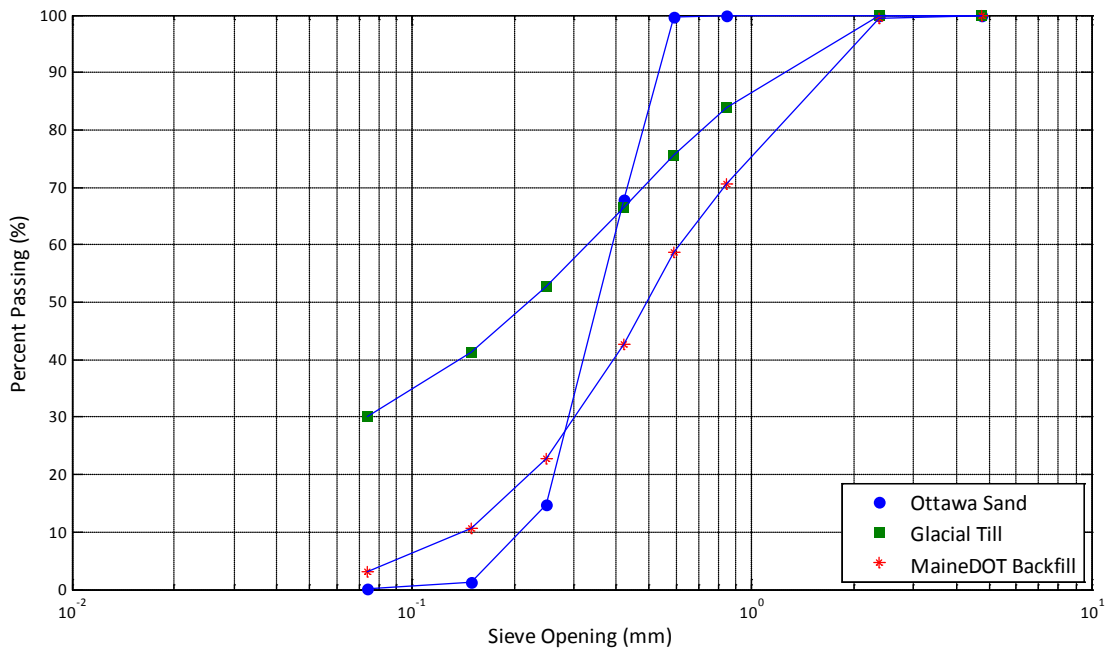
Three soils were used to determine the interface friction angle of the FRP material: Ottawa sand, Maine Department of Transportation (MaineDOT) Backfill, and a glacial till. Prior to all testing, grains above the number 8 sieve were removed to meet the requirements of ASTM D3080[19] for the minimum sample height to maximum grain size ratio in interface friction tests. The grain size distributions for these soils can be seen in Figure 3.1.

Figure 3.1 Grain Size Distribution of Selected Soils

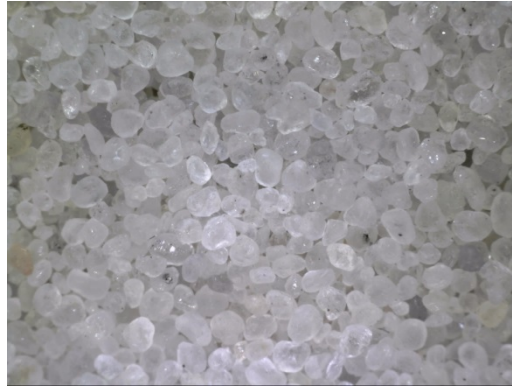
Figure 3.2 Ottawa Sand

Ottawa sand was selected because it is a well-documented soil. Ottawa sand is sub-rounded with small range of grain sizes. The Ottawa sand can be seen in Figure 3.2.

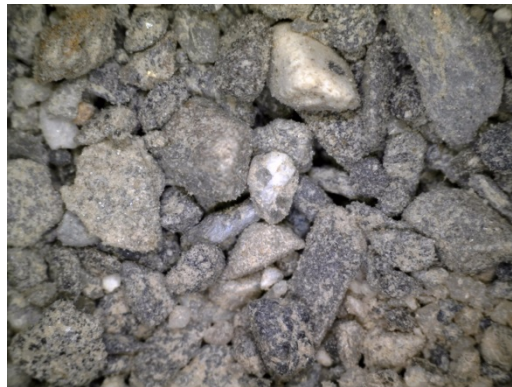
Figure 3.3 MaineDOT Backfill

This soil was selected because it is an engineered granular fill meeting the requirements for MaineDOT Type B Aggregate [20]. It is a sub-angular soil with little fines content. The MaineDOT Backfill can be seen in Figure 3.3.

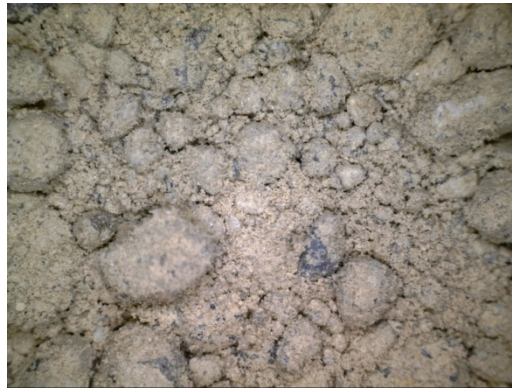
A glacial till was selected because it is a soil that is commonly encountered in Maine and can produce difficult driving conditions. The till used in this testing was obtained from an open excavation at the corner of Long Road and Rangeley Road in Orono, ME. This soil is angular to sub-angular with high fines content. The glacial till can be seen in Figure 3.4.

Figure 3.4 Glacial Till

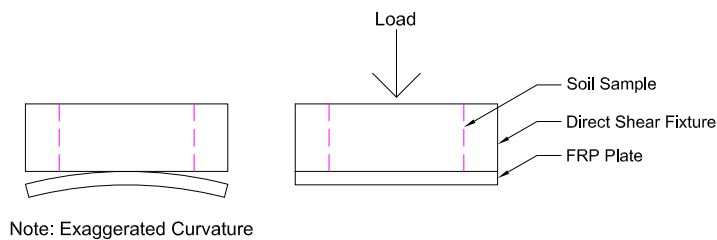
FRP plates used for the testing had a slight curvature. This curvature was not able to be removed prior to testing because the plates were manufactured using a thermoset resin. This curvature will depress under the normal stress applied during the test. This is illustrated in Figure 3.7. The test fixture was calibrated to account for the additional change in vertical height caused by the depression of the FRP plates.

Figure 3.7 Flattening of FRP Plate under Load

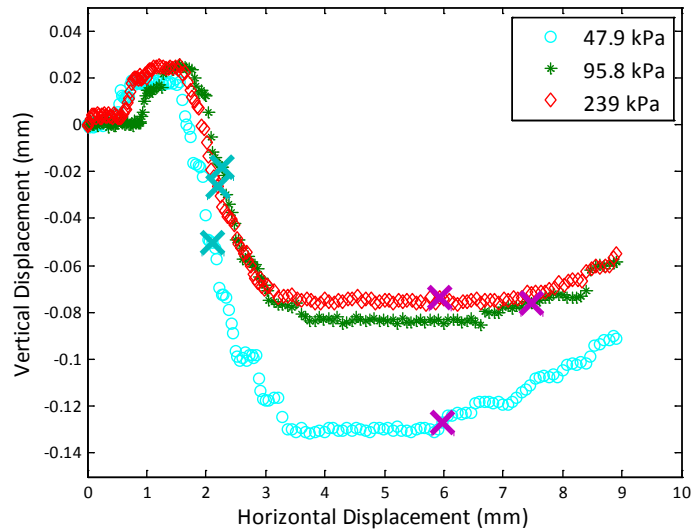
who did not note any dilation. Work by O'Rourke et al [27] suggests that soil particles predominately slide across hard, smooth materials, creating little or no dilatant behavior. An example of dilatancy seen in interface friction testing of medium dense MaineDOT backfill can be seen in Figure 3.8.

Figure 3.8 Dilatancy of Medium Dense MaineDOT Backfill during Interface Friction Testing

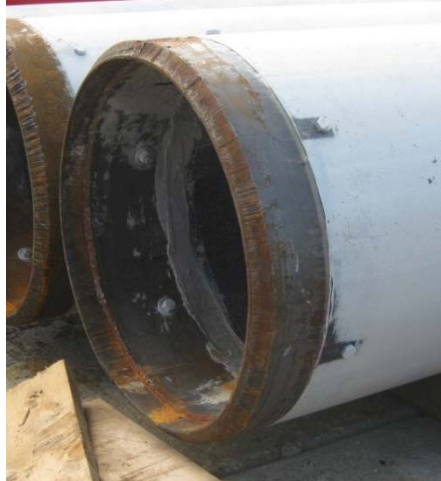
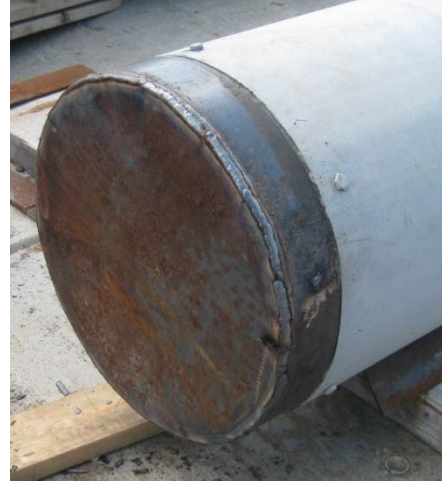
Figure 4.1 Driving Shoe for Hollow (a) and Concrete-Filled (b) Piles

All Piles were driven using a steel driving shoe designed by Harbor Technologies. Driving shoes for hollow and concrete-filled piles can be seen in Figure 4.1.

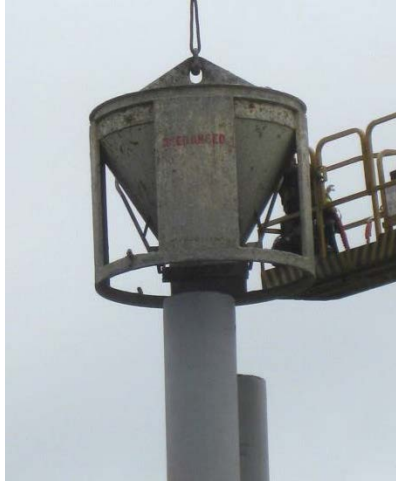
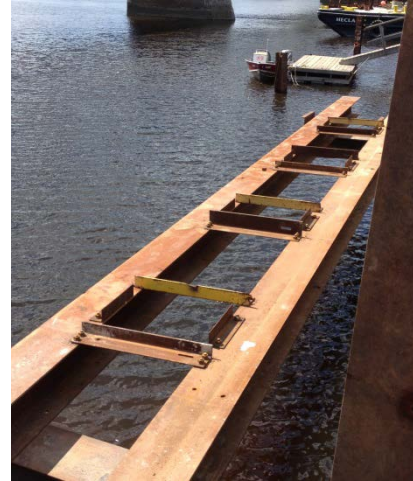
Figure 4.2 Concrete Placement (a) and Driving Template (b) for FRP Piles

Maine Department of Transportation (MaineDOT) Class A concrete [20] with a target 28 day compressive strength of 30 MPa (4350 psi) was placed in the piles on August 14, 2013. This concrete contained no expansive or non-shrink additives. A 0.76 cubic meter (1 cubic yard) concrete bucket was used to fill the piles while they stood vertically in the template used for driving. The filling process and driving template can be seen in Figure 4.2. Concrete was allowed to free-fall and 0.91 m (3 ft) at the head of the pile was consolidated using a pencil vibrator.

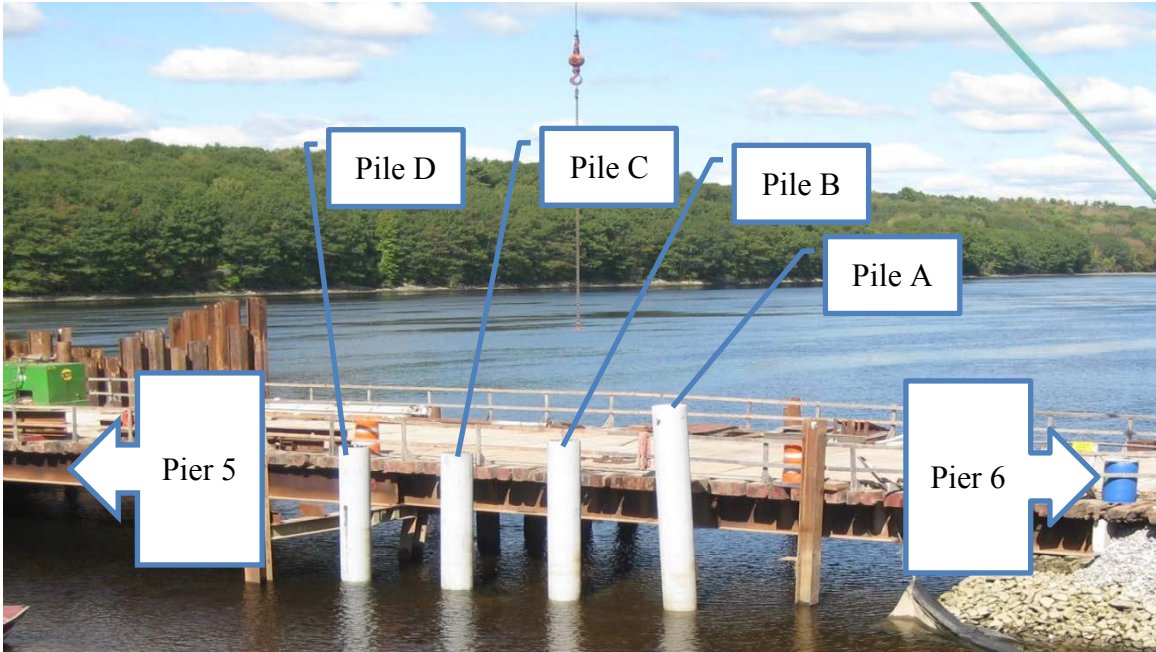
FRP piles were driven by Reed and Reed Inc. at a bridge connecting Richmond, ME and Dresden, ME over the Kennebec River (MaineDOT PIN 12674) on August 28, 2013. The driving site was located between Pier 5 and Pier 6 of the proposed bridge at approximate station 121+65. A restrike of Piles C and D was conducted on October 11, 2013. The configuration of the piles can be seen in Figure 4.3.

Figure 4.3 Configuration of Driven Piles (Looking Upstream)

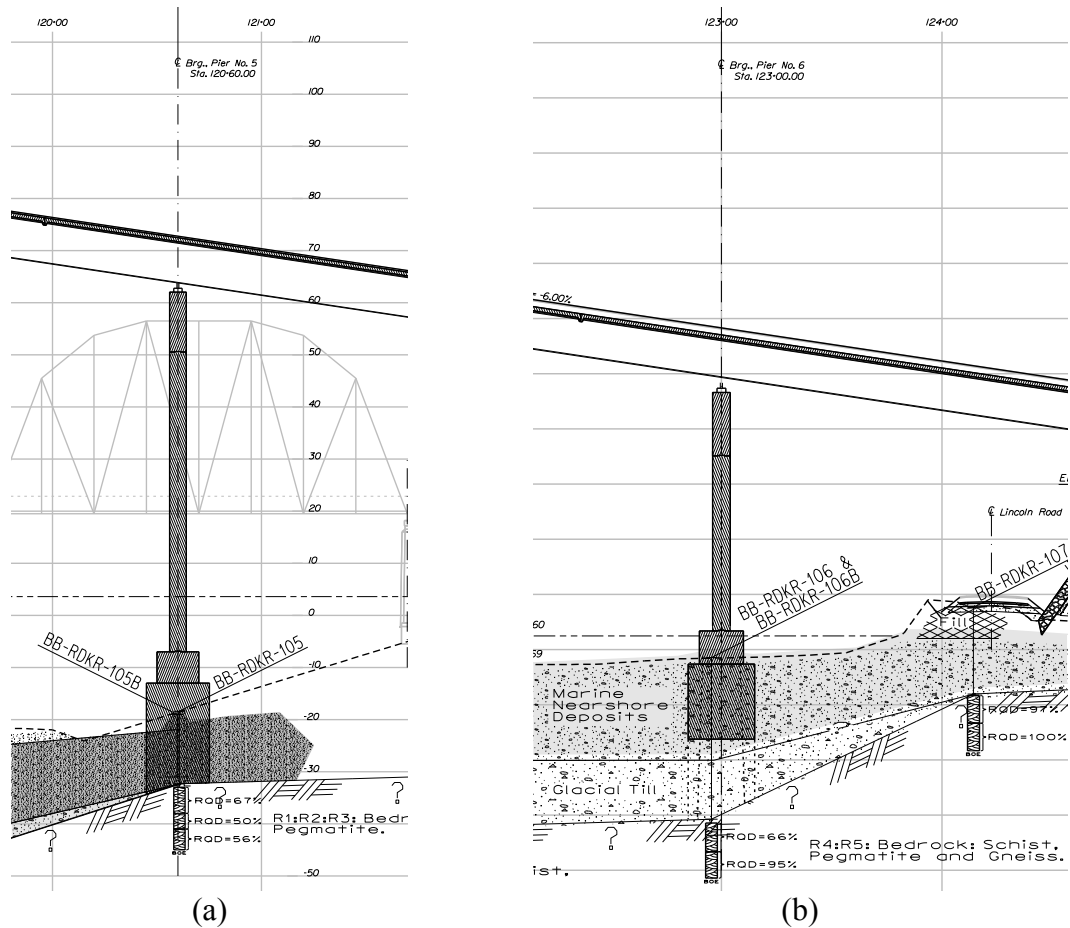
Pier 5's soil conditions are characterized by glaciomarine silty clay overlain by alluvium and a depth to bedrock of approximately 4.57 m (15 ft). Pier 6's soil conditions are characterized by glacial till overlain by marine nearshore deposits and a depth to bedrock of approximately 6.10 m (20 ft). This can be seen in Figure 4.4 (courtesy of MaineDOT) [34, 35].

Figure 4.4 Soil Conditions at Pier 5 (a) and Pier 6 (b) of Proposed Bridge

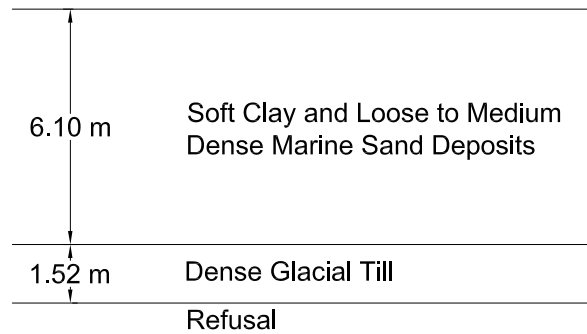
Two supplementary borings were taken at the driving site on November 20, 2013. The logs show refusal at approximately 7.62 m (25 ft) with possible medium dense to very dense glacial till (about 5 ft thick) above refusal. This is overlain by soft clay and loose to medium fine sand deposits. This can be seen in Figure 4.5 [34, 36].

Figure 4.5 Subsurface Conditions from Supplementary Borings

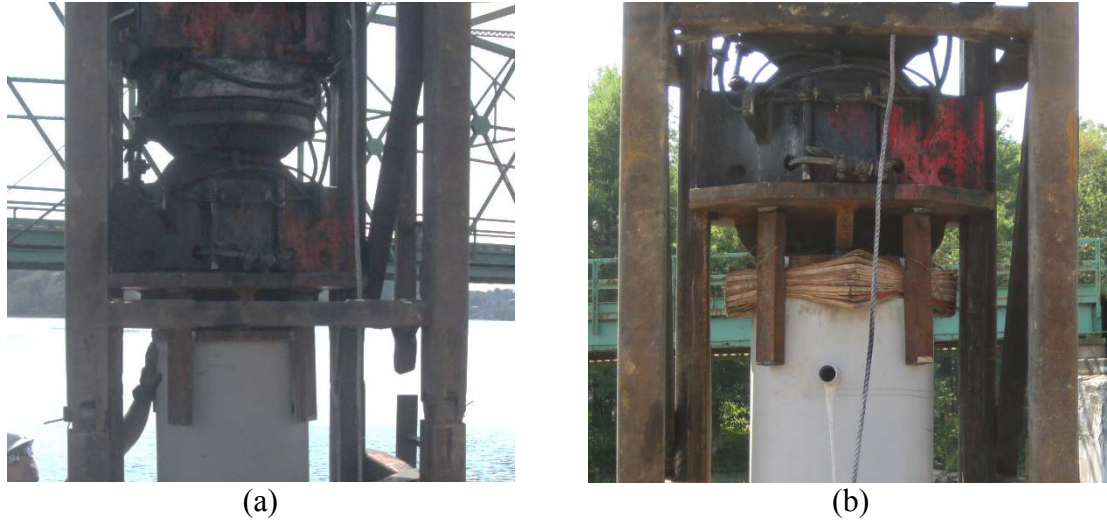
During initial driving, all piles were driven using a steel driving cap designed and manufactured by Reed and Reed Inc. Pile A, which was fully filled with concrete was driven with a 152 mm (6 in) thick plywood cushion between the steel driving cap and pile. All other piles were driven with the steel driving cap directly contacting the pile. The driving cap can be seen in Figure 4.6.

Figure 4.6 Driving Cap for Hollow (a) and Fully Concrete-Filled (b) Piles

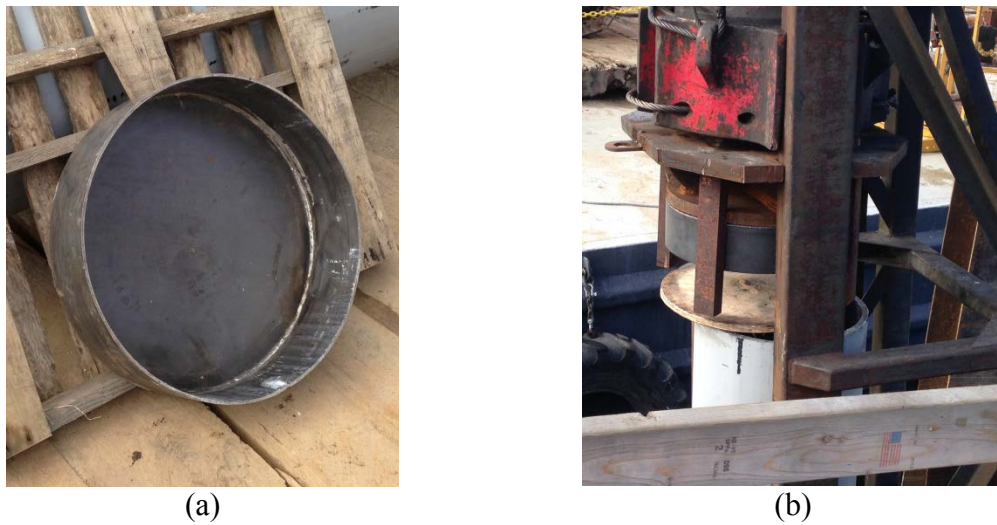
Figure 4.7 Steel Insert for Driving Cap (a) and Plywood Cushion (b) for Restrike

During the restrike, a steel insert was added to the driving cap. Pile C was driven with a 76 mm (3 in) thick plywood cushion and Pile D was driven with a 25 mm (1 in) thick plywood cushion. This can be seen in Figure 4.7.

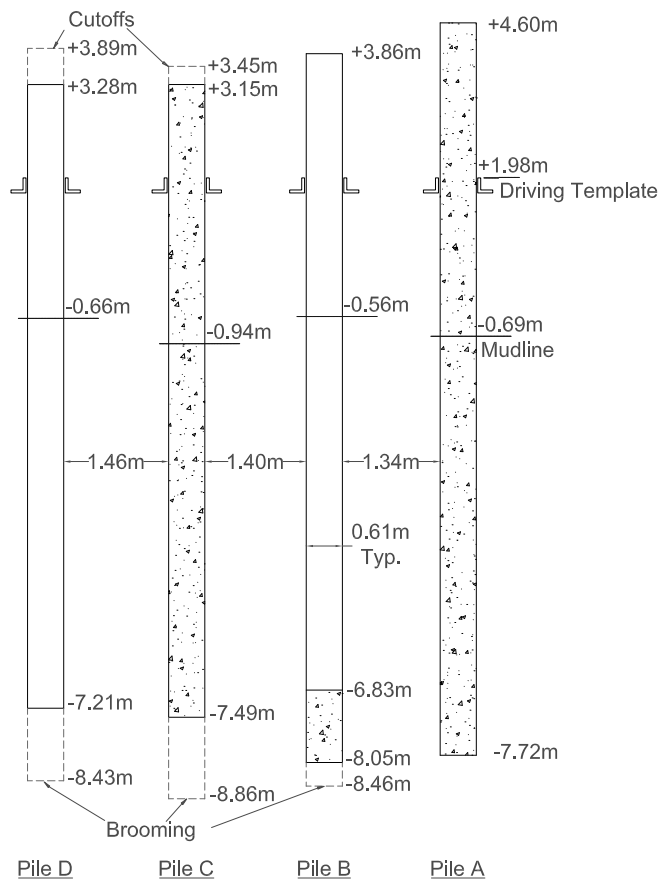
Some piles received excessive damage at the head and/or toe resulting in a reduction in length. The final configuration of the driven piles is illustrated in Figure 4.8. All elevations were determined using the elevation of the driving template and penetration data from the field driving logs. The driving template is assumed to be at a constant elevation of +1.98 m (+6.5 ft) for all piles. The mudline elevations were determined using visual references on extracted piles.

Figure 4.8 Pile Layout After Restrike

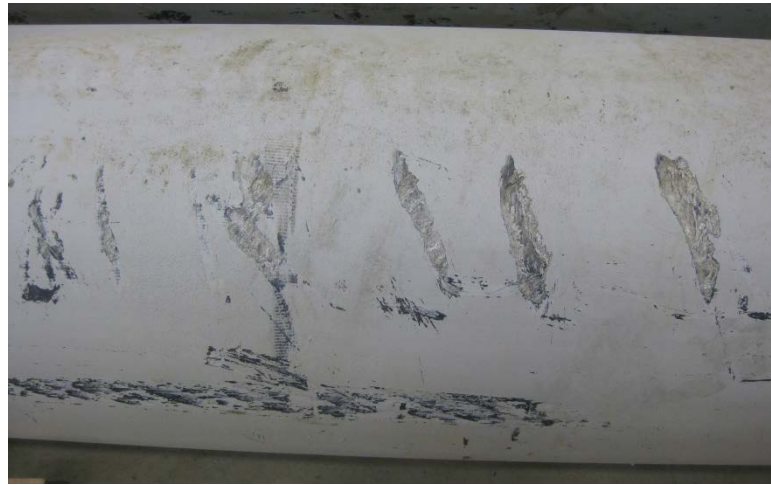
gouges occurred above and below the mudline, and are therefore believed to have occurred during the extraction process, when a steel wedge was driven next to the piles to loosen the surrounding soil. These scrapes and gouges were present for all testing of residual properties but did not appear to affect the location of failure in flexural testing.

Figure 4.9 Typical Damage Due to Pile Driving/Extraction

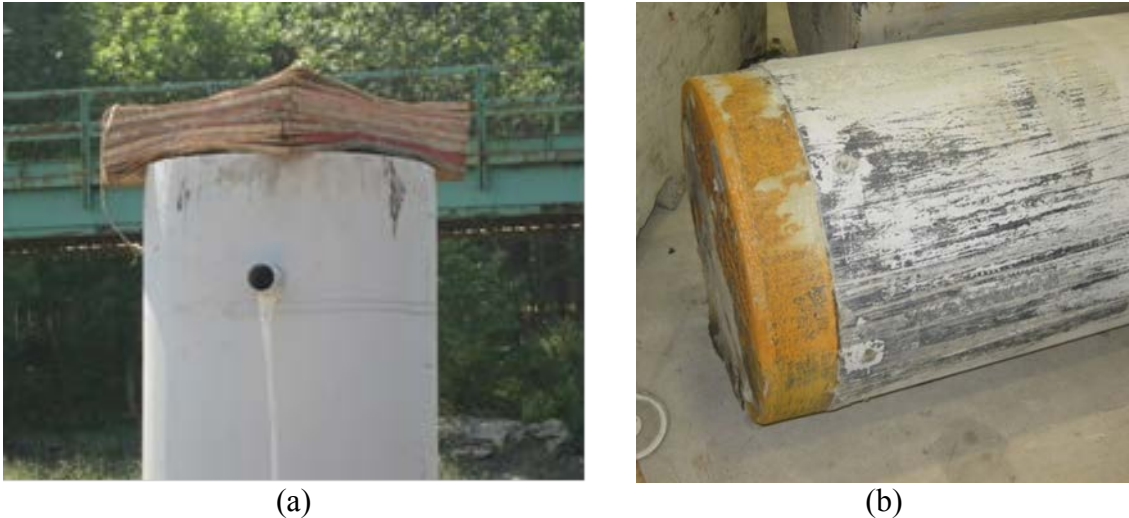
The condition of the head and toe of Pile A can be seen in Figure 4.10.

Figure 4.10 Head (a) and Toe (b) of Pile A after Initial Driving

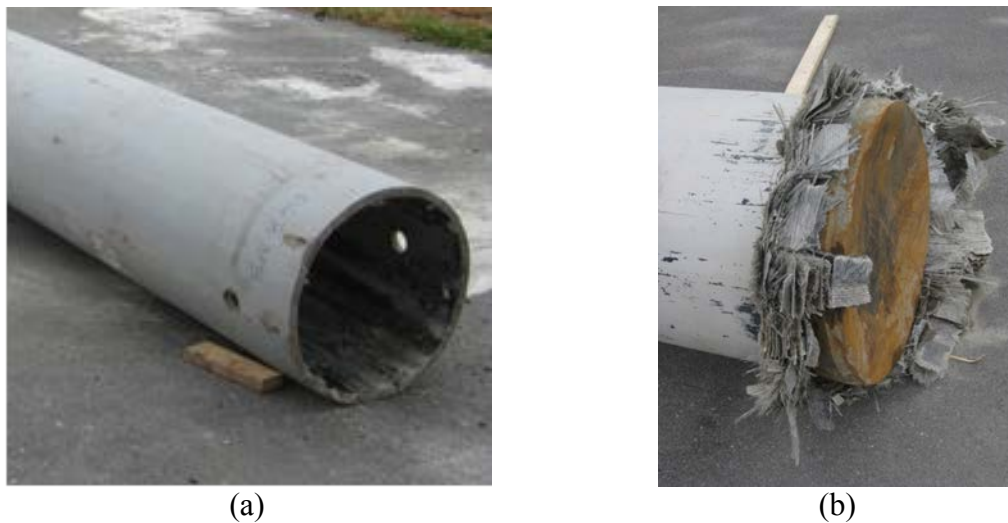
The condition of the head and toe of Pile B can be seen in Figure 4.11.

Figure 4.11 Head (a) and Toe (b) of Pile B after Driving

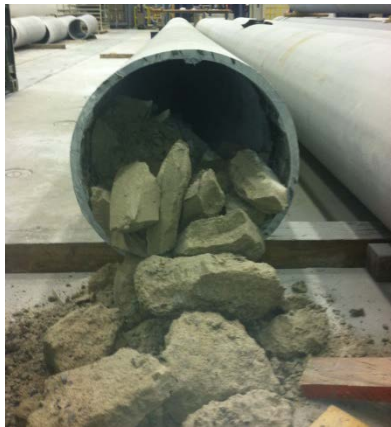
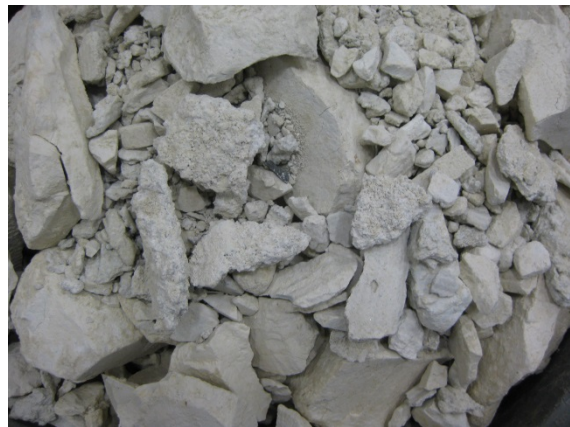
Figure 4.12 Concrete Plug of Pile B (a) and Removed Concrete (b)

The concrete plug was removed from Pile B prior to residual strength testing. The bottom portion of the plug was mainly sand and coarse aggregate. The same concrete used for this plug was also used to fill Pile A, but had very different visual properties. The upper 152 mm (6 in) resembled chalk and was lightweight and could easily be broken by hand. The removed concrete can be seen in Figure 4.12. It is believed that water infiltrated the piles, potentially through the driving shoe, during concrete placement and washed the cement from the concrete. The concrete was placed in the pile while its toe was in the water. By inspection, the concrete in the plug did not meet the specified

strength. The concrete from Pile B was also tested with a Schmidt Concrete Test Hammer. This equipment was not calibrated, but was verified against concrete with known design strengths in at the Advanced Structures and Composites Center at the University of Maine. The concrete did not register on the test hammer's scale, which has a minimum value of 10 MPa (1450 psi).

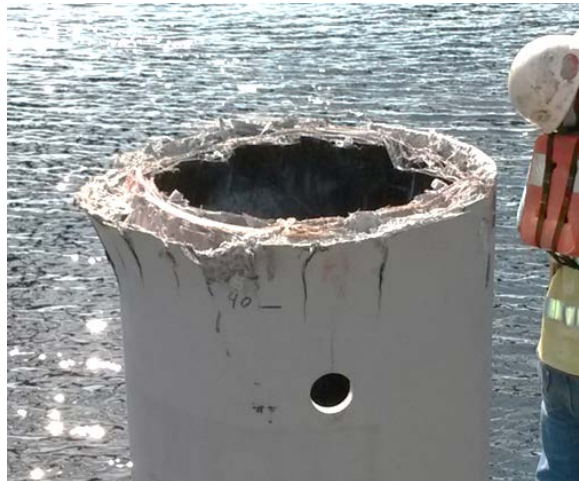
The condition of the head of Pile C after initial driving can be seen in Figure 4.13.

Figure 4.13 Head of Pile C after Initial Driving

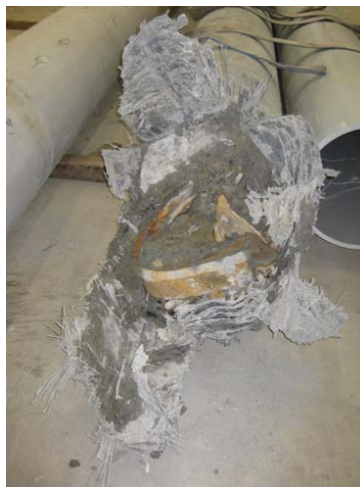
Upon the extraction of Pile C, it was found that 1.37 m (4.5 ft) had broomed at the pile toe. The condition of the toe of Pile C after the restrike can be seen in Figure 4.14.

Figure 4.14 Toe of Pile C after Restrike

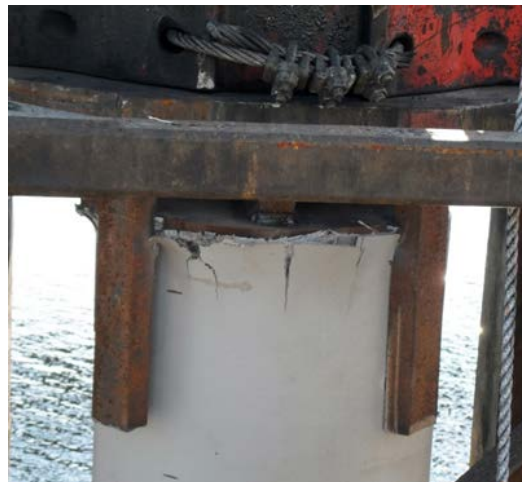
The condition of the head of Pile D after initial driving can be seen in Figure 4.15.

Figure 4.15 Head of Pile D after Initial Driving

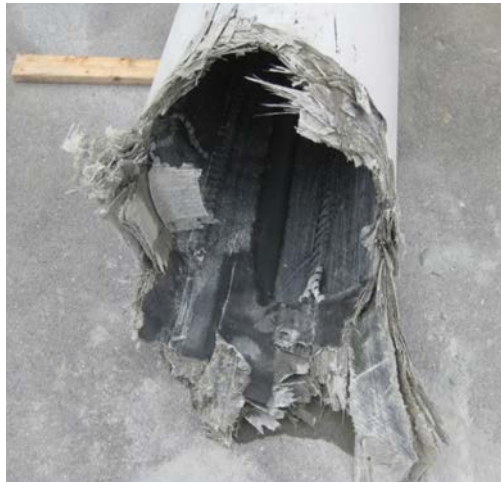
Upon the extraction of Pile D, it was found that 1.22 m (4 ft) had broomed at the pile toe. The condition of the toe of Pile D after the restrike can be seen in Figure 4.16.

Figure 4.16 Toe of Pile D after Restrike

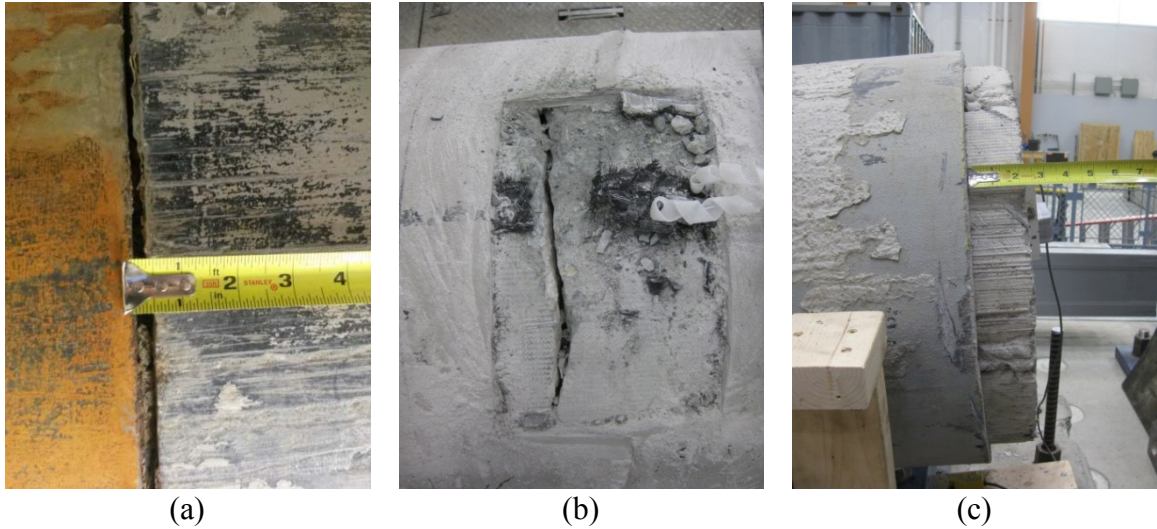
The FRP piles driven at Richmond-Dresden were tested to failure in flexure in the laboratory after being extracted. This is discussed further in Chapter 5. Both concrete-filled FRP piles that received hammer blows during initial driving and during the restrrike (Piles A and D, respectively), failed in flexure when the concrete infill slid relative to the FRP shell. The movement of the concrete was relatively small in Pile A because it was restrained by the closed driving shoe. The loss of composite action in Pile A was evident due to a loud cracking noise and the pile jumping in its supports. The movement of concrete in Pile C was much more noticeable because the concrete infill was not restrained by an end cap. This behavior was not seen in any of the baseline piles that had been filled with concrete or piles subjected to 20,000 load cycles. Therefore it is believed that horizontal cracks formed during driving and created a plane for the pile to fail by loss of composite action. The loss of composite action can be seen in Figure 4.17.

Figure 4.17 Concrete Movement in Pile A (a), Internal Cracking in Pile A (b), and Concrete Movement in Pile C after Loss of Composite Action (c)

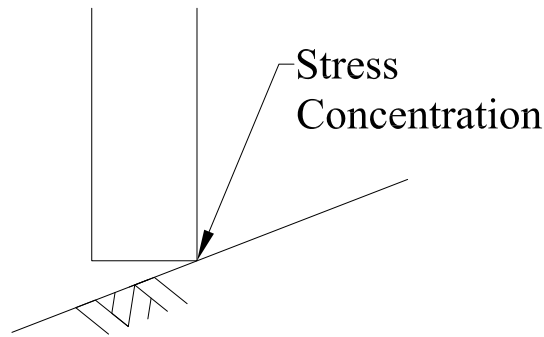
If FRP piles are driven to bedrock in areas with sloping bedrock or encounter obstructions such as boulders, the toe of the pile may see stress concentrations. The relatively low driving stresses at failure seen at the pile head indicate that stress concentrations at the toe may be a critical concern. This is illustrated in Figure 4.18.

Figure 4.18 Stress Concentration on Sloping Bedrock

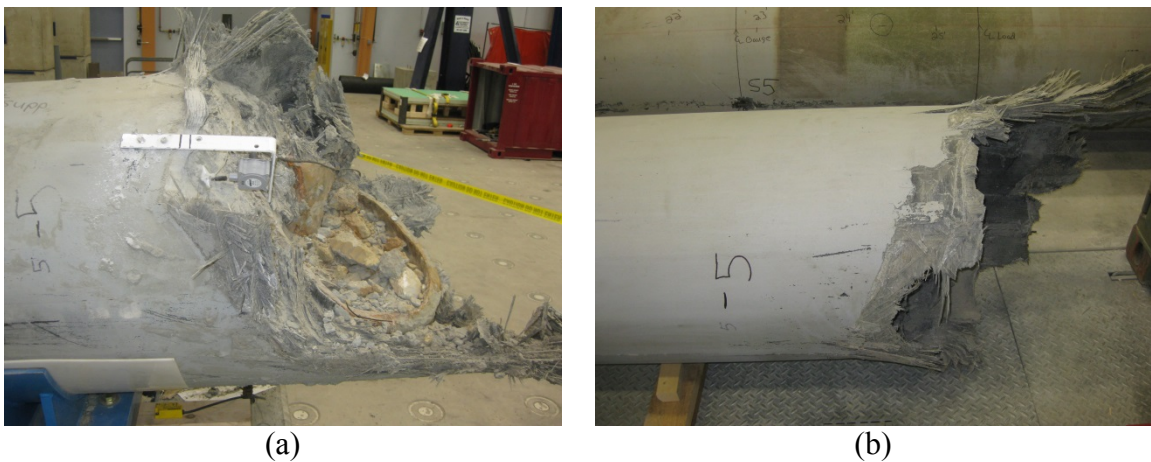
The geotechnical report for the Richmond-Dresden driving site [34, 35] shows bedrock with an approximate linearly interpolated slope of 3.2% between Pier 5 and Pier 6 of the proposed bridge. This slope was calculated using bedrock elevations and stations from boring logs BB-RDKR-207 and 208. Boring logs at Pier 5 and Pier 6 also indicated cobbles and boulders. The toe damage seen on piles that were driven hollow is more severe on one side of the pile, indicating that it may have occurred when an obstacle or sloping bedrock was encountered. The orientation of the toe damage relative to the interpolated bedrock elevation is unknown. The toe damage can be seen in Figure 4.19.

Figure 4.19 Sloping Toe Damage on Pile C (a) and Pile D (b)

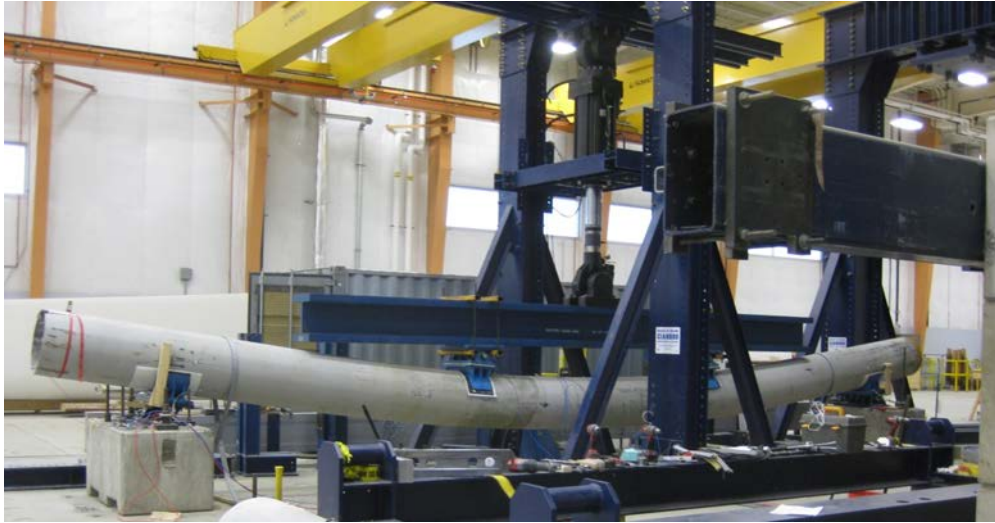
Figure 5.1 Flexural Test Configuration

All piles were tested in a four-point bending configuration which can be seen in Figure 5.1. The span length for each test was 10.1 m (33 ft). The load was applied using a

single 1330 kN (300 kip) actuator with a spreader beam. Load points were at the 1/3 points of the span, except for testing Pile C when load points were adjusted to create higher moments. Changes in the test configuration for Pile C will be discussed further in 5.6.

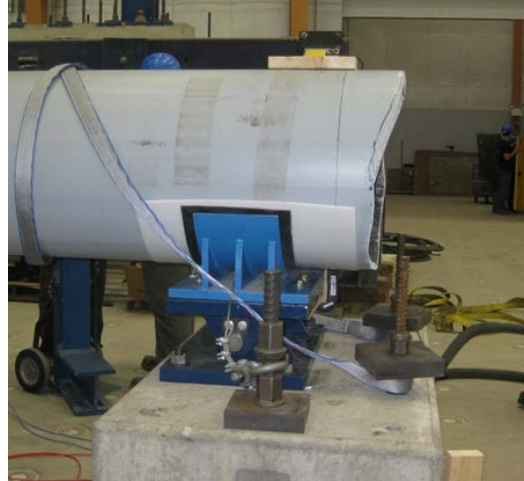
Figure 5.2 Saddle and Support Configuration

Saddles with a curvature equal to that of the piles were used at loading points and end supports to distribute load over the pile. Each saddle was lined with neoprene to aid in load distribution and a plastic sheet to allow lateral translation. These saddles were mounted on pinned supports that allowed rotations associated with the large expected deflections. A saddle and pinned support can be seen in Figure 5.2.
