### **Technical Report 17- 4**

*Experimental Evaluation and Design of  
Unfilled and Concrete-Filled FRP  
Composite Piles*

*Task 7 – Final Report - Thesis*

**EXPERIMENTAL EVALUATION OF FIBER REINFORCED POLYMER  
PILES IN LOAD-BEARING APPLICATIONS**

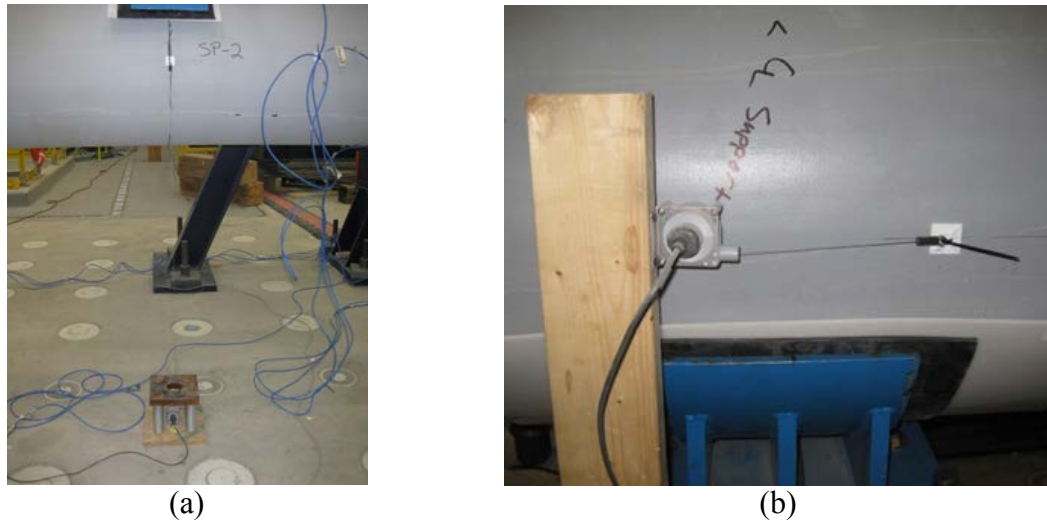
Deflections were measured at the mid-point of the span and both loading points using Celesco SP2-50 string potentiometers (string pots). Lateral translations were measured at each support using Celesco SP2-25 string pots. These can be seen in Figure 5.4. All measurements were taken at the mid-height of the cross section.

Figure 5.4 Measurement of Vertical Deflection (a) and Lateral Translation (b)

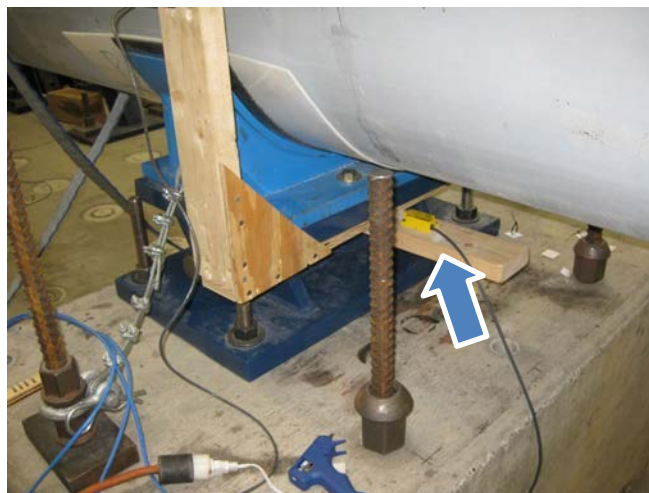
Figure 5.5 Longitudinal Rotation Measurement

Axial rotation was measured at each pinned end support using +/- 60 degree TURK B2N60H-Q20L60-2LU3/S97 inclinometers. This can be seen in Figure 5.5.

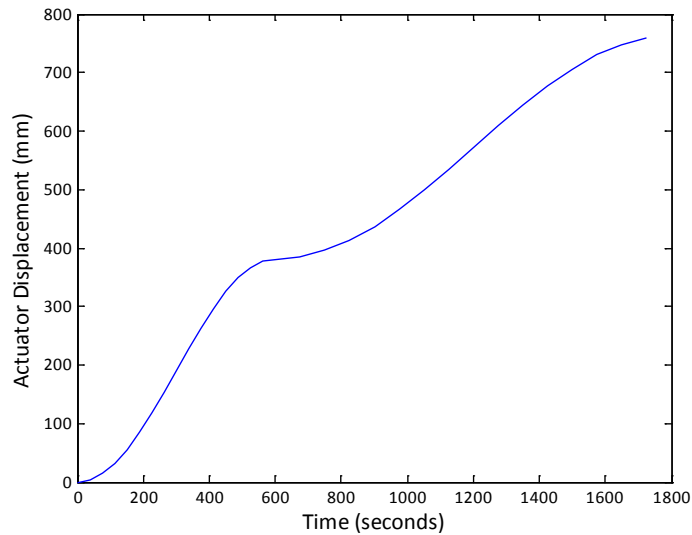
Flexural tests fell into 2 categories; statically loaded and cyclically loaded. Static piles were loaded to failure by controlling the rate of displacement. Piles were loaded at a rate of 38.1 mm (1.5 in) per minute for the first 381 mm (15 in) of deflection. Then the loading rate was transitioned to 25.4 mm (1 in) per minute using a sinusoidal ramp. A plot of the loading profile can be seen in Figure 5.7.

Figure 5.7 Static Loading Profile

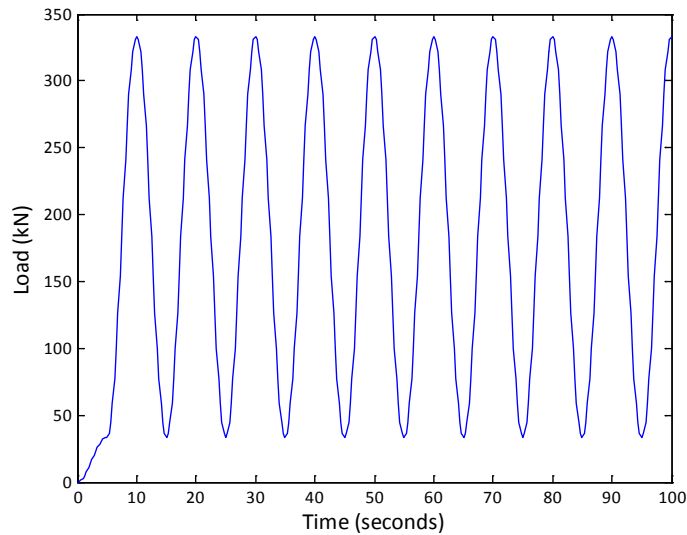
Load-cycled piles were loaded to approximately 50% of the average ultimate load piles determined during static testing. This load was determined to be 334 kN (75 kips). The piles were cycled between 33.4 kN (7.5 kips) and 334 kN (75 kips) for 10,000 cycles at a frequency of 0.05 Hz. After 10,000 cycles, the piles were rotated 180 degrees about their longitudinal axis and subjected to an additional 10,000 cycles. Then, the piles were tested statically to failure. Strain and displacement measurements were taken at the maximum and minimum load of each cycle. Data was collected over the entire loading cycle for 10 cycles every 1,000 cycles. A plot of the loading profile can be seen in Figure 5.8.

Figure 5.8 Cyclic Loading Profile

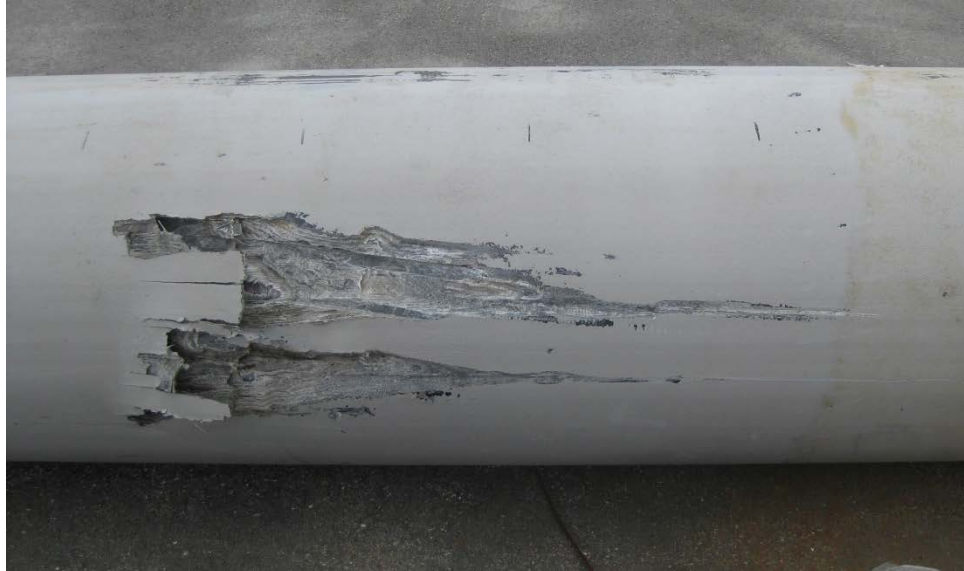
Pile D was not tested in flexure due to excessive damage from the pile extraction process. The damage can be seen in Figure 5.9.

Figure 5.9 Damage to Pile D from Pile Extraction

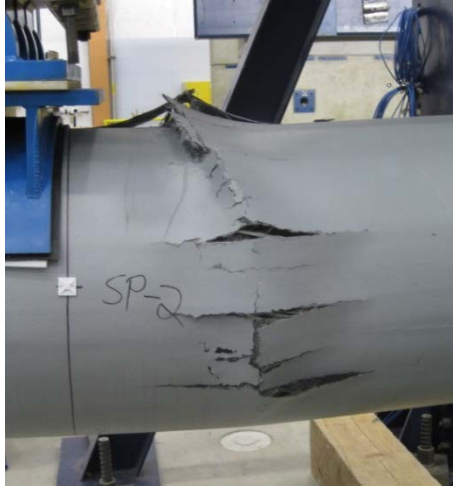
Figure 5.10 Compression Failure of Pile I

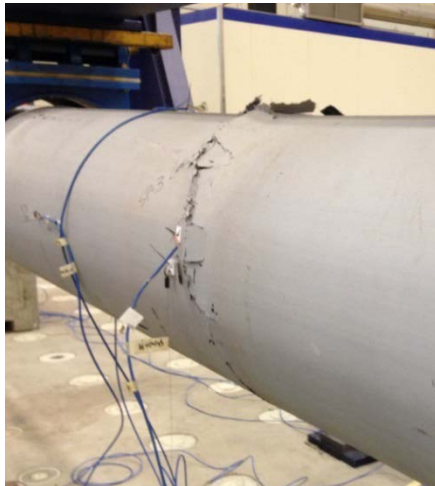
Figure 5.11 Compression Failure of Pile J

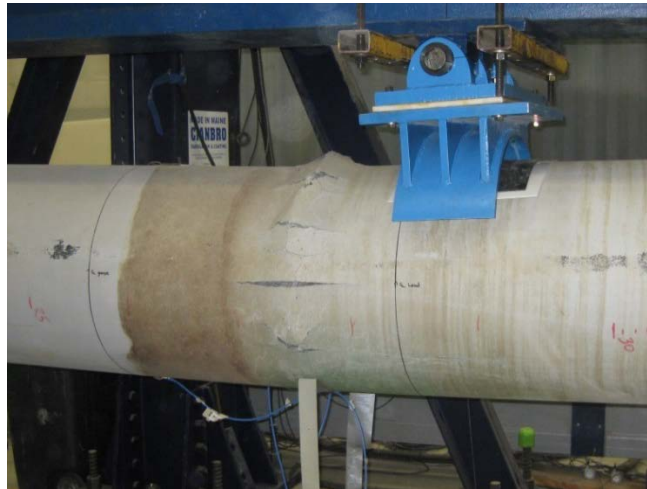
Figure 5.12 Compression Failure of Pile B

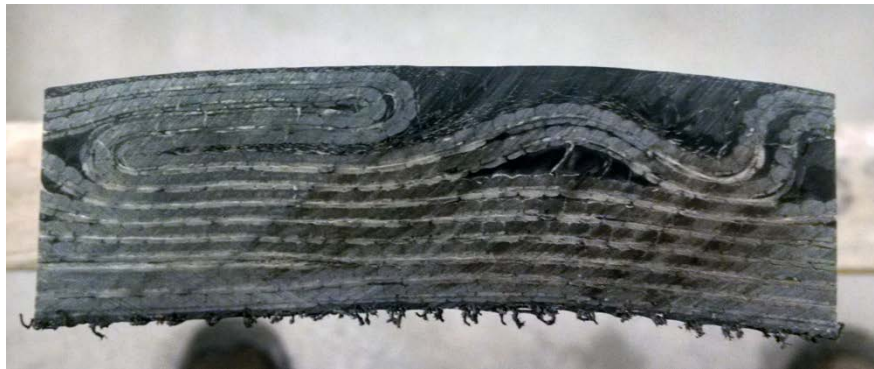
Figure 5.15 Folds in Reinforcing Fabric and Areas of High Resin Content in Pile B

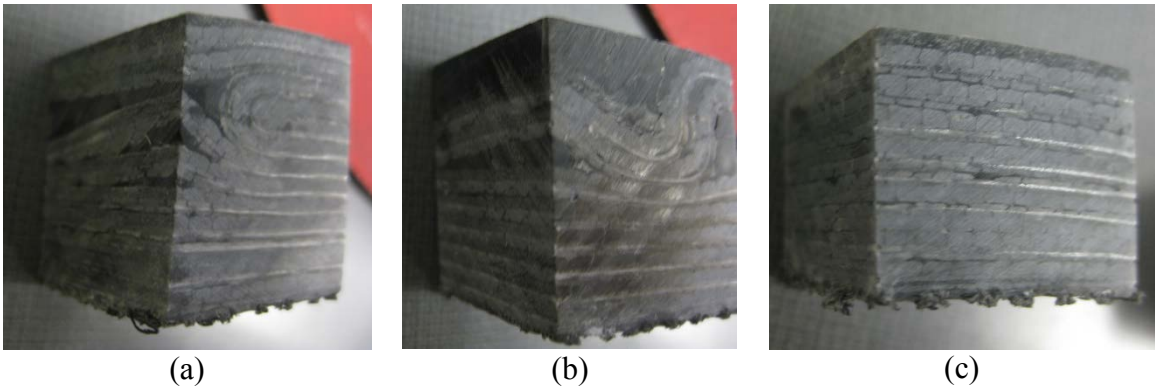
Figure 5.16 FVF Samples with High Fiber Content in Pile B (a), High Resin Content in Pile B (b), and Typical Fiber/Resin Content (c)

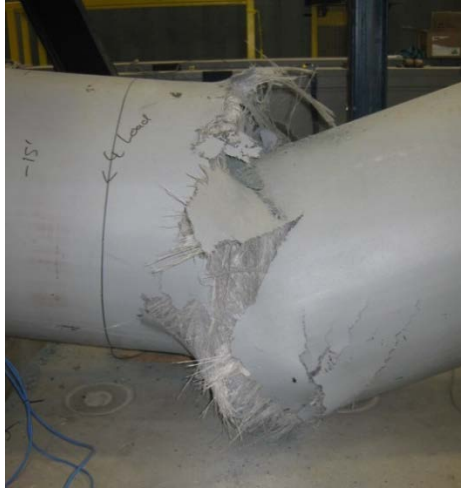
Figure 5.17 Tension Failure of Pile G

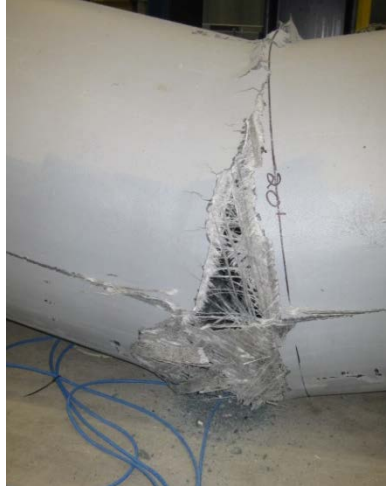
Figure 5.18 Tension Failure of Pile H

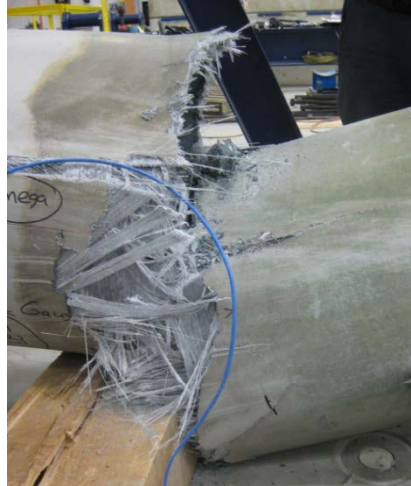
Figure 5.19 Tension Failure of Pile A

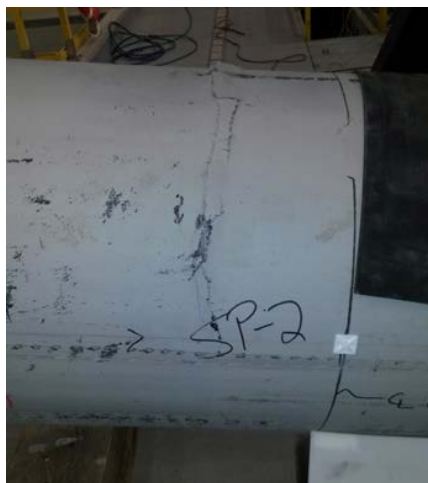
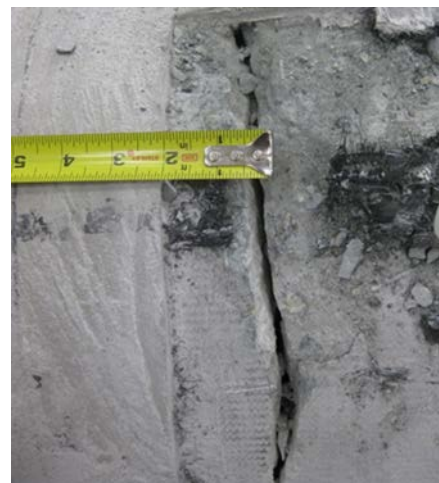
Figure 5.20 Compression Wrinkle (a) and Internal Cracking (b) in Pile A

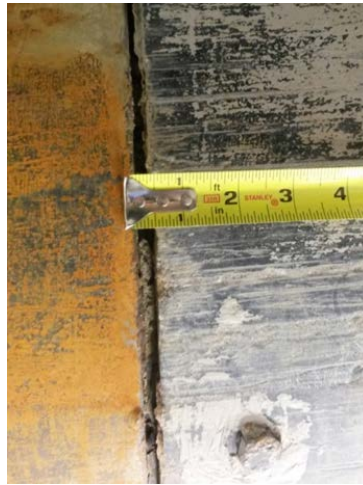
Figure 5.21 Concrete Movement in Pile A

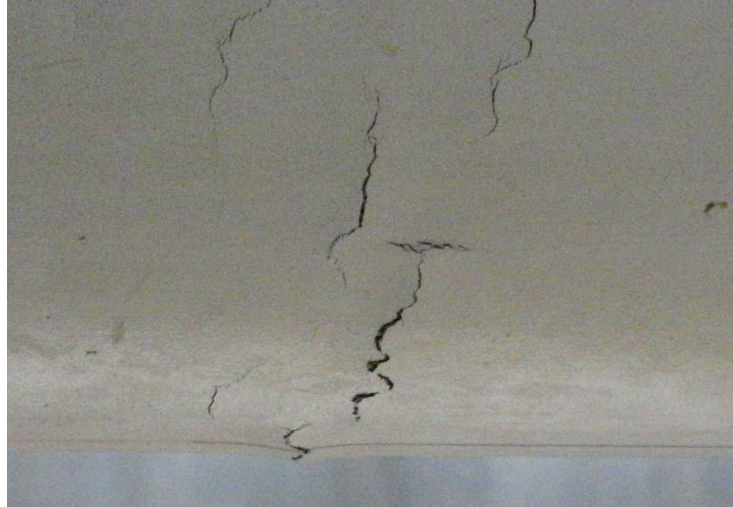
Figure 5.22 Cracking of FRP Shell in Pile E during Cyclic Loading

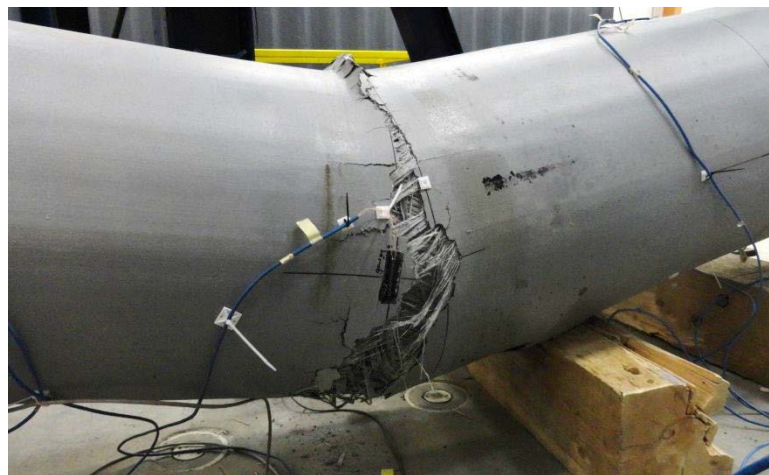
Figure 5.23 Tension Failure of Pile E

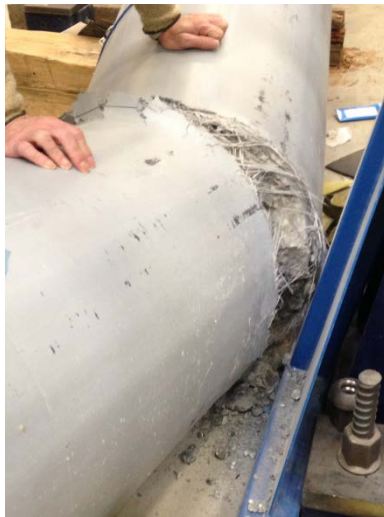
Figure 5.24 Tension Failure of Pile F

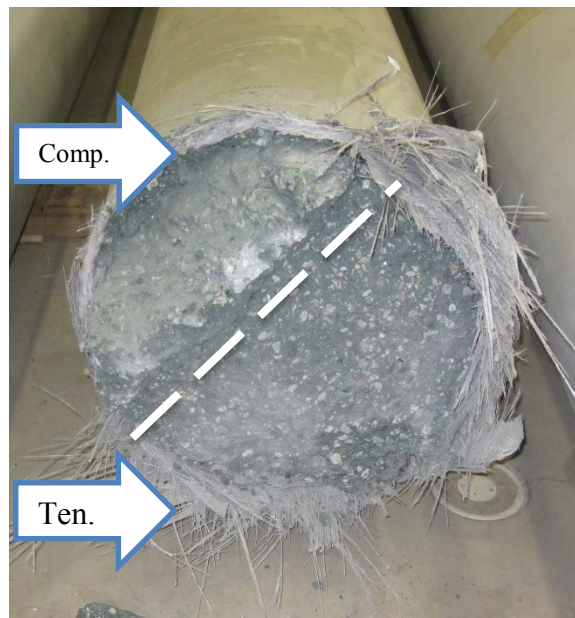
Figure 5.27 Tension and Compression Zone in Concrete-Filled Pile

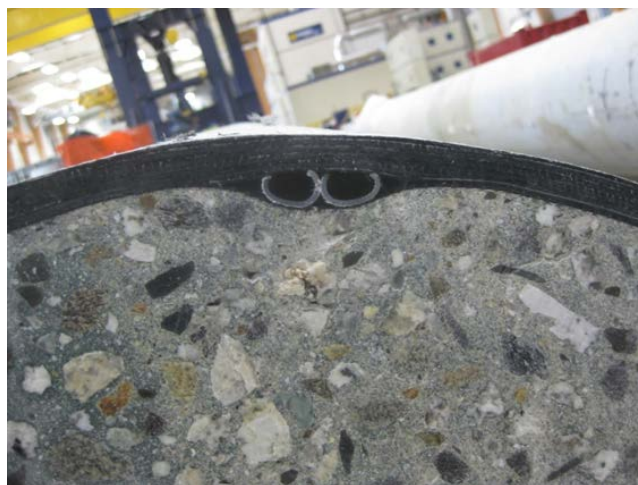
Figure 5.28 Concrete-FRP Interface

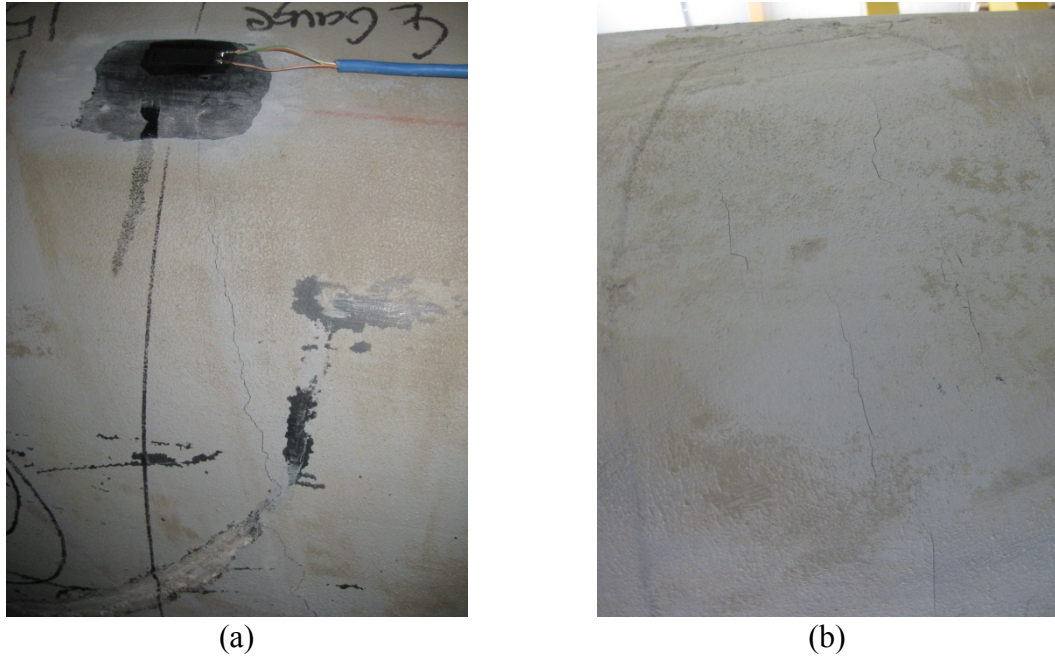
Figure 5.30 Cracks Inside (a) and Outside (b) of the Constant Moment Region

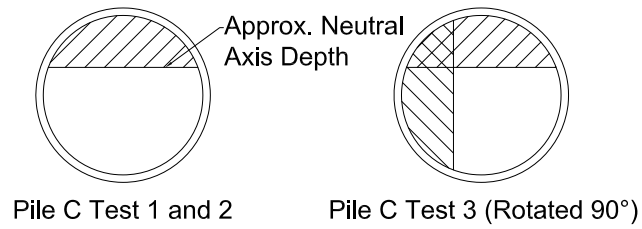
Figure 5.31 Rotation of Pile C prior to Test 3

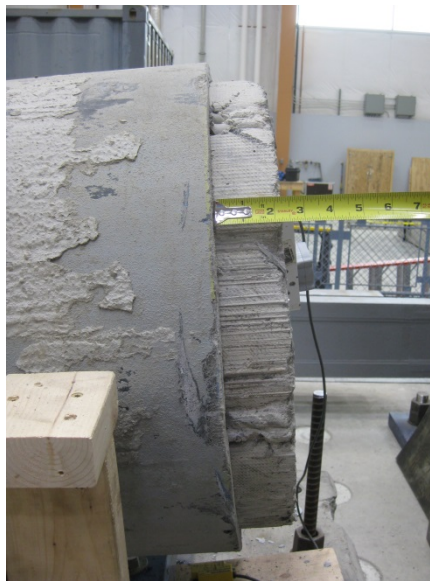
Figure 5.32 Loss of Composite Action in Pile C

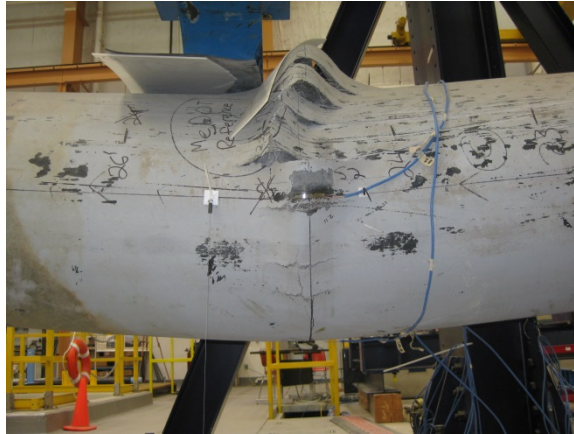
Figure 5.33 Compression Failure of Pile C

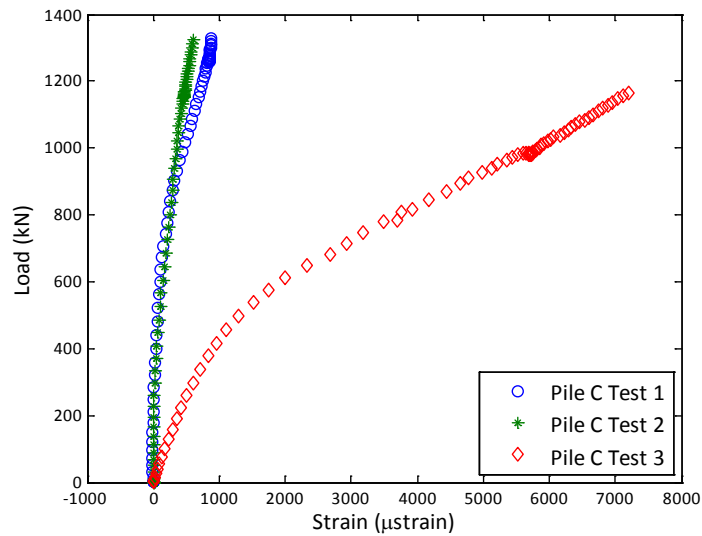
Figure 5.36 Hoop Strain During Pile C Tests

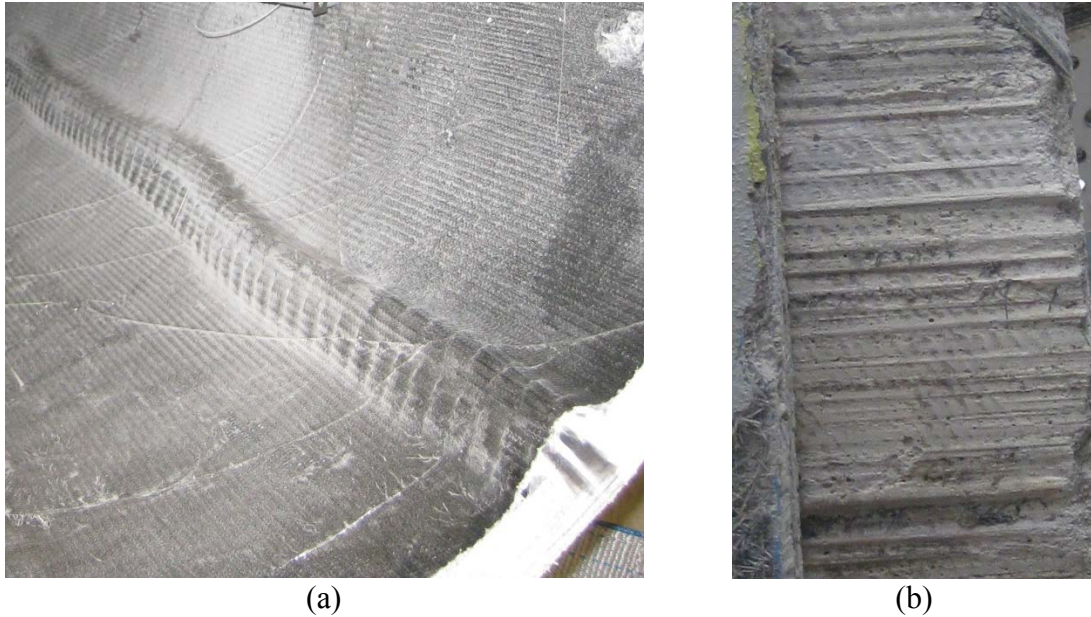
Figure 5.37 Ridges inside FRP Shell (a) and Impressions on Concrete (b)

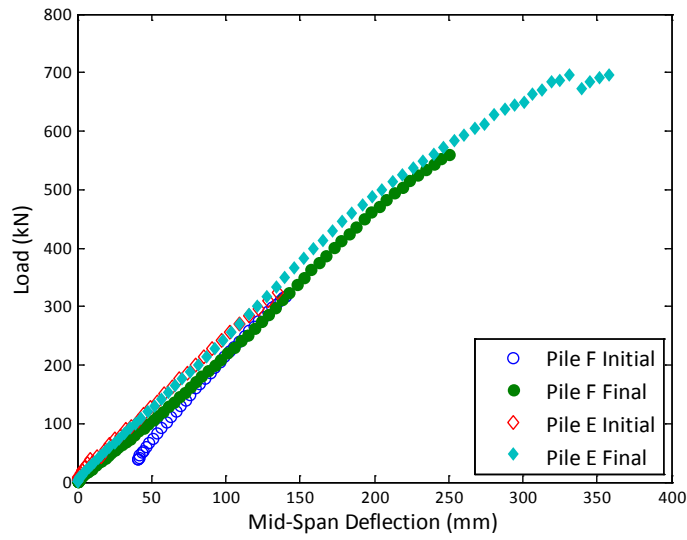
Figure 5.38 Load-Deflection of Load-Cycled Piles in Flexure

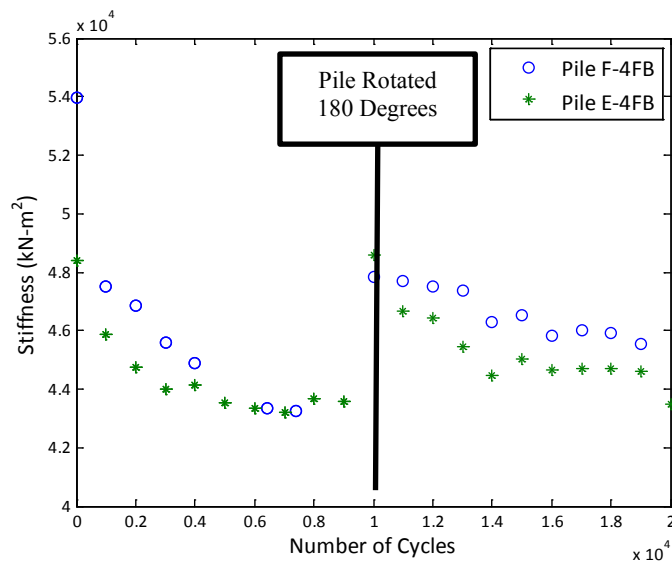
Figure 5.40 Reduction in Dynamic Stiffness with Cyclic Loading

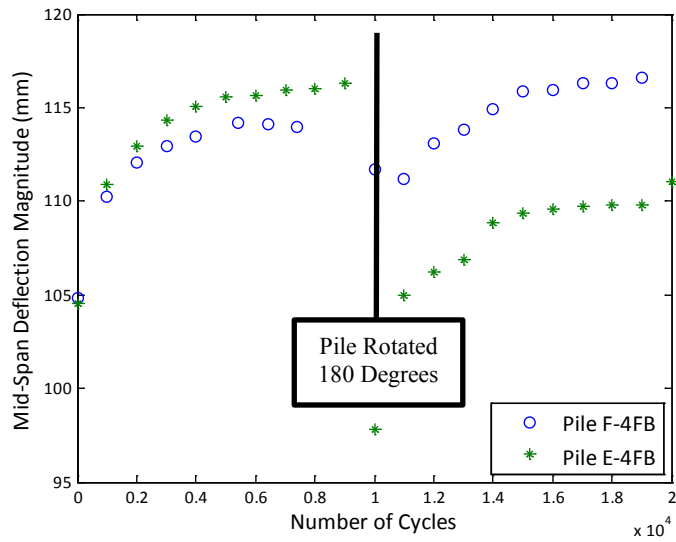
Figure 5.41 Increased Deflection Magnitude with Cyclic Loading

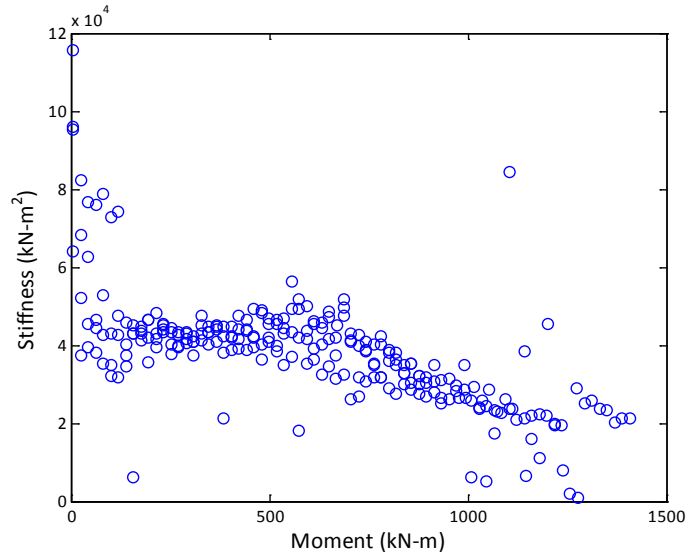
Figure 5.42 Decrease in Stiffness during Flexural Testing of Concrete-Filled Piles

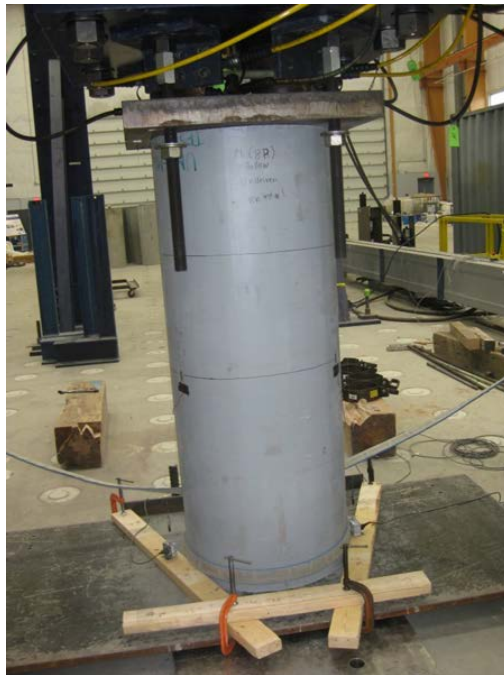
Figure 6.1 Axial Compression Test Configuration

Axial compression samples were loaded under a test frame with 4 concentric hydraulic cylinders. Load was distributed over the top of the pile section using a 76.2 mm (3 in) thick steel plate and at the bottom using a 50.8 mm (2 in) thick steel plate supporting a larger 25.4 mm (1 in) thick steel plate that was used to move samples in and out of the frame. The test configuration can be seen in Figure 6.1.

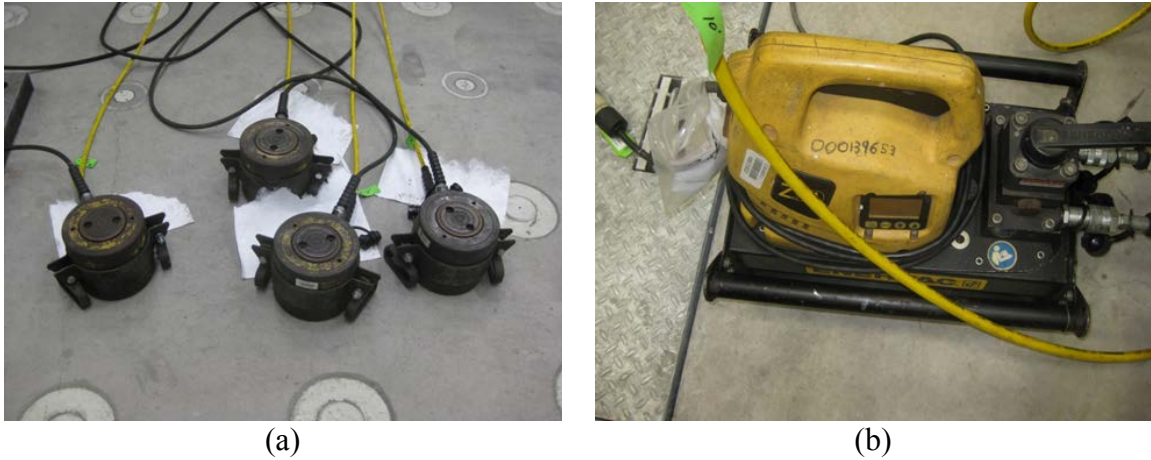
Figure 6.2 150 Ton Enerpac Cylinders (a) and Hydraulic Pump (b)

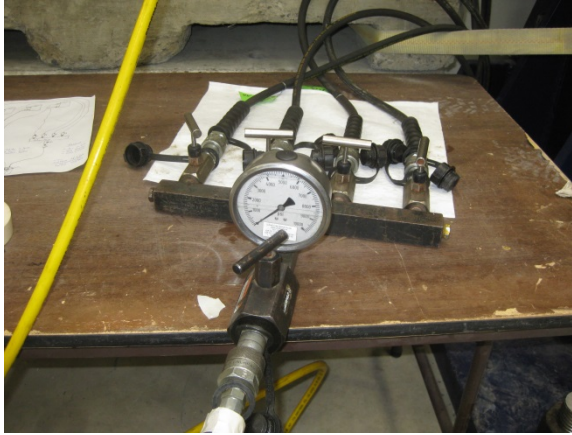
Figure 6.4 Dial Gauge Used for Pressure Readings

Pile sections were manually loaded using increments of  $10.3 \text{ MPa}$  ( $1500 \text{ psi}$ ) of hydraulic pressure to  $51.7 \text{ MPa}$  ( $7500 \text{ psi}$ ), and then loaded to  $55.2 \text{ MPa}$  ( $8000 \text{ psi}$ ) and  $60.0 \text{ MPa}$  ( $8700 \text{ psi}$ ). Pressure readings were taken from a calibrated dial gauge, as pictured in Figure 6.4, and matched to strain and deflection data using timestamps. The load was held for 5 seconds at each pressure increment to correlate data acquisition.

Some error may be introduced into the data due to the manual loading of the pile sections. The dial gage used to monitor hydraulic pressure had a resolution of 689 kPa (100 psi). Pressure readings are believed to be within +/- 345 kPa (50 psi) which is equivalent to +/- 27.1 kN (6.1 kips). A maximum hydraulic pressure of 60.0 MPa (8700 psi), which is an equivalent load of 4750 kN (1068 kips), was selected to ensure all pile sections exceeded the proof load of 4450 kN (1000 kips).

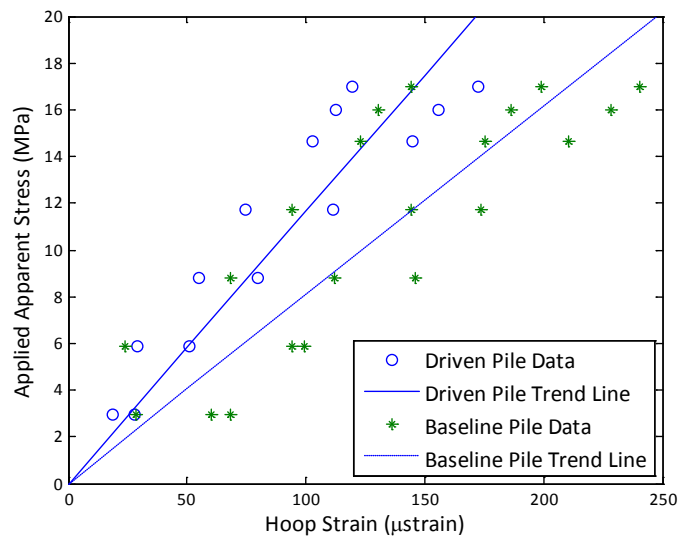
Figure 6.10 Hoop Strain during Axial Compression of Concrete-Filled Piles

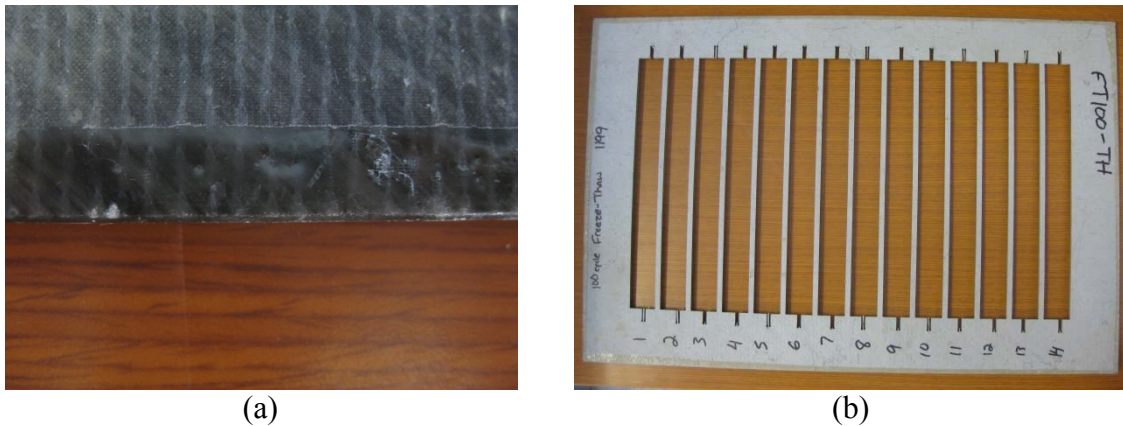
Figure 7.1 Sealed Edges (a) and Edge Distance (b) on FRP Panels for Conditioning

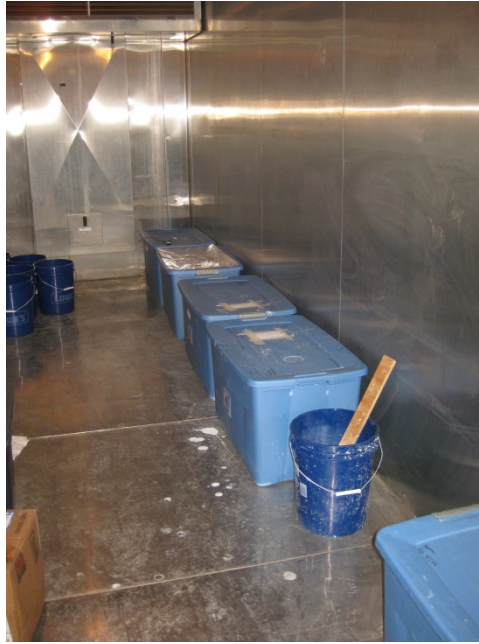
Figure 7.2 Alkali Exposure Test

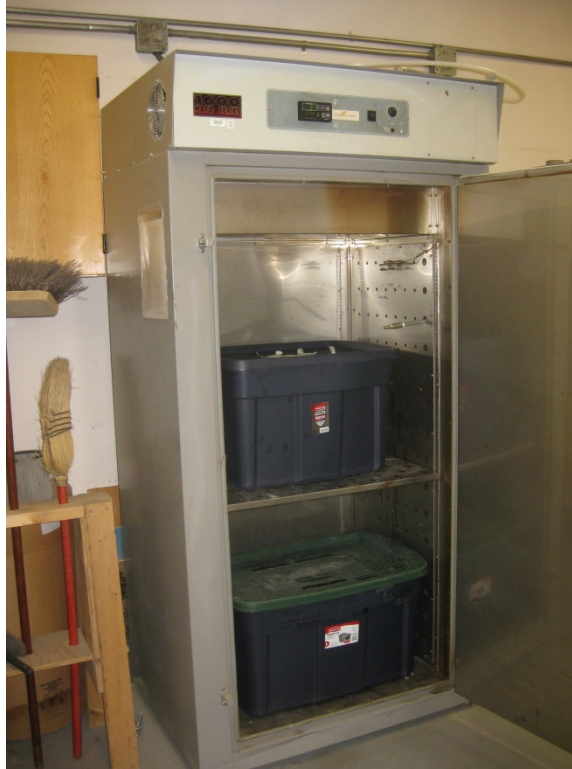
Figure 7.3 Water Exposure Test

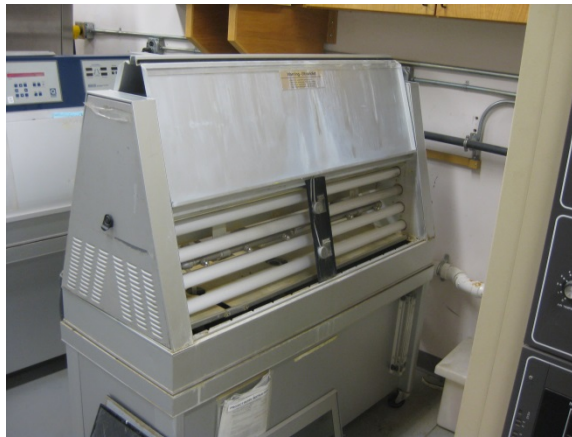
Figure 7.4 UV/Condensation Humidity Test Chamber

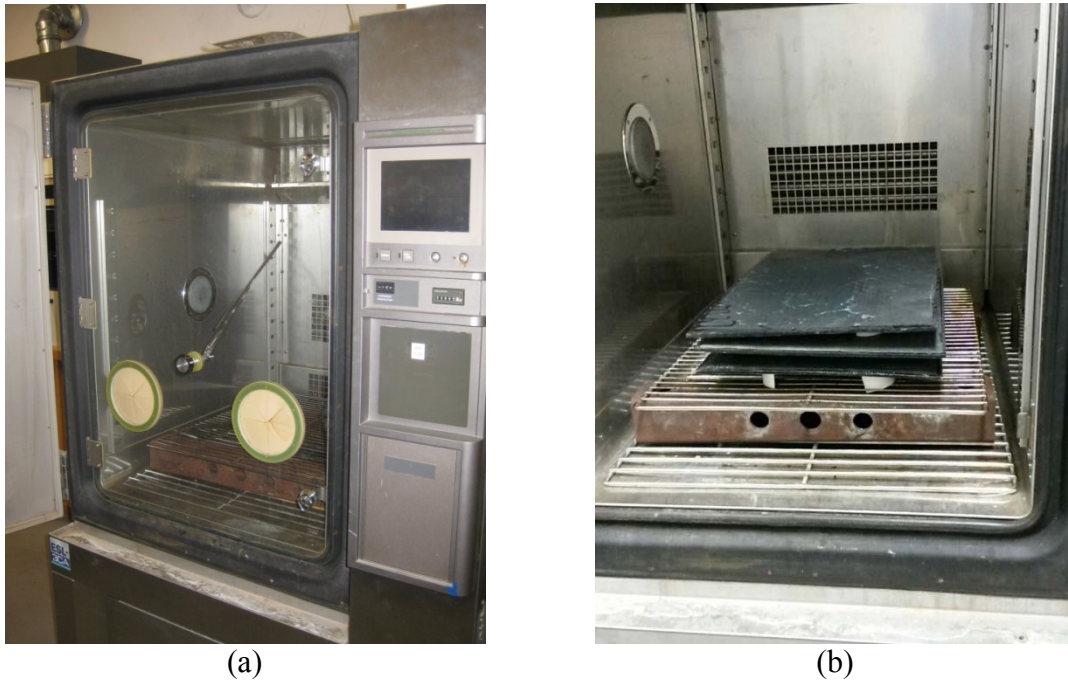
Figure 7.5 Freeze-Thaw Chamber (a) and Sample Configuration (b)

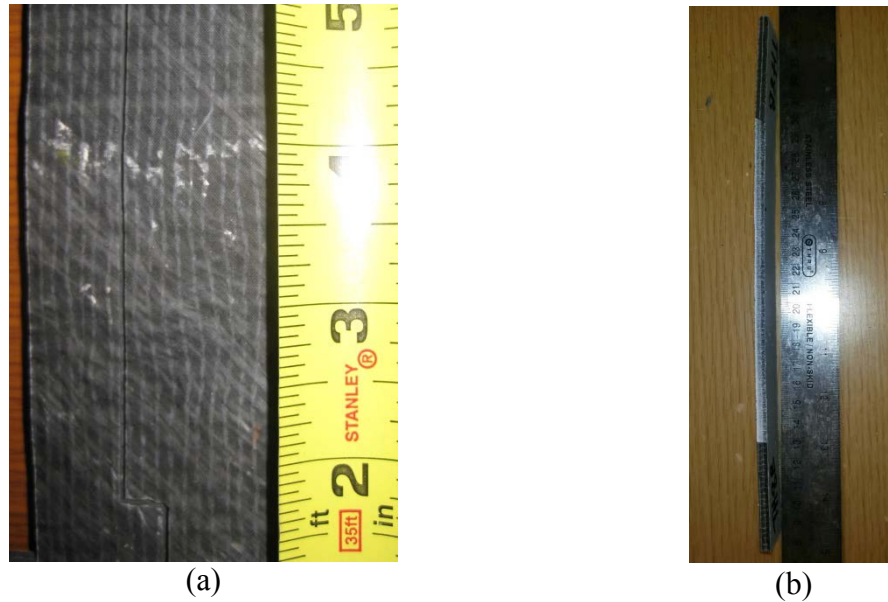
Figure 7.6 Misaligned Fibers (a) and Warping (b) in Durability Samples
