LUC-2-1682 Long Term Maintenance of the Anthony Wayne Suspension Bridge Main Cables

January 2017

Final Report

The University of Toledo

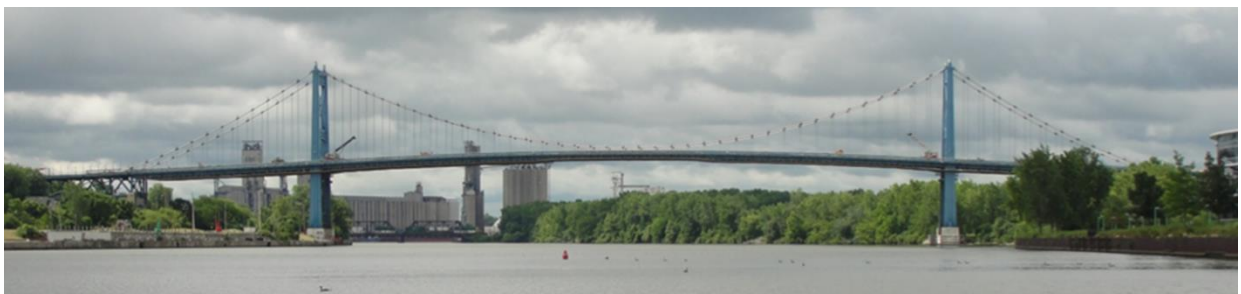
Construction on the AWB (Figure 1-1) was completed in 1931 and it is currently the only suspension bridge in the ODOT inventory. The bridge is 4 lanes wide with a 60 foot wide deck. The bridge also carries pedestrian traffic in each direction. The main cable-supported span is 785 feet with two side spans that are each 233.5 feet. The total length of the bridge, including the two approaches, is 3215 feet. The two main cables are 13-5/16 inches in diameter and contain 19 strands of galvanized steel

Figure 1-1: Anthony Wayne Bridge at the Beginning of the Rehabilitation

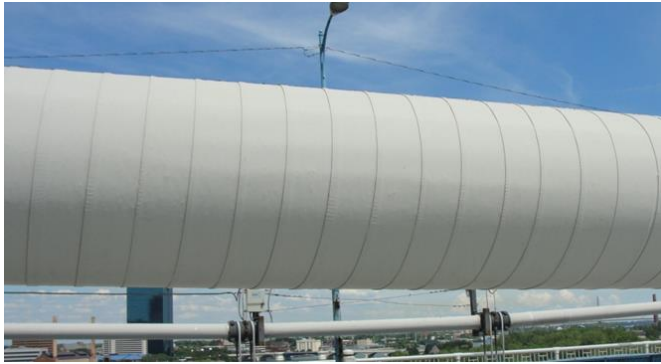
It was critical to know the current state of the main cables before proceeding with an extensive and expensive rehabilitation process. Small windows had been opened in the wire wrap surrounding the cable previously, but the cable had never undergone a thorough inspection. The existing elastomeric wrap had been applied to the cables in 1997 and 1998 (Figure 1-3).

Figure 1-3: Existing Cable

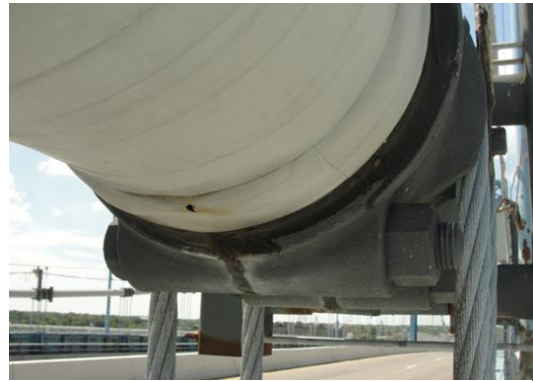
Figure 1-4: Elephant's Foot at Cable Band

This elastomeric wrap was leaking. Water was retained in elephant foot bulges near the cable bands (Figure 1-4) and dripped out of a drain hole at the midspan sag points (Figures 1-5A and 1-5B). It was important to have a detailed understanding of the physical condition of the cable throughout its entire volume. Therefore, ODOT elected to install an acoustic emission monitoring system and perform an inspection on the cables in general conformance with NCHRP-534.

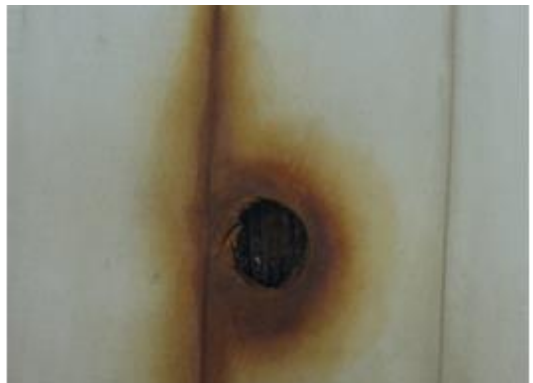
Figures 1-5A and B: Overview and Close-up of Drain Hole at Midspan

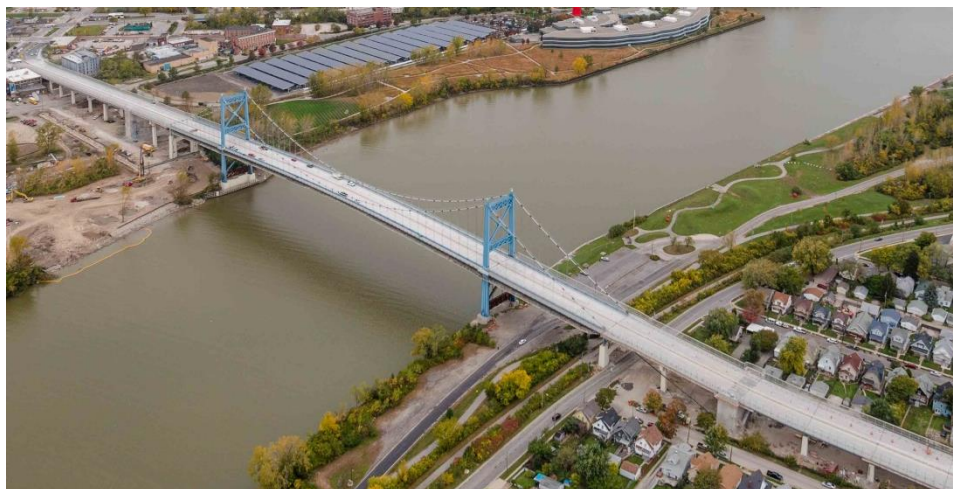
Figure 1-9: AWB after the conclusion of the approach and superstructure rehabilitation.

Throughout construction the acoustic monitoring system remained active and showed no signs of new wire breaks. Maintenance was done on the AE system in August 2015. In October 2015, the bridge was reopened to traffic. The bridge with the completed superstructure rehabilitation is shown in Figure 1-9. Note the new piers on the approach spans. Immediate plans for the AWB include a two year painting project on the superstructure beginning in summer 2016.

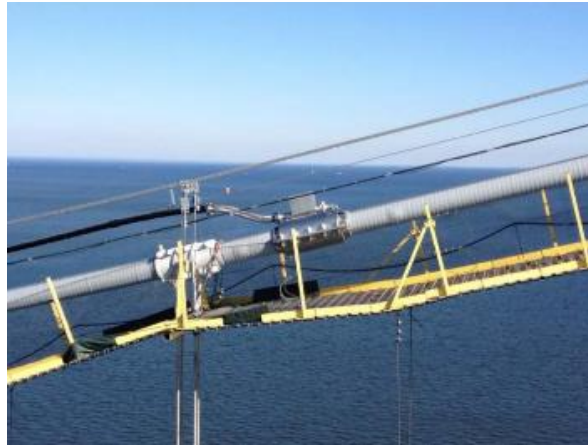
The locations of the injection and exhaust points are a large part of the design of a dehumidification system. Using classical fluid mechanics relationships, pressure drop across a

Figure 3-3: Example of an injection point, with connection to dry air flow visible. [Nader et al, 2015]

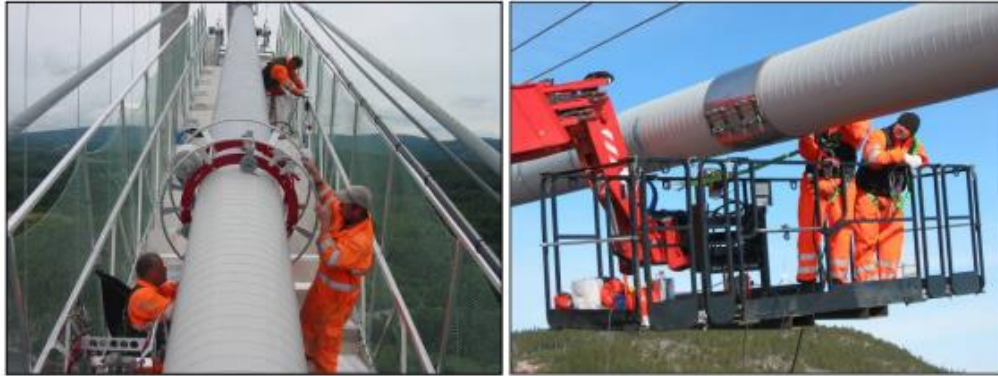
An additional exterior layer is added to existing bridge cables to further protect them and allow pressurized air flow. These cable sealing systems are specialized and usually patented products of specific companies. One example is the Cableguard Wrap System, which was the preferred product in studies by Bloomstine [2006, 2013]. It is an elastomeric wrap that is applied under tension with a special machine. Strips are overlapped so that they can be sealed with a heat bond. Some advantages to this system cited by Bloomstine include comparably shorter periods of installation, limited maintenance, and no required painting. Additionally, the wrap does not bond with the cable itself, meaning that it can easily be removed and replaced.

Figure 3-4: The Cableguard Wrap System during installation [Bloomstine, 2006]

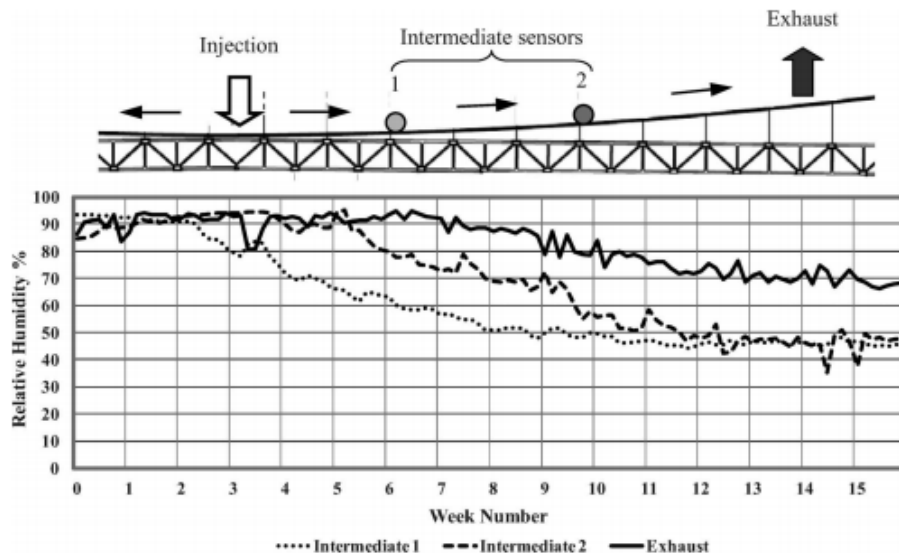
Three plants stations were installed on the bridge, one on each span. In determining the blowing lengths, it was decided to install a trial section before proceeding with the rest of the installation. This trial section was the midspan of the cable on the main span and construction was completed in 2008. The progress of the drying process can be seen in Figure 3-6. Based on these positive results, construction on the rest of the cable length was commissioned.

Figure 3-6: The progress of the drying process on the trial length of the dehumidification on the Forth Road Bridge. [Cocksedge et al, 2009]

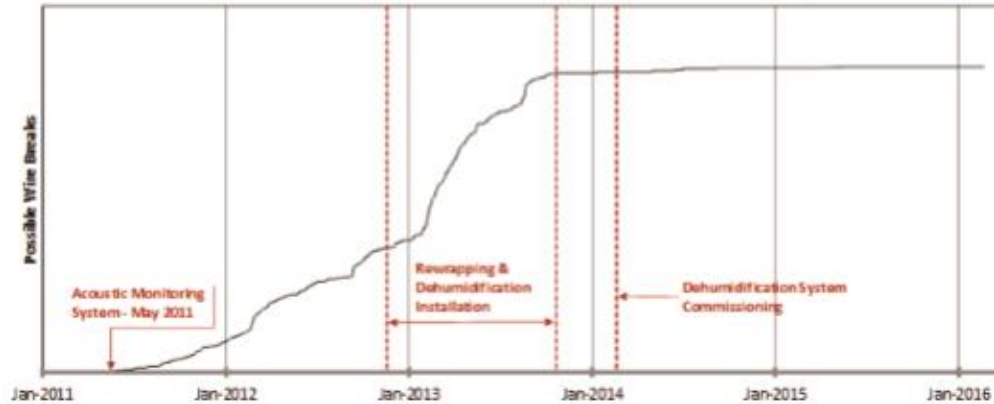
The dehumidification system has been running on the Westbound Bridge since February 2014 and on the Eastbound Bridge since September 2015. Within about nine months of the start of dehumidification, relative humidity in the Westbound Bridge dropped below 40% and the cables were essentially dried out. The effectiveness of this was confirmed by an existing acoustic monitoring system showing nearly no new potential wire breaks within the cables. This can be seen in Figure 3-7.

Figure 3-7: Potential wire breaks on the Westbound Bay Bridge [Waldvogel et al, 2016]

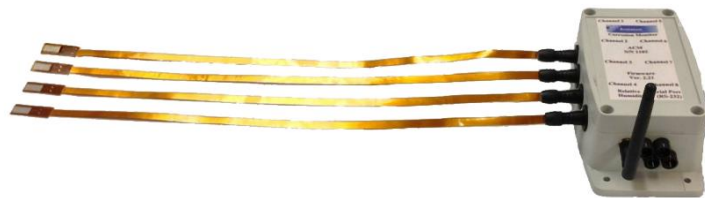
The LPR corrosion sensor is custom manufactured based on the need. The sensor itself is constructed of the same material that is being monitored. A shim of the source material is attached to an electrode grid and then placed on a flexible Kapton backing. The shim is prepared with electro chemical etching. The DAQ box allows up to eight sensors to be connected at once.

Figure 3-8: AN110 data acquisition unit with attached LPR sensors, per the manufacturer

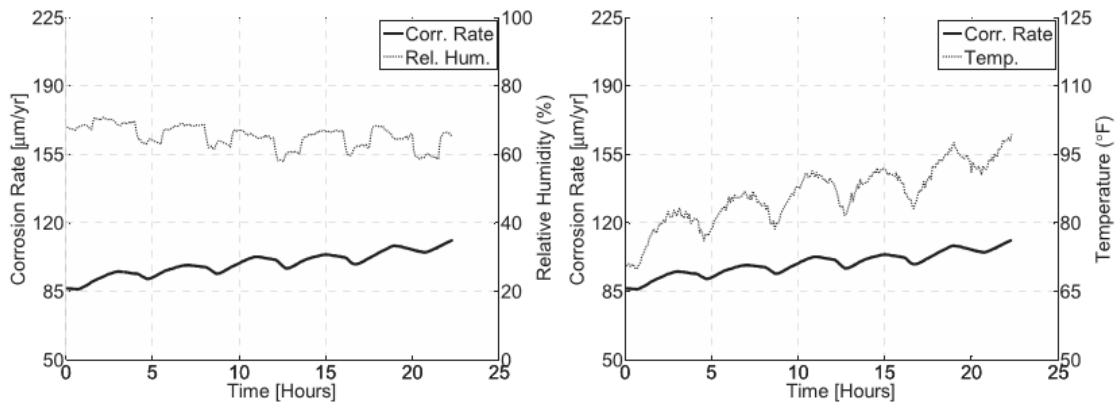
linear relationship between relative humidity and corrosion rate. The same was true of the relationship between temperature and corrosion rate. The trends can be seen in Figure 3-10.

Figure 3-10: Experimental results from cyclic testing of corrosion sensor within a cable [Sloane et al, 2013]

The sensors provided much more consistent readings when closer to the center of the cable, where conditions stayed more stable. They were ultimately viewed as a valuable resource in conducting a broader study analyzing the distribution of humidity and temperature within the cross section of a cable. The authors demonstrated that the corrosion rate readings responding directly to changes in relative humidity warranted future studies and in-field tests.

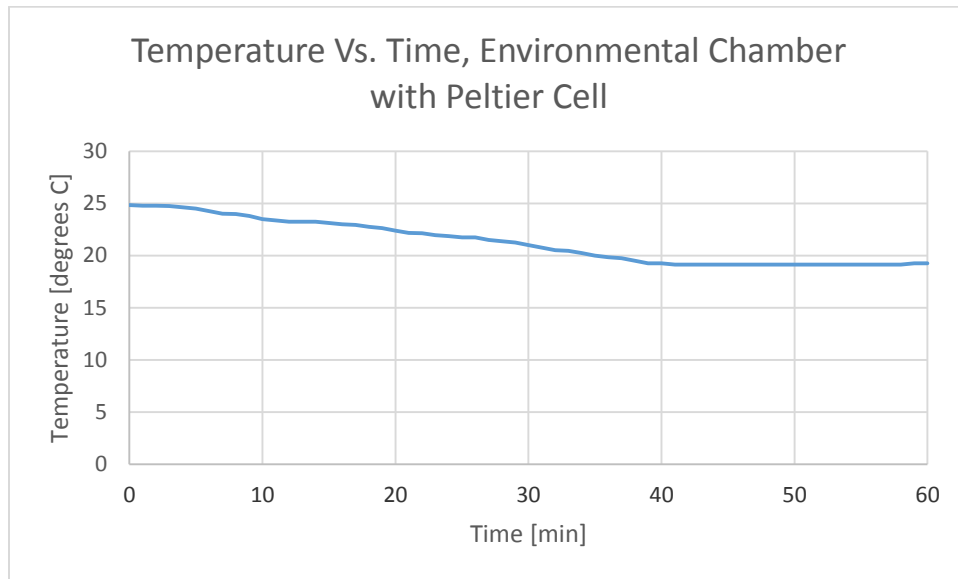
Figure 4-2: Temperature versus time in environmental chamber when using Peltier cooling cell

The Peltier cooling cell dropped the internal temperature of the chamber approximately 5 degrees Celsius from the ambient room temperature. Starting at 24.28 degrees Celsius, the temperature dropped before stabilizing at 19.13 degrees Celsius.

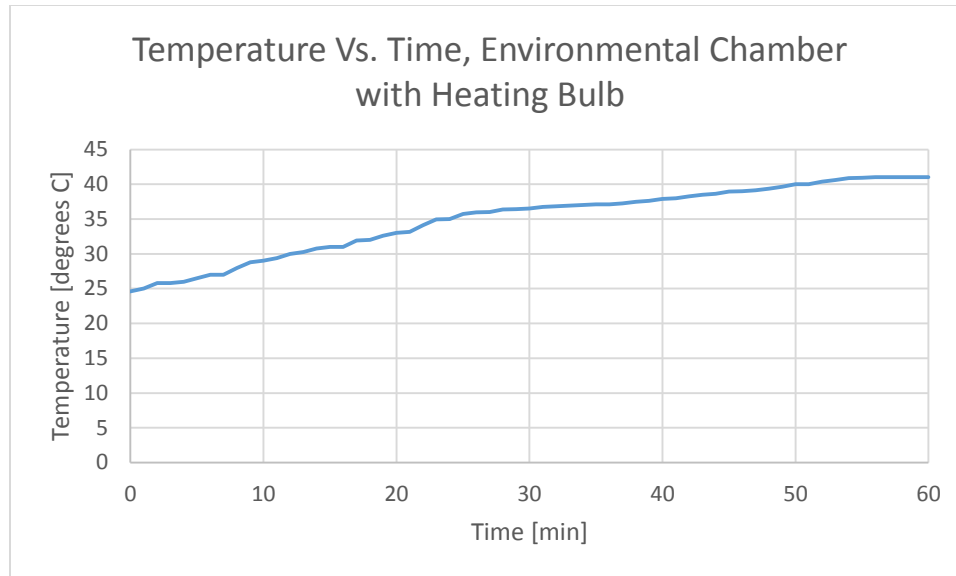
Figure 4-3: Temperature versus time in environmental chamber when using heating bulb

The heating lamp bulb raised the environmental chamber's internal temperature from 24.63 degrees Celsius to a stabilized temperature of 41.00 degrees Celsius, or approximately 106 degrees Fahrenheit.

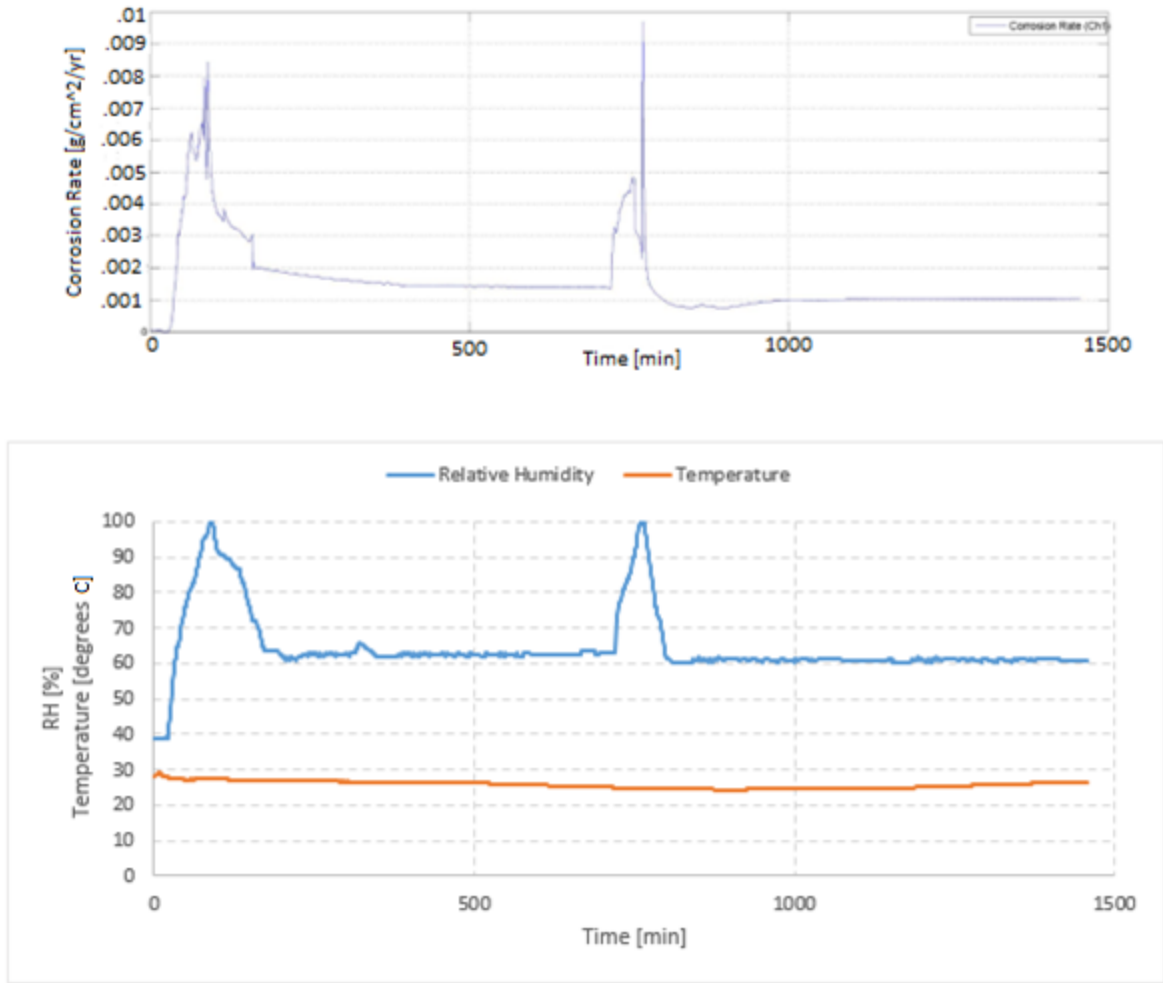
Figure 4-5: Test 1, Corrosion rate and relative humidity over 24-Hour period

Corrosion rate increased directly in relation to relative humidity. The first cycle of humid air began entering the chamber at 20 minutes into the test, when the humidity rose above 40% for the first time. The corrosion sensor output its first non-zero rate at 30 minutes, where the relative humidity was recorded at 57.5%. The first cycle of humid air can be seen in more detail in Figure 4-6 below.

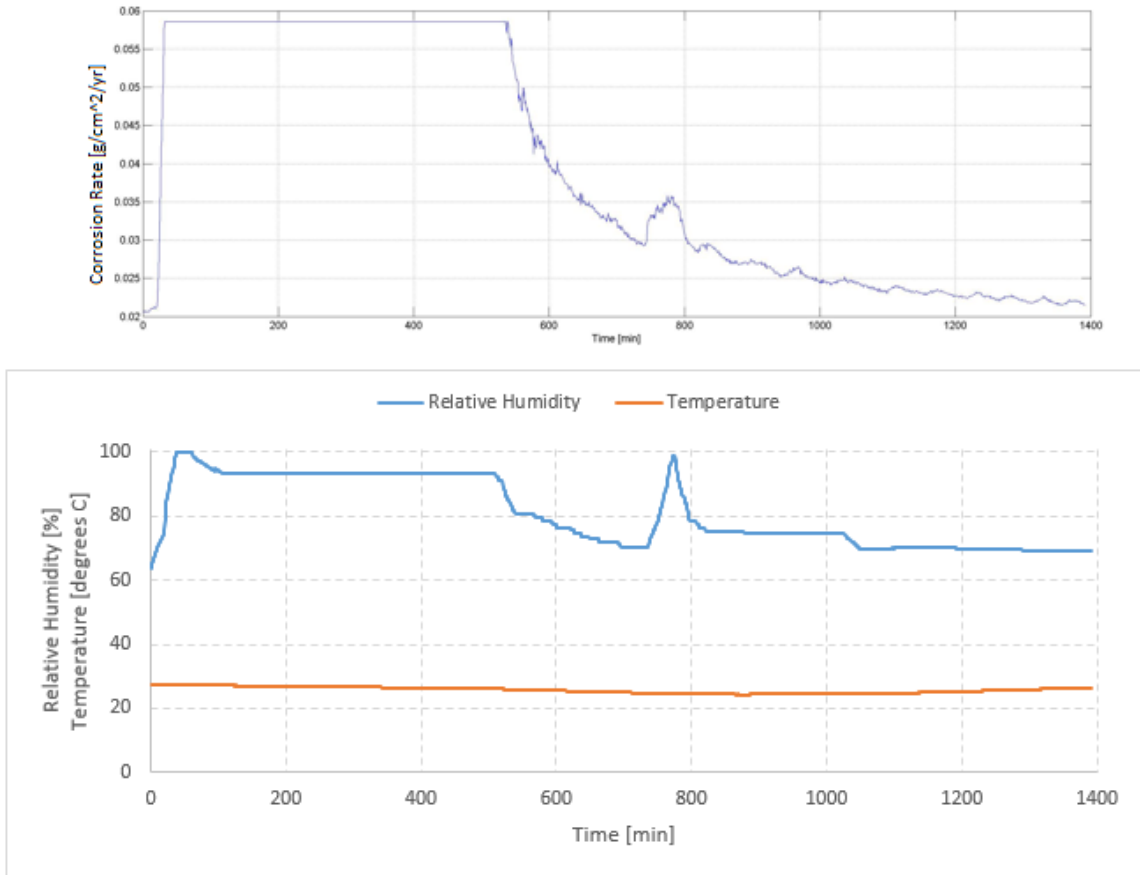
Figure 4-11: Test 3, corrosion rate and relative humidity through third 24-hour testing period

The relative humidity throughout Test 3 stabilized at much higher levels than the two previous tests, leading to much higher corrosion rates for longer periods of time. Additionally, corrosion rates were nearly 10 times as large as the two previous tests. All three tests were performed consecutively, with 12 hour breaks between them. A combination of the humidification process and repeated testing led to humid air condensing and remaining in the chamber, a scenario also experienced by Betti in other corrosion studies (Betti, 2013). The corrosion sensor nonetheless responded to changing levels of relative humidity. The first cycle of humid air can be seen in greater detail in Figure 4-12 below.
