**Michigan Department of Transportation and the Roadway Safety Institute**

# **EVALUATION OF R1-6 GATEWAY TREATMENT ALTERNATIVES FOR PEDESTRIAN CROSSINGS: FOLLOW UP REPORT**

**Draft Report**

Prepared by:  
Western Michigan University

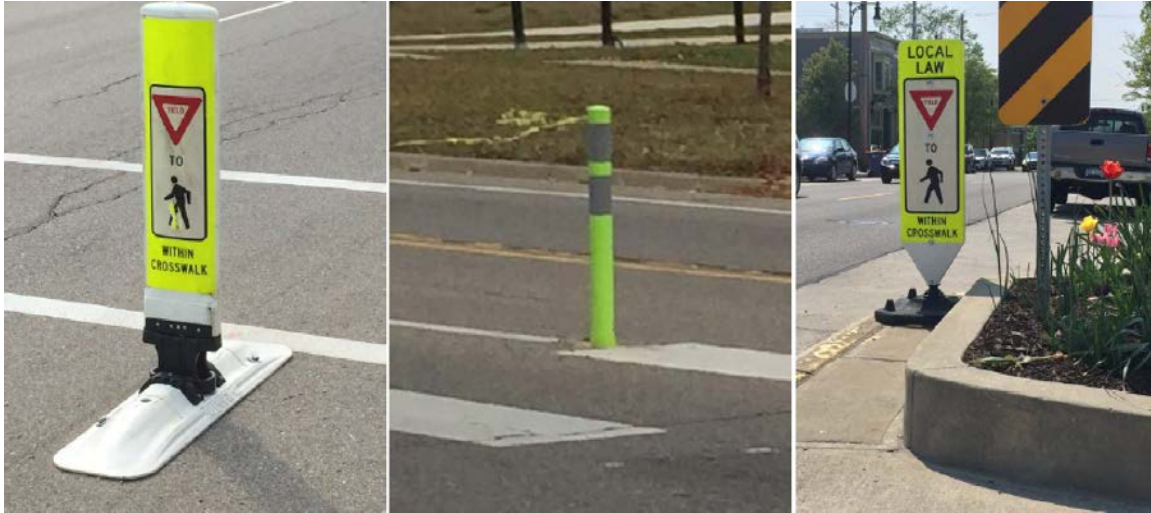
Figures 1a-c. Figure 1a (above left) shows an R1-6 sign installed on a removable curb base. Figure 1b (middle) shows a flexible delineator installation. Figure 1c (above right) shows an R1-6 sign mounted on a flush mounted base.

Three types of traffic control devices (TCD)s were used in this study. The first TCD device was the R1-6 in-street sign with a curb type base with a flexible rubber connector between the paddle and the curb type base. The second was a flexible delineator and the third was a R1-6 sign with a flush mounted base and a spring loaded pivot at the base.

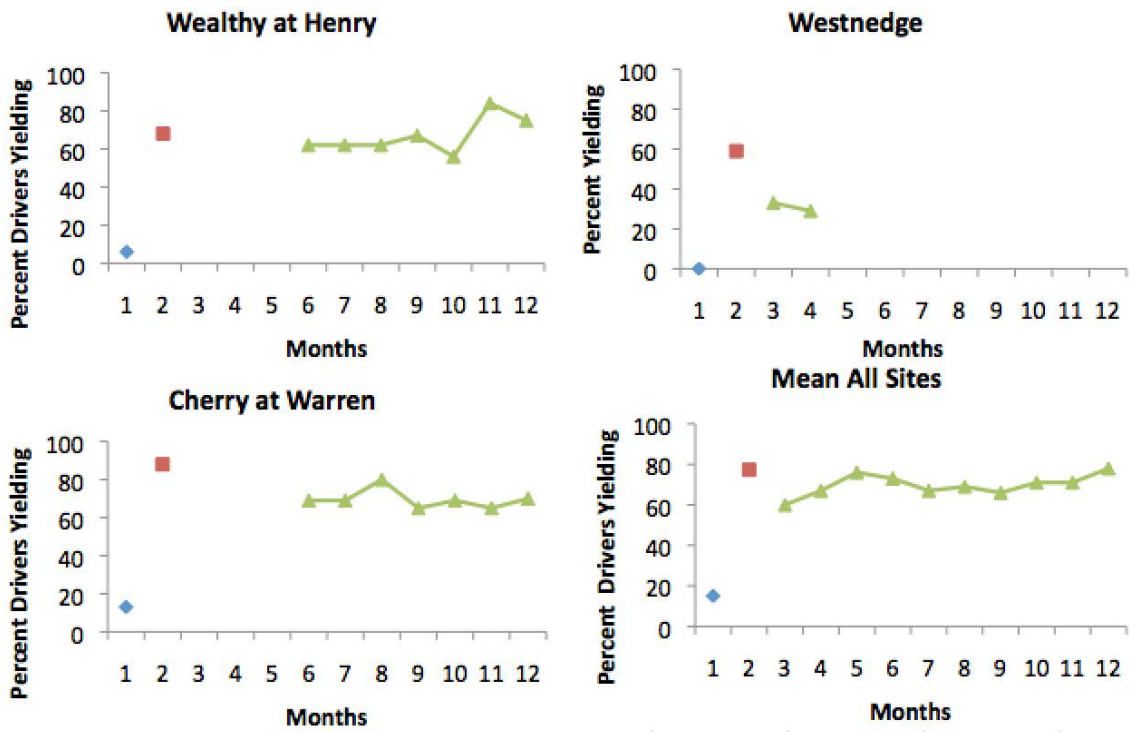
Figure 1.4. The percentage of drivers yielding during baseline (blue triangle), temporary sign condition (red square) and during each month after the permanent installations (green triangles) at three additional midblock and intersection sites. The graph on the bottom right is the average across all sites.

Figure 1.4, shows the percentage of drivers yielding at each of the sites as line graphs. The blue diamond shows the average percentage of drivers yielding during baseline before the gateways was installed. The red square shows the average level of yielding behavior during days when a temporary gateway configuration was installed. The green diamonds show the percentage of drivers yielding during each month after the permanent gateway was installed. Note that one of the edge signs forming the one lane gateway was destroyed during the third month at the Marshall NW Leg site and at the E. Main at 5<sup>th</sup> site.

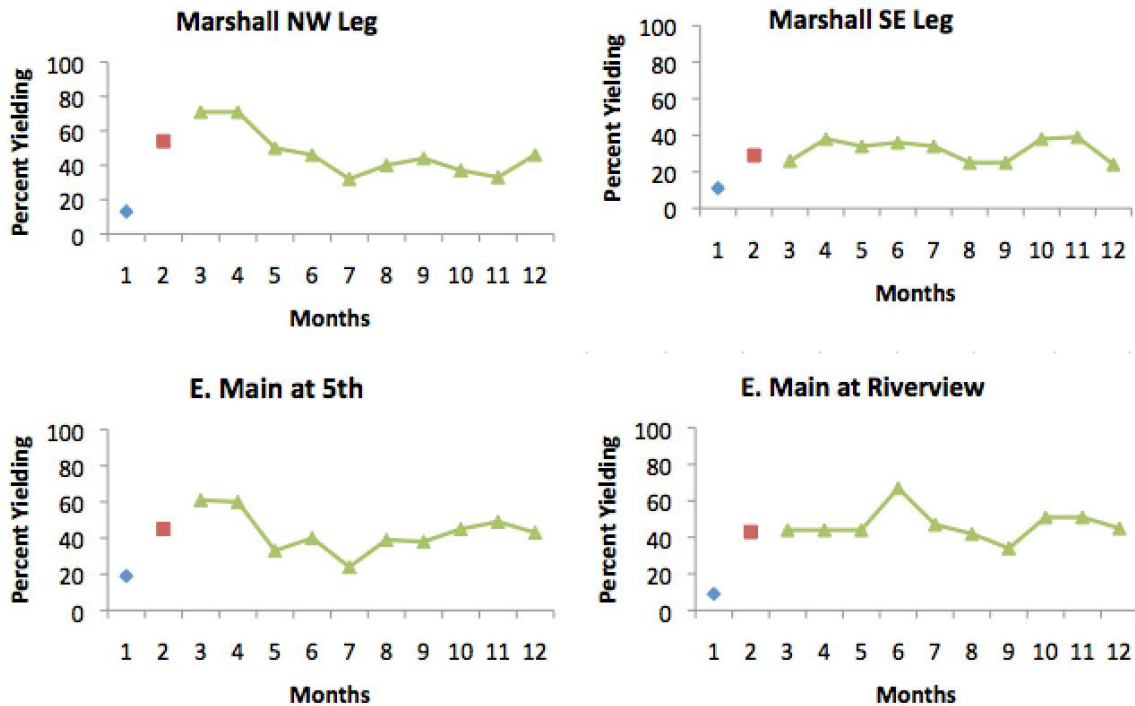
Figure 1.5. The percentage of drivers yielding during baseline (blue triangle), temporary gateway treatment (red square) and during the each month after the permanent installation (green triangles at two traffic circle sites (top frames) and at the two roundabout sites (bottom frames).

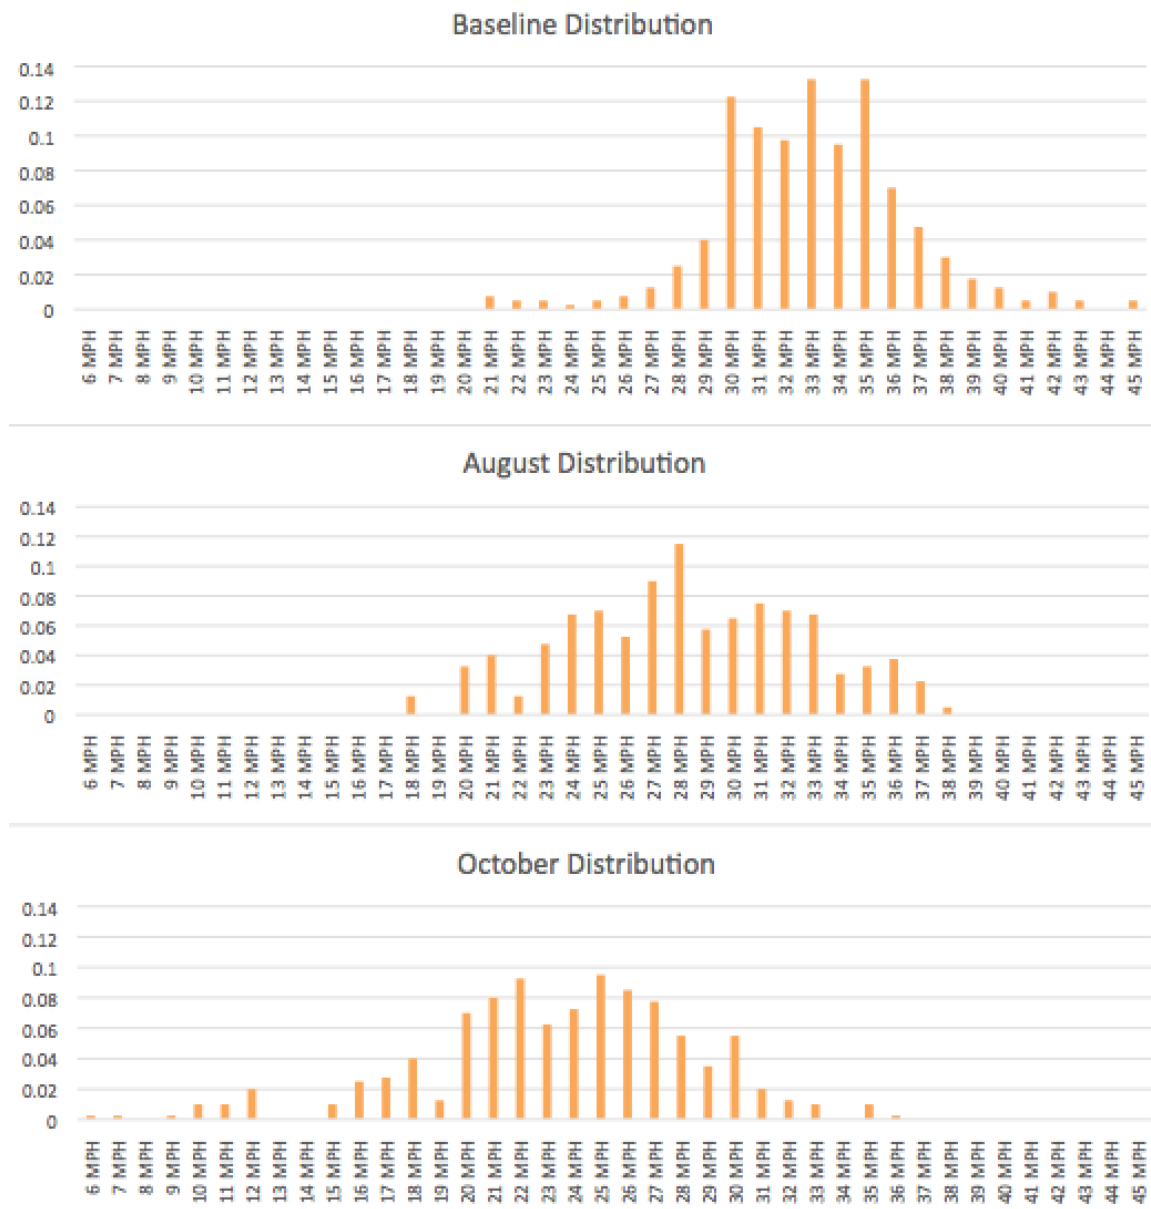
Figure 2.2. The speed distribution at the crosswalk for Huron. The top frame shows the distribution of speeds for baseline, the middle frame shows the distribution in July and the bottom frame shows the distribution in August (The treatment was not introduced until July at this location).

Mean speed reductions as the vehicle traverse the crosswalk for all sites with a baseline mean speed of 25 mph or more are shown in Table 2.1 and Figure 2.2. These data show that the speed reductions at these sites averaged around 4 mph and remained consistent over the 5-month measurement period. The one site with consistently smaller speed reductions, Monroe in Allegan, lost one of the two curbside gateway signs after the June speed reading and driver yielding also was reduced at this site. Speed data are missing for Westnedge because most of the gateway at this site had been destroyed after June. Speed data were not collected at division in October because of construction.

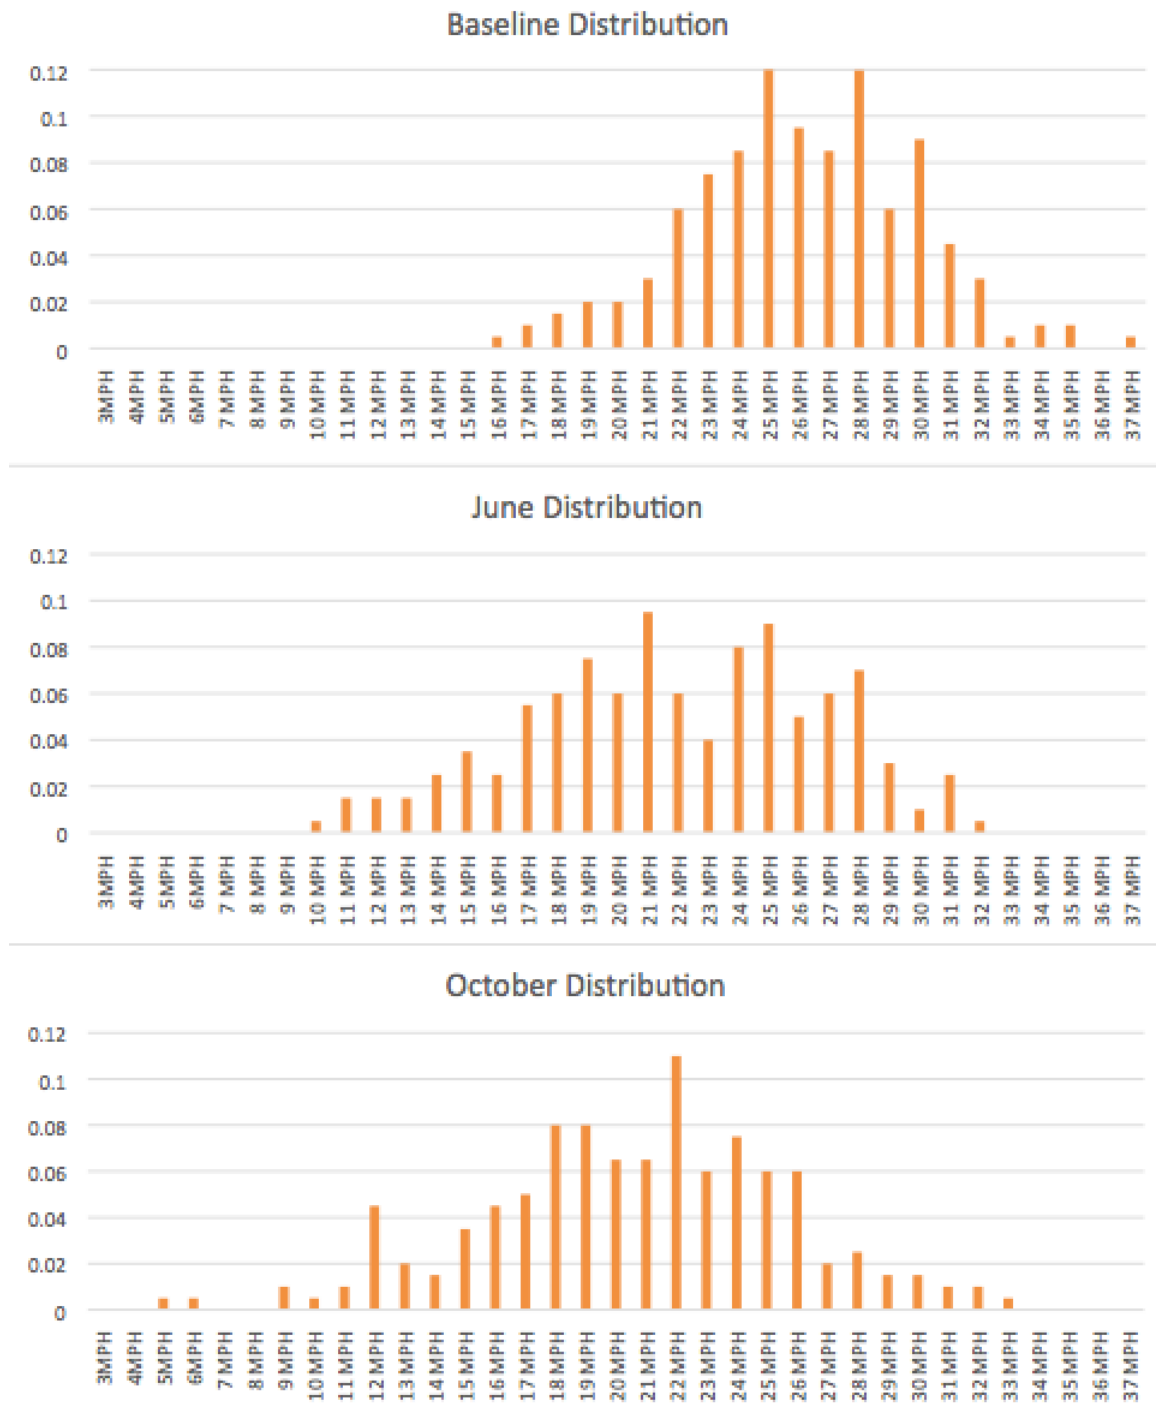
Figure 2.6. The speed distribution at the crosswalk for Cherry Street at Hollister. The top frame shows the distribution of speeds for baseline, the middle frame shows the distribution in June and the bottom frame shows the distribution in October.

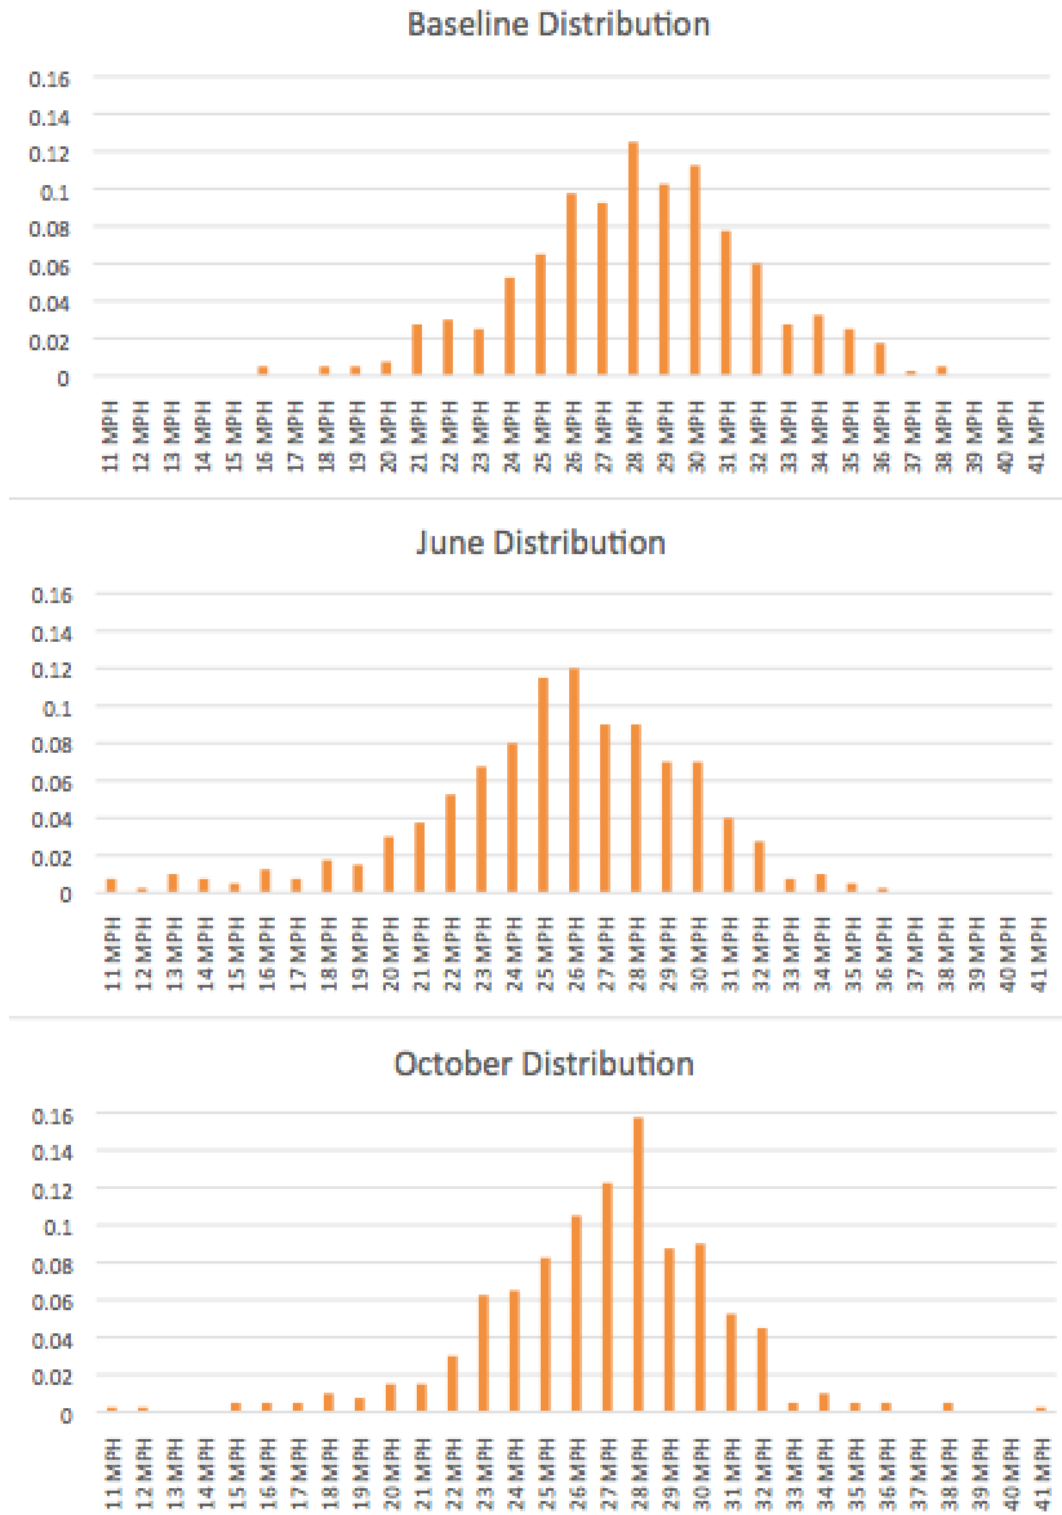
Figure 2.7. The speed distribution at the midblock crosswalk on Monroe in Allegan. The top frame shows the distribution of speeds for baseline, the middle frame shows the distribution in June and the bottom frame shows the distribution in October.

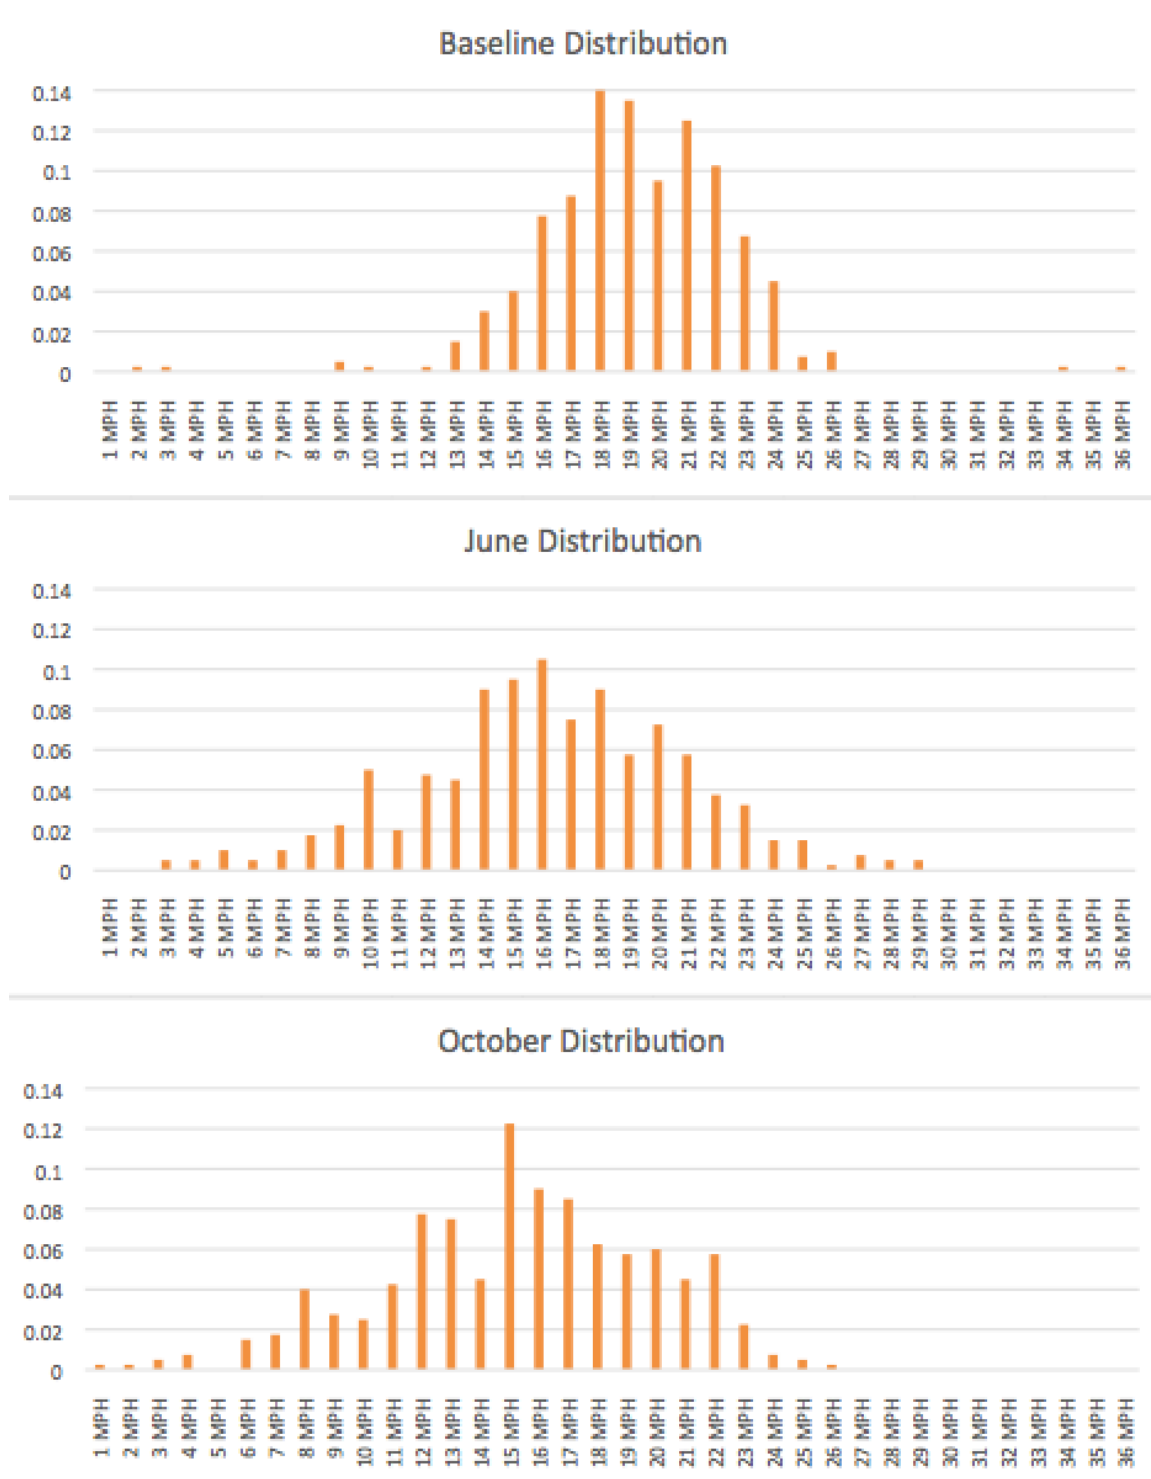
Figure 2.8. The speed distribution at the crosswalk at the approach to the roundabout on W Main St. at Riverview Dr. in Benton Harbor. The top frame shows the distribution of speeds for baseline, the middle frame shows the distribution in June and the bottom frame shows the distribution in October.

Figure 2.8 shows the speed reductions entering one of the roundabouts in Benton Harbor. At this site a similar progressive shift toward slower speeds was observed with a larger shift in October than in June. Figure 2.9 shows a similar progressive shift in speed after the gateway was introduced at a midblock site in Three Rivers.

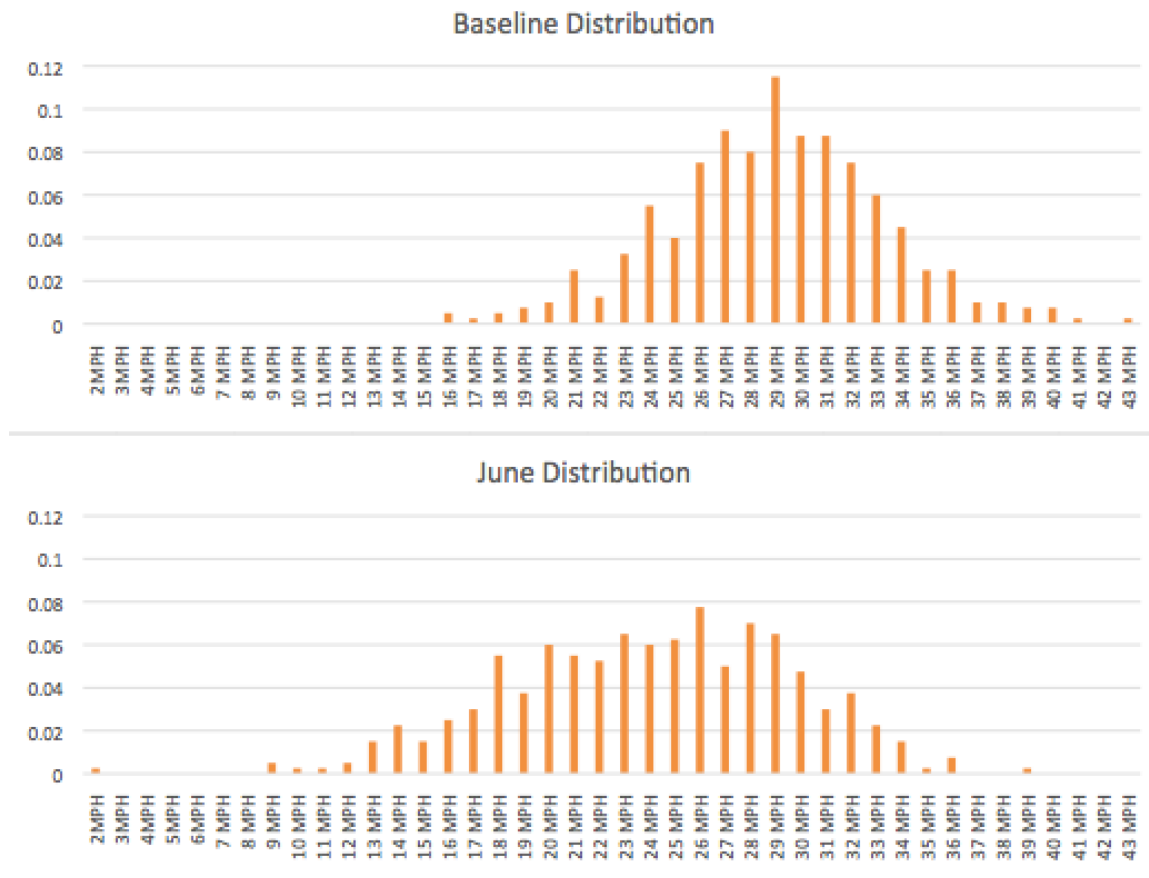
Figure 2.10. This Figure shows the speed distribution at the crosswalk on South Westnedge at Ranny. The top frame shows the distribution of speeds for baseline, the bottom frame shows the distribution in June. Two out of three gateway elements were destroyed at this site after the June speed measures. Parked cars often screened the third element.

The final graft shows the speed distribution during baseline before the gateway was introduced at the crosswalk on South Westnedge Avenue (a one-way street). The introduction produced a large shift in speeds toward lower speeds. Data were only shown at this site for June because two flush mounted signs were lost after the June speed data were collected. Because there were only three signs at this site, and parked vehicles often screened the remaining sign, data collection was suspended at this site.

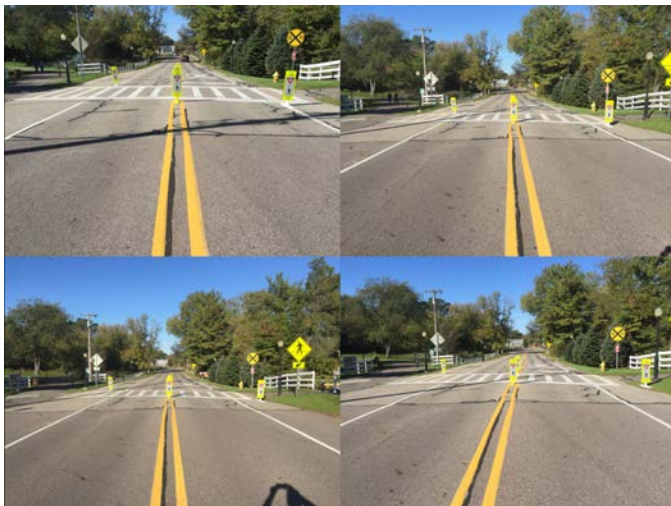
Figure3. 1. Gateway widths: (Top left) 12ft, (top right) 14ft, (bottom left) 16ft, and (bottom right) 18ft.

The present study used the R1-6 in-street sign in a gateway configuration (Bennett, Manal, & Van Houten, 2014). The distance between the signs was manipulated in 2ft increments, and the change in driver yielding to pedestrians was measured (see Figure 3.1).

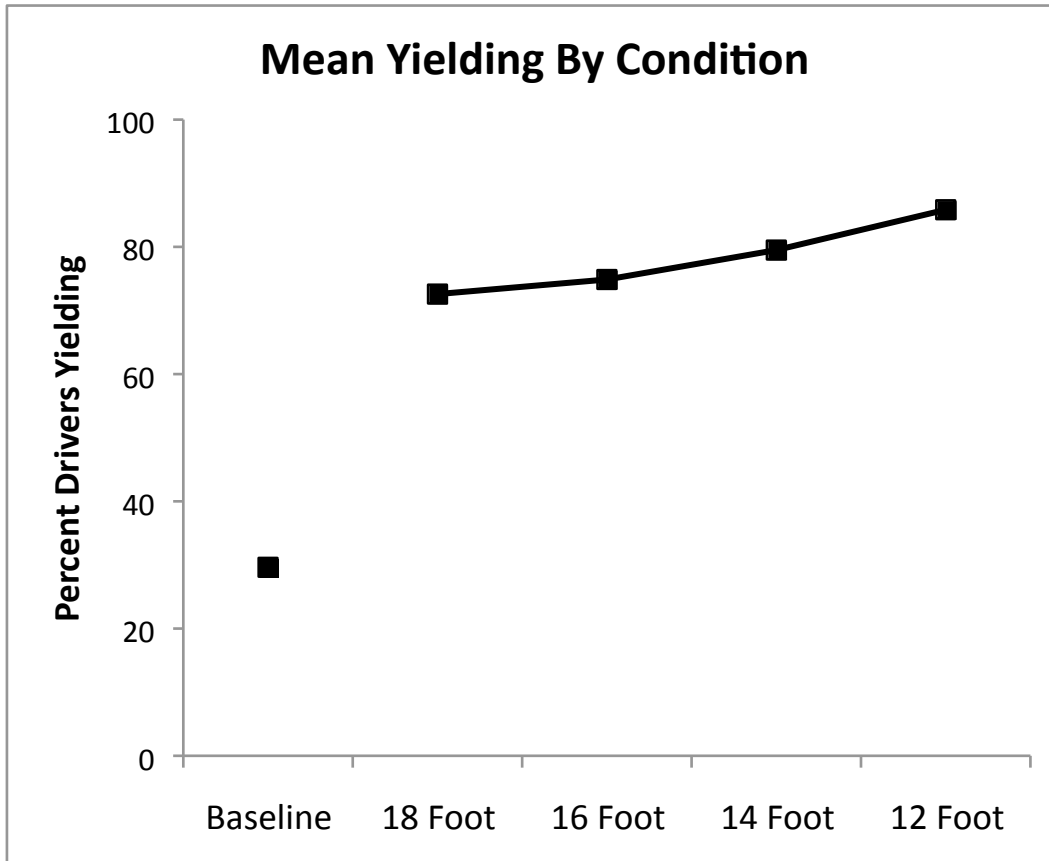
Figure 3.3. The percentage of drivers yielding to pedestrians at each of the gateway gap distances. The black square shows baseline yielding and red line shows the function between gap width and yielding behavior.

The results of the study are presented in Figure 3.3. During baseline 29.6% of drivers yielded right-of-way to pedestrians in the crosswalk. The introduction of the gateway treatment was associated with an increase in yielding at all distances, with the percentage of yielding inversely

related to the narrowness of the gateway. In other words the narrower the gateway the higher the percentage of drivers yielding to pedestrians. When the distance between the gateway signs was 18 ft., 72.6 percent of drivers yielded to pedestrians, when the distance between the signs was 16 ft., 74.8 percent of drivers yielded to pedestrians, when the distance was 14 ft., 79% of drivers yielded and when the distance was 12 ft. 85% of drivers yielded.

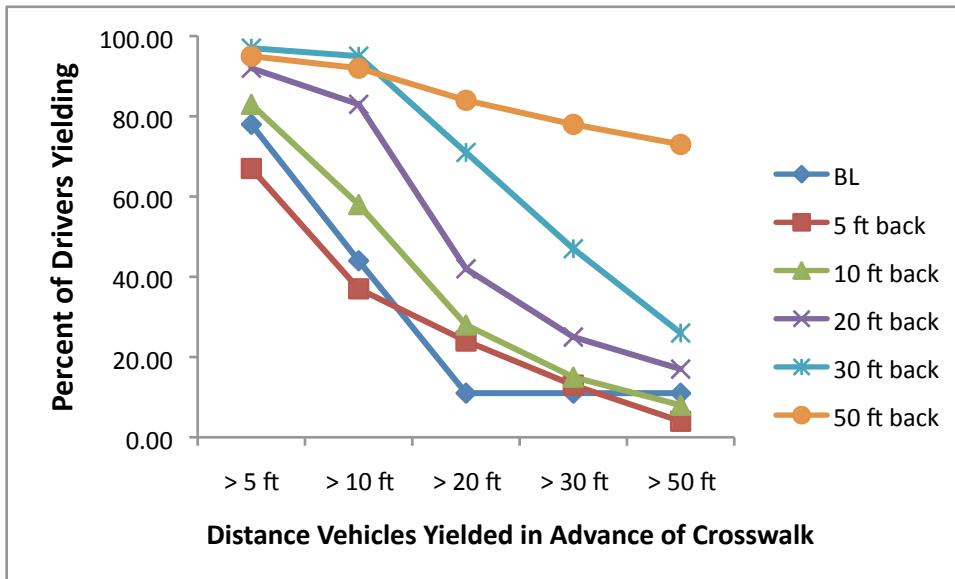
Figure 4.2. The percentage of drivers yielding greater than 5, 10, 20, 30 and 50 ft in advance of the crosswalk during Baseline, and when the gateway is placed 5, 10 20, 30 and 50 ft. in advance of the crosswalk.

Figure 4.2 shows the percentage of drivers yielding more than each distance from the crosswalk. These data show that the use of the gateway produces a very large in advance of the crosswalk increases the distance that drivers yield in advance of the crosswalk. When the gateway was placed 50 ft in advance of a crosswalk not only did yielding increase but drivers also yielded further back from the crosswalk.

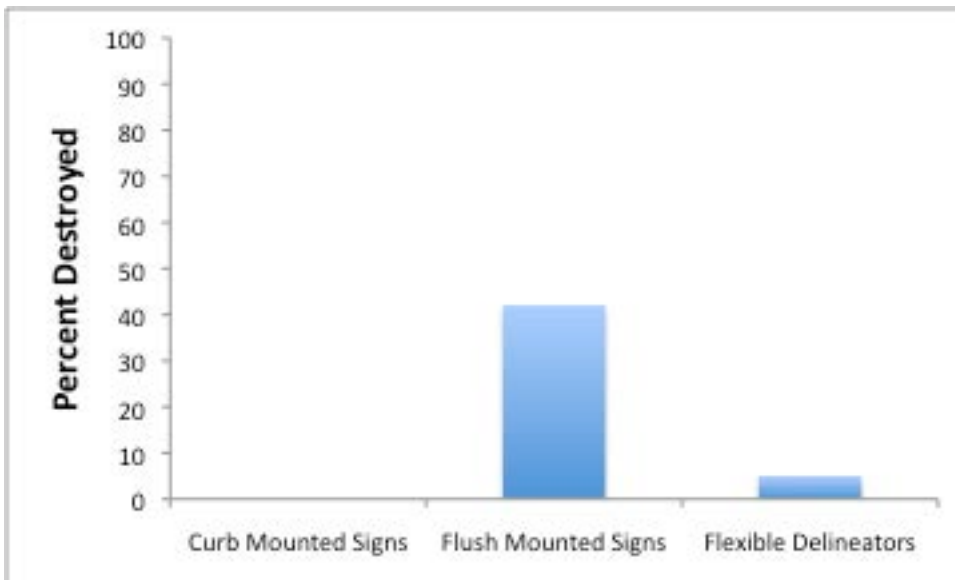
Figures 5.1. The percentage of curb type base mounted signs, flush type base mounted signs and flexible delineators destroyed in 2016 during the study period.

Table 5.1 shows the number of each type of sign installed along with the number of each type of sign destroyed and Figure 5.1 shows the percentage of each type of sign destroyed. Generally, signs mounted on a curb type base affixed to a detachable flexible rubber boot that support the sign panel in a vertical position, and capable of restoring the sign to the vertical position if struck by a vehicle, installed on the right lane line showed little evidence of being struck and only one was damaged although it continued to work in its damaged state (see Figure 5.2 a for a picture of the only damaged curb type mounted sign). Forty two percent of the signs installed in on the right lane line with flush mounted bases and a spring loaded pivoting connector were destroyed. In all cases these signs were sheared from their base, see Figure 5.2b for a picture of a base where the sign has been sheared off. It is important to note that all of the signs destroyed were located on the right side of the road and were mounted on the lane line. No signs mounted in the gutter pan or on a curb top were destroyed.
