GEORGIA DOT RESEARCH PROJECT 15-11

FINAL REPORT

**IMPLEMENTATION OF AUTOMATIC SIGN INVENTORY
AND PAVEMENT CONDITION EVALUATION ON
GEORGIA'S INTERSTATE HIGHWAYS**

February 2017

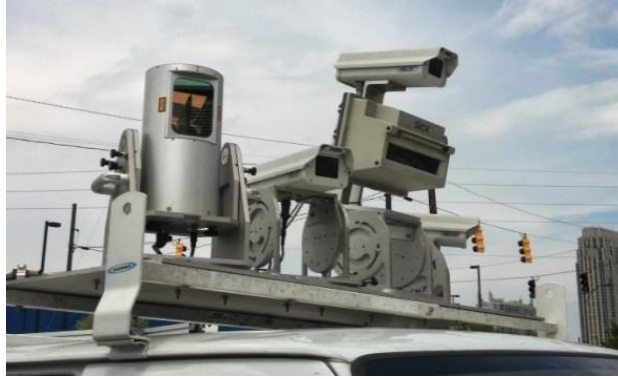
The mobile imaging sub-system used in this project consists of three primary components, including the LiDAR sensor, the precise positioning system, and the camera system. The LiDAR sensor is used to acquire the point cloud of the target, e.g. a traffic sign. Each point includes the accurate distance from the sensor to the target, the relative angle of the laser beam with respect to the LiDAR sensor, and the corresponding reflectance intensity. The precise positioning system is used to acquire accurate global positioning system (GPS) coordinates and poses for the LiDAR sensor. Thus, the GPS coordinates of each point from the LiDAR sensor can be derived. The positioning system is composed of a GPS, an inertial measurement unit (IMU), and a distance measurement instrument (DMI) to acquire the precise GPS coordinates. The camera system is synchronized with the LiDAR sensor to provide corresponding color images. FIGURE 2-1 illustrates the mobile imaging sub-system on the GTSV.

Mobile imaging sub-system on GTSV

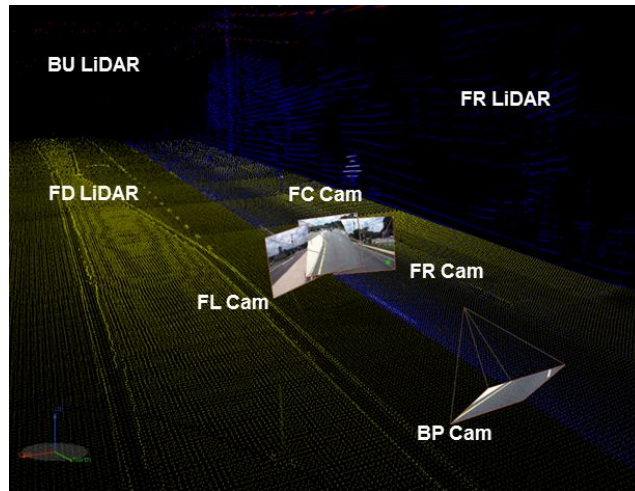
The current LiDAR sensor can produce 10,000 laser points per second. As the vehicle moves in the longitudinal direction, the scanning line of the LiDAR system is aligned perpendicularly to the ground. The scanning range is $\pm 40^\circ$ to the horizontal direction, which produces an 80° fan covering the roadside. For example, if a standard 48 in. \times 60 in. speed limit sign is mounted on the roadside with a lateral offset of 12 ft. to the edge of the road, the current configuration will be able to acquire a point cloud containing approximately 12×8 points at 60 mph (100 km/h). Based on the previous study, the frequency of the LiDAR system is configured at 100 Hz and 100 points within each scan, while the LiDAR heading angle is configured at 20° . Such a configuration was carefully recommended in the previous study for better acquiring the traffic sign data (Ai and Tsai, 2015). The three video cameras (i.e., front right, front center, and front left camera) are synchronized and calibrated with the LiDAR sensor so that the corresponding 2-D images can be integrated with the 3D LiDAR point cloud in the same location-referencing coordinates. The data collection interval of 5 meters is used for collecting the video log images, as recommended in the previous study for optimizing the data storage with sufficient overlap in the video log image sequence (Ai and Tsai, 2015). FIGURE 2-2 shows an illustration of the collected sensing data using the mobile imaging sub-system.

Illustration of the collected sensing data using the mobile imaging sub-system

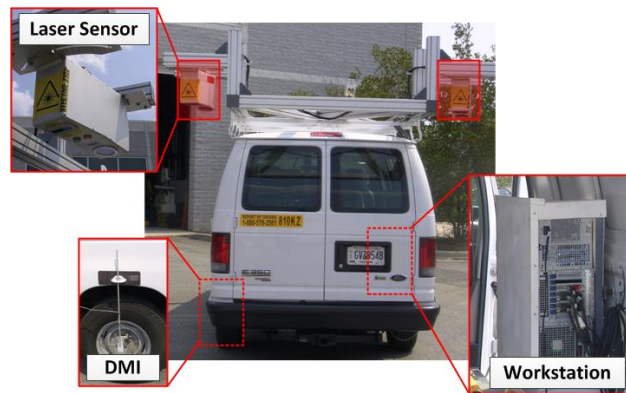
FIGURE 2-3

The 3D line laser consists of three primary components, including the imaging component, the distance-measuring component, and the data processing component. The imaging component is used to capture the pavement texture data using external infrared laser illumination and the spatial high-intensity camera. This component consists of two separate laser sensors to cover a full-lane width. Each laser sensor includes a dedicated infrared laser illumination and a high-intensity, area-scanning camera. The distance-measuring component provides a data-capturing signal by using a DMI, which is user-customizable. The data processing component computes the captured data into 3D range results using a high-performance workstation. As shown in FIGURE 2-3, the two laser sensors are installed on each side of the roof at the back of the GTSV. The current sensor delivers a resolution of 5 mm in the longitudinal direction and 1 mm in the transversal direction, with a resolution of 0.5 mm in the vertical direction. The field of view of the two sensors covers a full-lane width, i.e. 4 m. The research team configured both sensors at approximately 15 degrees clockwise to the transverse direction to avoid overlooking transverse cracks in the pavement. During data collection, each laser sensor uses a high-powered laser line

projector with a customized filter to generate a fine infrared laser line illuminating a strip of the pavement. The corresponding spatial high-intensity camera captures the deformed laser line on the pavement. From the captured image, range measurements are extracted (Tsai and Wang, 2013). FIGURE 2-4 illustrates the collected data using the 3D line laser sub-system.

Components of 3D Line Laser System Integrated on the GTSV

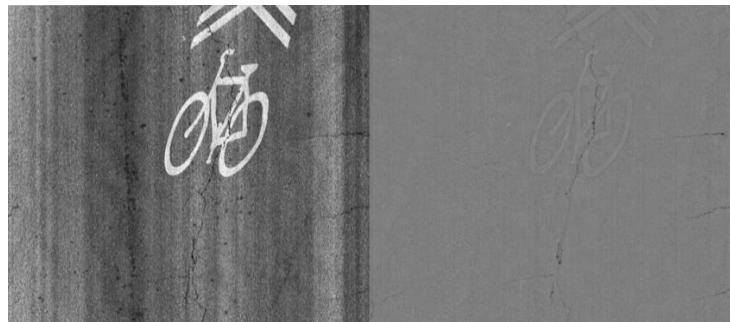
FIGURE 2-4

Illustration of the collected data using the 3D line laser sub-system

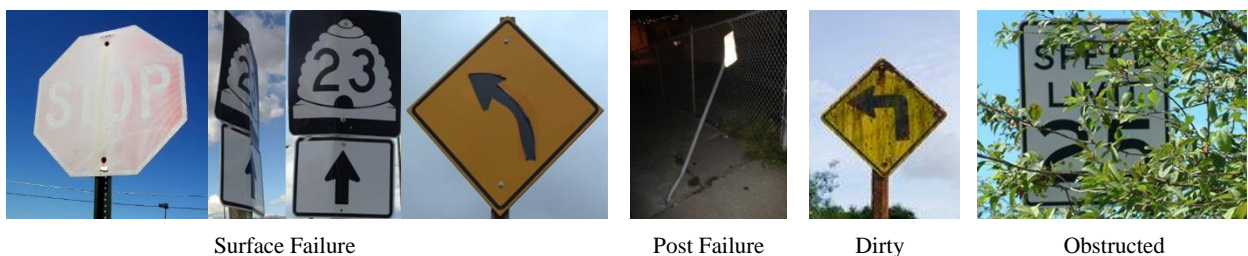
Sign Condition: Traffic sign condition is represented by the visual defects and the retroreflectivity. In this study, daytime inspection using video log images is the focus that identifies visual defects; studying the retroreflectivity condition, which is covered by nighttime inspection, is not in the scope of this research project, and recommended for future research. Four categories of poor sign conditions are defined in this study, including post failure, dirty, obstruction, and surface failure. Based on the Signs Chapter of GDOT's Foreman's Academy (2008), the four categories of poor sign conditions correspond to four maintenance actions defined by Highway Maintenance Management System (HMMS) (Hensing and Rowshan, 2005), including straightening, cleaning, vegetation trimming, and replacing. FIGURE 3-1 shows several examples of signs in poor condition in each category.

Examples of four categories of poor sign conditions

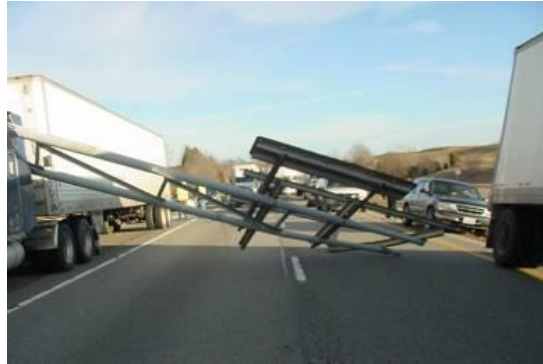
damage of these signs and/or their corresponding support, e.g. panel failure, support structure failure, etc., may potentially lead to serious hazards to road users. FIGURE 3-2 shows an example of such hazardous situations.

FIGURE 3-2
Example of overhead sign failure (FHWA, 2013)

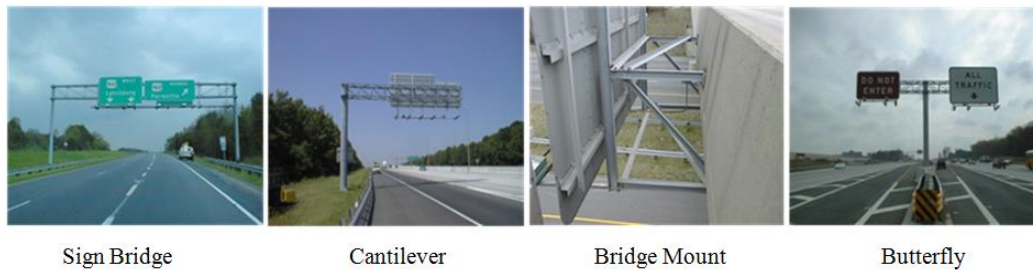
Therefore, overhead signs are specially categorized and inventoried in detail. According to the different supporting structures for overhead signs defined in the Signs Chapter of GDOT's Foreman's Academy (2008), three categories are inventoried, including Sign-Bridge-Mounted, Cantilever-Mounted, and Bridge-Mounted and Butterfly-Mounted traffic signs. FIGURE 3-3 illustrates these three categories. Inventorying the detailed categories of overhead signs and identifying the spatial locations of these signs will be beneficial to the subsequent maintenance and/or more detailed structure inspection.

FIGURE 3-3
Examples of the overhead sign categories defined by GDOT

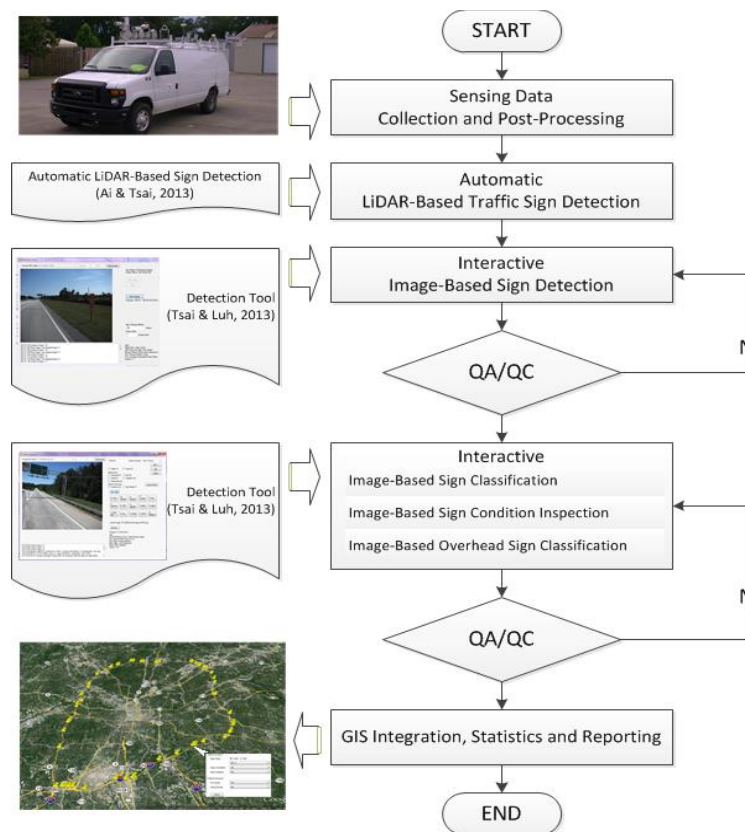
In this study, a streamlined procedure for sign data collection that aims to improve the data quality and productivity of the data collection practice while keeping field engineers from being exposed to roadway hazards was applied. The procedure utilizes both the available automatic method for traffic sign detection and several customized interactive tools for traffic sign recognition and the extraction of other characteristics. FIGURE 3-4 shows the flowchart of the proposed procedure, which consists of five primary steps. The quality assurance and quality control (QA/QC) steps are used to guarantee the quality of the results.

**Flowchart of the proposed streamlined traffic sign inventory procedure
(Ai and Tsai, 2015; Luh and Tsai, 2012; Tsai, 2009; Tsai and Wang, 2013)**

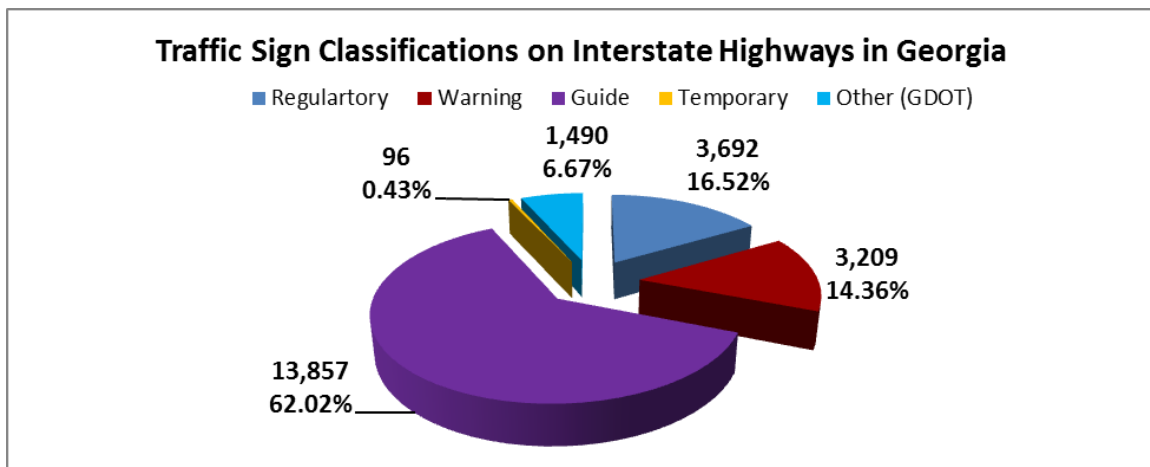
In this study, there are 22,344 traffic signs that are inventoried through the proposed approach. Among all the identified signs, the majority of the signs are guide signs that make up 62.0% of the total population (13,857 signs). The rest of the population consists of 3,692 regulatory signs, 3,209 warning signs, 1,490 other signs (customized signs in Georgia), and 96 temporary signs. FIGURE 3-5 shows the distribution of the traffic signs on the interstate highways in Georgia based on their classifications.

Distribution of traffic sign classifications on interstate highways in Georgia

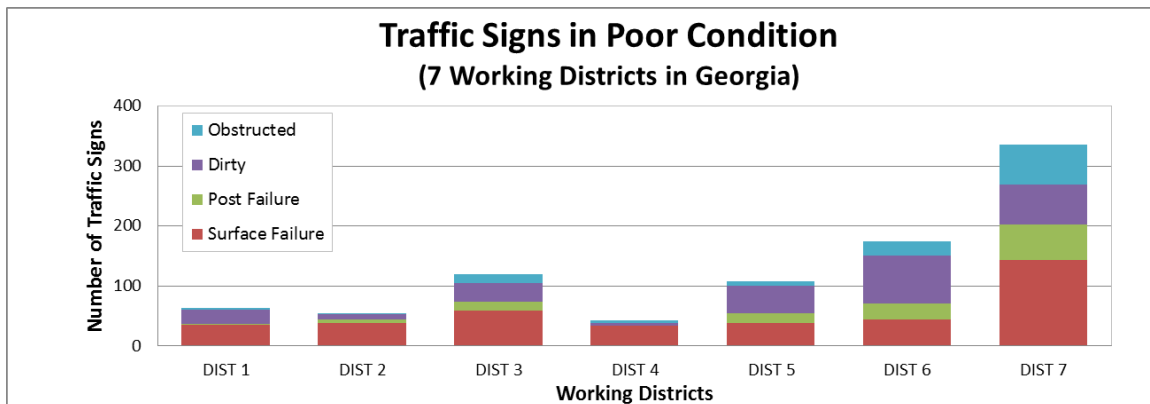
FIGURE 3-9 shows the distribution of the traffic signs in poor condition in the seven working districts. Similarly, it can be observed that District 7 has more traffic signs in poor conditions (i.e., 335 signs, approximately 5% of the total signs in District 7) than the

ones in other districts. While surface failure is the major reason in all working districts for traffic signs in poor condition, it should be noticed that traffic signs with dirty surfaces occur more frequently in District 6 and obstruction and post failure in District 7. These observations may provide some insight in guiding an improved maintenance effort, such as traffic sign cleaning in District 6 and post repair and vegetation trimming in District 7. TABLE 3-4 shows the detailed statistics.

Distribution of traffic sign in poor condition in the 7 working districts

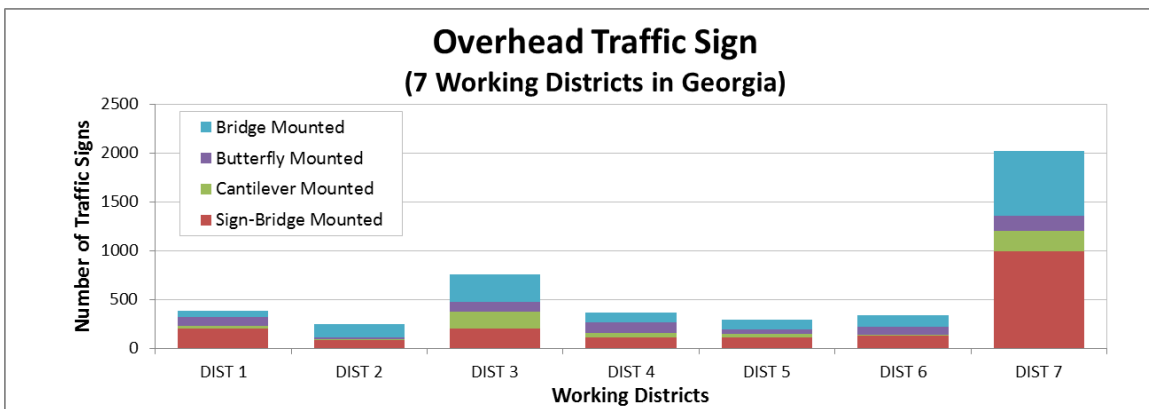
FIGURE 3-10 shows the distribution of the overhead traffic signs in the 7 working districts. It can be observed that District 7 has a significantly larger number of overhead traffic signs (i.e., 2,022 signs, more than 30% of the total signs in District 7) compared to other districts, because of the frequent overpasses and intersections in the urban region.

FIGURE 3-10
Distribution of the overhead traffic signs in the 7 working districts

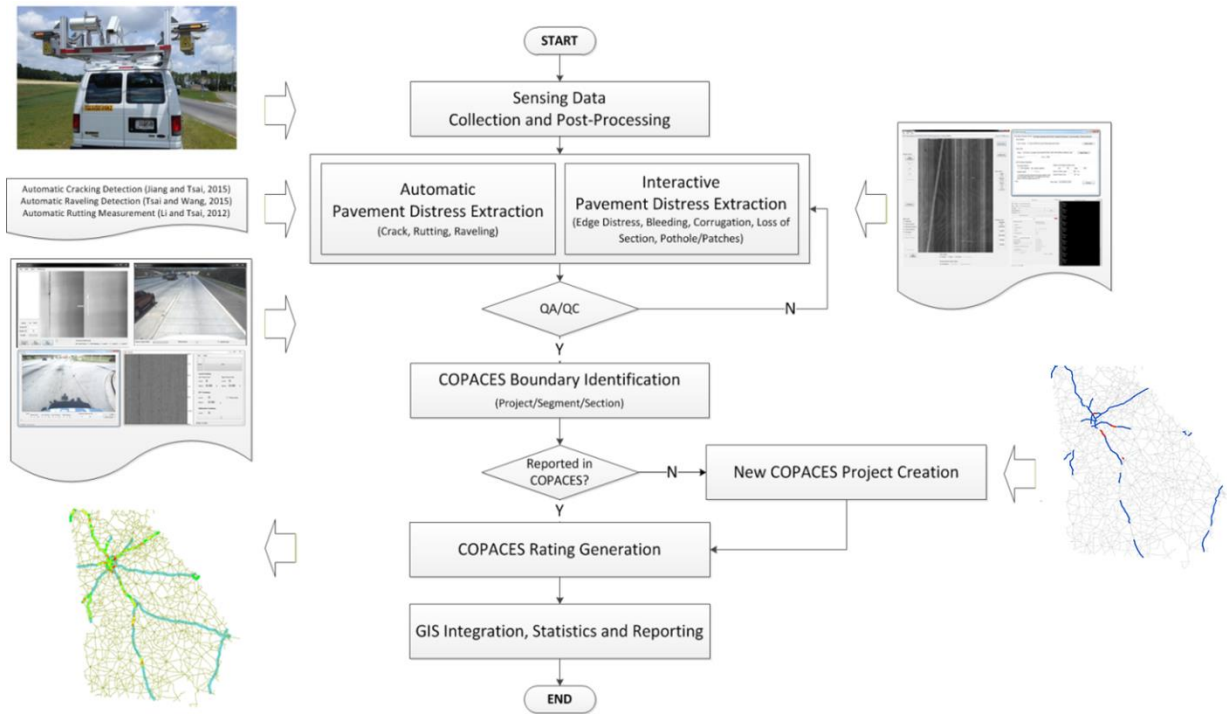
In this study, a streamlined procedure for pavement condition evaluation following GDOT's COPACES survey method was applied. It aims to improve the productivity and reliability of the data collection practice while keeping field engineers from being exposed to roadway hazards. The procedure utilizes both the available automated methods for pavement distress extraction (including crack, rutting, and raveling) and several customized interactive tools for the extraction of other characteristics. FIGURE 4-1 shows the flowchart of the proposed procedure, which consists of five primary steps. The QA/QC steps are used to guarantee the quality of the extraction results. Since the automatic results are generated covering all the interstate highways with asphalt surface using the interval of a frame in the sensing data collection (i.e., 5 m), the steps of COPACES boundary identification, and COPACES rating generation steps were proposed to summarize the automatic results into COPACES reporting unit, i.e., segments and projects. New reporting segments and projects are generated for the locations without any previous COPACES reporting. In the following sections, the mechanisms for matching existing COPACES reporting segments and projects for generating new COPACES reporting segments and projects are presented.

Flowchart of the proposed streamlined sign data collection procedure (Jiang and Tsai, 2016; Tsai, 2015; Tsai and Wang, 2013; Tsai and Wang, 2014; Tsai and Li, 2012)

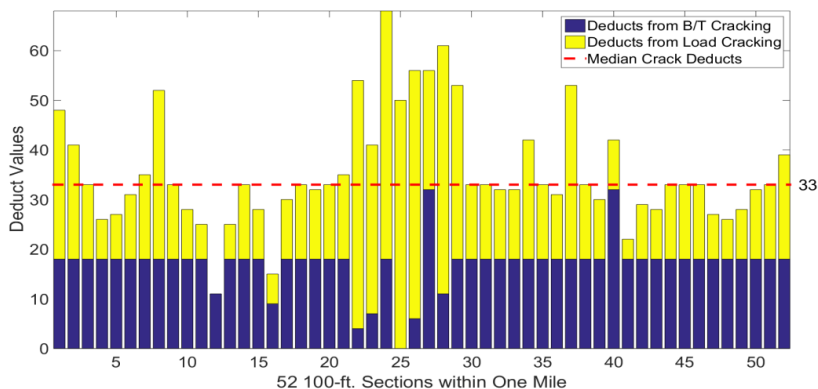
In COPACES, walking survey is conducted for cracking in a 100-foot representative sample section in each 1-mile segment. Using the automatic pavement distress extraction results, the research team reported the detailed difference for each data frame (i.e., 5 m interval). Therefore, for each 1-mile segment, the automatic results can generate fifty-two

100-foot sections, whereas results from six data frames are aggregated for the corresponding 100-foot section. FIGURE 4-2 illustrates the fifty-two 100-foot sections reported within a 1-mile segment. In order to mimic the selection criteria performed by GDOT for a representative section, the deduct value for each individual section is computed, whereas a 60 percentile of the deduct distribution is used for selecting the “representative” section to represent the 1-mile segment. Therefore, the severity level and extent values for the selected “representative” section are used to represent the entire 1-mile segment. The percentile is calibrated by comparing the results from the automatic crack extraction and the results manually reviewed by field engineers from GDOT. It is observed that 60 percentile can best capture the field engineers’ judgment in selecting the “representative” section. It should be noted that although a 60 percentile is used to generate the COPACES ratings in this study, the derived results using the automatic distress extraction have the capability to generate a full-coverage, continuous crack severity level and extent values without the need to aggregate into the “representative” 100-foot section artificially.

Illustration of the fifty-two 100-foot sections reported within a 1-mile segment

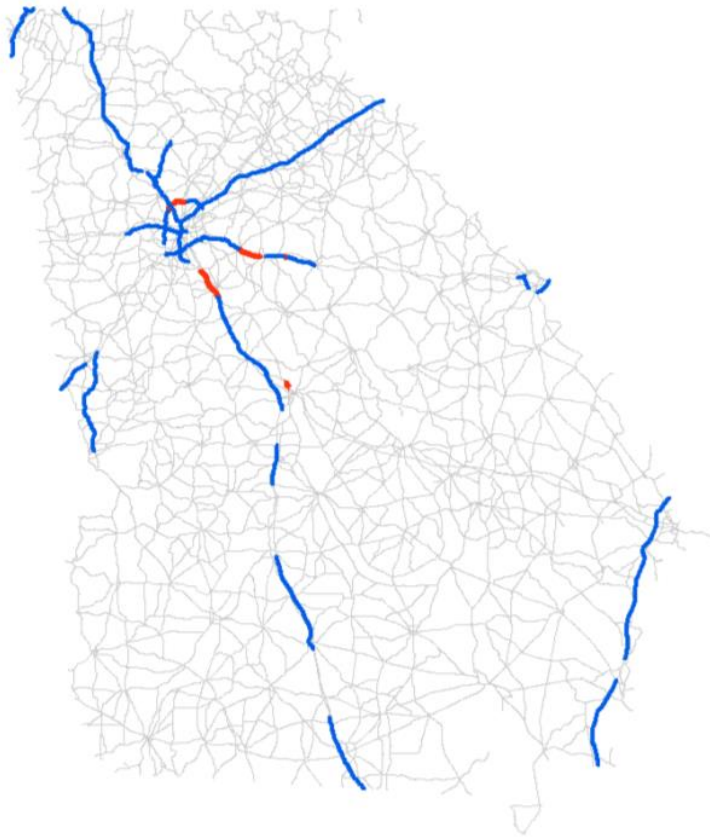
As mentioned in the above section, the FY2015 COPACES survey covers 95.3% of the interstate highways with an asphalt surface, which indicates approximately 4.7% of the interstate highways with asphalt surface in Georgia were not reported in the FY2015 COPACES database. It is necessary to append the unreported locations to the full COPACES database. It is necessary to append the unreported locations to the full COPACES survey. FIGURE 4-3 shows the locations of the interstate highways with asphalt surface by a blue line showing the reported locations and a red line showing the unreported locations in the FY2015 COPACES database by GDOT. It is observed that small portions of I-75, I-20, and I-285 were not reported.

Locations and extents of the interstate highways with asphalt surface

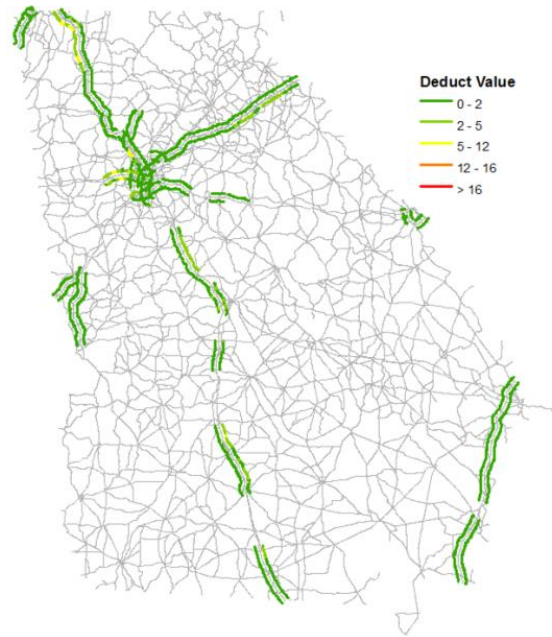
FIGURE 4-5

Detailed COPACES deducts in the major distresses, such as load cracking, block cracking, raveling, and rutting, were further studied, as shown in FIGURE 4-5. It can be observed that the overall deduct value related to load cracking, block cracking, and

rutting on interstates is relatively low. Most of the load-cracking-related deduct value is below six points (i.e., less than 10% of load cracking at Severity Level 1); it is below seven points for block cracking (i.e., less than 30% of block cracking at Severity Level 1); and it is below five points for rutting (i.e., less than ¼ inch). However, the majority of the deducts contributed by raveling are above eleven points (i.e., more than 45% of raveling at Severity Level 1, or more than 25% of raveling at Severity Level 2).

LOAD CRACKING

BLOCK CRACKING

RAVELING

RUTTING

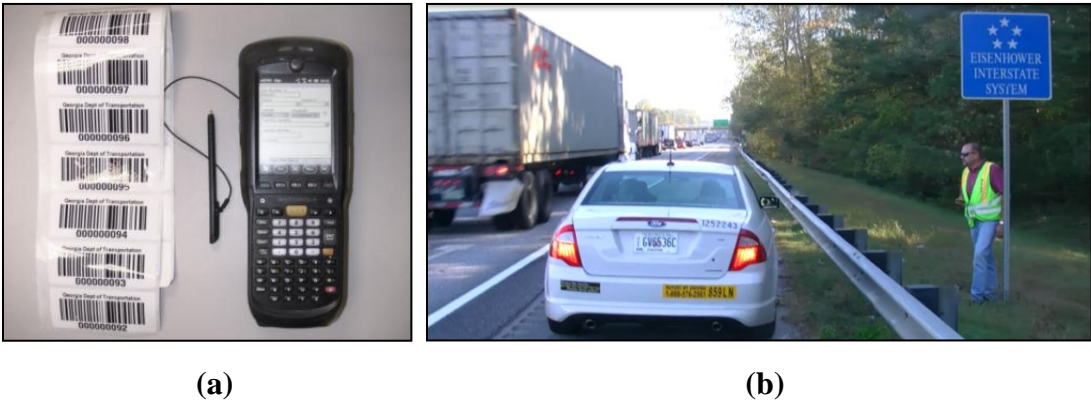
Based on a review of sign inventory literature, the current traffic sign inventory method carried out by state DOTs, including GDOT, is primarily a manual process that includes a field engineer's physically collecting a sign's attribute data in the field. For efficiency, personal digital assistants (PDAs), as shown in FIGURE 5-1 (a), barcode scanners, and GPS devices are used in GDOT's inventory. Some state DOTs also use digital cameras (Rasdorf et al., 2009). FIGURE 5-1 (b) shows the process of traffic sign inventory using a PDA. In many transportation agencies' practices, a manual survey using PDAs provides a means for traffic sign inventory, but the process is time-consuming and unsafe due to two major drawbacks: 1) field engineers are required to approach traffic signs to collect the data. Many traffic signs are close to the roadside, in medians, or overhead, etc., which make getting to them very difficult, time-consuming, and, sometimes, dangerous; 2) the distribution of the traffic signs requires extensive amounts of travel time.

FIGURE 5-1
The PDA used in GDOT and field operation in GDOT

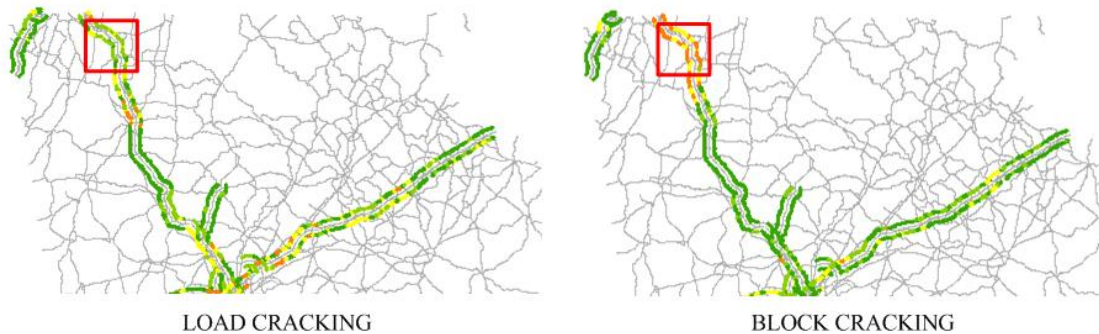
representative section in a one-mile segment, a recorded section is typically selected at the location where safe shoulder parking is possible. FIGURE 5-2 shows a sample segment on I-75 northbound near Tennessee (i.e., Segment #248; the color in the figure indicates the level of difference between the derived result using the proposed method and the results reported in the FY2015 COPACES database). The overall rating reported in the FY2015 COPACES database for this segment is 55, while the derived result using the proposed method for this segment is 82. The primary difference in the deduct value is from the load cracking (14 vs. 0) and block cracking (18 vs. 4).

Sample segment on I-75 NB with different deducts from load cracking and block cracking

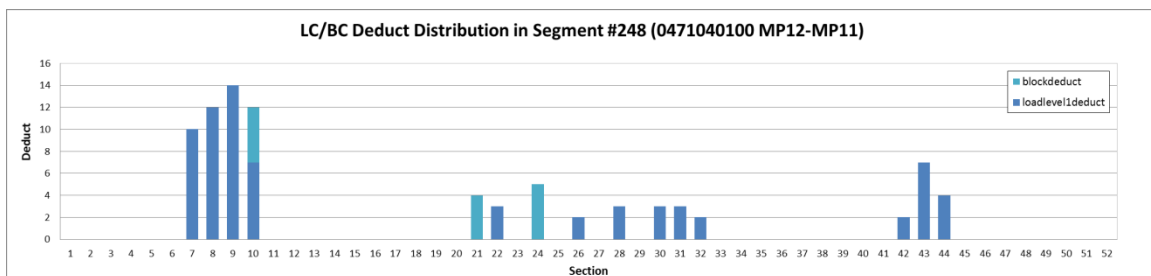
FIGURE 5-3

sections 6-10, while the rest of sections contain fewer load and block cracks.

Coincidentally, sections 6-10 are the same sections for which the field engineers conducted a detailed survey. Hence, the field survey happened to capture the worst sections within the segment instead of the “representative” ones. A further investigation showed that sections 6-10 present a better parking space, while the remainders of the sections present narrower shoulders due to the placement of guardrails and concrete barriers.

Distribution of the load cracking and block cracking in Segment #248

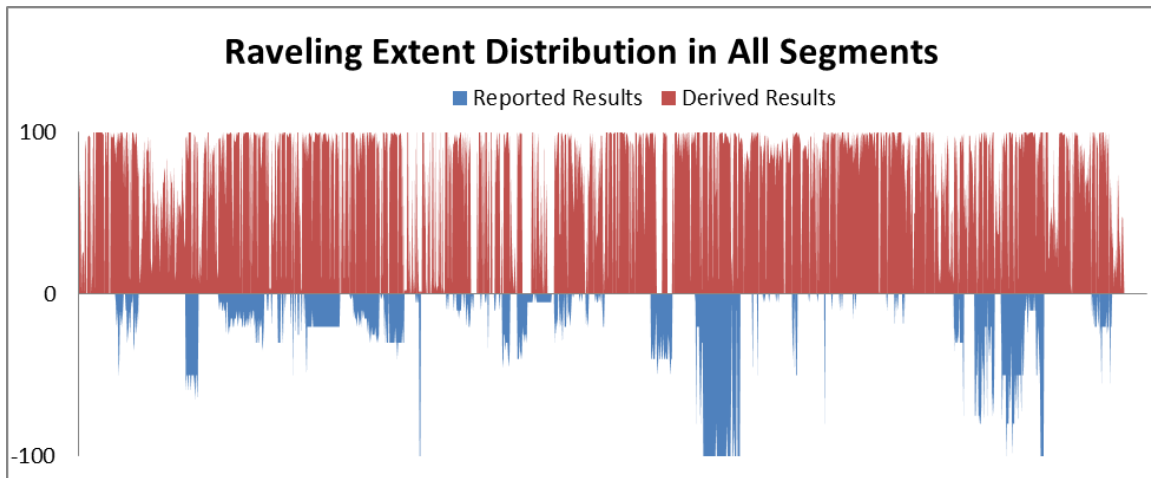
The results derived from the proposed method show a large extent of raveling on the interstate highways in Georgia and a majority of the raveling is at Severity Level 1, as shown in FIGURE 4-5. FIGURE 5-4 shows the extent difference between the reported and derived raveling extents for all the segments. It can be observed that while the derived results capture more segments containing raveling, the derived results report a higher percentage of raveling (i.e., extent).

Raveling extent difference in all of the 1-mile segments covering interstate highways in Georgia

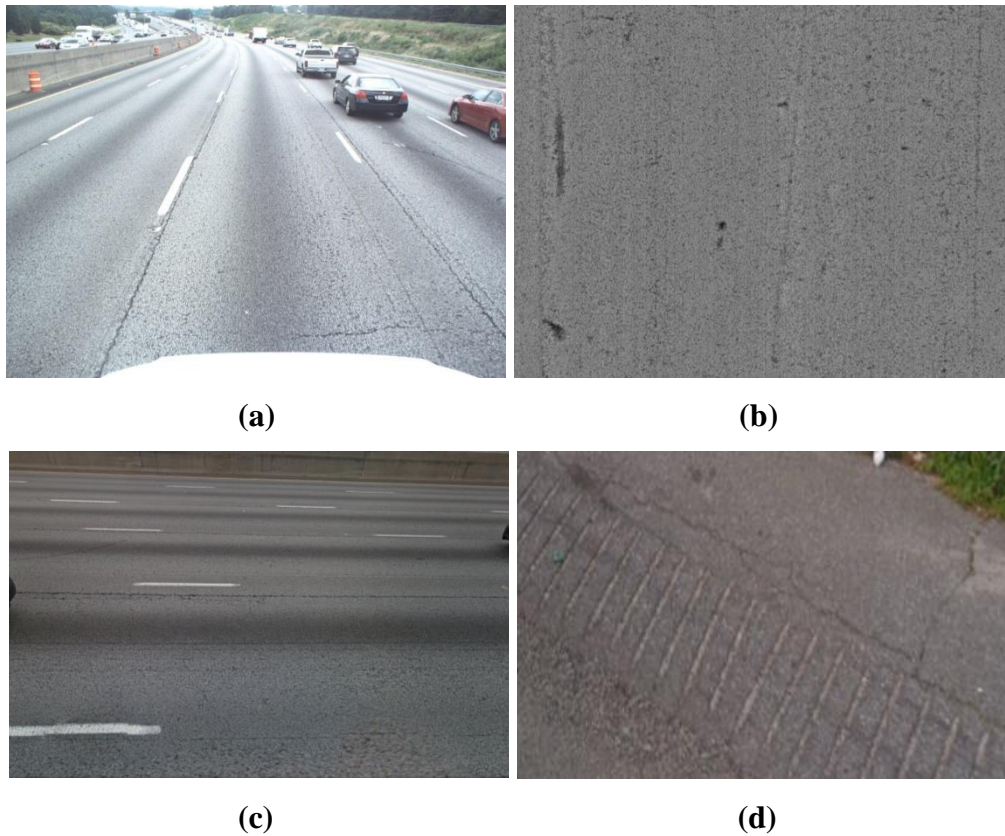
To further investigate whether the derived method over-estimates raveled area or the field survey tends to overlook many of the raveled areas, the research team compared different data sources of the pavement. FIGURE 5-5 shows a sample section collected in Segment #811 on I-75 Southbound. In the results reported in the FY2015 COPACES database, the deduct value for raveling is zero (i.e., no raveling), whereas a deduct value of 13 for raveling was derived using the proposed method (i.e., Severity Level 1 raveling >45%).

FIGURE 5-5(a) shows the front view video log image that is similar to the field engineer's view during the windshield survey; FIGURE 5-5(b) shows the 3D pavement-scanning image; FIGURE 5-5(c) shows the side-view image captured on the shoulder; FIGURE 5-5(d) shows the lost aggregates accumulated in the rumble strip on the shoulder. It can be observed that it is challenging to observe raveling using only the front-view video log image, especially when the raveling is still at the early stage, as shown in this case. However, based on the side-view and the slight aggregate accumulation in the rumble strip, the raveling could be confirmed. Using the developed automated raveling extraction algorithm and the 3D pavement data, the streamlined procedure can capture and reveal the raveling at the early state when only a few aggregates were lost.

FIGURE 5-5
Sample images for Segment #811 on I-75 SB
