**Draft Final Report**

### Rheology Limits for Grout Materials used for Precast Bent Cap Pile Pockets in Hot Weather

Contract Number BDV30 TWO 977-16 FSU Project ID: 037124

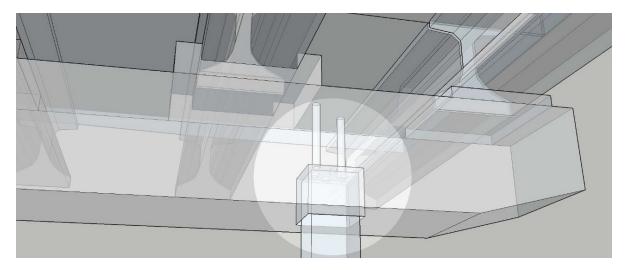
Figure 1.2: 3D model - connection detail

The State Structure Design Office (SSDO) currently develops standard details and specifications<sup>6</sup> for different ABC elements and construction details. The general concept of PBES for a pile-to-bent cap interface may be addressed in different ways, and a grouted pile-pocket inside the bent cap appears to be a promising solution. Figure 1.2 illustrates such a concept for a pile with a square cross section. The lower portion of the bent

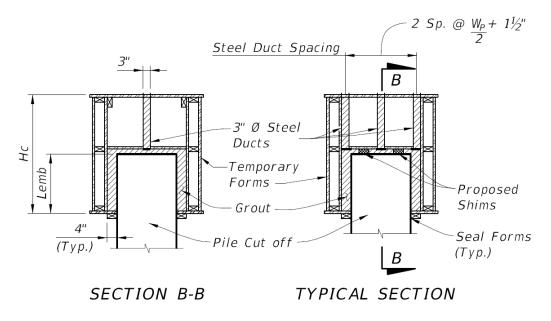
Figure 1.3: Mockup specimen for connection type Level 1 20710 series

Different connection types are currently under development for FDOT implementation. FDOT's proposed Index D20710 series — pile and bent cap with grouted pile pockets — as exemplified in Figure 1.2 is considered one of the most common connection types used for bridge constructions in Florida. Therefore, this research focused on this particular connection and does not discuss other types of connection details. However, most pile/column to bent connections follow a similar concept and the results are expected to be applicable to many of these other systems as well. Figure 1.3 illustrates two (2) sections of FDOT's Index D20710 series, that were obtained from a preliminary (08/03/2016) design, which has not been published by FDOT yet. The

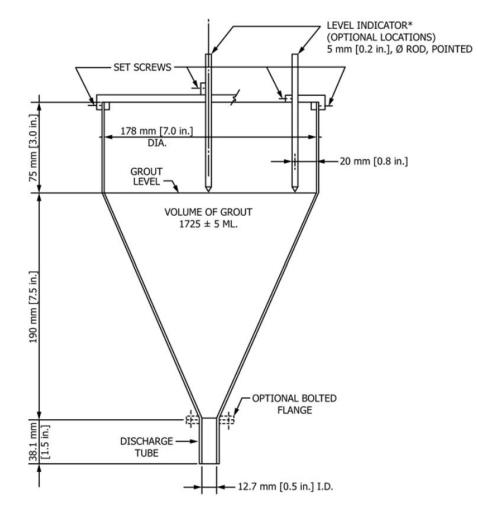
Figure 2.2: Side view flow cone (ASTM-International, 2016b)

The following Figure 2.2 illustrates the flow cone, which is suitable for use in the field or in the laboratory. The cone in the picture is made from cast iron that holds a stainless steel orifice on the bottom. The cone

rods are mounted inside of the cone and 0.8 in. (20 mm) or 3.5 in. (89 mm) from the outside wall. Before filling the cone, it has to be leveled and moistened at all inner surfaces. Then the orifice is closed and the cone can be filled with grout material so that it reaches up to the lower tips of the threaded rods. After a short resting period, the orifice is opened and the time measurement begins. The time measurement is stopped at the moment light passes through the bottom orifice. To guarantee proper equipment conditions, a trial run with water —  $1725\pm5 \text{ mL}$  — is performed before actual grout testing. The equipment is acceptable for ASTM testing, if the water discharges from the cone within 7.8s to 8.2s. Afterwards the actual test procedure is conducted twice for two (2) different grout samples and the efflux time of each test run is recorded (ASTM-International, 2016b).

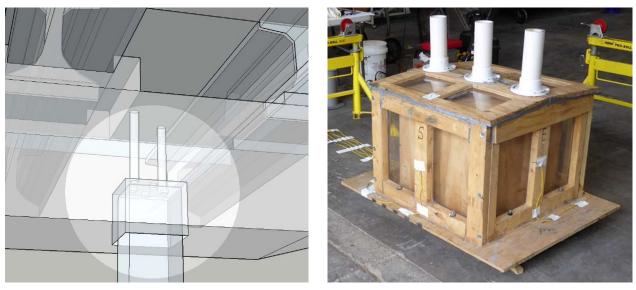
(a) Wire model (of actual connection)

Figure 3.1 compares the on-site bent cap-to-pile head connection to the laboratory formwork that was constructed for each mockup specimen. On the left, Figure 3.1(a) shows a wire model rendering of the actual

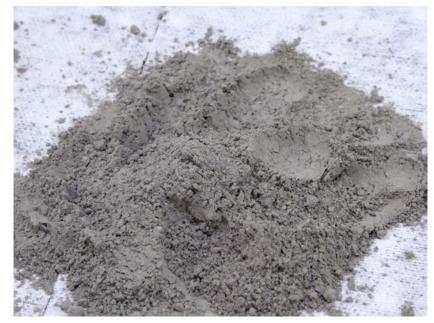
(a) Grout powder bag

(b) Lose grout powder

For this research project, the same dry grout powder that was used on the construction site for the US 90 demonstration project was used, because that material appeared sensitive during the hot weather grouting in Florida. The specific material is produced by BASF and is termed "MasterFlow 928". The material was obtained through Coastal Construction Products in Jacksonville (Florida, USA), and it was delivered in prepacked 55 lbs. (24.9 kg) bags. Figure 3.3 shows a closed grout bag as it was delivered (a) and the actual content of the bag — the dry grout powder (b). Detailed information and precise material proportions of the grout powder are proprietary and therefore unknown — specifics cannot be listed here. However, MasterFlow 928 is known as a hydraulic cement-based grout with mineral aggregates. From the material data sheets and manufacturers specifications, it is know that this specific product is designed for an extended working period during installation, and reduced shrinking during hardening (BASF Corporation Contruction Systems, 2016). According to the manufacturer, the allowable temperatures for the fresh grout material

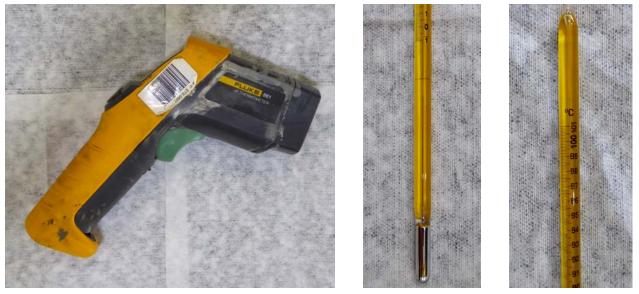
(a) Thermometer Gun

Two (2) different types of thermometers were used throughout the experimental phase of this research. Figure 3.4 illustrates both thermometer types in three (3) different photos. Figure 3.4(a) shows a side view

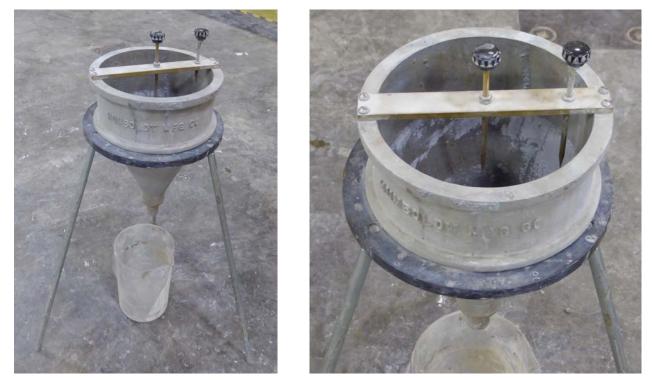
(a) Overview

The procedure idea behind the flow cone method according to ASTM C 939 (ASTM-International, 2016b) is described in the previous chapter. Figure 3.6 shows the equipment, that was used twice — directly after each batch was mixed — to quality control the targeted fresh grout properties. As shown in Figure 3.6(a),

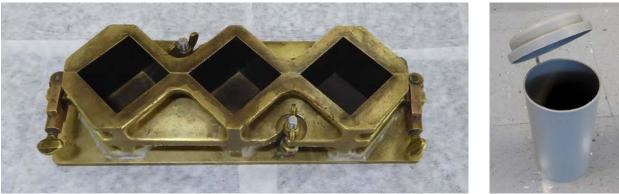
(a) Cube molds

To evaluate the compressive strength of the grout material at different maturity levels, grout subspecimens — cubes and cylinders — were produced. Figure 3.7 shows two (2) different types of molds, that were used for this research. Figure 3.7(a) illustrates the 2 in. (50 mm) cube molds. Each brass mold system (Humboldt

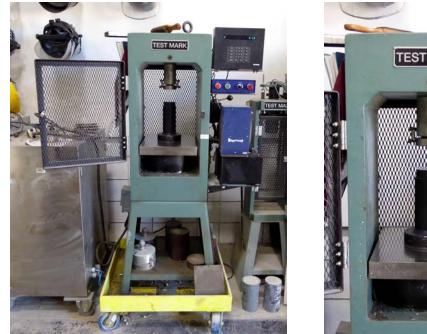
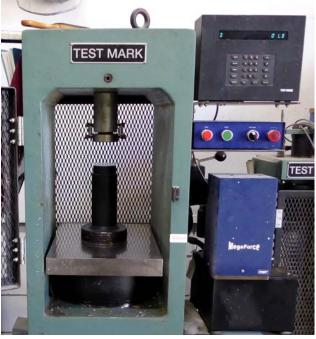
Figure 3.10: Compressive strength test machine

(a) Front view

(b) Detailed view

As explained above in Subsection 3.2.1, the hardened grout material has to reach a minimum strength to be acceptable for FDOT projects. Accordingly the companion subspecimens that were produced throughout this research study had to be tested for compressive strength. Figure 3.10 shows two (2) photos of the machine that was used to test the grout cubes and cylinders — an overview is presented in Figure 3.10(a), while a more detailed view is shown in Figure 3.10(b). The Test Mark load frame and test system was provided by the FDOT Structures Research Center. This machine meets the requirement of ASTM 109 (ASTM-International, 2016d) for grout strength evaluations. Both photos show the set up that was used to test the 2 in. (50 mm) cubes, which required an additional stand — black cylinder — to reach the appropriate distance between the top and bottom compression interface. To test the cylindrical specimens with a 3 in.

(75 mm) diameter and a length of 6.0 in. (150 mm), the black steel cylinder was replaced by a smaller stand. For all tested samples — cubes and cylinders —, the load rate for these compressive strength tests was set up to 300 lbs./s. The machine was thoroughly cleaned after each cube or cylinder test, to prevent stress concentrations at the compression interfaces.

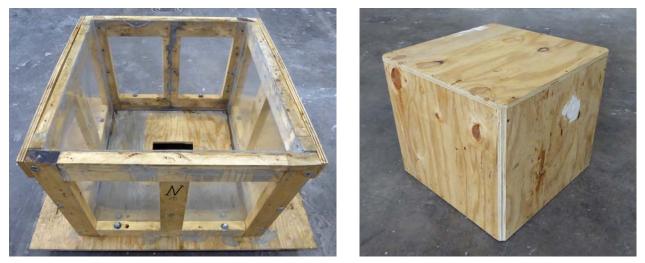
(a) Outer formwork — bent cap pile-pocket

(b) Inner formwork — pile head

First, the formwork for the mockup specimen, that is introduced in Subsection 3.1.1, was built. In total eleven (11) different mockup specimens were produced and tested. The major materials used for the formwork were plywood, solid wood and acrylic glass. Each individual specimen consisted of an outer and an inner formwork to simulate the targeted gap size openings listed in the test matrix. Figure 3.11 separately exemplifies the bent cap pile-pocket model and the pile head model, that ultimately were pieced together to form the mockup specimen. The outer formwork was made from four (4) vertical side walls and one (1) bottom plywood sheet as shown in Figure 3.11(a). Two (2) parallel vertical side walls were as wide as the inner dimensions of the grout body, while the other two (2) parallel side walls as wide as the outer dimensions of the formwork, such that all four (4) elements were structurally sound while meeting the dimensional requirements. The frame

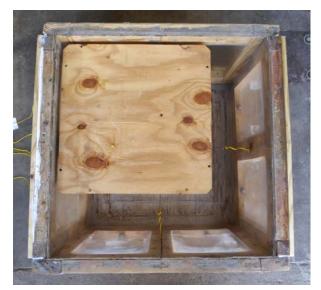
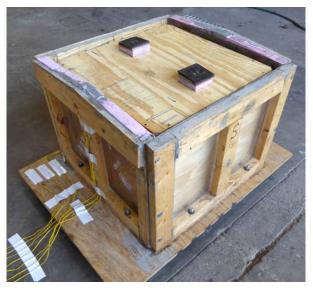
Figure 3.12 illustrates the assembly process and shows how the elements were pieced together. The

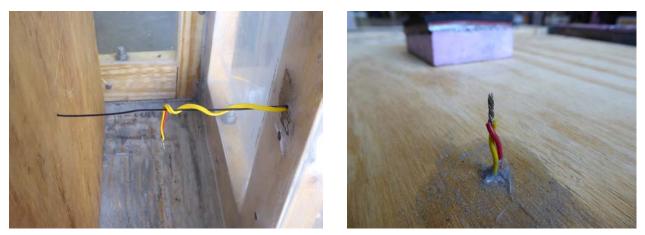
(a) Vertical side volume

After the pile head plywood box was placed inside the pile-pocket and attached to the bottom plywood sheet, the thermocouples were installed. Figure 3.13 illustrates the thermocouple set up for the vertical side volumes as well as for the horizontal top volume. The measuring end of each thermocouple was placed at the center of each grout volume. Figure 3.13(a) shows the location of thermocouple and how it was held in place for the vertical side volume. As seen in the photo, a wire was used to hold the thermocouple in position during the grouting process. Because the thermocouple had to span a shorter distance for the smaller gaps with 0.5 in. (12.5 mm), supporting wires were not used in these vertical side volumes. The

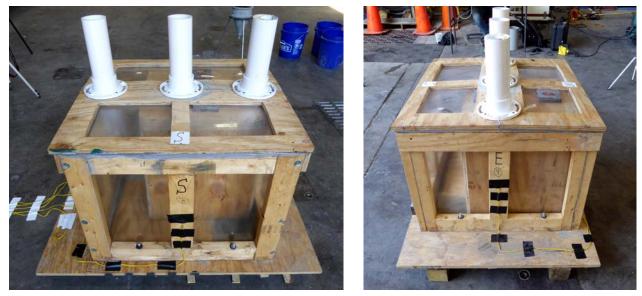
(a) South side

The completely assembled formwork for the mockup specimen is shown in Figure 3.14, to exemplify the entire setup via MU8 through two (2) distinct side views. After the inner formwork and the thermocouples were installed, silicon was applied to the top of the shims to guarantee a proper fit and to prevent grout material from seeping between the shims and the formwork lid. As Figure 3.14(b) shows, the formwork lid (pile-pocket roof) consisted of two (2) individual pieces, that were jointed at the centerline below the fill/ventilation pipes, to accommodate a tapered top volume — for the specimens in Task 2. Both parts were screwed down to the side walls to securely and tightly connect the lid to the outer formwork . For proper ventilation and to facilitate the filling process, three (3) PVC pipes with an diameter of 3 in. (75 mm) were installed along the centerline. Then, the thermocouple wire were carefully routed around the formwork and secured to the formwork via adhesive tape, as it can be seen in Figures 3.14(a) and(b). Finally, all joints were caulked with silicon to avoid leakage and to prevent unnecessary waste of fresh grout.

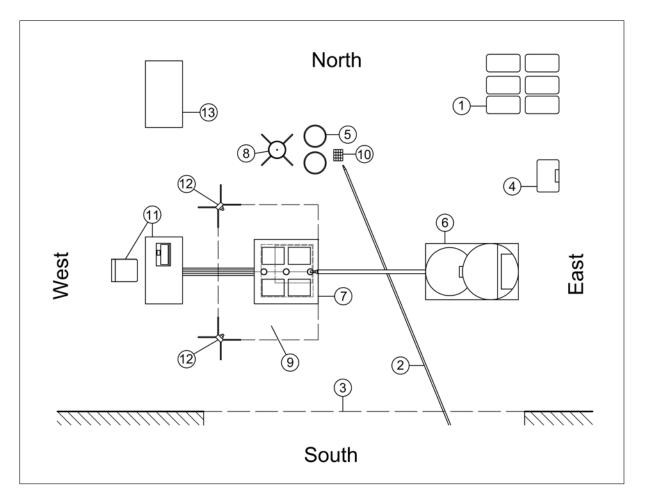
Figure 3.15: Laboratory Setup

After the formwork for an individual mockup specimen was prepared and set up, the laboratory was readied for the grouting process. For consistency purposes, the laboratory was identically arranged and prepared for each mockup specimen. Figure 3.15 illustrates the floor plan for the experimental setup and shows all relevant materials and devices, that were needed throughout the batching, mixing, and filling process. The cardinal directions — in reference to the FDOT Structures Research Center — are shown along the four (4) sides of the figure. The dry grout powder, BASF MasterFlow 928, was stored at the Northeast corner (1). The temperature of the dry grout powder was very important to target the test temperatures of the fresh grout material. Relative to the mixing water, the dry grout powder has much more mass and a higher heat capacity. Depending on the target temperatures of the fresh grout, the grout powder (inside the sealed bags) was preconditioned to to reach uniform temperatures Depending on the time of the year and ambient temperatures in the laboratory, the grout powder was either preheated in an oven, or exposed to the surrounding ambient temperature for more than 24 hours. The required grout powder temperature was experimentally determined via small size batches, which were evaluated for temperature and efflux time via the flow cone. For example, for Task 2 throughout August and September, it was found that the grout powder had to be at 85 °F (29.5 °C) for the fresh grout to reach 85 °F to 90 °F (29.4 °C to 32.2 °C) as it was targeted by test matrix. Sometimes, up to 6 lbs. (2.72 kg) ice had to be substituted for parts of the mixing water to stay within the desired fresh grout temperature range. A hose provide a continuous water source for mixing and equipment cleaning (2). The water-hose was connected to a faucet outside of the laboratory (3),

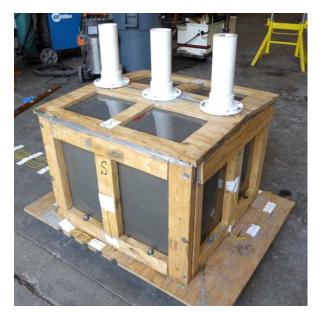
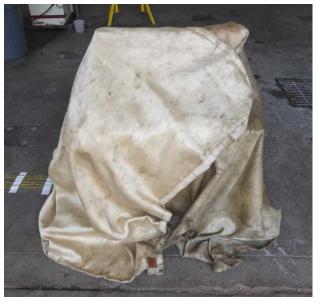
clearly over flowed into the other two (2) PVC pipes. Figure 3.16 shows two photos that were taken directly after the filling process was completed. After the formwork was completely filled as shown in Figure 3.16(a),

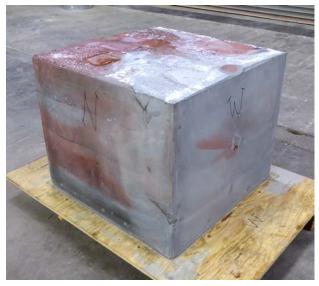
#### Figure 3.18: Mockup specimen 48 h after grouting

(a) MU8 — before demolding

(b) MU8 — after demolding

Figure 3.18 shows mockup specimen MU8 at 48 h after grouting — inside the formwork and after the formwork was removed. Photo (a) demonstrates the specimen with formwork, while part (b) illustrates the specimen after the formwork was completely removed. After the individual pieces of the pile-pocket model were carefully removed, the formwork was thoroughly cleaned for reuse. Afterwards the vertical and horizontal surfaces of the grout body were carefully examined and evaluated for surface air voids and air pockets.

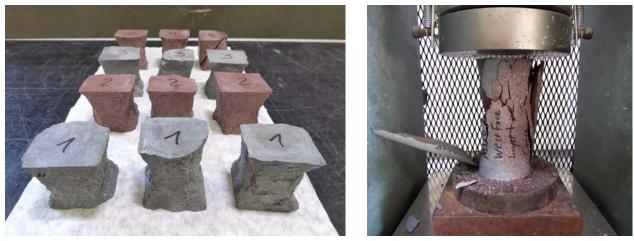
(a) Tested cubes

(b) Tested cores

MU7 and MU8, because these mockup specimens provide a gap size that was large enough to accommodate the cylinder length. In total three (3) cubes per batch were extracted from two (2) different vertical side volumes for MU9 & MU10 and from one (1) vertical side volumen for MU7. Two (2) cores from each batch from two (2) different — perpendicular to each other — vertical side volumes were drilled out of MU7 and MU8. All extracted samples were tested 28 days after grouting was completed. Figure 3.19 illustrates two (2) photos of the compression tested cubes and cores — these particular companion samples were tested for MU8. On the left side, Figure 3.19(a) shows all MU8 cubes that were cast for 28 day compressive

strength testing, after they were taken to failure. Figure 3.19(b) shows an extracted core that failed after it

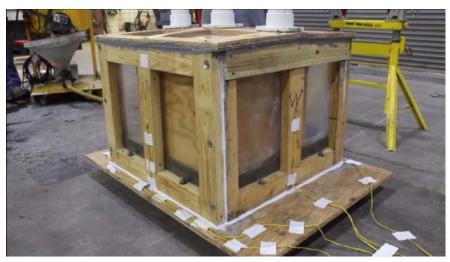
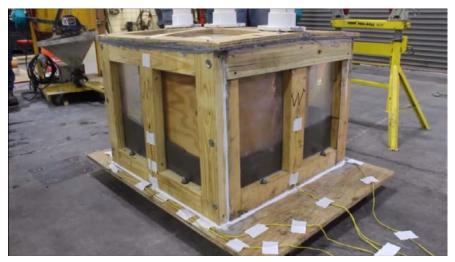
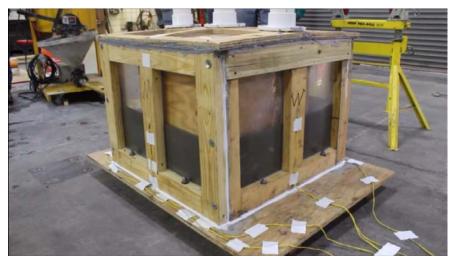
Figure 4.1 illustrates the filling sequence for the vertical side volumes of MU7. Three (3) pictures, that were taken from the same position, are chronologically ordered to illustrate the grout flow inside the formwork at different times. For this particular specimen, two (2) vertical gaps measured 0.5 in. (12.5 mm) at two (2) adjacent sides, the other two (2) adjacent vertical side gaps had a thickness of 7.5 in. (187.5 mm). The presented view shows the corner with the two (2) adjacent 0.5 in. (12.5 mm) thick vertical volumes, which was chosen because this was the minimum thickness throughout Task 2 (MU7 through MU11), and therefore,

(a)  $2\min 37s$  after pumping was initiated (Batch 1)

(b)  $3\min 40s$  after pumping was initiated (Batch 2)

(c)  $4\min 10s$  after pumping was initiated (Batch 2)

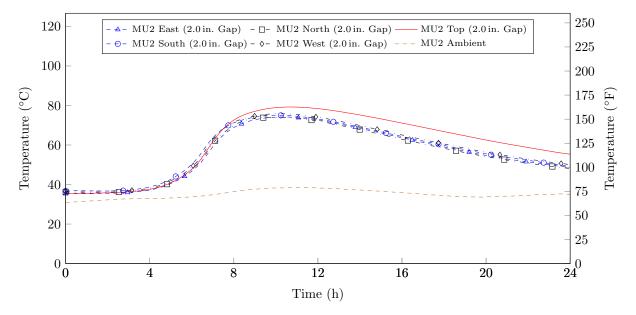
Figure 4.4: Temperature development after mixing grout for MU2

used to model the pile head for specimen MU2. MU1 is not shown here, because the data acquisition system malfunctioned throughout the temperature monitoring phase. However, the following Figure 4.4 graphs the temperature developments for specimen MU2, which measured the same gap size openings as MU1. Furthermore, the temperature trends shown in the figure, are representative for specimens MU2 through MU4.

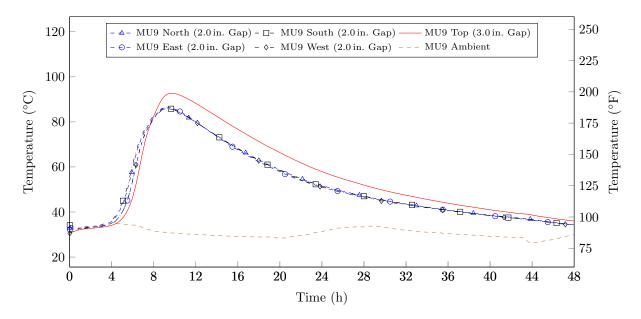
Figure 4.5: Temperature development after mixing grout for MU9

All specimens from Task 2 — MU7 through MU11 — were made from grout with an efflux time from about 48 s and a temperature range between 85 to 90 °F (29 to 32 °C), so that the fresh grout material had the highest temperature and the highest efflux time, which was evaluate in this research project. Figure 4.5 illustrates the temperature development that was recorded for MU9, which was produced with a minimum horizontal (top) gap size of 2.0 in. (50 mm). Due to the tapered surface at the roof of the bent cap the top gap increased to a maximum thickness of 3.0 in. (75 mm). The graph plots time, in hours, on the horizontal axis and the temperatures, in °F and °C, on each vertical axis. The data shows that all four (4) vertical volumes responded identically with the same temperature development due to the hydration heat.

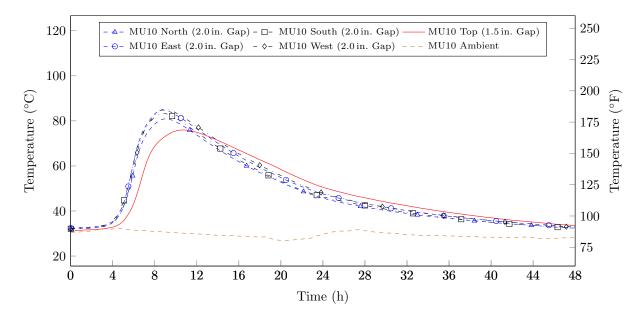
Figure 4.6: Temperature development after mixing grout for MU10

Figure 4.6 illustrates the temperature measurements for MU10 which was geometrically identical to MU9, except for the horizontal volume at the top of the specimen — it was less massive with a maximum thickness of 1.5 in. (37.5 mm). Similar to MU9 (Figure 4.5), all 2 in. (50 mm) vertical volumes responded identically to the hydration process, with a rapid temperature increase between hour four (4) and eight (8), and a cool down period thereafter — relatively fast until the  $24^{th}$  hour, and then less rapidly to eventually reach equilibrium with the ambient temperature after approximately 48 hours. The maximum temperature of the vertical volumes was  $185 \,^{\circ}\text{F}$  ( $85 \,^{\circ}\text{C}$ ) after approximately eight (8) to nine (9) hours. However, compared to MU9 (Figure 4.5), it is clear that the top volume in Figure 4.6 (MU10) did not reach such high temperatures — but instead peaked at  $185 \,^{\circ}\text{F}$  ( $85 \,^{\circ}\text{C}$ ), which remained well below all other temperatures measured for that specimen.

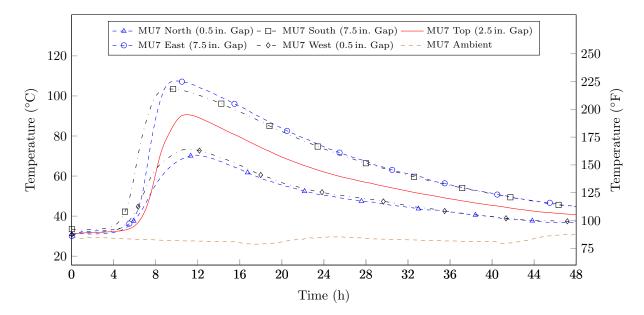
Figure 4.8: Temperature development after mixing grout for MU7

Figure 4.8 plots the temperature data of MU7 on the y-axis against the maturity along the x-axis. For this particular specimen, the top horizontal volume was built with a a minimum vertical gap size of 2.0 in. (50 mm) and a taper of 0.5 in. (12.5 mm) over a length of 14.0 in. (300 mm) — leading to a slope of 3.5%. Consequently, its thickest dimension at the center line (under the ventilation pipes) measured 2.5 in.

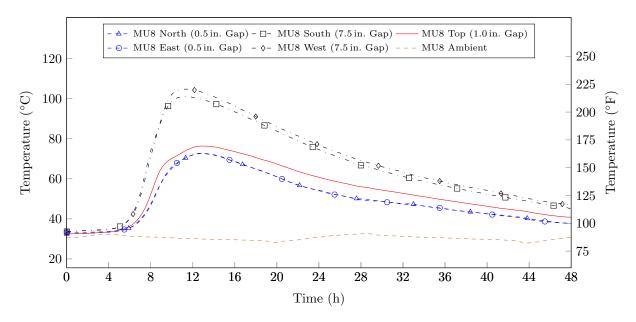
Figure 4.9: Temperature development after mixing grout for MU8

The temperature development plot for MU8 is provided in Figure 4.9. MU8 was built very similarly to MU7, but with a lower minimum gap size of the top volume of 0.5 in. (12.5 mm), such that the maximum thickness of the horizontal grout volume at the centerline under the ventilation pipes measured 1.0 in. (25 mm) instead of 2.5 in. (62.5 mm). The only significant difference between Figures 4.8 and 4.9 are the recorded temperatures for the horizontal top volume. The thinner top volume for MU7 peaked at 170 °F (75 °C), whereas the previously graphed thicker top volume for MU8 measured a maximum temperature of 195 °F (90 °C). Furthermore, the ambient temperatures varied slightly between 75 °F to 85 °F (25 °C to 30 °C) reflecting the differences between night and day temperatures.

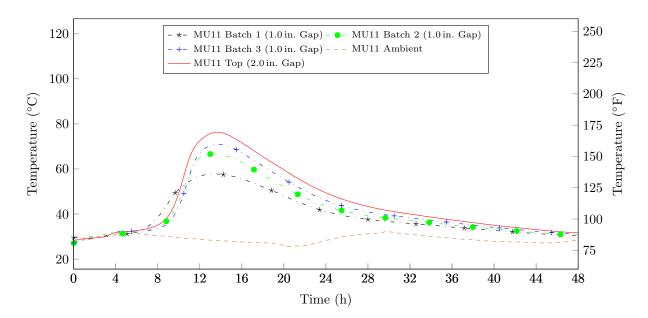
Figure 4.10: Temperature development after mixing grout for MU11

Besides the ambient temperature and the temperature within the top grout volume, Figure 4.10 plots the temperature development for the three (3) different batches that were necessary to fill MU11. Because all four (4) vertical volumes measured an identical gap size opening of 1.0 in. (25 mm), the presented data are the averaged results from two (2) thermocouples at the center of each batch at two adjacent sites (e.g.: North and East side). The top gap measured a maximum thickness of 2.0 in. (50 mm). As seen in Figure 4.10, the first batch reached the lowest maximum temperature of all three (3) batches with approximately 140 °F (60 °C). It was followed by Batch 2, and then by Batch 3 (top batch) with more than 160 °F (70 °C) The highest maximum temperature was measured for the 2.0 in. (50 mm) — most massive — horizontal grout volume. A similar dormant period of seven (7) hours was measured for all batches, but the temperatures rose rapidly thereafter. As Figure 4.10 shows, MU11 batches reached their peak temperature about 14 hours after the first batch was poured. After 48 hours, all grout volumes reached equilibrium with the ambient temperature, which did not change significantly throughout the monitoring period.

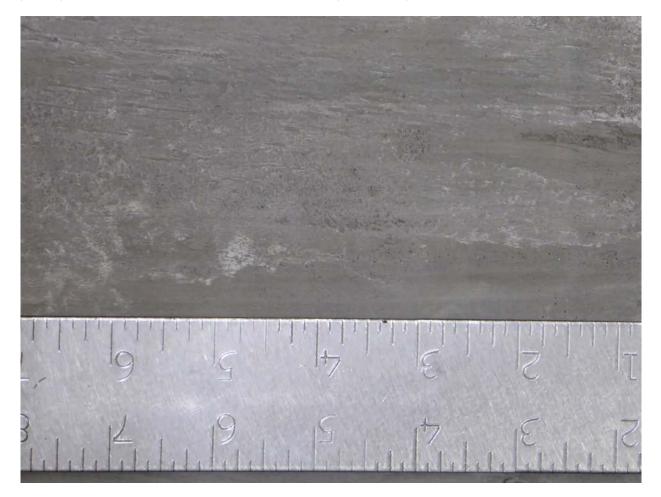
Figure 4.12 shows the inner vertical side surface of MU9, that was produced with a gap size of 2.0 in. (50 mm). The surface appeared very smooth and tight (dense grout), and the grout material was fine enough

Figure 4.12: Inner vertical side surface for MU9 — maximum grout volume thickness of 2.0 in. (50 mm) Gap to mirror the minute surface imperfections of the plywood texture. No significant air voids were visible.

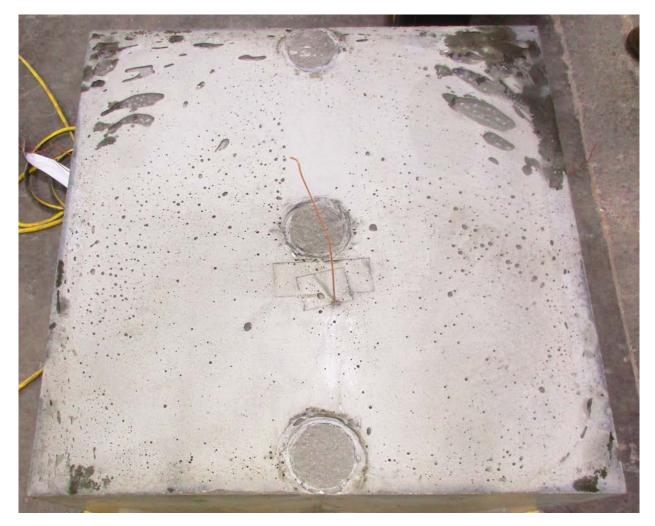
Generally, the top surface of a grouted volume is most susceptible to air voids, because entrapped air that does not vent out during grout placement has a tendency to rise and float to the top surface, if the viscosity of the placed grout is low enough. The following described figures exemplify the properties of the top surface from all mockup specimens from Task 1 - MU1 through MU6 - which were produced with a completely leveled top surface. The following Figure 4.13 is representative for the top surface of the first three (3) mockup specimens (MU1 through MU3). While the photo shows the top surface of specimen MU3, it displays the

Figure 4.13: Top Surface MU3 — representative for specimens with lower water-to-material ratio

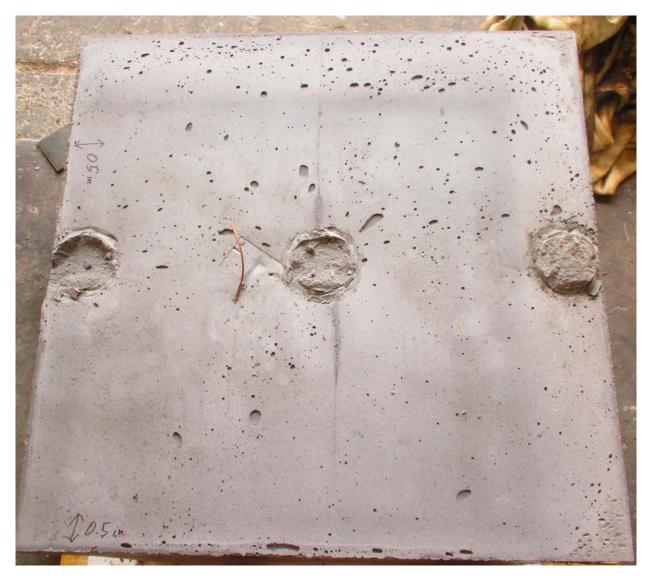
Figure 4.15: Top surface MU6 — representative for specimens with higher water-to-material ratio

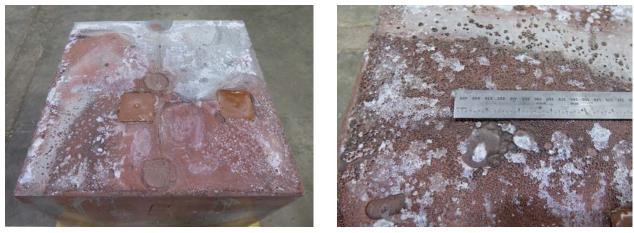
(a) Overview

(b) Detail — Closeup of North West corner

Figure 4.16 presents two (2) different views on the top surface of MU8, which are also representative of MU7 with the same top surface taper. The entire top surfaces is shown on the left in Figure 4.16(a), and Figure 4.16(b) on the right shows a closeup of parts of the surface, which was produced with a 0.5 in. (12.5 mm) taper over a length of 14 in. (350 mm) with a slope of 3.5%. Figure 4.16(b) illustrates little air voids as well as some bigger bubbles up to a diameter of 1.5 in. (37.5 mm). Compared to Figure 4.16(a), it

can be seen that these spots were noticeable throughout the entire horizontal top surface. Both photos show a partially colored mockup specimen. As described in Chapter 3, MU8 was produced to also examine the intermixing of different batches/layer within one mockup specimen. Therefore, the second and fourth batch of MU8 were produced with red color pigments. The findings based on the color tinted batches are discussed in Section 4.4.

The three (3) circular patterns at the centerline of the top surface (shown in Figures 4.16 (a) and 4.17 (a)), were reflective of the ventilation pipes and not a concern for the quality of the connection. Because it was necessary to completely fill the flow space with grout and to overfill the formwork into the ventilation pipes, these patterns occurred for all specimens in Task 2. It was noted that small air voids occurred for all Task 2 specimens within the close vicinity of the ventilation pipes. While these air voids (dark spots) appeared consistently along the ridge, they were considered insignificant because they were very small and traced back

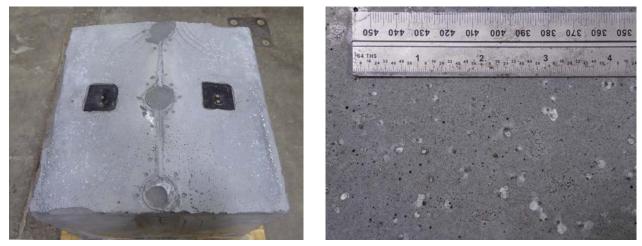
(a) Overview

For comparison, Figure 4.17 illustrates the 1.0 in. (25 mm) surface of MU11. Like the previously shown Figure 4.16, Figure 4.17 offers a complete overview of the top surface (a), and a closeup view of the Northwest corner (b). Figure 4.17 demonstrates findings, that were representative for all mockup specimens with a slope of 7% (MU9 through MU11). More air voids as noticed on the sides could be seen, but in total, the surfaces was very tight and almost non-porous. As seen in the North West corner, numerous 1.0 in. (25 mm) dark

spots appeared on that surface, which was similar to MU9 and MU10. However, overall the surfaces were very smooth with insignificant air voids. Compared to the previous Figure 4.16, and therefore compared to a lesser slope for the top surfaces, there are significantly less air voids.

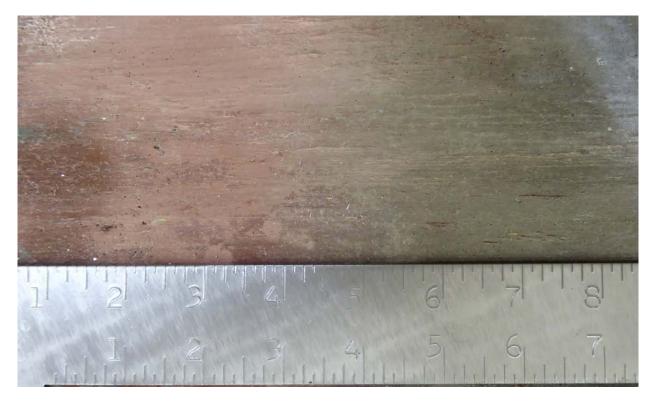
For quality control at the interface at the top of the pile head, the grout was dismantled and visually inspected. Figure 4.18 shows the bottom surface of the horizontal grout volume of MU11, which was produced with a minimum top gab size of 1.0 in. (25 mm) and a taper of 1.0 in. (25 mm) over 14 in. (350 mm) length. The surface appeared well consolidated with virtually no air voids. No significant differences between the

Figure 4.18: Inner top surface for MU11 — maximum grout volume thickness of 1.0 in. (50 mm)

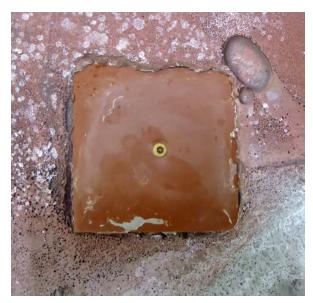
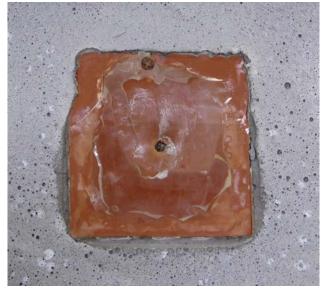
As explained previously, all Task 2 specimens were produced with two (2) shims with dimensions of 4.0 by 4.0 in. (100 by 100 mm) in each top volume. Figure 4.19 shows the grout surface conditions around the rubber shims 48 hours after grouting. Figure 4.19 (a) illustrates the shim detail for MU8 (0.5 in. (12.5 mm)) taper with a slope of 3.5%, while Figure 4.19 (b) shows the area around the shim for MU9 (1.0 in. (50 mm)) taper with a slope of 7.0%. The surface of MU8 (a) showed light air void accumulation around the entire shim and besides such small air bubbles, isolated air voids with a diameter of up to 2.0 in. (50 mm) occurred, as seen on the right above the shim. In contrast, these larger air voids did not appear for MU9 in Figure 4.19 (b). The air void size was no larger than 1/8 in. (3.0 mm), and the voids were evenly distributed around the shim.

(a) Shim in specimen MU8 — 0.5 in. (12.5 mm) Taper

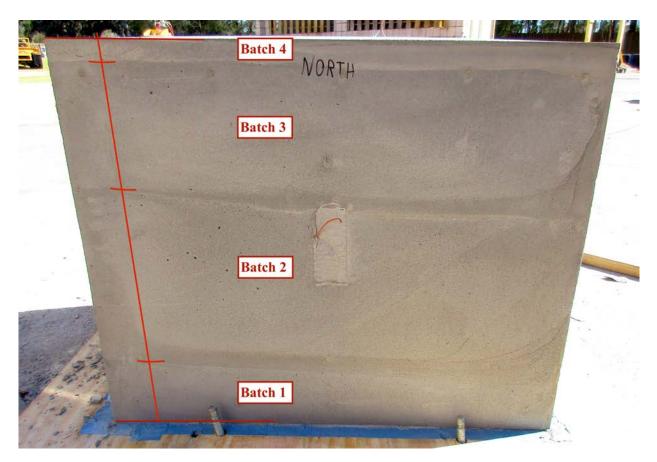
Figure 4.20: Outer side surface MU1 - 2.0 in. (50 mm) gap

Figure 4.20 shows the vertical surface of one (1) randomly chosen specimens — MU1 — that was representative for all other specimens. According to the discolorations as shown on this vertical side volume with a gap thickness of 2.0 in. (50 mm), the four (4) different layers — marked in the picture — seem to be visible. If the this layering effect is truly noticed, the batches are critical isolated from each other. The imprint at the center of the surface resulted from the thermocouple installation and is of no further interest for the research.

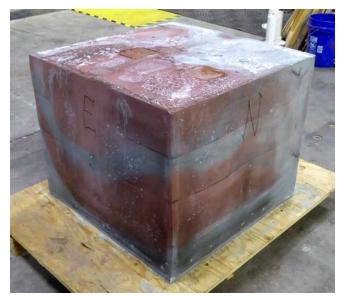
Figure 4.21: MU8 with color coded layers

(a) Isometric view on Northeast surfaces

(b) Cylindrical cored from horizontal volume (West face) after compression failure

to MU8 and the blending of different grout batches/layers. This particular specimen, MU8, was made from four (4) consecutive grout batches. While the colored grout material in Figure 4.21(a) can be assigned to an individual batch, it can clearly be seen that the pumped material mixed very well with the placed material, such that no horizontal layering occurred. Instead, the materials mixed so well that random color patterns developed and that transition zones with various red-gray shades appeared.

To gain further insight about the properties of the inner volume of the grout, horizontal cores were taken from those mockup specimens, that provided enough sidewall thickness for 6 in. (152.4 mm) long cylinders. A minimum of two cores per batch were extracted from MU7 and MU8, each with a diameter of 3 in. (75 mm)and a length of 7.5 in. (187.5 mm). The failed cylinder from MU8 in Figure 4.21(b), demonstrates that the transition zone between consecutive grout layers appeared randomized throughout the third dimension (length of cylinder = thickness of grout volume) as well, and therefore, that the material did not transition — between placed and flowing grout — at the same elevation. Furthermore, randomized little colored spots were found in some cylindrical cores, as seen on the right side of the core shown in Figure 4.21 (b)

After the cores were taken from the mockup specimens, they were tested for compressive strength. Strength results are detailed in Subsection 4.5.3. However, it is noted here that the tested cores did not

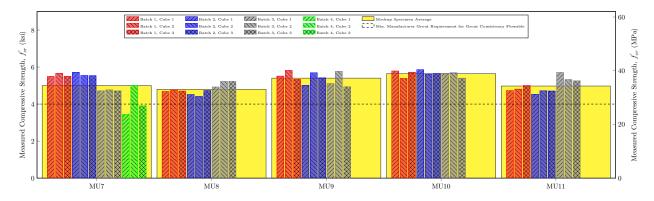
Figure 4.22 presents the compressive strength for all specimens and batches at one (1) day of curing. The Graph shows individual bars, that represent the (individual) cube strength. Moreover, batches are

Figure 4.22: Cast cube compressive strength after one (1) day — Task 2

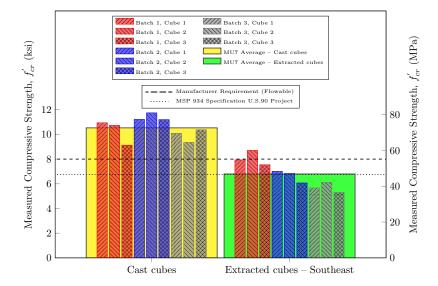
The bar graph in Figure 4.28 illustrates the strength measurements for MU7. The cubes extracted from

Figure 4.28: Compared Cube Compressive Strength for MU7 after 28 days

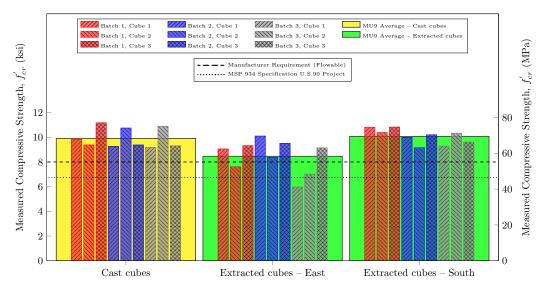
The 28-day compressive strengths for MU9 are illustrated in Figure 4.29. Because two (2) vertical volumes

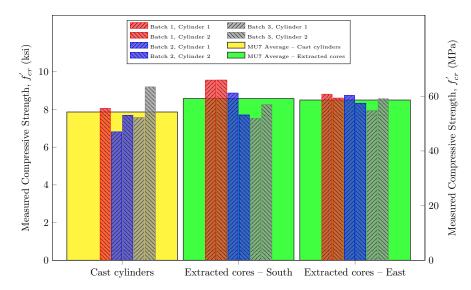
The cast and extracted cylindrical specimens for MU7 are visualized in Figure 4.31. The bar graphs show
