Guidelines for Replacement of Deficient Bridges with Low-Water Stream Crossings in the Rural Midwest

A Transportation Pooled Fund Study - TPF-5(318)

Final Report

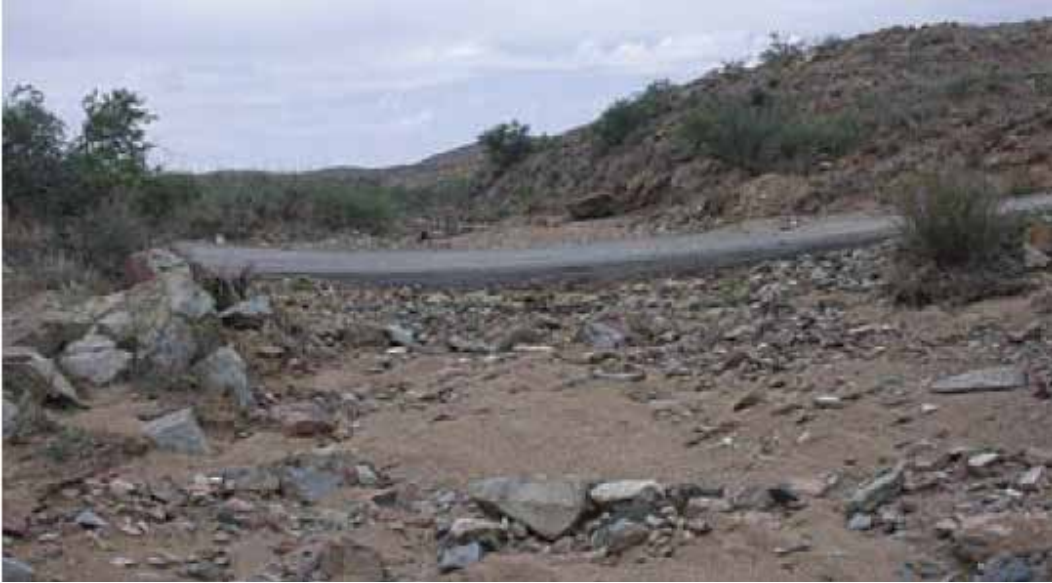
Figure 1.2: Unvented Ford on an Ephemeral Tributary of the Agua Fria River in Arizona
Source: Clarkin et al. (2006)

Unvented fords are structures constructed at or just above the streambed level where all streamflow passes over the roadway. The ford and the approach sections are typically constructed of reinforced concrete. Cut-off walls of reinforced concrete or sheet pile may be needed to prevent the stream undermining of the roadway slab. Unvented fords work best on ephemeral streams with small drainage areas, low banks, and beds of rock or cobble.

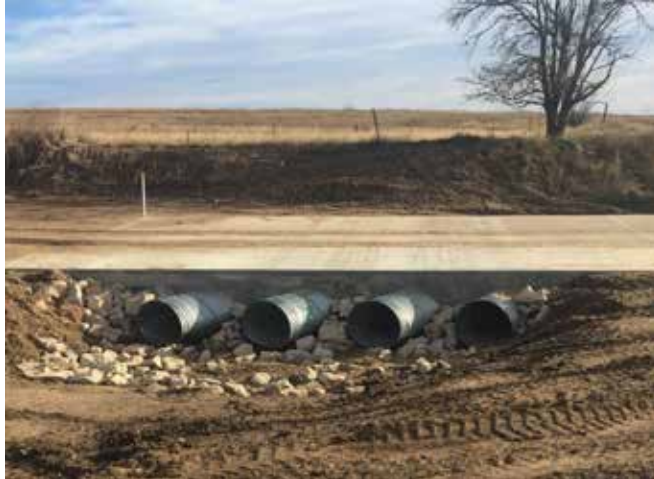
Figure 1.3: Vented Ford in Kiowa County, Kansas

A vented ford is a ford with one or more conduits beneath the roadway to convey very low flows. The vents are typically circular, elliptical, arch-shaped, or rectangular conduits made of concrete, corrugated metal, or high-density polyethylene (HDPE). Vented fords tend to trap woody debris and can require frequent maintenance. Vented fords can also restrict aquatic organism passage. Installing the flowlines of the vents below the streambed and using larger vents may mitigate this impact to some extent. Federal environmental regulations have made it difficult to obtain permits for vented fords in some locations, particularly where threatened or endangered aquatic species may be present. The ford and the approach sections are typically constructed of reinforced concrete. A low roadway profile is preferred to minimize backwater effects and reduce debris accumulation. Vented fords work best on ephemeral or intermittent streams with small drainage areas and low banks.

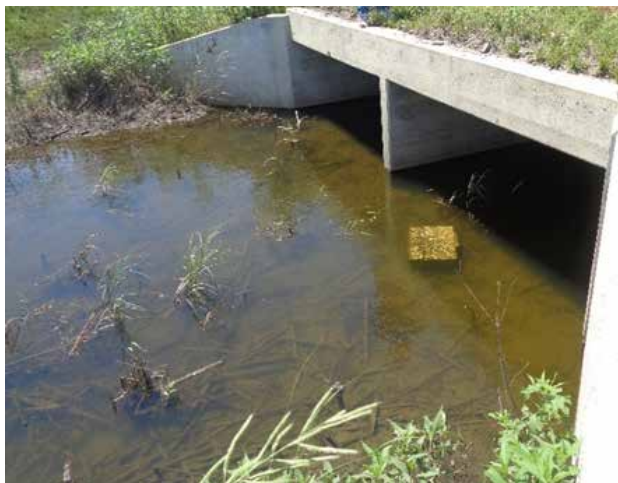
Figure 1.4: Low-Profile Box Culvert in Shawnee County, Kansas

A low-profile box culvert is overtopped much more often than a culvert designed for higher volume roads or critical routes. The roadway surface is typically no higher than the channel banks. Headwalls and wingwalls retain the embankment and roadway, toe walls protect the structure from undermining, and rock riprap protects the embankment from erosion. The floor of the culvert should be placed below the stream bed to facilitate aquatic organism passage. Culverts with total clear spans over 20 feet are classified as bridges and are subject to federal bridge inspection requirements.

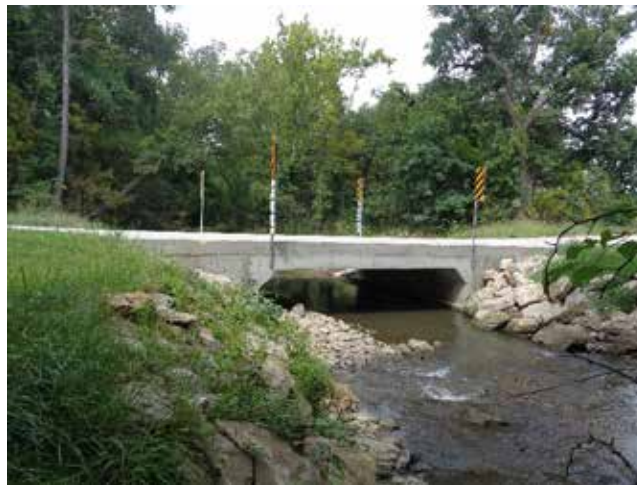
Figure 1.5: Low-Profile Bottomless Culvert in Johnson County, Kansas

Bottomless culverts can be three-sided box culverts or semi-circular, semi-elliptical, or arch-shaped structures of reinforced concrete or corrugated metal. A variety of precast concrete and prefabricated metal structures are available. Bottomless culverts are better for aquatic organism passage than non-embedded pipes or box culverts. From a hydraulic standpoint, a bottomless culvert is no different than a culvert with an embedded bottom. However, a bottomless culvert may have less structural strength than an enclosed conduit and is more susceptible to undermining by scour. Consequently, a bottomless culvert requires a more substantial foundation. The type and cost of the foundation depends on subsurface conditions. A geotechnical investigation is needed to determine the appropriate type of foundation. If a firm rock layer is present at a shallow depth, the structure can be supported on spread footings keyed into rock; otherwise, a deeper pile foundation might be needed.

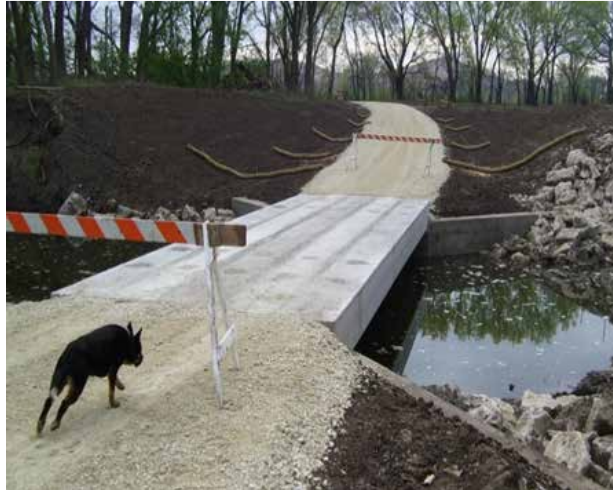
Figure 1.6: Low-Profile Open-Span Bridge in Geary County, Kansas

A low-profile bridge is a stream-spanning structure designed to be overtopped much more often than a standard bridge. The roadway surface is typically lower than the tops of the channel banks. Because guardrails can trap floating debris, low-profile bridges typically have no guardrails. The foundation requirements for a low-profile bridge are the same as for a standard bridge. The abutments must be protected against scour and erosion from frequent pressure flow

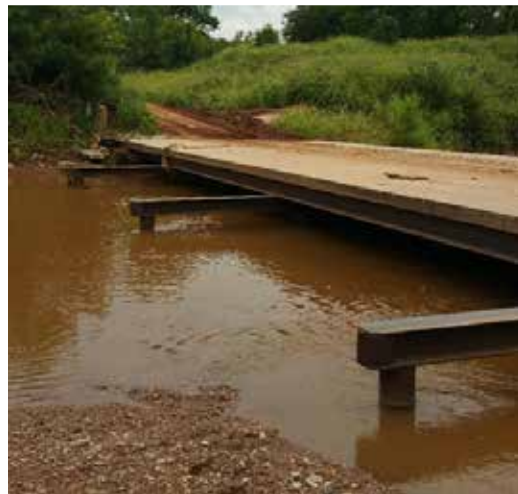
Figure 1.7: Low-Profile Open-Span Bridge in Sumner County, Kansas

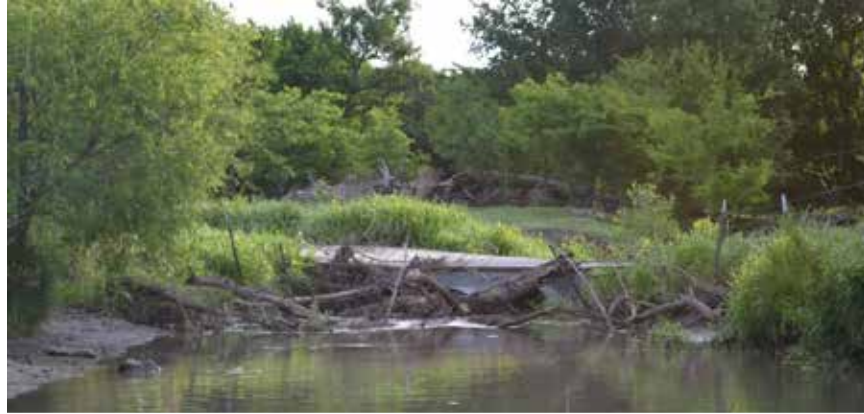
Figure 2.1: Woody Debris Trapped on Upstream Side of Vented Ford in Phillips County, Kansas

The amount of woody debris or crop residue that a stream carries at high flow is also an important consideration. Unvented fords and low-water box culverts, bottomless culverts, and bridges may trap floating debris. The accumulation of debris starts at the water-surface level and grows downward toward the streambed. Trapped debris obstructs the waterway beneath the roadway, and increases the depth and duration of flow over the roadway. Vented fords and very low-profile structures are not recommended on streams that carry debris loads at high flows due to the high cost of frequent debris removal. The presence of a heavily wooded riparian area upstream of the crossing may indicate a potential debris issue, particularly if the channel is laterally unstable. Figures 2.1 and 2.2 show examples of woody debris accumulation at the upstream face of a vented ford and a low-water bridge.

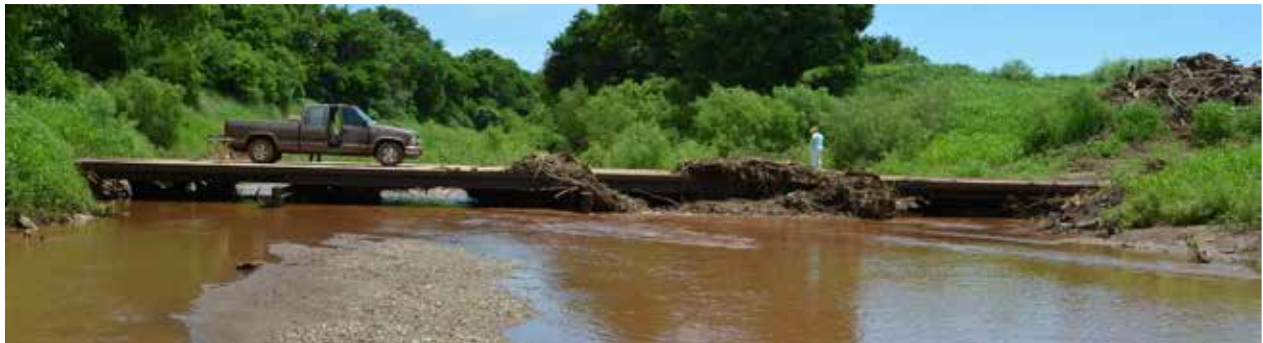
Figure 2.2: Woody Debris Trapped on Upstream Side of Low-Water Bridge in Sumner County, Kansas

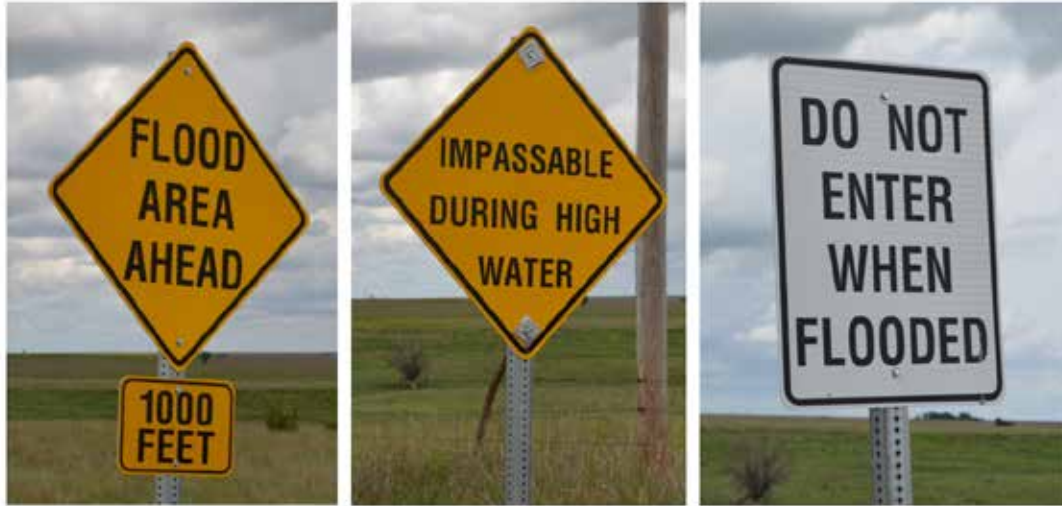
Figure 4.1: Examples of Recommended Signage for Low-Water Crossings

Low-water crossings require appropriate signage to alert drivers to the possibility of a flooded roadway. The *Manual on Uniform Traffic Control Devices for Streets and Highways* (FHWA, 2012) does not specify standard signage for low-water crossings. The *Handbook of Traffic Control Practices for Low Volume Rural Roads* (Russell, Mulinazzi, & Kornala, 2005) recommends as many as three signs on each side of the crossing. Figure 4.1 shows examples of the recommended signage. The *Handbook* provides general guidelines for locating the signs. The distances from the crossing to the signs should be adjusted for local conditions based on engineering judgment. The first sign should be placed ahead of the last detour opportunity before the crossing.

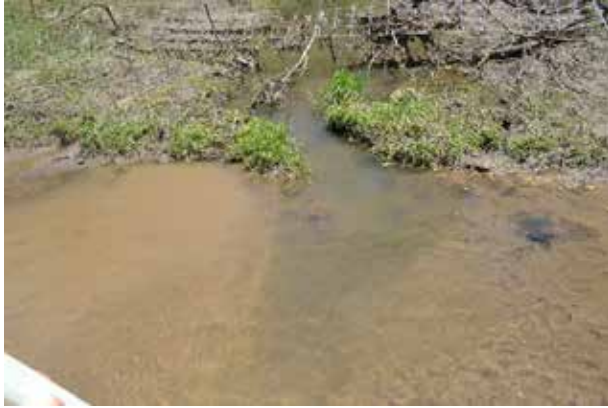
Figure 5.5: Low-Flow Channel on the Upstream Side of the Ford

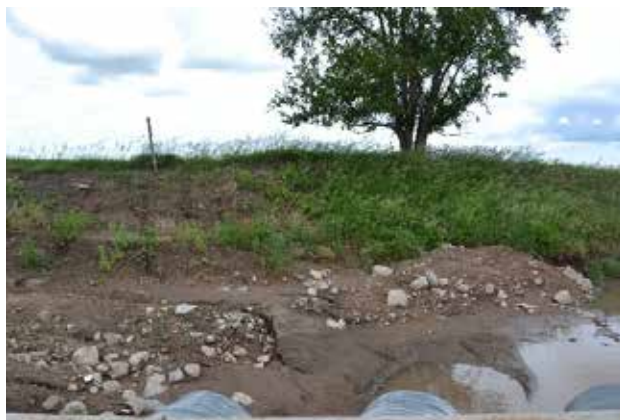
Figure 5.23: Washed-Away Aggregate Stabilization on Downstream Left Bank

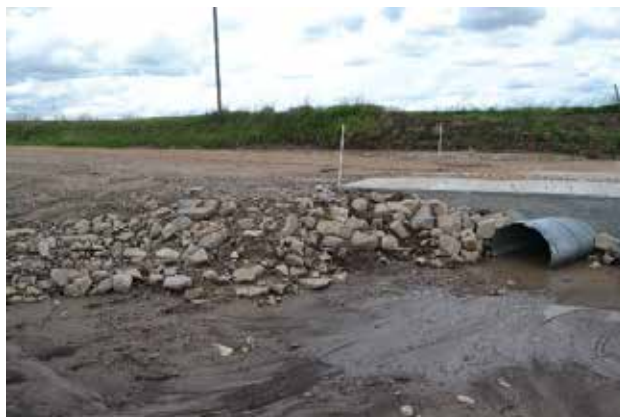
Figure 5.24: Bank Stabilization and Silt Accumulation on Downstream Side of Structure

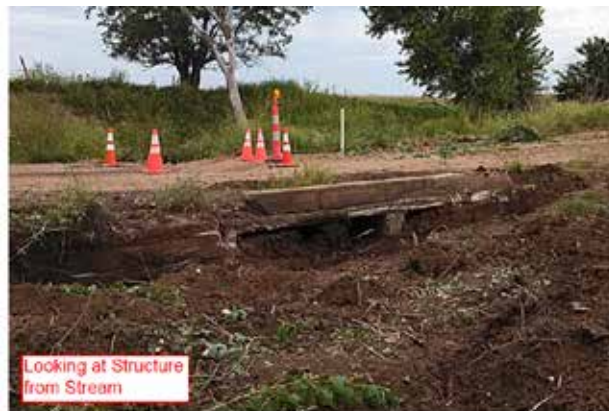
Figure 5.25: Old Structure Filled with Sediment

The previous structure was a two-cell reinforced-concrete box culvert with a total span of 22 feet and a rise of 8 feet. As Figures 5.25 and 5.26 show, the old culvert was almost entirely filled with soil due to channel aggradation and its deck was collapsed.

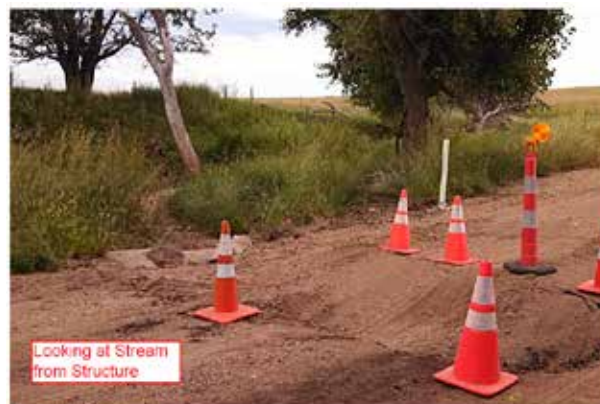
Figure 5.26: Partially Collapsed Culvert Deck

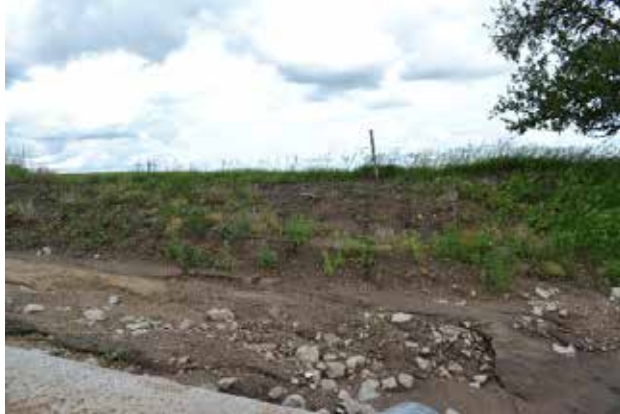
Figure 5.27: Sediment Deposited on Top of Rock Riprap on Downstream Side of Structure

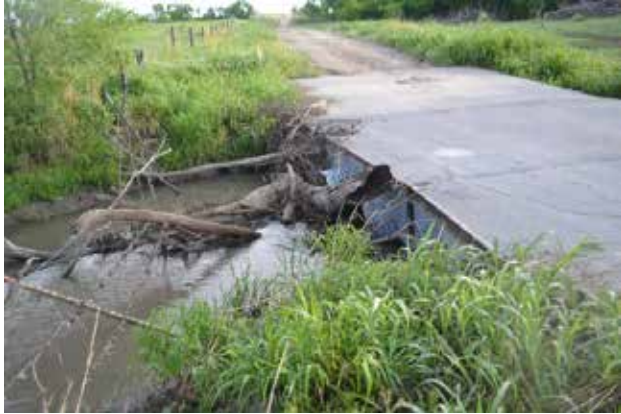
Figure 5.33: Timber Build-Up on the Upstream Face of Structure

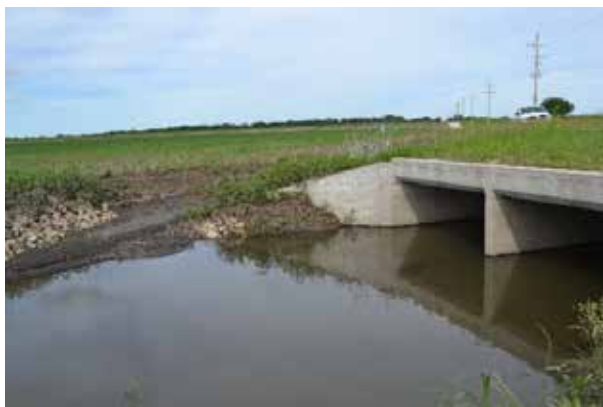
Figure 5.44: Upstream Wingwall with Riprap Stabilization Covered in Silt

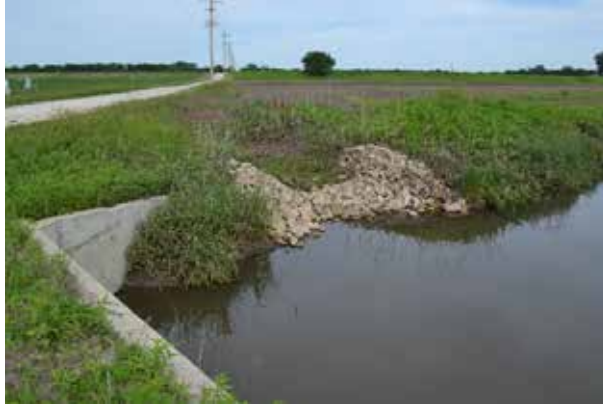
Figure 5.45: Downstream Wingwall with Riprap Stabilization

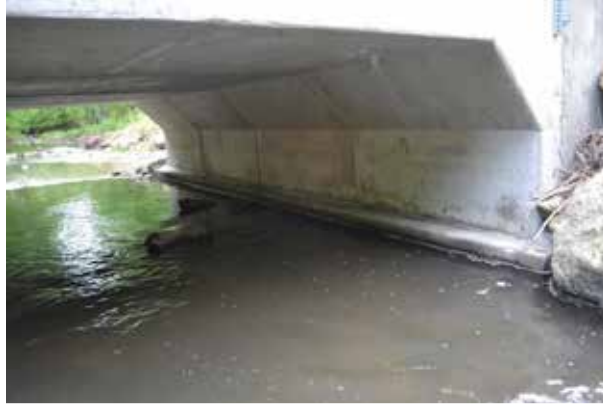
Figure 5.53: East Abutment from Downstream Side, Showing Exposure of Stem Wall

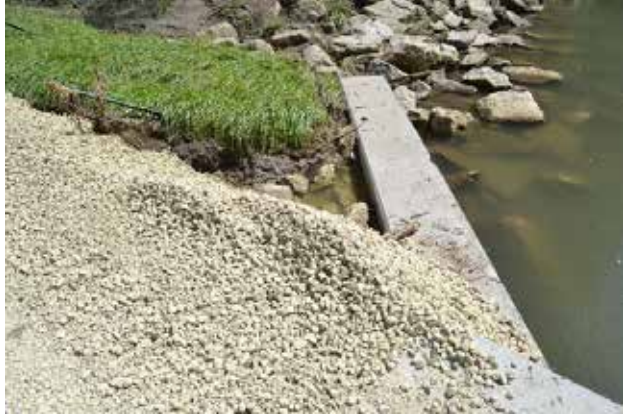
Figure 5.79: Scouring Behind the Upstream Right-Bank Wing Wall
