Report No. UT-12.18

I-15 RECONSTRUCTION LONG-TERM EMBANKMENT MONITORING STUDY – FINAL REPORT

Utah Department of Transportation
Research Division

University of Utah
Civil and Environmental Engineering Dept.

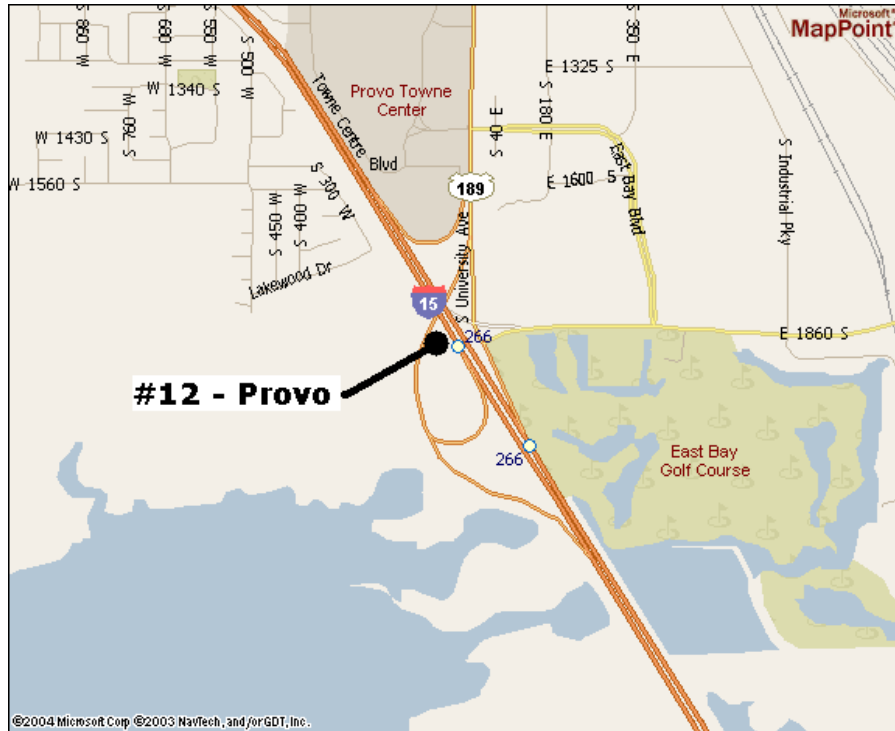
Figure 2-4. Provo instrumentation array.

Technology Type	Array Name	Array No.
Lime Cement Columns	LCC	#1 (Fig. 2-2)
MSE Walls	2 nd South	#2 (Fig. 2-1)
	35 th South	#3 (Fig. 2-3)
Geofoam	1 st South	#4 (Fig. 2-1)
	SS-07	#5 (Fig. 2-2)
	SS-05	#6 (Fig. 2-2)
	33 rd South	#7 (Fig. 2-3)
Large Earthen Embankments	4 th South	#8 (Fig. 2-1)
	9 th West	#9 (Fig. 2-2)
	I-15 Mainline	#10 (Fig. 2-2)
	I-15 Merger	#11 (Fig. 2-2)
	Provo	#12 (Fig. 2-4)

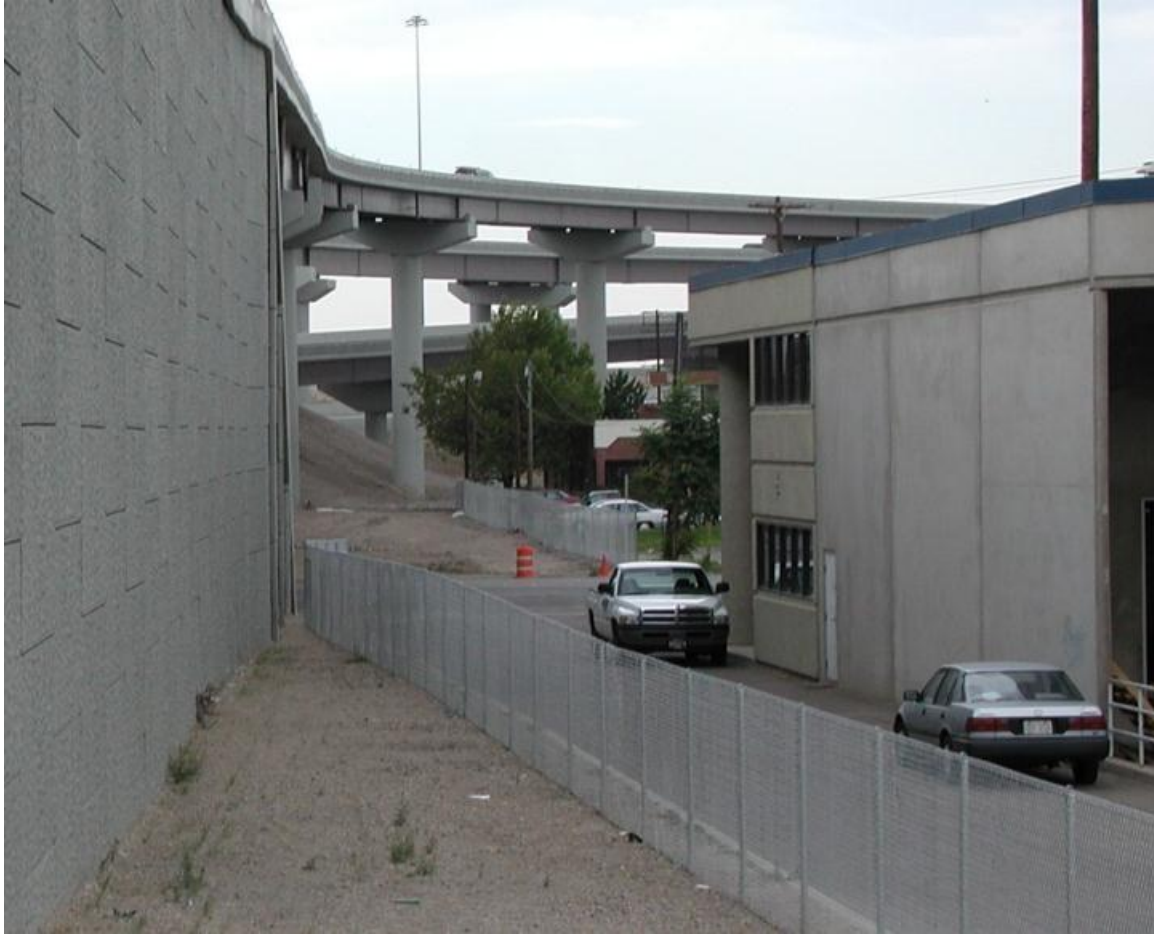
Figure 4-1. LCC stabilized foundation site and adjacent building.

The single lime cement column site on the reconstruction project was selected for soil stabilization primarily because of the wall proximity to an adjacent commercial building (See Figure 4-1). At its closest point, the adjacent building is located about 26 ft (8 m) from the wall face and 20 ft (6 m) from the edge of the lime cement column treated zone.

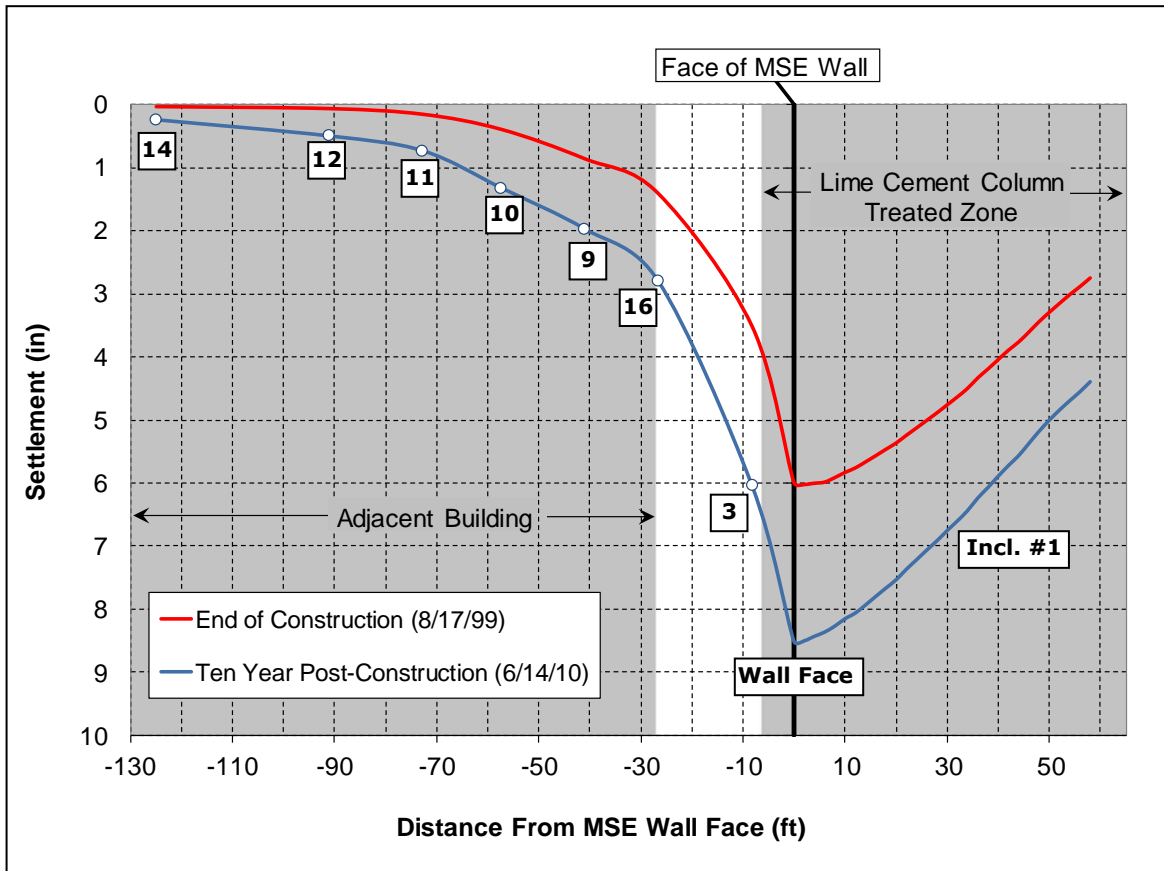
Figure 4-3. Construction and post-construction settlement profile for the lime cement column area.

Figure 4-3 shows the interpreted end-of-construction and ten year post-construction settlement profiles measured at the LCC Array using the settlement points placed around the building and the horizontal inclinometers that extended into the wall. Although the settlement points used in this figure were not located along a straight line perpendicular to the wall, this profile has been obtained by plotting the settlement for each point with the corresponding perpendicular distance to the wall face. Each point has been labeled and the corresponding location can be seen in Figure 4-2. The resultant profile is a

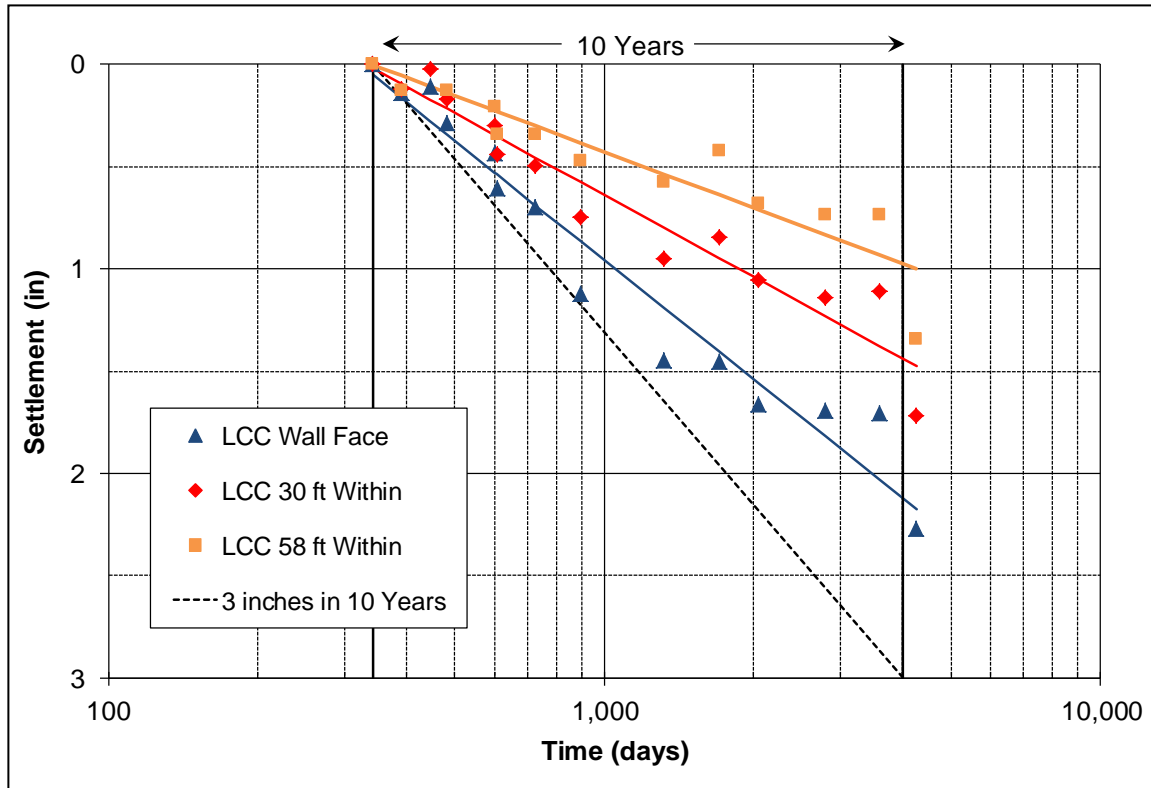
Figure 4-4. Rate of post-construction foundation creep for lime cement columns.

Figure 4-4 presents a summary of post construction settlements measured at the lime cement column site. To ensure that the rates are shown appropriately, the creep settlement plots are shown with the settlement plotted against the elapsed time (in days)

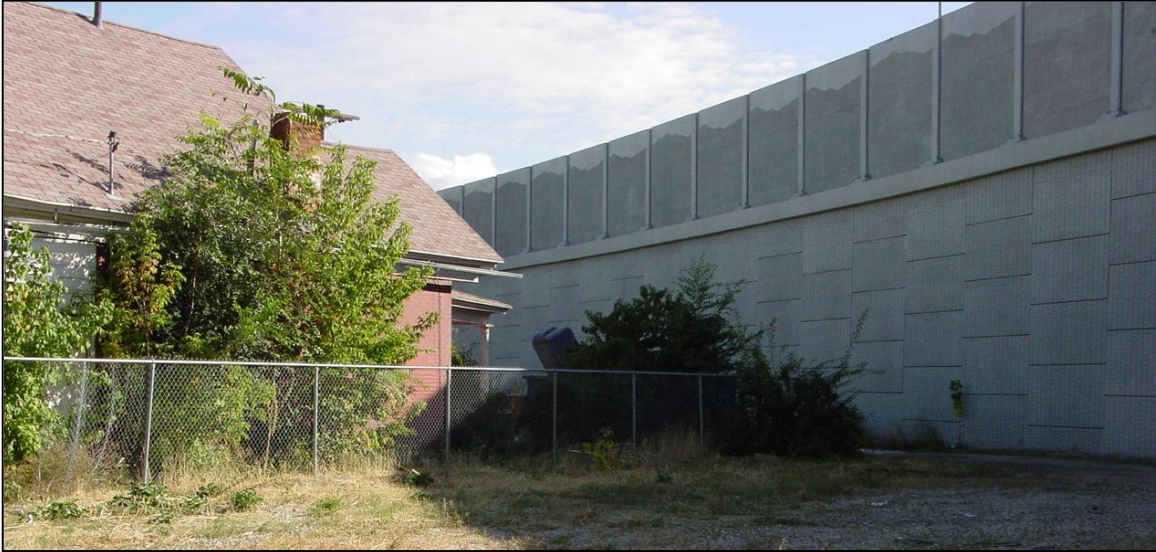
Figure 4-5. Proximity of residential structure adjacent to the 200 South MSE wall.

South Street location a 26 ft (8-m) high wall and embankment was constructed and surcharged with an additional 13 ft (4 m) of temporary fill. PV drains were installed at this location at 4.9 ft (1.5-m) triangular spacing to a depth of 82 ft (25 m), to expedite primary consolidation settlement. Figure 4-5 shows the proximity of a residential structure adjacent to the 200 South MSE wall.

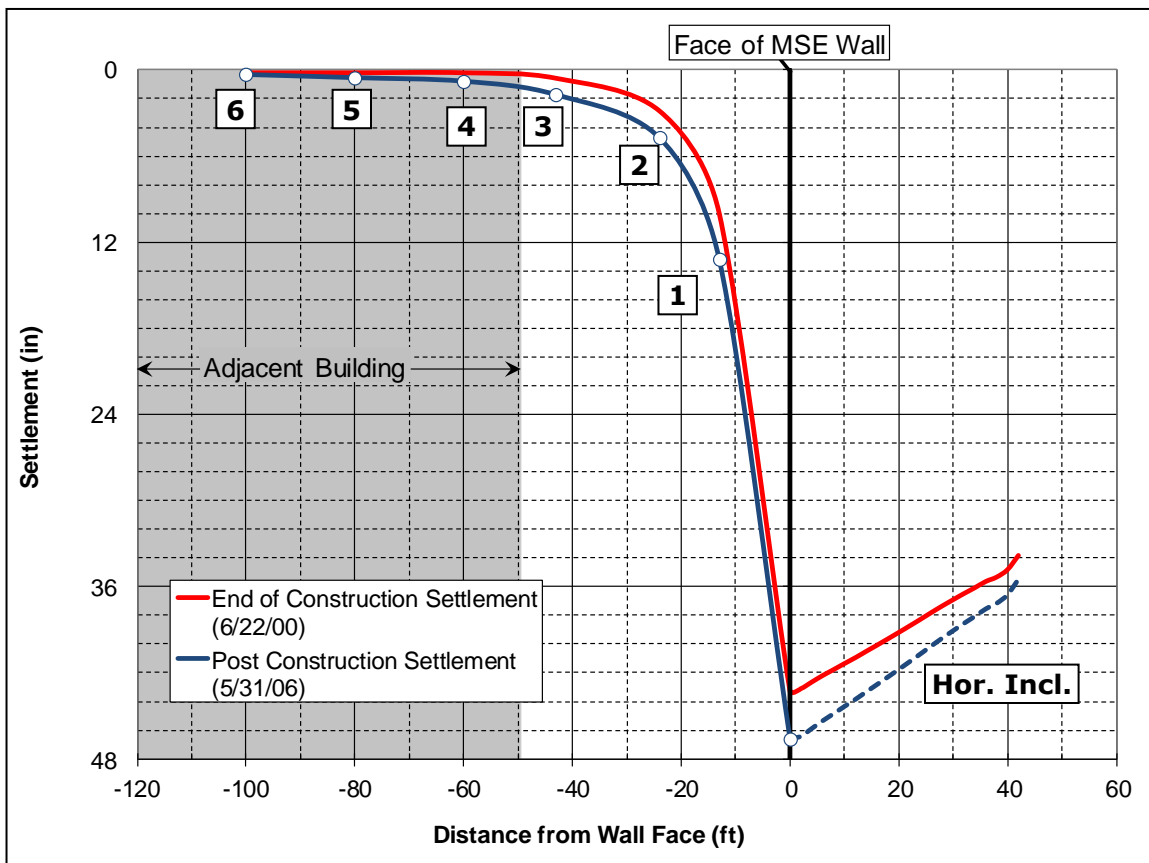
Figure 4-7. Construction and post-construction settlement profile for the 200 South MSE wall site.

The settlement profile for the 200 South Street MSE wall is shown in Figure 4-7. The instrumentation and corresponding settlement values have been plotted at the nearest perpendicular distance to the wall face. This figure shows that the amount of the consolidation settlement decreased with increasing distance into the wall, due to the influence of the existing embankment, similar to what occurred at the lime cement column array (Figure 4-3). This wall also exhibited some angular distortion due to the pre-existing embankment. As explained previously, upon completion of primary settlement, the surface was leveled after removal of the surcharge so that the surface pavement was placed at the appropriate elevation and drainage slope. Although the effect to the surface elevation is minor, the welded wire wall facing and reinforcement strips would be subjected to the full angular distortion. As reported in Report UT-08.05 (Farnsworth and Bartlett, 2008), MSE walls should have limiting differential settlements

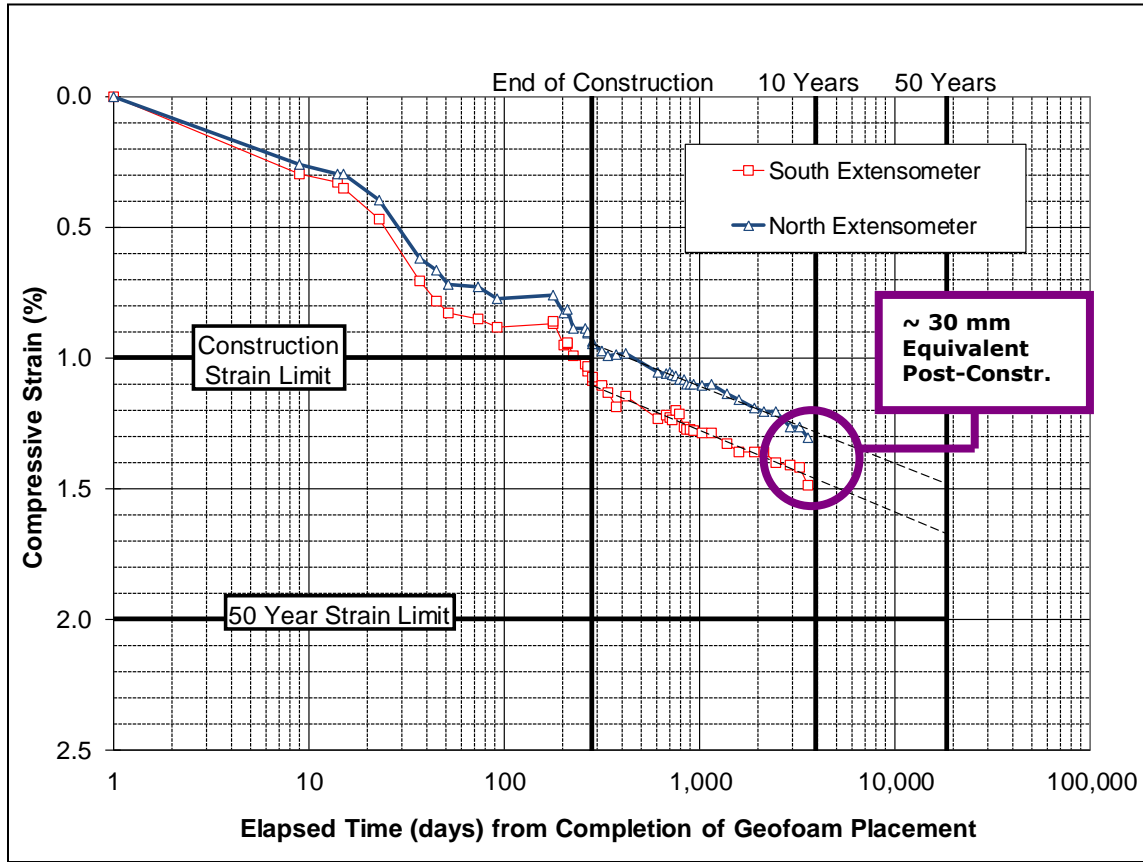
Figure 4-9. Compressive strain for magnet extensometers within the geofoam embankment at 100 South.

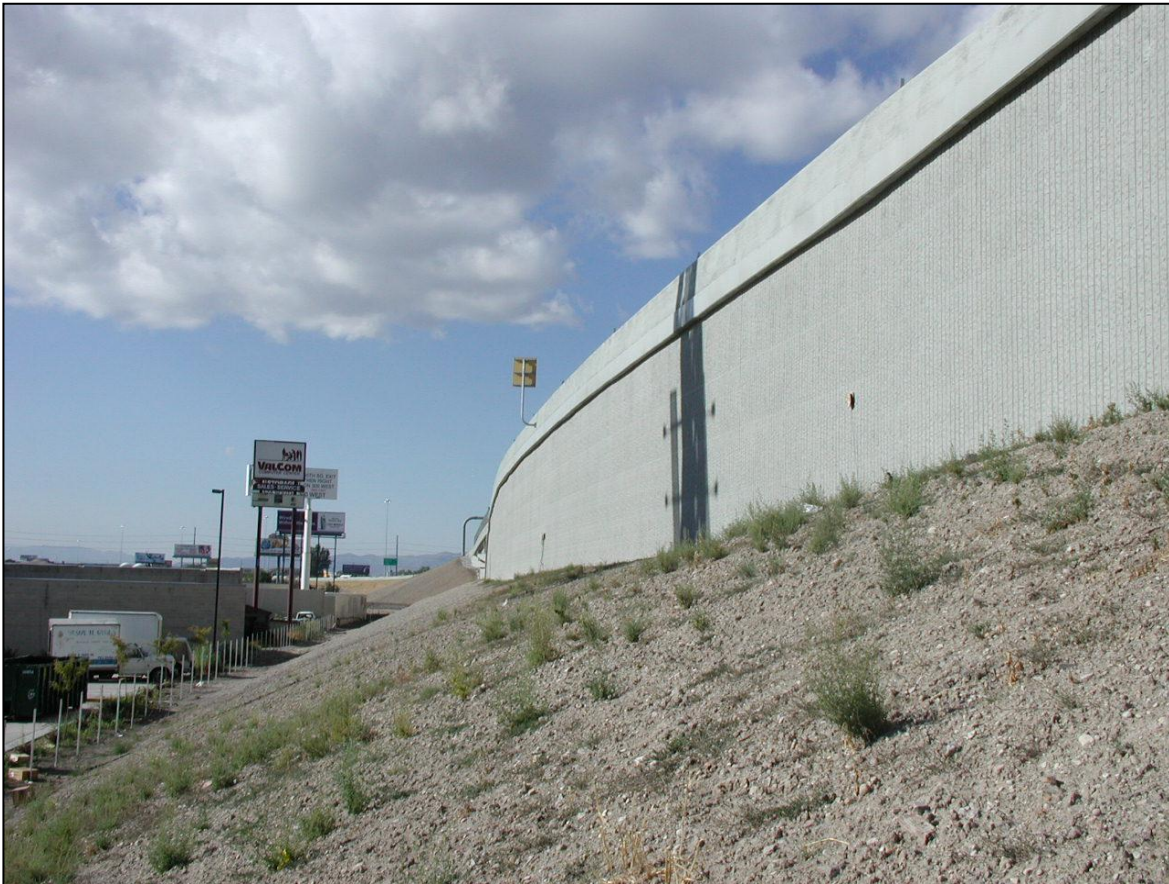
Figure 4-10. 3300 South geofabric embankment with toe berm.

Both the 100 South and 3300 South Street geofoam arrays experienced more foundation settlement than anticipated. The foundation settlement at the 3300 South Street has already been described and illustrated in UT-08.05 (Farnsworth and Bartlett, 2008). In summary, the geofoam embankment and pavement materials initially caused about 0.6 in (15 mm) of foundation movement over a one year time period. A 5-ft (1.5 m) toe berm that was placed at the base of the geofoam wall (See Figure 4-10) caused an additional 1 in (25 mm) of foundation settlement over the next five years. The total projected ten year

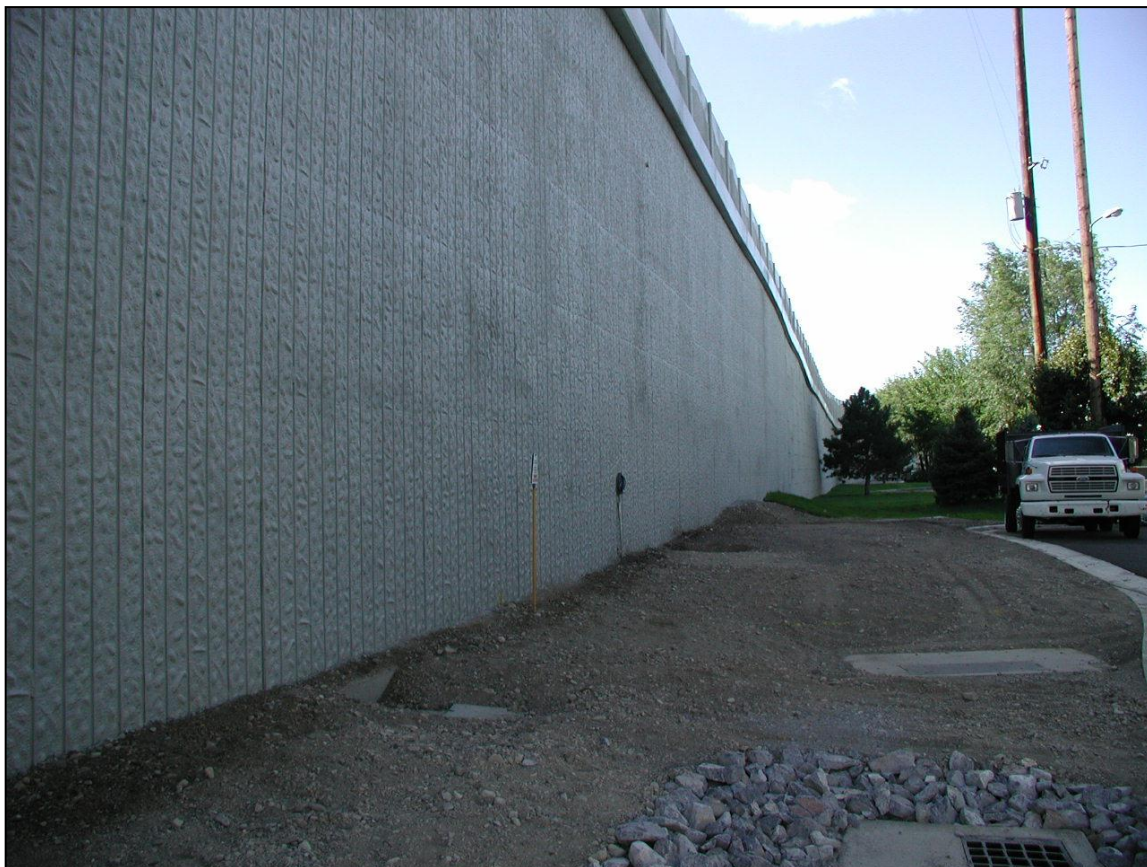
Figure 4-11. 100 South geofabric embankment.

The 100 South Street geofabric array (Figure 4-11) has also exhibited much more foundation settlement than was intended in the design. The construction details for this geofabric embankment and the corresponding construction related performance results

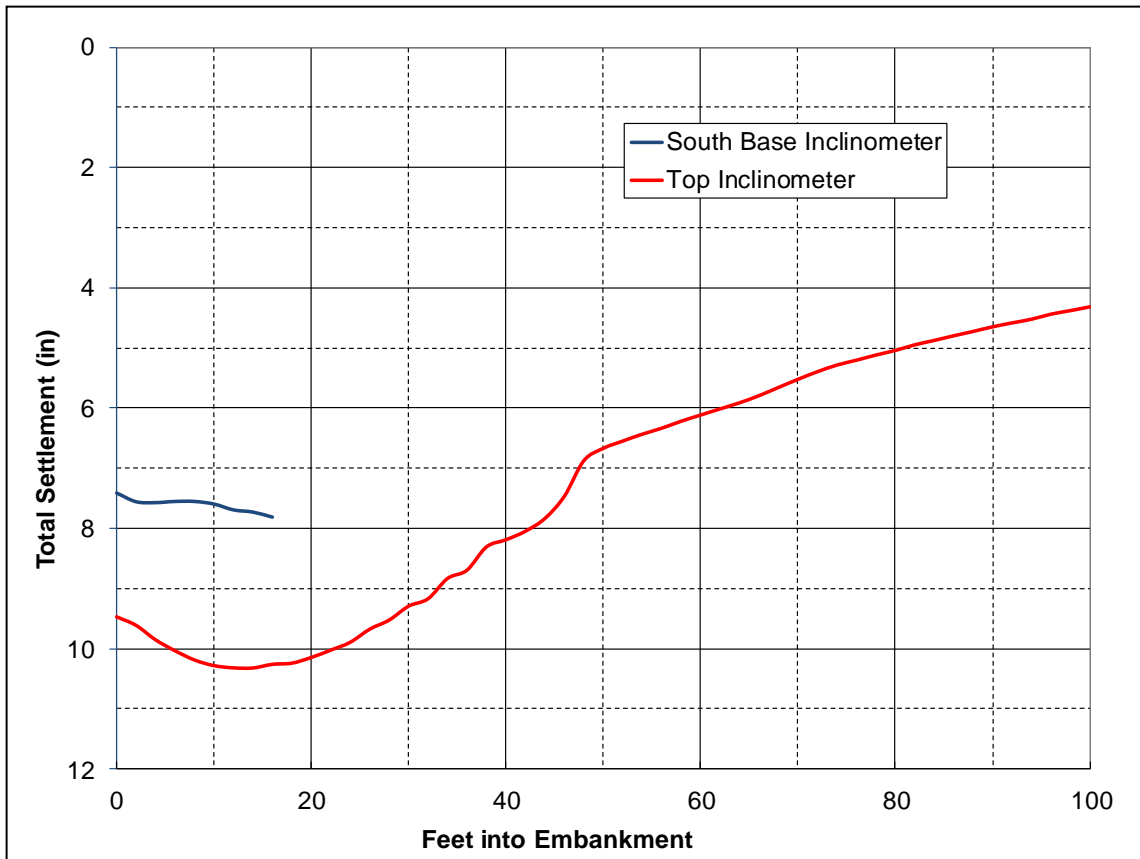
Figure 4-13. 100 South horizontal inclinometer total settlement results.

of foundation settlement has occurred in the rear portion of the embankment. Furthermore, this figure indicates that there has also been some angular distortion across this profile. The authors have not been able to identify any corresponding pavement surface cracking due to this differential settlement and are unaware of any drainage issues resulting from the corresponding angular distortion.

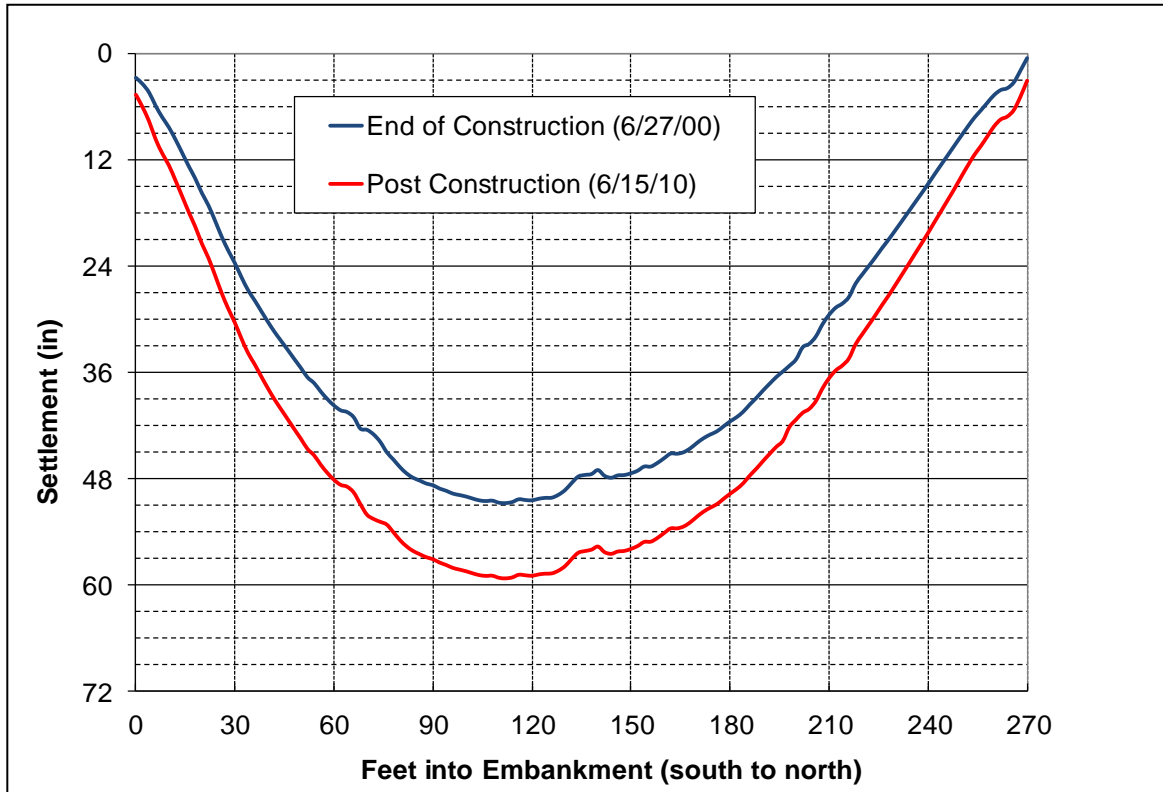
Figure 4-15. Construction and post-construction settlement profile for the Provo site.

The maximum settlement was located within the middle of the embankment at approximately 110 feet (33.5 m) from the south end of the embankment toe. The

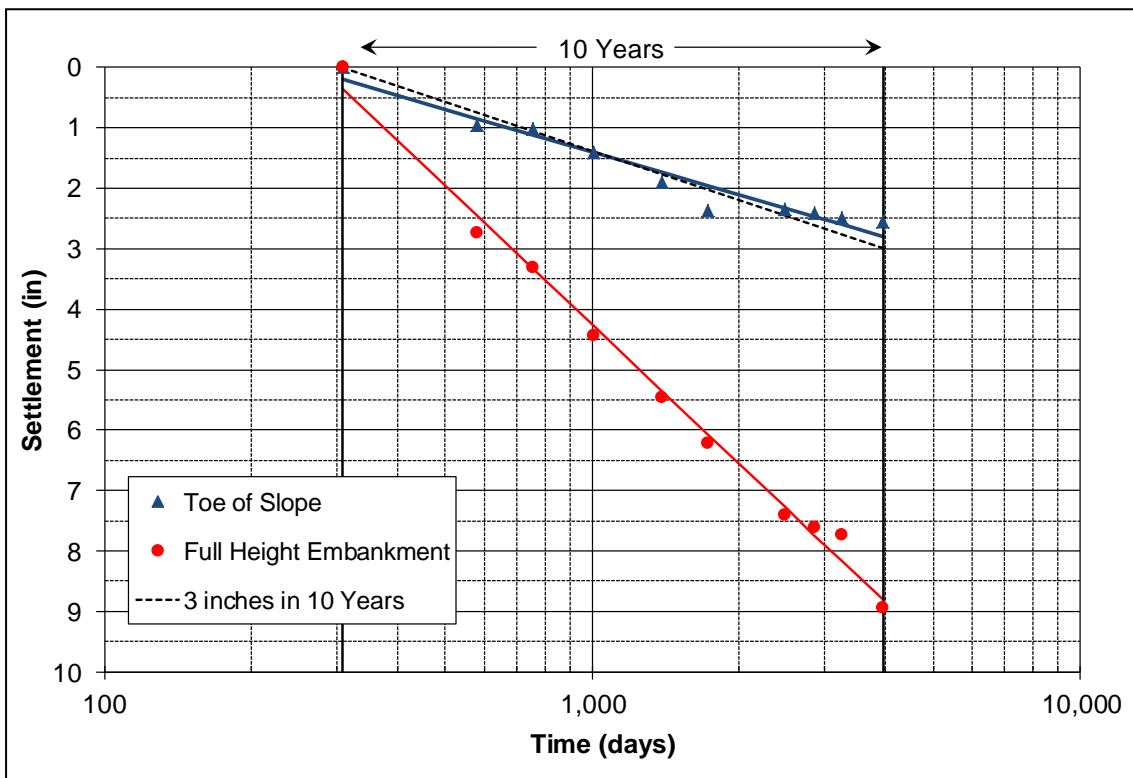
Figure 4-17. Rate of post-construction foundation creep for Provo site.

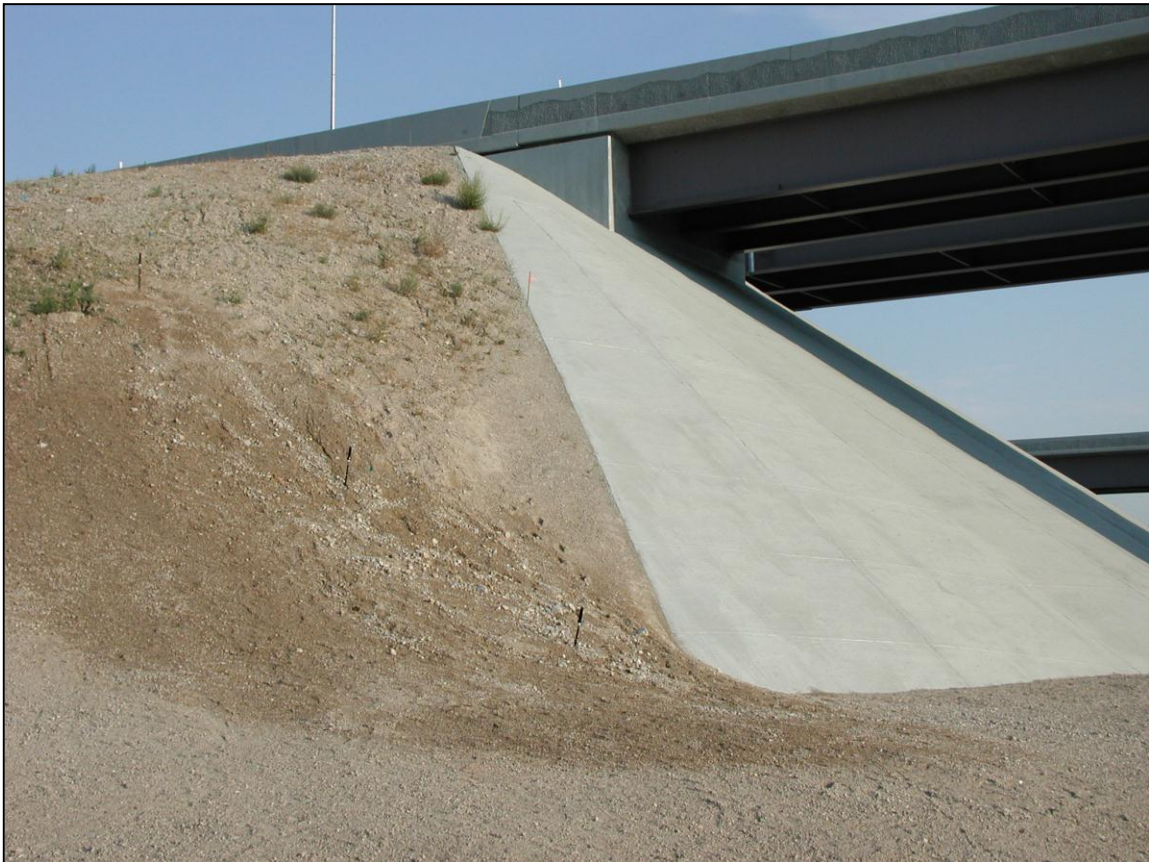
Figure 4-18. 900 West large earth embankment.

review of the I-15 Reconstruction projects records indicated that the 900 West Street embankment was essentially not surcharged. Therefore, the settlement results for this embankment show the creep behavior of the foundation soils for the normally consolidated case. This case will be useful for comparing the creep settlement rate of surcharged to non-surcharged embankments. Figure 4-18 shows the 900 West Street embankment at the bridge approach shortly after construction. Figure 4-19 shows the I-15 Merger embankment.

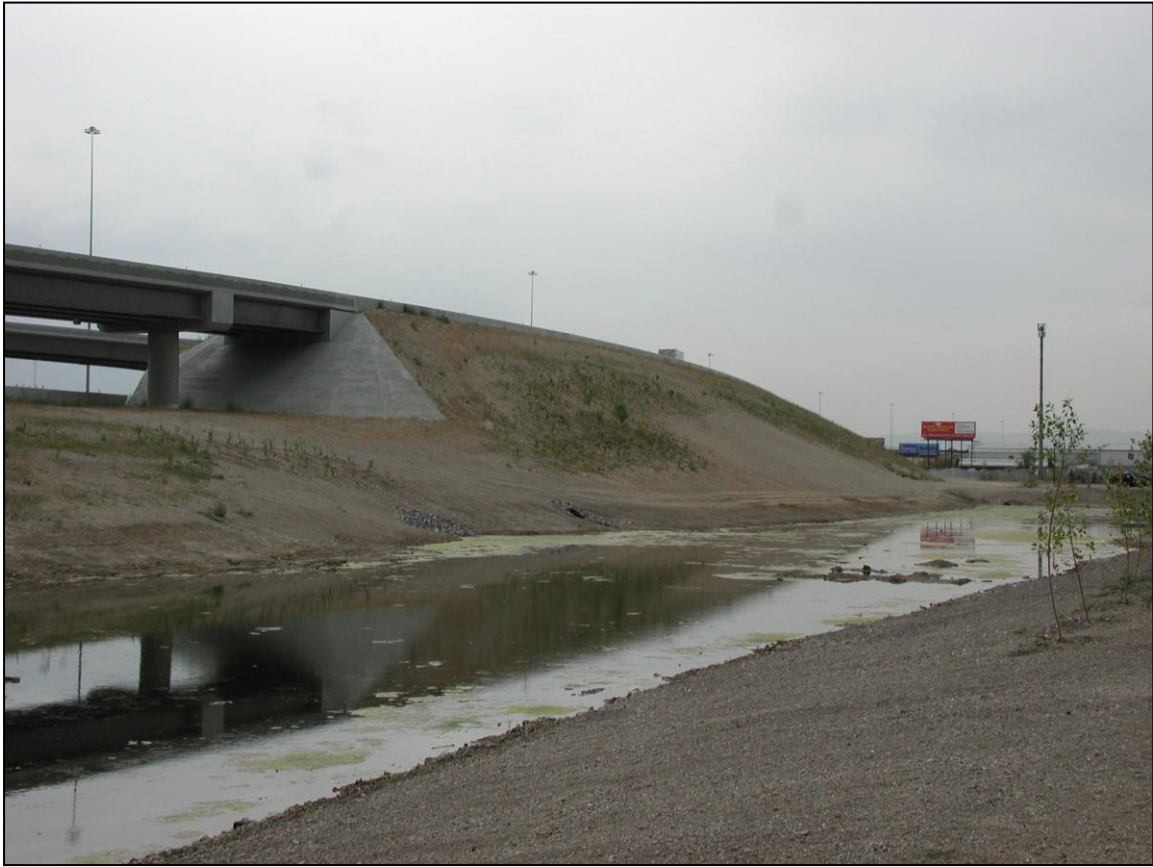
Figure 4-19. I-15 Merger large earth embankment.

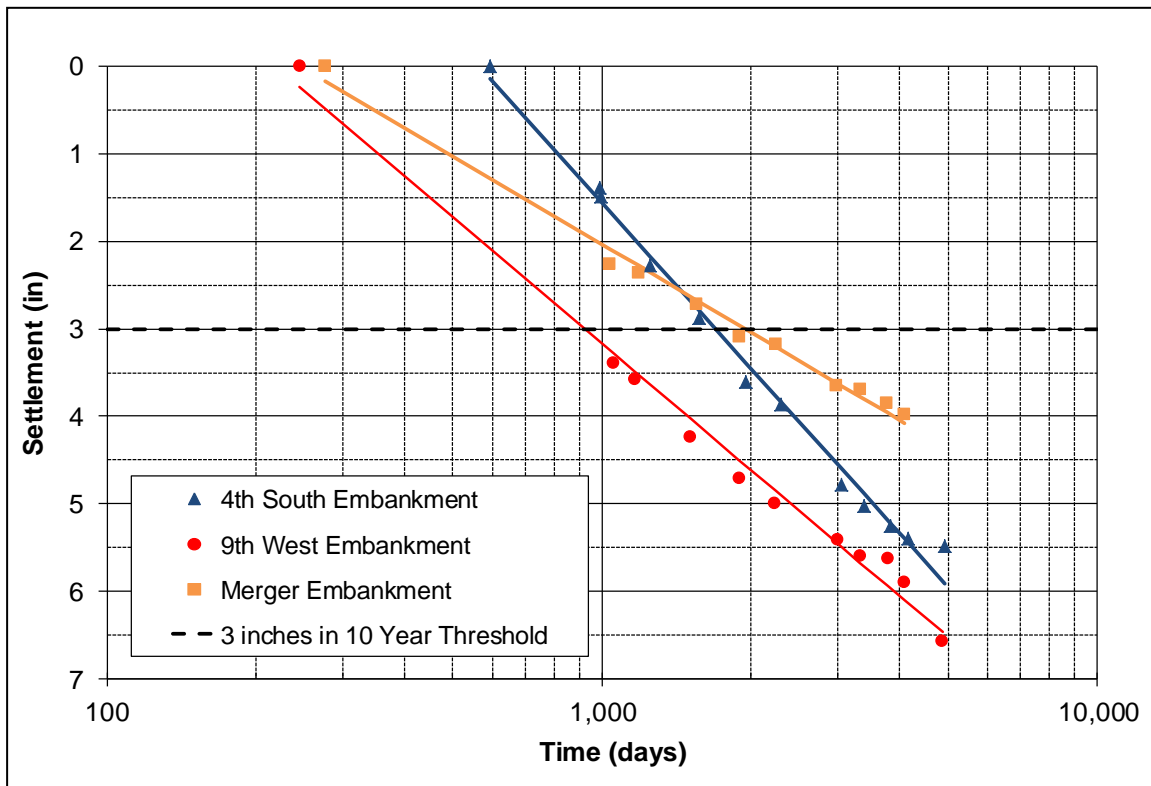
Figure 4-20. Rate of post-construction foundation creep for large earthen embankment sites.

exceeded the ten-year post-construction settlement goal. The 9th West embankment has produced the largest post-construction settlement at about 6.5 in (165 mm) followed closely by the 4th South embankment at about 5.5 in (140 mm). The I-15 Merger embankment has shown the least amount of post-construction settlement, 4.5 in (110 mm), yet still exceeding the design goal by more than about 30%. Since these embankments were primarily constructed in areas of new alignment or where pre-existing embankment had not significantly preloaded the foundation soils, locations over or adjacent to pre-existing embankment may not have experienced post-construction settlement rates of this magnitude.
