# **High Speed Ground Penetrating Radar for Road Pavement and Bridge Structural Inspection and Maintenance**

## **Final Report**

**Project Number: SPR-RSCH017-738**

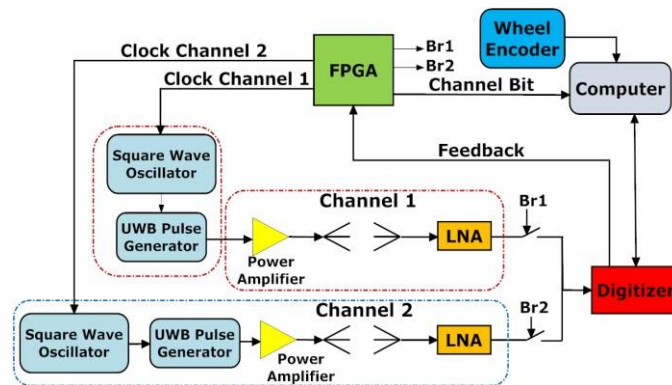
Fig. 1 illustrates the system diagram of the dual-channel GPR system developed in our UVM laboratory. Overall, the system has four primary functional units: 1). Radio frequency (RF) front end circuit; 2). Ultrawide bandwidth (UWB) antennas; 3). A high speed digital data acquisition unit with fast speed data transmission and storage; and 4). Field Programmable Gate Array (FPGA) controller.

Fig. 1. System diagram of the dual-channel high speed UWB GPR

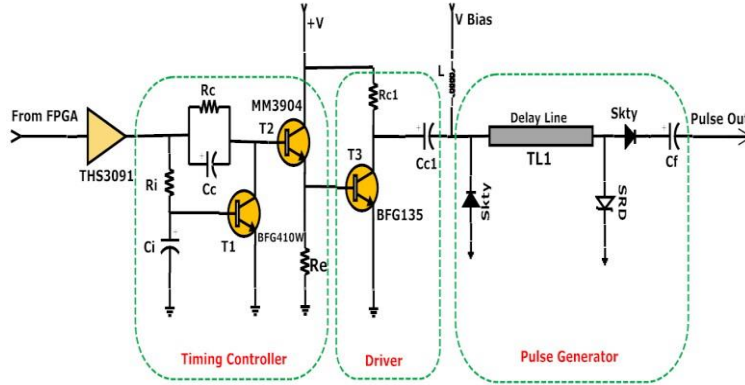
For an impulse GPR, it is important to design a UWB pulse generator capable of producing high quality pulses with large amplitude and low levels of ringing. In this research we develop a high performance monocycle pulse generator using a Step Recover Diode (SRD) and a simple yet effective pulse shaping network. The circuit schematic is presented in Fig. 2 which comprises of four parts: (1) Op-amp to amplify the digital clock from a FPGA, (2) Edge triggered timing circuit to maintain constant driving pulse irrespective of the input PRF, (3) Bipolar junction transistor

(BJT) driver circuit to generate a sharp negative driving pulse, and (4) Gaussian pulse generator using a SRD for sharpening the transition edge and microstrip delay line. Fig. 3 is the photo of the fabricated circuit board. Fig. 4 illustrates the measurement waveform. As shown, the pulse width is about 1 ns while the amplitude is approximately 18 Volts.

Fig. 2. Pulse generator circuit schematic

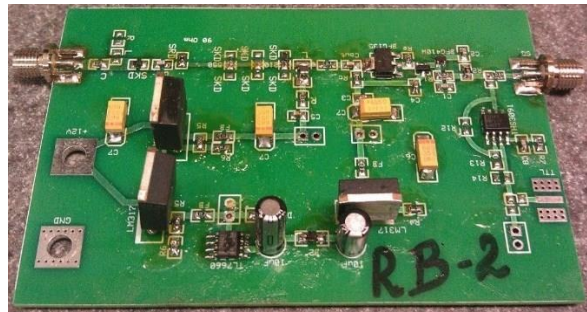
Fig. 3. Pulse generator circuit board

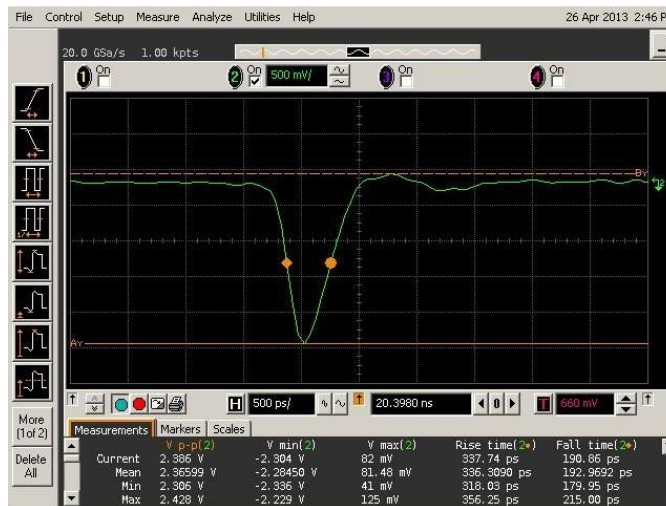
Fig. 4 Measured Gaussian pulse (upon 20 dB attenuation)

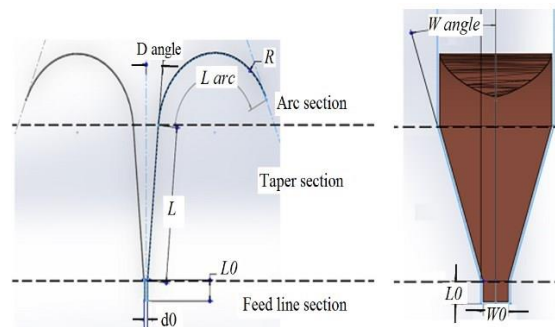
Fig.5 illustrates our developed UWB antenna. As shown, the antenna structure consists of three sections: feed line, waveguide taper segment and a rounded shaped aperture. The feed line and the taper section can be modeled as a series of  $N$  parallel-plate transmission line segments. Each segment consists of two metal plates that are separated by a dielectric media with varying width.

Fig. 5– Top view and side view of the horn antenna

In order to characterize the parallel plate structure, an analytical model is developed to study the effect of feed point length  $L_0$  on feed line input impedance across wide frequency band. The model assumes 50 ohms output impedance, which is replaced by the actual input impedance of the taper section later in the full model. The feed line width is  $W_0$ , feed line height is  $d_0$ . Simulations show that when  $L_0 = 6\text{mm}$ ,  $d_0 = 3\text{mm}$  and  $W_0 = 12\text{mm}$ , the feed line demonstrates minimal impedance variations across the frequency band ranging from 600 MHz to 6 GHz.

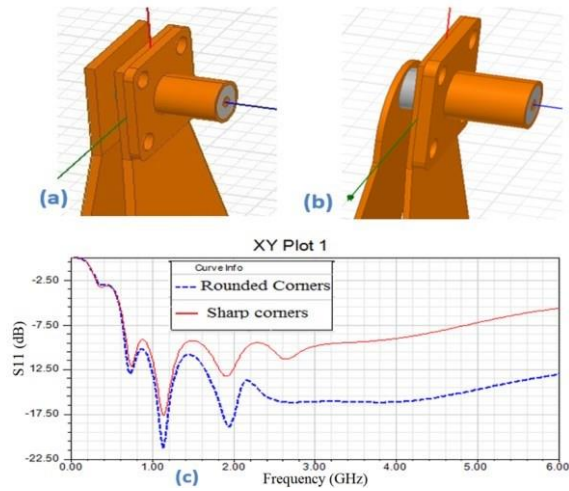
To further improve antenna performance, extra structure optimization measures are taken. One structure change is rounding the edges at the feed point. Fig. 6a and Fig. 6b illustrate the traditional sharp edges versus the edge rounding at feed point respectively. Results in Fig. 6c demonstrates that the rounded corners structure leads to the improved S11 performance. The second structure optimization measure is rounding the flare edges. Fig. 7a and Fig. 7b illustrate two flare edges. Fig. 7c is the simulation resulting validating the performance improvement.

Figure 6. Feed point (a) sharp corners; (b) rounded corners; (c). S11 simulation results

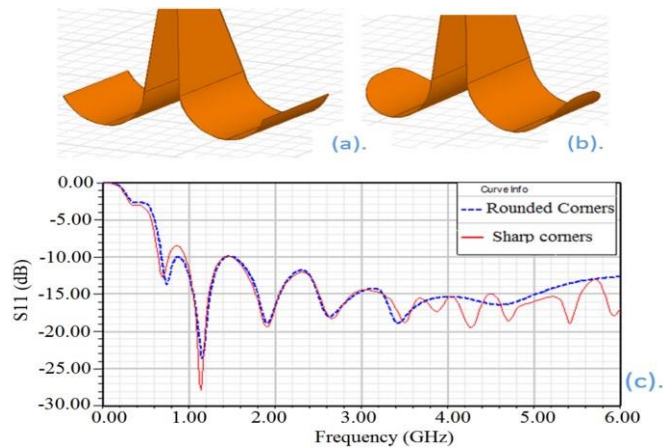
Figure 7 – Flare edges of the antenna (a) sharp corners; (b) rounded edges  
(c) S11 simulation results

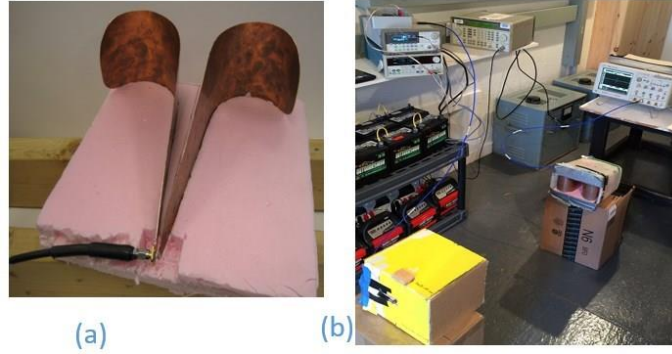
Fig. 8 shows the fabricated antenna and the antenna test setup. While in Fig. 9, both the measured and simulated S11 parameter curves are plotted. As can be observed, the antenna achieves good impedance across a wide spectrum from 600 MHz up to 6 GHz.

Fig. 8 (a) the fabricated antenna (b) direct pulse signals transmission and receiving

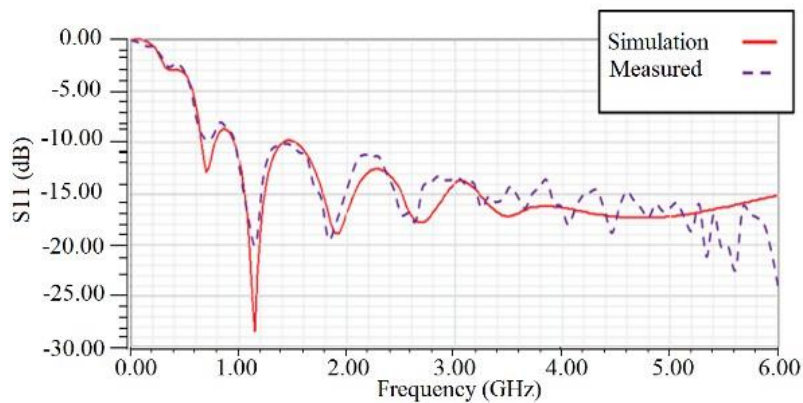
Fig. 9. S11 parameter simulation and measurement

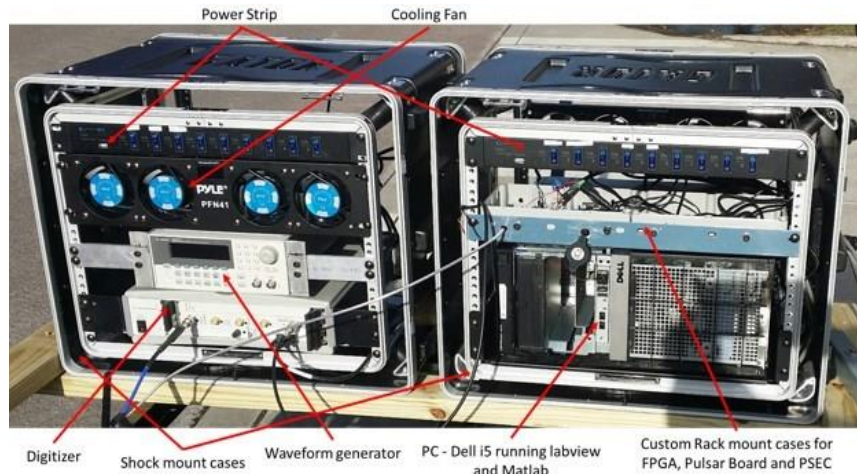
As illustrated as Fig. 11, all the GPR functional elements are integrated into the shock mount cases: (1) a Radio Frequency (RF) pulsar board; (2) a data acquisition unit comprised of a high-speed real-time digitizer and a high-speed data transmission and storage unit; (3) a multi-core computer; (4) a Field-Programmable Gate Array (FPGA) based digital controller; (5) power strip and cooling fan.

Fig. 11. UVM GPR System integrated into shock mount cases

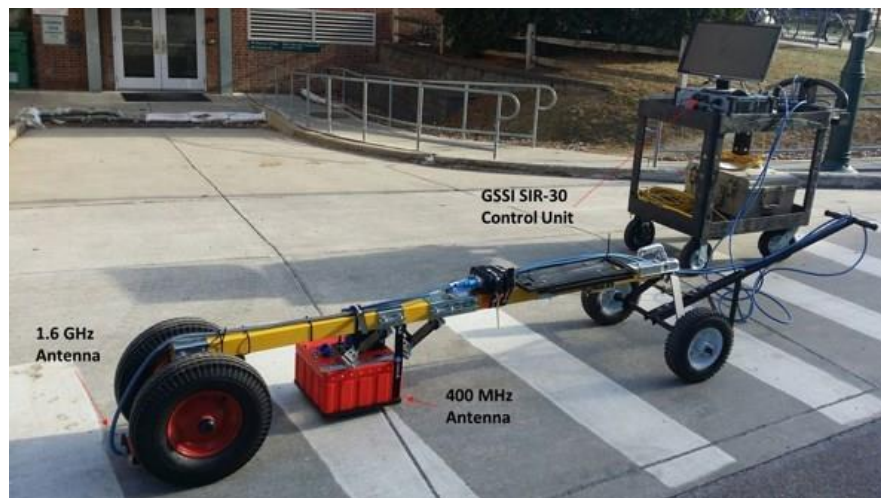
For this project, a GSSI SIR-30 GPR was purchased as the reference system. We developed the mounting structure to have two sets of antennas installed, a 400 MHz antenna and a 1.6 GHz antenna. The configuration enables GPR to operate in the dual-channel dual-band operation mode with the wheel encoder trigger. The mounting structures are shown in Fig. 12.

Fig. 12 GSSI SIR-30 dual-antenna installation

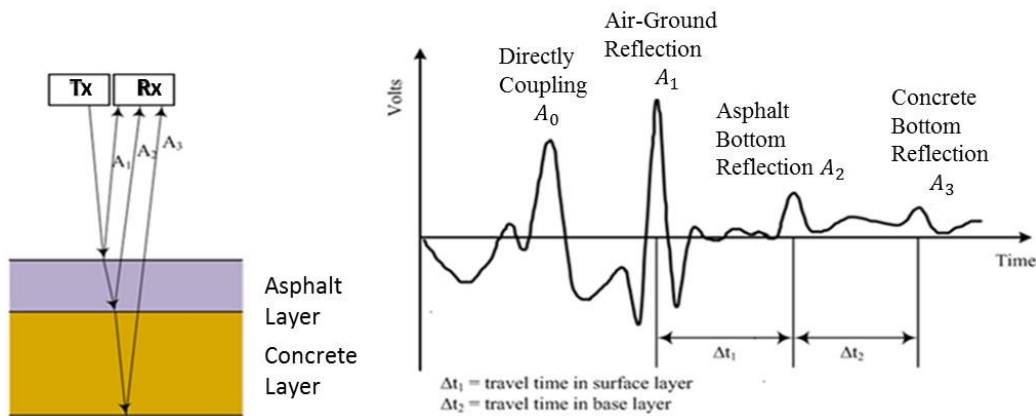
Fig. 14 demonstrates the GPR asphalt pavement inspection scenery. The 1<sup>st</sup> echo in the A-Scan trace shows the antenna directly coupling signal, the 2<sup>nd</sup> echo is the air-ground reflection signal, and the 3<sup>rd</sup> echo is the asphalt bottom surface reflection signal. Thus, upon the Hilbert transform processing, the 2<sup>nd</sup> and 3<sup>rd</sup> signal peaks are extracted, and the time instances for the 2<sup>nd</sup> signal peak and the 3<sup>rd</sup> peak are recorded as  $t_1$  and  $t_2$  respectively

Fig. 14 GPR Asphalt Pavement Test Scenery

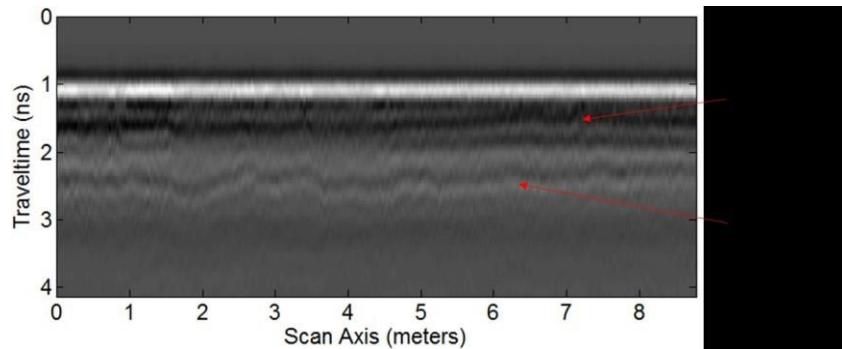
Fig. 16 plots the B-Scan image for one scan line at the first test site. In the image, the air-ground interface and asphalt pavement bottom surface are marked respectively. The thickness of the asphalt pavement on this scan line is relatively even and smooth. Combining all 7 scan lines, the thickness map for the first test site is plotted in Fig. 17. The horizontal axis in this figure specifies GPR travel distance in the scan direction, while the vertical axis specifies the width of the scanning area. The color-to-thickness mapping is shown on the right. From the thickness map, it is observed that at the center portion of this on-campus driveway, the asphalt pavement thickness is smaller than that the border portion. We think it is because this driveway has a single lane, most traffic loads utilize the center portion of the road, which causes the center portion of the pavement to be thinner.

Fig. 16 B-Scan Image for One Scan Line on the 1st Test Site

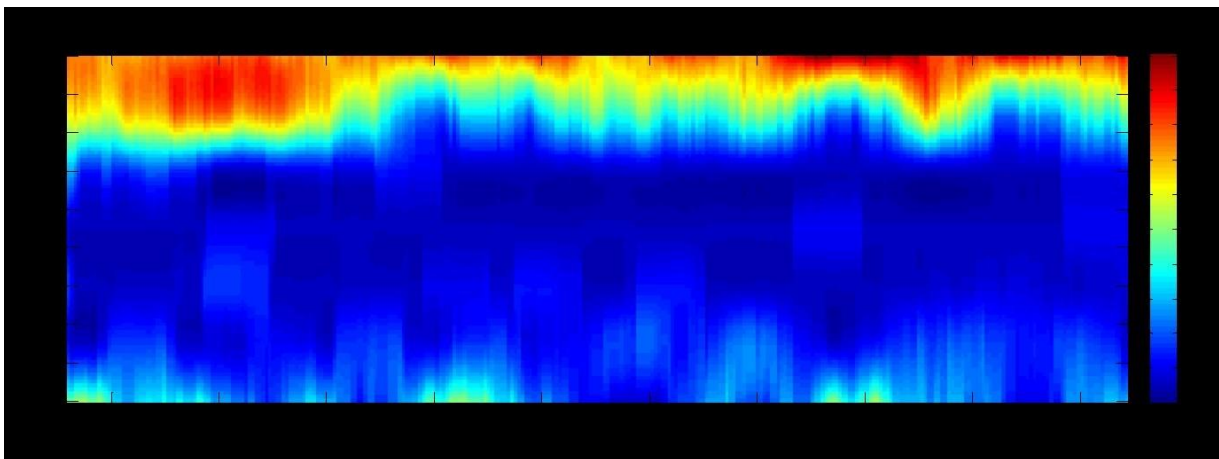
Fig. 17 Asphalt Pavement Thickness Map for the 1st Test Site

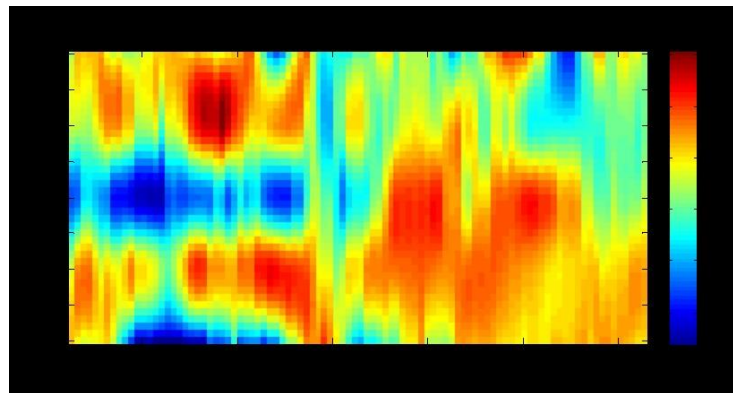
Fig. 19 Asphalt Pavement Thickness Map for the 2nd Test Site

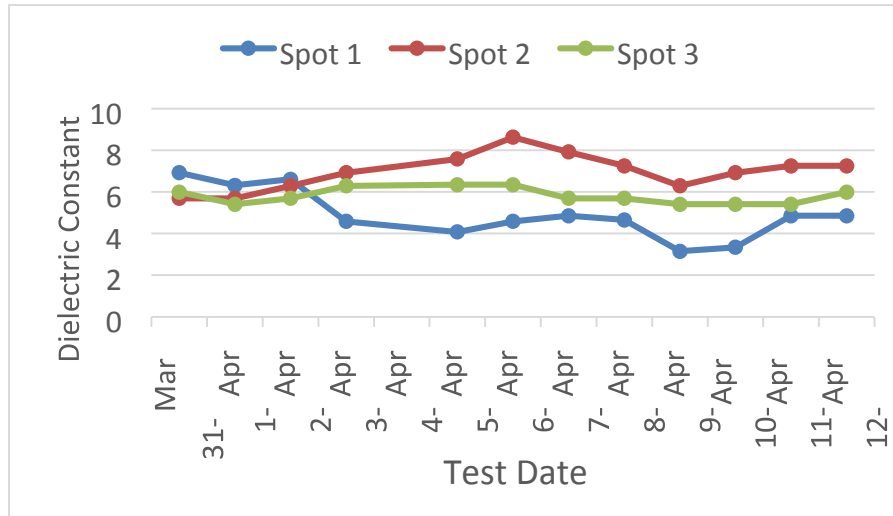
Fig. 21 Dielectric Constant of 3 Test Spots

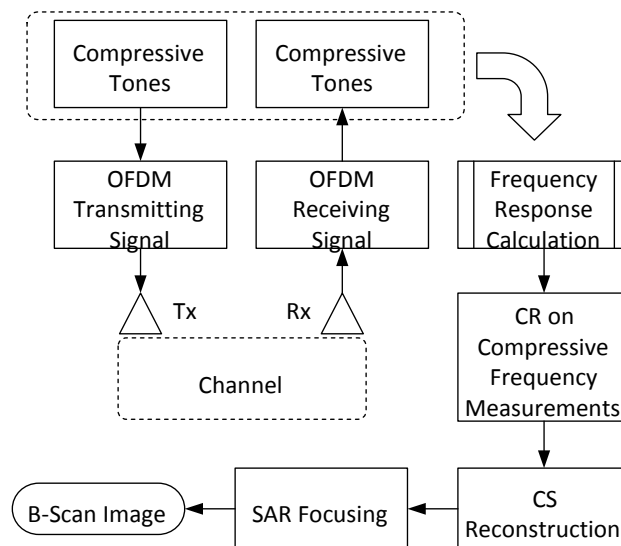
Fig. 22 depicts the operating mechanism of the compressive sensing OFDM GPR. In the operation, a set of randomly selected frequency tones were radiated concurrently using an OFDM modulation scheme, and the echoes from the object were received. By analyzing the transmission and receiving OFDM signals, the compressed frequency responses of the scatters, including the gain and phase variations, were calculated. A frequency domain clutter removal was applied on the compressed frequency response spectrum. The CS reconstruction was then performed on the compressed frequency response data matrix to recover and synthesize the time domain response of the full spectrum. Finally, a synthetic aperture radar (SAR) focusing algorithm was employed to mitigate the hyperbolic distortion in the GPR B-Scan image.

Fig. 22. Compressive OFDM GPR system

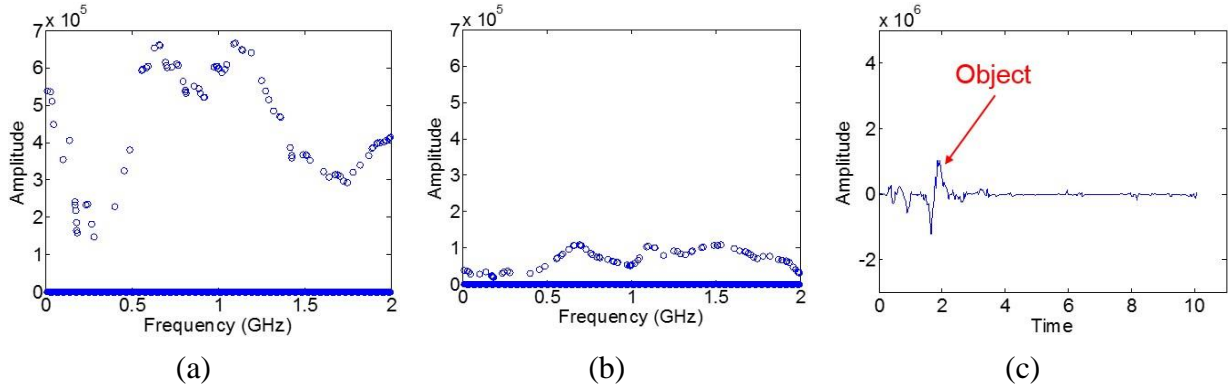
signal. The compressed OFDM spectrum is plotted in Fig. 23(a). The compressed OFDM spectrum after performing clutter removal processing is depicted in Fig. 23(b), and the corresponding reconstructed A-Scan waveform is displayed in Fig. 23 (c), where the reflection signal component corresponding to rebar reflection is pronounced.

Fig. 23 Reconstructed A-Scan with  $p=20\%$ : (a) Compressed frequency spectrum; (b) Compressed frequency spectrum after clutter removal; (c) Recovered A-Scan trace

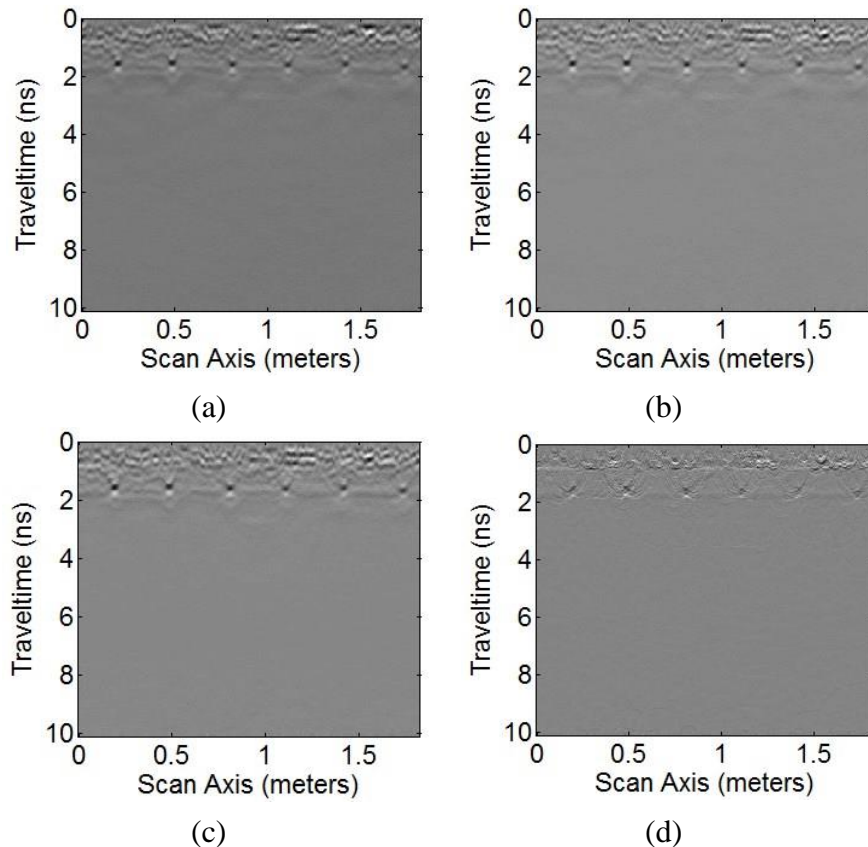
Selected B-Scan images are displayed in Fig. 24. In the experiment setup, six rebars buried in the concrete walkway were expected to be detected. When  $p$  is higher than 30%, the reconstructed B-Scan image was obtained with a good fidelity. When  $p$  is reduced to 5%, the reconstructed image becomes fuzzy, however, the signature patterns corresponding to six rebars are still recognizable.

Fig. 24 Compressive OFDM GPR reconstructed B-Scan with various  $p$ :  
 (a)  $p=100\%$ ; (b)  $p=60\%$ ; (c)  $p=30\%$ ; (d)  $p=5\%$

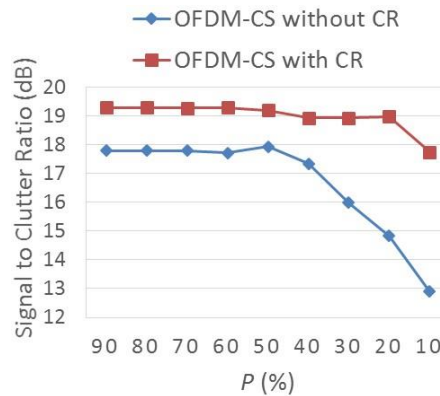
Signal-to-Clutter ratio (SCR) is a metric characterizing the power ratio of the backscattering signal from the targets under test and from the ground surface reflection. To quantitatively evaluate the performance of the compressive OFDM GPR sensory system, SCR of the reconstructed B-Scan images under different values of  $p$  were calculated. The results are depicted in Fig. 25. For the clutter removal coupled compressive OFDM GPR sensory system, the SCR of the reconstructed B-Scan image was stable and higher than 19 dB when  $p$  was higher than 20%. When  $p = 10\%$ , SCR slightly dropped to 17.8 dB. However, for the compressive OFDM GPR without clutter removal, the SCR dramatically decreased from 18 dB to below 13 dB when  $p$  was reduced from 50% to 10%.

Fig. 25 SCR under various values of  $p$  for compressive OFDM GPR with and without clutter removal

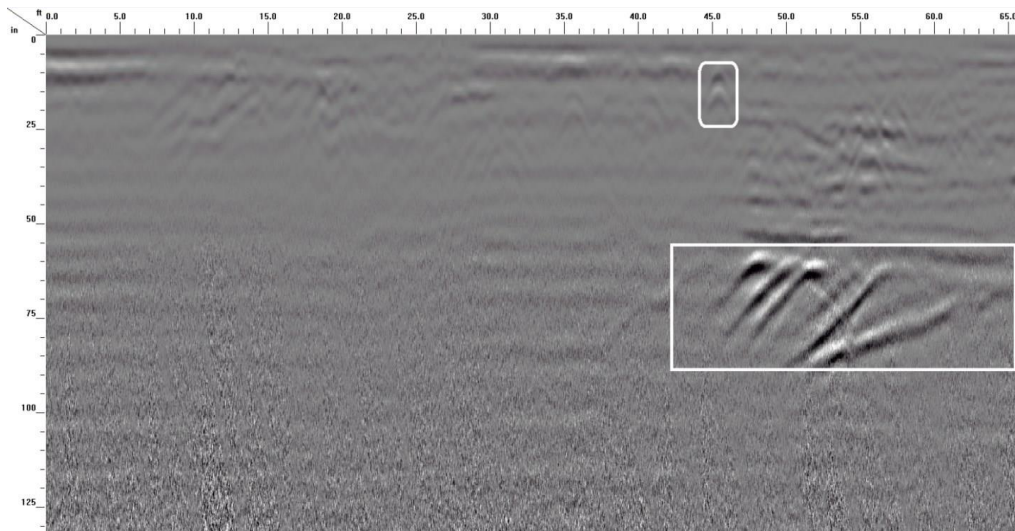
The processed GPR results from the parallel inspection scans were combined and plotted in one B-Scan image. Detected objects and regions of interest are marked by the white outlined rectangles in the B-Scan image. In the image, the horizontal axis specifies the distance from the starting location of the scan, while the vertical axis shows the depth of the object. Figure 34 shows the processed B-Scan image corresponding to a segment with a horizontal range between 0 and 65 feet. A pipe shown as a hyperbola in the figure was detected at a depth of 12 inch. Another region of interest was buried at a depth of 60 inches.

Figure 34 Processed B-Scan image: 0-65 feet horizontal range

A metal pipe, as shown in Figure 43, was also excavated from a depth of about 12 inches. The diameter of this metal pipe was 3 inches. This excavation result agrees with our GPR test result shown in Figure 34.

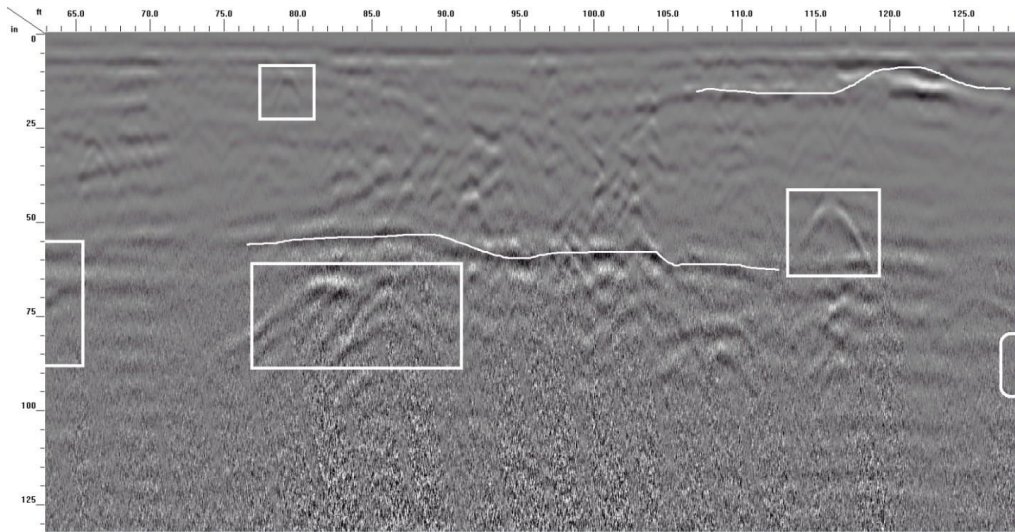
Figure 35 shows the processed B-Scan image corresponding to the segment with a horizontal range between 65 and 125 feet. A pipe at the 78<sup>th</sup> ft mark and at a depth of 12 inches is shown as a hyperbola in the figure below. Another pipe at the 116<sup>th</sup> ft mark and at a depth of 40 inches was also detected. Those two pipes are marked by white outlined rectangles. Two layers were also detected and marked by white lines.

Figure 35 Processed B-Scan image: 65 -125 feet horizontal range

Checking the excavation site, a layer buried about 60 inches deep was detected, marked in Figure 42. This layer's burying depth and horizontal location agree well with our GPR inspection results that are shown in Figure 35.

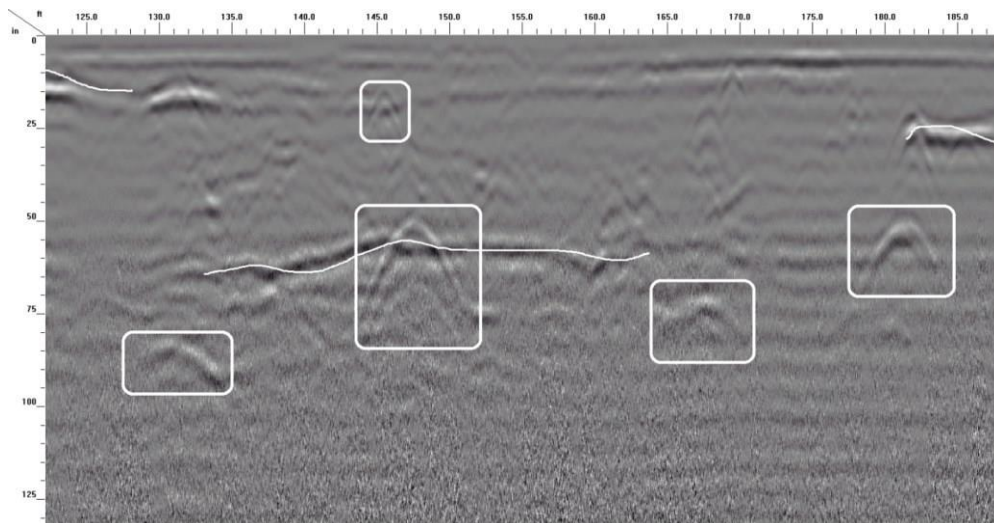
Figure 36 illustrates the processed B-Scan image of the segment with a horizontal range between 125 and 185 feet. Five pipes were detected and marked by the white outlined rectangles. One layer was detected from 133 ft to 165 ft at a 60 inch depth.

Figure 36 Processed B-Scan image: 125-185 feet horizontal range

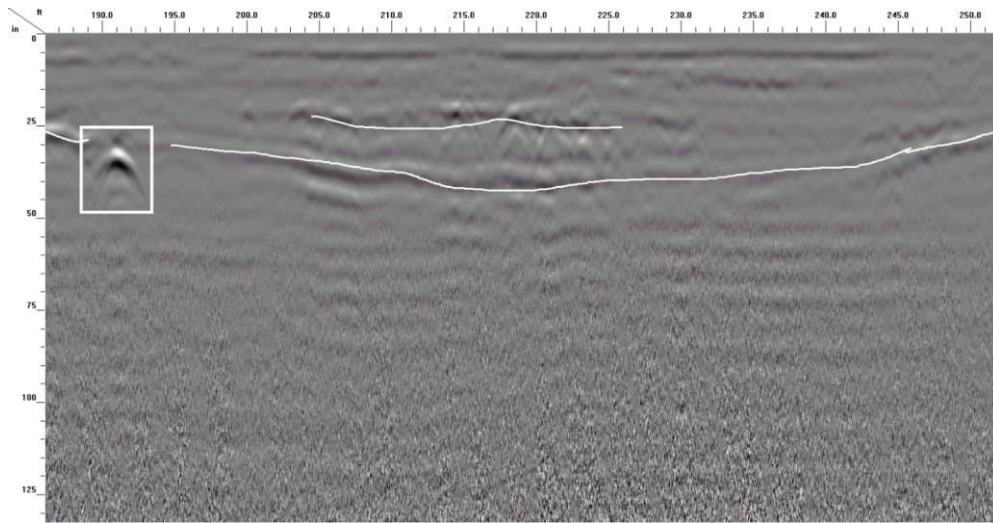
Figure 37 shows the processed B-Scan image 185-250 feet away from the starting point. One pipe was detected at 190 ft, two layers were detected and marked by white curves.

Figure 37 Processed B-Scan image: 185-250 feet horizontal range

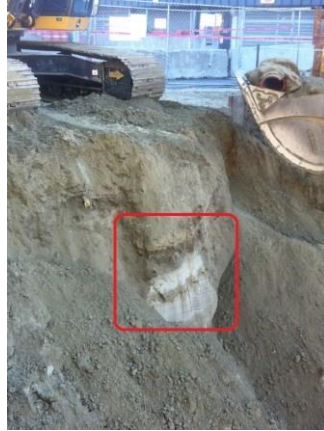
Figure 42 A layer is observed which is consistent with the GPR result in Figure 35

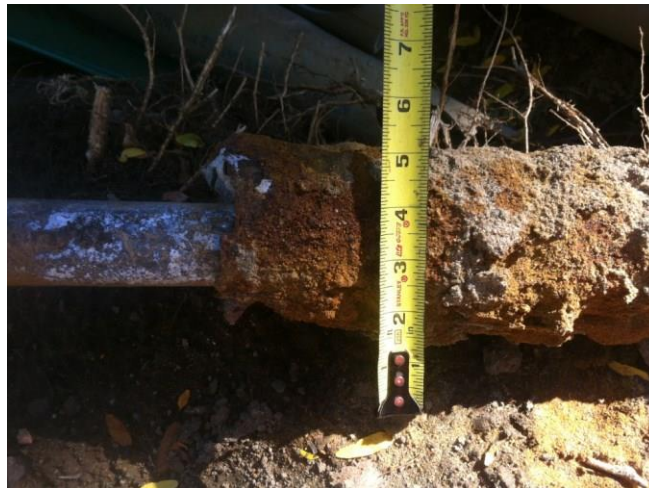
Figure 43 An excavated pipe which was consistent with the GPR result in Figure 34

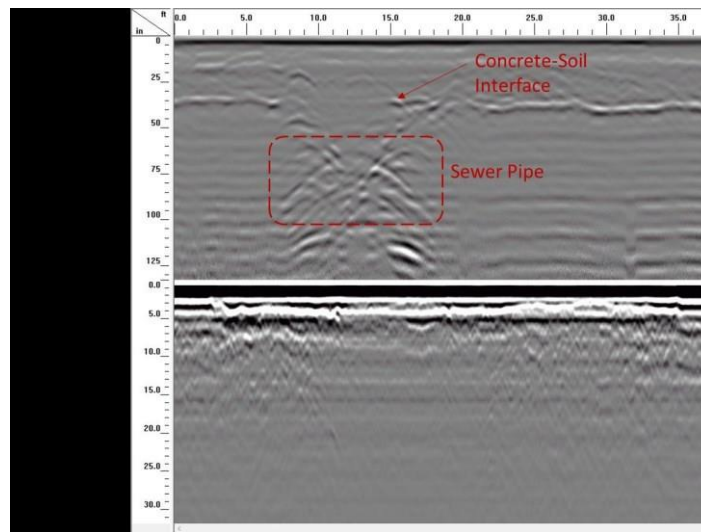
The B-Scan images obtained with the 400 MHz and 1.6 GHz antenna sets are displayed in Figure 46. The 400 MHz B-Scan image shows the underground object at a deep depth (> 3 feet or 36 inches). In the B-Scan image, a cylinder object shows hyperbolic signature. The hyperbola representing the sewer can be observed at a 70 inch depth in the 400 MHz B-Scan image. Also, the subsurface concrete-soil interface was observed at a 37 inch depth.

Figure 46 B-Scan Image of Sewer from 400 MHz (Top) and 1.6 GHz (Bottom) Antenna Sets

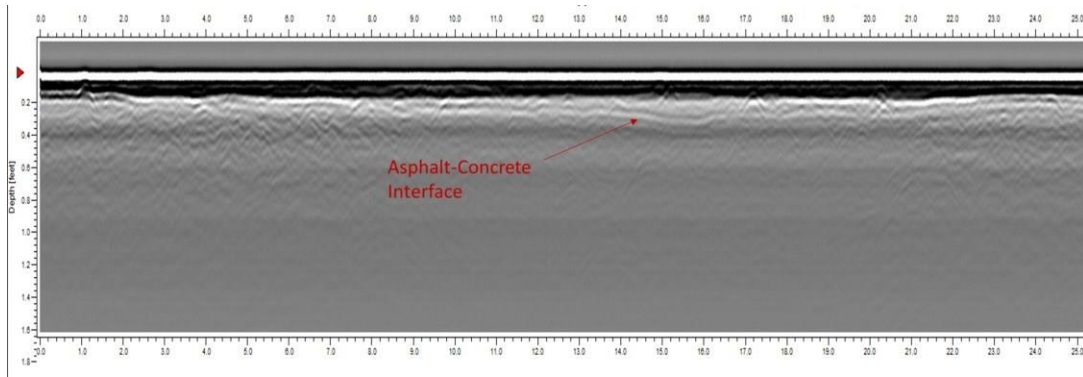
Figure 47 B-Scan Image of Sewer from 2.3 GHz Antenna Set

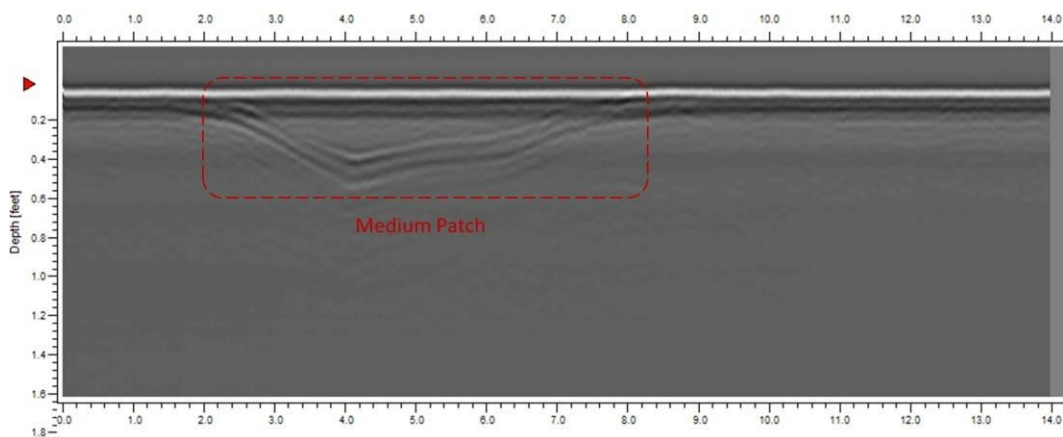
Figure 50 B-Scan Image of Medium Asphalt Patch from 2.3 GHz Antenna Set

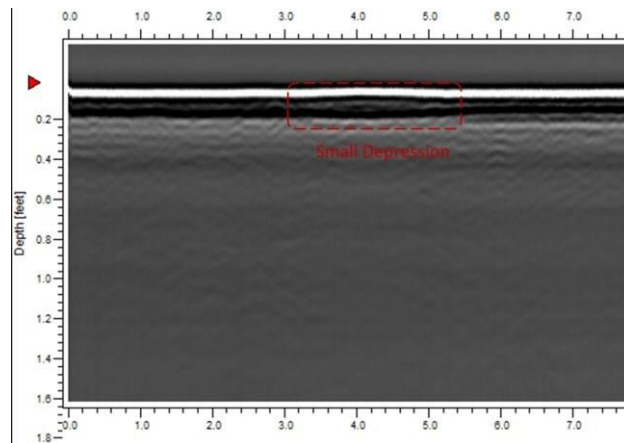
Figure 52 B-Scan Image of Small Asphalt Depression from 2.3 GHz Antenna Set

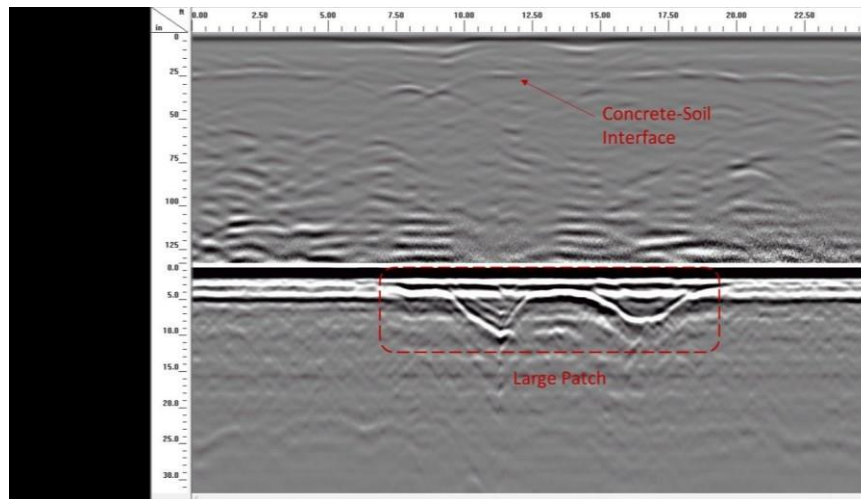
Figure 54 B-Scan Image of Large Asphalt Patch from 400 MHz (Top) and 1.6 GHz (Bottom) Antenna Sets

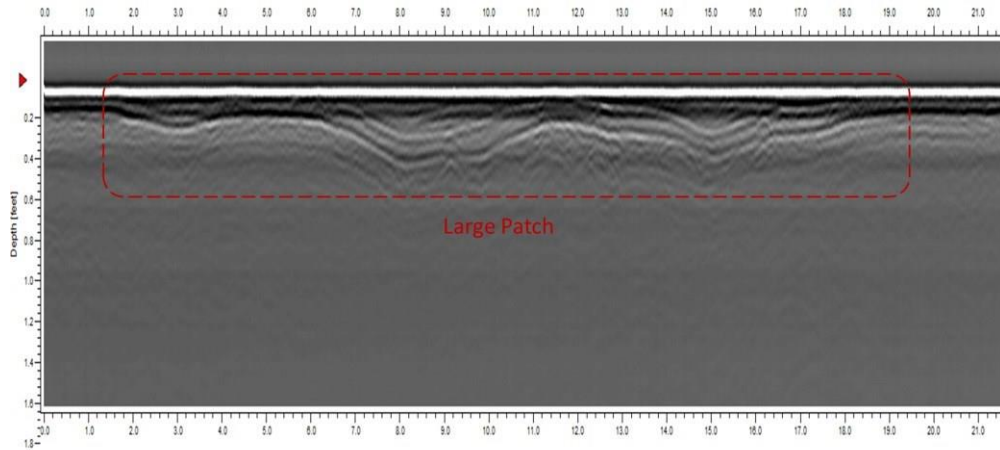
Figure 55 B-Scan Image of Large Asphalt Patch from 2.3 GHz Antenna Set

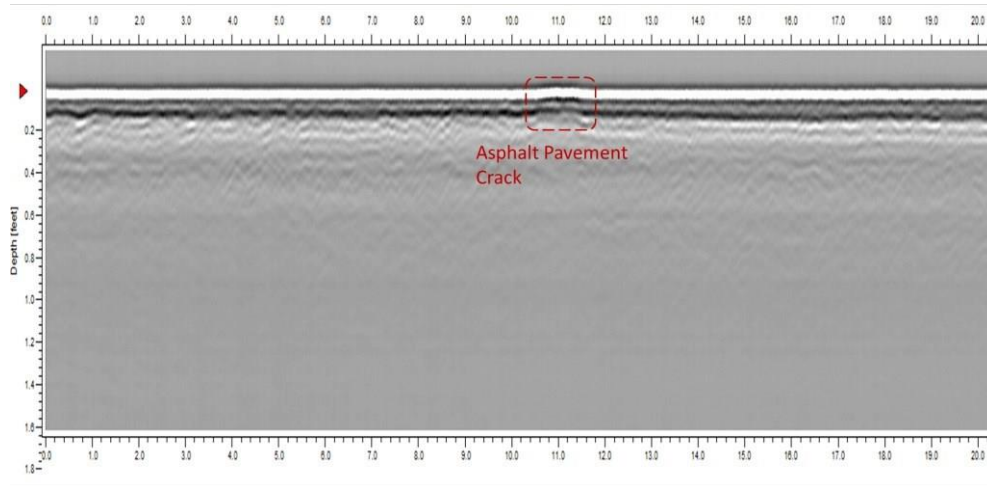
Figure 59 displays the B-Scan image from the 2.3 GHz antenna set. In this B-Scan image, the cracks on the asphalt pavement surface can be detected, which is marked by a red rectangle.

Figure 59 B-Scan Image of Underground Concrete Pipe and Surface Asphalt Crack from 2.3 GHz Antenna Set

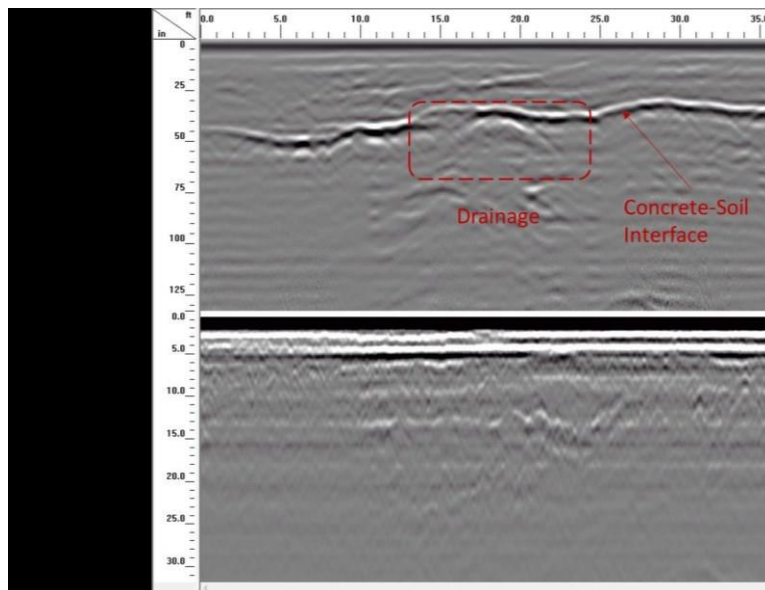
Figure 62 B-Scan Image of Underground Golf Course Drainage from 400 MHz (Top) and 1.6 GHz (Bottom) Antenna Sets
