JOINT TRANSPORTATION RESEARCH PROGRAM

INDIANA DEPARTMENT OF TRANSPORTATION
AND PURDUE UNIVERSITY

Development of a Cost-Effective Concrete Bridge Deck Preservation Program *Volume 2—Final Results and Recommendations*

1. Report No. FHWA/IN/JTRP-2016/23	2. Government Accession No.	3. Recipient's Catalog No.	
4. Title and Subtitle Development of a Cost-Effective Concrete Bridge Deck Preservation Program: Volume 2— Final Results and Recommendations		5. Report Date July 2016	6. Performing Organization Code

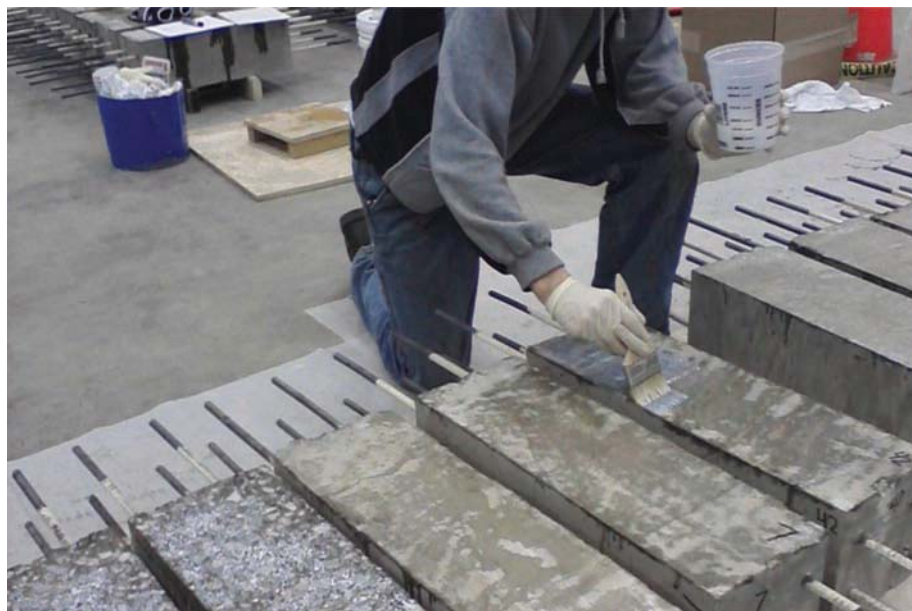
Figure 2.10 Application of deck sealers (Lyrenmann, 2011).

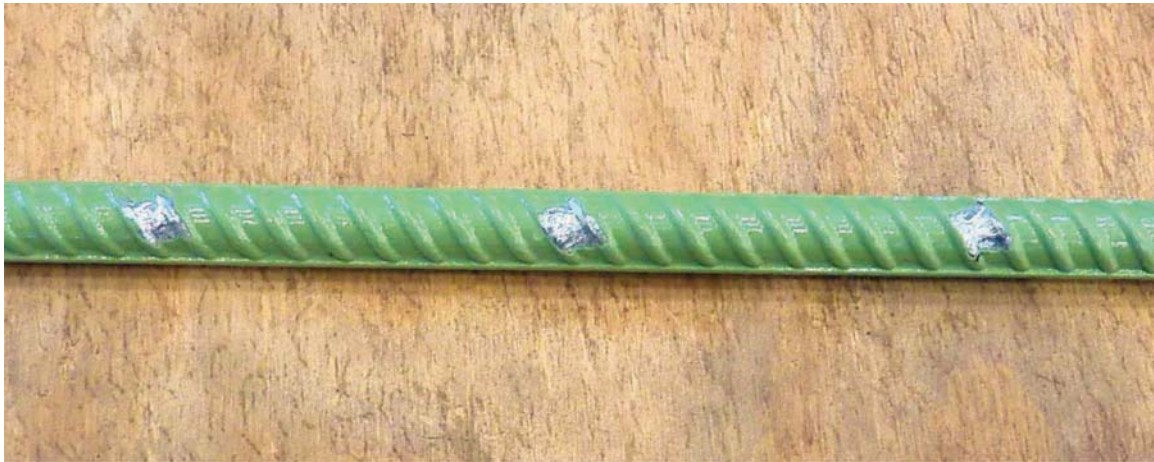
Figure 2.12 Damage introduced in epoxy coating (Lyrenmann, 2011).

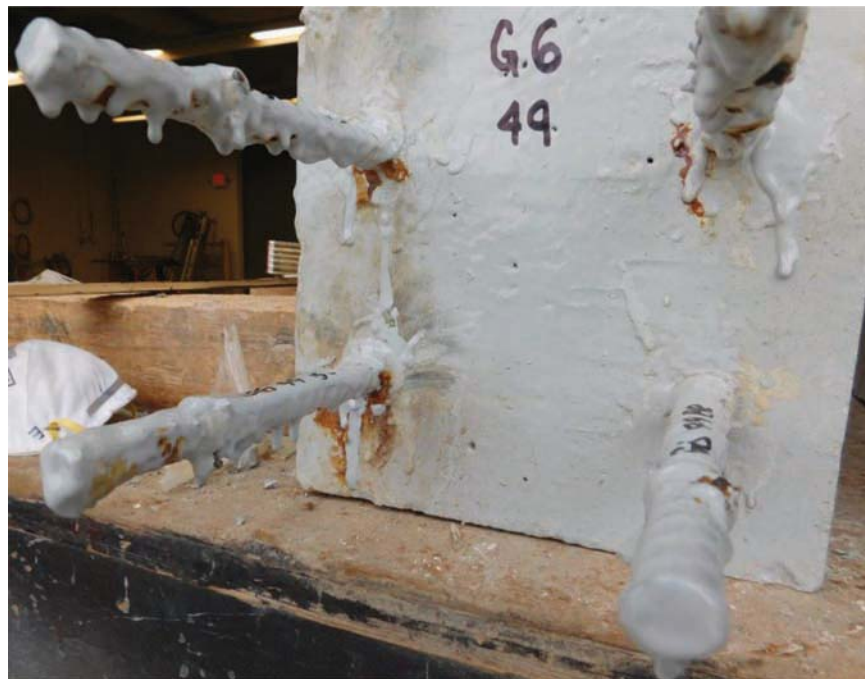
Figure 3.1 Corrosion of exposed steel.

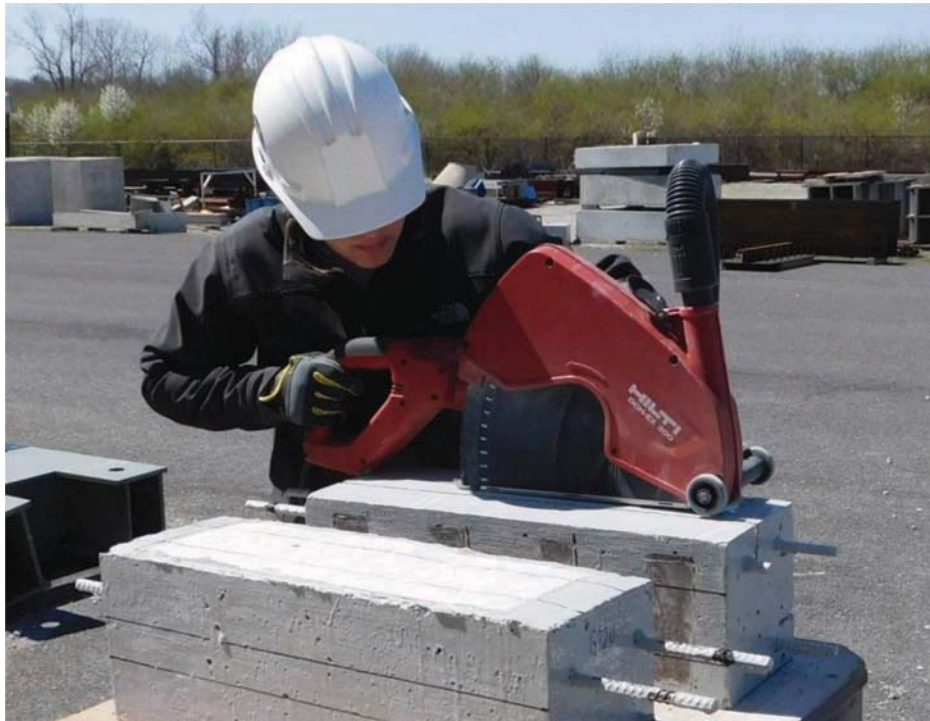
Figure 3.3 Cutting the specimens.

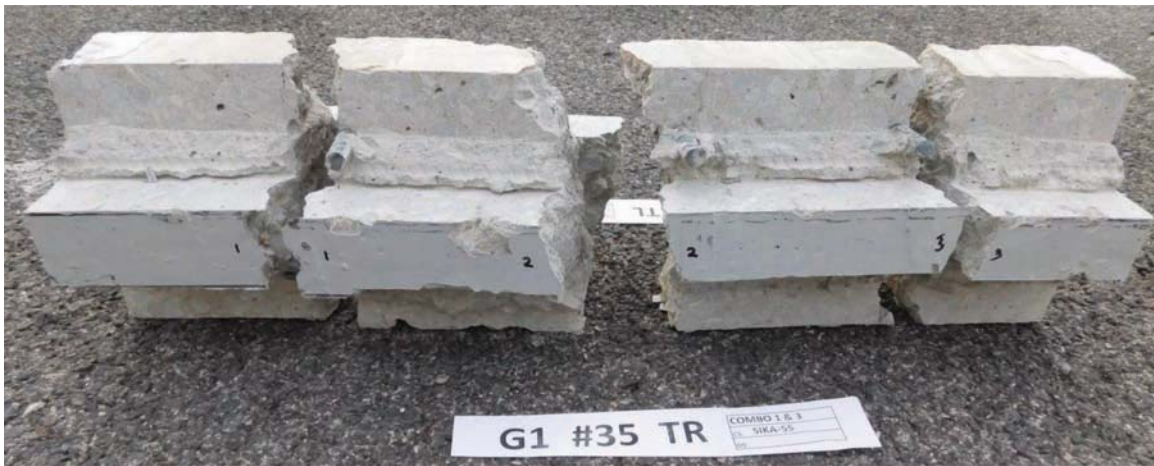
Figure 3.7 Specimen split at the cracks.

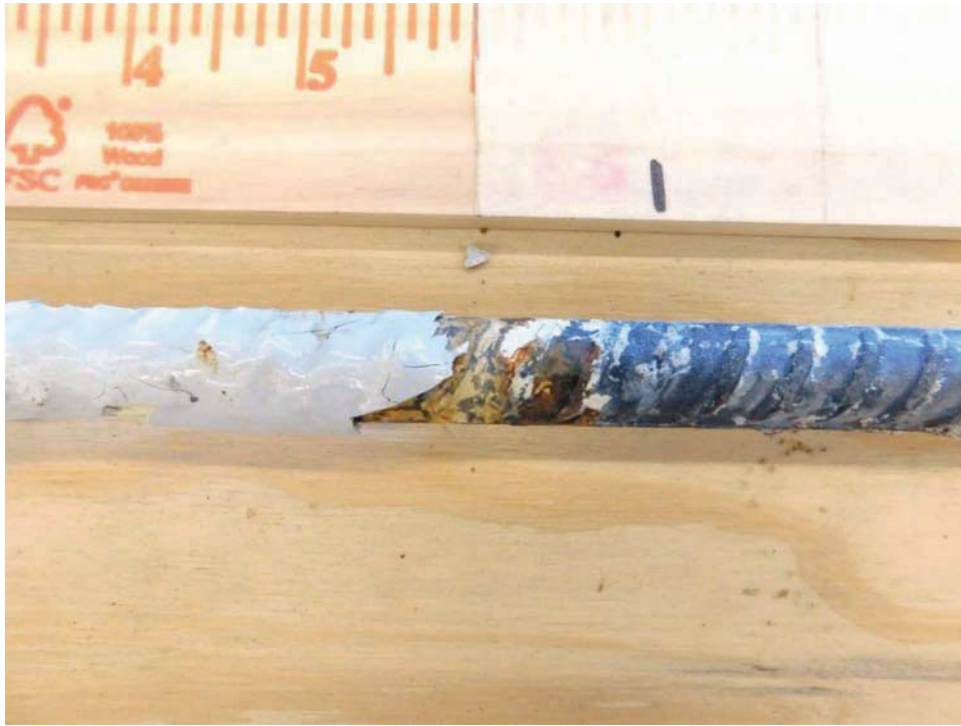
Figure 3.15 Corrosion on top half of increment No. 1.

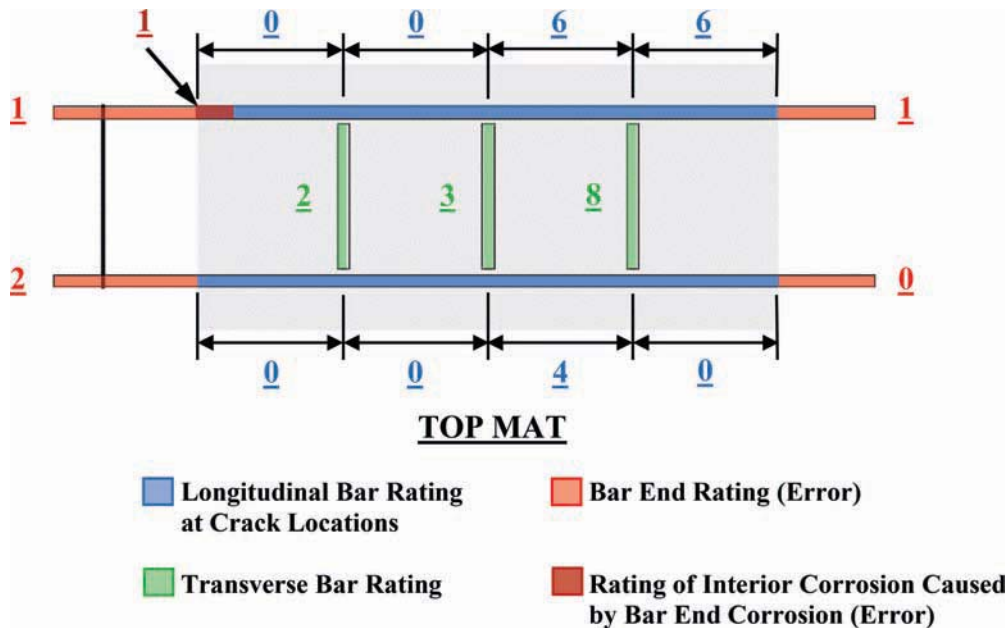
Figure 3.20 Example Autopsy Crack Location Rating (uncracked specimen).

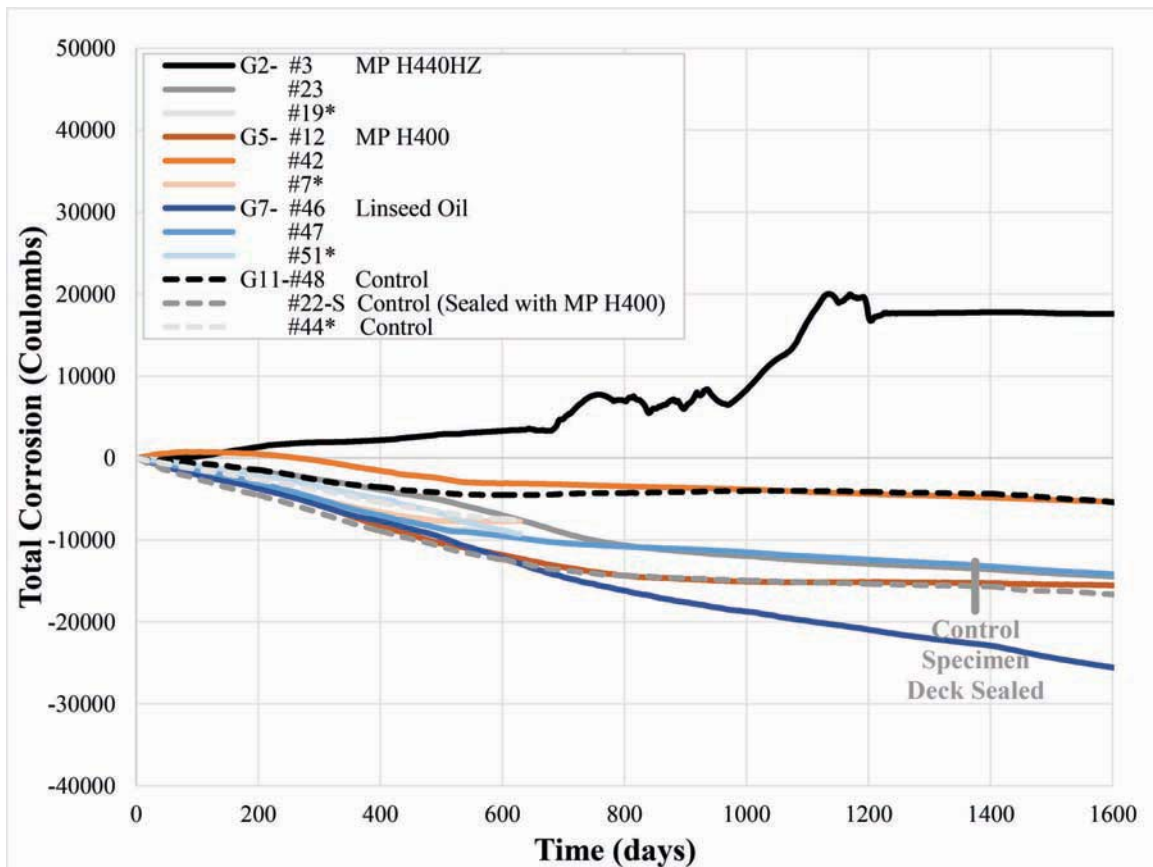
Figure 4.15 Deck sealers—electrical activity history.

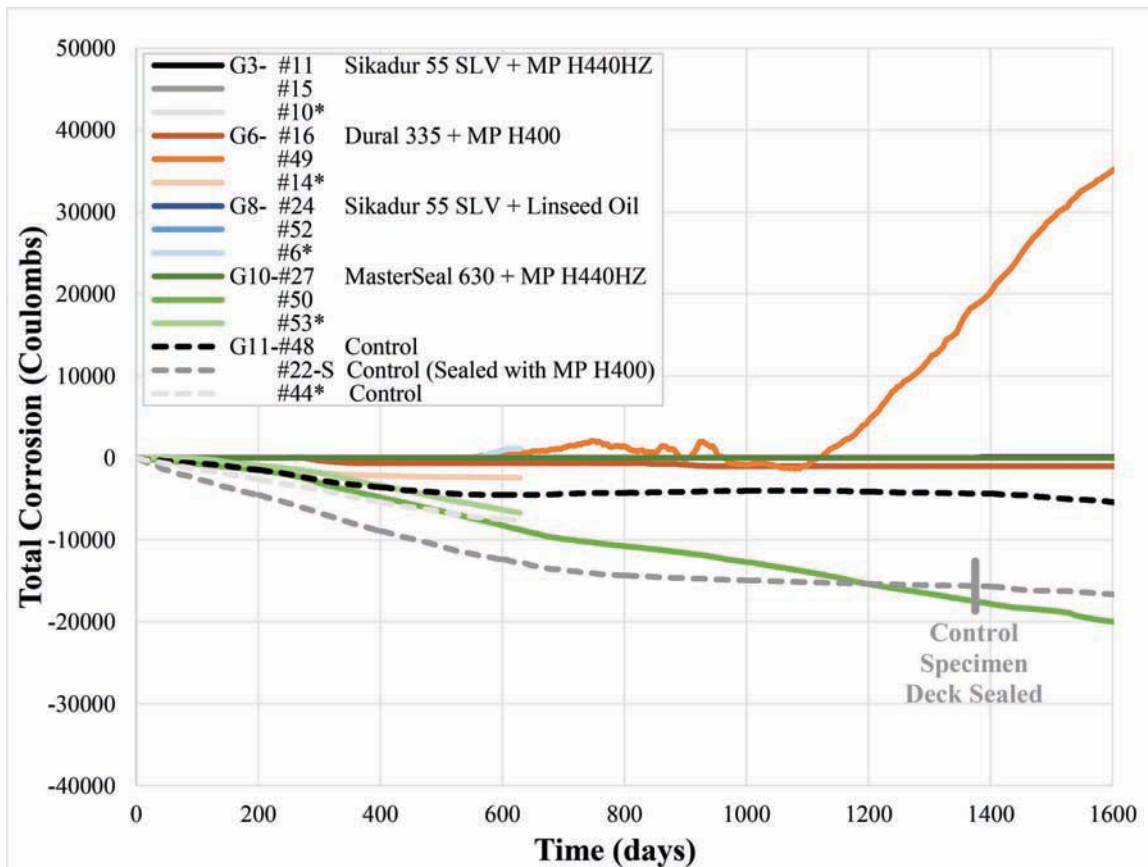
Figure 4.22 Sealer combinations—electrical activity history.

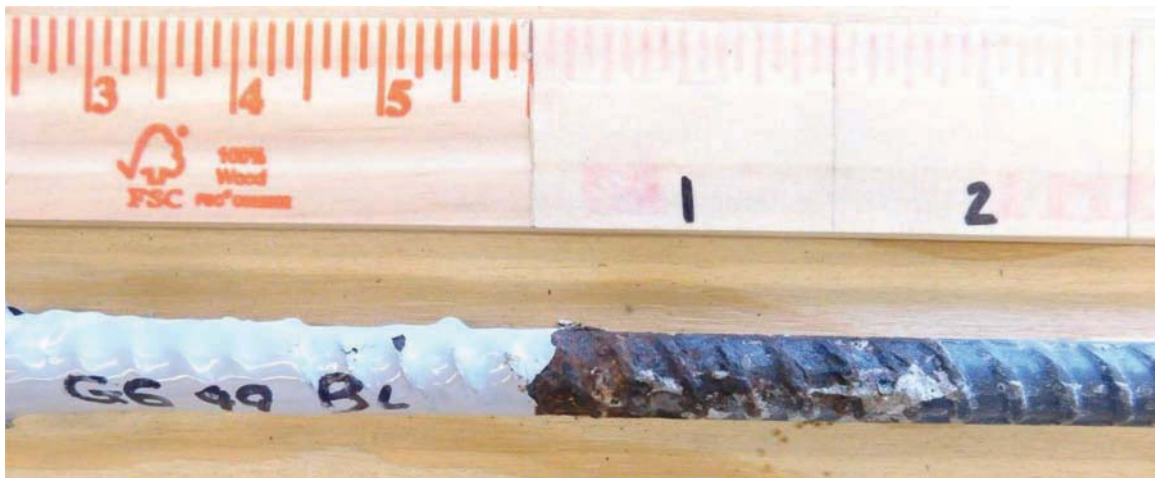
Figure 4.29 Specimen No. 49—corrosion on bottom left longitudinal bar.

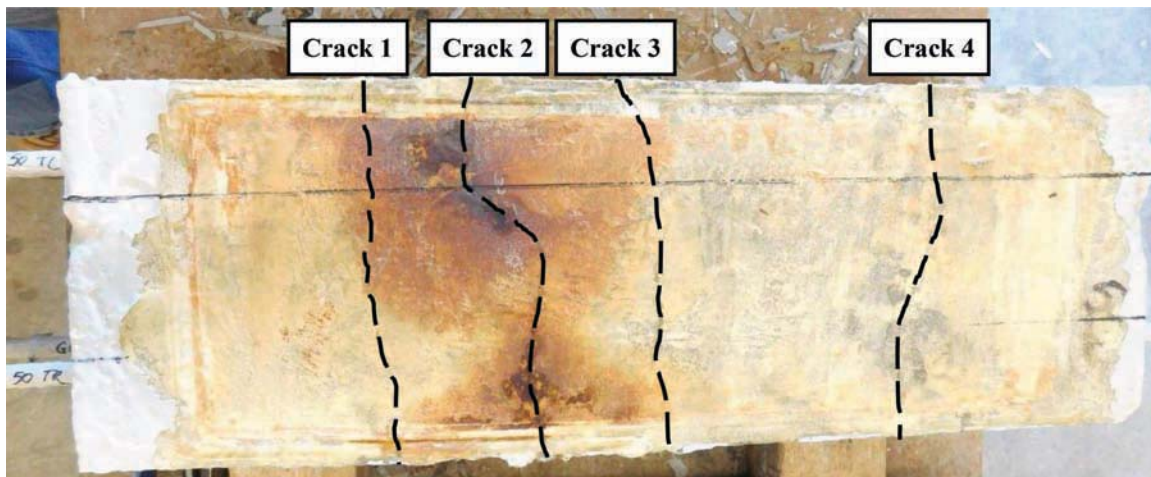
Figure 4.32 Specimen No. 50—surface corrosion staining.

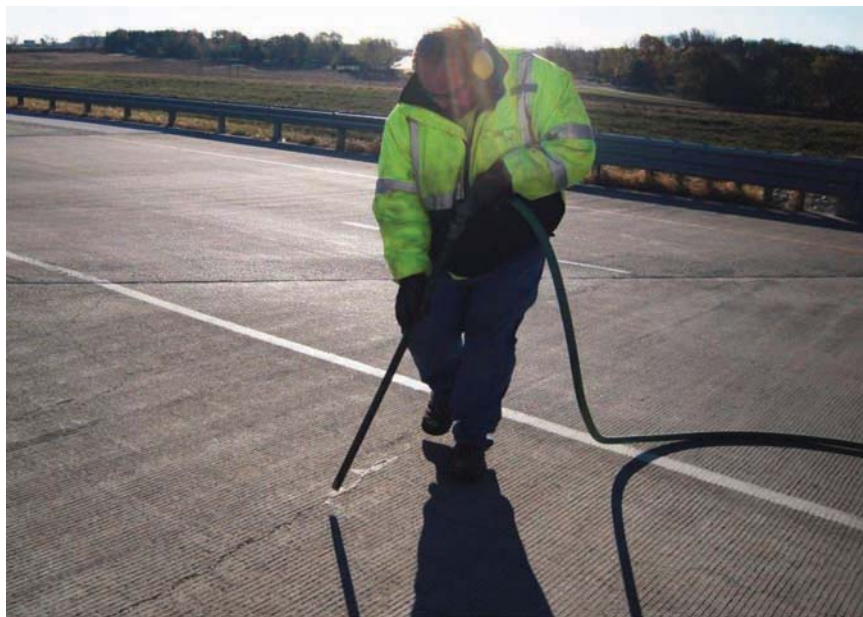
Figure 5.3 Using compressed air to clean the cracks.

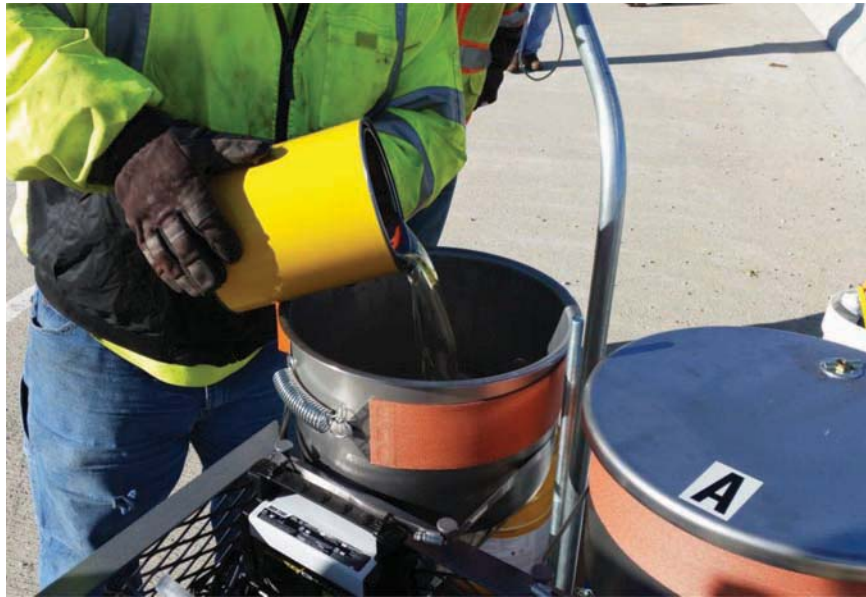
Figure 5.4 Pouring sealer components into reservoir tanks.

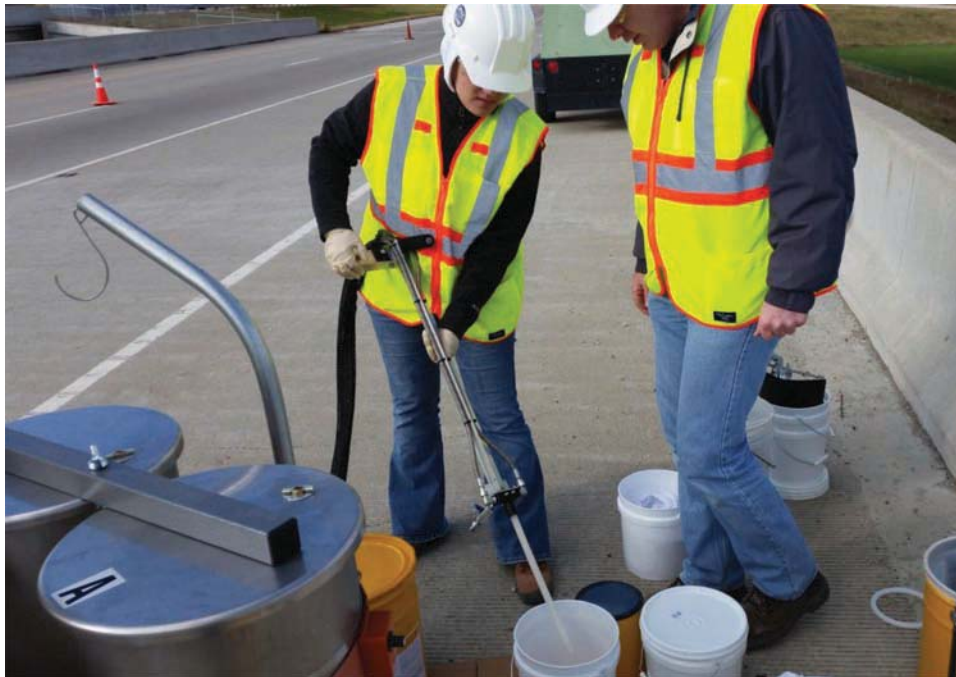
Figure 5.5 Ensuring proper mixing of sealer components.

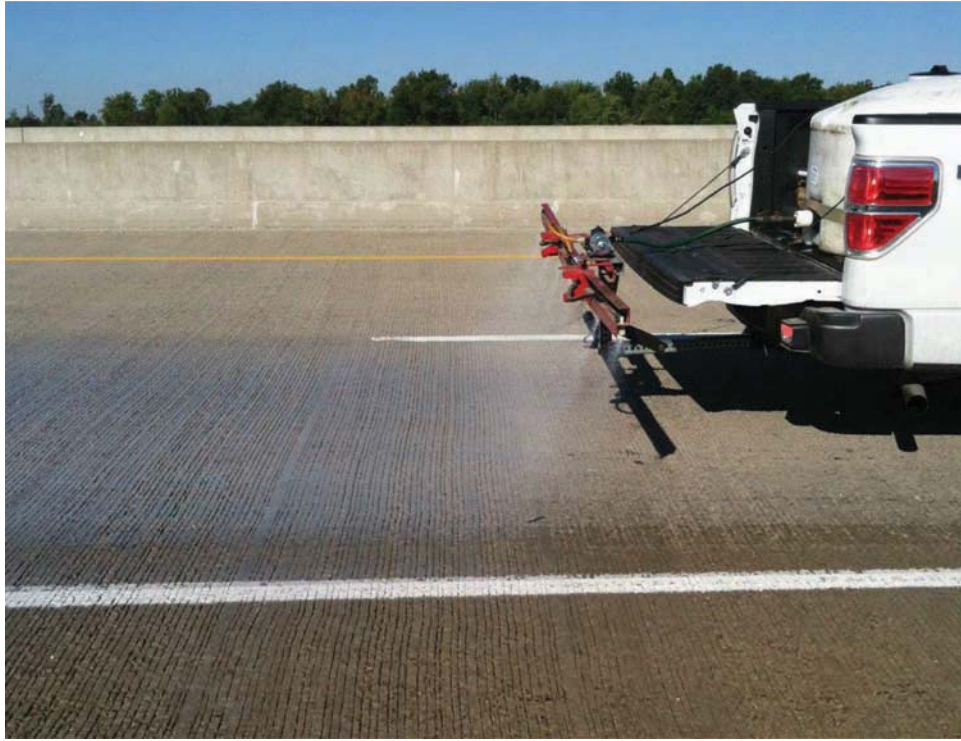
Figure 5.8 Application of MasterProtect H 400 using truck-mounted sprayer bar.
