Evaluation of the Effectiveness of ATM Messages Used During Incidents

Minnesota
Department of
Transportation

Research Project
Final Report 2016-04

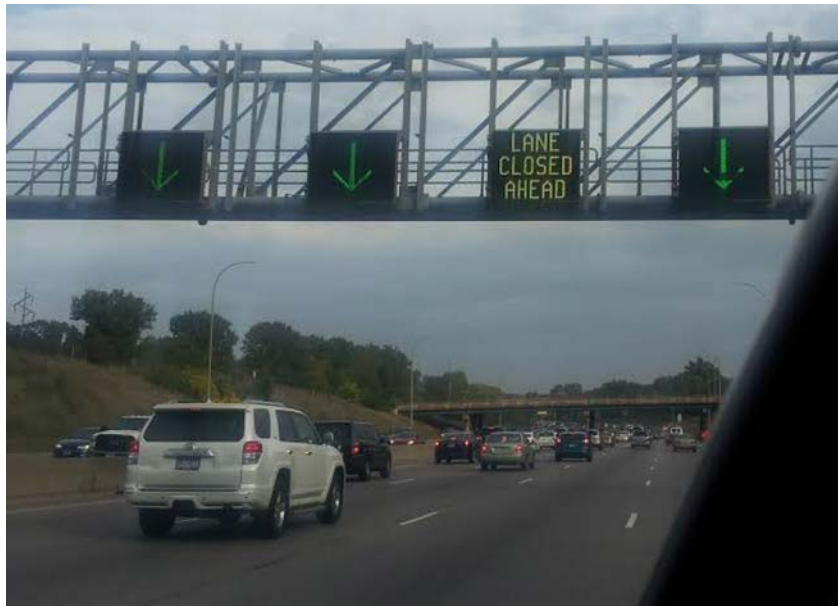
Figure 1-1. Gantry displaying ILCS messages.

Active Traffic Management (ATM) strategies have been deployed in cities all over the world to deal with rife roadway congestion and safety concerns. The Twin Cities, MN, in particular, uses many resources to deal with the ever changing roadway conditions. Two key components were developed as part of the implementation of the Intelligent Lane Control Signs (ILCS), Active Incident Management and Variable Speed Limits (VSL). Active Incident Management is a relatively new tool for traffic management. So far, two corridors in the Twin Cities have been equipped with the necessary infrastructure required by these systems, I-94 and I-35W. Active Incident Management aims to proactively warn drivers upstream of an incident by displaying various signs above each lane to alert drivers and direct them to the best route through the corridor. Driver compliance to these signs is paramount for the effectiveness of this strategy.

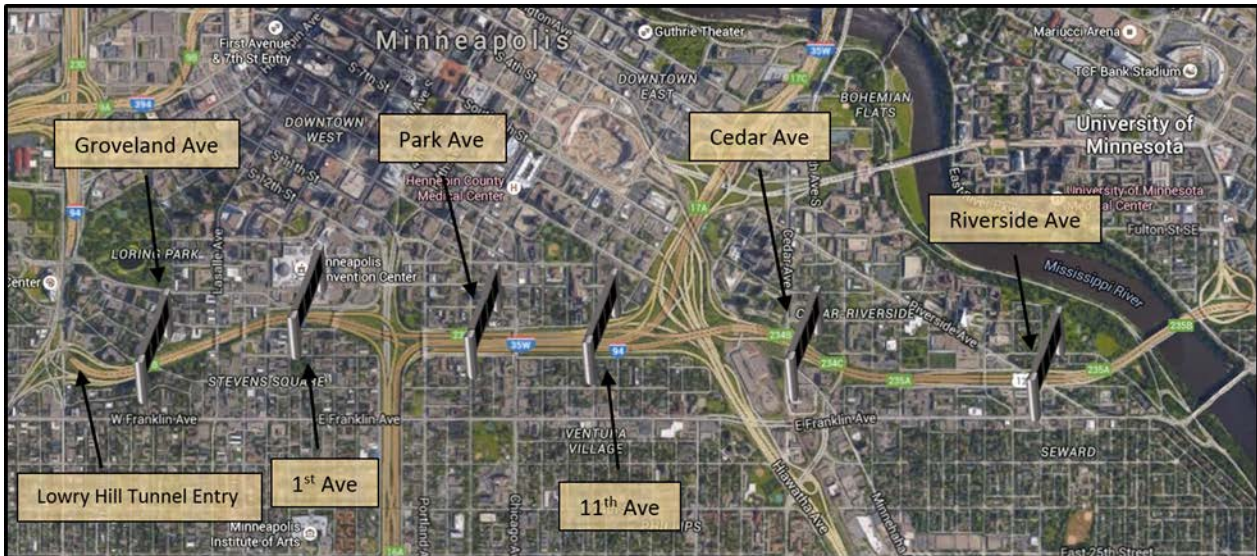
Figure 2-1. I-94/I-35W commons in Minneapolis.

Interstate 94 is the main artery connecting Minneapolis and St. Paul, and as such is a highly traveled corridor. It carries an average daily traffic volume of more than 80,000 vehicles in each direction. This study is conducted in the westbound section of I-94 from Riverside Avenue to the Lowry Hill Tunnel. A 1.7 mile section of the interstate from 11th Avenue to the Lowry Hill Tunnel has been identified by MnDOT as the highest crash area in the state. The crash rate in this corridor for the study period was 4.81 crashes/MVM (million vehicles miles) which is roughly equivalent to one crash every two days. This corridor was equipped with the ILCS as a strategy to deal with pervasive congestion and safety concerns.

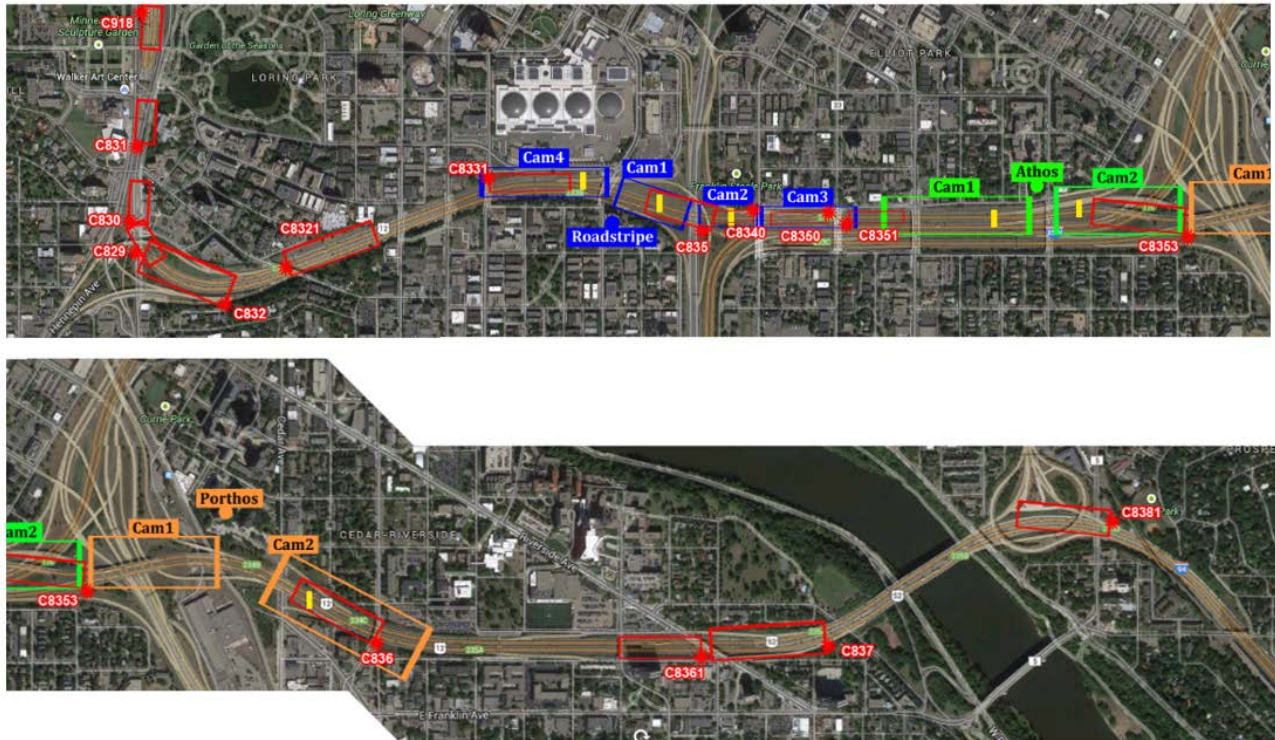
The region of interest is the corridor of I-94 westbound from Riverside Avenue to the Lowry Hill Tunnel. Along this section of I-94 there are eight rooftop cameras controlled by the MTO referred to as the Beholder system. Beholder is made up of cameras emplaced on three rooftops along the corridor. Four cameras are located on an apartment building at 1707 3rd Ave S Minneapolis, MN (designated Roadstripe). The two Athos-designated cameras are located at Augustana, a senior living center located at 1020 E 17th St Minneapolis, MN. Two cameras are located on a Minneapolis Public Housing building located at 730 Cedar Ave Minneapolis, MN (designated Porthos). Supplementing these cameras are sixteen RTMC cameras which were captured on the MTO's Galileo system, consisting of four-channel recording devices. Galileo 1 contains the DVR1 videos which contains four separate cameras DVR1 – Cam1, DVR1 – Cam2, DVR1 – Cam3, and DVR1 – Cam4. Galileo 2, 3, and 4 have the same organization. The Galileo videos' internal naming scheme and their locations are shown in Table 2-1. Figure 2-1 shows the locations of the Beholder and Galileo cameras and the stretch of I-94 that they observe. This corridor contains six ILCS gantries of interest (L94W42 – L94W52) shown in further detail later in this report.

Beholder (MTO)

Galileo

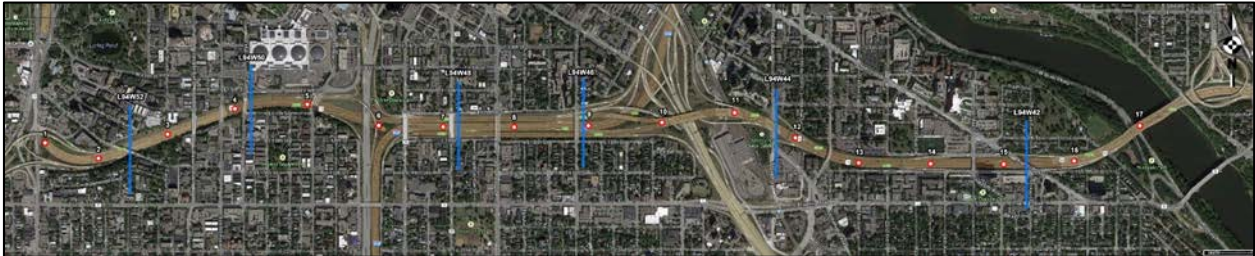
Figure 3-1. ILCS gantry locations along I-94 westbound.

- Events were narrowed down to the corridor of interest shown in Figure 3-1. The gantries included in this project indicated by their device ID are as follows.
 1. L94W52
 2. L94W50
 3. L94W48
 4. L94W46
 5. L94W44
 6. L94W42

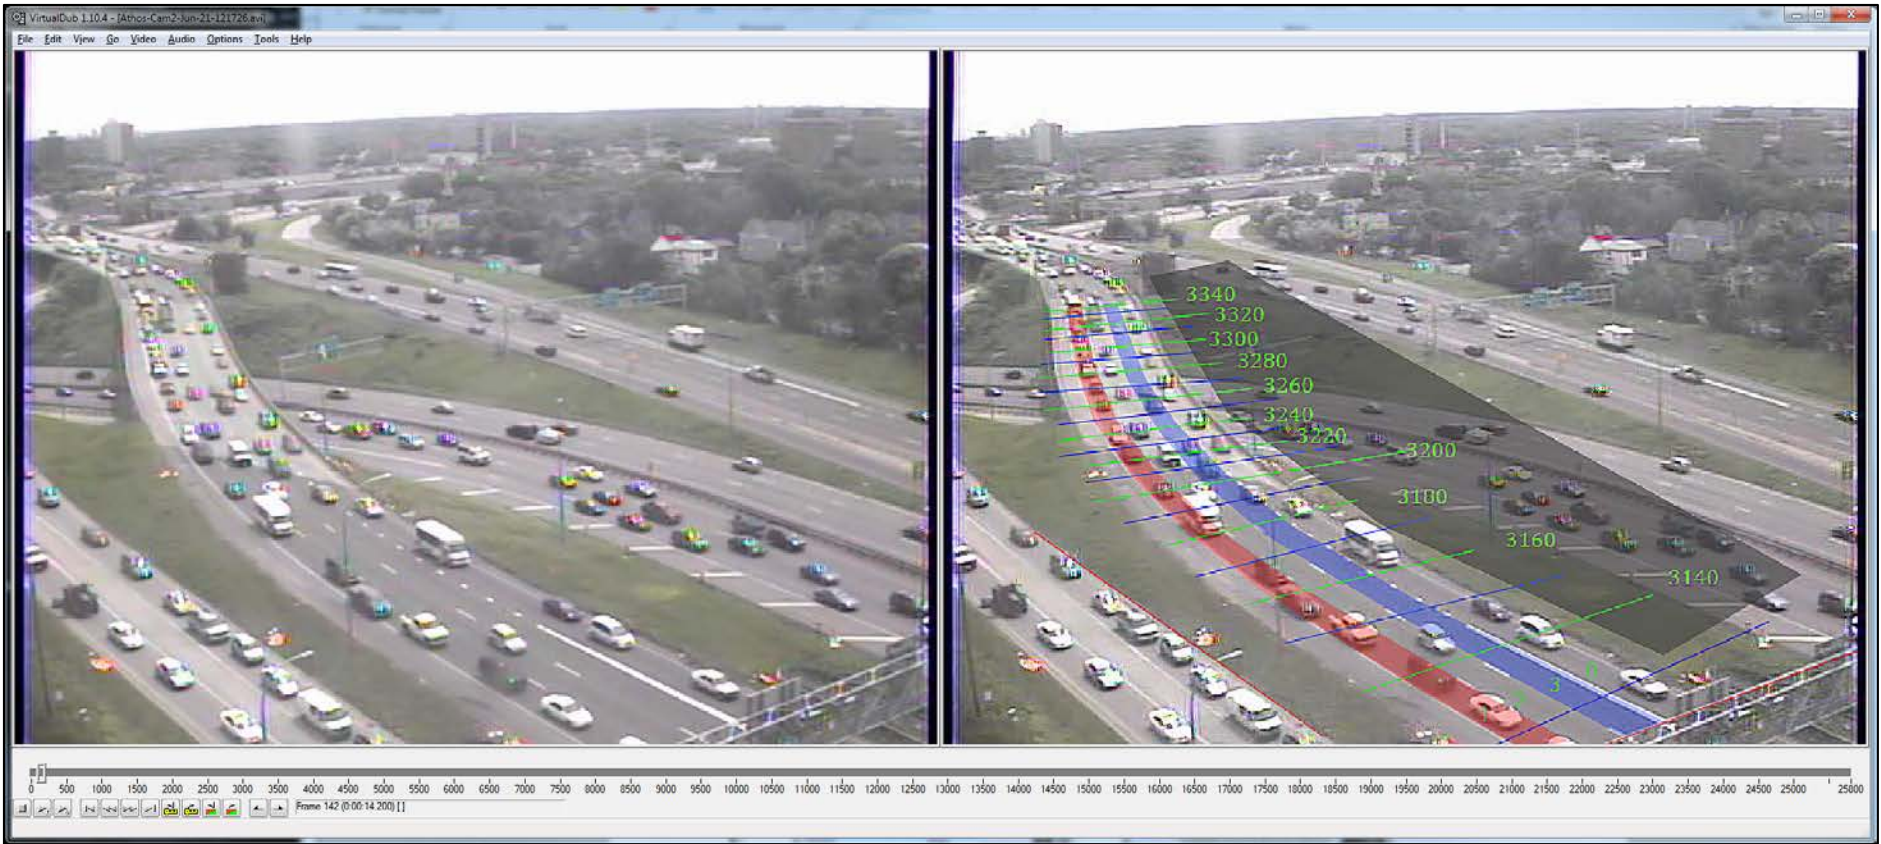
Figure 3-4. Ortho-rectified distance overlays for lane change geo-location.

In each ortho-rectified image, landmarks were used as reference points to map the freeway and place the evenly-spaced 10 meter marks so that they matched the GIS point set. With each increment noted on the rectified image, marks were added to the actual camera screenshot accounting for perspective. The end result of these efforts can be seen in Figure 3-4 below.

As can be seen in the figure, in addition to the increment markings, lanes were highlighted and numbered and additional reference lines were added to ensure that the overlay matched the view captured by the camera. In most cases the camera views shifted slightly across the capture period, resulting in multiple slightly shifted overlays for each location.

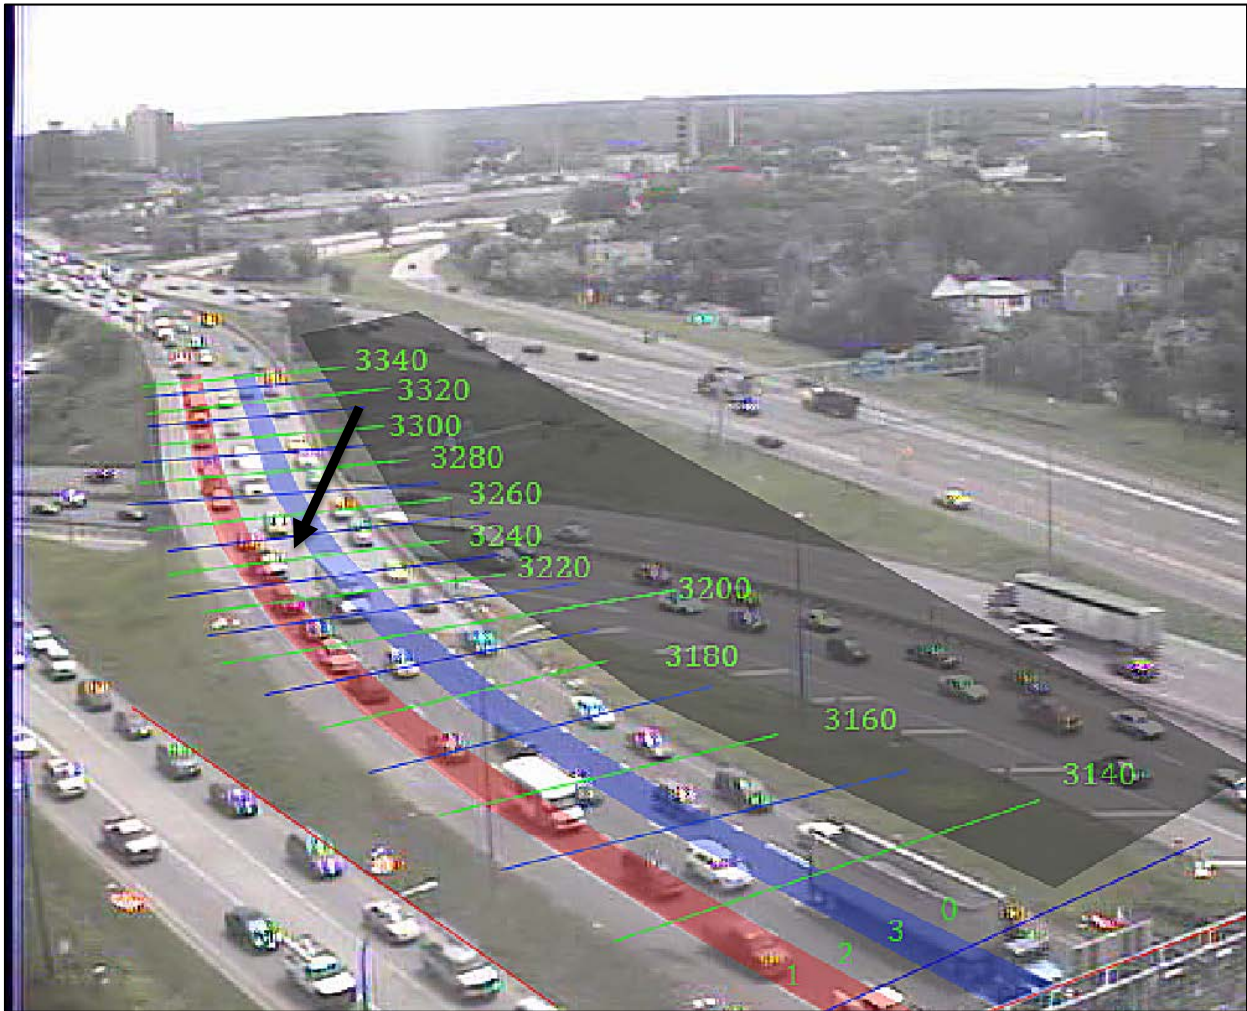
Figure 3-5. Example of a lane change, marker 3240.

By adding the overlay to each video image, lane changes into and out of targeted lanes were collected for ILCS events. Lane changes were noted at the point when a vehicle entered into an adjacent lane far enough to 'control' the lane. In most cases this was when the front of the vehicle had traversed 75% of the way to fully over the lane line. An example can be seen in Figure 3-5 with the truck changing lanes at marker 3240 in the middle of the screen. Lane changes were noted in both space and time, allowing for further analysis as will be described further in the report.

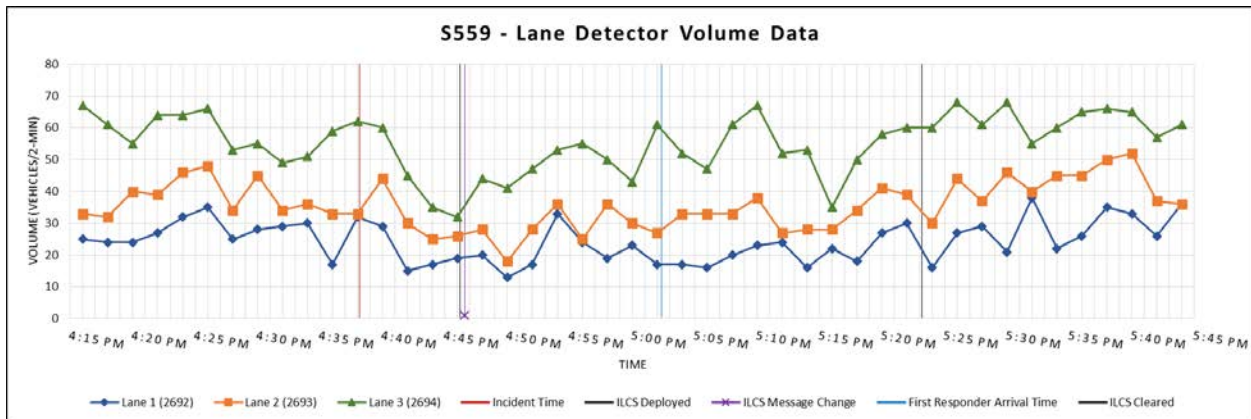
Figure 4-2. Volume data at Station 559 (upstream of 11th Avenue) - 8/13/2013.

Lane three showed a drop in volume and speed after the shockwave from the incident reached 11th Avenue. Speeds and volumes recovered after the implementation of the ILCS, but remained highly variable over the remainder of the event. Lanes one and two were largely unaffected by the presence of the incident vehicles on the shoulder and the deployment of the ILCS.

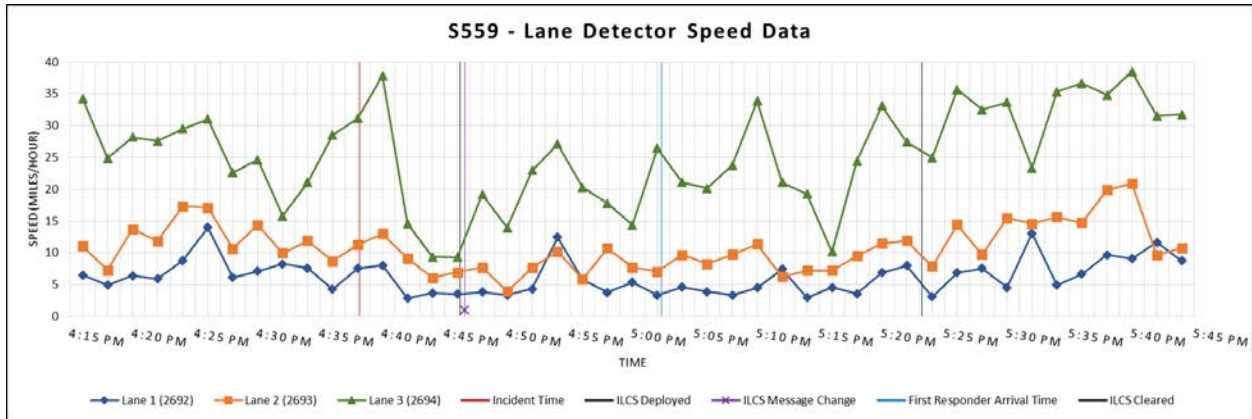
Figure 4-3. Speed data at Station 559 (upstream of 11th Avenue) - 8/13/2013.

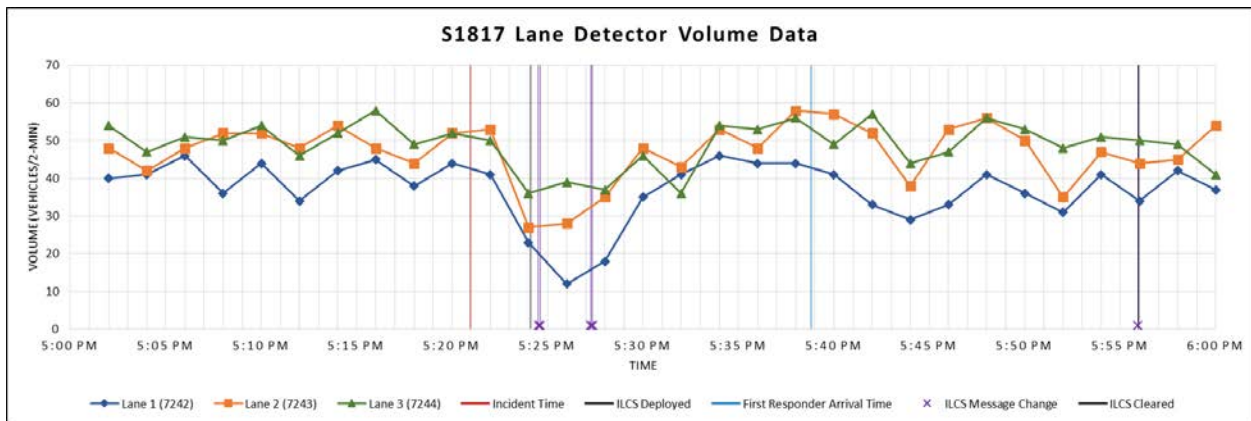
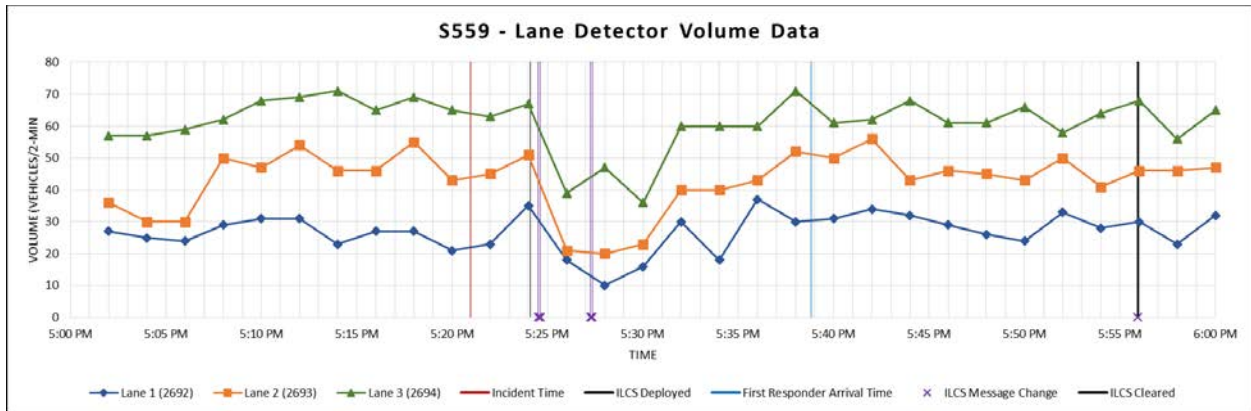
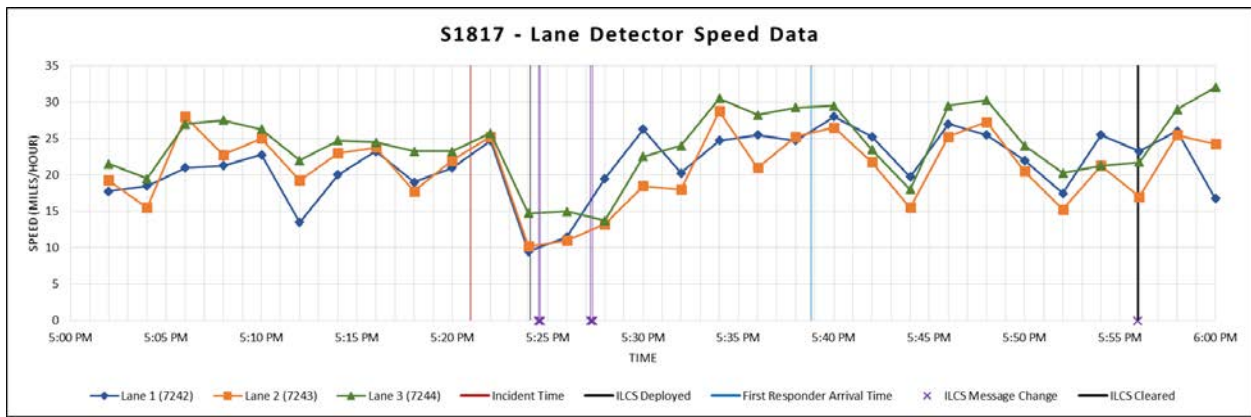
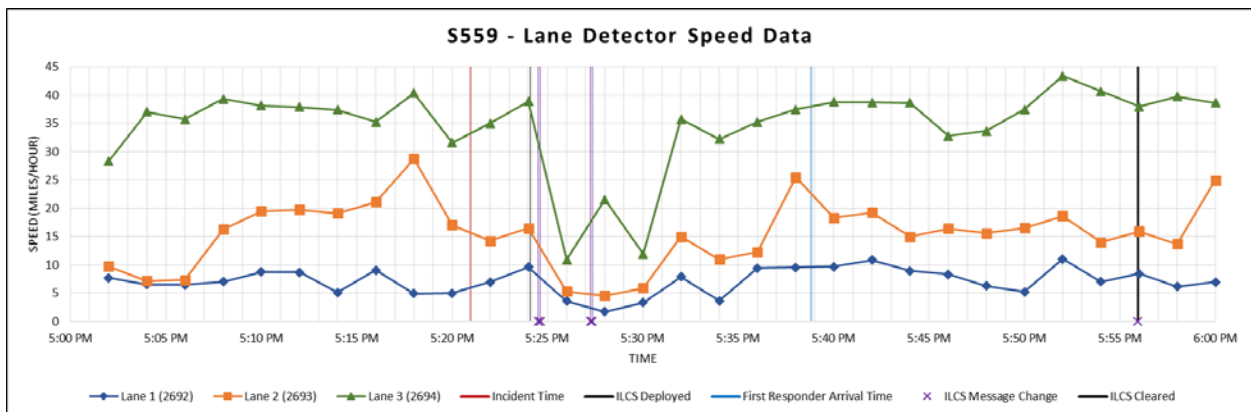
Figure 4-7. Volume data at Station 1817 (Park Avenue) - 8/2/2013.

Figure 4-8. Volume data at Station 559 (upstream of 11th Avenue) - 8/2/2013.

Figure 4-9. Speed data at Station 1817 (Park Avenue) - 8/2/2013.

Figure 4-10. Speed data at Station 559 (upstream of 11th Avenue) - 8/2/2013.

The loop detector data show the shockwaves emanating from the crash. All three lanes experienced a severe reduction in volume and speed, first at station 1817 near Park Avenue, then at 11th Avenue a short time later. Once the ILCS system was activated, speeds and volumes began to return to pre-incident levels. Stable traffic patterns remained throughout the rest of the event.

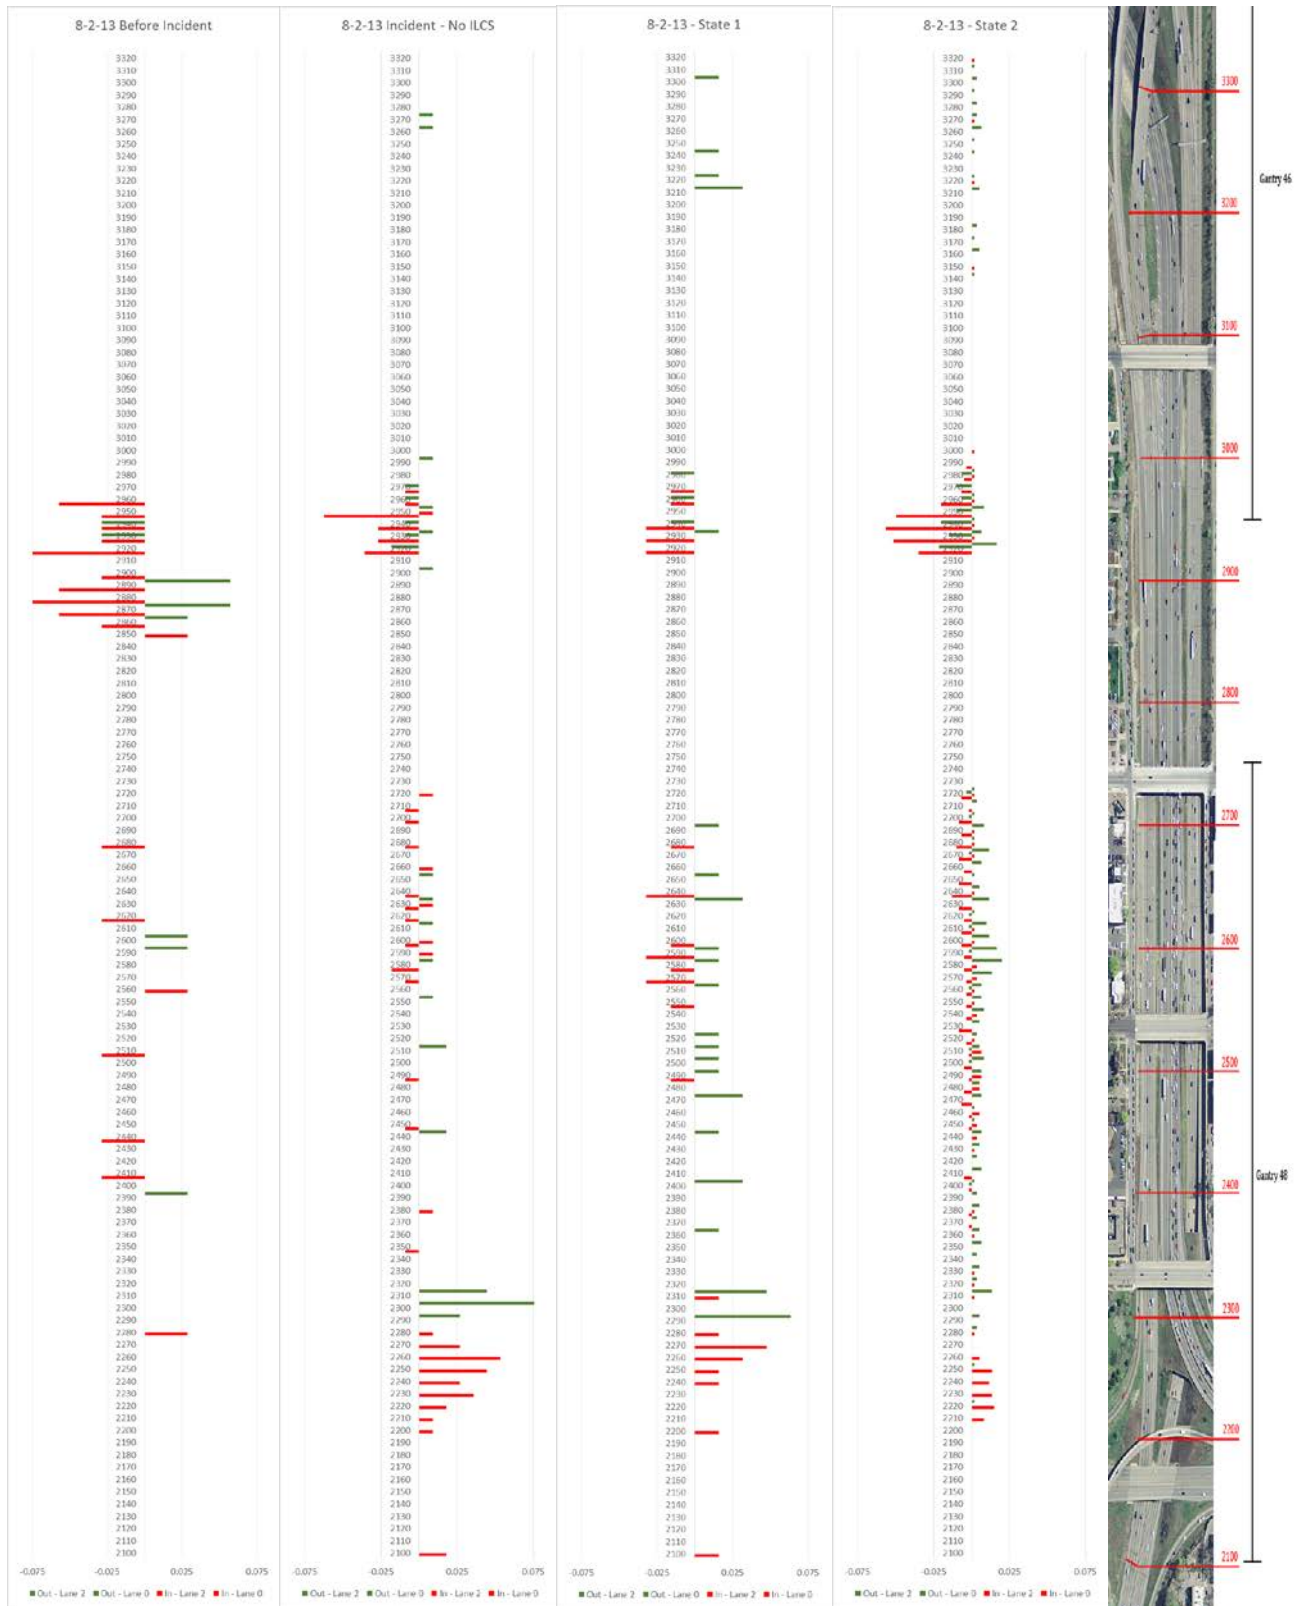
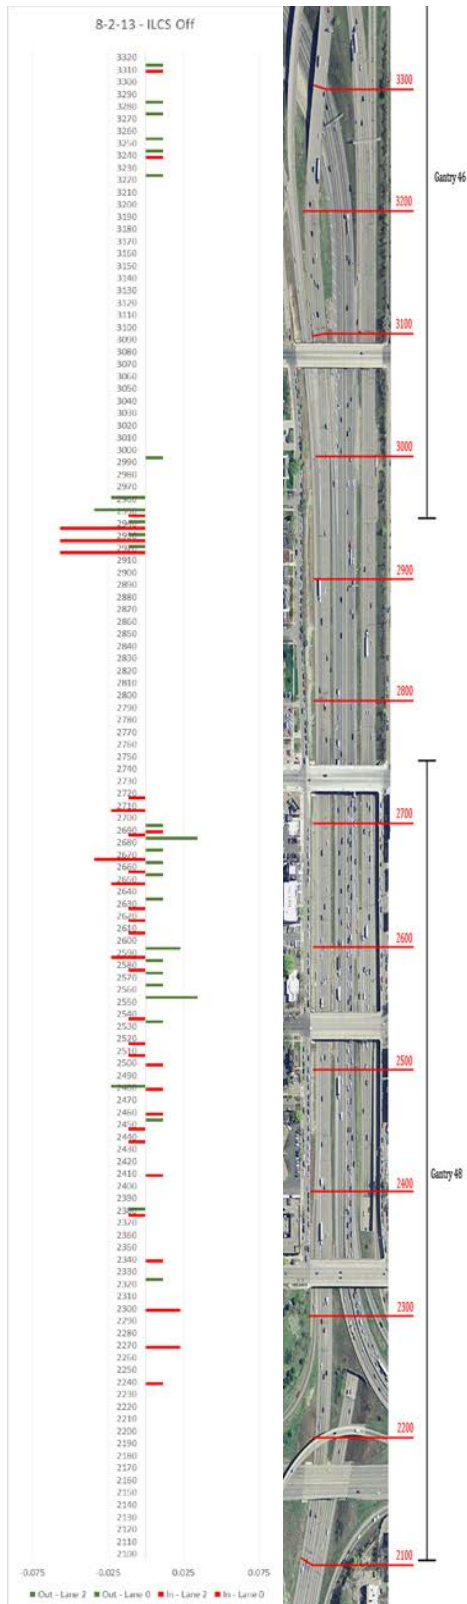
Figure 4-11. Lane changes by state for 8/2/2013.

Figure 4-12. Lane changes by state for 8/2/2013 continued.

Lane changes along the corridor prior to the incident exhibited the normal pattern for the region: significant lane changes into and out of lane one occurred at the merge point just west of 11th Avenue and sparse lane changes throughout the remaining corridor. The incident itself can be clearly seen with a pattern of exiting and re-entering lane changes near Portland Avenue. The activation of the ILCS appeared to induce exiting lane changes throughout the space between 11th Avenue and Portland in anticipation of passing the incident area.

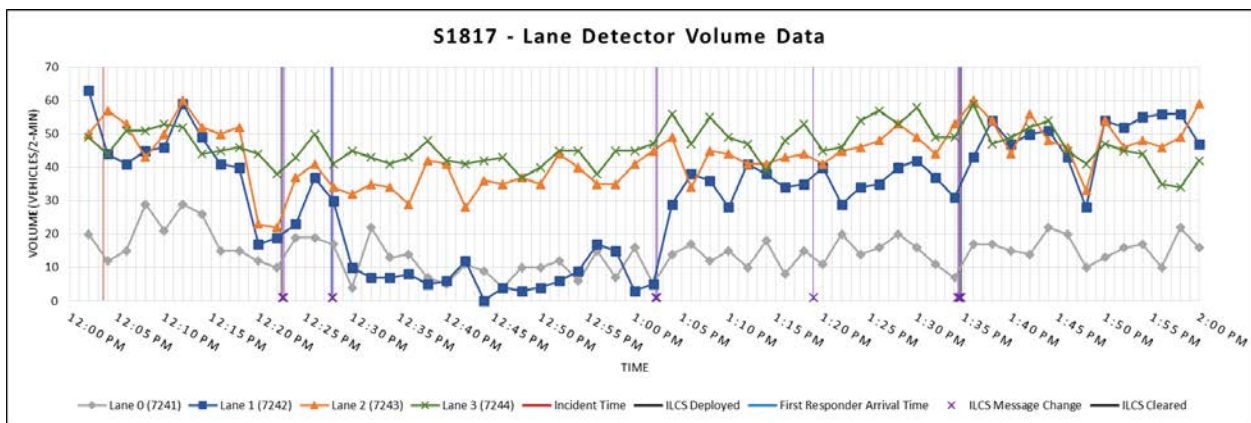
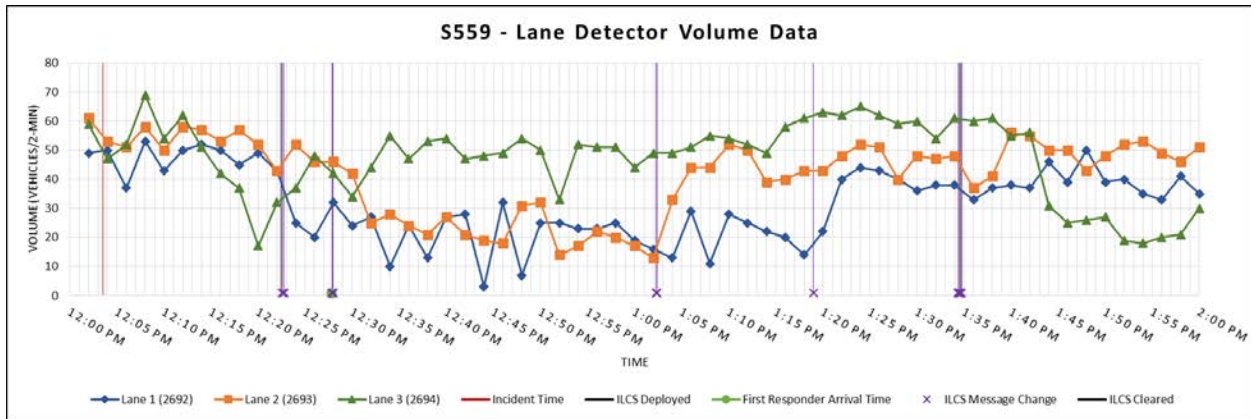
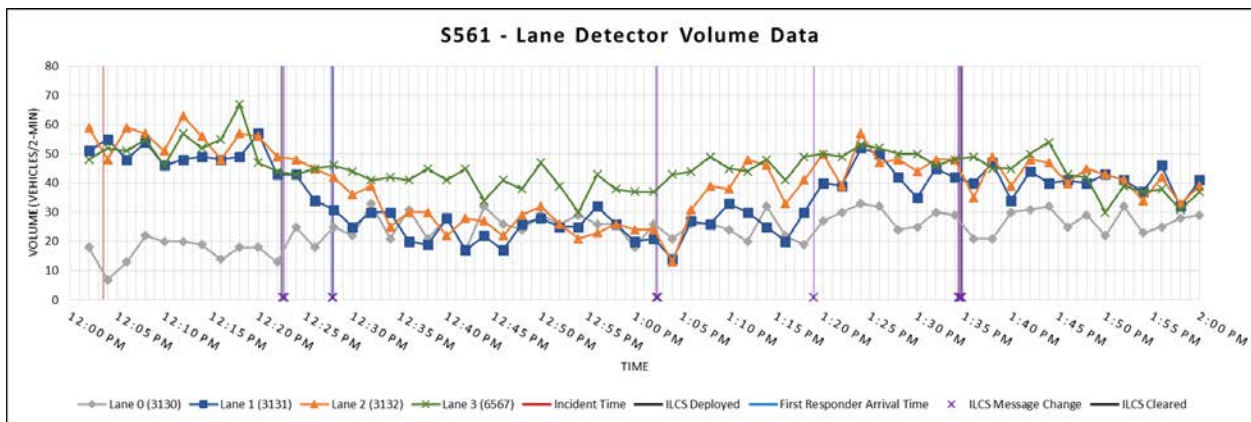
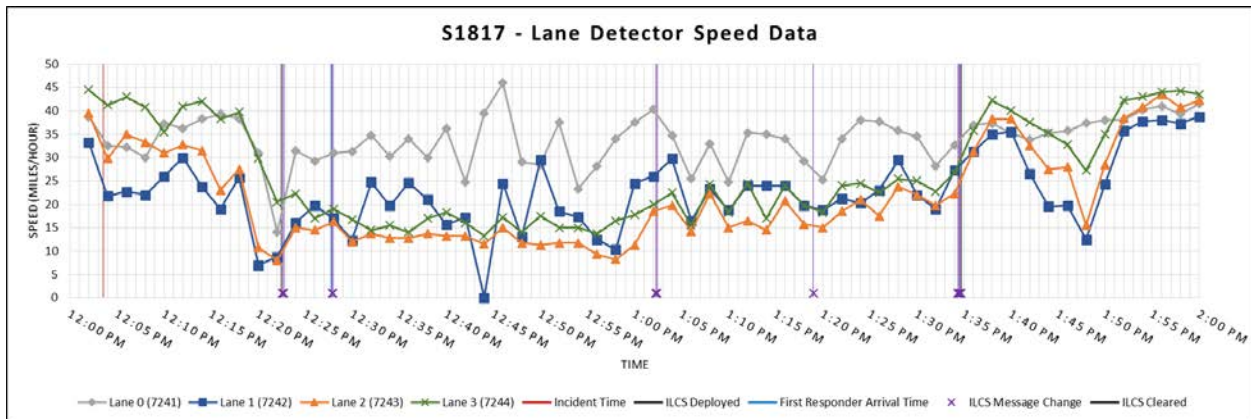
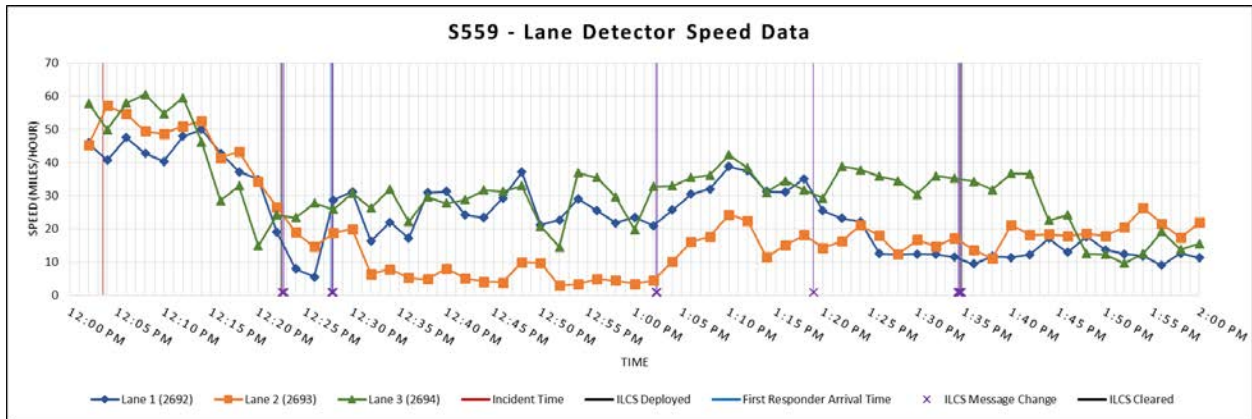
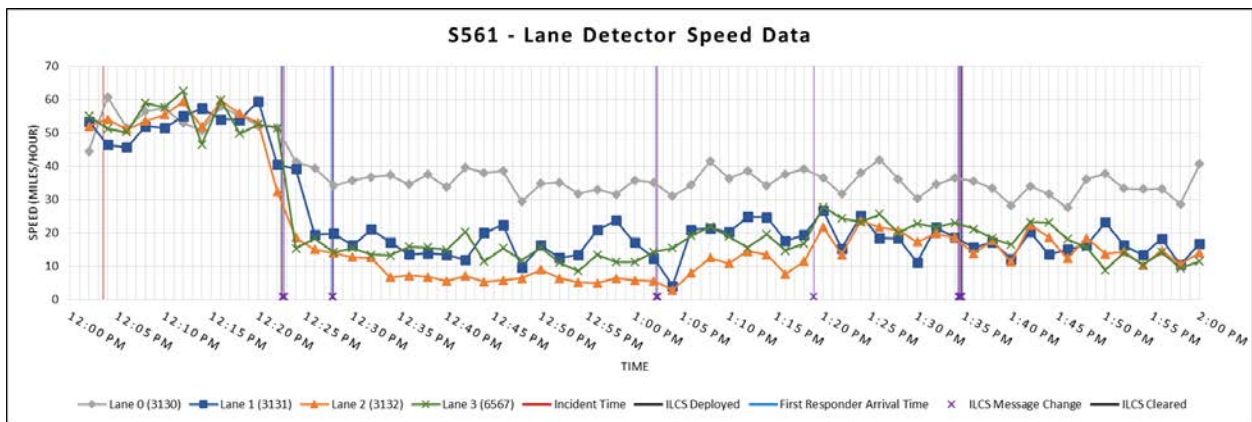
Figure 4-17. Volume data at Station 1817 (Park Avenue) - 6/21/2013.

Figure 4-18. Volume data at Station 559 (upstream of 11th Avenue) - 6/21/2013.

Figure 4-19. Volume data at Station 561 (Cedar Avenue) - 6/21/2013.

Figure 4-20. Speed data at Station 1817 (Park Avenue) - 6/21/2013.

Figure 4-21. Speed data at Station 559 (upstream of 11th Avenue) - 6/21/2013.

Figure 4-22. Speed data at Station 561 (Cedar Avenue) - 6/21/2013.

The loop detector data along the corridor captured the propagation of queues upstream of the incident. Although the first crash at 12:03 produced a small decrease in speeds for lane one at Station 1817, conditions upstream were unaffected. The secondary crash at 12:16 produced a much larger and sharper decrease in speed and volume for both lane one and two. A recovery in speed for both lanes can be noted after the activation of the ILCS and the clearing of lane one.

As the congestion wave moved upstream, speeds and volumes decreased at Station 559 at roughly 12:22 and station S561 at roughly 12:25. Once the congestion reached each station, speeds remained roughly stable until much later within the incident.

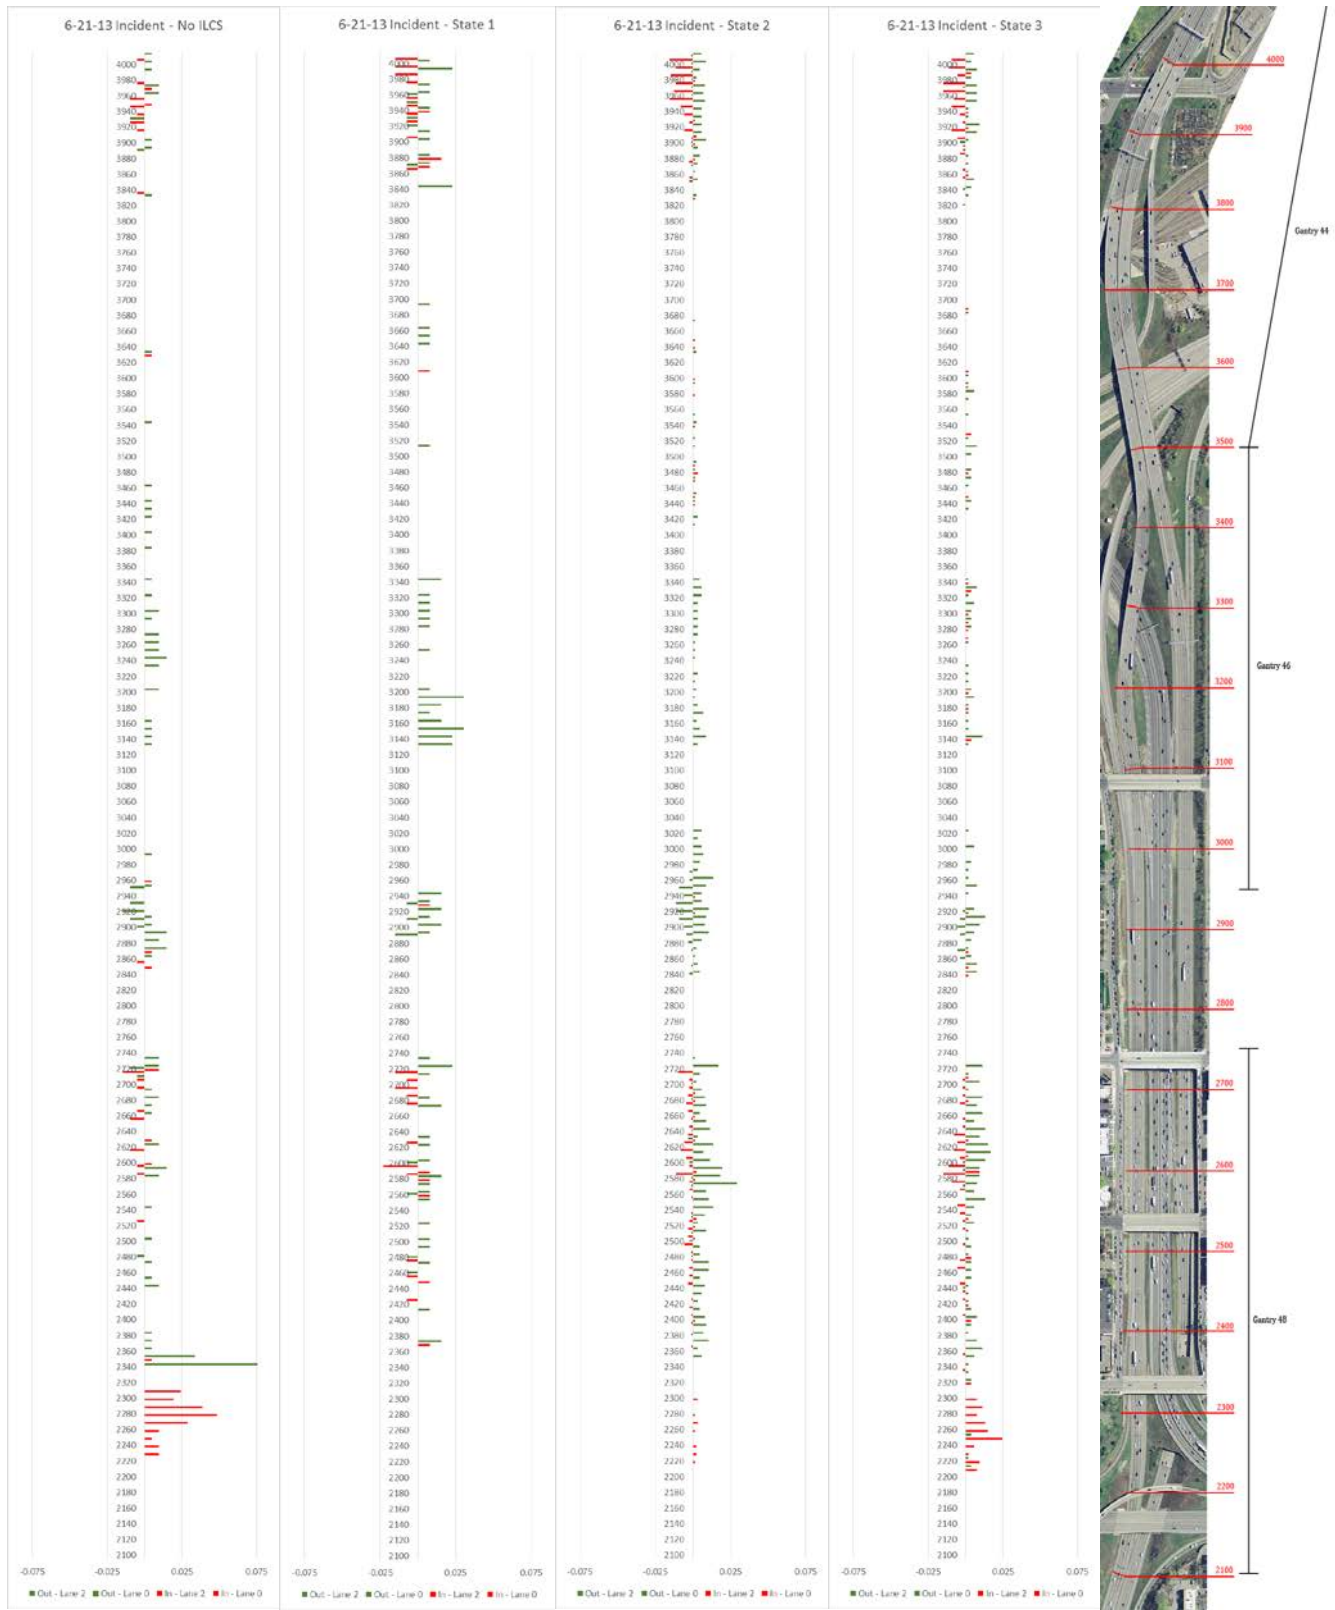
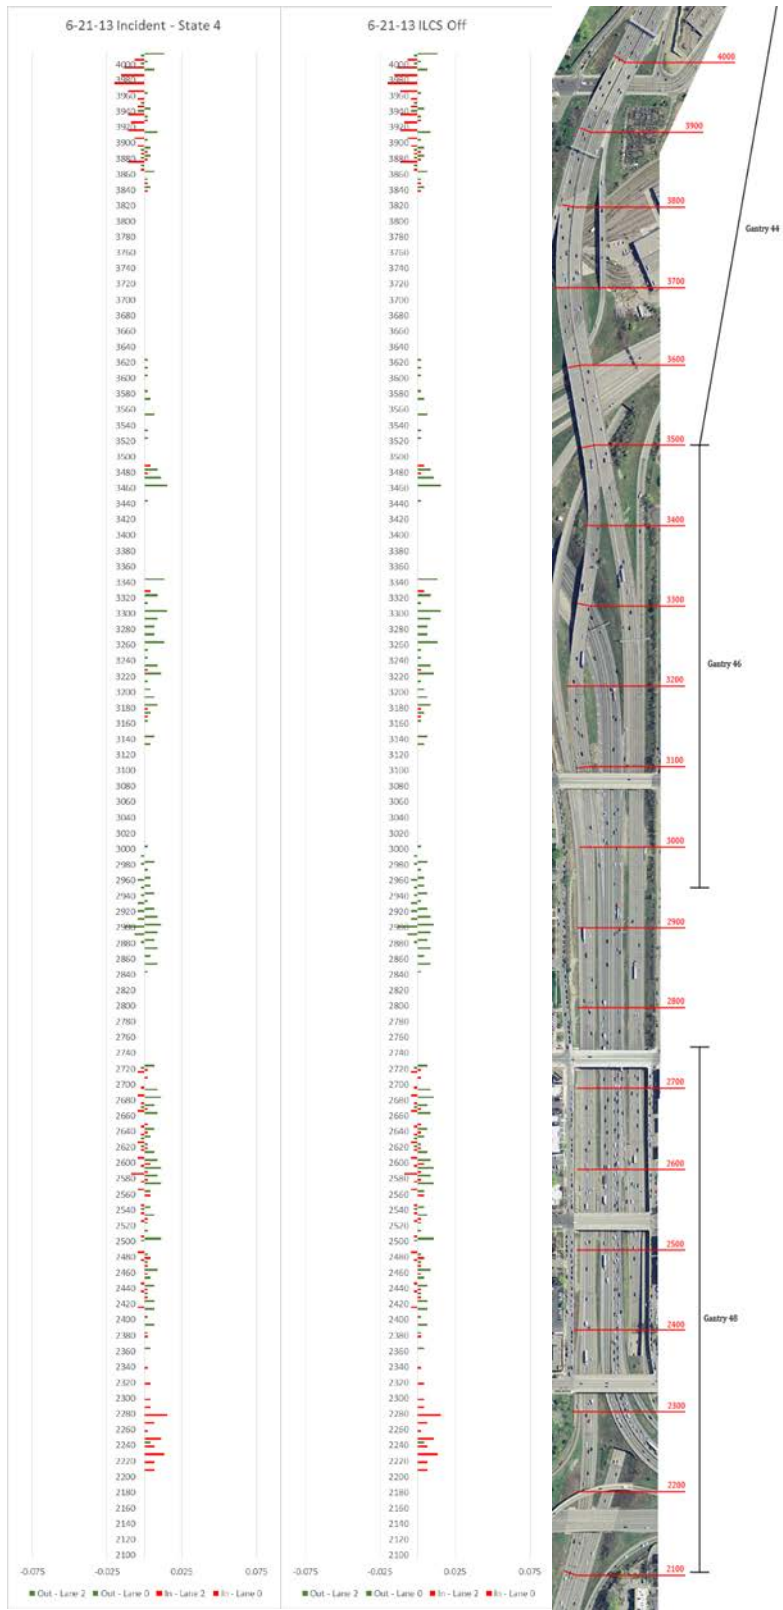
Figure 4-23. Lane changes by state for 6/21/2013.

Figure 4-24. Lane changes by state for 6/21/2013 continued.

The lane changes for this incident clearly show the location of the crash prior to the activation of the ILCS. Once the signs were deployed, strong positive lane changes were observed, especially just upstream of gantry 46 (the first sign showing a Lane Closed message), with a more mixed effect around gantry 48. The response at the LCA sign at gantry 44 is, like gantry 48, mixed with lane changes both in and out of lane one. This suggests that encountering the Lane Closed sign is a strong signal to drivers to depart the lane.

Throughout the other states, similar positive effects can be observed near gantries 46 and 48, although their impact is diminished after the Lane Closed signs are replaced with Use Caution.
