Evaluation of the Effectiveness of ATM Messages Used During Incidents

Minnesota
Department of
Transportation

Research Project
Final Report 2016-04

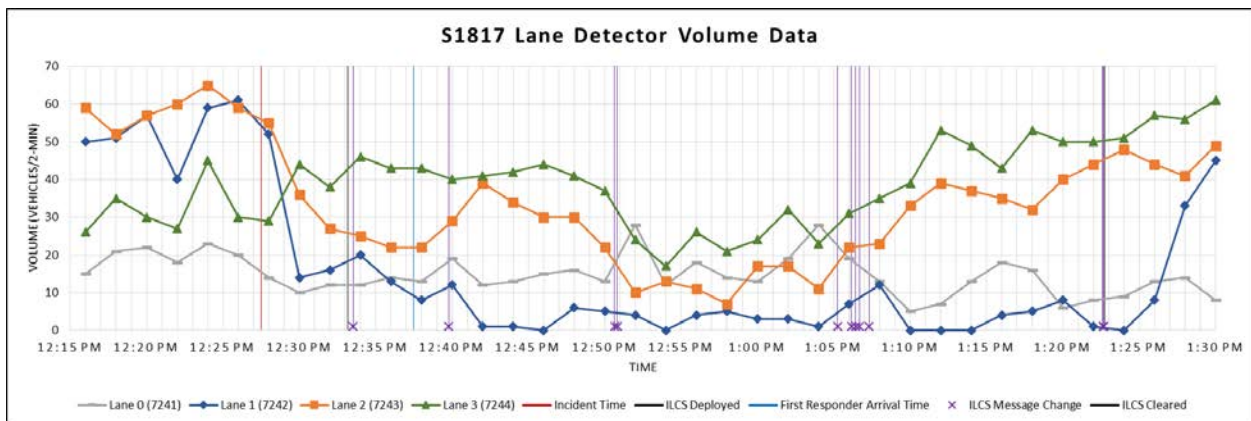
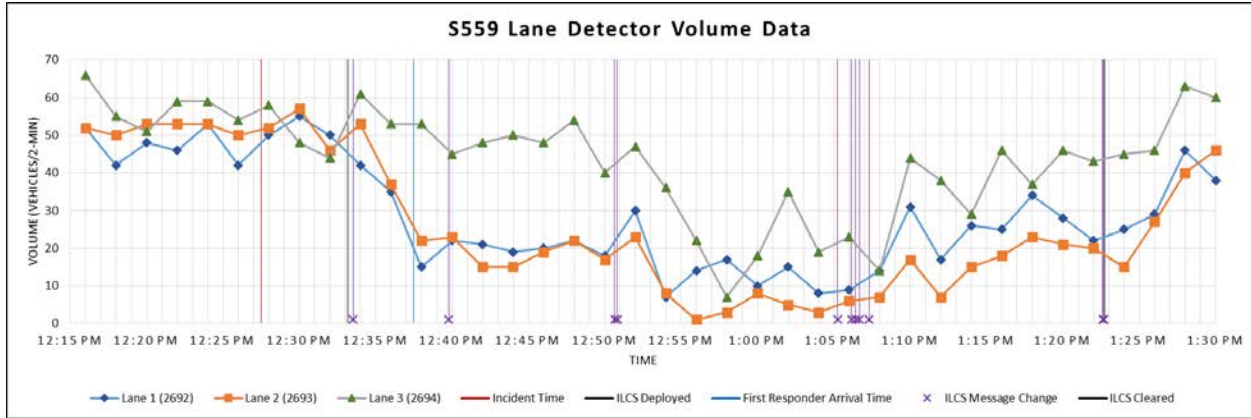
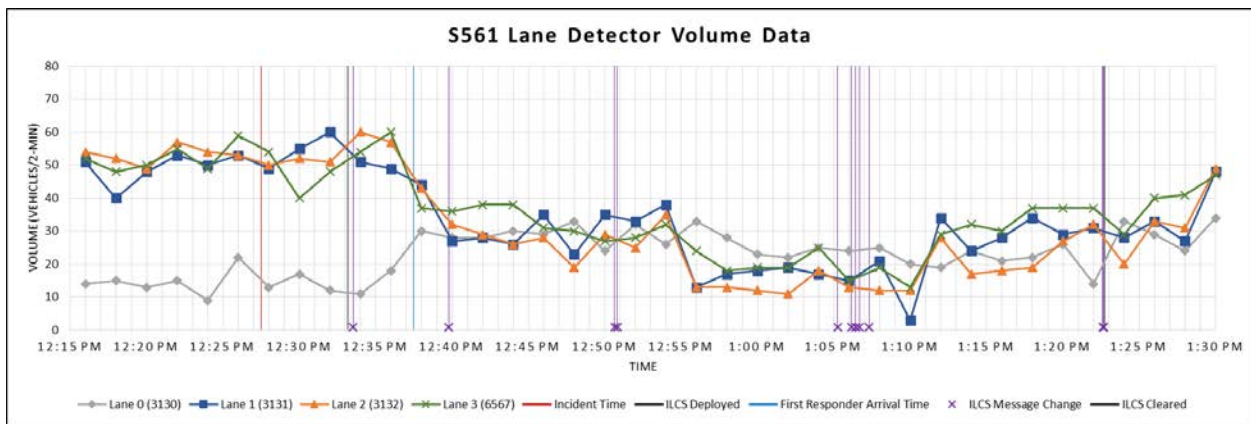
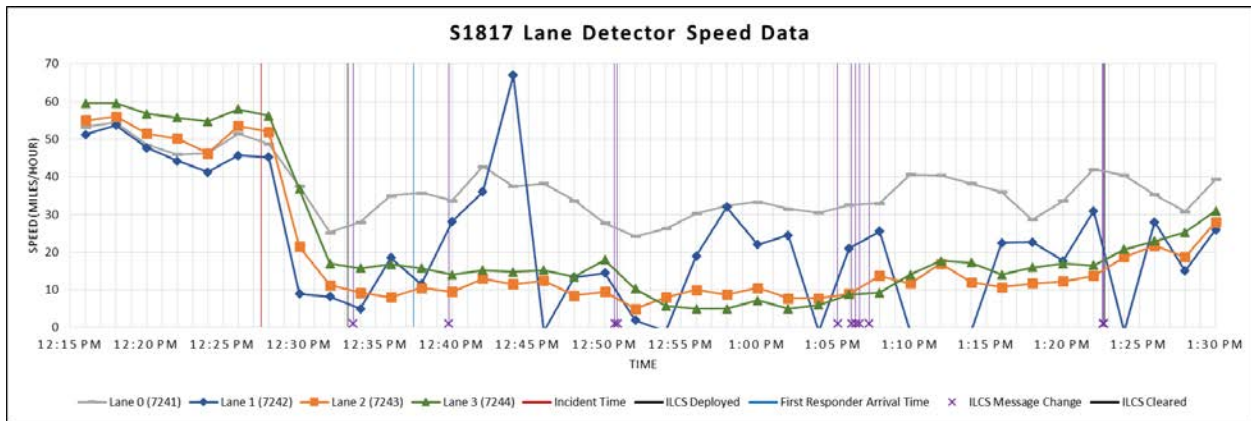
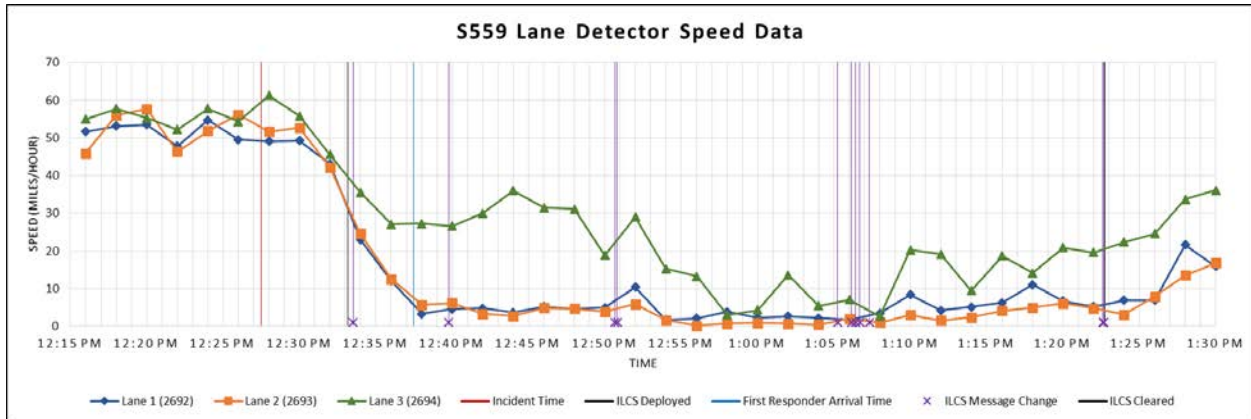
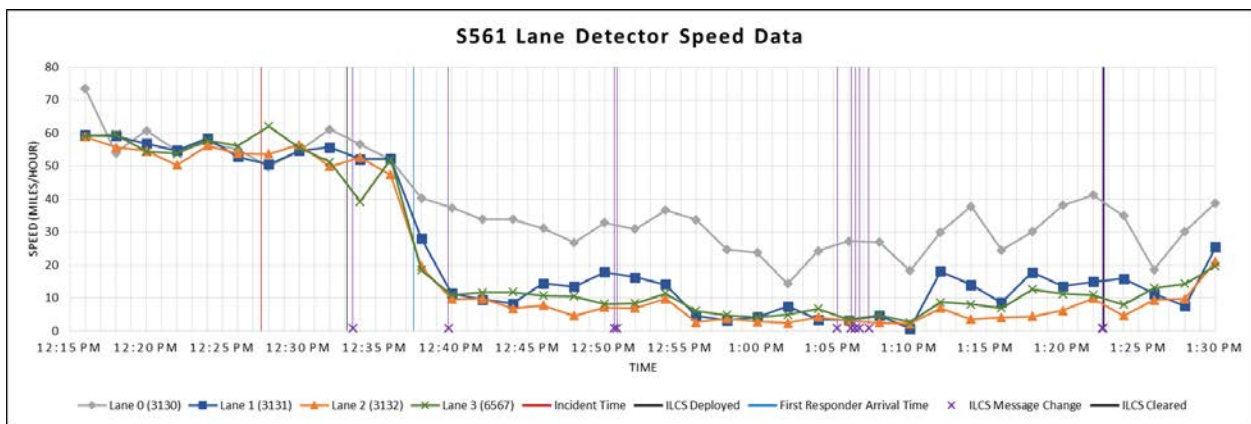
Figure 4-29. Volume data at Station 1817 (Park Avenue) - 8/21/2013.

Figure 4-30. Volume data at Station 559 (upstream of 11th Avenue) - 8/21/2013.

Figure 4-31. Volume data at Station 561 (Cedar Avenue) - 8/21/2013.

Figure 4-32. Speed data at Station 1817 (Park Avenue) - 8/21/2013.

Figure 4-33. Speed data at Station 559 (upstream of 11th Avenue) - 8/21/2013.

Figure 4-34. Speed data at Station 561 (Cedar Avenue) - 8/21/2013.

At the crash location, volumes in lane one dropped precipitously, and speeds across all lanes fell to roughly 10 MPH for the entire duration of the event. Further upstream, a similar pattern occurred shortly thereafter. Speeds in lanes one and two were reduced to near zero at 11th Avenue, especially during the two-lane closure period.

The queues propagated upstream to Cedar Avenue at roughly the same time as the arrival of the first wave of first responder vehicles. A second slowdown occurred with the two-lane closure condition, with speeds dropping to near zero just like at 11th Avenue. After the conclusion of the incident, speeds and volumes slowly recovered at all locations, but did not immediately return to pre-incident levels.

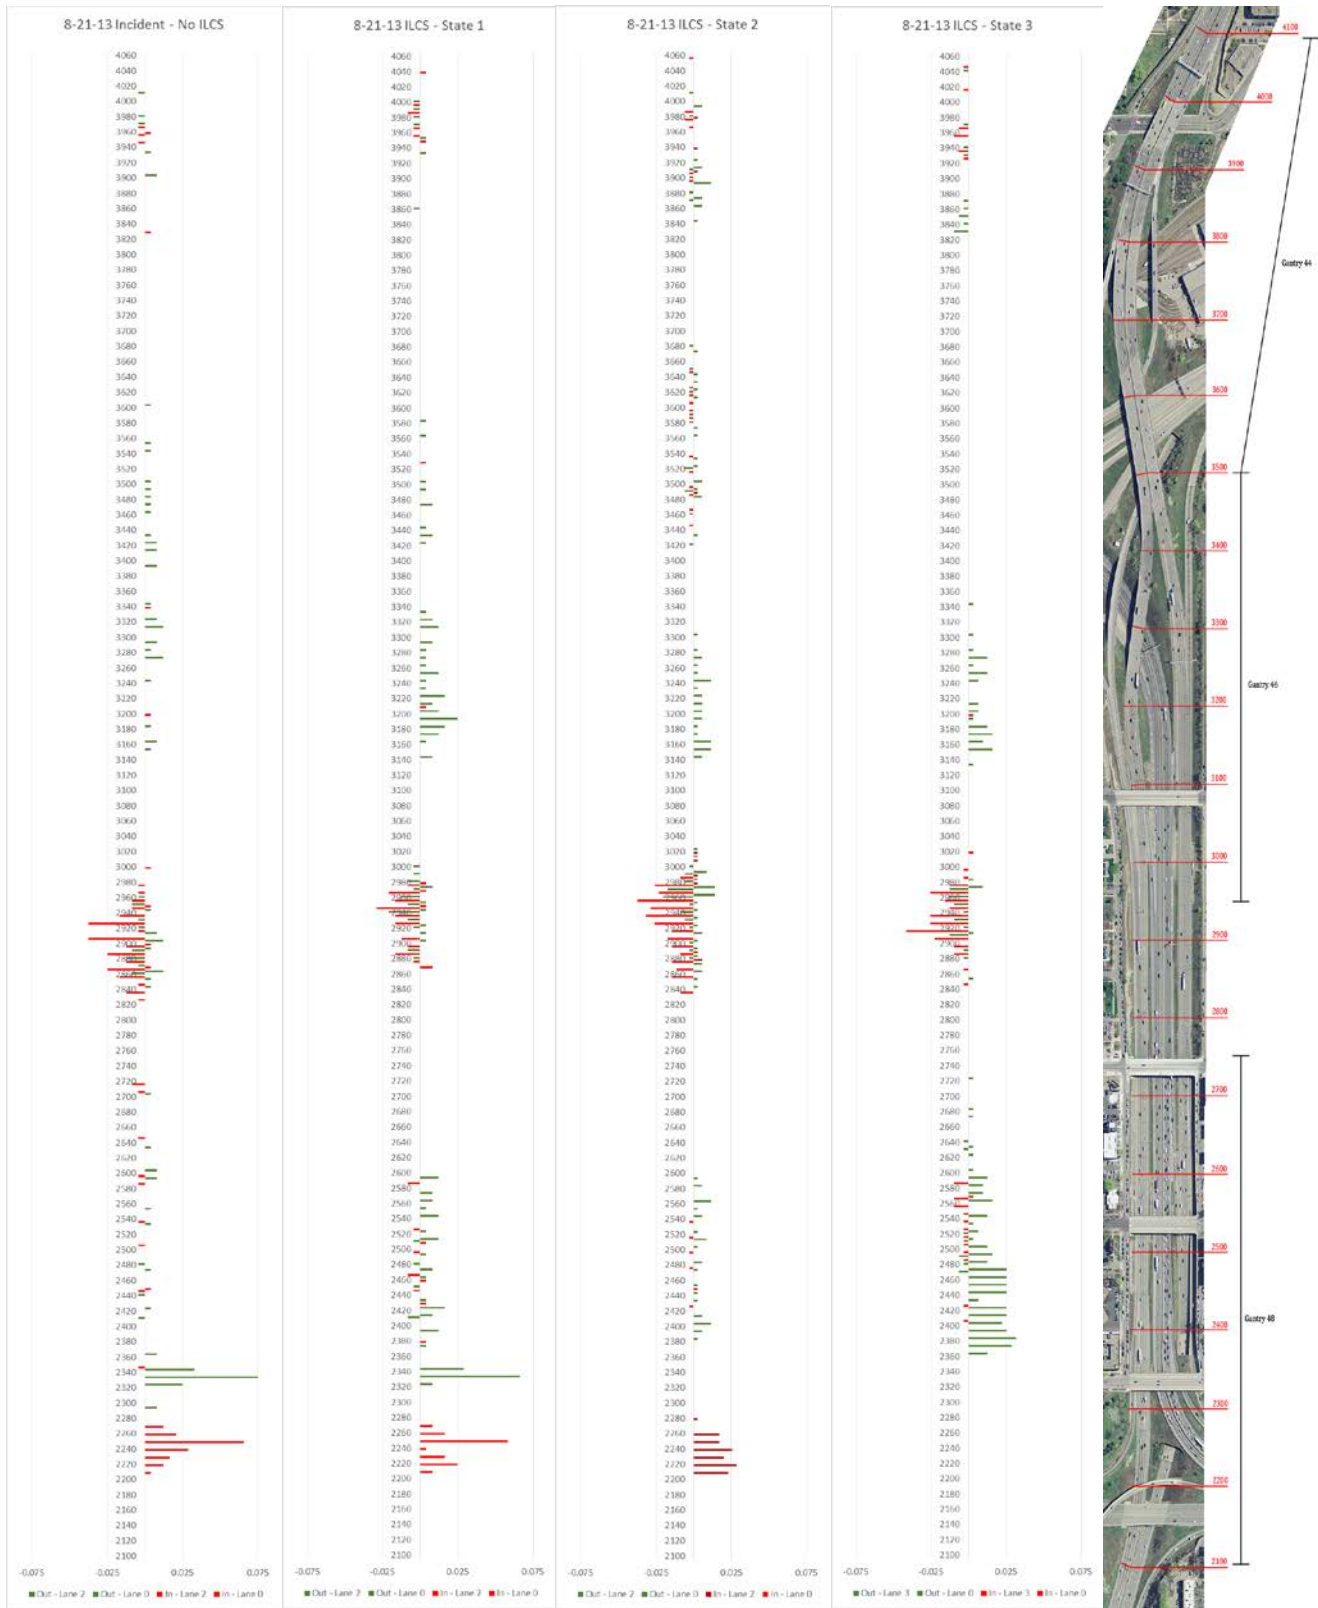
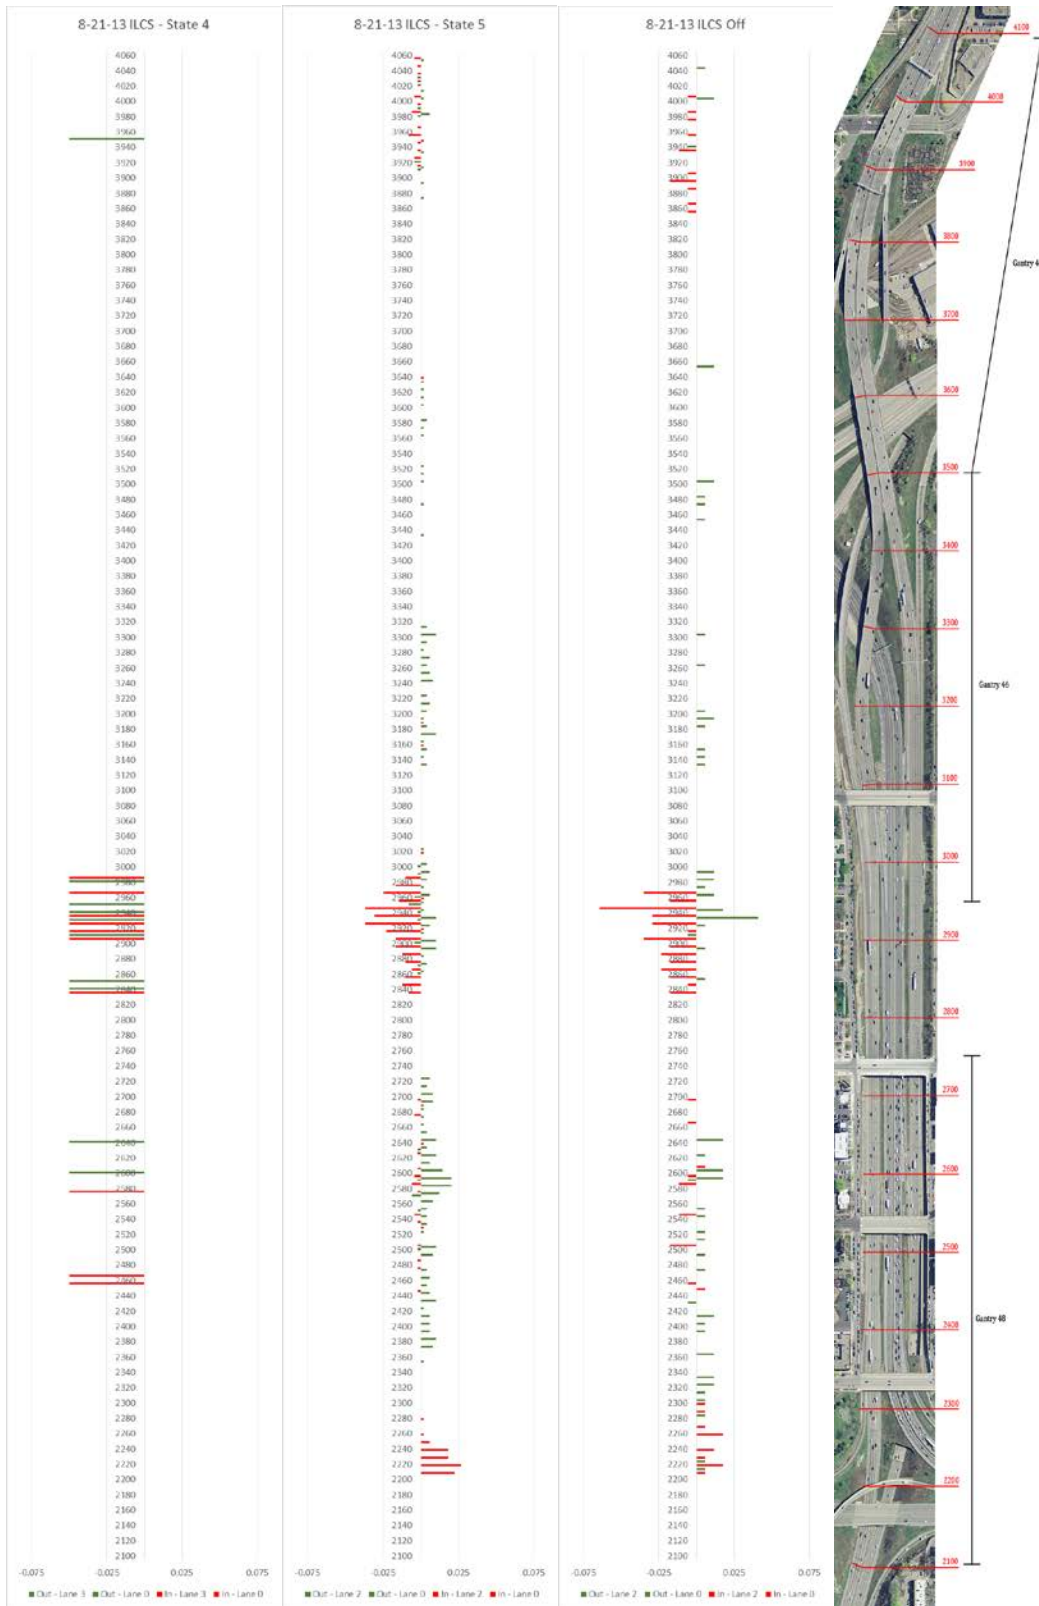
Figure 4-35. Lane changes by state for 8/21/2013.

Figure 4-36. Lane changes by state for 8/21/2013 continued.

Within each state of the ILCS, some positive impacts can be seen. An increase in lane 1 to lane 2 lane changes can be seen in State 1 near marker 3200 (just upstream of 11th Avenue). This pattern continues through states 2, 3, and 5. Further downstream, positive lane changes are shown just upstream of the event, although these may have been due to either the presence of the ILCS or the presence of first responder vehicles. A signal showing the exact location of the incident can be seen at the far-downstream end of the corridor with vehicles leaving and re-entering lane one near marker 2300 (just downstream of Portland Avenue).

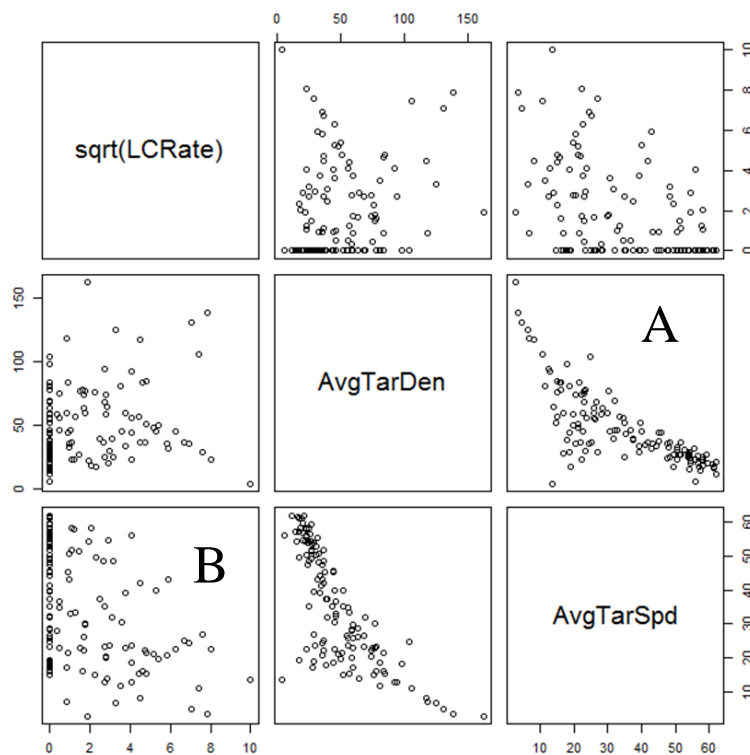
Figure 5-1. Sample output from *pairs()* function in R.

Using the *pairs()* function, a scatterplot of each of the quantitative variables can be plotted against one another to show the relationships between the variables. An example can be seen in Figure 5-1 below. This example shows the relationship between the square root of the Average Lane Change Rate, the Average Target Density, and the Average Target Speed. In the figure, reference A describes the relationship between target lane density and speed which is approximately linear. Reference B shows the relationship between the root of lane change rate and target lane speed which does not show an obvious direct relationship. Note that the scatterplots in the upper right portion of the figure are mirrors of the plots in the lower left.

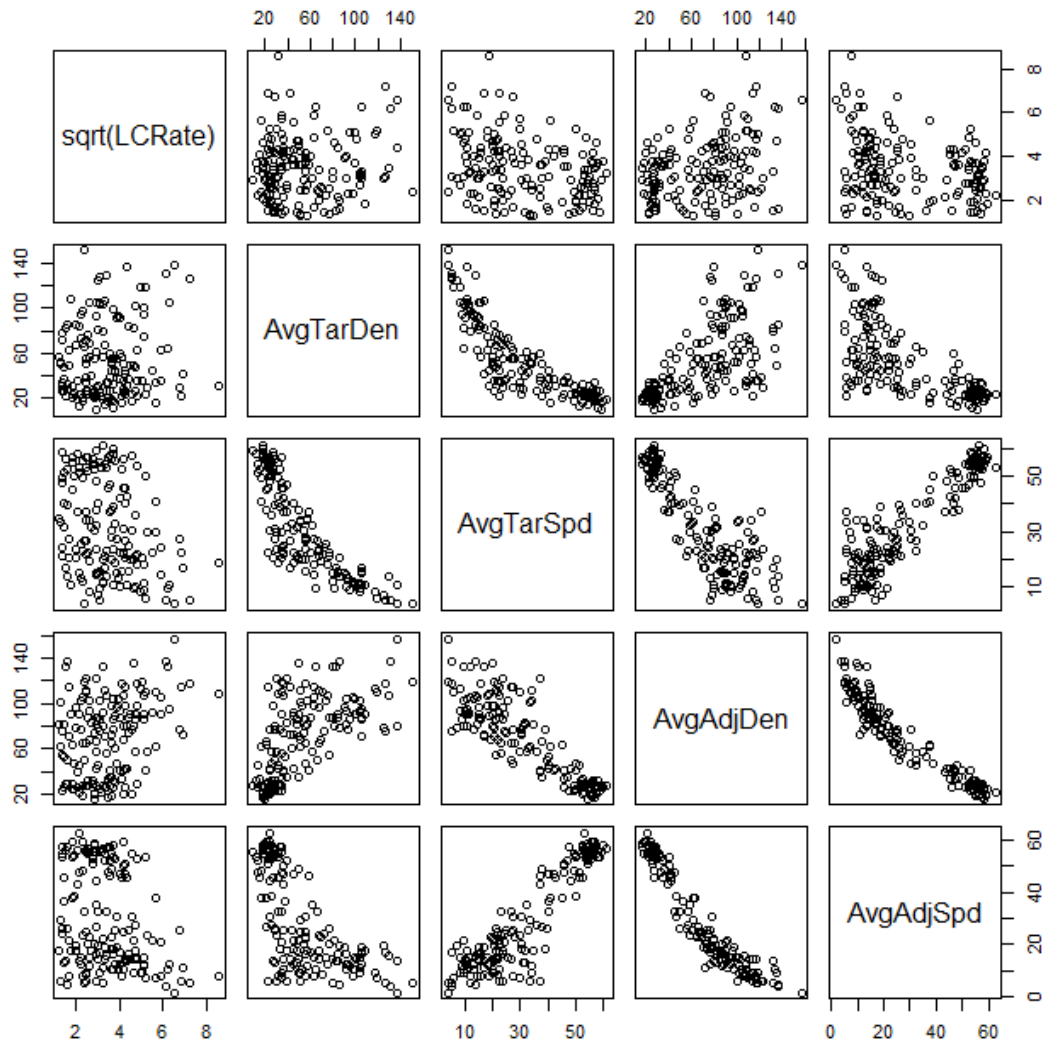
Figure 6-1. Scatterplot for variables in Hypothesis 2 model.

The scatterplots show that there is some multicollinearity in the model, which was expected. The densities and speeds in the target and adjacent lanes are related to one another (via the fundamental relationship). The predictors do seem to show a relationship with the response variable, so the OLS model assumptions were checked. None of the assumptions were violated, so the output of the model was fit and the estimates were generated.
