Friction Management on Kansas Department of Transportation Highways

Humaira Zahir
Shuvo Islam
Mustaque Hossain, Ph.D., P.E.

Kansas State University Transportation Center

Final Report

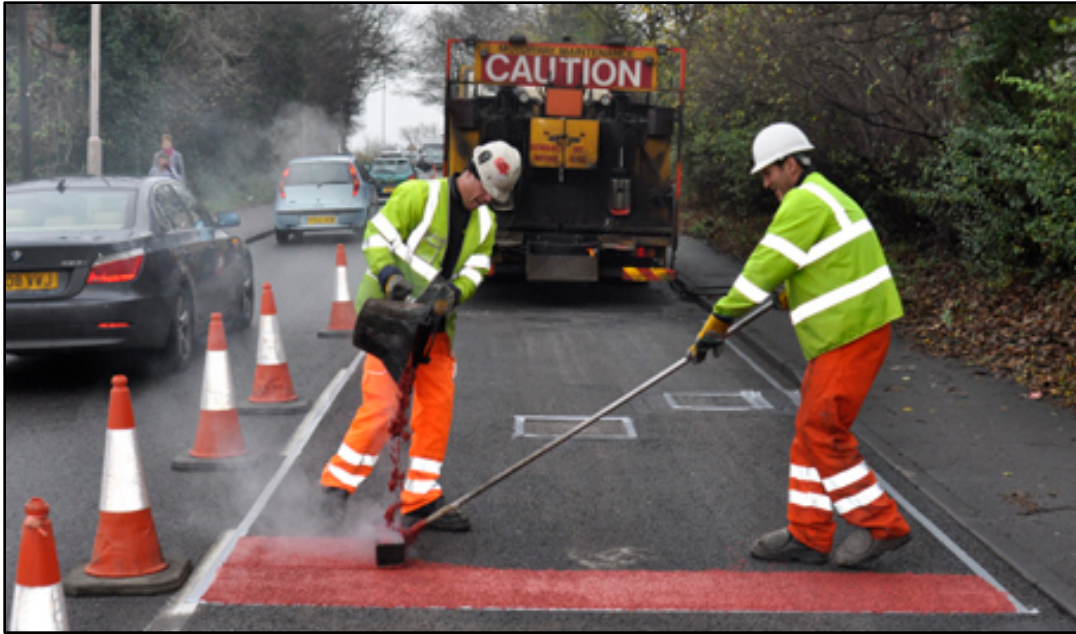
Figure 2.1: Hot-Applied HFST
Source: Jointline Group Limited (2014)

HFST application can be categorized as hot-applied high friction surfacing or cold-applied high friction surfacing (Nicholls, 1997). Thermoplastic resin, which is used in hot-applied high friction surfacing, becomes liquid when heated and solid when cooled to ambient temperature. In hot-applied high friction surfacing, high friction aggregate and resin are heated thermostatically and applied to the surface while hot (Figure 2.1). This system is not weather dependent, and treated road segments can be opened to traffic within 15 minutes of material application. Overheating of the high friction material, however, can decrease this system's durability.

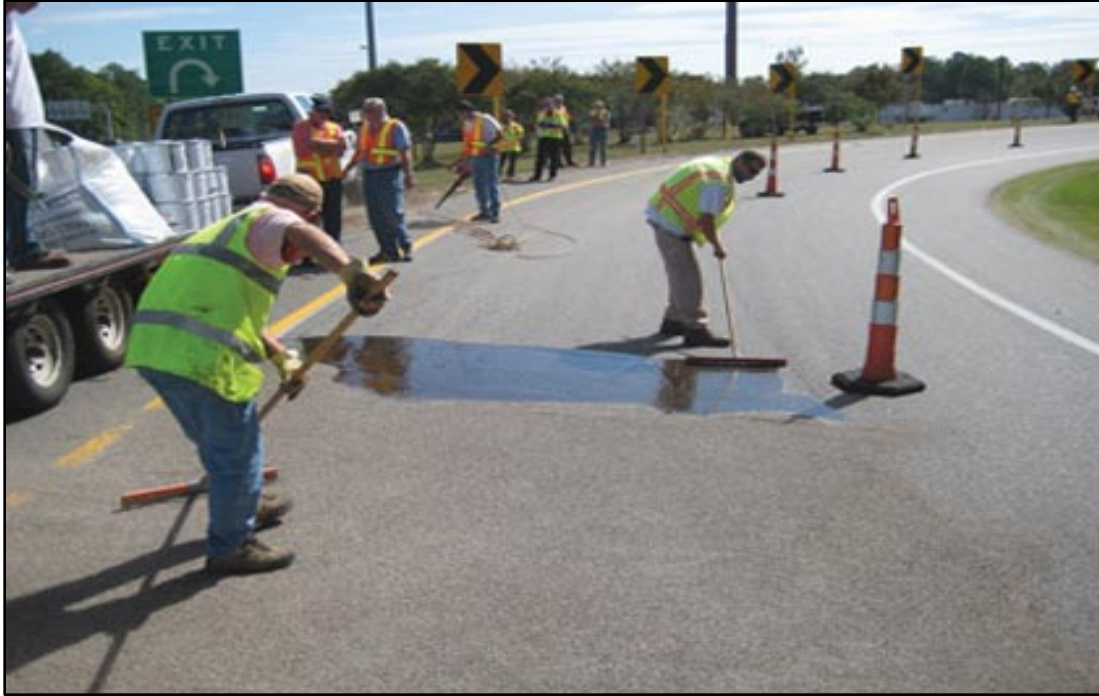
Figure 2.2: Cold-Applied HFST
Source: Hill (2015)

In cold-applied high friction surfacing, epoxy or polyurethane-based resins must be spread within a certain period of time (depending on the workplace temperature) after mixing due to initiation of a heat-producing chemical reaction that results in hardening of the resin. The required amount of aggregate is then applied over the resin (Figure 2.2), requiring a few hours (based on the workplace temperature) to set completely.

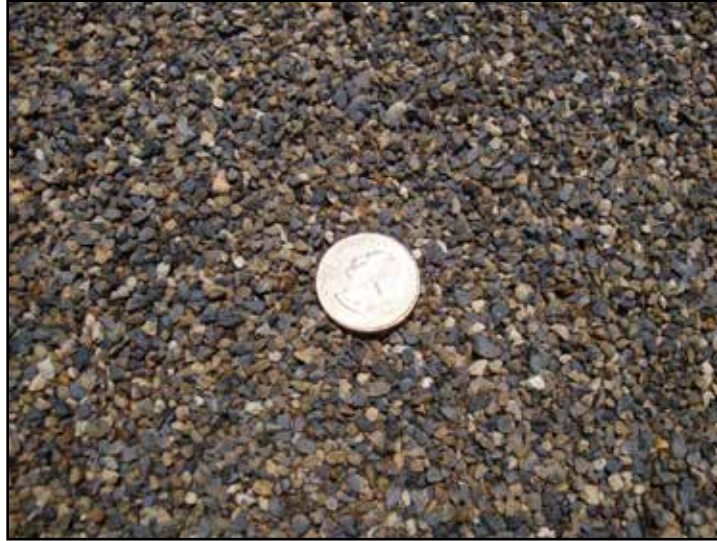
Figure 2.3: Calcined Bauxite Aggregate

Bauxite undergoes calcination process, in which the aggregate is collected from aluminium ore and exposed to prolonged heating at an elevated temperature of approximately 1600 °C to increase its physical stability and hardness. Depending on the source of bauxite aggregate, its density varies from 2.6 to 3.4 g/cm³ (De Leon Izeppi, Flintsch, & McGhee, 2010). Typical PSVs of calcined bauxite range from 60 to 70; density is a good indicator of PSV (i.e., high density usually indicates high PSV). A picture of calcined bauxite aggregate is shown in Figure 2.3 below.

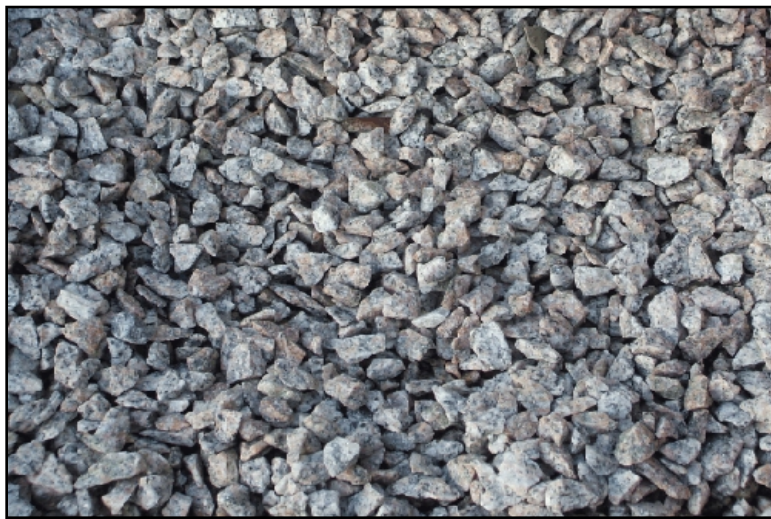
Figure 2.5: Granite Aggregate

Granite aggregate generally consists of quartz and potassium feldspar. This aggregate varies in color from very light to medium tones of gray, as shown in Figure 2.5. Due to its mineral composition and interlocking crystals, granite is hard and abrasion resistant. Compressive strength of granite is usually above 200 MPa, and it is harder than sandstone, limestone, or marble. The average density of granite is between 2.65 and 2.75 g/cm³, and it shows PSVs of 62 or greater (Huhta et al., 2001).

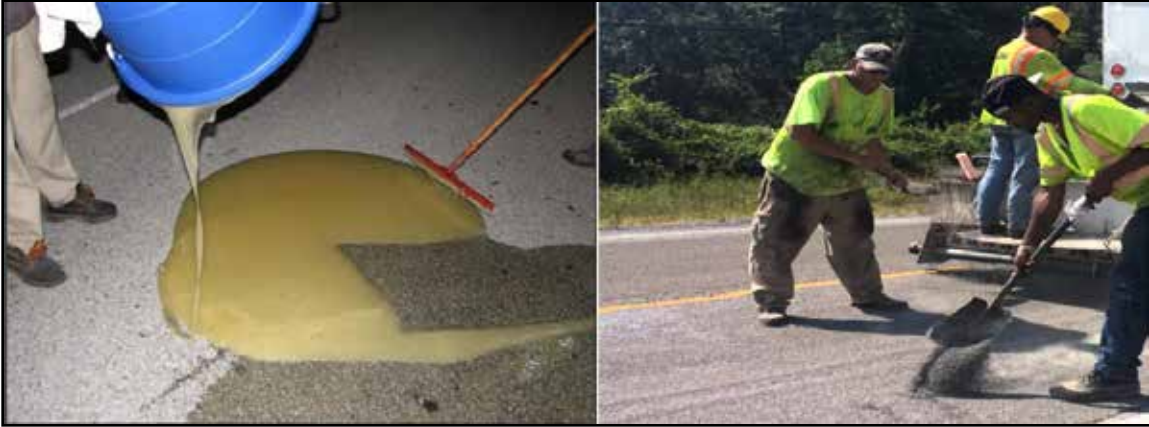
Figure 2.9: HFST Manual Application
Source: FDOT (2015)

Epoxy-aggregate application can occur as manual application, semi-automated application, and fully automated application. The epoxy usually consists of Part A and Part B. In the manual method, both parts are mixed manually using a slow-speed drill fitted with a helical mixing blade. Aggregates are distributed manually immediately following binder spreading. After a certain curing time (based on the workplace temperature), excess or loose aggregates are removed from the surface using a brush (Figure 2.9). Production rate in this method varies from 160 to 400 m²/hr.

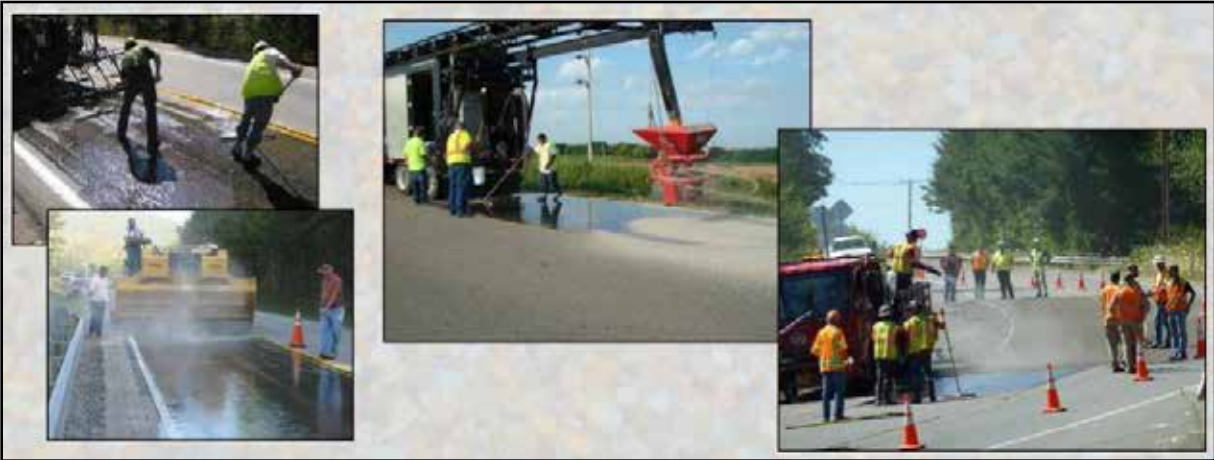
Figure 2.10: HFST Semi-Automated Application
Source: FDOT (2015)

In the semi-automated method, machine-aided broadcasting of aggregate is followed by machine mixing with hand application of the resin binder (Figure 2.10). The production rate in this process is up to 1,650 m²/hr. In the fully automated method (Figure 2.11), machines mix the resin and apply the resin and aggregates on the pavement surface. The production rate in the fully automated method can be up to 3,000 m²/hr.

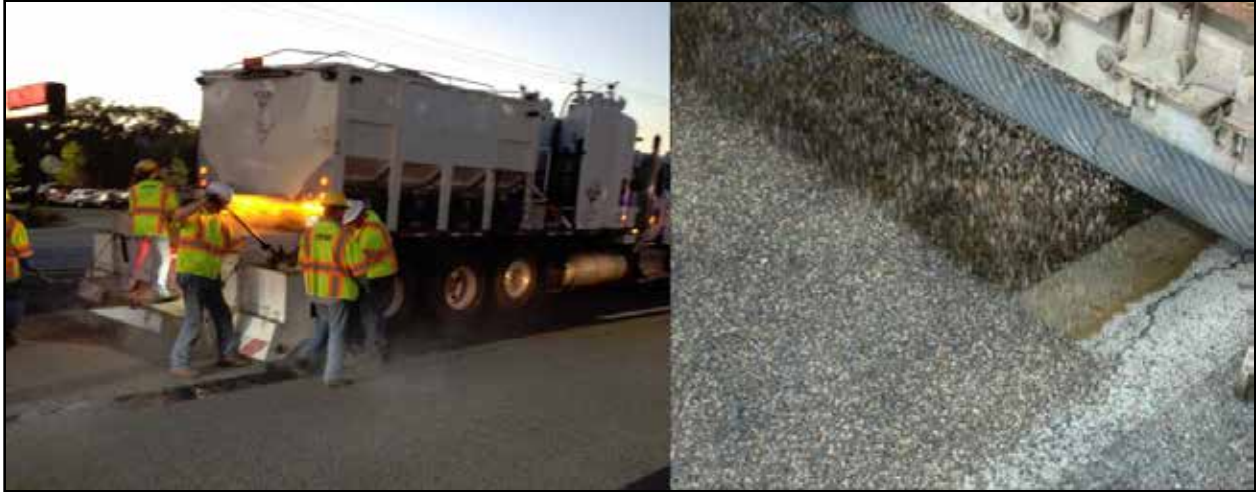
Figure 2.11: HFST Fully Automated Application

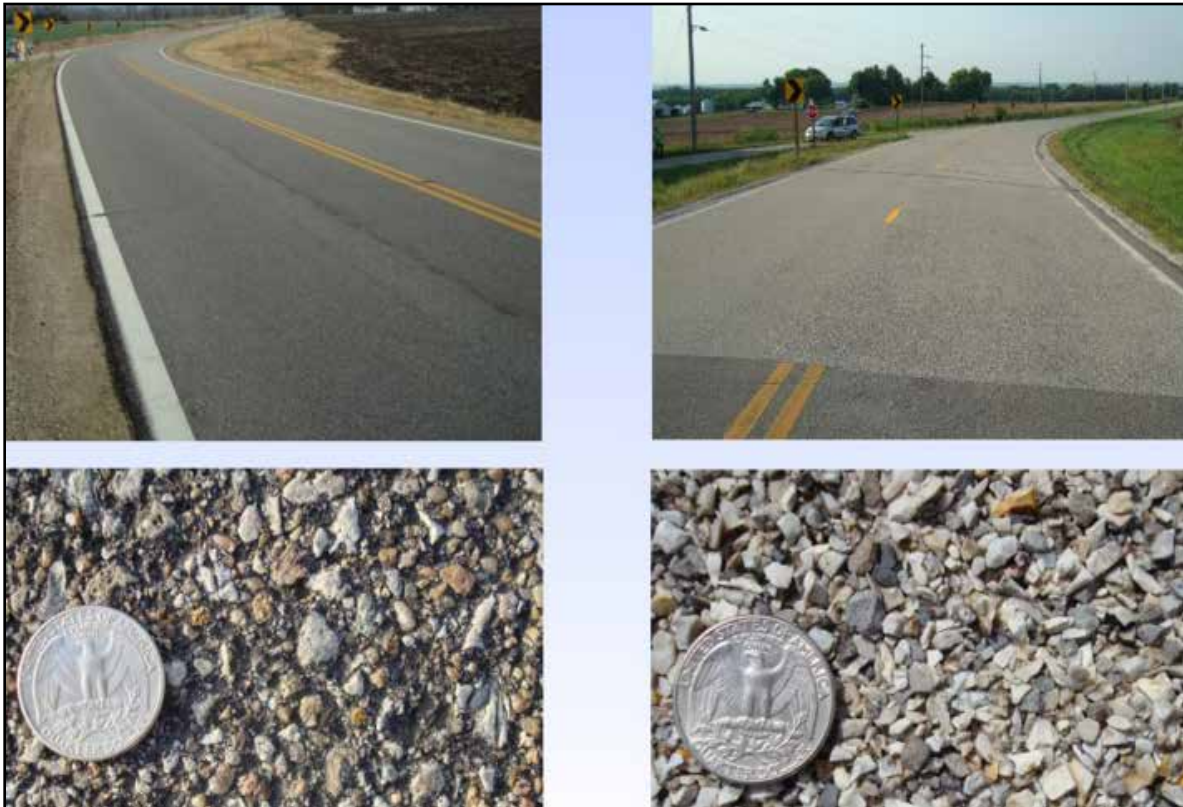
Figure 2.16: Before and After HFST on K-99 in Wabaunsee County (Asphalt Pavement)

but K-5 had the lowest traffic level of all testing sites. Pull-off test results exhibited significant asphalt bonding at the K-5 location. Complete failure of high friction surface bond to concrete substrate was observed on the I-35/I-635 and K-96/US-54 ramps. The K-99 location suffered from significant bond failure between 2010 and 2011 and was removed from the program. High friction surfacing on K-99 and K-5 locations is shown in Figures 2.16 and 2.17.

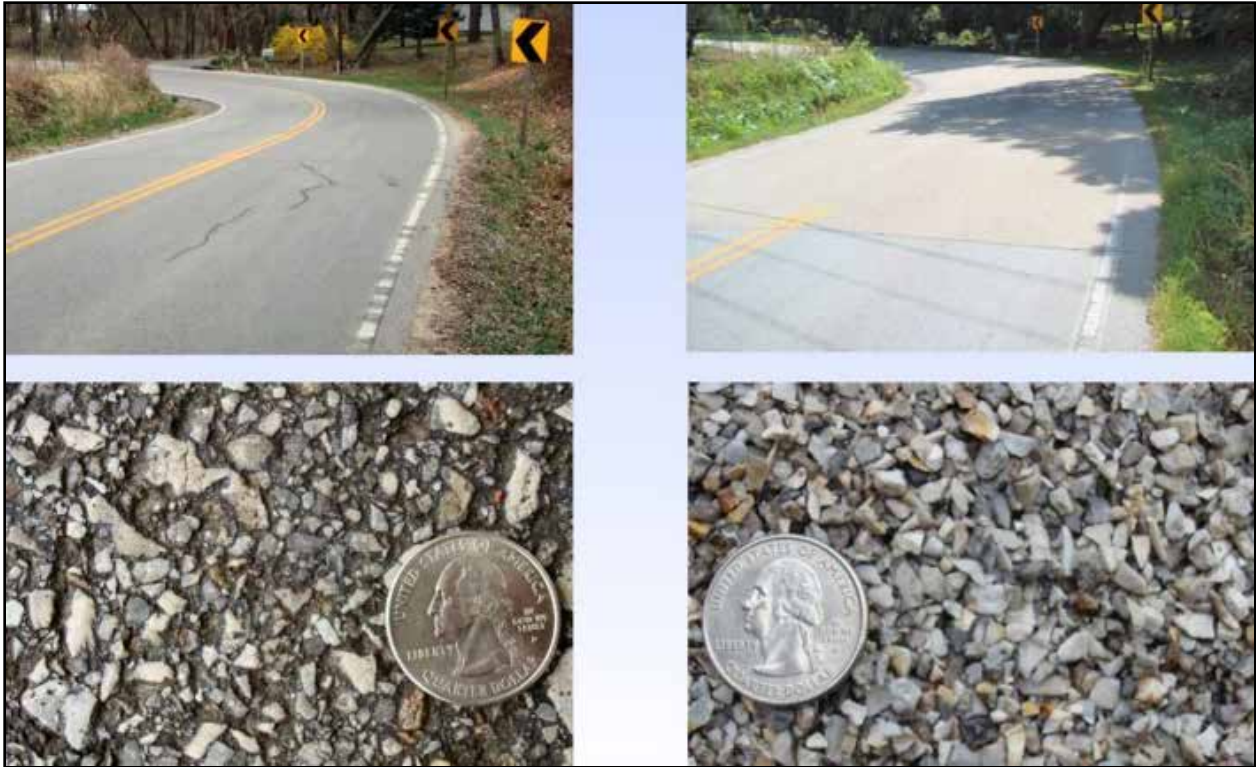
Figure 2.17: Before and After HFST on K-5 in Leavenworth County (Asphalt Pavement)

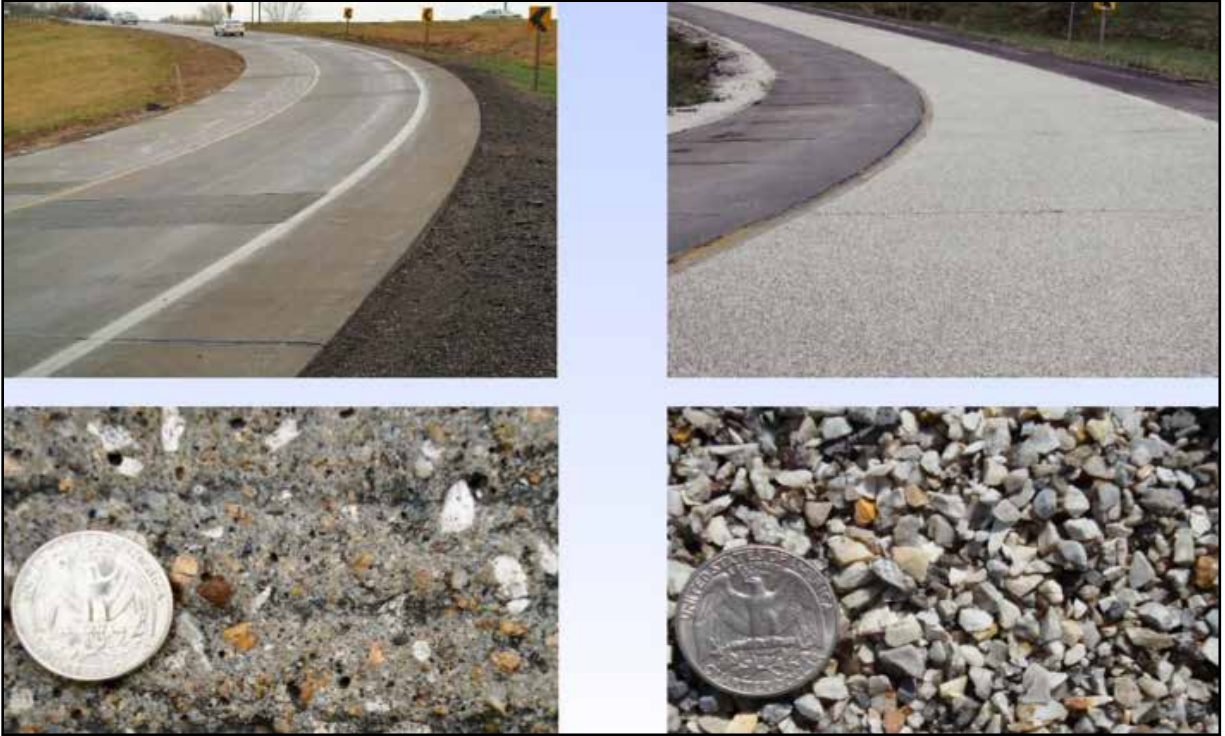
Figure 2.18: Before and After HFST on I-35/I-635 Ramp in Kansas City (Concrete Pavement)

Thicknesses of high friction surfaces in these projects were measured by removing cores from each location. Thickness was 3.05 mm on K-5 (asphalt), 3.25 mm on I-35/I-635 (concrete), and 3.85 mm for K-96/US-54 (concrete) application. The RCP test was also performed on the cores to determine permeability of the substrate paving material. RCP values indicated that the treatment afforded protection of the pavements from water penetration. K-5 had an RCP value of 33 coulombs on the top 50 mm and 167 on the bottom 50 mm of the core. Average RCP at the I-35/I-635 location was 856 coulombs on the top 50 mm and 1477 coulombs on the bottom 50 mm. At the K-96/US-54 location RCP was 1868 coulombs on the top 50 mm and 2983 coulombs on the bottom 50 mm. HFST projects on I-35/I-635 and K-96/US-54 locations were shown in Figures 2.18 and 2.19.

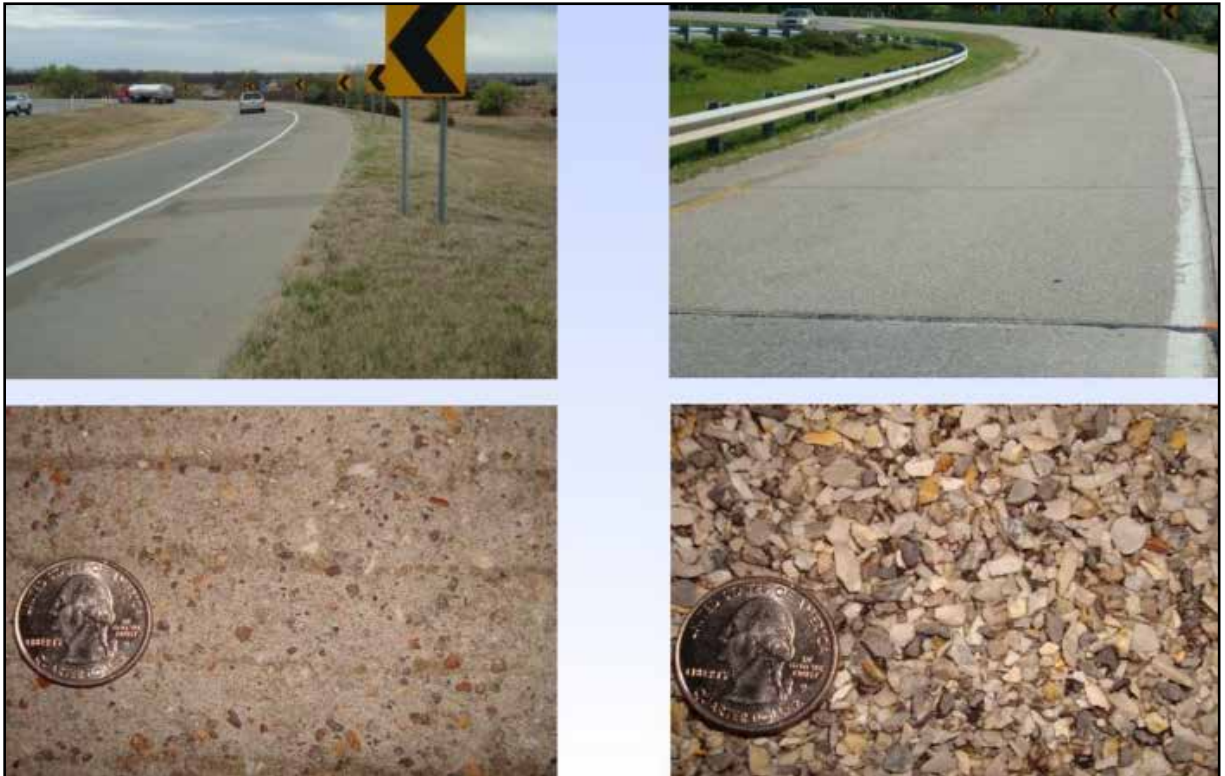
Figure 2.19: Before and After HFST on K-96/US-54 Ramp in Wichita (Concrete Pavement)

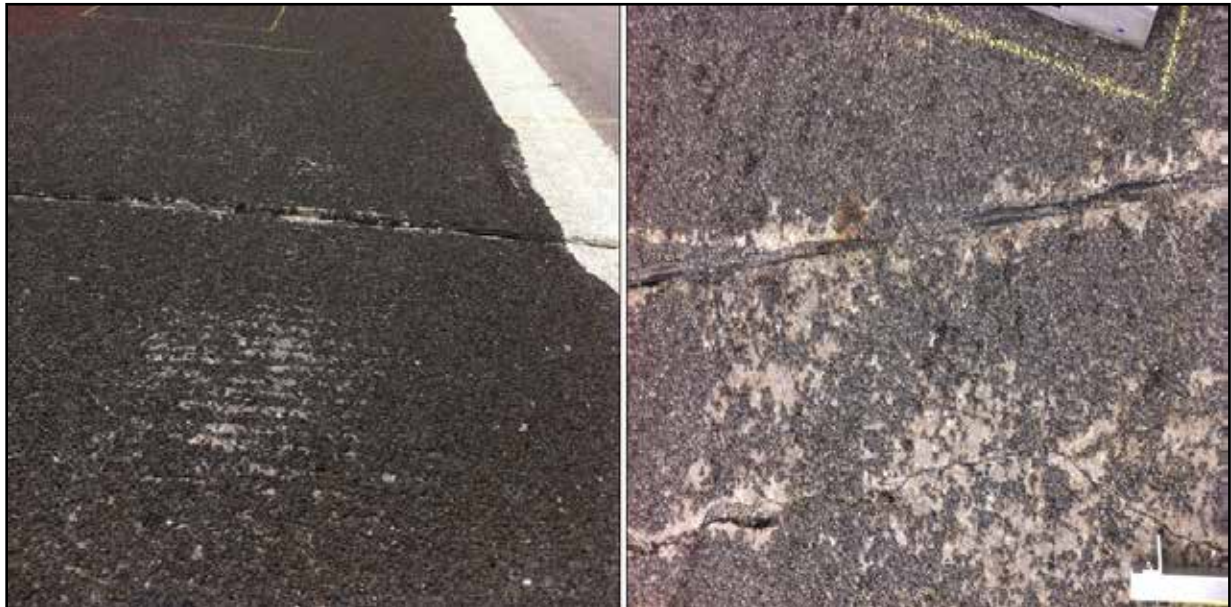
Figure 2.21: De-Bonding of High Friction Surface Aggregates

6%). However, the concrete section contained sharp increases and declines in texture depths, possibly due to the de-bonding of HFST at some locations (Figure 2.21), potentially resulting in varying texture depth values (standard deviation of 11%).

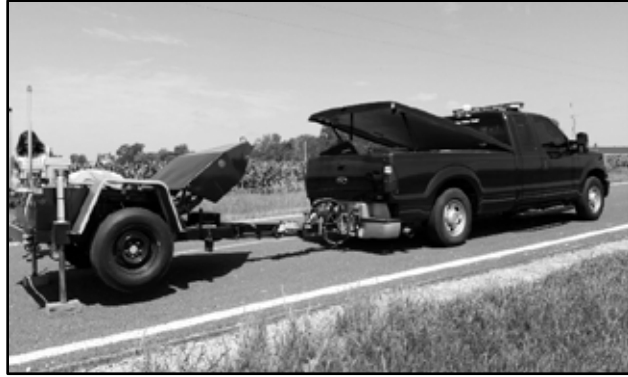
Figure 2.24: ASTM Locked Wheel Skid Trailer

This is a skid trailer (Figure 2.24) that measures steady-state friction force following an ASTM standard (ASTM E2340, 2015). The trailer contains a locked wheel that is dragged under constant load at a constant speed (40 or 65 mph) over a wet pavement. Friction is determined from the resulting force and reported as skid number. High skid numbers represent greater skid resistance (Wambold, 1988). Two types of tire (ribbed and smooth) are used to measure skid numbers on roadway surfaces (Henry, 2000). The skid trailer can be operated near posted highway speed and can take measurements on longer stretch of roadway without causing lane closures.

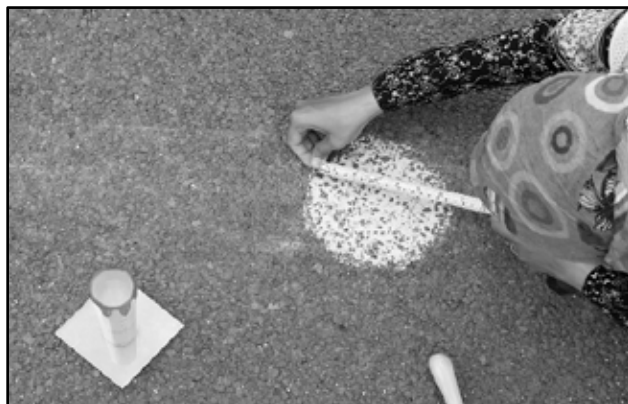
Figure 2.25: Sand Patch Test

The sand patch method (ASTM E965, 2001) is a volumetric approach of measuring pavement macro-texture. A known volume of sand (or glass beads) is spread properly on a pavement surface to form a circle, thus filling the surface voids with sand (Figure 2.25). The diameter of the circle on which the sand material has been spread is measured and the area of the circle is calculated. The volume of sand/glass beads used divided by the circle area is recorded as the Mean Texture Depth (MTD) of the pavement. MTD is defined as the mean average vertical height of the texture. The test results are highly dependent on the operator resulting in poor repeatability (Henry, 2000). However, this test is quite popular due to inexpensive test setup and a knowledge base of test results.

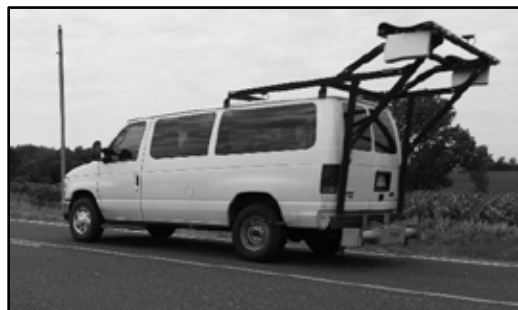
Figure 2.28: KDOT LCMS System

The LCMS (Figure 2.28) has two high performance 3-D laser profilers that measure complete transverse road profiles with 1-mm resolution at highway speeds. The high resolution 2-D and 3-D data acquired by the LCMS is then processed using algorithms that were developed to automatically extract crack data including crack type (transverse, longitudinal, alligator) and severity, rutting (depth, type), potholes, and raveling. LCMS can be operated under various types of lighting conditions and on various pavement types (Laurent & Hébert, 2002). A data analyzing software analyzes data and reports MTD values of five standard AASHTO bands (center, right, and left wheel paths and outside bands; Laurent et al., 2008). LCMS is very precise and safer to use because it can be operated at posted highway speeds without interrupting the flow of traffic. MPD is the difference between the average value of “peak level 1st” and “peak level 2nd” among the 100 data points taken by LCMS at 1-mm intervals over a 100-mm length of pavement.

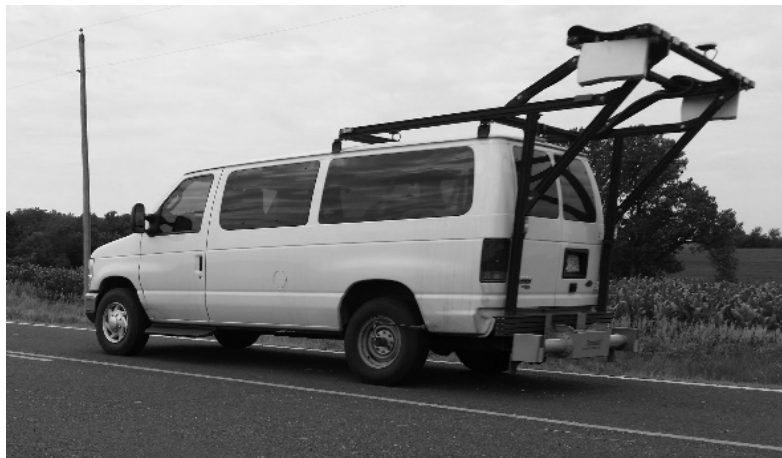
Figure 3.1: KDOT Laser Crack Measurement System Used in this Study

As mentioned earlier, the LCMS is composed of two high performance 3D laser profilers that measure complete transverse road profiles with 1-mm resolution at highway speed. A unit owned and operated by KDOT (Figure 3.1) was used in this study. The high resolution 2D and 3D data acquired by the LCMS is processed by a data analyzing software that reports MTD values of five standard AASHTO bands (center, right, and left wheel paths and outside bands).

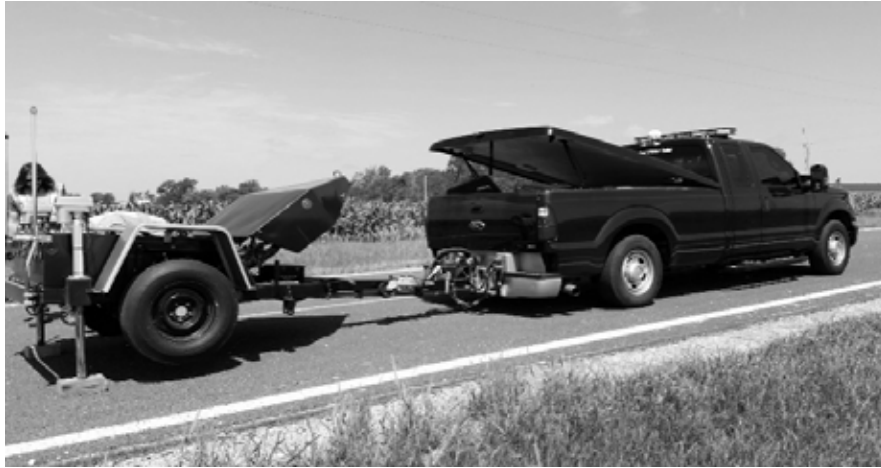
Figure 3.2: KDOT Locked Wheel Skid Trailer

LWST, which measures steady-state friction force, contains a locked wheel that is dragged under constant load at a constant speed over wet pavement. A KDOT-owned and operated unit (Figure 3.2) was used in this study.

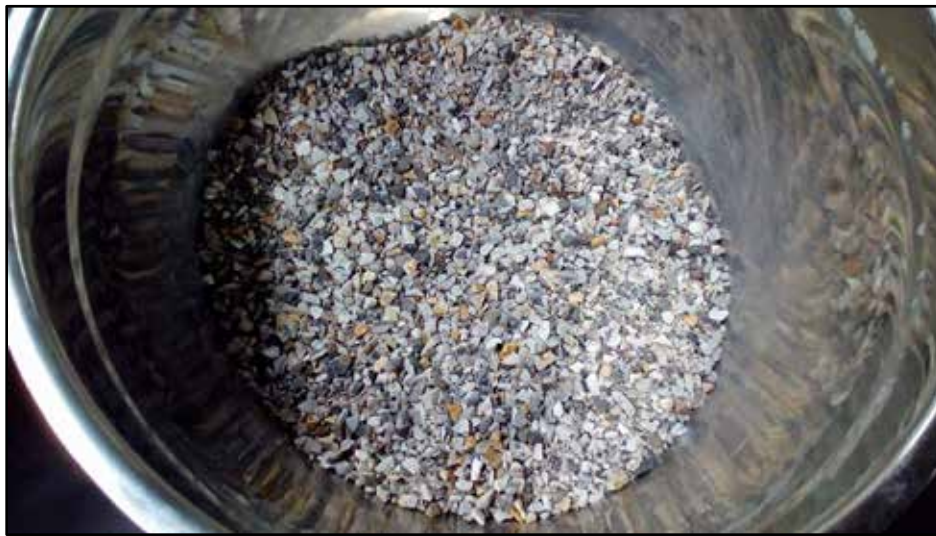
Figure 3.4: Picher, Oklahoma, Flint Aggregate Used in this Study

The flint aggregate used in this project came from Picher, Oklahoma, and was supplied by Cornejo & Sons, a construction company from Wichita, Kansas (Figure 3.4). The supplier tested a few physical properties of the aggregate (dry and saturated surface dry specific gravity, moisture content, soundness ratio, compressive strength ratio, and percent wear) but did not test the chemical composition of the product. In this study, aggregate gradation, specific gravity, moisture content, and fine aggregate angularity tests were performed in the laboratory for both bauxite and flint aggregate in order to determine aggregate quality and compliance with specification. The supplier reported the flint aggregate's resistance to degradation as 9 (according to the AASHTO T 96 [2002] test method), which indicates hard aggregate, but it contained a significant amount of fine/dust particles. For that reason, Sand Equivalent (SE) and Durability Index (DI) tests were also performed for flint aggregate in addition to the four aggregate tests mentioned above.

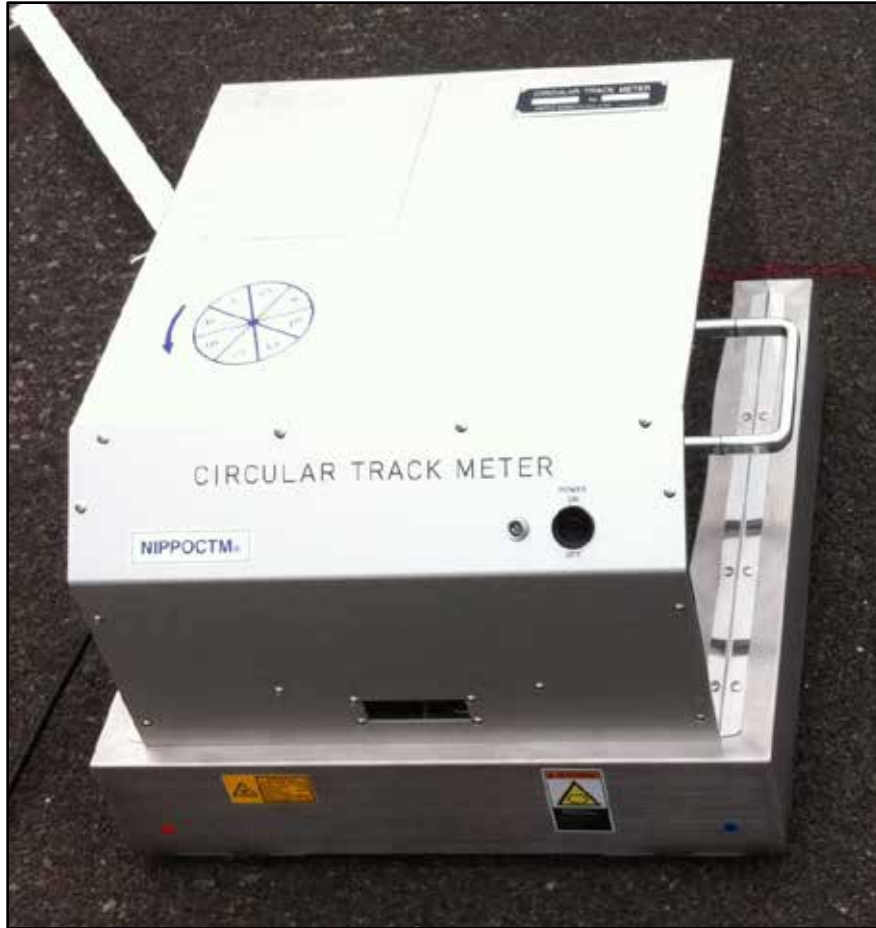
Figure 3.17: Circular Track Meter for Measuring Texture Depth

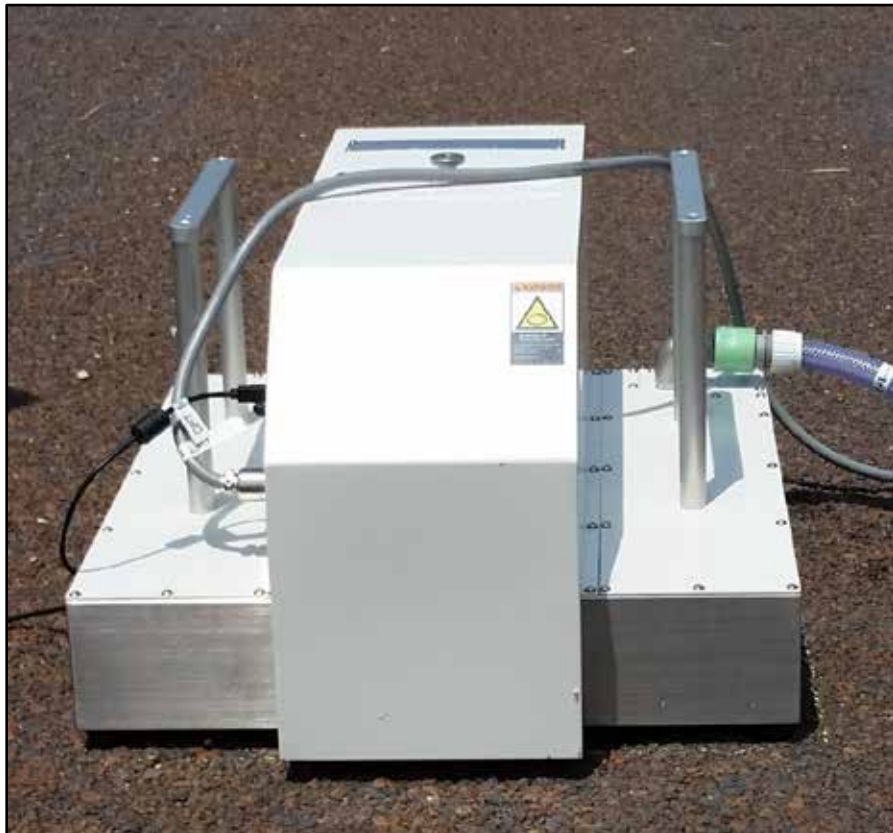
Figure 3.19: Dynamic Friction Tester for Measuring Frictional Coefficient

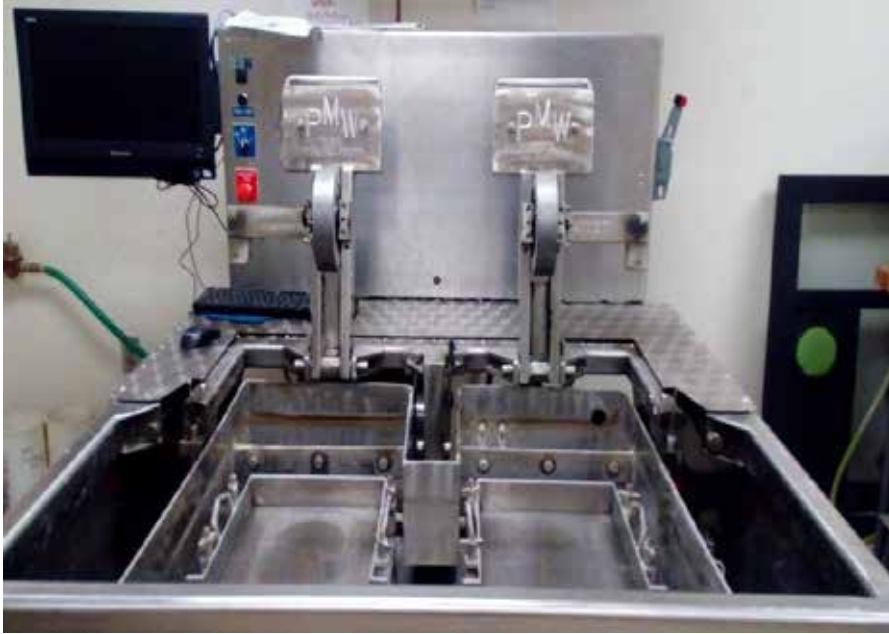
Figure 3.20: Hamburg Wheel Tracking Device

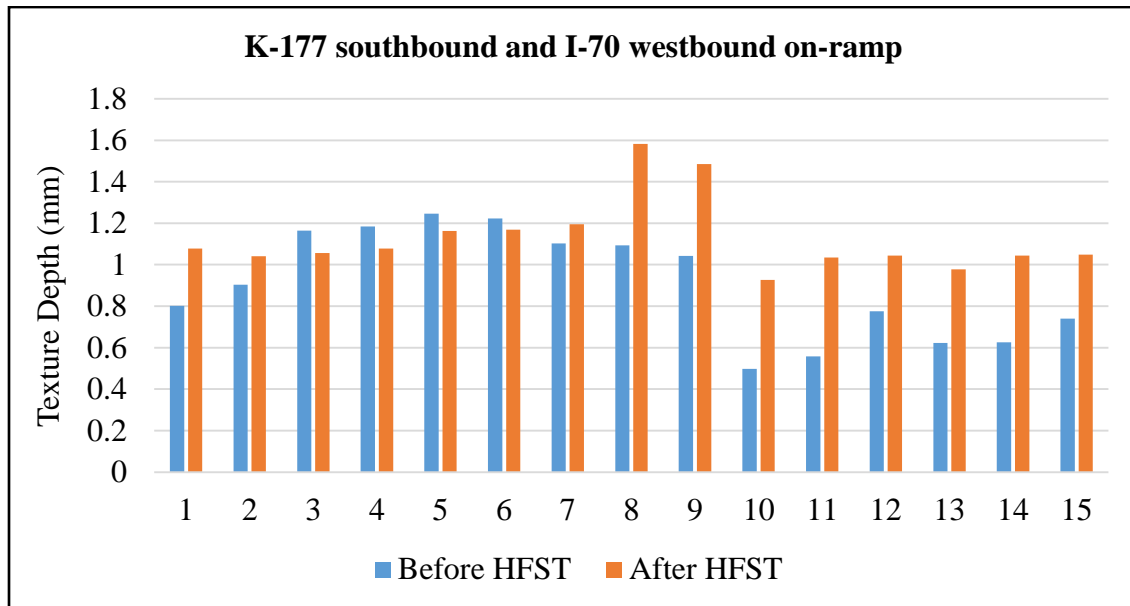
Figure 4.2: Texture Depth Values Along K-177/I-70 On-Ramp

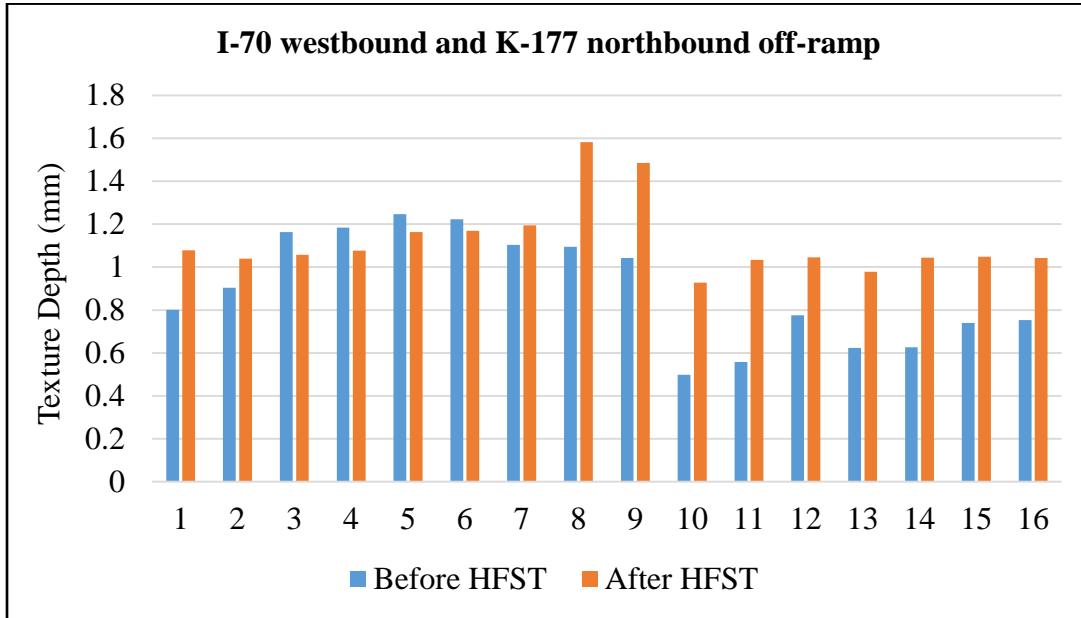
Figure 4.3: Texture Depth Values Along I-70/K-177 Off-Ramp

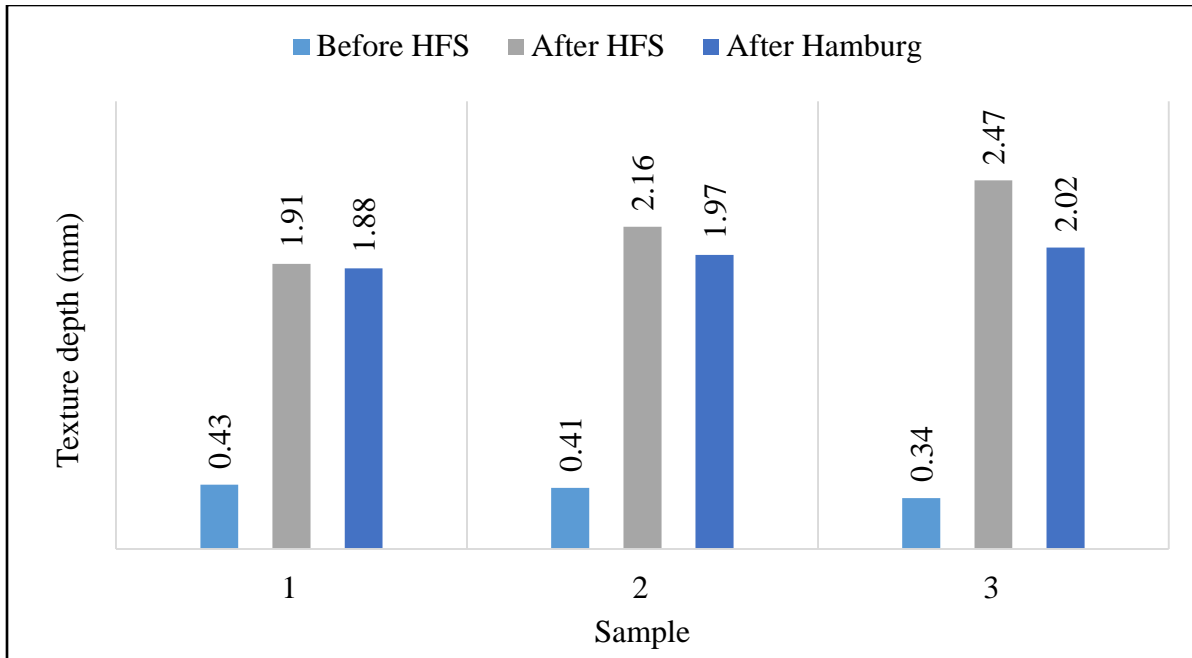
Figure 4.7: Texture Depth of Combination 1

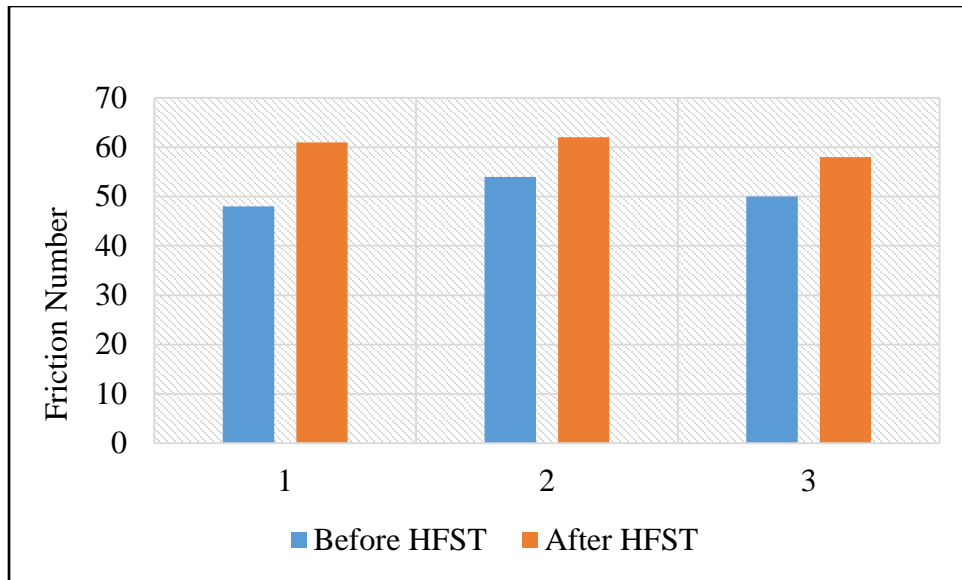
Figure 4.10: Improved FN of HFSS Prepared with Combination 2

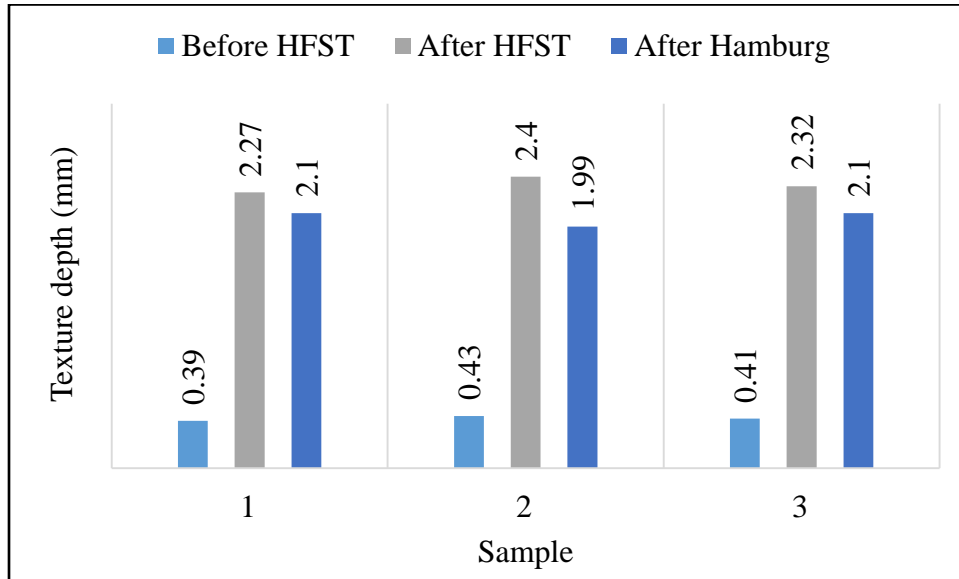
Figure 4.12: Texture Depth of Combination 4

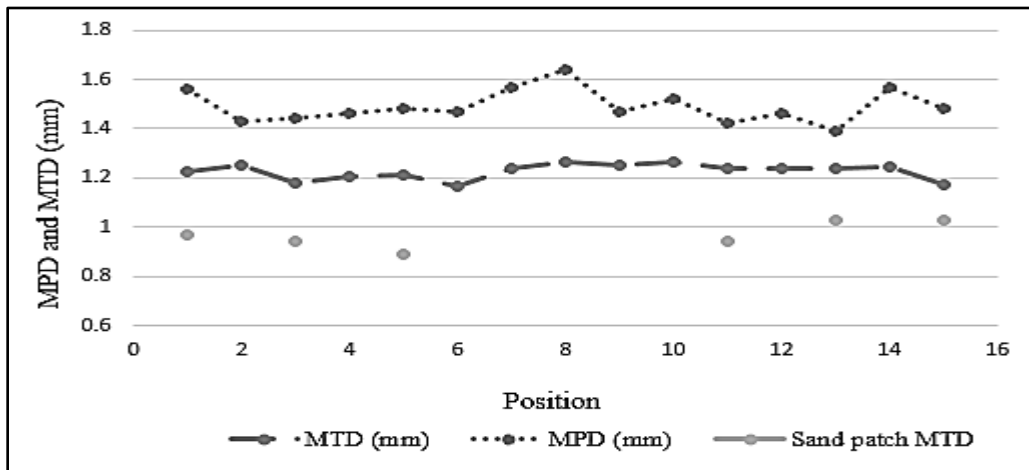
Figure 5.1: MTD and MPD Values on K-87

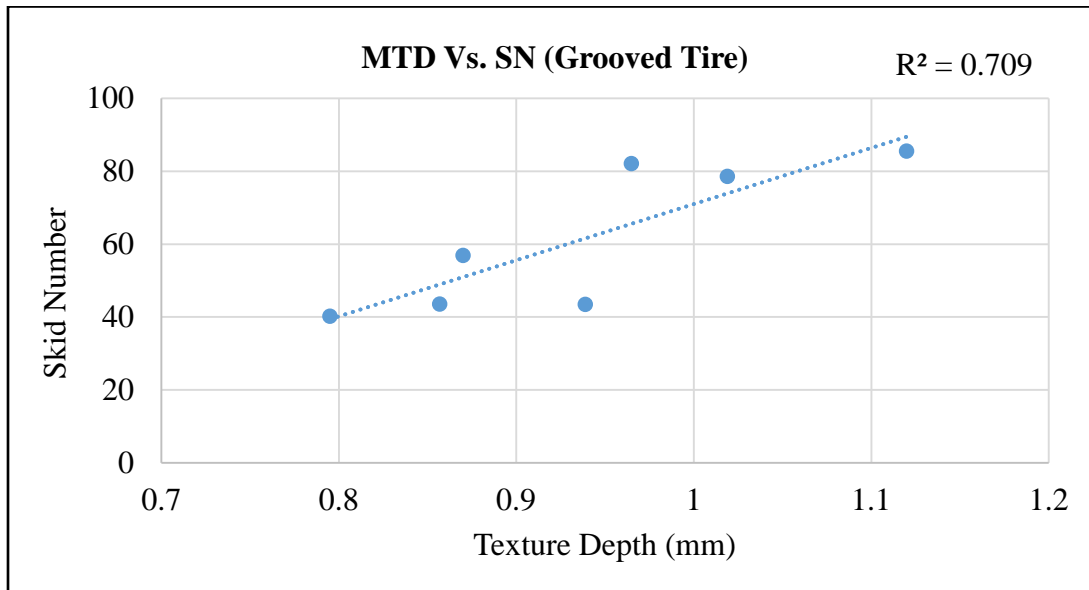
Figure 5.2: Relationship between Texture Depth and Skid Number (using Grooved Tire)

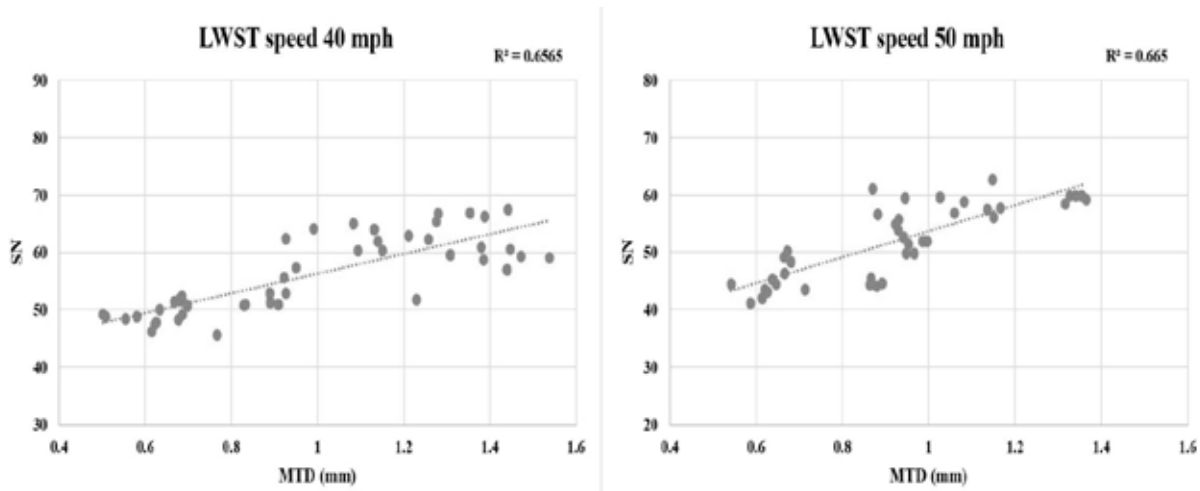
Figure 5.4: Texture Depth and Skid Number Relationship of SM 9.5A Surface Mix

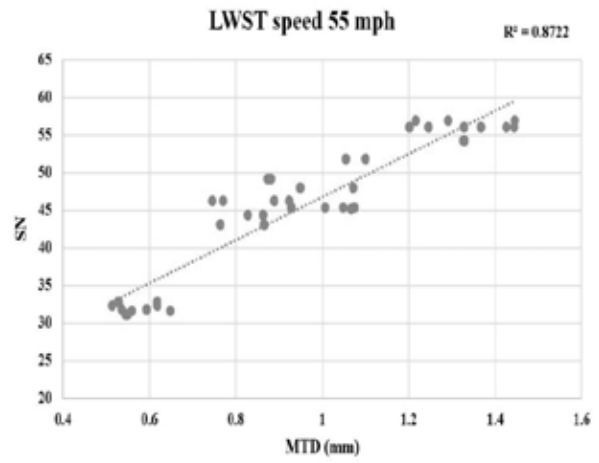
Figure 5.5: Texture Depth and Skid Number Relationship of SM-12.5A Mix
