Effects of Tree Canopy on Rural Highway Pavement Condition, Safety, and Maintenance

February 2017

Final Report

Ohio Research Institute for
Transportation and the Environment

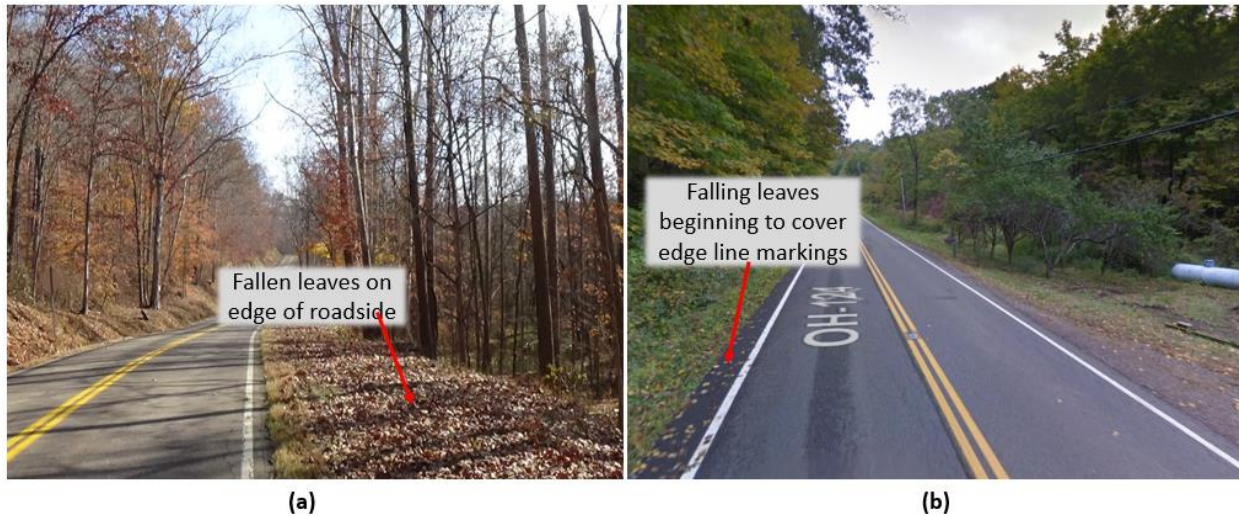
Figure 6. Effect of Fallen Leaves on Roadside.

During the fall season, leaves from trees alongside the roadway had fallen off as seen in Figure 6(a) on OH-356. These fallen leaves, depending on roadside edge (slope/no-slope or shoulder size), have the potential of covering the edge lines (see Figure 6(b) on OH-124) of the roadway and this can become a safety concern especially during foggy, and wintery snow conditions when drivers have a reduced vision and use line markings to maintain their position on within the travelled lane. Also, the fallen leaves store moisture within their layers which could potentially freeze during the evenings (when temperatures drop during the winter) and form a layer of ice. This mix of leaves (coated with ice) can potentially be a safety concern for drivers

who are unaware of the presence of the slick surface. Additionally, there can potentially be concerns of the fallen leaves blocking ditches, culverts and drop inlets.

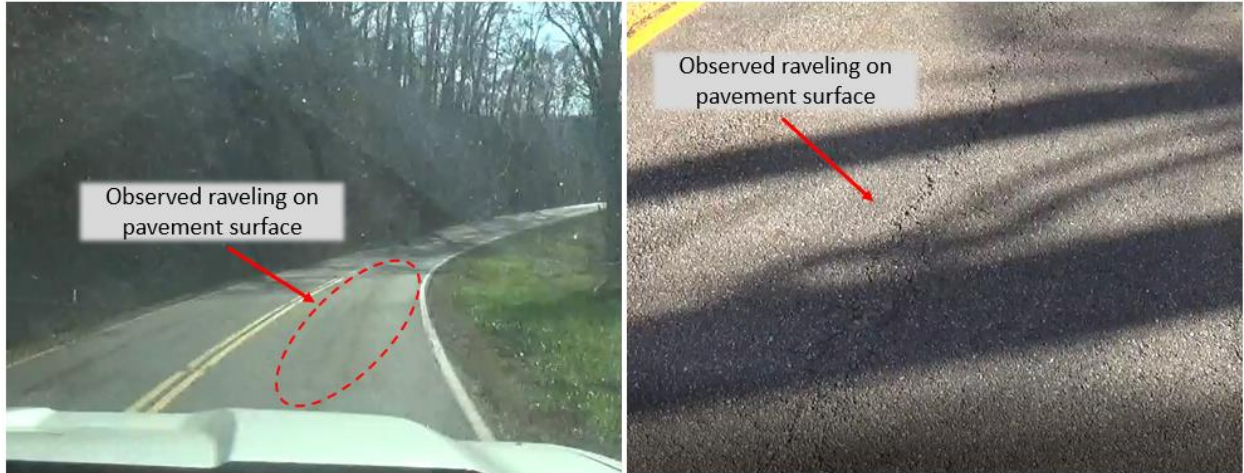
Figure 7. Raveling on Canopy Covered Pavement Sections.

On the canopy section of roadway, there was noticeable amounts of raveling occurring on the pavement surface as shown in Figure 7. The observed stripping of aggregate particles and cracking is partially due to the presence of moisture on the pavement surface. It is likely that moisture is present for long periods due to a lack of exposure of the pavement to direct sunlight. It was also observed that within the canopy shaded sections, there were a number of locations that were patched (see Figure 8) due to localized raveling as opposed to unshaded sections that had no patching.

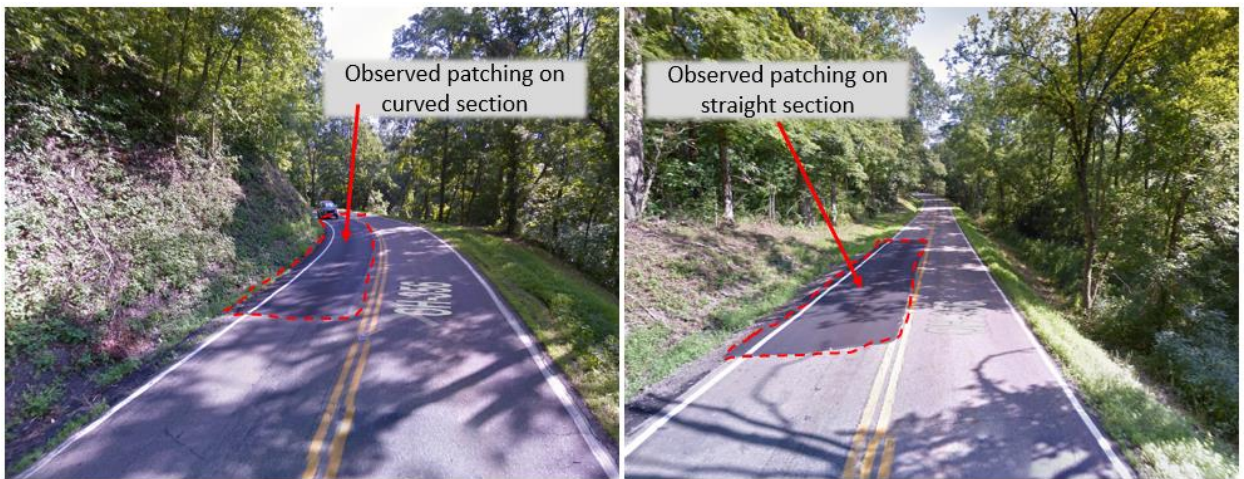
Figure 8. Patched Pavement Sections Under Canopy Cover.

Additionally, the curved sections of the roadway had relatively more patching than on the straight sections. On one hand, it is likely that the curved sections are prone to raveling faster than straight sections because there is an increased amount of traction and braking going on between the tires and pavement on the curved sections. On the other hand, and from a safety perspective, this is a concern because (i) during the winter, the moisture present on the pavement could potentially freeze and cause the pavement surface to become slippery, and (ii) there is a high potential of hydroplaning.

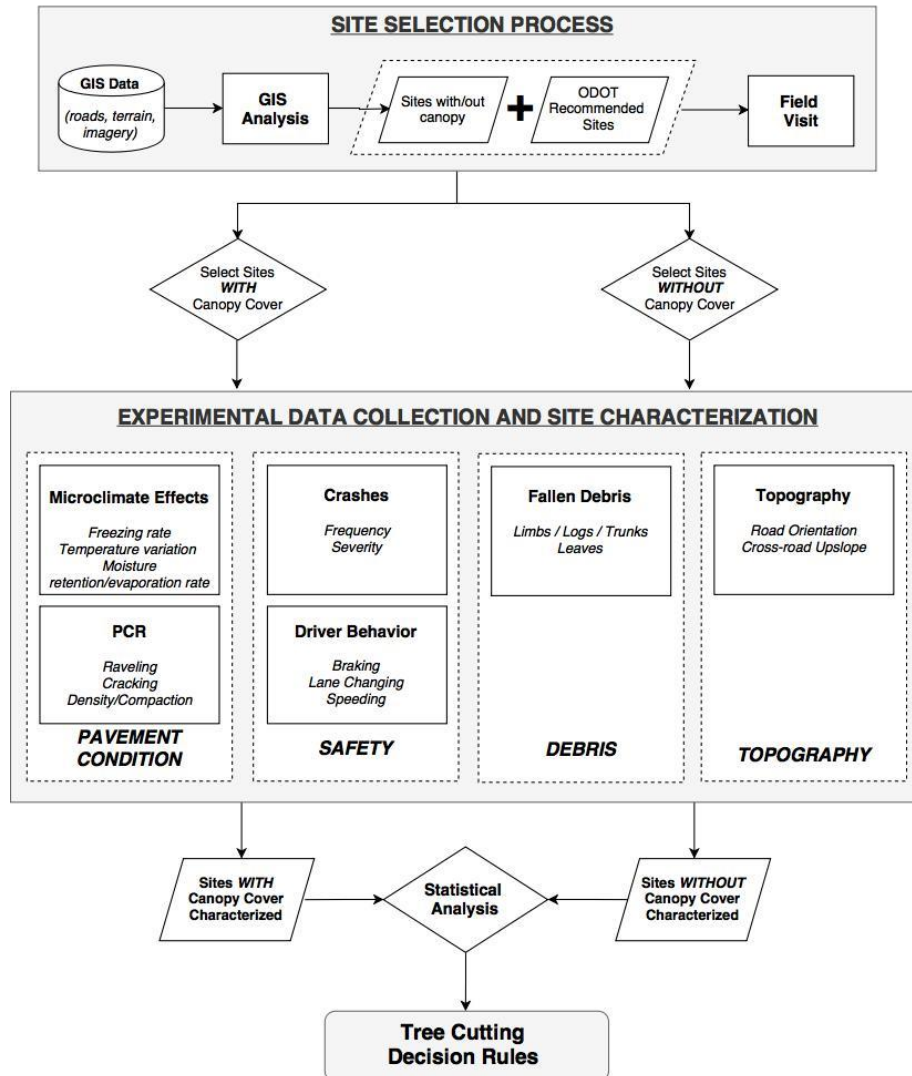
Figure 10. Proposed Study Design for Phase II.

On the recommendation of the technical panel, the Ohio University research team anticipate pursuing the recommendations that have been presented. The overall goal of phase II would be to provide ODOT with a better understanding of the effects of tree proximity on pavement integrity, drivable surface condition, and safety. The proposed design for the tree and pavement study to be adopted for phase II is depicted in Figure 10. Specifically, phase II will attempt to fill the gap in the body of knowledge on how trees influence pavement degradation and safety in a cool-temperate climatic region. Based on the findings from phase I, the research team propose to pursue the following testable predictions.
