## Evaluation of R1-6 Gateway Treatment Alternatives for Pedestrian Crossings: Follow-Up Report

**Ron Van Houten**  
**Jonathan Hochmuth**

Final Report

CTS 17-05

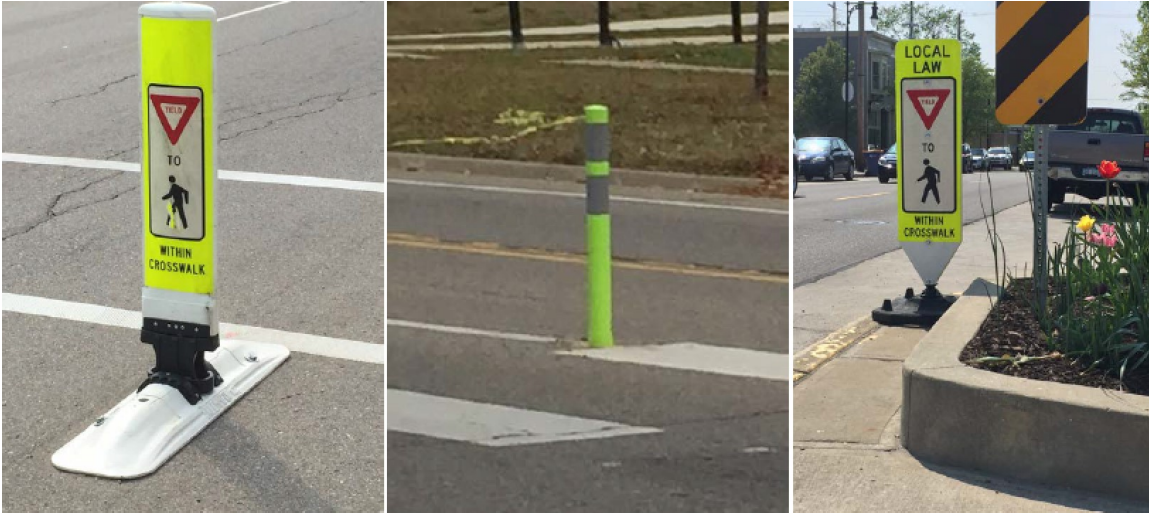
Three types of traffic control devices (TCD)s were used in this study. The first TCD device was the R1-6 in-street sign with a curb type base with a flexible rubber connector between the paddle and the curb type base. The second was a flexible delineator and the third was a R1-6 sign with a flush mounted base and a spring loaded pivot at the base.

**Figure 3.1.** Figure 3.1a (above left) shows an R1-6 sign installed on a removable curb base. Figure 3.1b (middle) shows a flexible delineator installation. Figure 3.1c (above right) shows an R1-6 sign mounted on a flush mounted base.

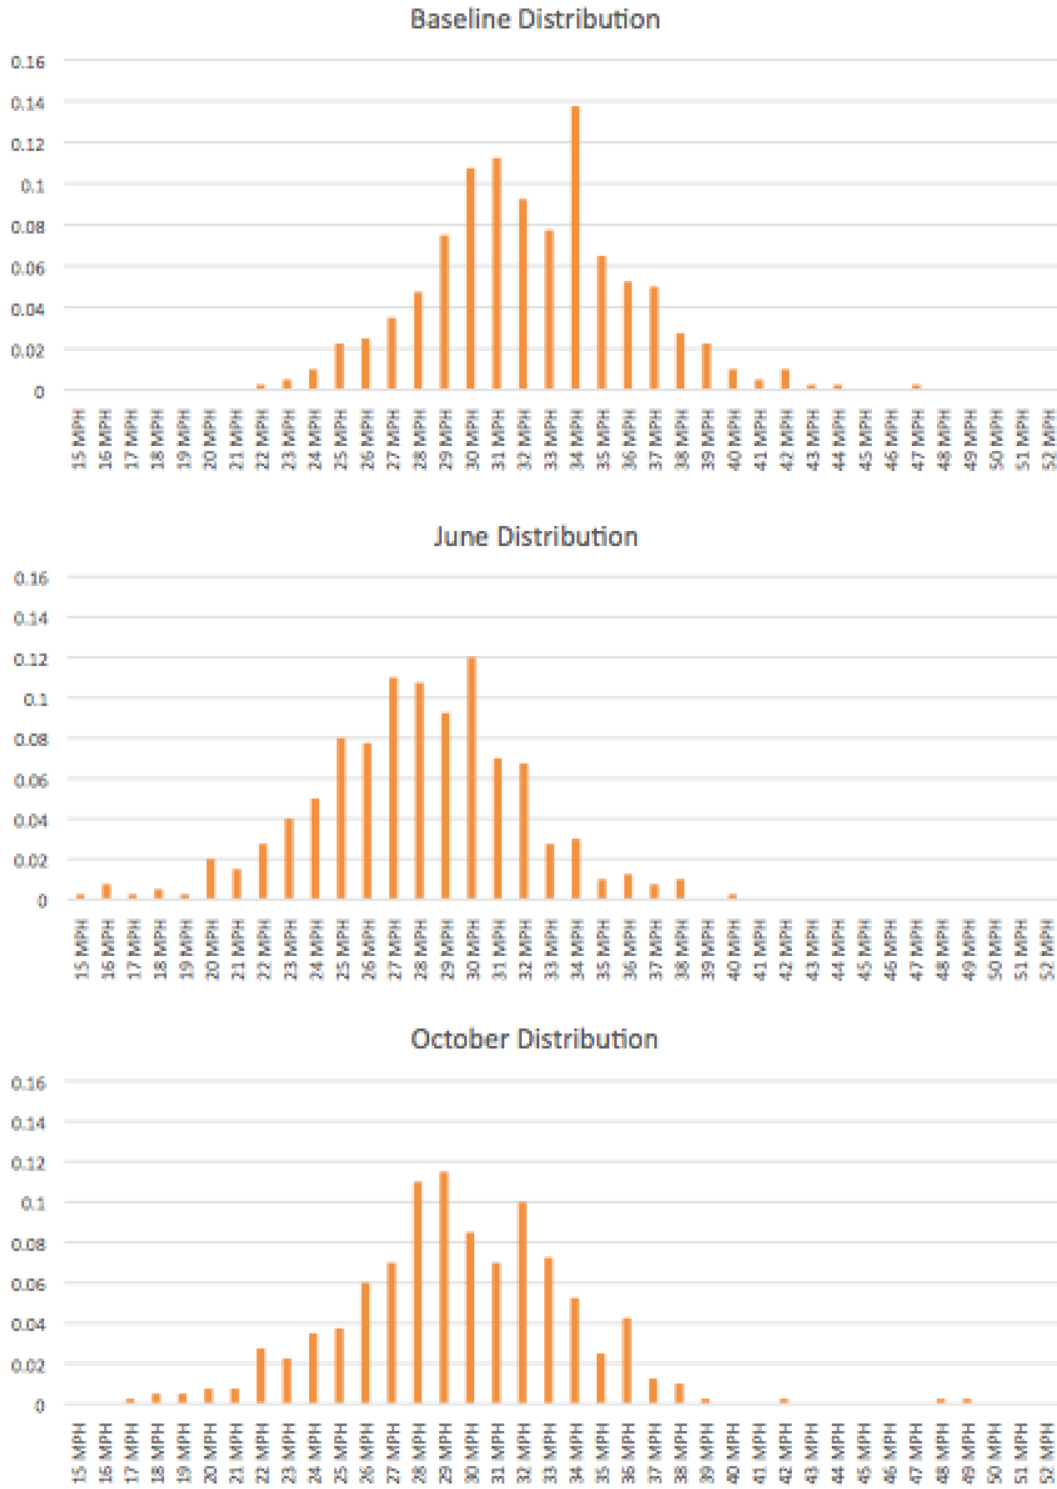
Figure 4.1 Speed distribution at the crosswalk for Nixon at Bluett. The top frame shows the distribution of speeds for baseline, the middle frame shows the distribution in June and the bottom frame shows the distribution in October.

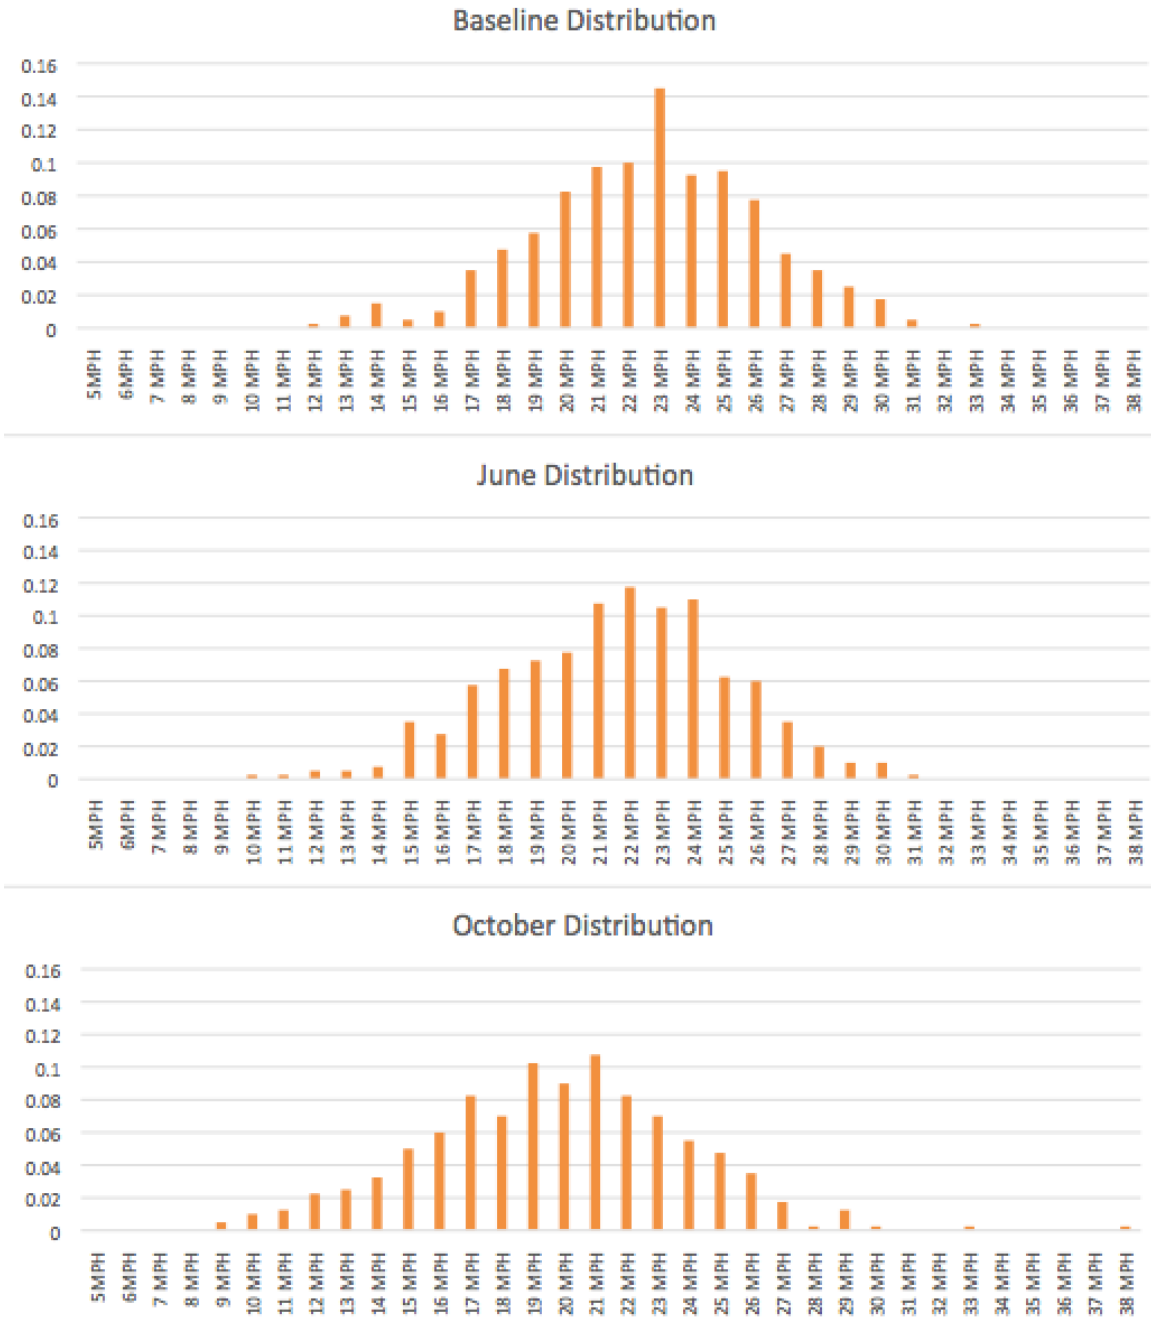
Figure 4.9 The speed distribution at the midblock crosswalk on Main Street in Three Rivers. The top frame shows the distribution of speeds for baseline, the middle frame shows the distribution in June and the bottom frame shows the distribution in October.

Figure 4.8 shows the speed reductions entering one of the roundabouts in Benton Harbor. At this site a similar progressive shift toward slower speeds was observed with a larger shift in October than in June. Figure 4.9 shows a similar progressive shift in speed after the gateway was introduced at a midblock site in Three Rivers.

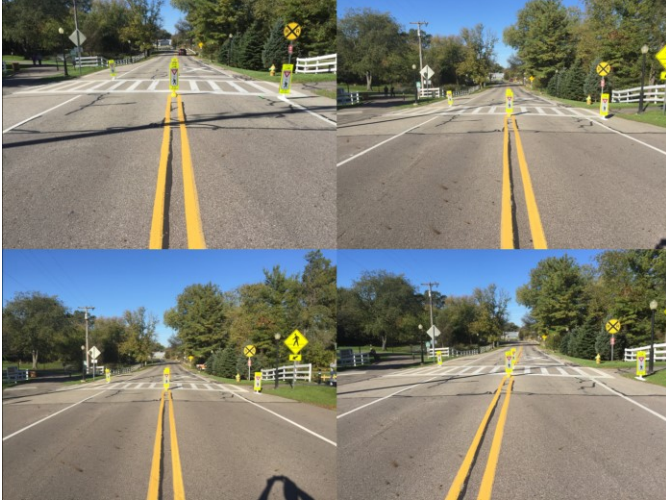
The present study used the R1-6 in-street sign in a gateway configuration (Bennett, Manal, & Van Houten, 2014). The distance between the signs was manipulated in 2ft increments, and the change in driver yielding to pedestrians was measured (see Figure 5.1).

**Figure 5.1 Photographs of different Gateway widths: (Top left) 12ft, (top right) 14ft, (bottom left) 16ft, and (bottom right) 18ft.**

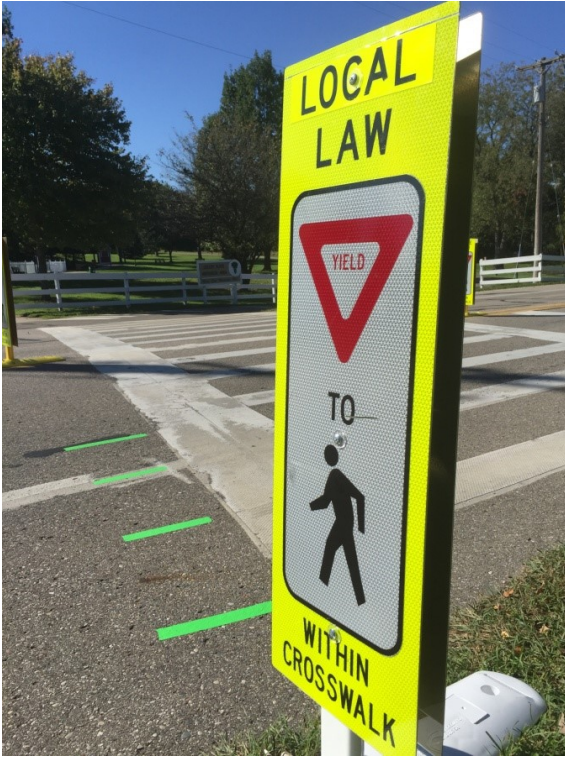
Initially, data were planned to be collected on widths ranging from 16ft to 10ft, as well as baseline (i.e., no gateway treatment), however when the signs were placed at the 10ft interval, one experimenter became concerned that this might increase the probability of a sign being struck. In response to this, it was agreed to make the fourth sign width 18ft. Taped lines were placed on the ground at the set distances, and the signs moved to these positions with each change in conditions (see Figure 5.2).

**Figure 5.2 Photograph of crosswalks with tape lines marking placement of sign for each gateway width.**

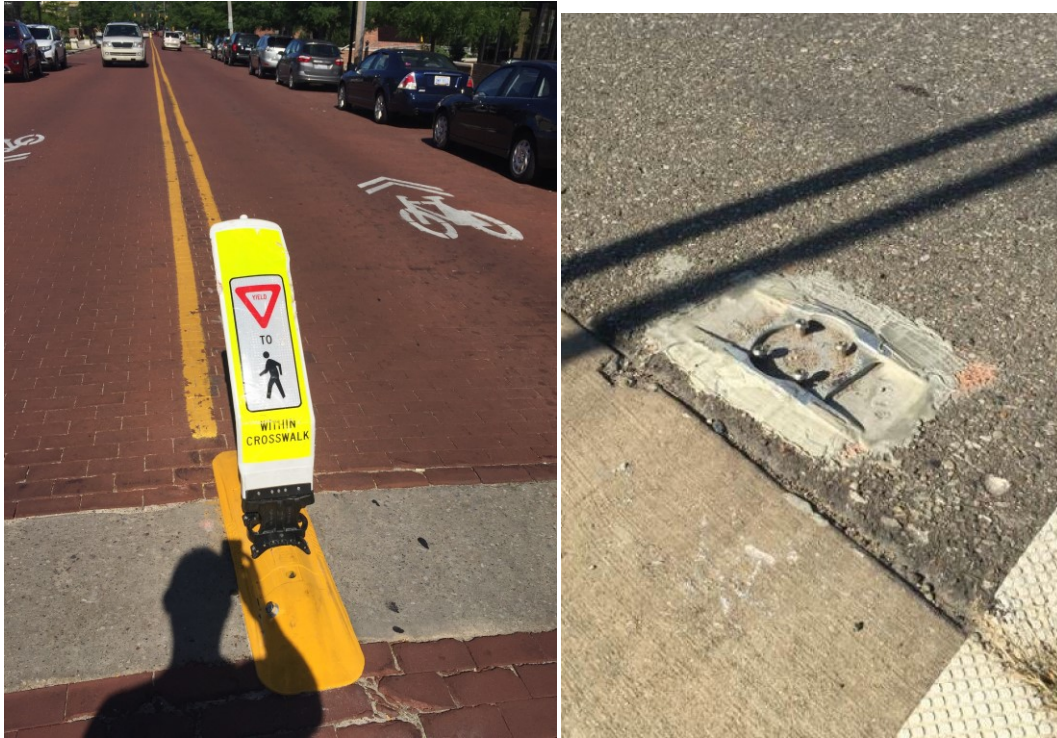
**Figure 7.2.** Figure 7.2a (above left) shows an R1-6 sign installed on a removable curb base that was damaged during the study. Figure 7.2b (above right) shows a sheared base of a flush mounted sign.

One type of R1-6 mounting (Flush mounted with a spring loaded pivot performed less well than the others. All of the R1-6 signs lost were of this type. Those mounted with a flexible rubber linkage on a curb type base all survived although one of the paddles was bent on one of these signs. It was decided not to replace lost signs to determine if the partial gateways offered some degree of effectiveness. The results indicated partial effect if one element was lost. At one site (Westnedge and Ranney) two out of three signs were lost and yielding returned to close to baseline levels.
