**WORK ZONE INTRUSION  
ALERT TECHNOLOGIES:  
ASSESSMENT AND  
PRACTICAL GUIDANCE**

**Final Report**

**SPR 790**

Oregon Department of Transportation

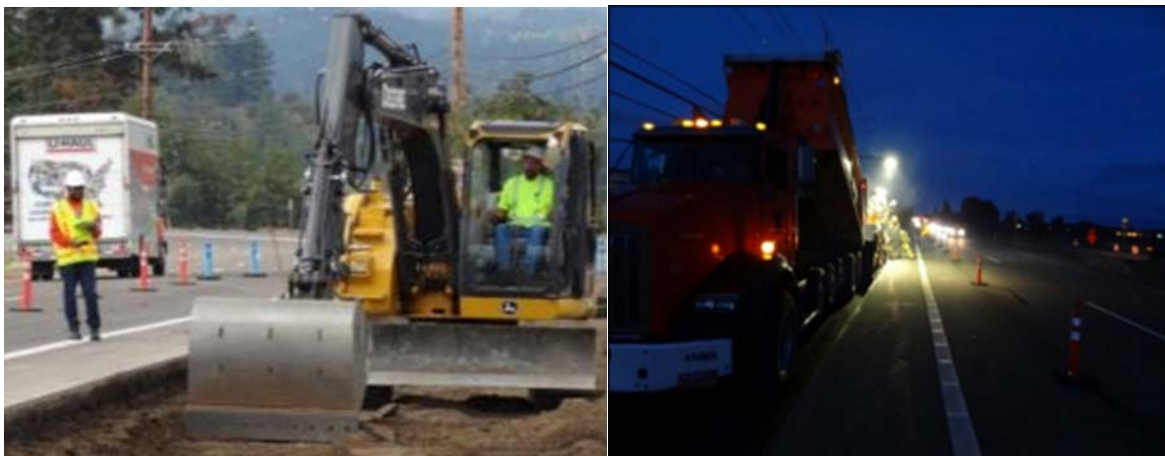
Figure 4.4: Daytime and Nighttime Observations

A two-phased data collection approach involving data gathering of daytime and nighttime operations was developed and used to ensure that the study would account for a broad range of project constraints and operational factors (Figure 4.4).

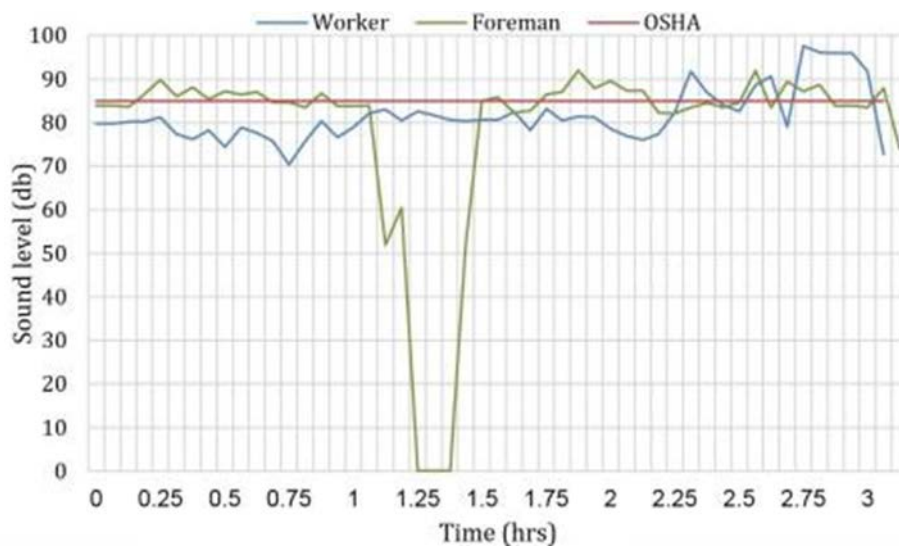
Figure 4.5: Sound Level in Close Proximity to Workers

field worker and a foreman under the supervision of the project manager. The foreman and field worker took turns operating the 135G John Deere Excavator, compactor, and 1,500 gallon water truck. The foreman started excavating at about 7:30am while the dosimeters for both worker and foreman were activated at approximately 8:04 am. It is important to note that each worker within close proximity of the excavator wore hearing protection. At approximately 10:45am, the field worker began compacting the soil using the roller. Prior to operating the roller, the worker operated the water truck and excavator. The research team set up a video camera close to the taper and another camera on the north side of the work zone to capture the whole operation. The data logging grid system was created using a laser distance measure to determine 25 feet by 20 feet offsets. Spray paint was used to create reference points for each station. The measurements along Grid-Line 1 were approximately four feet away from the actual construction area (but within the work zone). Data recording along the grid-lines began at about 8:25am and was concluded at approximately 11:30am. Figure 4.5 shows the noise level to which each worker was exposed between 8:04am and 11:06am. Both workers maintained close proximity to the equipment at all times except between 9:20am to 9:40am when the foreman left the work zone. The peak noise level recorded during the observation was between 10:40am and 11:02am when the field worker was using the roller. Figure 4.5 also shows the maximum noise level permitted by OSHA without hearing protection (85 decibels).

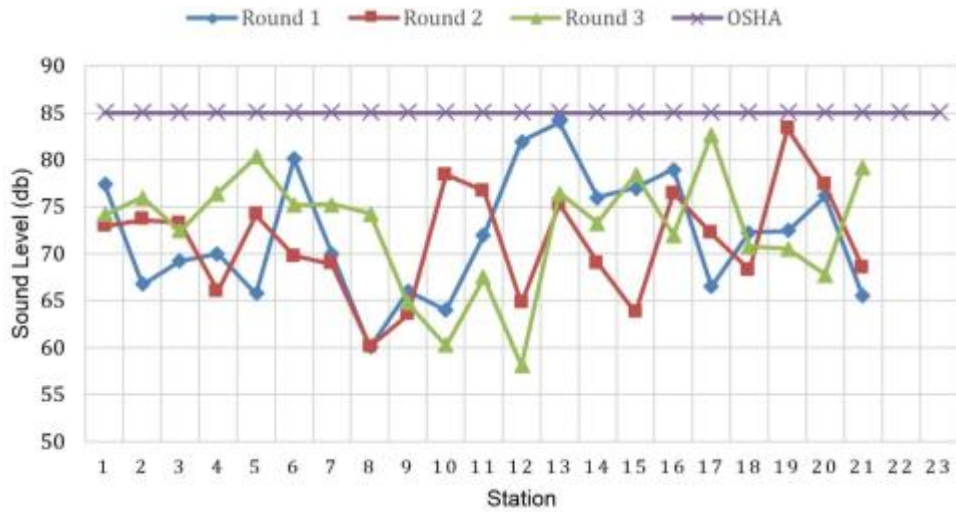
Figure 4.6: Sound Level along Grid-Line 1

The noise level around the work zone was recorded at the 21 stations using the locations identified on the grid system. Sound level measurements were taken three times (rounds). Each round of measurements was captured at each station to provide a range for noise level per station. Figure 4.6 shows that all of the measurements were observed to be below 85 decibels. Stations 13, 17, and 19 indicate the maximum noise level of each round of data collection. It was found that the peaks recorded resulted from the close proximity of the excavator to the station being observed.

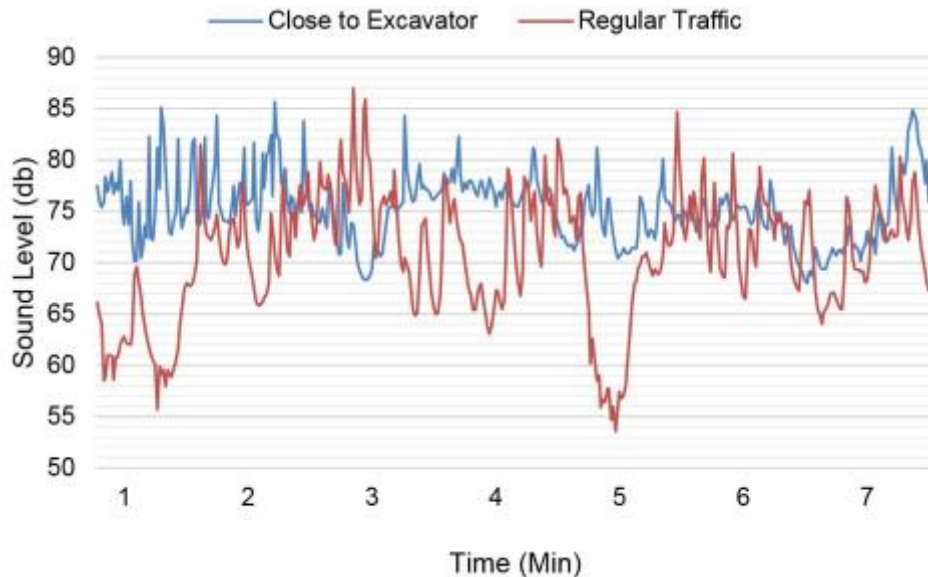
Figure 4.8: Sound Level in Close Proximity to the Excavator and Regular Vehicle Traffic

Figure 4.8 shows a seven-minute recording of sound level close to the excavator and vehicle traffic. Although both noise levels have similar peaks, the noise level around the equipment was relatively consistent over the seven minutes. The median noise level around the excavator and vehicle traffic was recorded as 75 and 71 decibels, respectively.

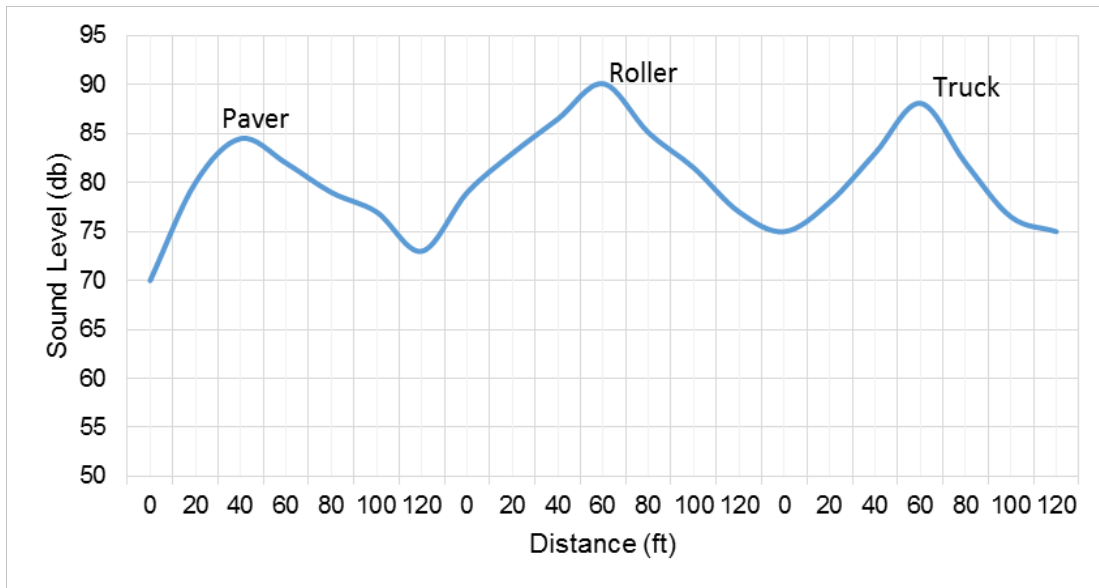
Figure 4.9: Average Sound Levels based on Distance from Construction Equipment Observed

The data collection process used during the daytime observation was repeated during a nighttime operation on September 17. The research team observed a paving operation between 7:00pm and 10:00pm. The operation fleet consisted of two rollers (Caterpillar CB54 and extra-wide Caterpillar CB54XW), a paver (CAT AP1055F), and asphalt dump trucks. Approximately 6 to 8 people were stationed within close proximity to the paver at any given time. Gridlines and stations had to be recreated because some of them were destroyed after the first observation (additional observation results from the nighttime along the gridlines can be found in Appendix E). One dosimeter was assigned to a worker operating the big roller and the other to the paver operator. Figure 4.9 shows the average maximum noise level recorded across a distance of 120 feet during the three observations along Grid-Line 1. During the operation, 84.5, 90.1, and 88.1 decibels were recorded as the peak noise level for the paver, roller, and asphalt truck, respectively. Note: These measurements were based on the relative distance from each piece of equipment on both sides of the equipment, and the station being observed. Therefore, there are multiple zero points along the horizontal axis.

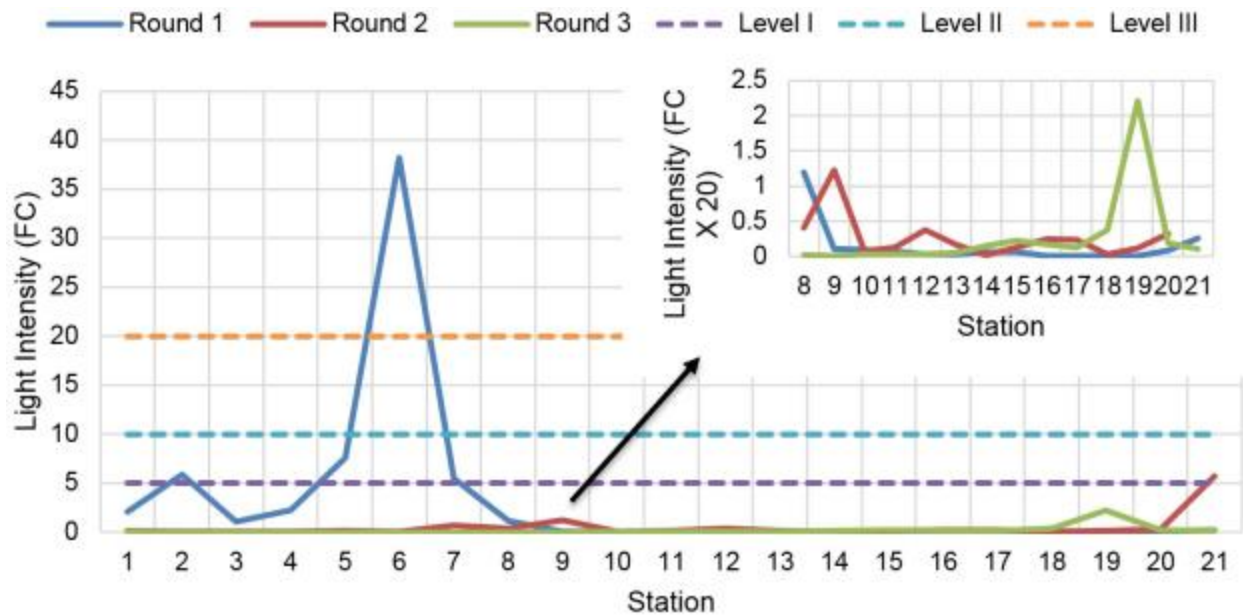
Figure 4.10: Light Intensity along Grid-Line 1 (Nighttime Observation)

Figure 4.10 shows the level of light for different stations within the work zone, collected at specific times from the nighttime observation. While recording the first round of measurements along Grid-Line 1, Station 6 recorded 38.2 Fc—the highest level of light intensity logged. The high values recorded were a result of the close proximity of the paver to Station 6. The second and third round of measurements peaked at Stations 21 and 19, respectively, due to the presence of the paver and roller. The observations indicate that most stations recorded light levels below the 5.0 Fc minimum illuminance level for a work zone. However, it should be noted that the field workers clustered around the paver most of the time.

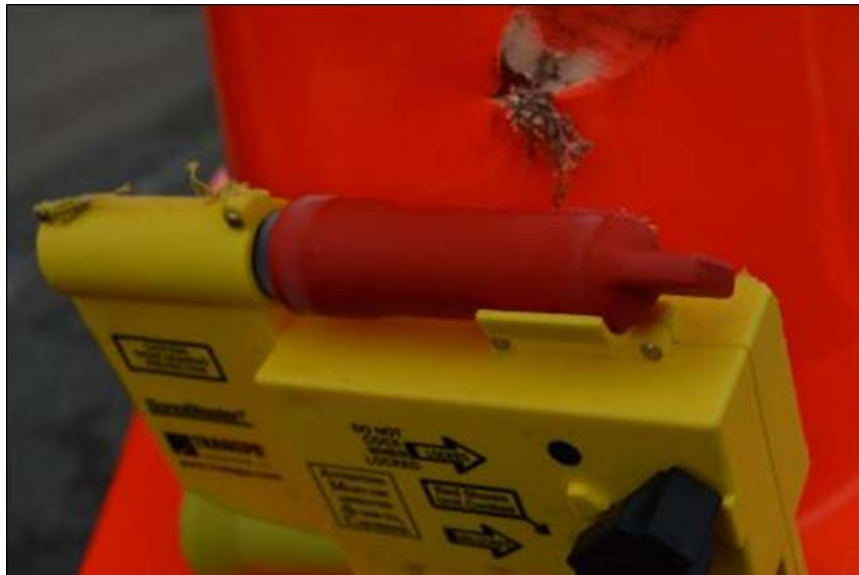
Alarms were triggered by the research team one at a time to record any possible false negatives. Results from this test showed that after more than 20 triggers, none of the technologies had a false negative alarm. That is, each intrusion alert system produced the expected alarm once triggered; in no cases was the alert triggered but the alarm not produced. Notwithstanding the success rate of the technologies, six false negatives were recorded when a SonoBlaster® device was used more than once (following changing of cartridge). The research team believes that the SonoBlaster® is not designed for reuse after impact. In fact, in real operations, it is anticipated that once a SonoBlaster® unit has been triggered by an intrusion, it will likely be discarded due to severe damage occurring to the unit (see Figure 5.2), thereby making the false negatives recorded during the testing more or less understandable and likely not present in practice.

Figure 5.2: SonoBlaster® Damaged after Simulated Intrusion (Vehicle Striking Cone)

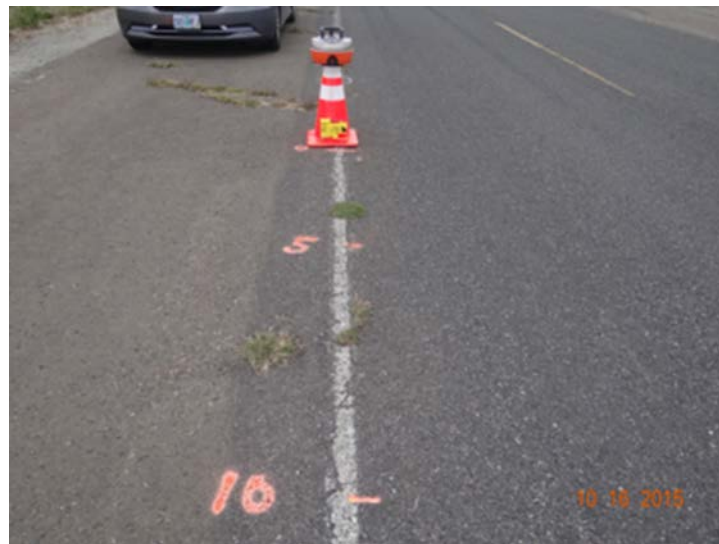
Figure 5.3: Distance Markings (in feet) on Roadway

The sound level which a worker is exposed to relative to his/her distance from each intrusion alert technology was measured. The level of sound was recorded between 5 feet and 500 feet in terms of distance between the technology and the sound meter, to provide sufficient information over an appreciable range of distances. Distance (in feet) starting from 0 feet was marked on the roadway using a spray marker and a 300 feet tape measure (Figure 5.3). For the Intellicone® and WAS, the source of alarm was placed at the 0 feet station facing a pre-determined position while the trigger mechanism was within transmission range. For the SonoBlaster®, the technology was attached to a cone and remained stationary on the 0 feet mark. Sound level measurements were then taken along the pavement striping marked for distances after each alarm was activated (Figure 5.4). The sound meter was positioned approximately 3 feet above the ground when recording sound levels.

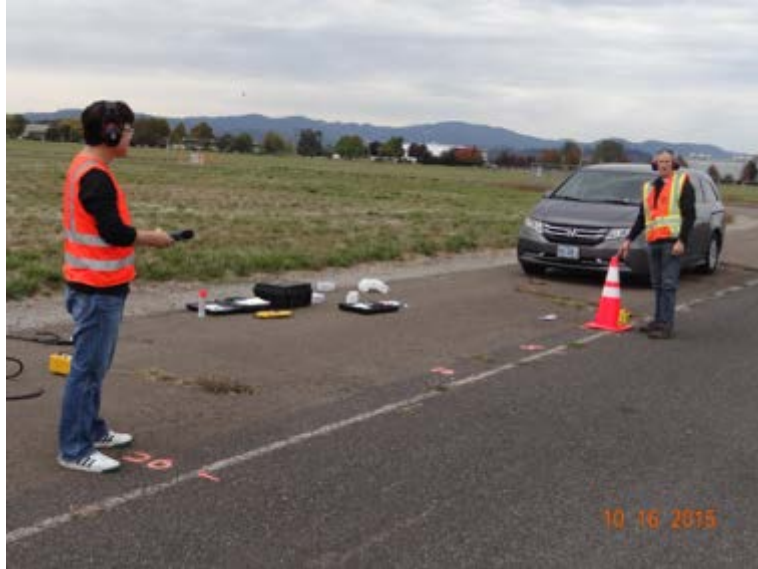
Figure 5.4: Sound Measurement at 20 feet

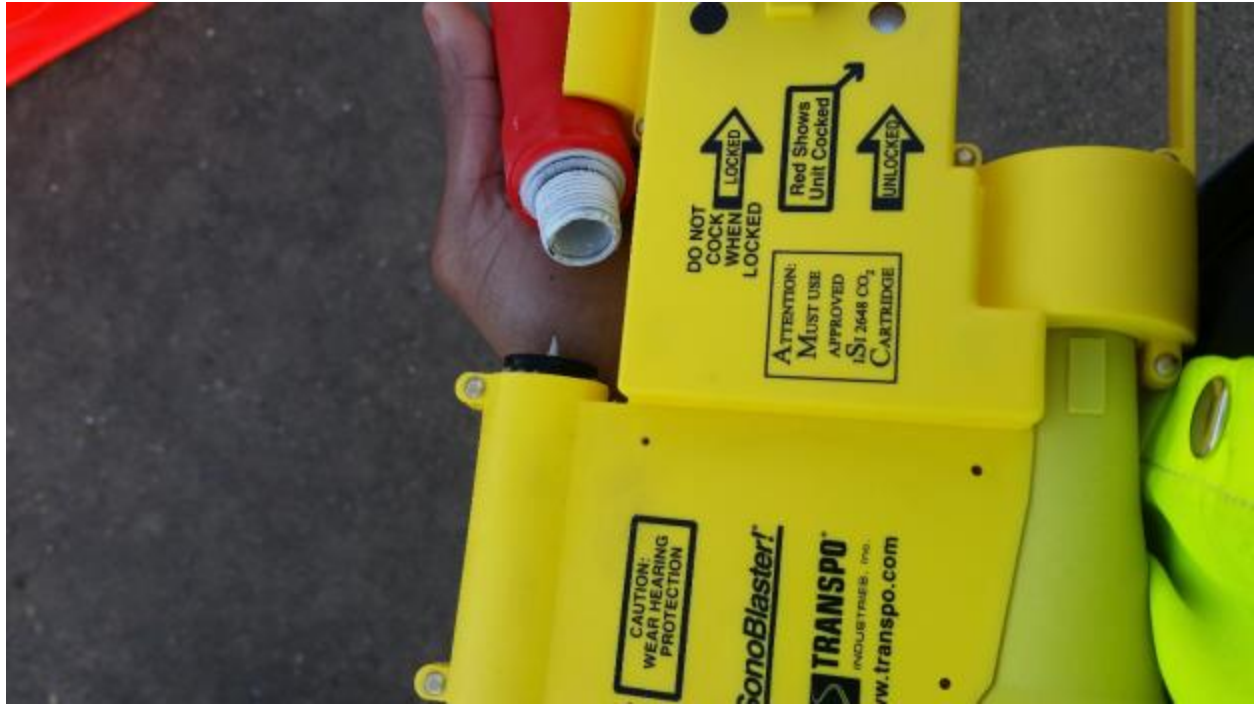
The inconsistency in the duration of sound produced by the SonoBlaster® appears to be largely due to its use of CO2 cartridges as an alarm-creating mechanism. The CO2 cartridge is required to be changed after every use. It was observed that after the SonoBlaster® was triggered once, subsequent uses of the SonoBlaster® with new cartridges produced shorter bursts of sound. Novosel (2015) pointed out that cold or wet weather could be a possible cause for this phenomenon (note that the pilot testing was conducted during the winter season). Also, accumulated ice was noticed on the nozzle after triggering the SonoBlaster®, especially in cold weather. The ice was caused by a reaction of the metallic nozzle to the pressurized CO2 being pushed through it. The accumulated ice made the cartridge changing process challenging because the ice made the cartridge stick to the nozzle, and replacing the cartridge was delayed until the ice melted (see Figure 5.5).

Figure 5.5: Ice Accumulation on Nozzle of SonoBlaster®

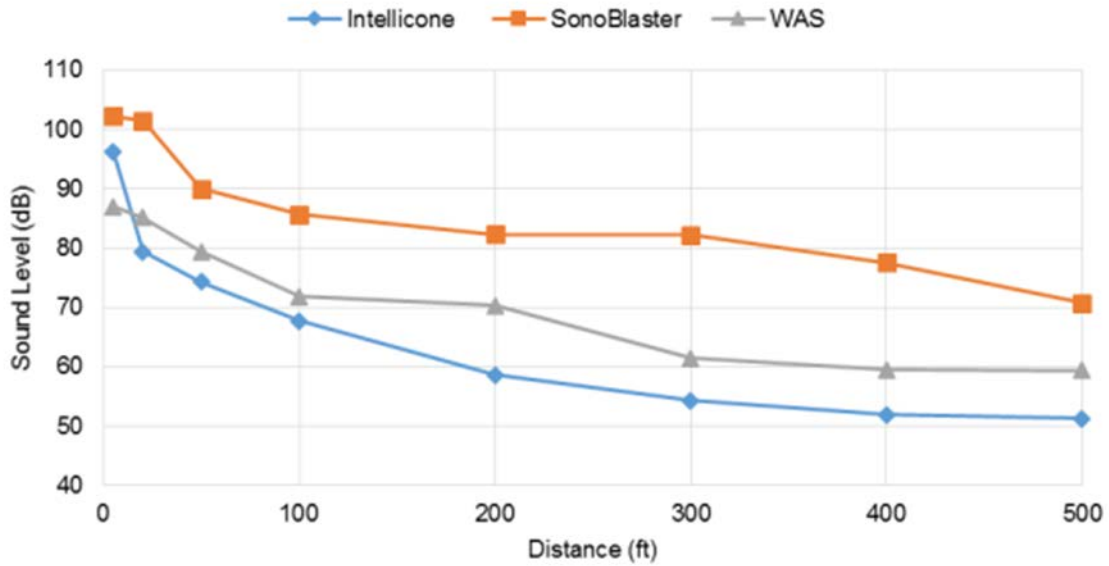
Figure 5.6: Median Sound Level vs. Distance from the Technology

The test results show that despite the variable nature of the alarm duration of the SonoBlaster®, it consistently had a higher sound level than the Intellicone® and WAS. Figure 5.6 shows the median sound level measured at various distances from the device for each technology. The figure shows a declining slope across all three technologies. This result is due to the continuous reduction in sound level as distance from the intrusion alert technology increases. It is important to note that the markers on each line in Figure 5.6 (and following figures) represent the median sound level measured at that given distance.

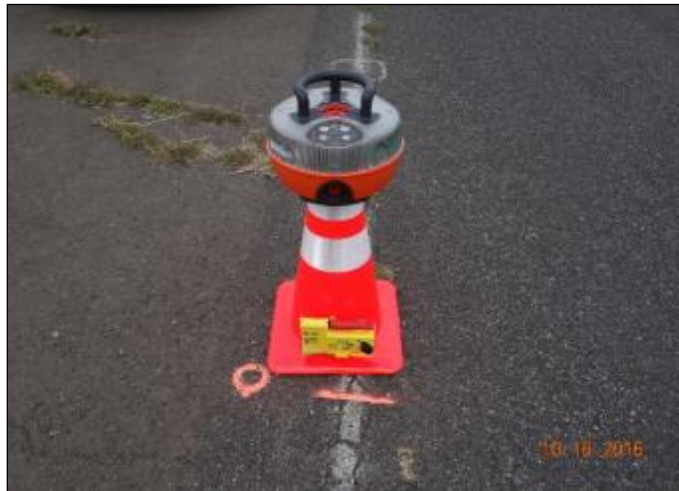
Figure 5.10: One Speaker Oriented towards Sound Meter

The Portable Site Alarm (PSA) of the Intellicone® has three speakers: one on the front of the unit, and two others each of which is located at 120 degrees from the front speaker (Figures 5.10 and 5.11). Two series of tests were carried out. The first test was conducted with the PSA facing forward to the sound meter (one speaker facing forward directly; Figure 5.10). The second test was conducted with the PSA facing backward (the two side speakers facing forward with 60 degree angles; shown in Figure 5.11).

The data collected show that a higher level of alarm sound was produced from the PSA when two speakers were oriented towards the sound meter (Figure 5.12). However, a higher sound level was recorded for the single speaker orientation at the 500 feet station. The research team noted that ambient noise, caused mainly by wind, could be a reason for this observation. Measurements taken at 500 feet tend to be slightly inconsistent (skewed) considering the sound level produced by the 6 mph wind on November 2, 2016. In short, the abnormality appears largely due to varying testing conditions.

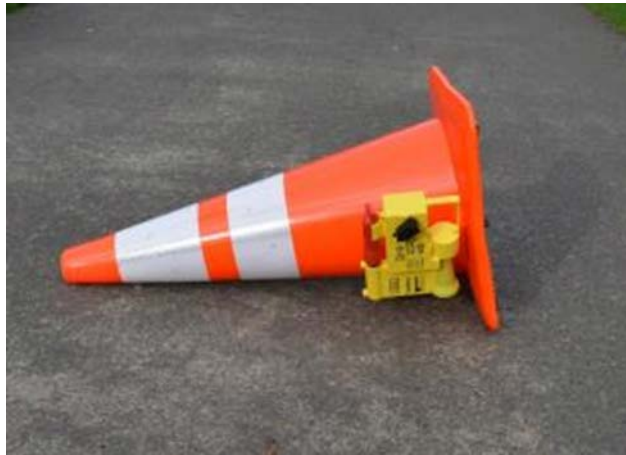
Figure 5.13: SonoBlaster® Outlet Facing Downward

The first series of tests was carried out orienting the outlet of the sound alarm face down when tilted, as seen in Figure 5.13. Since videos and documentation on the SonoBlaster® did not explicitly state a preferred direction for facing the technology in a work zone, and since a cone may be impacted in any direction by an intruding vehicle depending on the orientation of the cone to the oncoming traffic, the reverse direction (facing upward) was tested as well (see Figure 5.14).

Figure 5.15 shows that although both directions result in a similar trend in sound level, the sound produced was higher when the outlet faced down. This pattern was consistent for all distances except for the measurements acquired 5 feet and 500 feet away from the

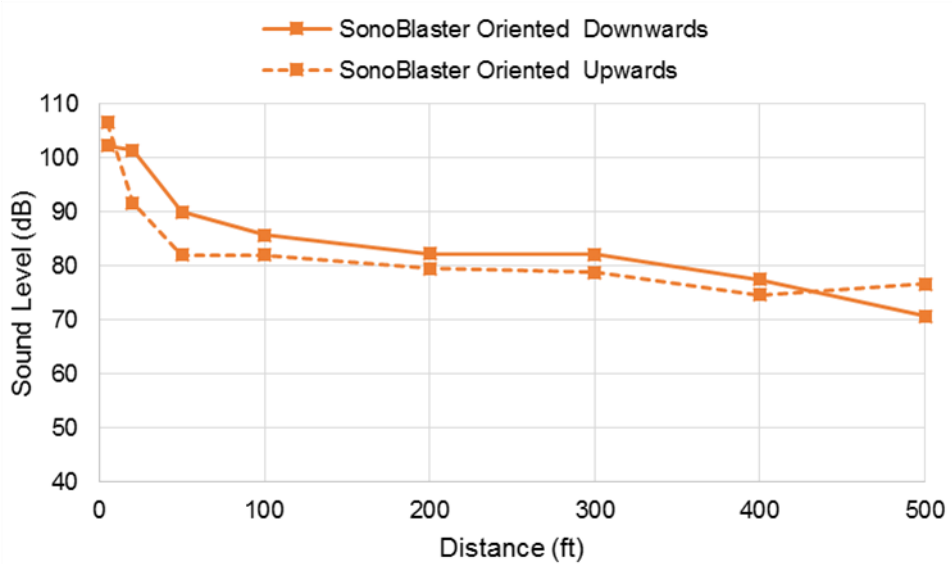
Figure 5.15: Median Sound Levels of SonoBlaster® relative to Alarm Orientation

device. These abnormalities may also be due to varying testing conditions, as noted above.

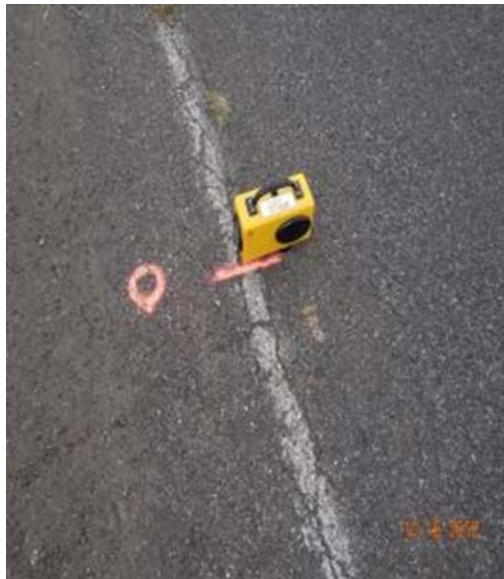
Figure 5.16: WAS Speaker Facing Sound Meter

The orientation of the WAS was changed as well to provide additional information on effective placement directions. First, the speaker was positioned to face toward the sound meter (Figure 5.16), and then it was rotated 90 degrees to the side for another measurement (Figure 5.17).

As shown in Figure 5.18, the results show that a higher level of sound was recorded by the WAS when the sound outlet was oriented towards the sound meter. An abnormality was recorded when measurements were taken at the 5 feet station. It is speculated that this inconsistency could be a result of the proximity of the sound meter to the technology.

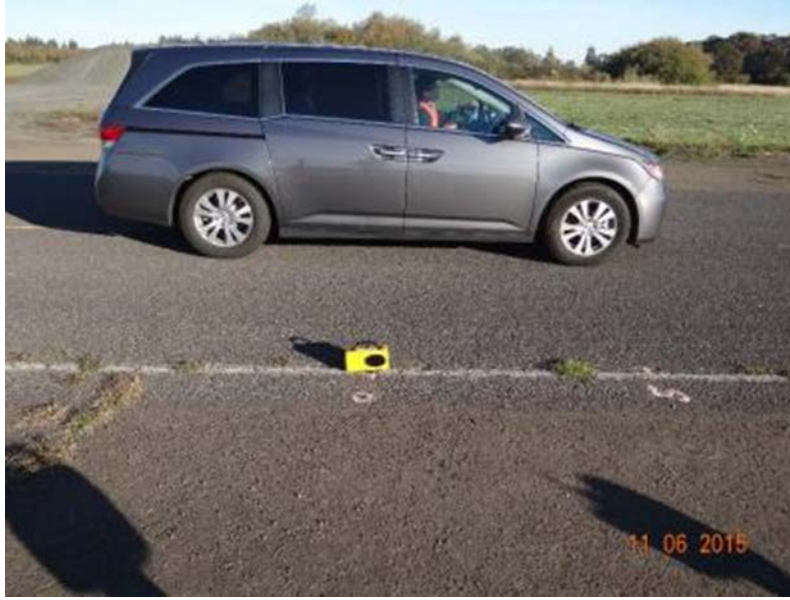
Figure 5.19: Test Setup for Sound Level Measurement inside Vehicle

Most tests carried out focused on how the alarm impacts construction workers. However, the research team also wanted to measure its impact on vehicle occupants, as it may also be important to determine how the occupants will react to sound alarms. To assess the sound level a vehicle occupant could be exposed to when an alarm is triggered, the sound level was measured from the driver's seat of a 2015 Honda Odyssey, a distance of 15 feet from the alarm, with windows fully closed (Figure 5.19). The test results show that despite the relatively low sound level within the vehicle, the relative sound levels emitted by each technology remained constant. Also, it should be noted that the sound levels were higher when the car moved faster, which shows the impact of engine and wind noise in a moving vehicle. Overall, the test yielded findings comparable to Figure 2.5; that is, the sound alarm of the SonoBlaster® was heard the most while that of the Intellicone® was heard the least (Figure 5.20). However, in general, the results of this testing activity did not produce a conclusive finding. Although inconclusive, the research team believes a similar test should be considered when assessing newer intrusion technologies to ensure that impacts of technologies on drivers are also accounted for.

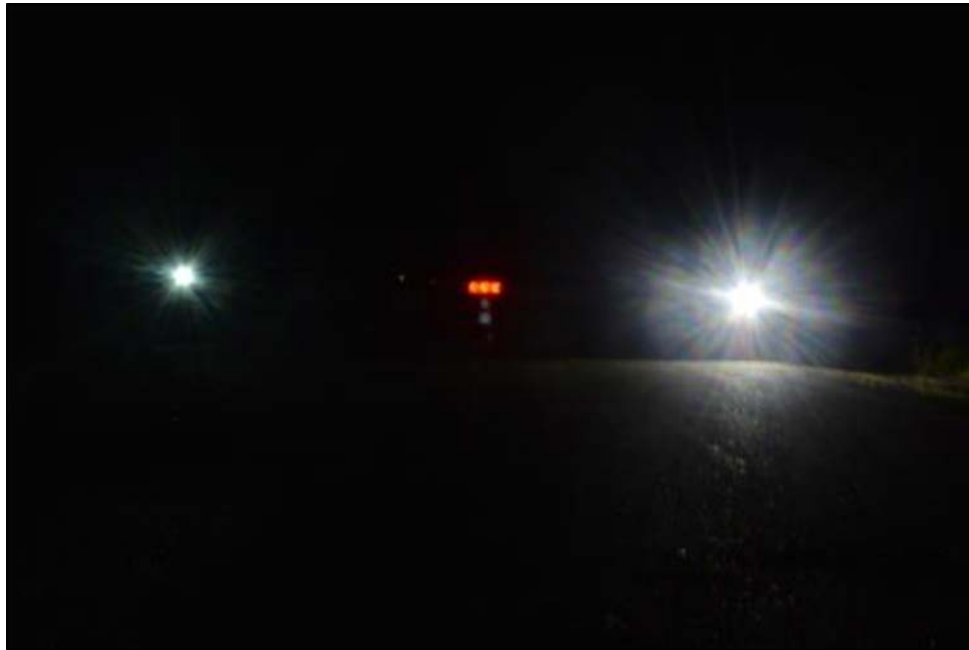
Figure 5.31: Reference Lights at 50 feet away from Intellicone®

reference lights on the Intellicone® and WAS, respectively. The pictures were taken at 50 feet away from the technologies using 14, 5, and 100 as the settings for the aperture, shutter speed, and ISO, respectively. Both figures show that the visual alarms of both technologies may not be visually outstanding compared to the work lights. Pictures taken 500 feet away from the alert systems indicate that the visual alert produced by the systems could be detected, meeting Oregon visibility law (see Figure 5.33). The researchers assume that the use of red strobe lights as emergency warning lights in work zones is acceptable in Oregon since Oregon Law does not prohibit the use of red strobe lights on safety equipment (OregonLaws 2015b).

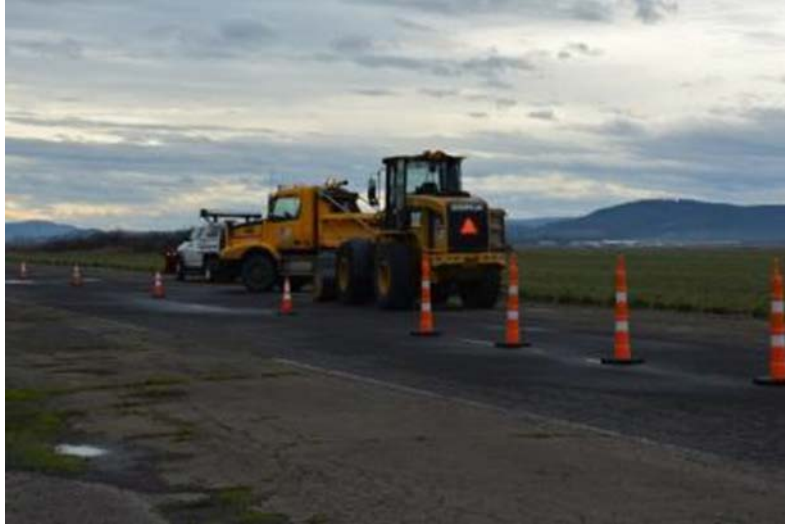
Figure 6.1: Setup for Demonstration

The event started at approximately 2:00pm on January 21, 2016 at the Corvallis Airport and lasted for approximately 2 hours. Figure 6.1 shows the wheel loader, dump truck, and safety cones that were used to mimic the setup of a real-life work zone.

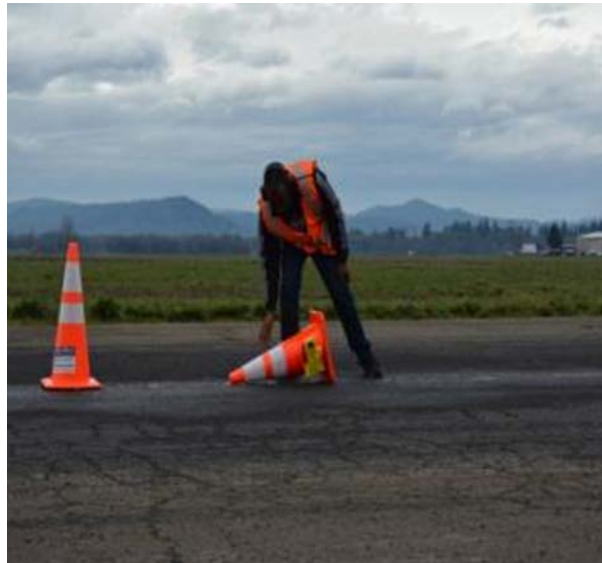
Figure 6.2: SonoBlaster® Activated Manually

tilting the safety cone (see Figure 6.2). The alarm triggered successfully and lasted for approximately 13 seconds. The researchers also showed the participants how the CO2 cartridge is changed and armed for subsequent use. The second demonstration was designed to mimic the collision between a vehicle and a SonoBlaster®-mounted cone and how the impact may possibly alert construction workers. A sedan, moving at approximately 20 mph struck and successfully triggered the SonoBlaster® intrusion alarm (see Figure 6.3 showing the cone and SonoBlaster® underneath the vehicle and workers trying to free it).

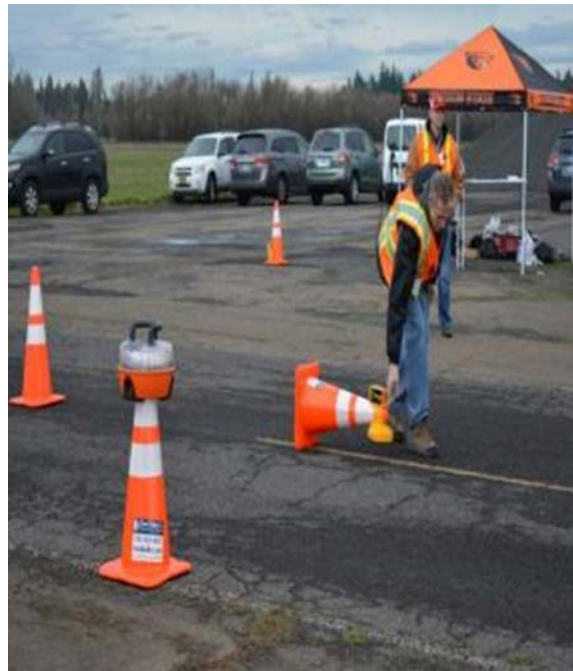
Figure 6.5: Intellicone® Activated Manually

The participants were also given an opportunity to evaluate the effectiveness of the Intellicone®. After showing the participants how to set up the Intellicone®, the Intellicone® was triggered manually by tilting a cone that had a strobe affixed on it (see Figure 6.5). Following the manual activation, the same sedan used to activate the SonoBlaster® was used to run over the cone (with the activated strobe). The Portable Site Alarm (PSA) unit was positioned within the work zone, about 50 feet from the construction equipment. Surprisingly, the Intellicone® did not activate after the vehicle impacted the strobe, thereby creating a false negative error. The strobes were switched and the activity was repeated. This time, the alarm triggered once the strobe hit the ground (see Figure 6.6).

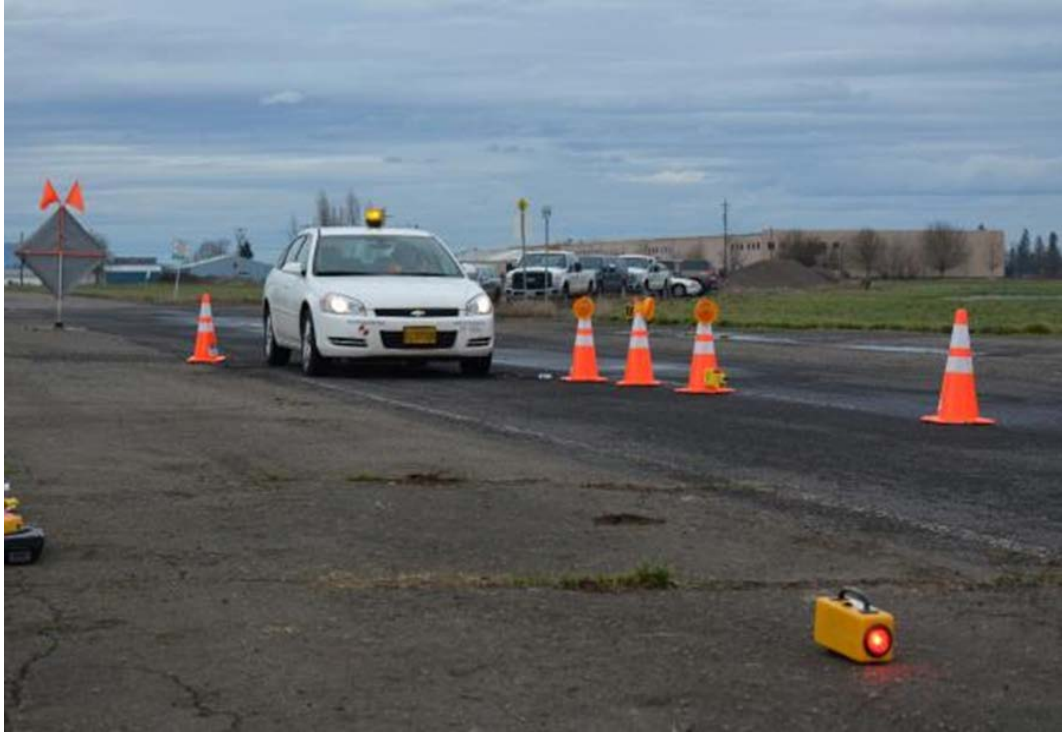
Similar to the previous two work zone intrusion technologies, the WAS technology was deployed and activated multiple times. The participants observed how to activate the WAS and how it could be installed along a work zone. The WAS was triggered manually by stepping on the pneumatic tube. For the first round of testing, the WAS was placed 50 feet away from the equipment, and then triggered by a moving vehicle. Next, the WAS alarm unit was attached to a wheel loader (using the base magnet). Furthermore, varying approach speeds of the sedan were tested to mimic the impact of different levels of speed on the WAS pneumatic unit. Changing the vehicle speed created the opportunity to evaluate how the relationship between triggered alarm and vehicle speed impacts a worker. Figures 6.8 and 6.9 show the different locations where the WAS alarm unit was placed.

Figure 6.8: WAS Located 50ft from Equipment while Activated by Intruding Vehicle

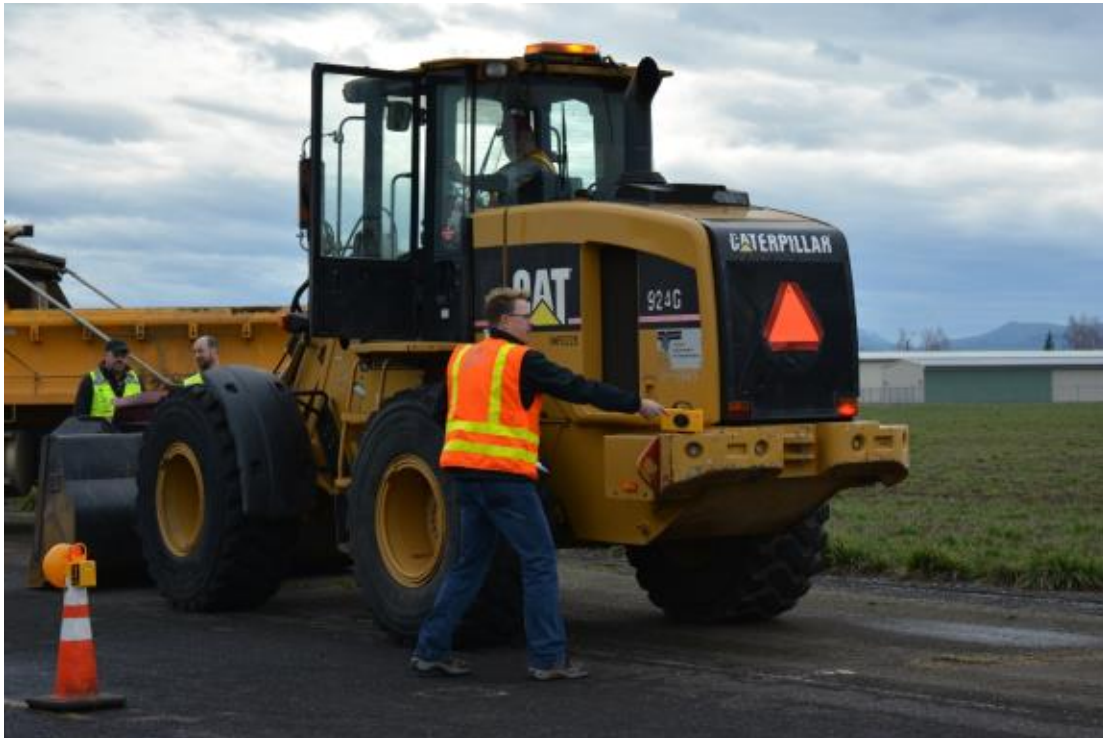
Figure 6.9: WAS Located on Wheel Loader

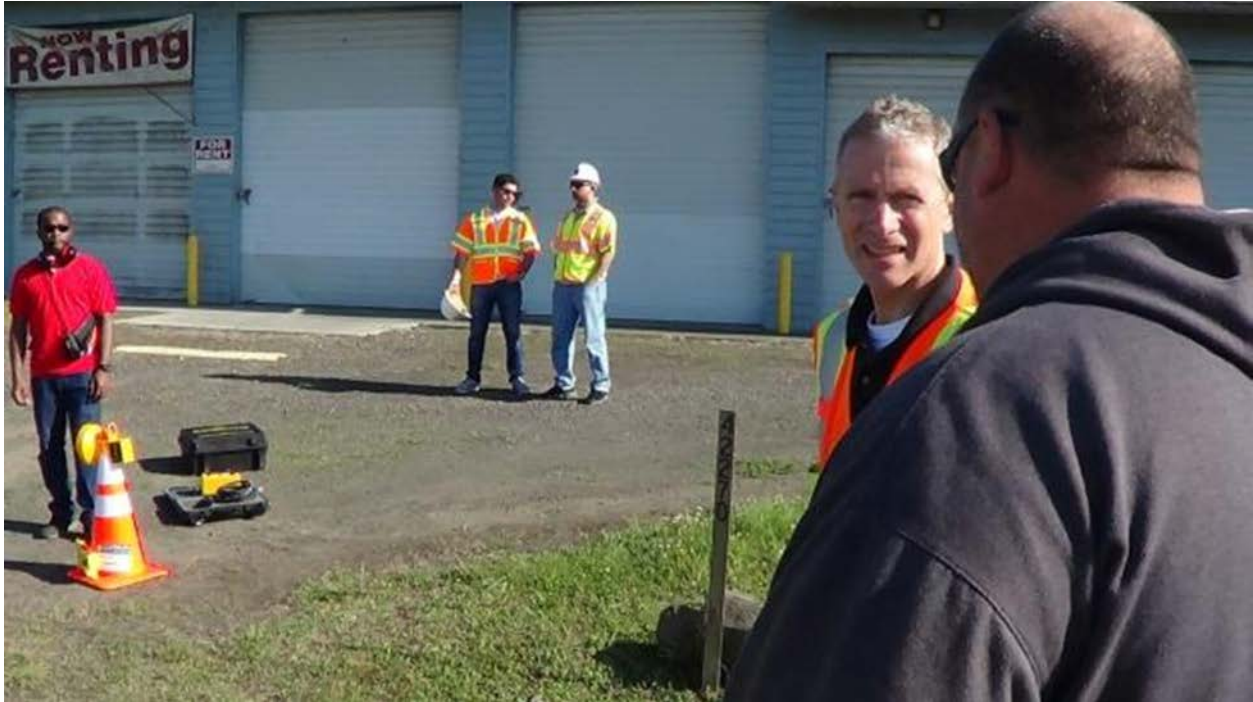
Figure 7.3: Demonstration Prior to Live Testing, Case Study Project #1, Day 1

The ODOT staff observed how each technology is activated, deployed, triggered, and deactivated (Figure 7.3). Following the demonstration, a survey questionnaire was distributed to the ODOT personnel to collect feedback. After collecting the survey forms, the researchers repeated the demonstration to construction crews involved in the paving, grinding, and rolling operation procedure. It should be noted that the workers were not asked to use the alert technology. The clickers were also distributed to each worker who was willing to be part of the study. The identification numbers of each clicker were recorded along with the job function of the worker handling the clicker to ensure accurate interpretation of data. An instruction was

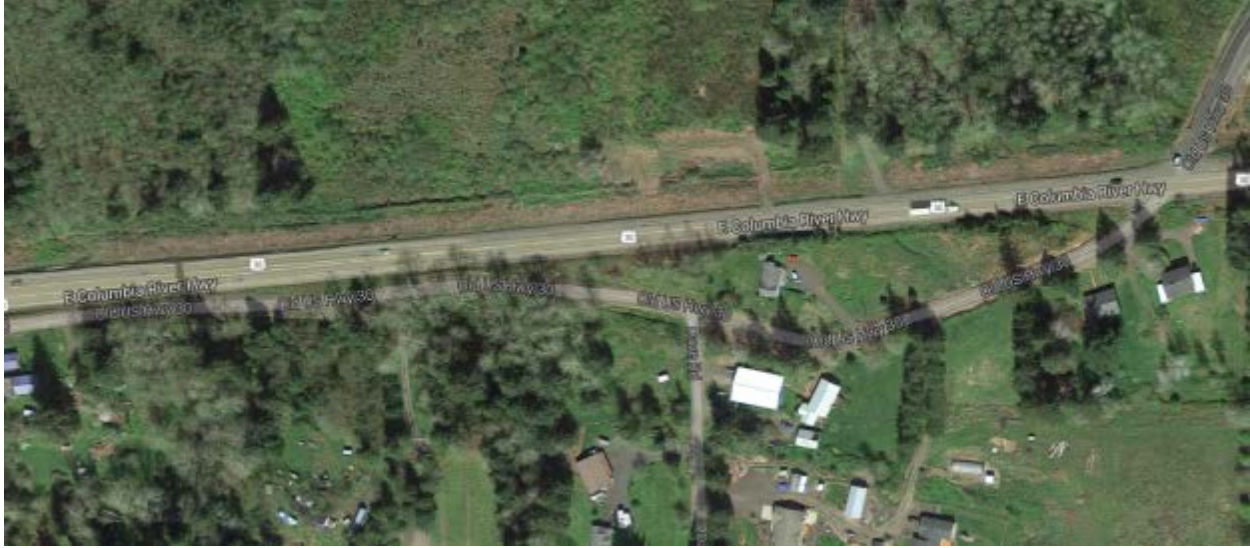
Figure 7.4: Site for Live Testing, Case Study Project #1, Day 1 (Image from Google Maps 2016)

Due to safety concerns around limited shoulder space on the east bound lane and the need to conceal the alert technologies from easy detection by workers, the researchers set up the alarms approximately 1 mile from the paving start point for the night (see Figure 7.4).

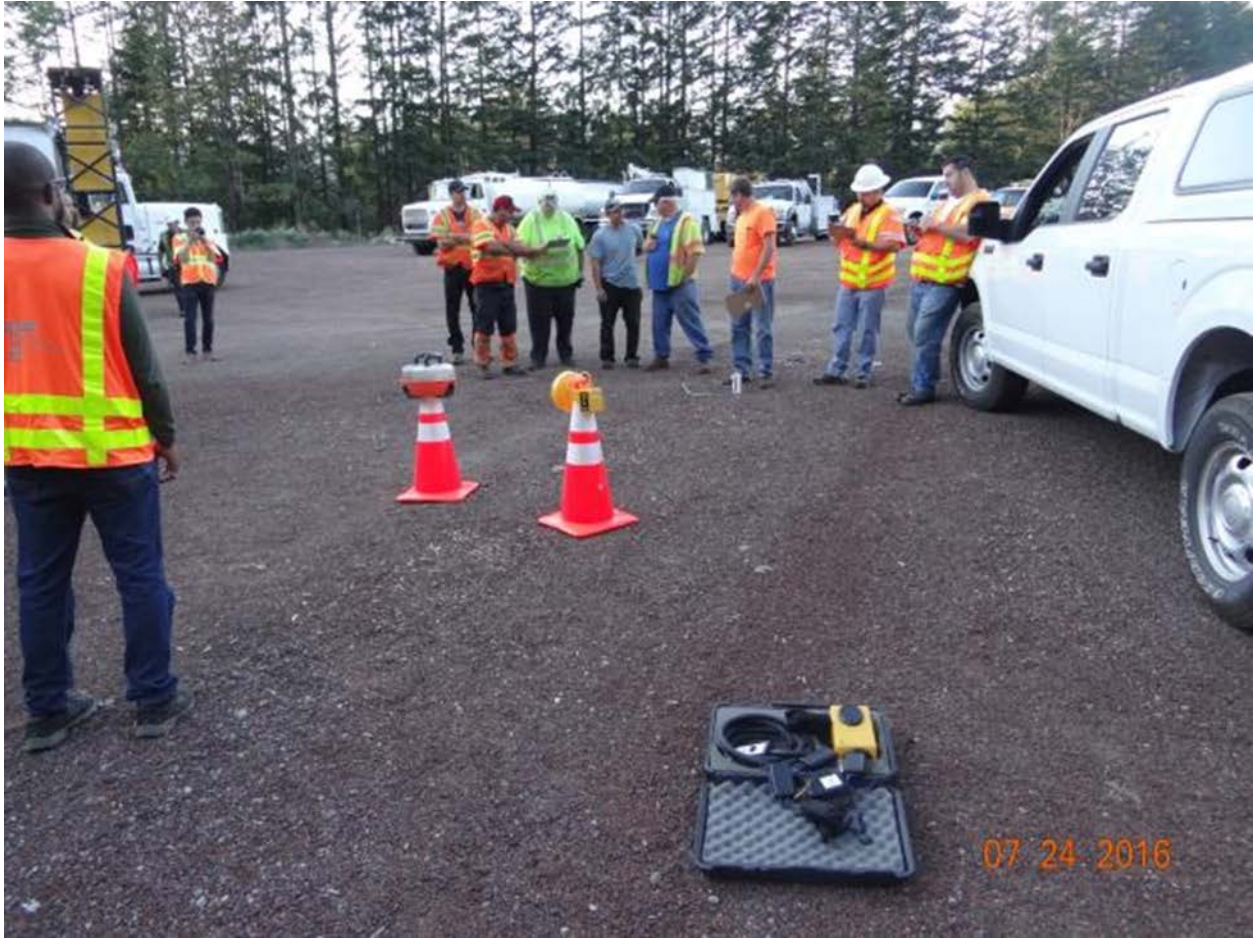
Figure 7.9: Demonstration Prior to Live Testing, Day 1 of Case Study Project #2

Similar to Case Study Project #1, the research team held a demonstration session with one ODOT personnel and 10 workers from the contractor to ensure the participants were provided with relevant background information on each technology to be tested on the I-84 project (see Figure 7.9). A questionnaire was completed by each participant at the end of the demonstration, providing feedback on the evaluation criteria for each technology.

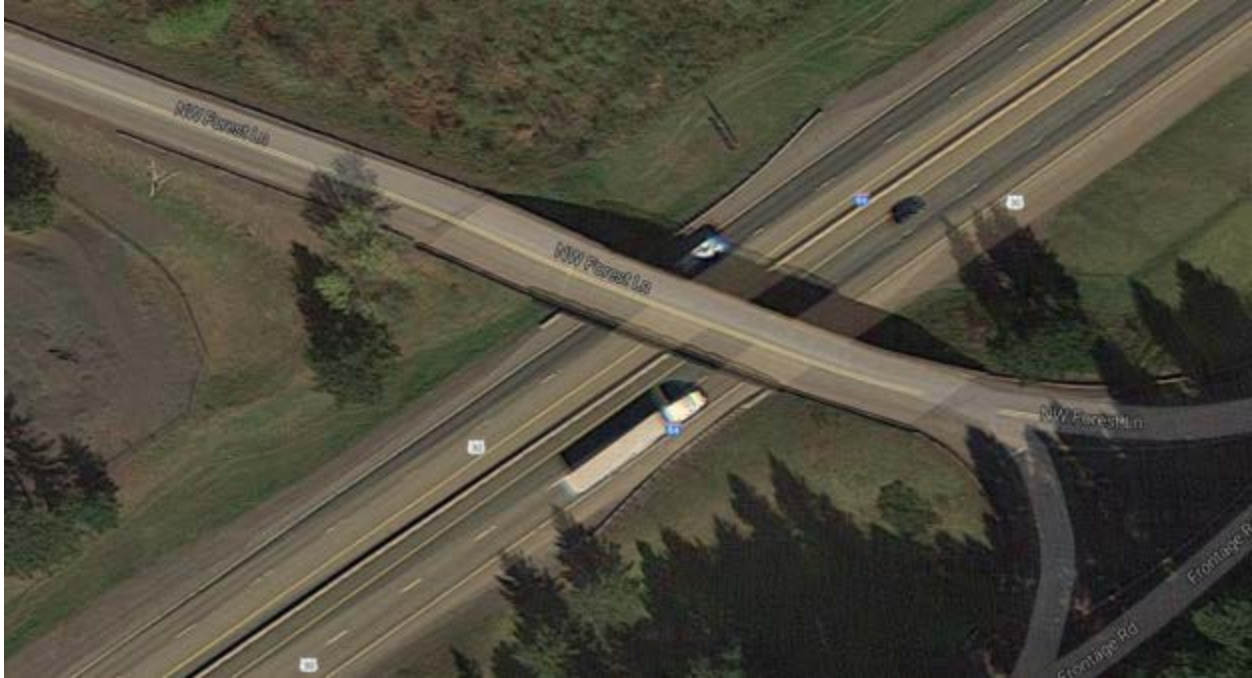
Figure 7.10: Site for Data Collection, Case Study Project #2, Day 1 (Image from Google Maps 2016)

After the demonstration session, ODOT personnel, alongside the research team proceeded to secure an ideal location for setting up the alert technologies for data collection. The research team set up equipment and tools behind the guardrail close to mile point 46, right before the NW Forest Lane crossover (see Figure 7.10).

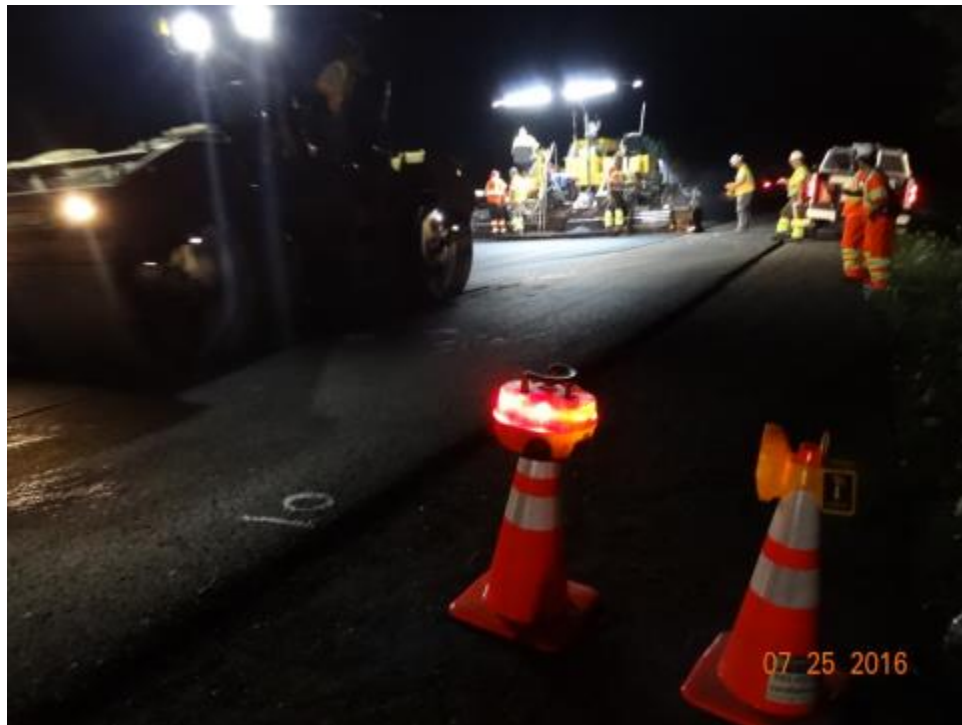
Figure 7.14: Intellicone® triggered 100 feet away from Paver

Data on the effectiveness of the WAS was collected first by triggering the alarm three times – at -150 feet, -100 feet, and -50 feet. Participant feedback on loudness and distinctiveness was collected at the end of the triggering session. The Intellicone® was triggered three times – first, when the paving operation crossed the +50 foot station, followed by the +100 foot station (see Figure 7.14), and finally, when the paver crossed +150 feet.

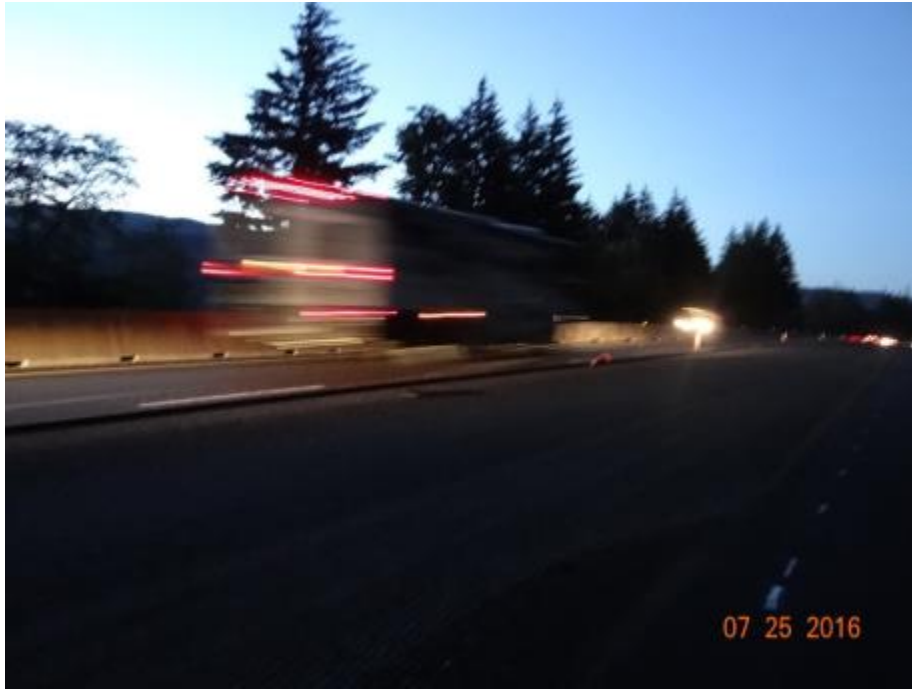
Figure 7.15: Cone in Work Zone Knocked Over

While collecting data, it was observed that at different times, traffic moving through the activity zone hit traffic cones, thereby causing the cones to fall over (see Figure 7.15). It is speculated that this event could lead to multiple false positive alarms for the SonoBlaster® and the

Intellicone® considering their design is dependent on the reliability and orientation of work zone cones.
