**WORK ZONE INTRUSION  
ALERT TECHNOLOGIES:  
ASSESSMENT AND  
PRACTICAL GUIDANCE**

**Final Report**

**SPR 790**

Oregon Department of Transportation

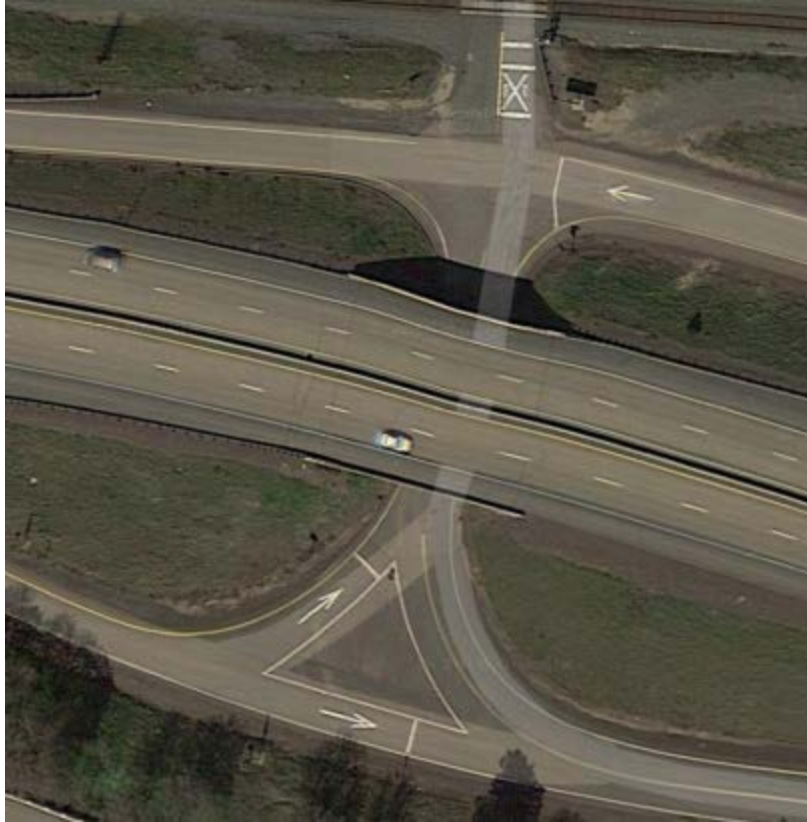
Figure 7.17: Site for Data Collection, Case Study Project #3 (Image from Google Maps 2016)

The selected operation for data collection involved slow lane paving 200ft before and 200ft after the bridge identified in Figure 7.17. Consistent with Case Study Project #2, the researchers chose to focus solely on the paving activity. A total of 10 contractor workers and two ODOT staff were involved in the activity. It is important to note that the crew involved in Case Study Project #3 were almost identical as those on Case Study Project #2 (the same contractor worked on both projects), so the research team decided not to host a demonstration session prior to live testing. Of the 10 active workers, four decided to take part in the research alongside one ODOT inspector. The participants were subsequently briefed on the research objectives by the researchers. Due to the study's complex setup, a group of six researchers took part in data collection to help improve the quality of data collected.

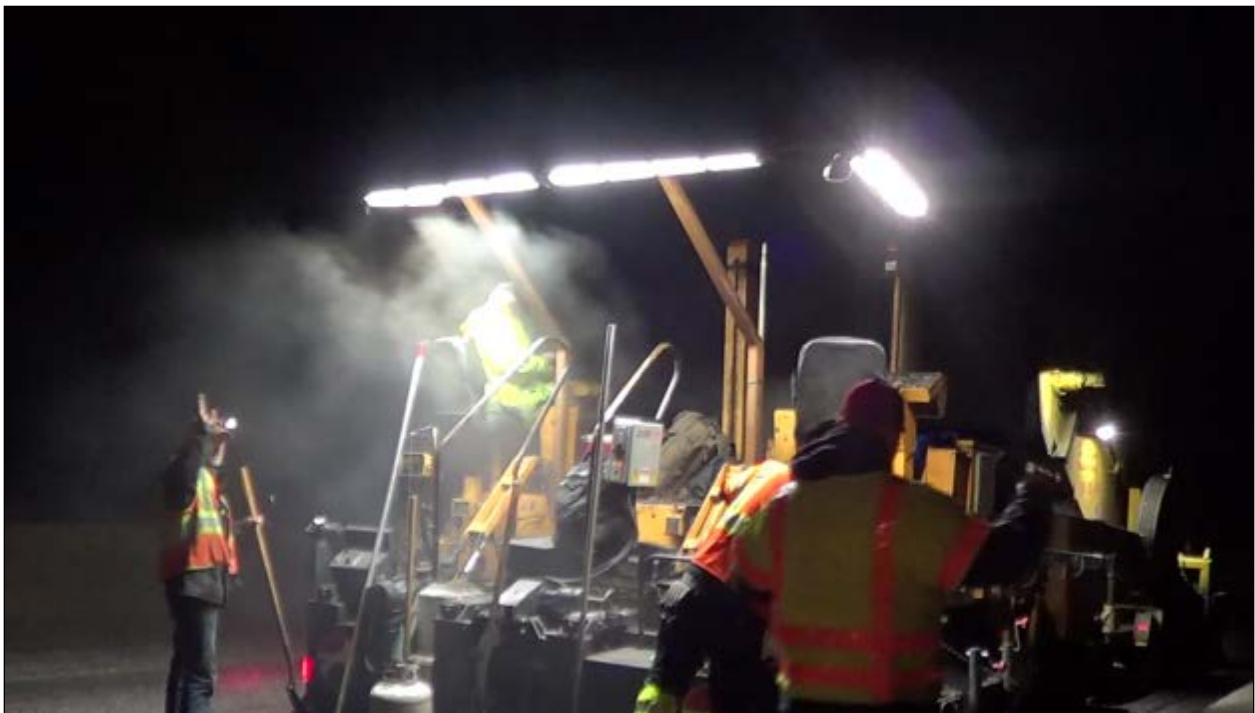
Figure 7.19: Two Workers Indicating Alarm was Heard, Case Study Project #3

Similar to the two previous case study projects, the workers were initially asked to click the clicker to indicate that they heard the alarm. However, following the review of videos from the past case study projects, an additional response mechanism that depicts confirmation of hearing the alarm was deemed necessary (See Figure 7.19). Therefore, the workers were asked to raise their hand if they heard the alarm in addition to using the clicker. Following the triggering of each technology, the researchers asked each worker questions regarding the loudness and distinctiveness of the alarms. Also, the workers were asked for additional comments on where and how the technology could be used the most.

**Target worker's reaction on video:** The research team recorded the reaction of each worker when the alarm was triggered. For case study project #3, workers were asked to acknowledge hearing or seeing the alarm by raising their hand. Reaction time was calculated by comparing the video time stamp and observed alarm trigger time (in video). In situations where the alarm trigger time was difficult to access through video, the manual recorded start time and clicker time stamp were referenced.

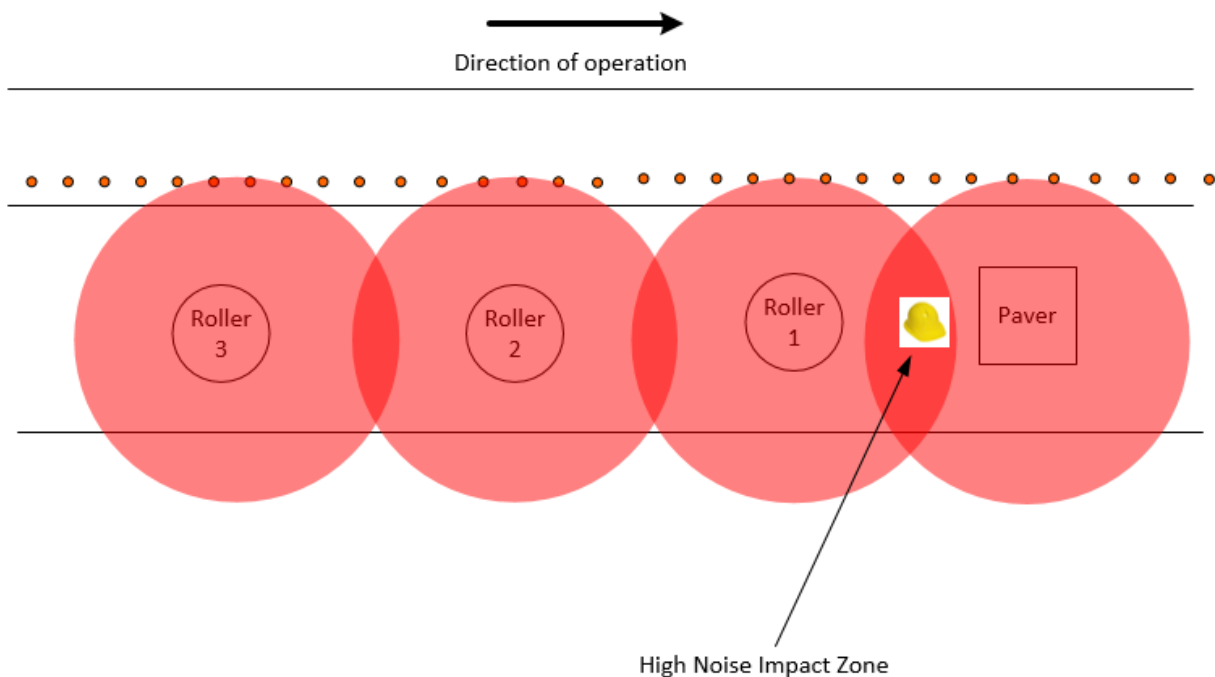
Figure 9.1: Equipment Noise Level Impact on Worker

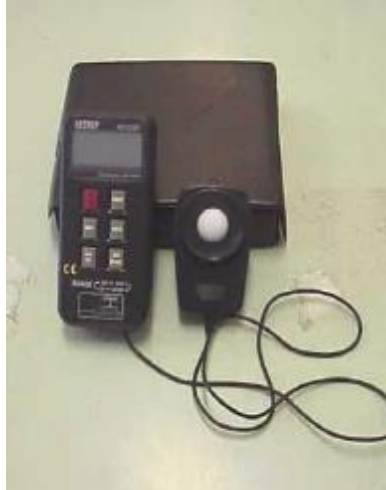
Figure D.1: Data Logging Light Meter

Considering that two of the available alert technologies (WAS and Intellicone®) can trigger visual alarms, it has become important to measure the level of light workers are exposed to within the work zone. An Extech 401036 light meter was used to collect data on light intensity in the work zone. Figure D.1 depicts the light meter used for the data collection.
