# Evaluation of Safety and Mobility of Two-Lane Roundabouts

Minnesota Traffic Observatory

Final Report 2017-30

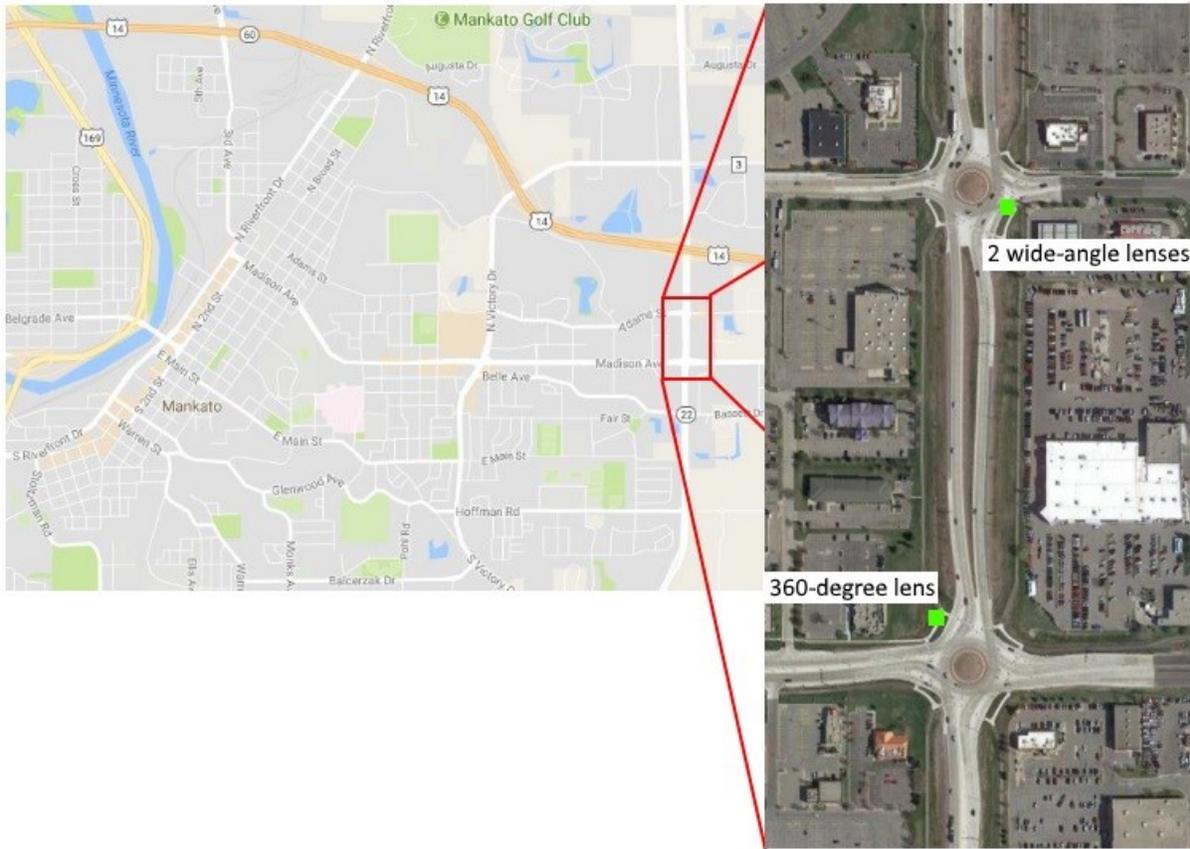
Figure 6: Mankato Roundabout 1 (to the north) and Mankato Roundabout 2 (to the south) with camera locations labeled.

Cameras were deployed at the two roundabouts in Mankato, MN, (Figure 6) in the Fall of 2014. In both roundabouts, the surveillance equipment was mounted on light posts as shown in Figure 7. The recording equipment was housed inside a weather-resistant housing installed by MnDOT at the base of the pole that provided 24/7 power as shown in Figure 8. The equipment consisted of a network video recorder (NVR) to record the camera feeds and an uninterruptible power supply (UPS) to protect against any brown-outs and provided short-term emergency power. External cables from the enclosure to the cameras provided power and data for the cameras and were secured at regular intervals along the length of the pole up to final install height of the cameras at approximately 20 feet. In the case of the Mankato Roundabout 1, two surveillance cameras were deployed whereas only one camera with a 360-degree lens was deployed at Mankato Roundabout 2.

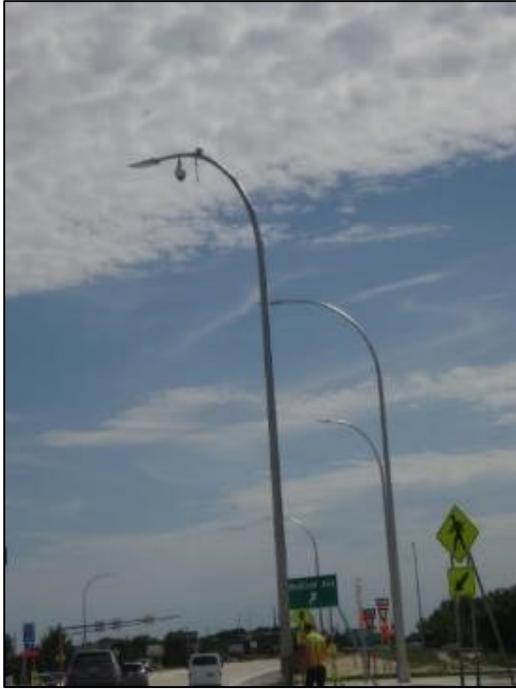
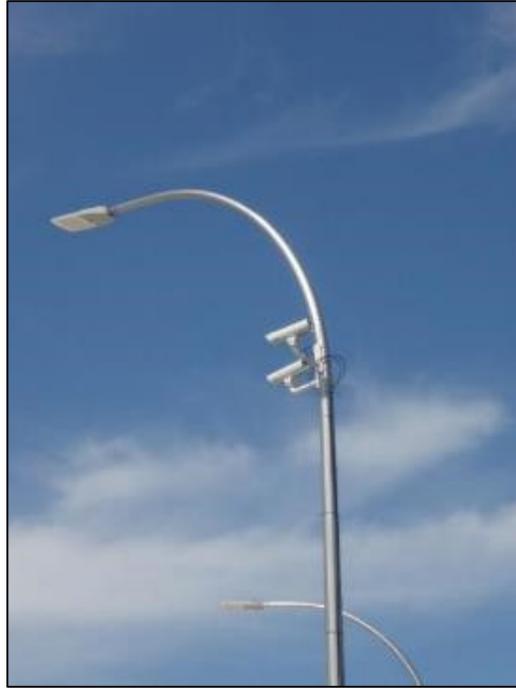
Figure 7: Cameras deployed at Mankato roundabouts. Left is the 360-degree camera covering the intersection of TH-22 and Madison Avenue. Right is the two wide angle cameras covering the intersection of TH-22 and Adams Street.

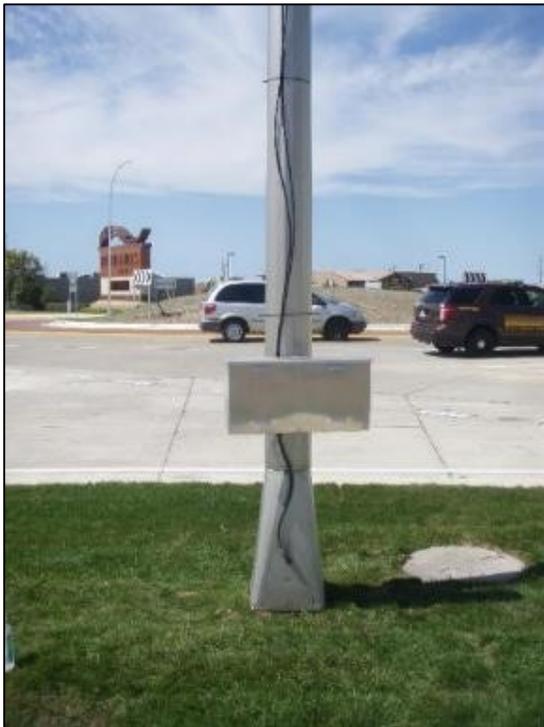
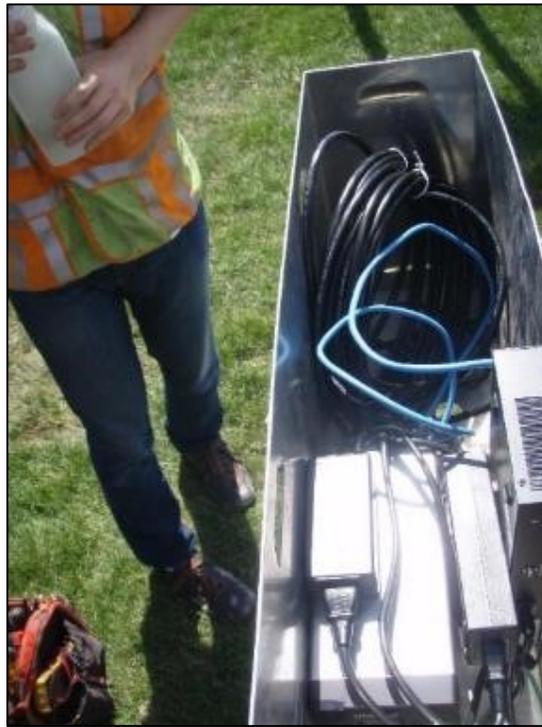
Figure 8 Local video recording box installed at the base of the two light poles used shown closed (left) and up-close (right).

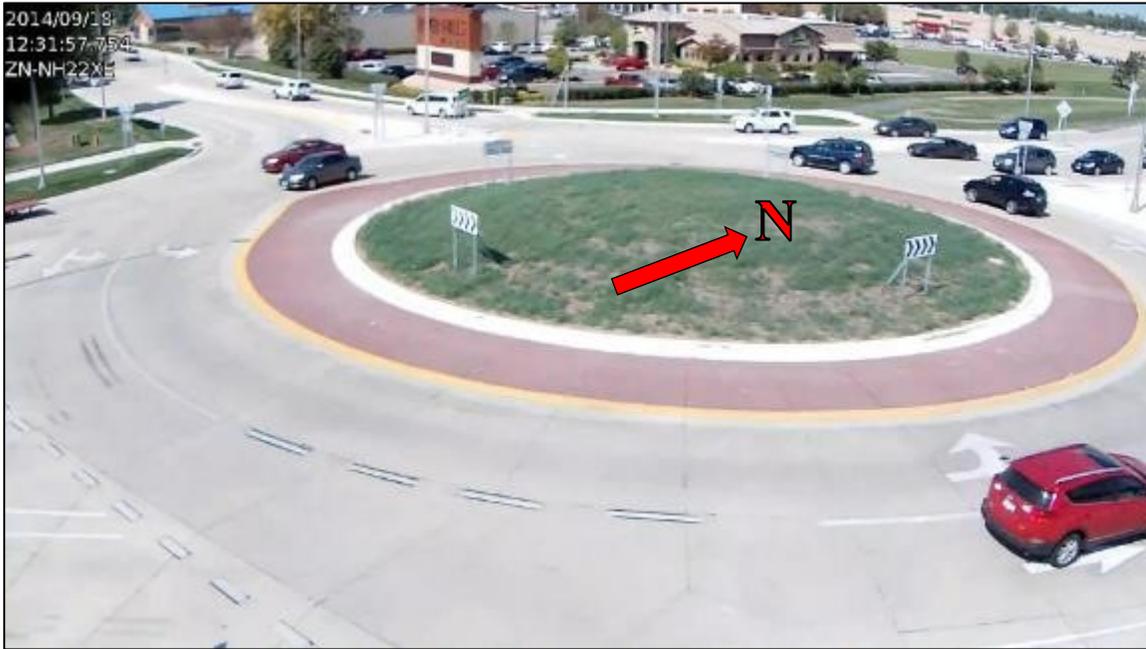
Figure 9. Mankato Roundabout 1 view 1 - west and south portions of the roundabout.

At Mankato Roundabout 1, two wide-angle cameras were deployed – one to capture the eastbound approach and the southern and western portions of the roundabout (Figure 9) and a second to capture the northbound approach and the east portion of the roundabout (Figure 10). At Mankato Roundabout 2, a single camera 360-degree lens camera was deployed to collect video of the entire roundabout (Figure 11).

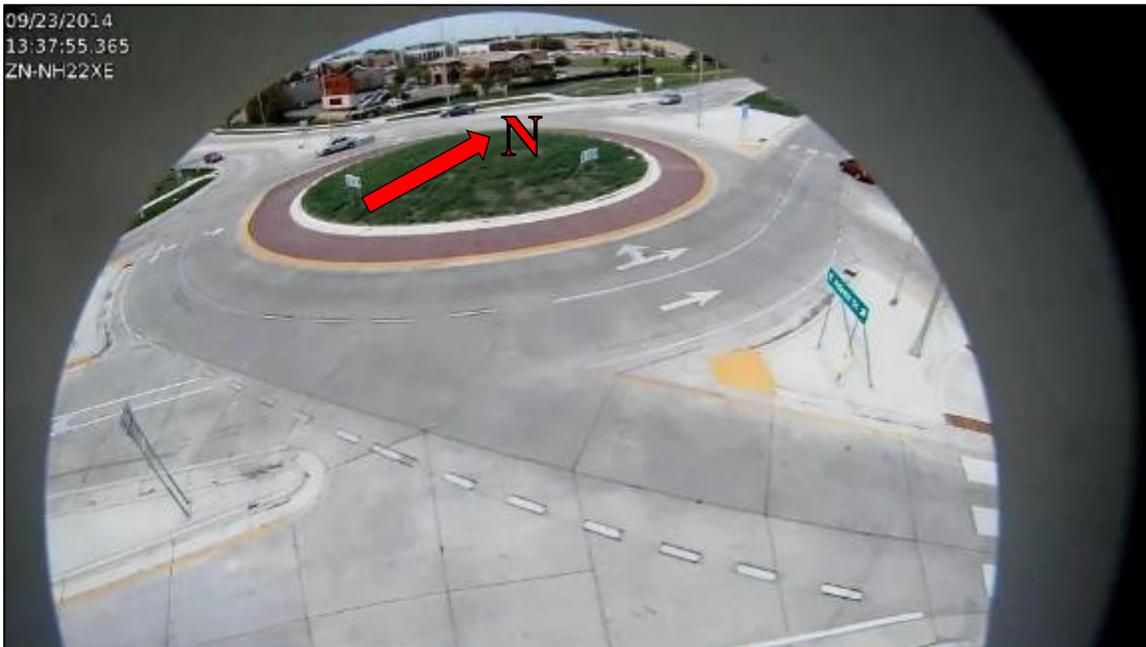
Figure 10. Mankato Roundabout 1 view 2 - south and east portions of the roundabout.

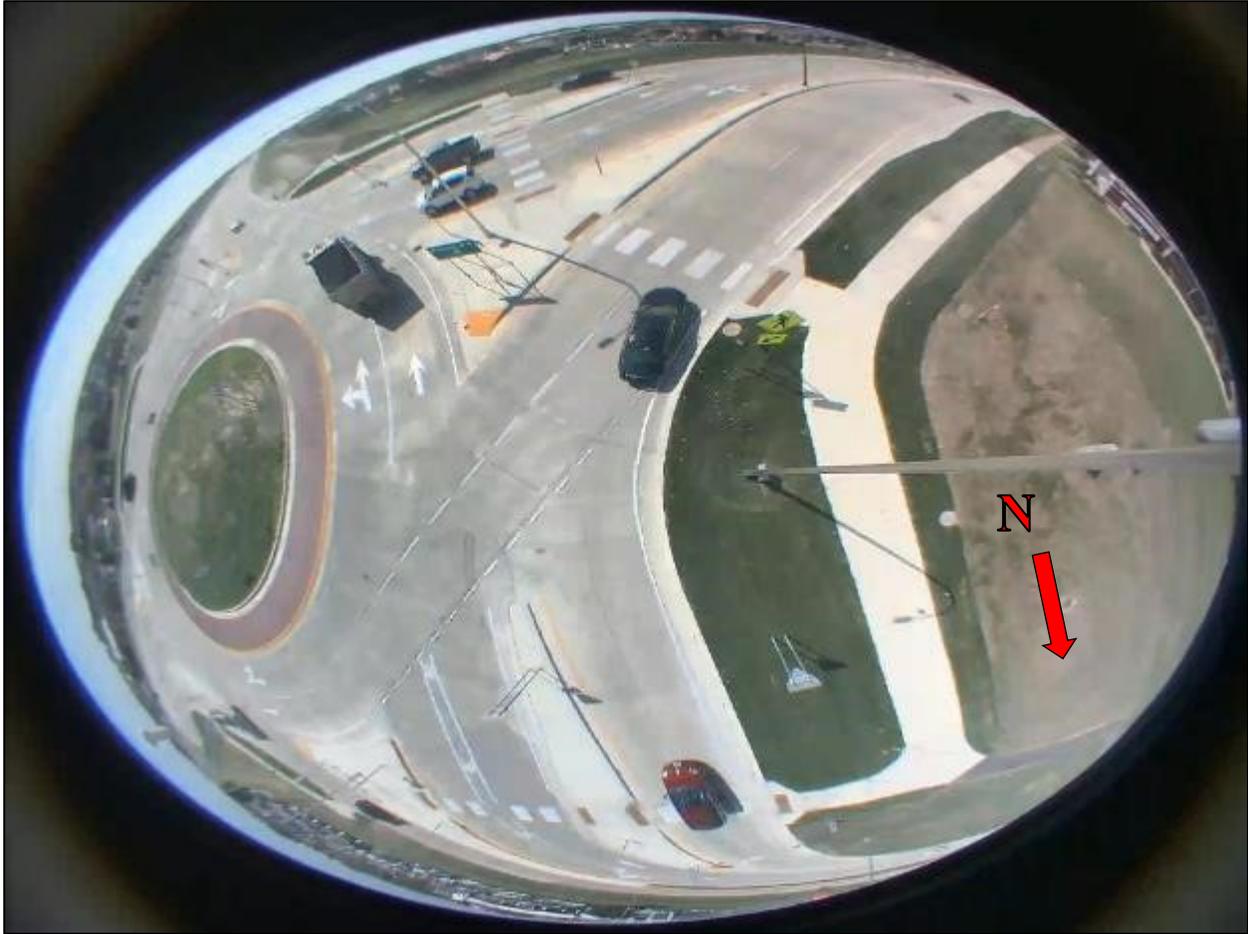
Figure 11. Mankato Roundabout 2 - note that north is toward the bottom of the image.

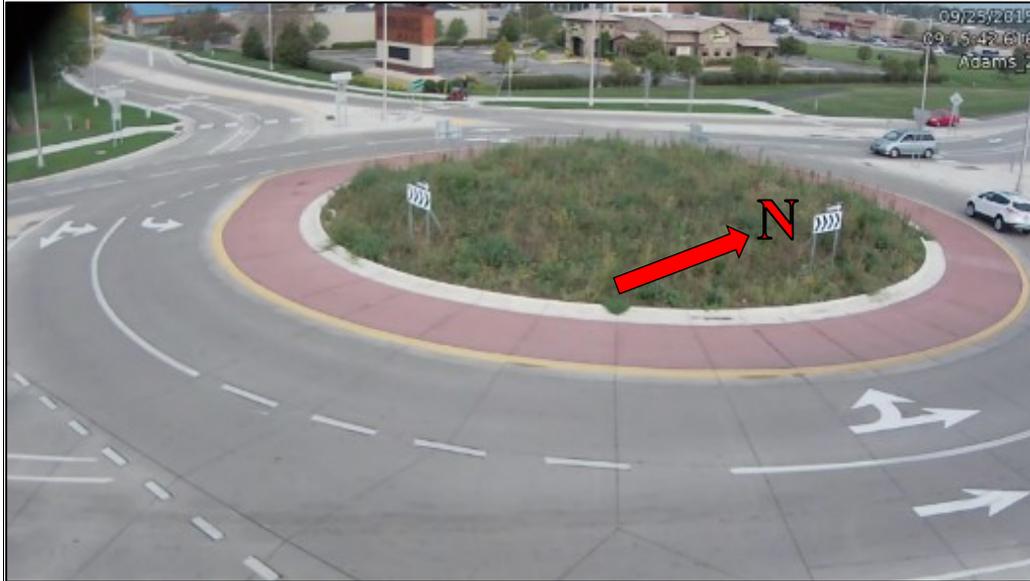
Figure 12: View from camera of the eastbound and southbound approaches of the Mankato Roundabout 1.

the eastbound and southbound approaches (Figure 12) and the northbound approach (Figure 13), with data collection focusing on the two-lane segments of the roundabout. The orientation of the camera viewing the northbound approach was adjusted to provide an expanded view of this approach. The 360-degree camera at Mankato Roundabout 2 remained in the same position.

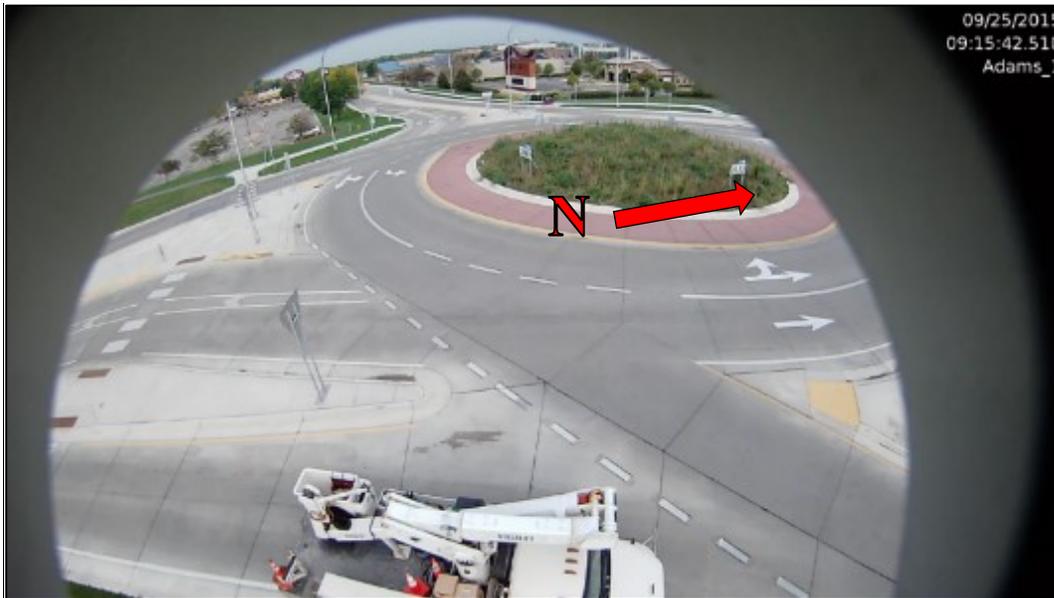
Figure 13: View from camera of the northbound approach of the Mankato Roundabout 1.

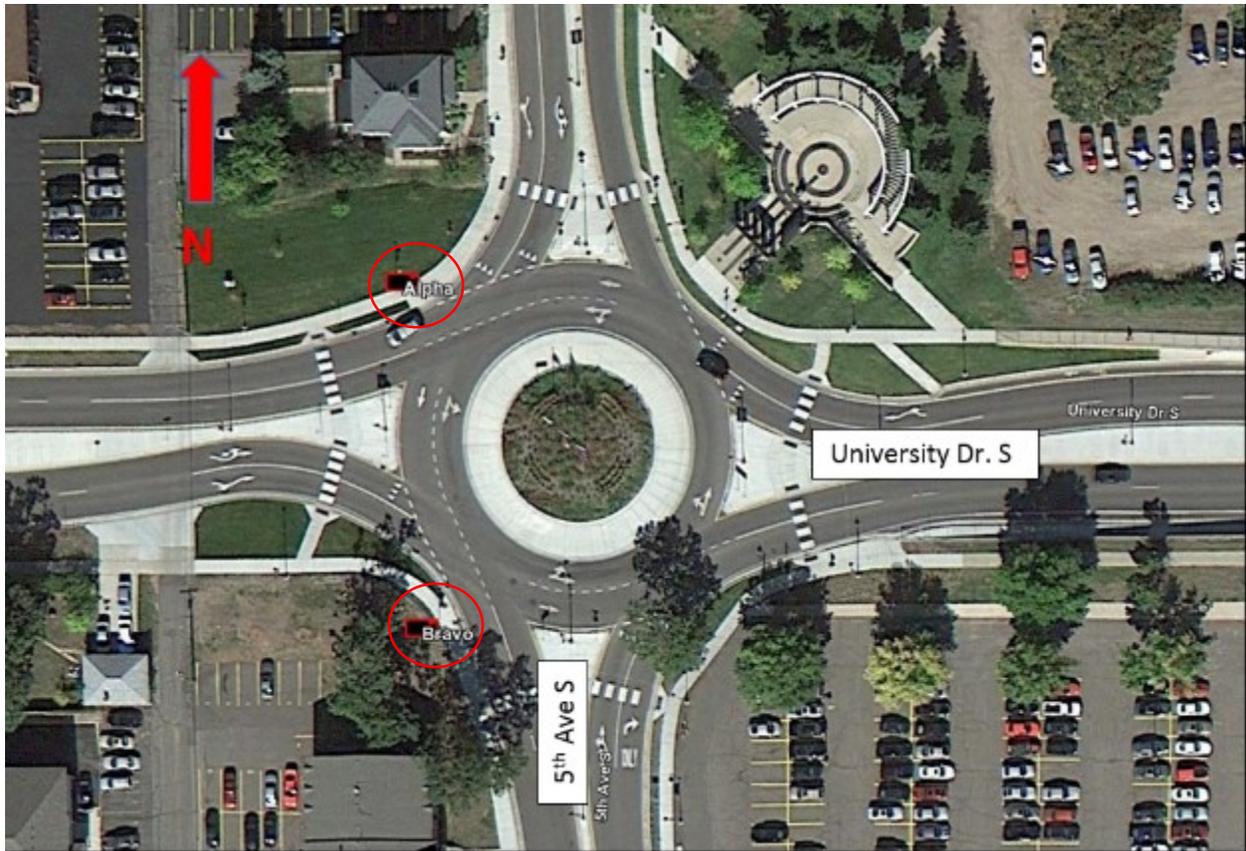
Figure 16. Aerial photo of roundabout at University Drive South and 5<sup>th</sup> Avenue South in St. Cloud, MN. Note the locations of cameras Alpha and Bravo on the northwest and southwest corners of the intersection.

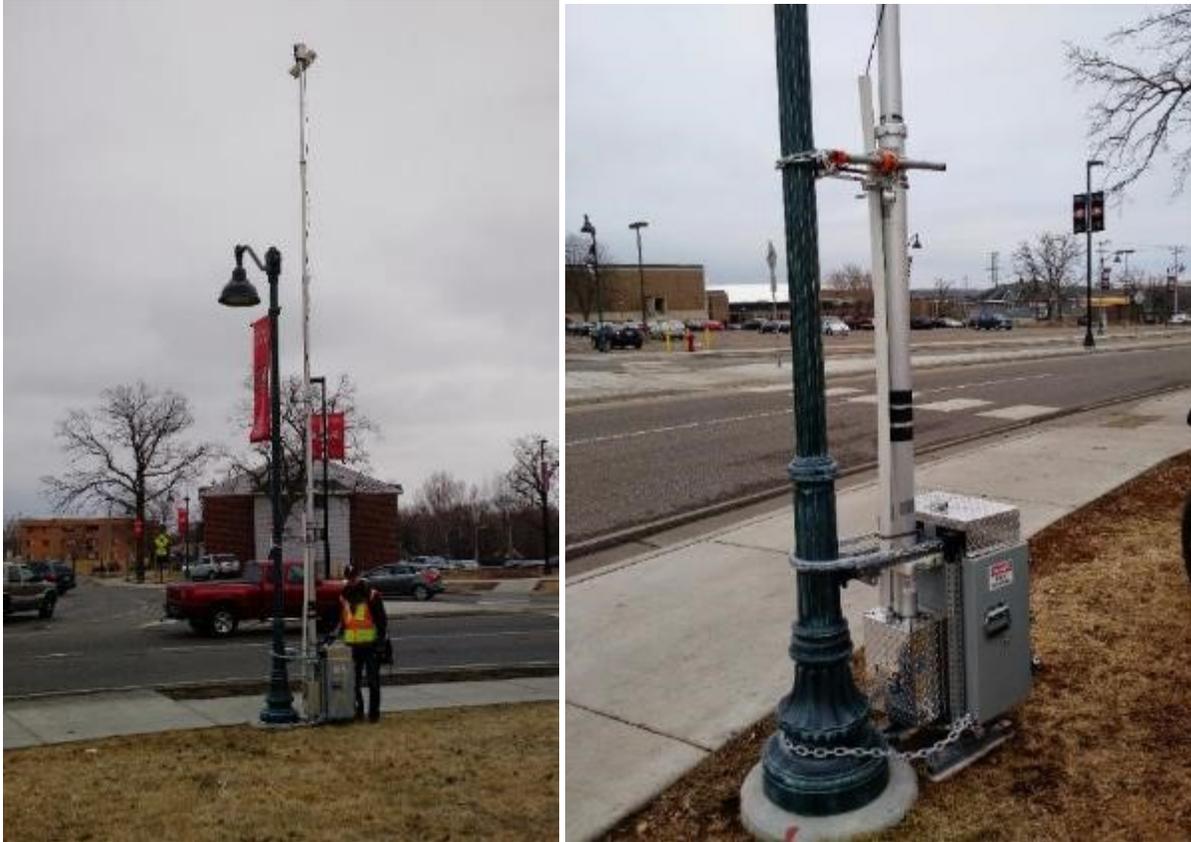
**Figure 17. Video recording station set up with camera pole fully extended (left). Closer view of bracing and security (right)**

The St. Cloud roundabout is located at the intersection of University Drive South and 5th Avenue South at the western edge of the St. Cloud State University campus (Figure 15). The roundabout was opened to traffic in 2011 and preliminary task reports showed a marked increase in Property Damage Only (PDO) crashes consistent with the trend identified at other previously-studied roundabouts. This roundabout, similar to Mankato Roundabout 1, is not a full 2x2 design but it does have two approaches with 2x2 conflicts which were the focus of data collection, two of the MTO's field-recording stations were placed at the edge of the roundabout at the northwest and southwest corners of the intersection (Figure 16). The stations consist of a camera, timer, recording device with local storage, and battery power with a heavy-duty metal housing and extendable mast for elevating the camera.

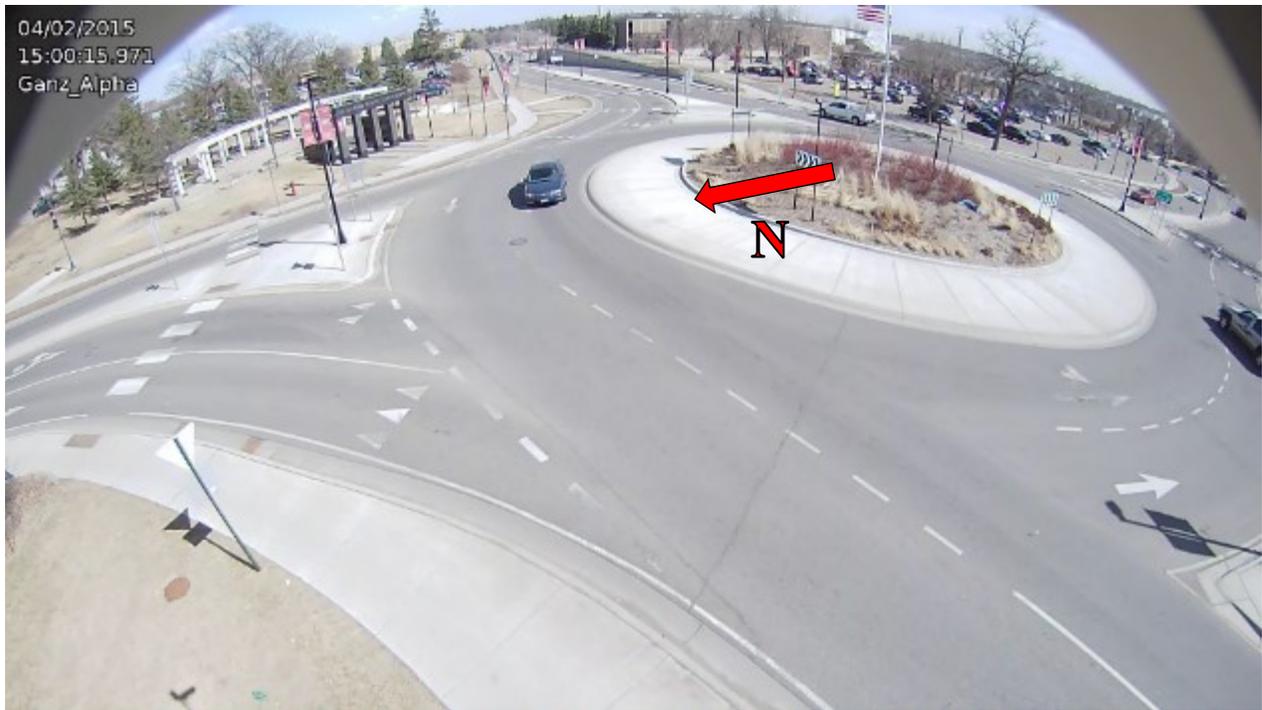
Figure 18: View from station Alpha - northern portion of the roundabout.

The cameras at each station were equipped with wide-angle lenses to provide a view of the entire roundabout. The camera at station Alpha on the northwest corner of the intersection was positioned to capture the southbound and westbound approaches and the northern side of the roundabout. The camera at station Bravo on the southwest corner was positioned to capture the northbound and eastbound approaches and the eastern, western, and southern portions of the roundabout. Images from each of these cameras can be seen in Figure 18 and Figure 19, respectively.

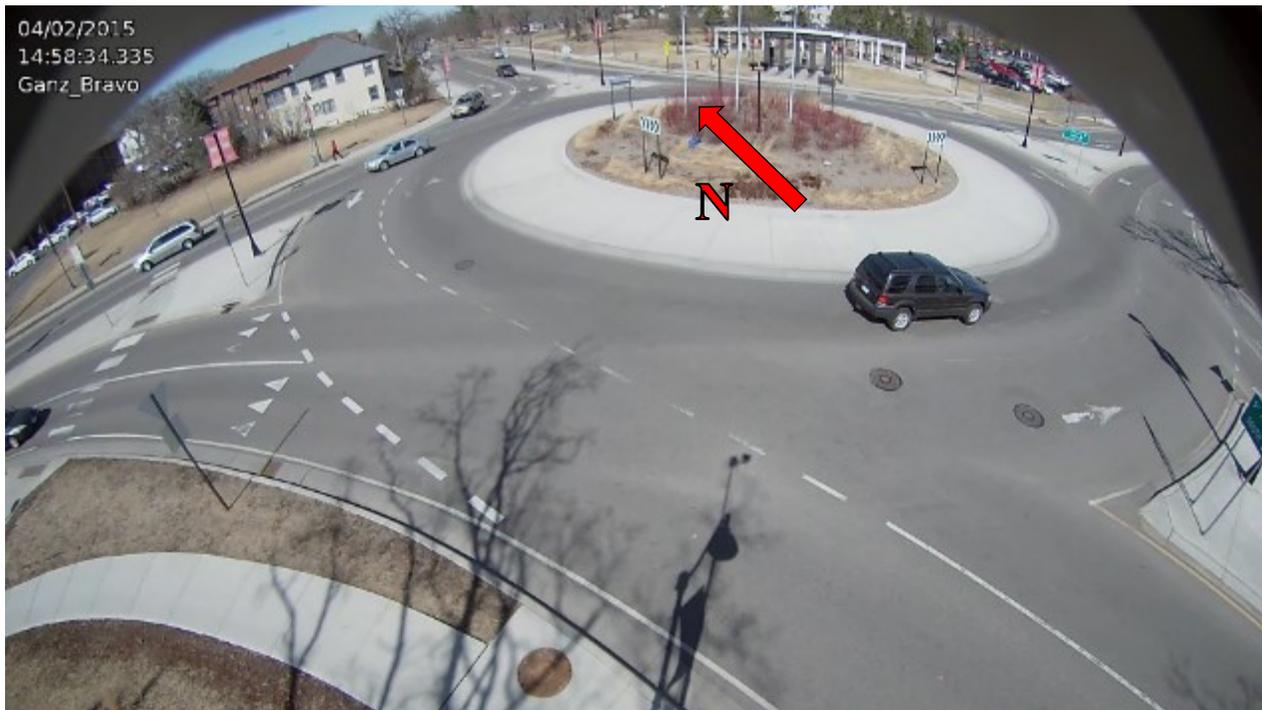
Figure 19: View from station Bravo – eastern, western, and southern portions of the roundabout.

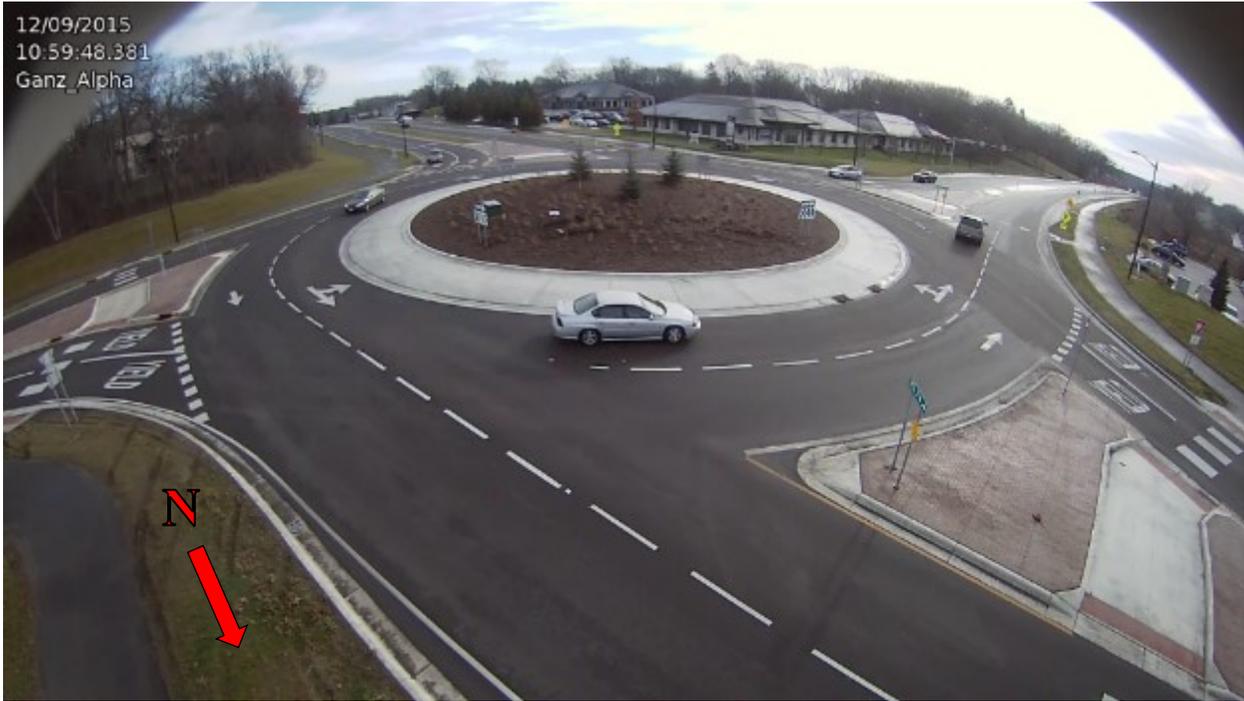
Figure 22: Lakeville Roundabout Camera - Alpha camera - Entire roundabout

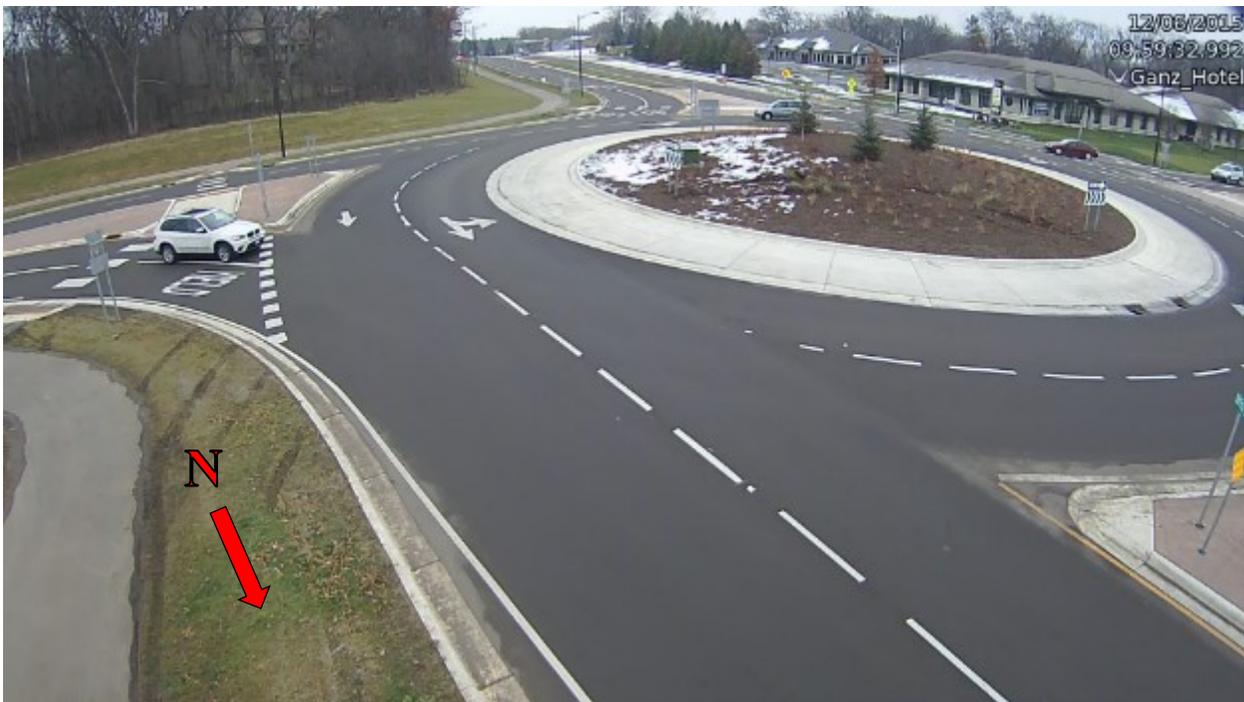
Figure 23: Lakeville Roundabout – Hotel Camera - Northwest Quadrant

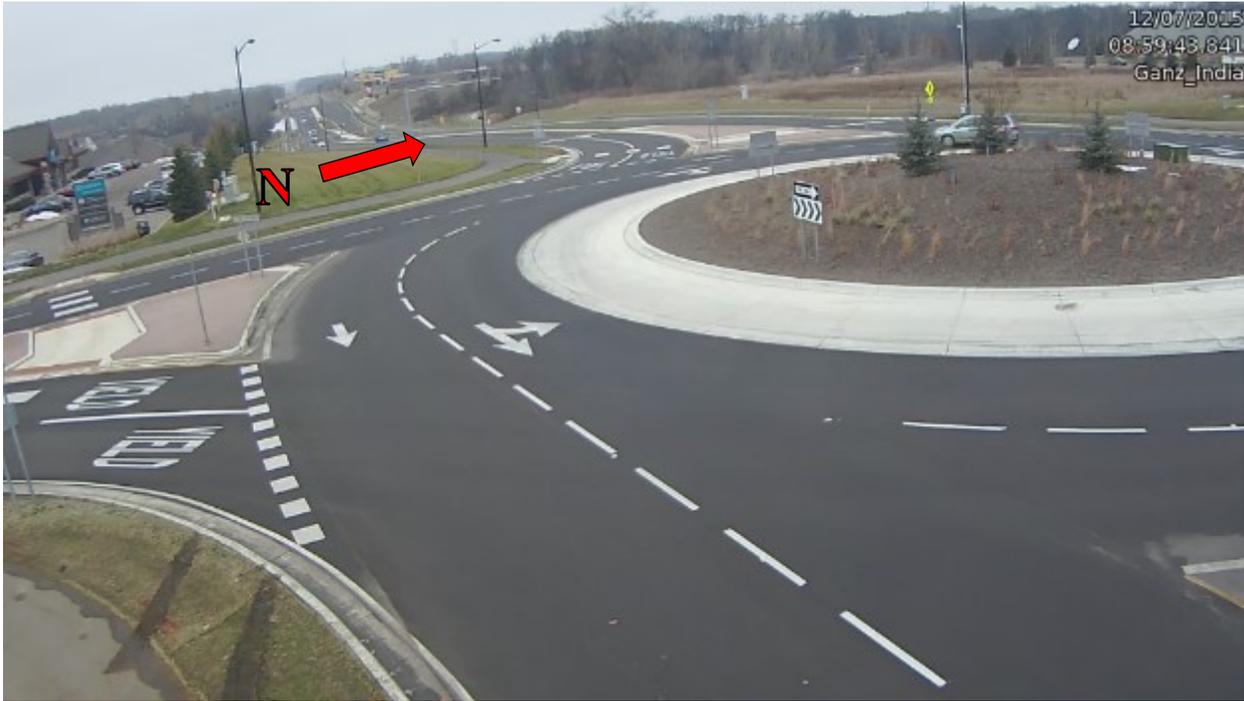
Figure 24: Lakeville Roundabout - India Camera - Southeast Quadrant

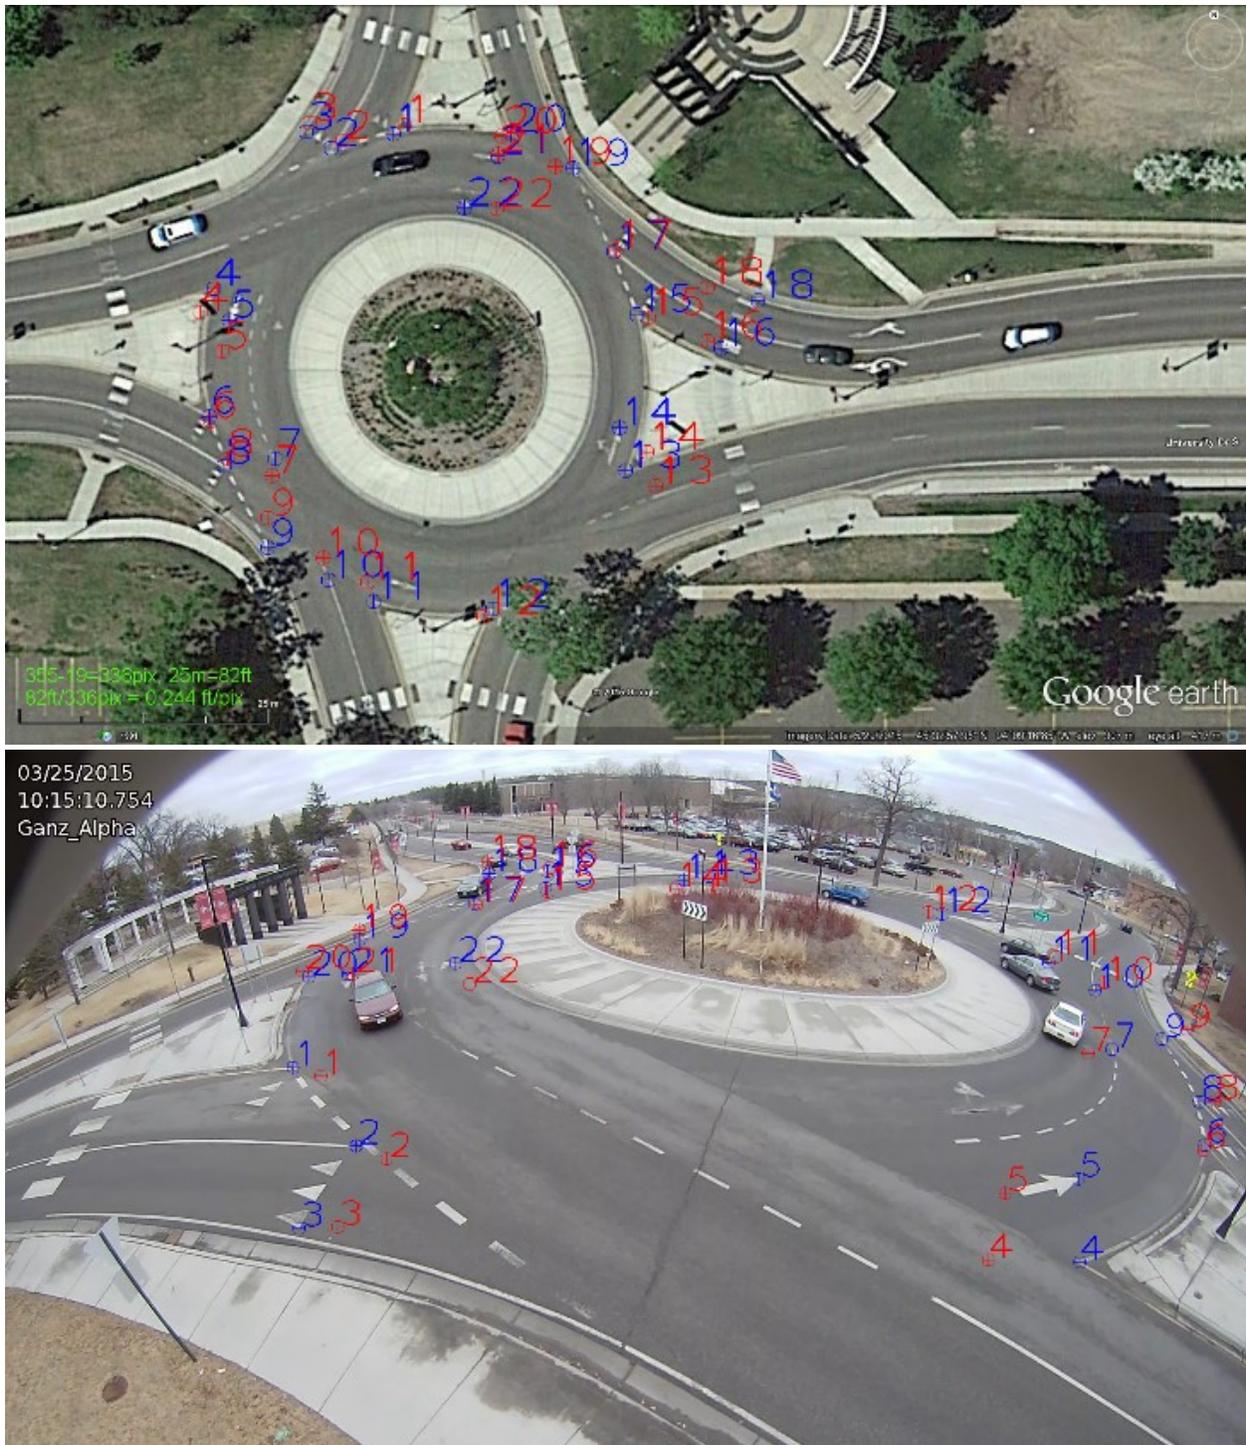
**Figure 25** Example of the aerial image (top) and camera frame (bottom) used to generate the homography for the Alpha view of the St. Cloud roundabout.

Extraction of trajectory data from video was done using the open-source computer vision program *TrafficIntelligence* (Jackson et. al, 2013), based on the OpenCV library developed by Dr. Nicolas Saunier at Polytechnique Montreal. This program was designed with traffic applications in mind which helps to simplify the process of configuring and calibrating the tracking system, allowing users to spend more time on their particular application. The main configuration step required to use this program with a particular set of video footage is the generation of a homography: a matrix for projecting the coordinates of objects from the perspective of the camera to world space. This step requires an aerial image of known scale (from Google Maps or similar) and a sample camera frame. The user must then select corresponding points in the two images, from which the system calculates the optimal homography that minimizes the total error of the projected points. An example of the points used for generating a homography for one of the sites can be seen in Figure 25.

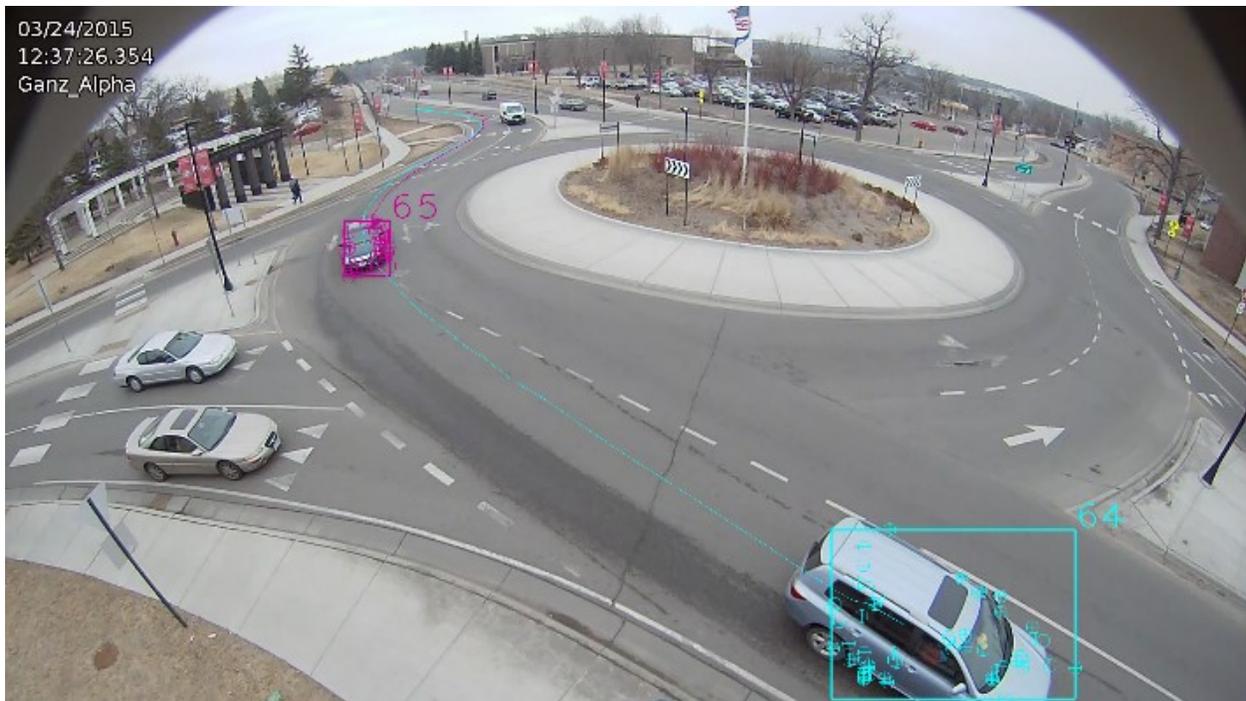
Figure 26 Example of “overgrouped” objects before (top) and after (bottom) cleaning. Notice how the average position of the single object before cleaning is outside of either of the actual vehicle positions.

To address this issue, a trajectory cleaning methodology that takes advantage of the geometry of the roundabout was devised to identify false groups and break them up to obtain more realistic data. The process works as follows: first, objects are examined at a time later in their trajectory (when their size in the image is largest), then the underlying feature data is probed to determine if the object position is a good representation of the features, as determined by the sum of the squared distance between the object position and each of the features. Objects that fail this test are then broken up using a mean shift clustering algorithm, resulting in data that is much more realistic. An example case of this, showing vehicles before and after the error is corrected, can be seen in Figure 26. Cases of vehicles tracked by multiple trajectories, which occur but are less disruptive to the analysis, are filtered out later during the trajectory analysis based on movement of objects that are close together in space and time.

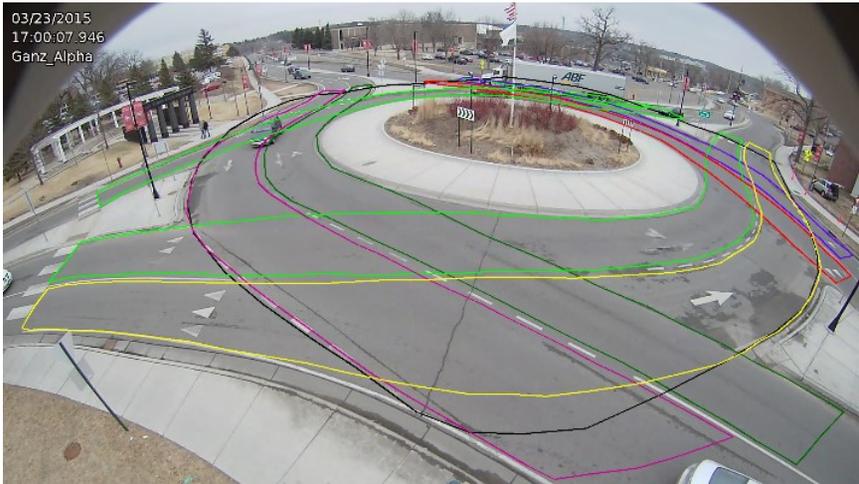
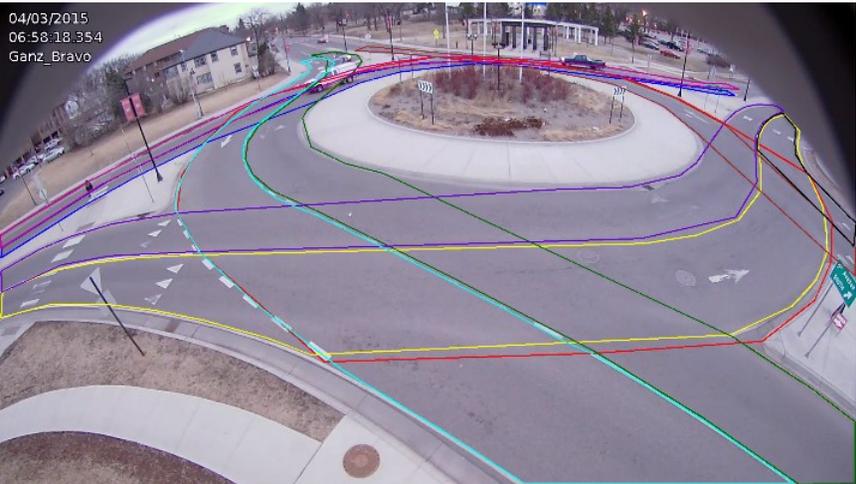
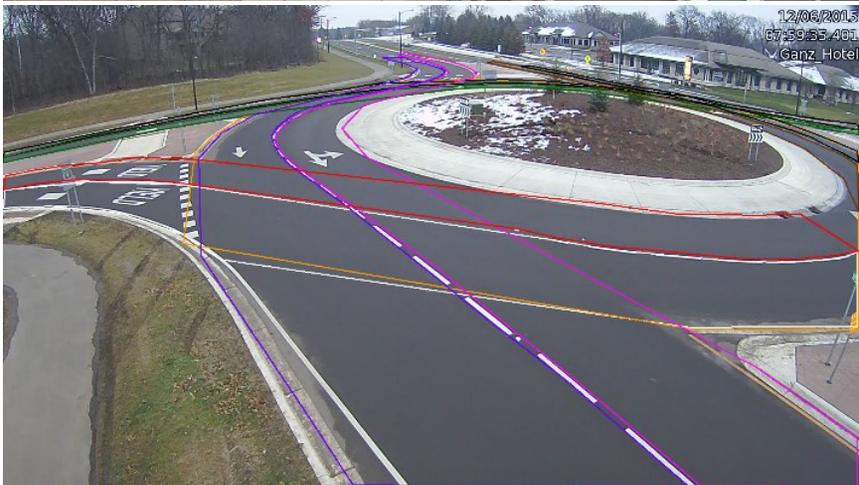
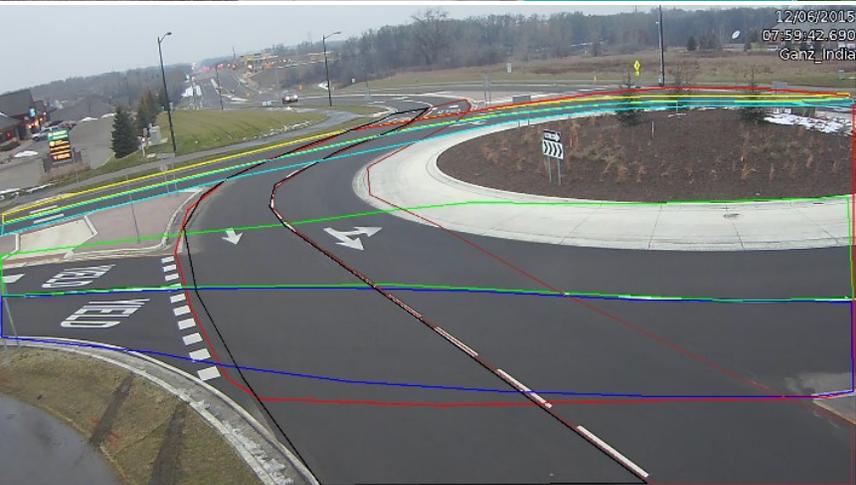
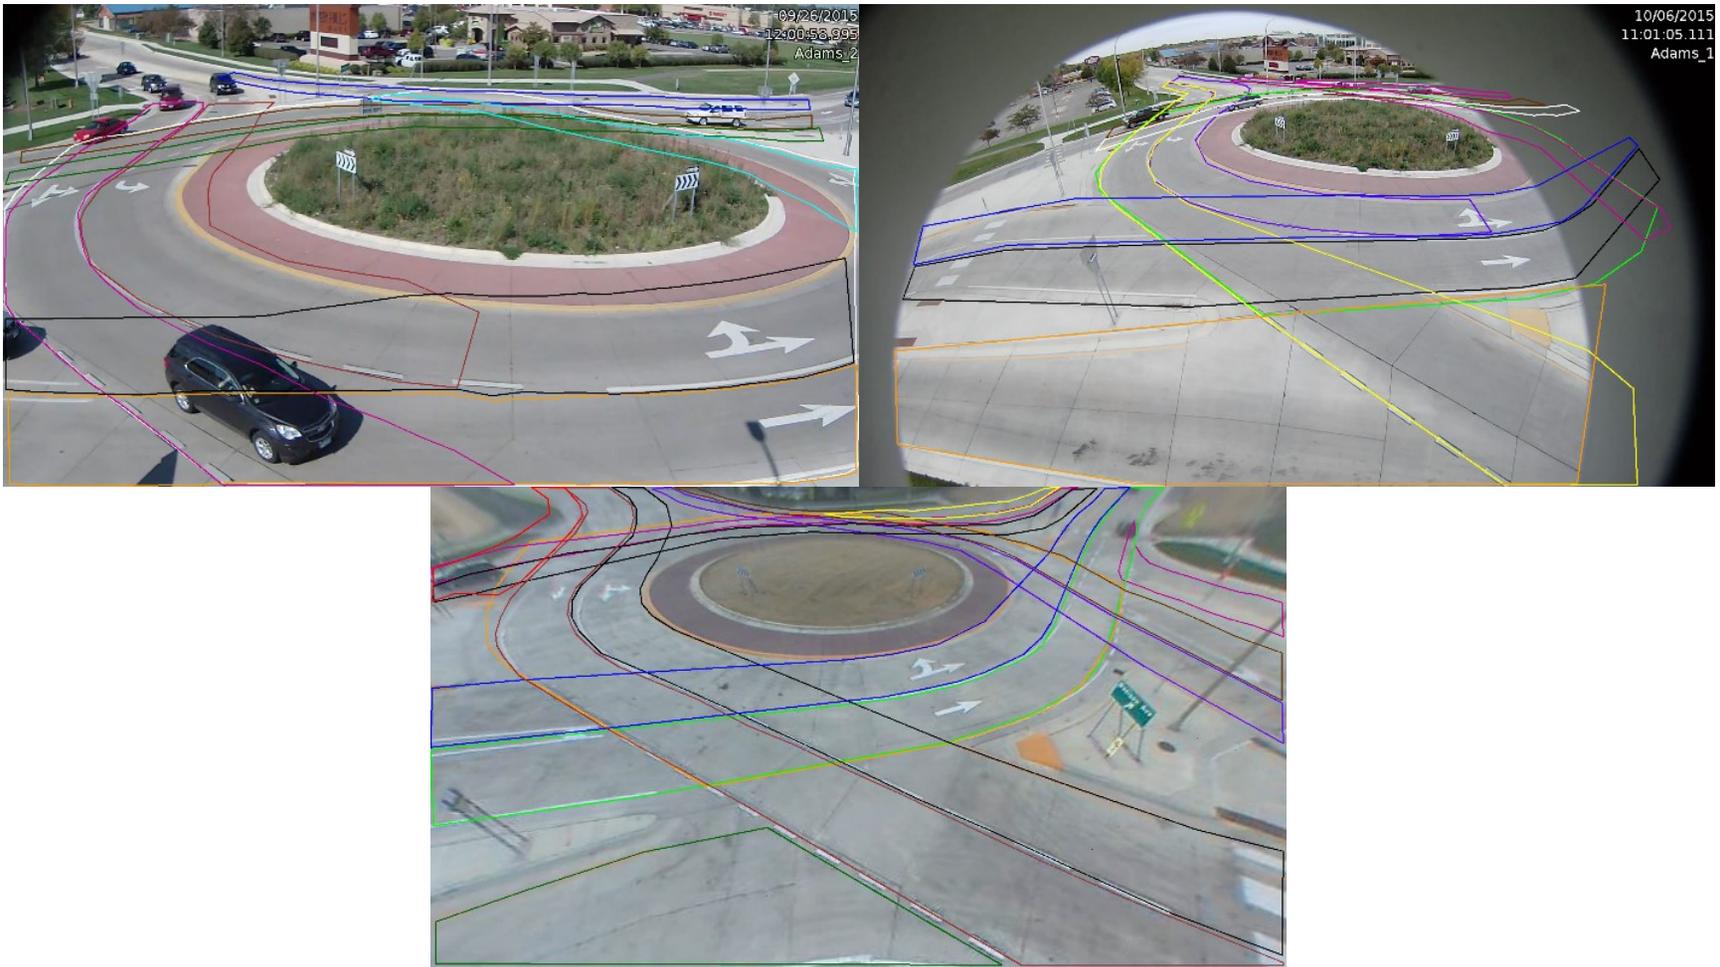
Figure 27 Sample frames from all views from each of the four roundabouts analyzed; from top to bottom, left to right: St. Cloud Alpha and Bravo, Lakeville Hotel and India, Adams Chanel 1 and Channel 2, and Madison (one camera).

The model developed for interpreting vehicle trajectories relies on a user-created lane configuration, defined by outlining the lanes in the camera frame. A sample of this configuration for each of the views of the roundabouts analyzed in this project can be seen in Figure 27. Using this configuration, the model analyzes the trajectories in a video to determine where the observed vehicles entered and exited the roundabout and which lanes were used in the process. The model has an understanding of what realistic movement through the roundabout looks like, as well as which maneuvers are correct and which constitute an illegal turn (as illustrated in Figure 28 and Figure 29). Unrealistic movement is filtered out to remove potential sources of error; the remaining data, which describes the vehicles that used the roundabout, all the lanes they used, and whether they committed an improper turn. Once this data has been generated, the resulting vehicle data is then processed using the conflict detection and evaluation algorithm to determine which vehicles, if any, failed to yield upon entry and caused a conflict.

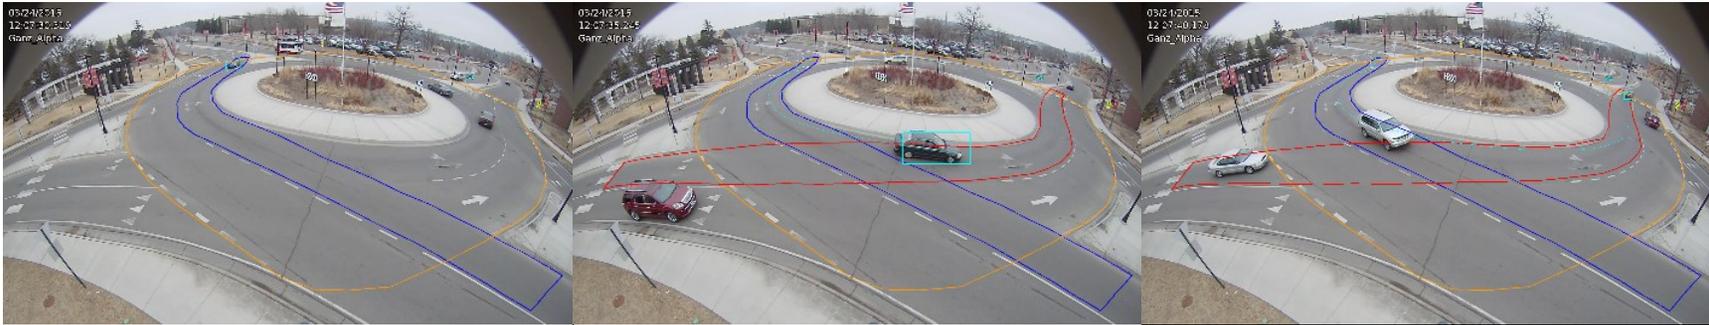
Figure 28 Example of a vehicle moving through the roundabout. The vehicle is observed entering the roundabout in one lane, then seen moving to another lane, then exiting from that lane.

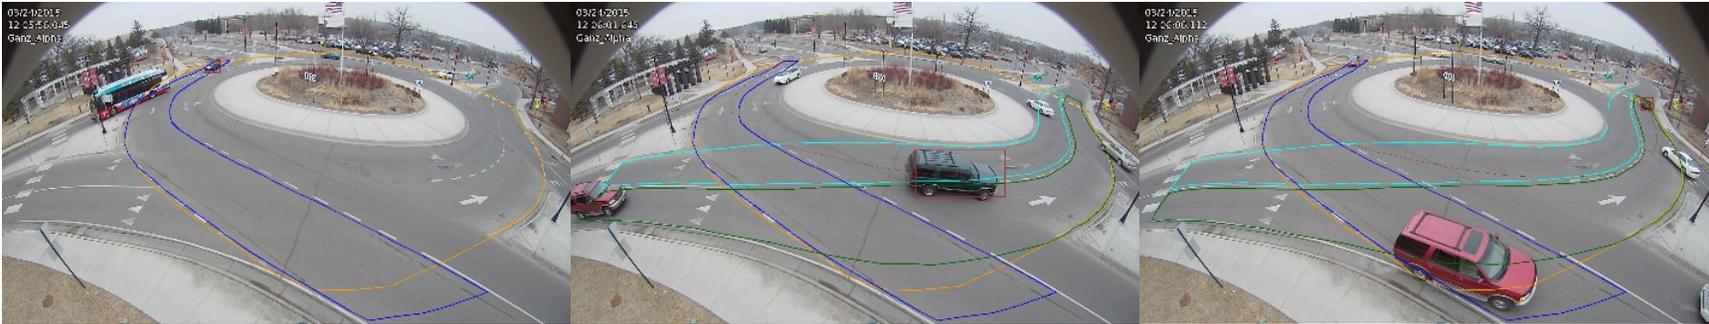
Figure 29 Example of a vehicle making an improper turn in the roundabout. The vehicle is flagged when it is observed making the maneuver from the outer lane to either lane of the next section, crossing over a lane of traffic to do so
