# Evaluation of Safety and Mobility of Two-Lane Roundabouts

Minnesota Traffic Observatory

Final Report 2017-30

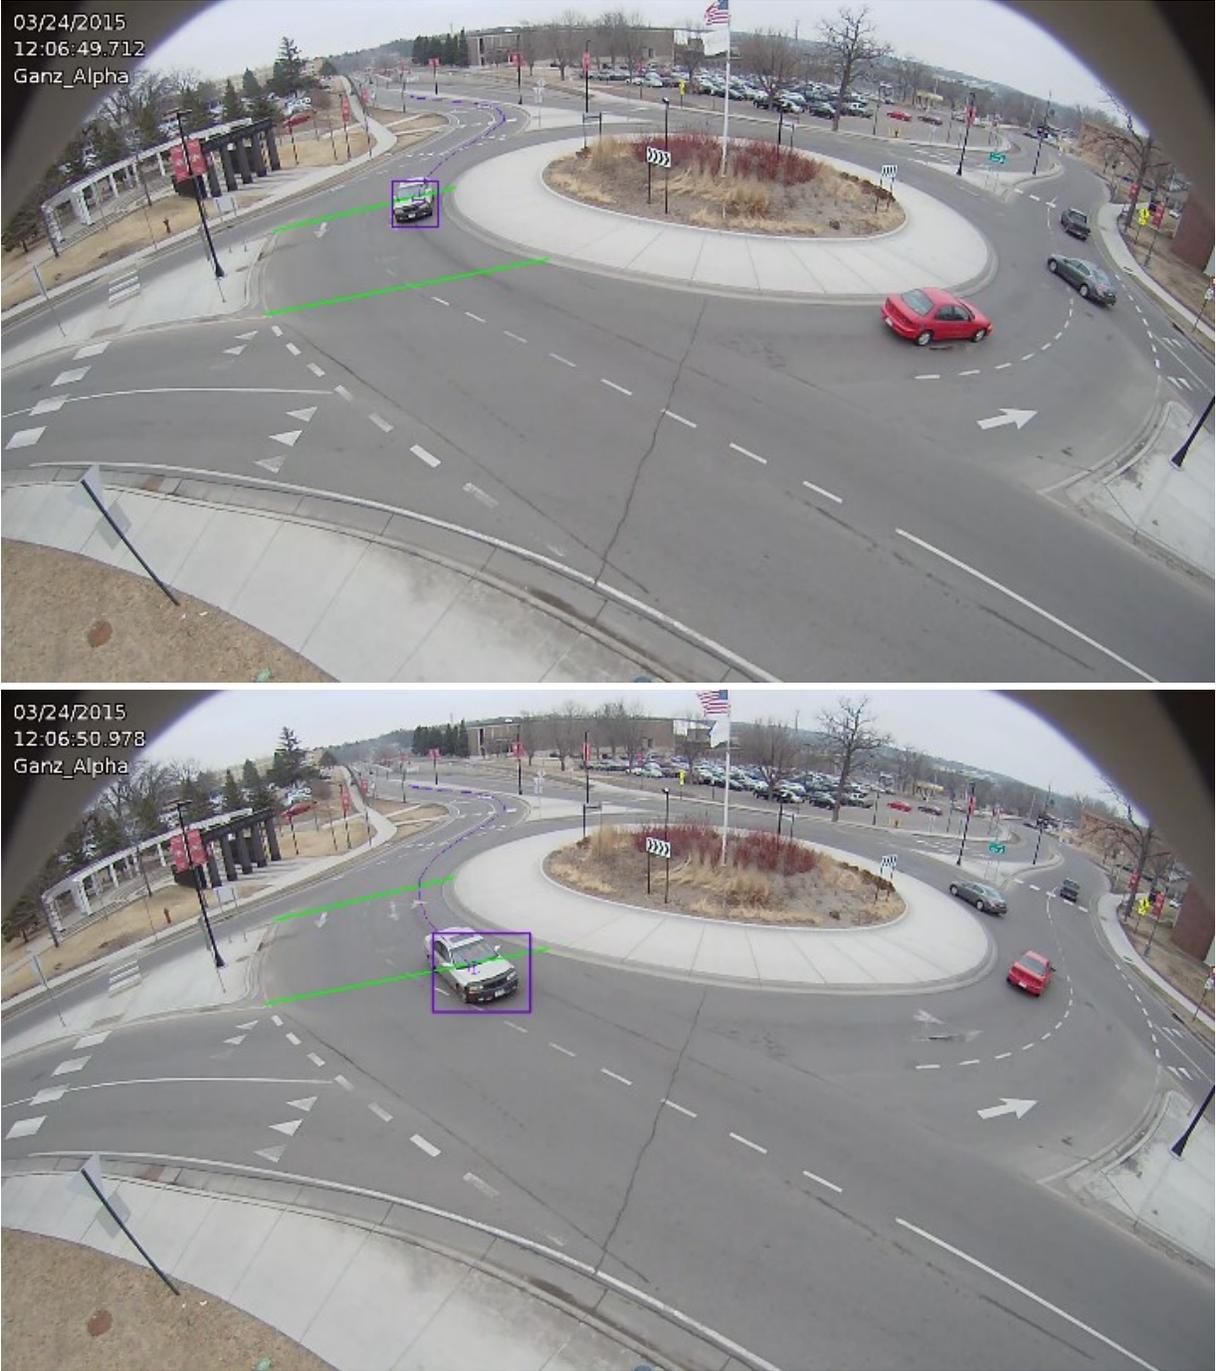
Figure 30 Example of measure lines used to generate statistics of typical movement through the roundabout. Similar measurements are taken at any point where an entrance conflict is possible.

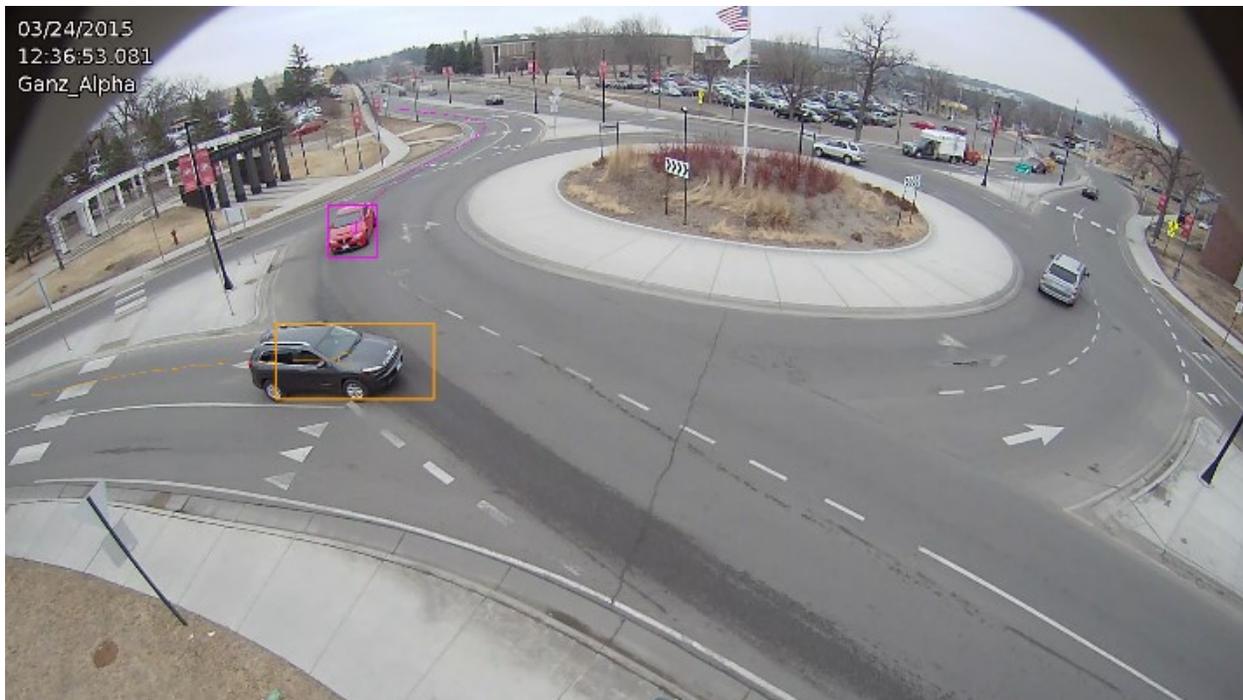
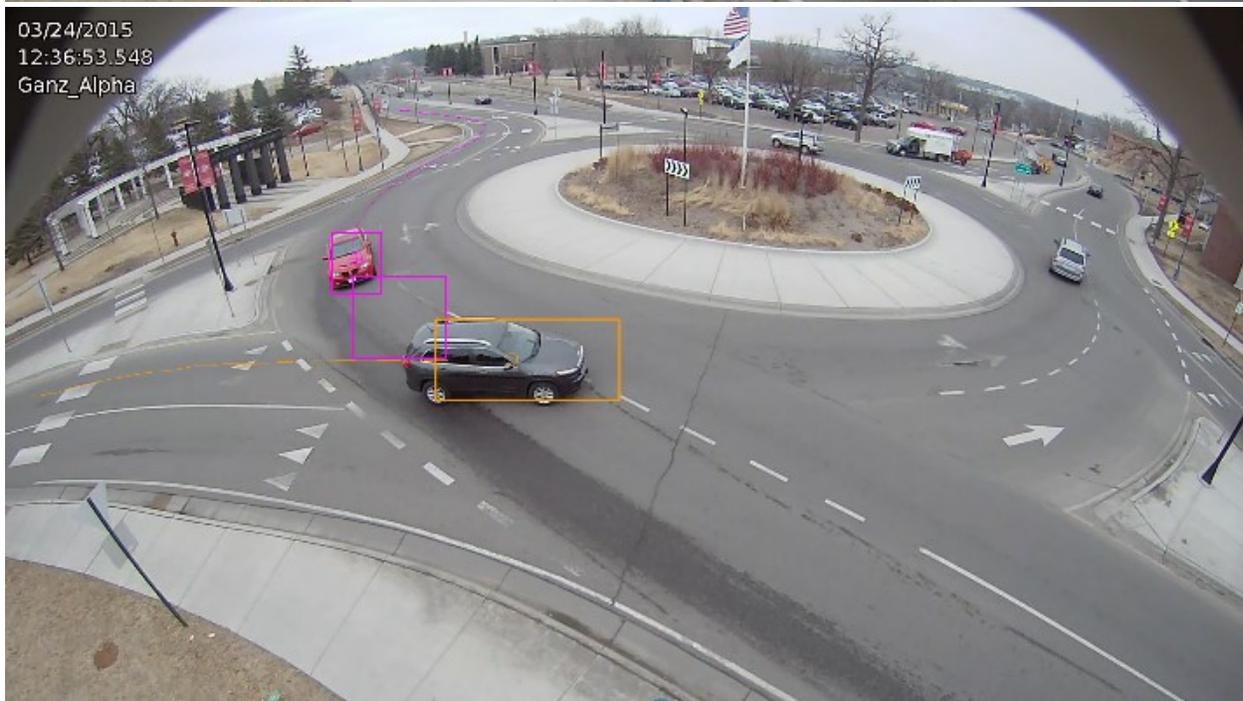
**Figure 31** Example of a yield violation as modeled in the system; note the predicted position of the object in the top frame is well within the collision threshold.

reduce the probability of a collision, like reducing their speed slightly. This is important because such evasive actions, though small, are often enough to make a conflict appear less dangerous than it was. The test criteria then, in effect, is whether the vehicle with right of way *would have* reached the conflict region before the entering vehicle was safe had they not taken any actions to avoid that. See Figure 31 for an illustration of this concept.

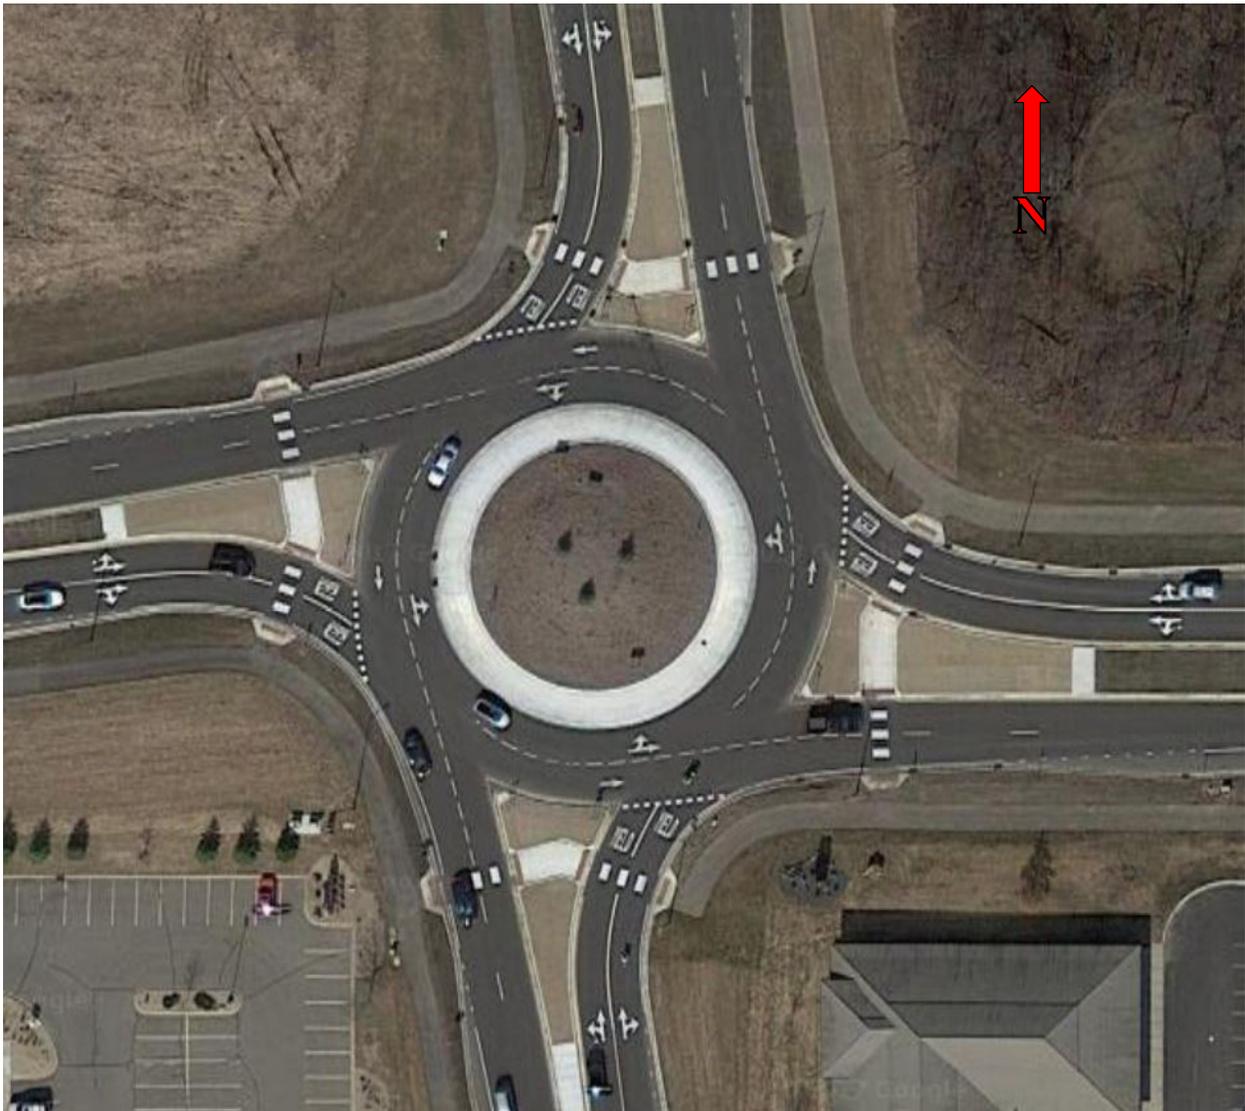
Figure 33 185<sup>th</sup> St W (running east/west) and Kenwood Trail (running north/south) in Lakeville, MN

Table 10 presents the entering volumes on each approach as total from 570 hours of observations, by entrance lane, and by turning movement. The demand in the Lakeville roundabout is much higher than the one in Richfield and St. Cloud but in difference to the latter, it has a more balanced demand between approaches. The results presented in the subsequent tables attempt to normalize the number of violations observed based on relevant volumes. Again, more than one normalization method is presented to facilitate deeper understanding of the driver tendencies and interactions that can affect the propensity for violations.

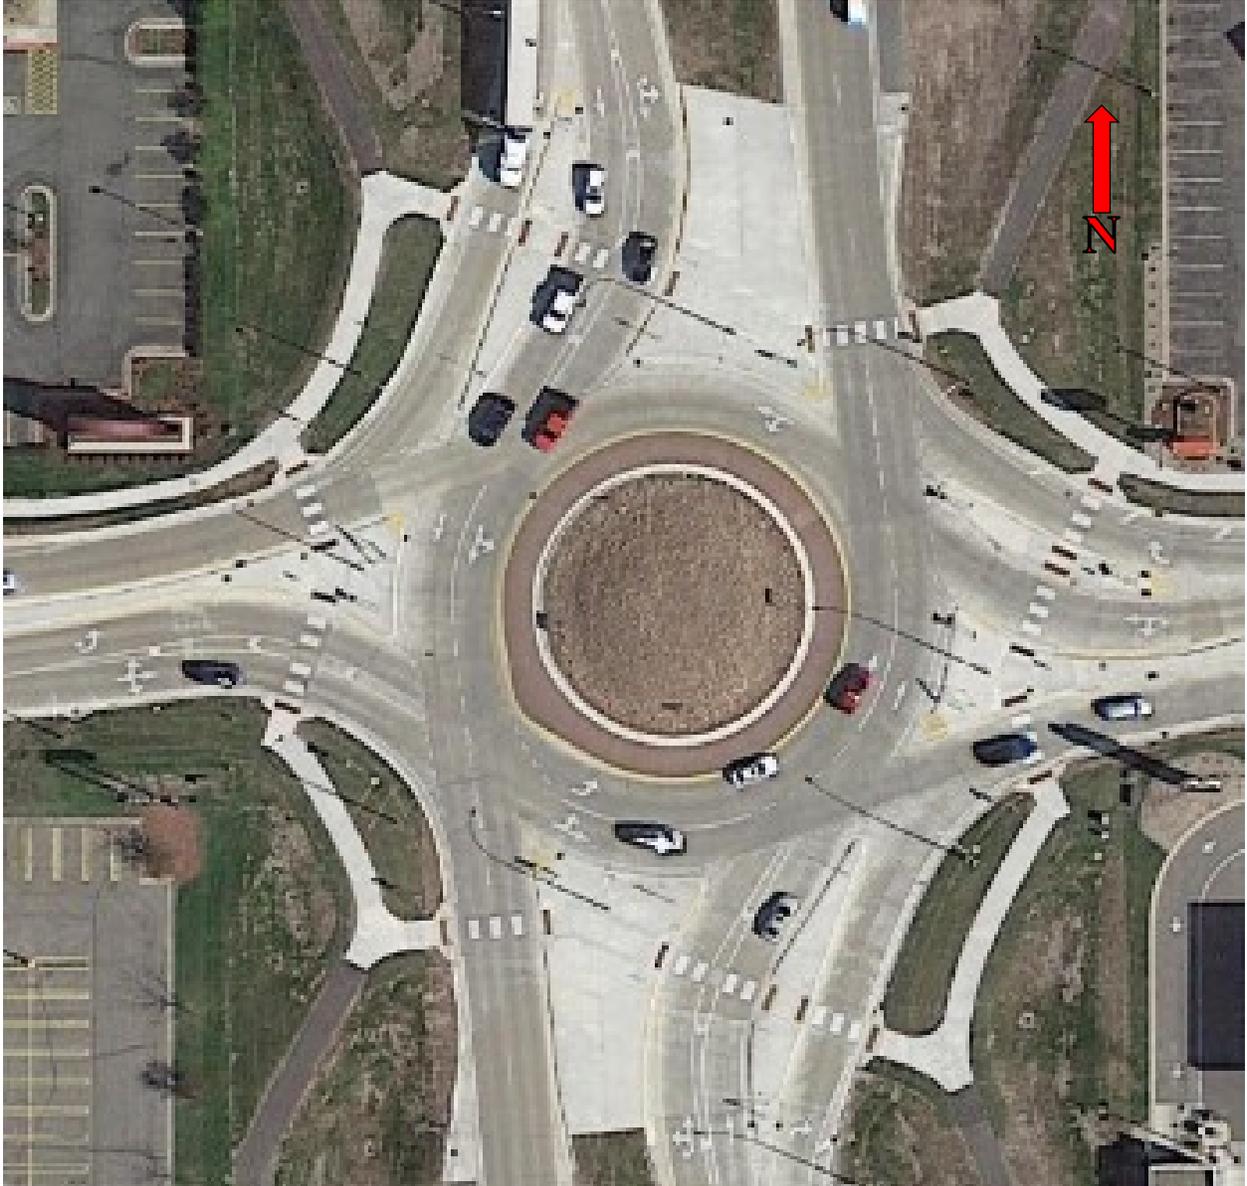
Figure 34 Adams St (running east/west) and TH-22 (running north/south) in Mankato, MN

Table 14 Adams roundabout: Volume over entire analysis period by approach, entrance lane, and turning movement.

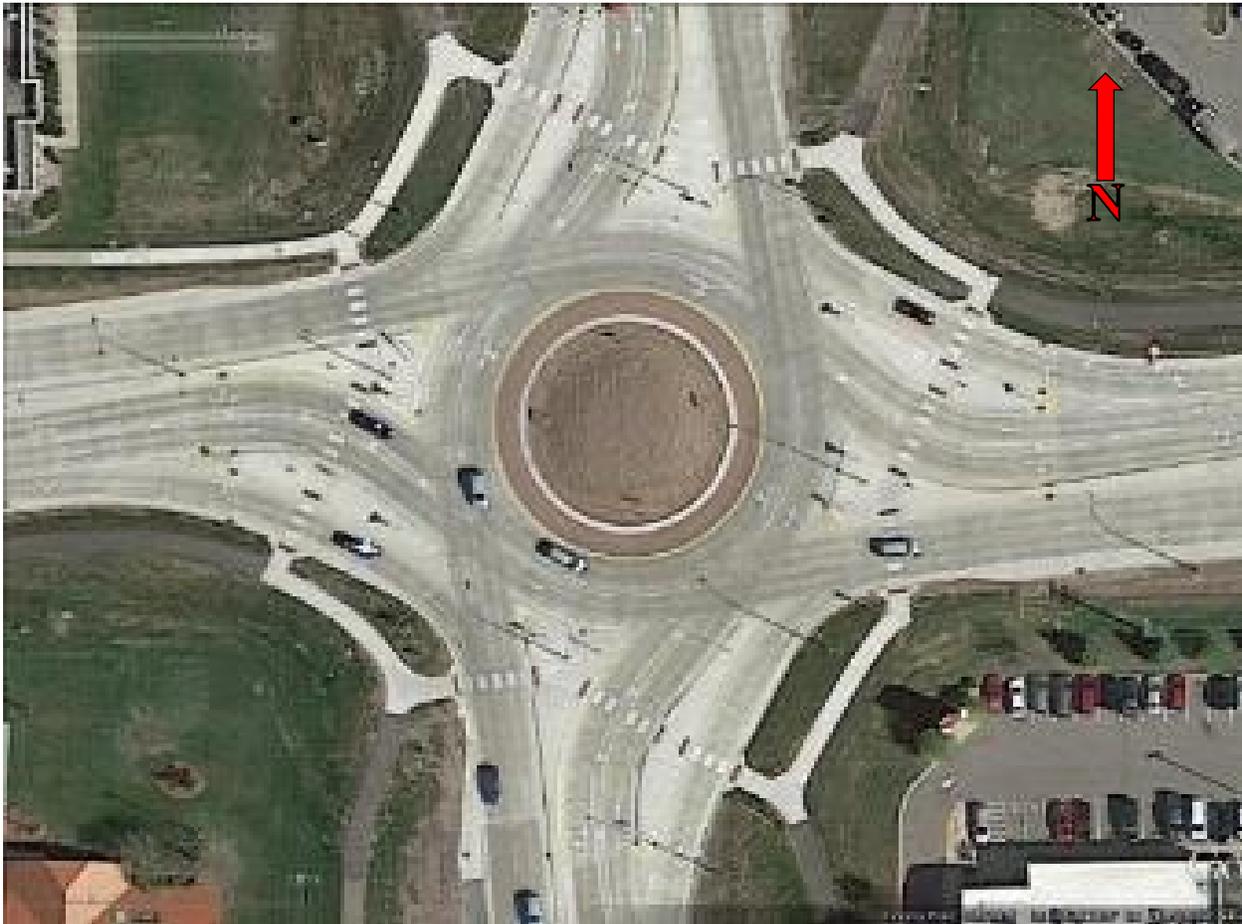
**Figure 35 Madison Avenue (running east/west) and TH-22 (running north/south) in Mankato, MN**

Table 20 presents the entering volumes on each approach as total from 570 hours of observations broken down by entrance lane, and turning movement. The demand in the Madison roundabout is much higher than those of the roundabouts in Richfield and St. Cloud but, in difference to the latter, it has a more balanced pattern between approaches. The results presented in the subsequent tables attempt to normalize the number of violations observed based on relevant volumes. Again, more than one normalization methods are presented to facilitate deeper understanding of the driver tendencies and interactions that can affect the propensity for violations.
