Evaluation of Work Zone Split Traffic Symbol Sign

Final Report Prepared for Missouri Department of Transportation
August 2017

Project TR201613

Report cmr17-009

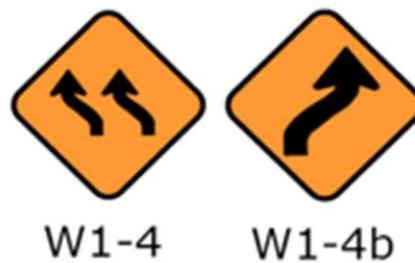
Figure ES.1. Horizontal alignment warning signs from MUTCD Section 6F (FHWA 2009)

Effective signage that is easy to understand facilitates safe driving through a work zone. The Manual on Uniform Traffic Control Devices (MUTCD) (FHWA 2009) provides guidance on signage for temporary traffic control (TTC) in work zones. While the MUTCD guidance is suitable for many conditions, there may be instances where alternative signage may be more effective at enhancing safety. In this project, the use of alternative signage for closure of a middle lane in a freeway work zone was evaluated based on its implementation at a work zone for a bridge rehabilitation project on I-170 near I-70 in December, 2016. The work zone included the shifting of three lanes, two lanes around one side and one lane around the other side of the work area. MUTCD signs W1-4 and W1-4b are shown in Figure ES.1, while the alternative signs tested in this study are shown in Figure ES.2. The alternative signage presented in Figure ES.2 displays the lane arrangement in a single sign.

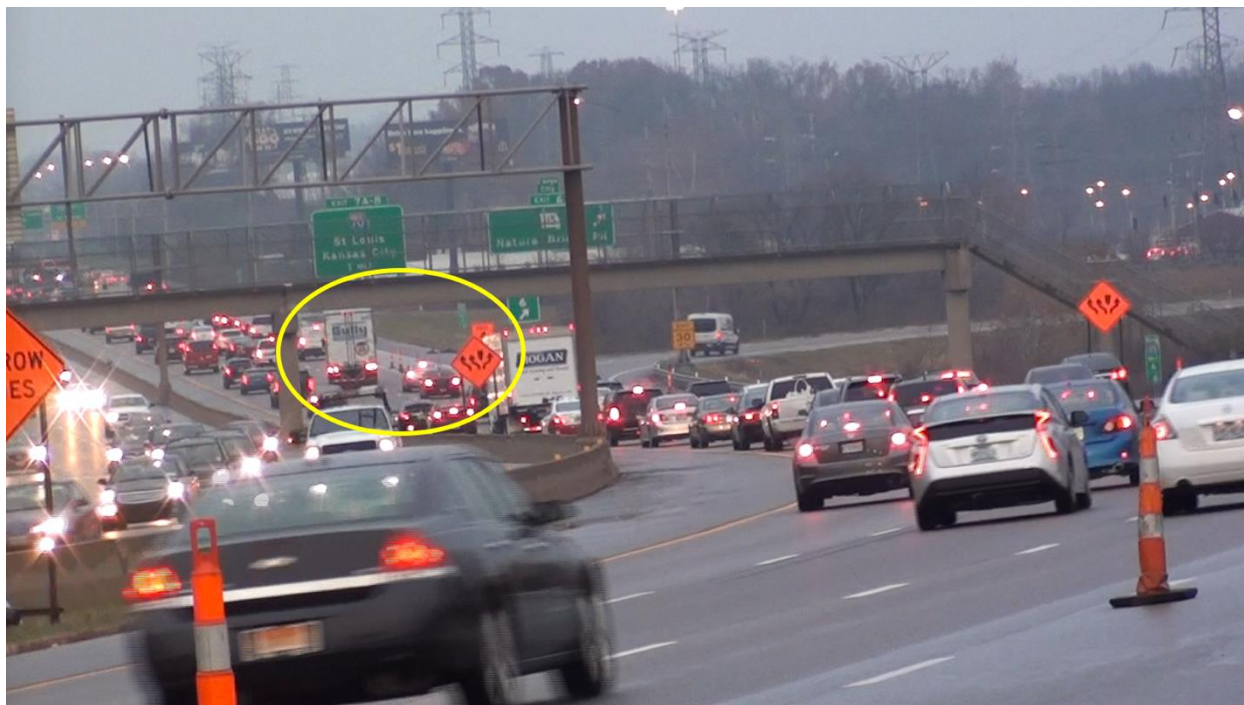
Some unusual driver behavior was observed in the videos, including aggressive lane changes before and at the gore point, vehicles driving across the lane closure area, and vehicles being stranded in the gore. Several aggressive lane changes before the gore point were observed. Examples of these are shown in Figures 2.20 and 2.21. In the event shown in Figure 2.20, a tractor-trailer made an aggressive lane change from the outside lane to middle lane and caused a vehicle queue to develop. In another event (Figure 2.21), a tractor-trailer suddenly changed lanes and applied the brakes, causing the following vehicle behind to move into a different lane.

Figure 2.21. Tractor-trailer making aggressive lane change causing following vehicle to change lanes (early construction, northbound, morning peak)

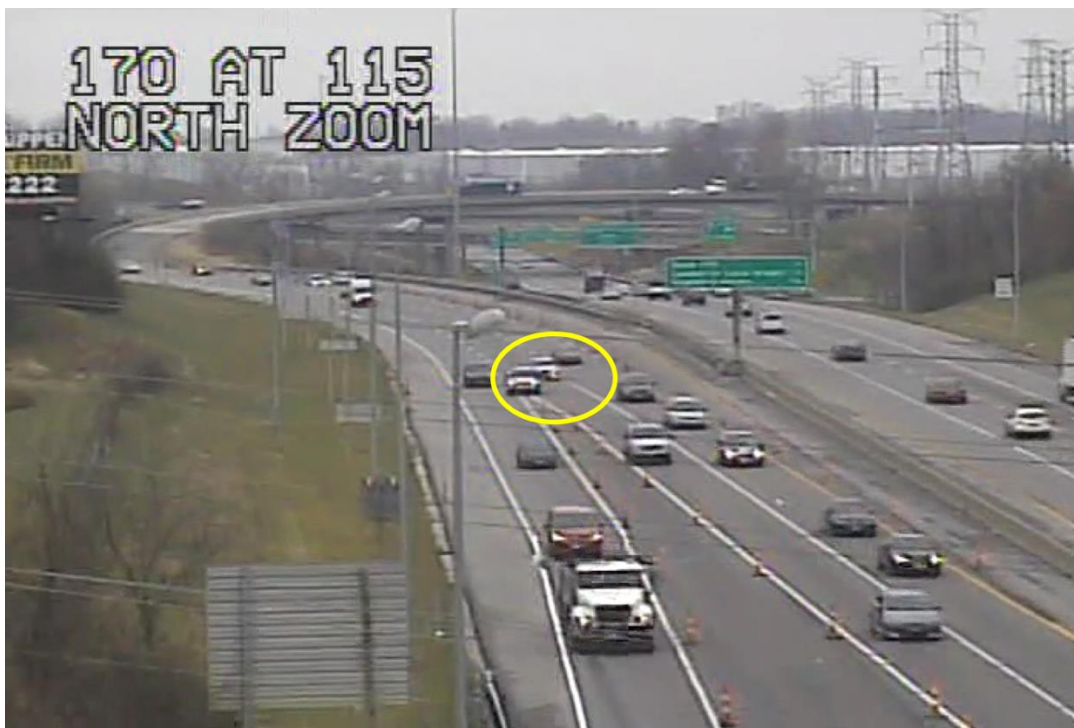
Several aggressive lane changes near the gore were captured in the videos. Examples of these events are shown in Figures 2.22 and 2.23. In both examples, vehicles traveled on the triangular gore area by traversing solid white lines.

Figure 2.23. Lane change near the gore example 2 (late construction, southbound, midday)

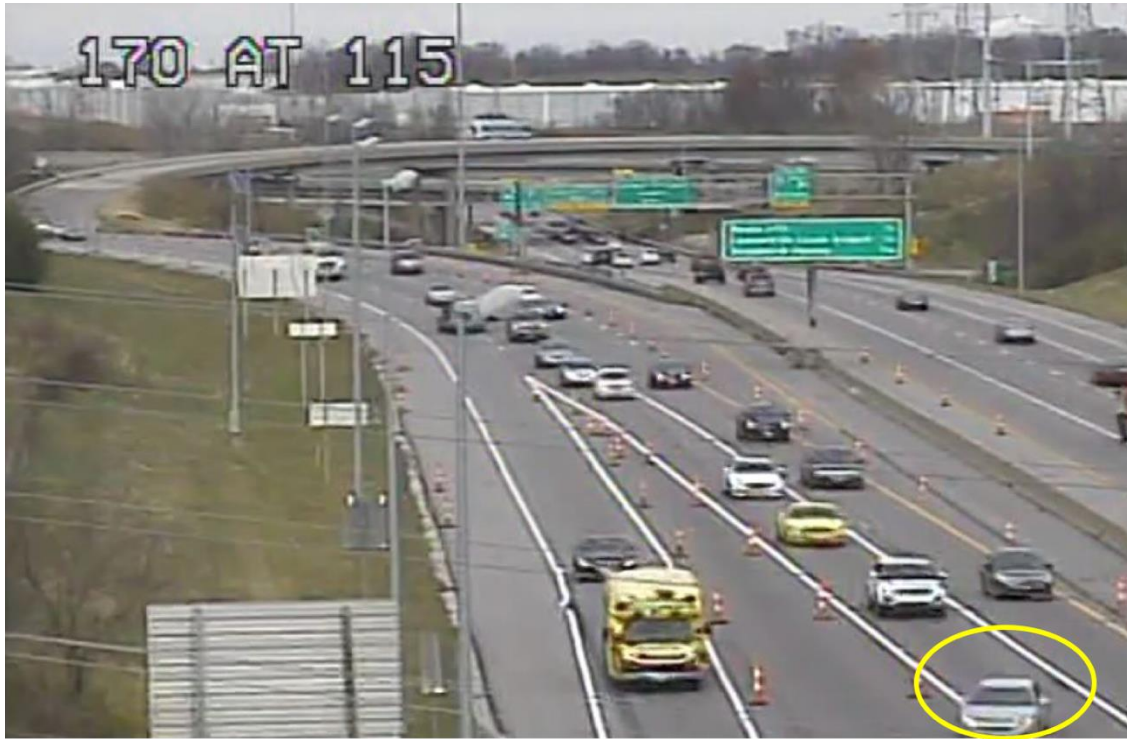
Several events in which vehicles drove through the lane closure area were observed in the videos. Examples of these events are shown in Figures 2.24 through 2.26. Multiple vehicles can be seen driving through the lane closure area in Figure 2.26.

Figure 2.24. Vehicle driving through lane closure area to outside lane (early construction, southbound, midday)

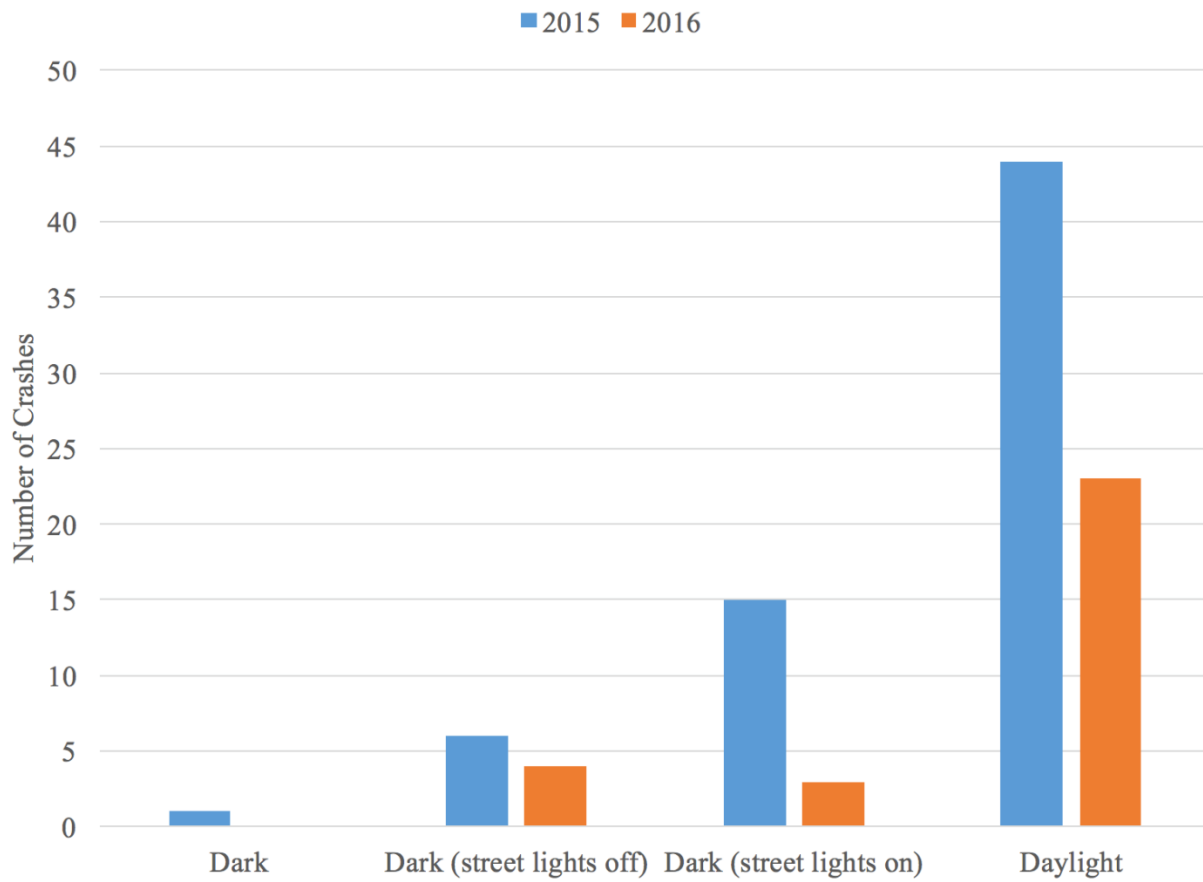
Figure 5.8. Crashes by light condition for I-170 Southbound

The distribution of crashes by light condition is shown in Figure 5.8. Most of the crashes occurred in daylight.

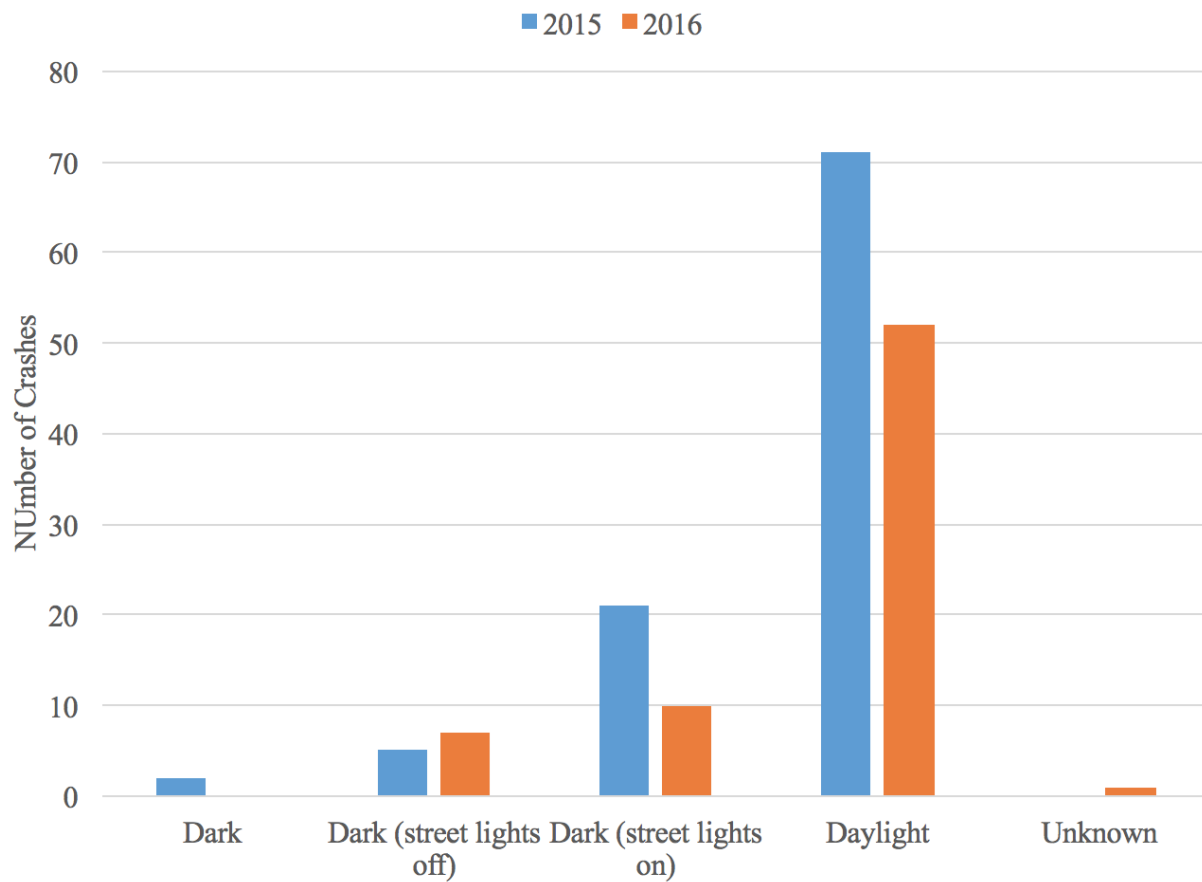
Figure 5.13. Crashes by light condition for I-170 Northbound

Figure 5.13 shows the distribution of crashes by light condition. More than 70 percent of the crashes occurred in daylight.
