MnDOT Thin Whitetopping Selection Procedures

Peter Taylor, Principal Investigator
National Concrete Pavement Technology Center
Iowa State University

June 2017

Research Project
Final Report 2017-24

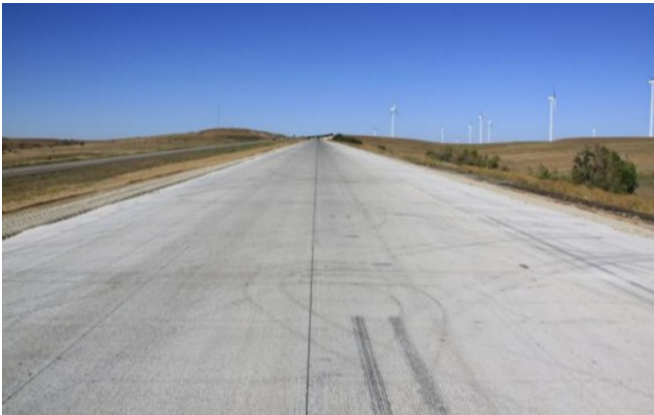
Figure 3. BCOA on I-70 in western Kansas.

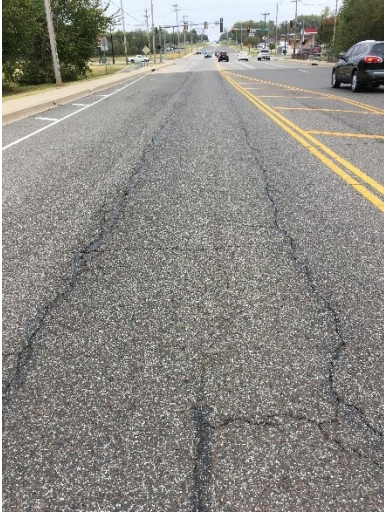
- Low (Figure 6). An area of cracks with no or only a few connecting cracks; cracks are not spalled or sealed; pumping is not evident.
- Moderate (Figure 7). An area of interconnected cracks forming a complete pattern; cracks may be slightly spalled; cracks may be sealed; pumping is not evident.
- High (Figure 8). An area of moderately or severely spalled interconnected cracks forming a complete pattern; pieces may move when subjected to traffic; cracks may be sealed; pumping may be evident.

Figure 6. Low-severity fatigue cracking in HMA that is not an issue for BCOA designs.

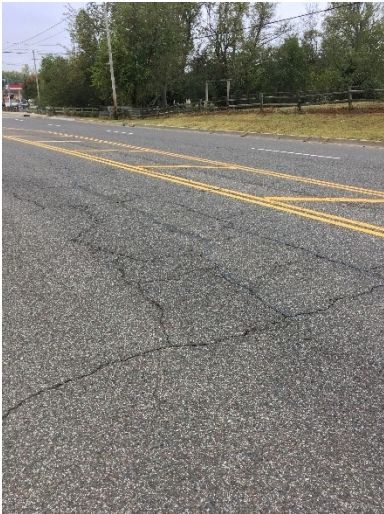
Figure 7. Moderate-severity fatigue cracking in HMA that is not an issue for BCOA designs.

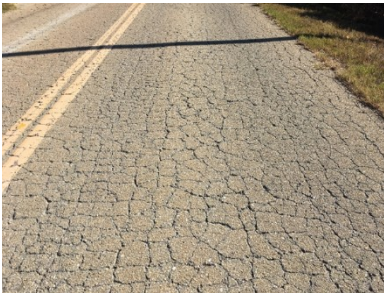
Figure 8. High-severity fatigue cracking in HMA that is not suitable for BCOA designs unless milling will expose HMA in fair to good condition.

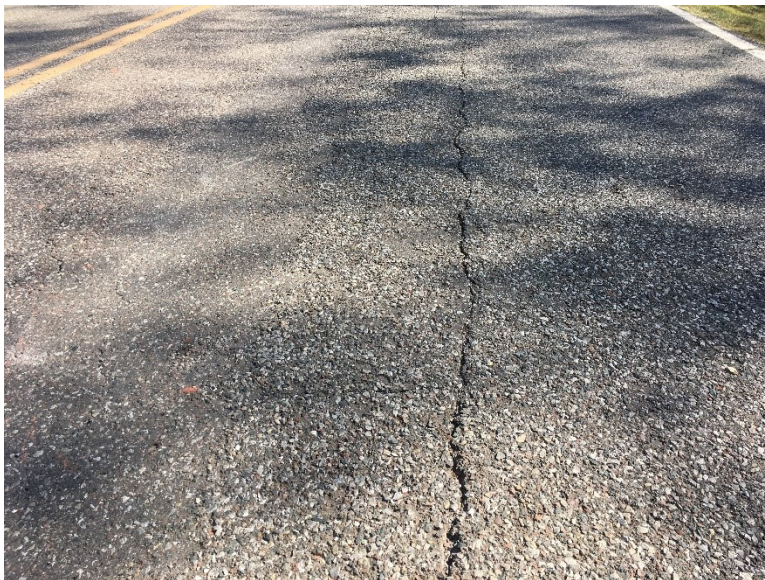
Longitudinal cracking in the wheel path (Figure 9) is typically not an issue for BCOA designs unless there is vertical displacement between the adjacent sides of the crack. Differential deflections between the adjacent sides of the crack exceeding 1/4 in. indicate problems with subgrade support and/or drainage issues. Both of these problems need to be mitigated regardless of the final pavement design.

Figure 9. Longitudinal cracking in the wheel path of an existing HMA pavement.

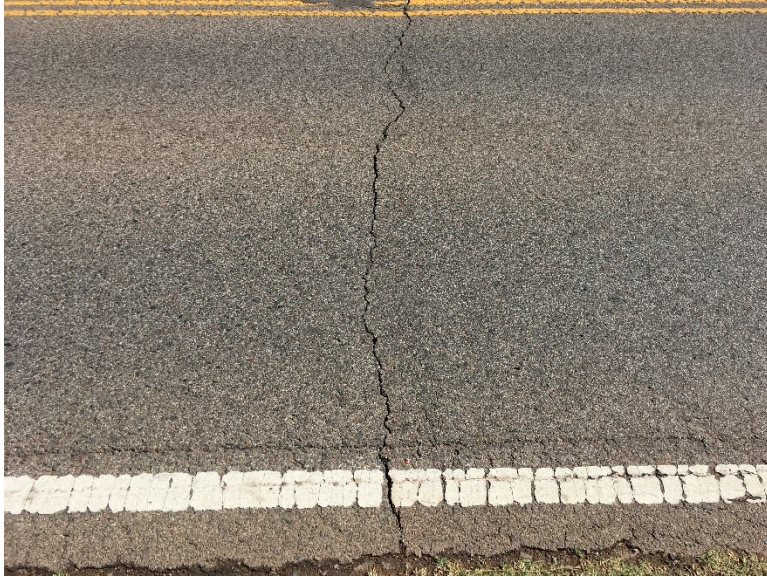
Transverse cracks develop in asphalt pavements due to the restraint of thermal contraction caused by the friction between the bottom of the asphalt and the base and the continuous nature of an unjointed asphalt pavement. A transverse crack is shown in Figure 10. These cracks can propagate up into the bonded concrete overlay when the asphalt is significantly stiff relative to the overlay, as shown in Figure 11.

Figure 10. Transverse (thermal) cracking in an existing HMA pavement.

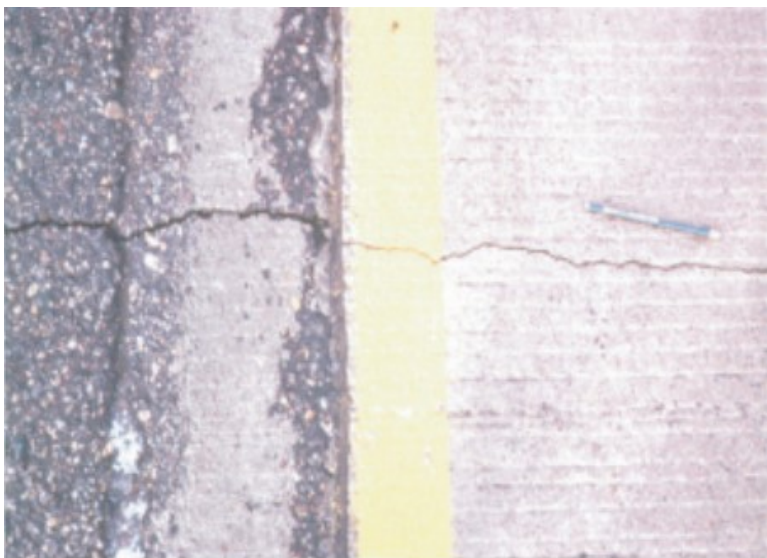
Figure 11. Reflective cracking observed at the Minnesota Road Research Facility (MnROAD).

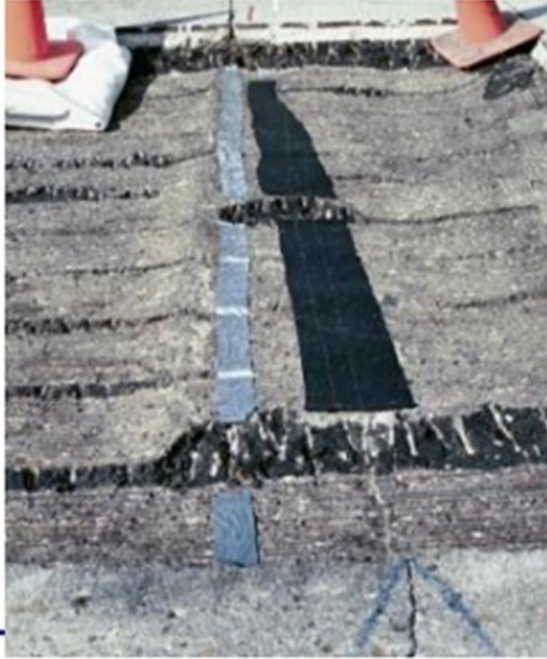
Debonding the overlay from the asphalt layer in the vicinity of the thermal crack will prevent the crack from reflecting up into the overlay. Tar paper stapled to the surface or duct tape placed over the crack, as shown in Figure 12, has been demonstrated to effectively deter reflective cracking. Some departments of transportation consider the development of a few reflective cracks in the concrete overlay to be acceptable, but the development of reflective cracking can be prevented as described above, if desired.

Figure 12. Prevention of reflective cracking by localized debonding.

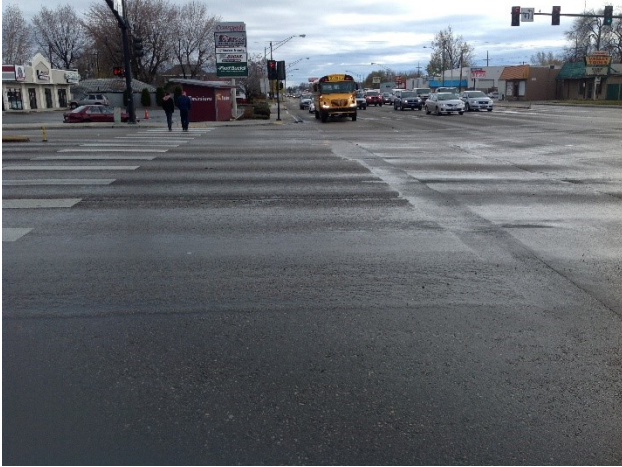
Deformations in the HMA due to rutting and shoving (Figures 13 and 14) are not a structural concern for BCOA designs. However, it is recommended that surface deformations greater than 2 in. be removed by milling in order to conserve the volume of concrete required for the BCOA. Quantify the area of milling in square yards required to remove these distortions during the visual survey.

Figure 13. Rutting in HMA evidenced by standing water in the wheel paths.

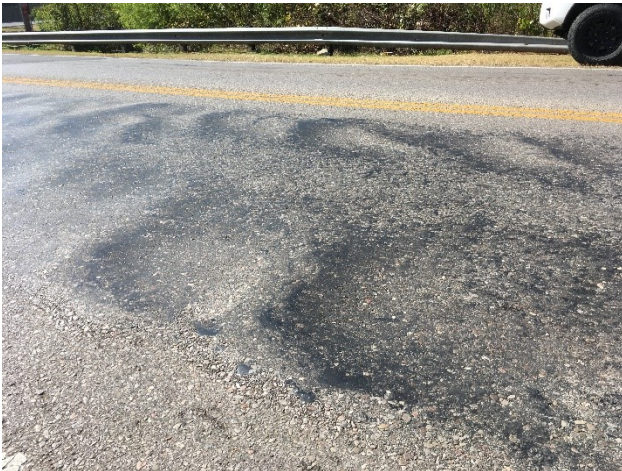
Figure 14. Shoving in HMA pavement at an intersection approach.

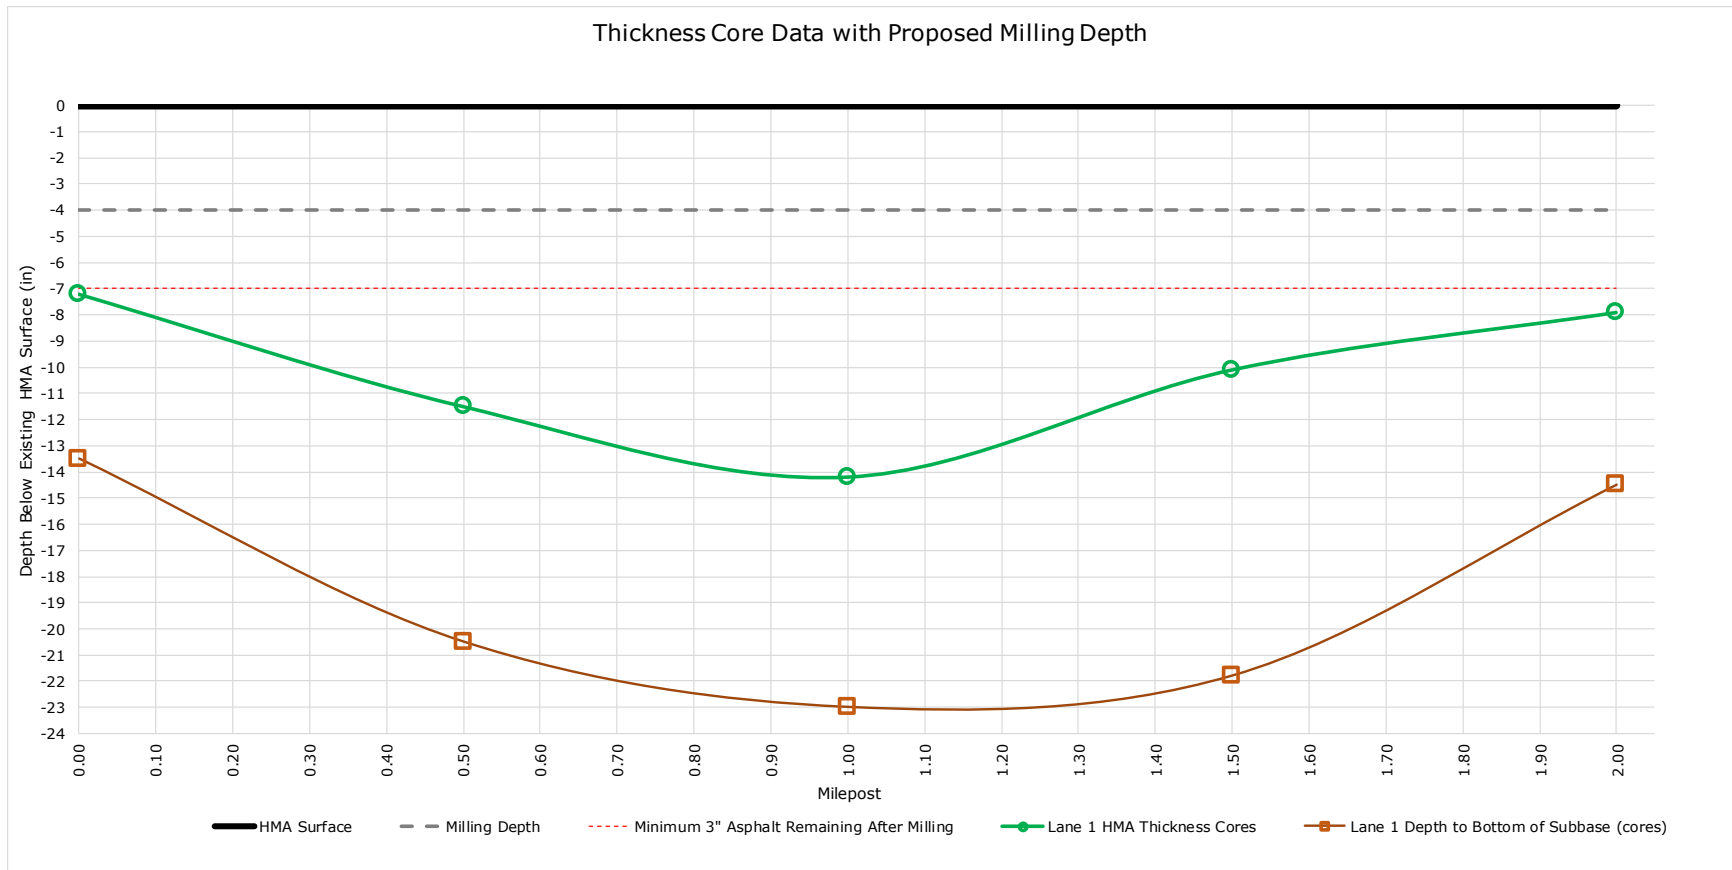
Next, the coring data from Table C-1 are plotted on an X-Y graph (see Figures C-1 and C-2).

Figure C-1. HMA and subbase thickness data plotted with proposed milling depth (4 in.).

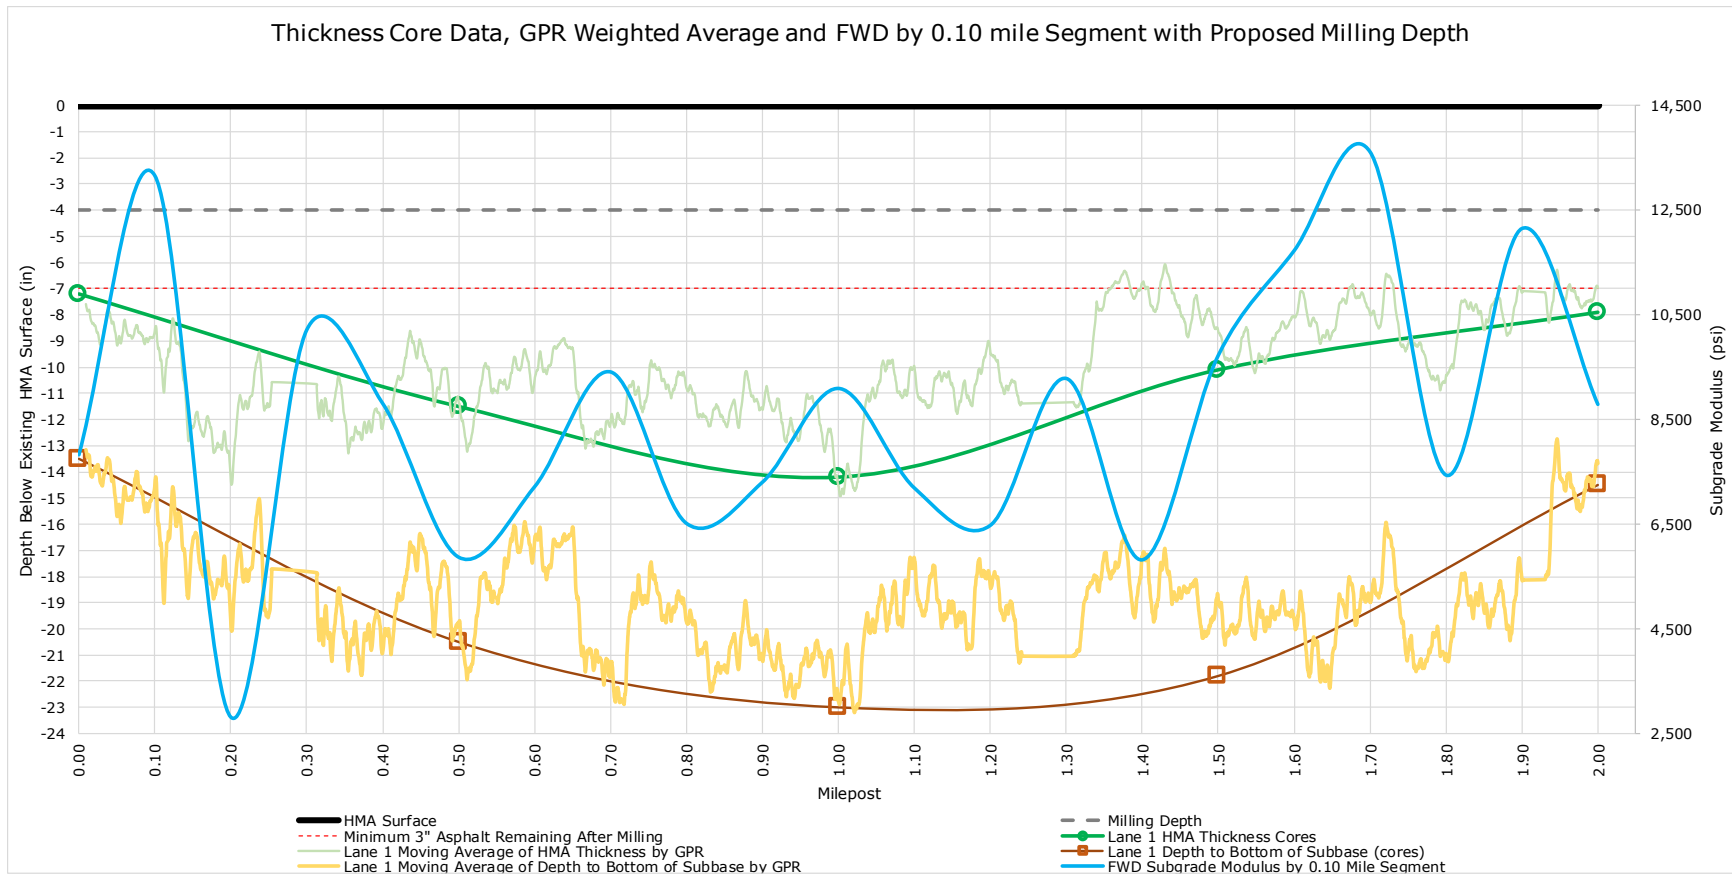
The line for FWD Subgrade Modulus by 0.10 Mile Segment in Figure C-5 shows typical results derived from FWD testing. Variability in the subgrade modulus should be expected. The data in Figure C-5 show an area at milepost 0.20 that should be further investigated to determine if a pre-overlay repair is necessary and the extent of this pre-overlay repair (undercut and base/subbase repair).

Figure C-5. X-Y Plot showing an area with potentially weak subgrade.

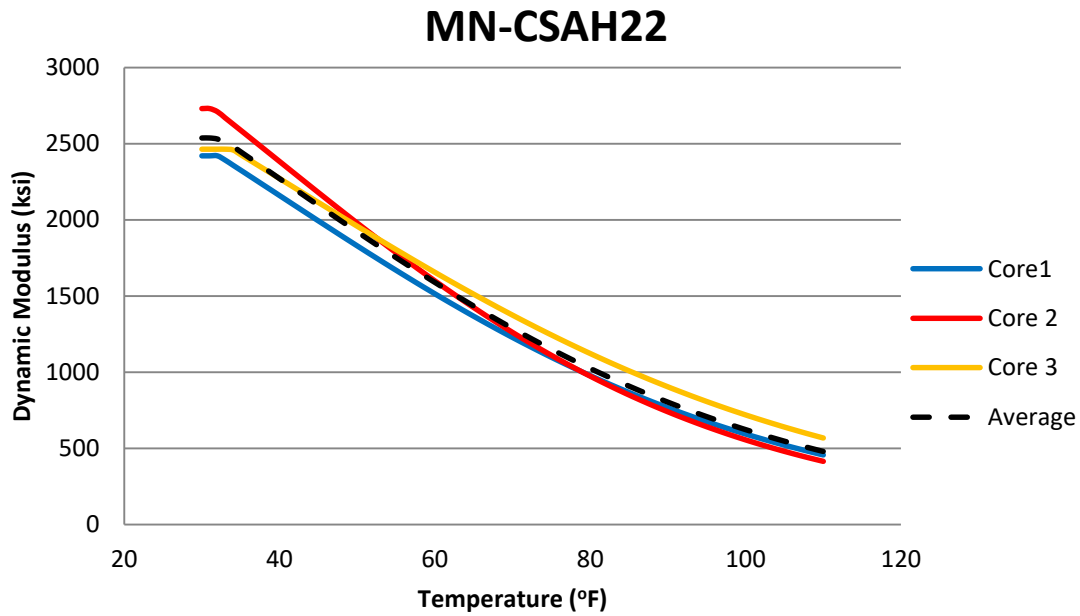
The stiffness versus temperature relationships and the master curve parameters for each core are provided in Figures D-1 through D-5 and Tables D-8 through D-12.

Figure D-1. Stiffness versus temperature curves for MN-CSAH

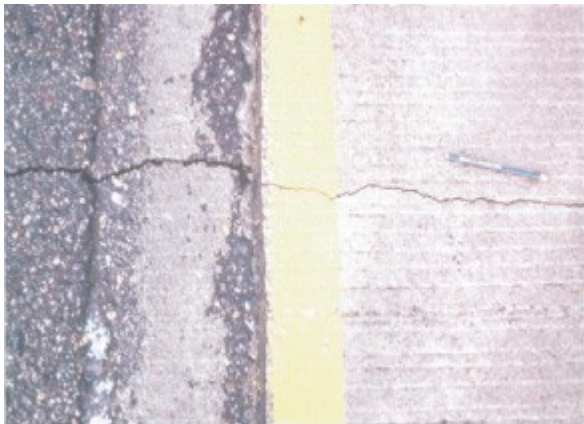
Transverse cracks develop in asphalt pavements due to the restraint of thermal contraction caused by the friction between the bottom of the asphalt and the base and the continuous nature of an unjointed asphalt pavement. These cracks can propagate up into the thinner bonded concrete overlay when the asphalt is significantly stiff relative to the overlay, as shown in Figure E-1.

Figure E-1. Reflective cracking observed at MnROAD.

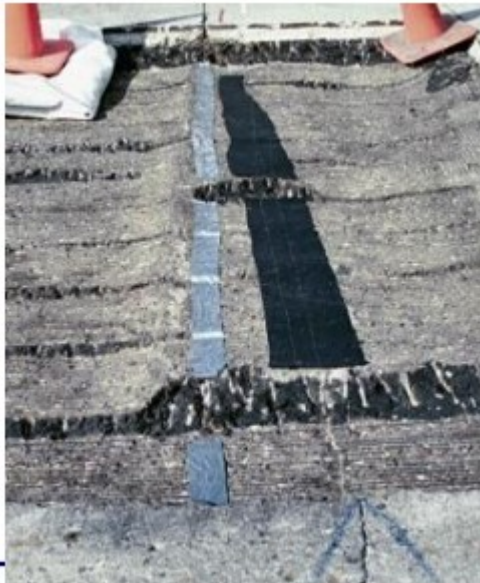
If the transverse crack width is less than the maximum coarse aggregate size used in the overlay mixture and the flexural stiffness ratio is less than 1, then preventive measures can be taken to ensure that the transverse crack does not propagate up into the overlay. Debonding the overlay from the asphalt layer in the vicinity of the crack will prevent the crack from reflecting up into the overlay. Tar paper stapled to the surface or duct tape placed over the crack, as shown in Figure E-2, has been shown to effectively deter reflective cracking. Some departments of transportation consider the development of a few reflective cracks in the concrete overlay to be acceptable, but the development of reflective cracking can be prevented as described above, if desired.

Figure E-2. Prevention of reflective cracking by localized debonding.

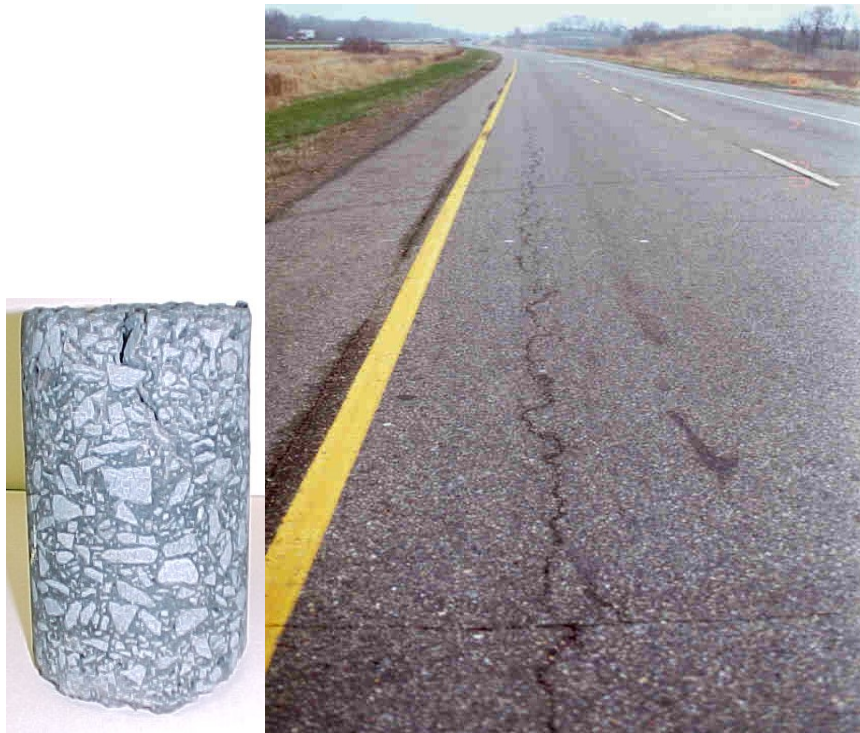
Longitudinal fatigue cracking generally develops in thicker asphalt pavements when the pavements are trafficked by trucks having high tire pressures. These high tire pressures result in high tensile stresses

perpendicular to the direction of the tire at the pavement surface, which results in longitudinal fatigue cracks that initiate at the pavement surface and propagate downward. See Figure E-3.

Figure E-3. Top-down longitudinal fatigue cracking at MnROAD.
