**LONG-TERM PERFORMANCE OF GRANULAR
BASES INCLUDING THE EFFECT OF WET-DRY
CYCLES ON INVERTED BASE PAVEMENT
PERFORMANCE**

GDOT Research Project No. 15-10

Final Report

Georgia Institute of Technology

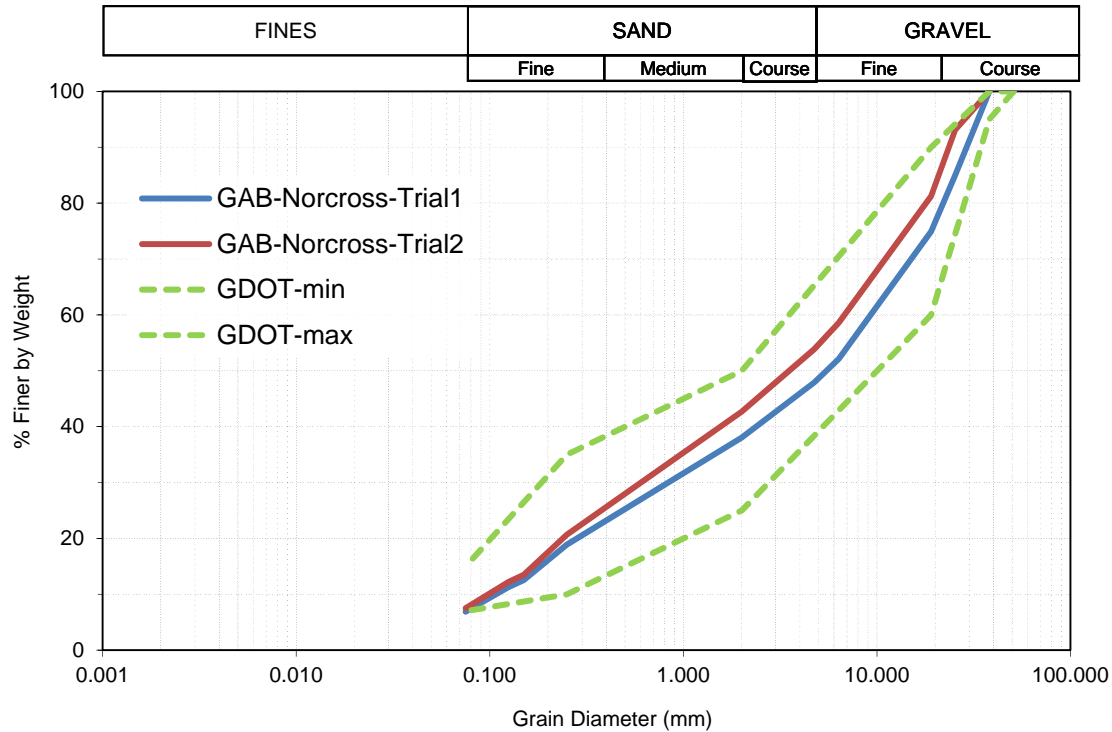
Figure 1: Grain size analysis for GAB material used for study.

USCS Classification	GW (well-graded gravel)
Percentage Fines (%)	7 - 7.5
Coefficient of Uniformity, C_u	70 – 90
Coefficient of Curvature, C_c	0.51 – 0.76

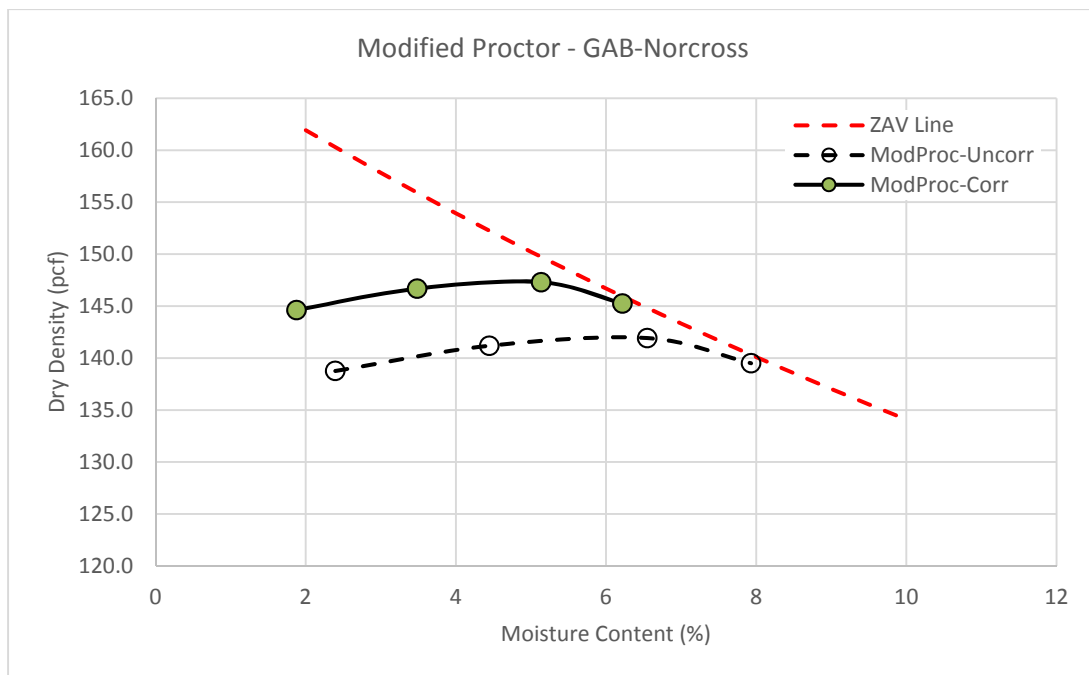
Figure 2: Proctor compaction curve obtained using the Modified method.

The specific gravity (G_s) of the GAB material was first computed as per ASTM D854, and estimated to be 2.737. A modified proctor test (ASTM D1557-12) was conducted at four sample water-contents to assess the moisture-density relationship of the material. The sample was sieved through a ASTM $\frac{3}{4}$ " sieve prior to compaction in the proctor mold to minimize particle-boundary interactions and edge-effects. This sample adjustment was then accounted for by using the correction method stated in ASTM 4718-87. Figure-2 present the compaction curve for the GAB material, where the dashes lines represents the modified sample (excluding $\frac{3}{4}$ " and bigger particles) and the solid line represents the

Maximum dry density and optimum water content values were estimated to be 148 pcf and 4.5% respectively, which are typical for GAB material.

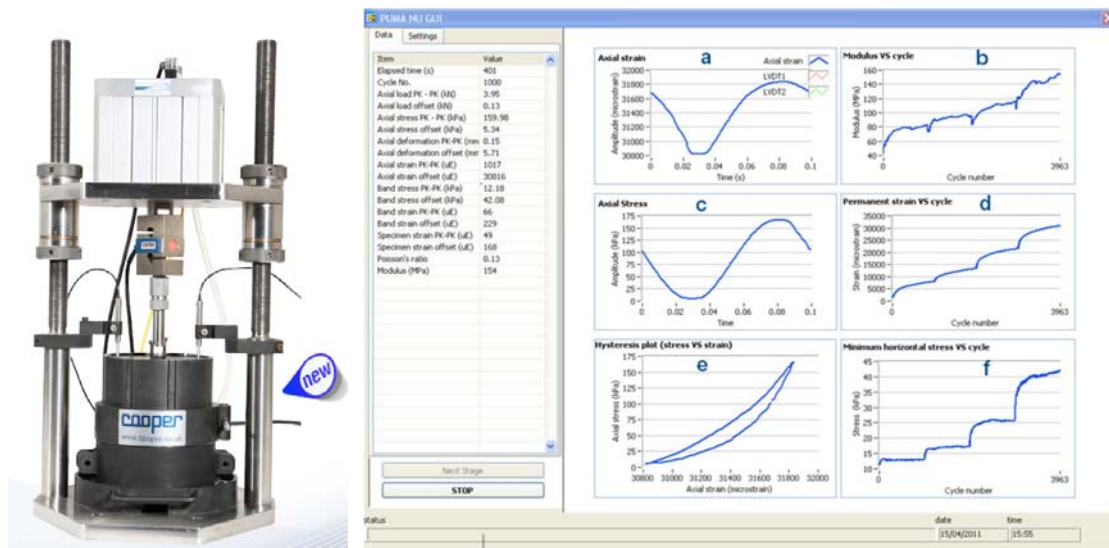
Figure 3: (a) Typical test apparatus showing the loading frame and specimen-mold, (b) screen capture of data monitoring software

Method: The PUMA is a new laboratory testing technique designed specifically for testing modulus and deformation behavior of pavement materials under multiple loading cycles. This method efficiently captures the unbound nature of the insitu road-base layer by using a flexible mold for the specimen [Brown, 2013]. The flexible wall is composed of eight curved wall segments, which are circularly arranged to form the mold, and a rubber-lined steel band is inserted around the mold to measure the horizontal strain experienced within the specimen. The horizontal strain in the specimen increases with increasing axial loads thus simulating the responsive nature of unbound pavements. The GAB test specimen was prepared in the 6"-tall by 6"-diameter using the modified method (5 layers with 56 blows/layer), and tested in a UTM loading frame as indicated in Figure 3. High frequency cyclic load was applied over thousands of cycles and the vertical-deformation at the surface is continuously monitored using two displacement transducers.

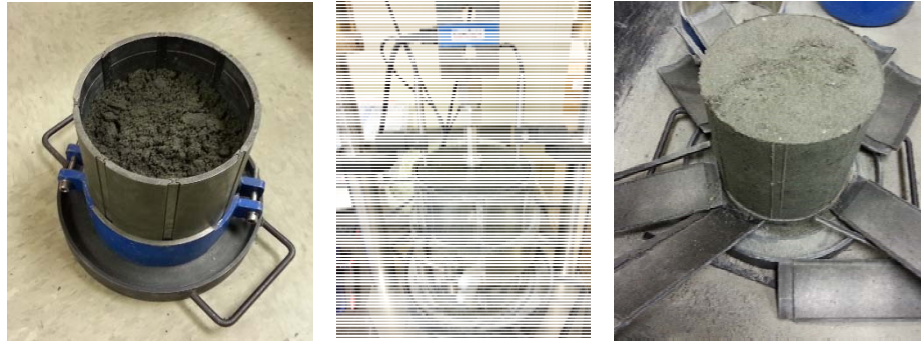
Figure 4: Stages of PUMA test (a) Sample preparation, (b) testing in loading frame and (c) specimen after test showing dismantled mold

Stage No.	Stress (psf)	Frequency (Hz)	No of Cycles
Stage I	418 (20 kPa)	10	1000
Stage II	835 (40 kPa)	10	1000
Stage III	1671 (80 kPa)	10	1000
Stage IV	3342 (160 kPa)	10	1000

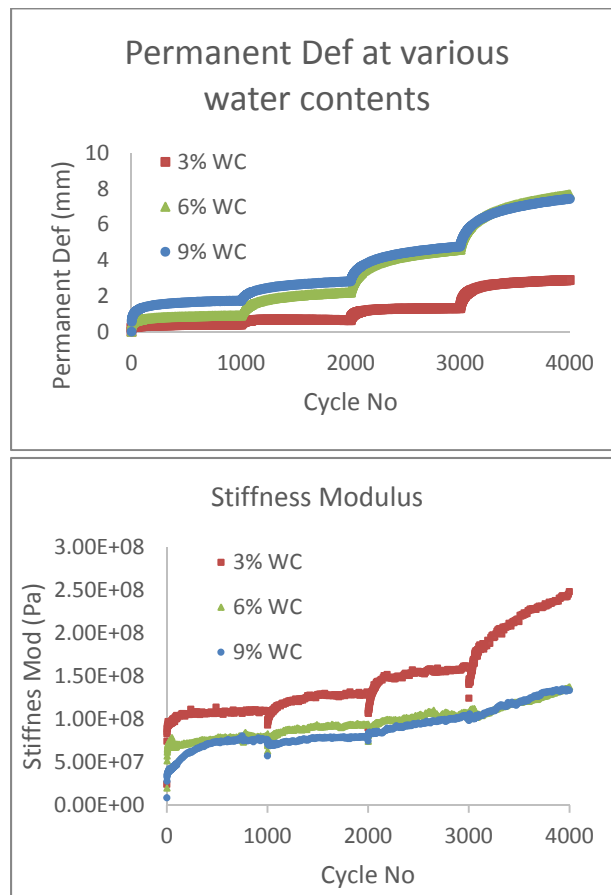
Figure 5: Plots showing evolution of permanent deformation and stiffness modulus with loading cycles

Results from the PUMA tests conducted on compacted GAB specimens are shown below. In general, higher permanent deformation and smaller stiffness modulus was observed for samples molded at water contents wet of optimum ($w_{opt} = 4.5\%$). Both parameters increased at higher axial stresses, with most of the increase occurring over the first few hundred cycles followed by a more steady rate of increase as seen in Figure 5.

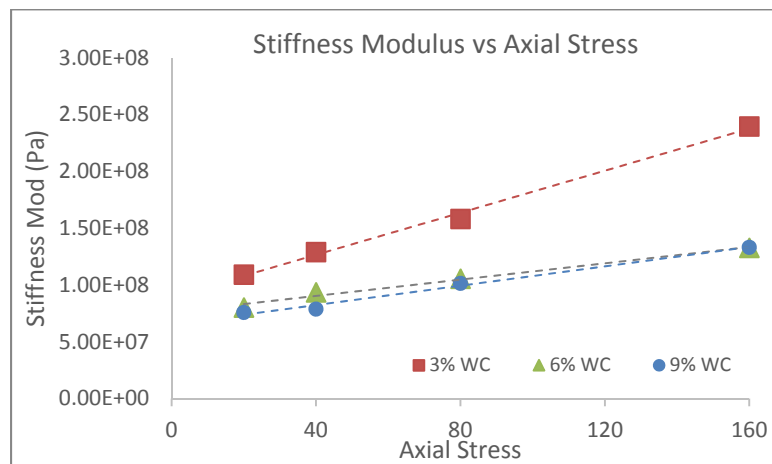
Figure 6: Stiffness modulus versus axial stress for all three tested specimens

- Effect of Water Content:
 - Specimens compacted on the dry side of optimum generally tend to show greater stiffness moduli than specimens compacted wet of optimum, as is seen in these scenarios.
 - There isn't much variation in the behavior of the 6 and 9% compacted specimens as both of these are wet of optimum, and considering the GAB material is a free-draining material, the excess water in the 9% specimen just flows out. It should be noted that water was indeed observed to being expelled while the test was in progress confirming the open drainage along the walls.

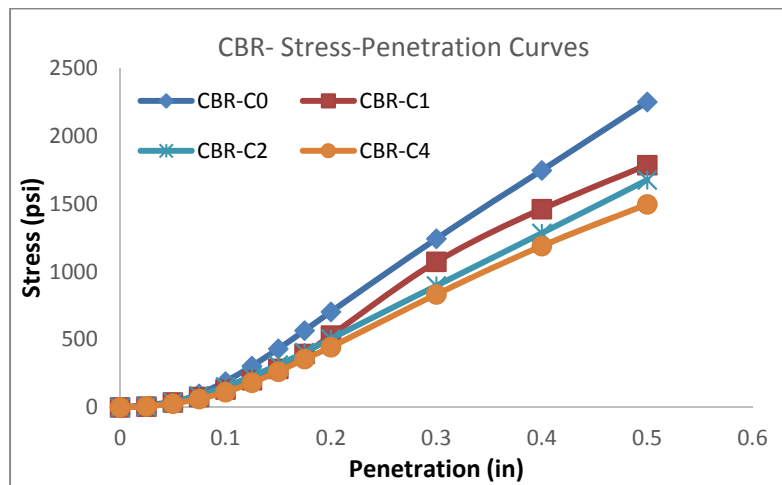
Figure 7: CBR stress versus penetration for four tested specimens

Results: The observed behavior of resistance to penetration for all four tested specimens is presented in Figure 7. The degradation in stiffness caused by wet-dry cycles is apparent, which is also exacerbated at larger strains. Although traditionally CBR stress-penetration curves are concave-upwards in shape, the initial convex shape observed herein can be attributed to a softer upper crust, loosened by water seepage/expulsion during the wet/dry cycles. Figure 8 shows the expected gradual reduction in 0.2"-CBR values (i.e. the CBR estimated at 0.2" penetration) for the four specimens. The 0.2"-CBR was selected for comparison over the 0.1"-CBR to get a more representative value of resistance after overcoming the surface irregularities caused by wet/dry cycles.

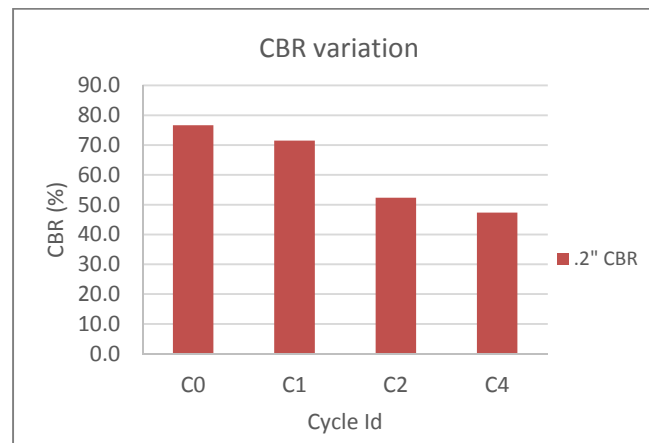
Figure 8: CBR estimated at 0.2" of penetration for four tested specimens

The loss in stiffness observed with wet-dry cycles can be attributed to sample disturbance caused by water forming flow channels through the specimen, which disturbs any previously-formed load-bearing contacts/chains among particles. Also, the CBR test involves penetration at the surface, which is also probably the zone that is most affected by moisture cycles being an open boundary. This is depicted in the pictures in Figure 9, showing some of the specimens that were tested. A stark contrast can be identified in the visibility of coarse aggregates at the surface in the C4 specimen relative to C1 and C0

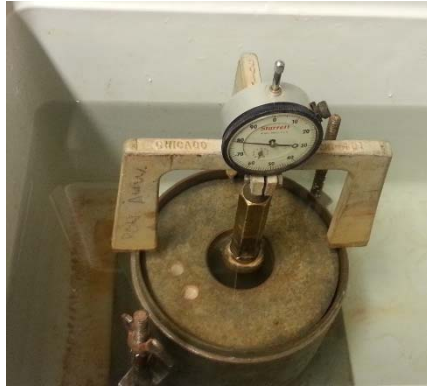
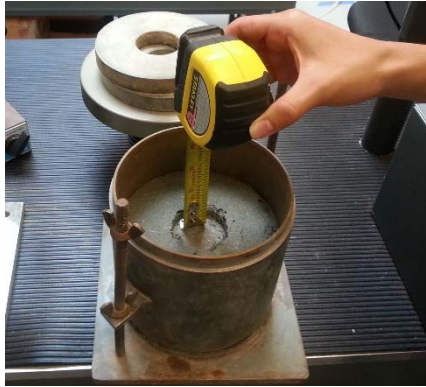
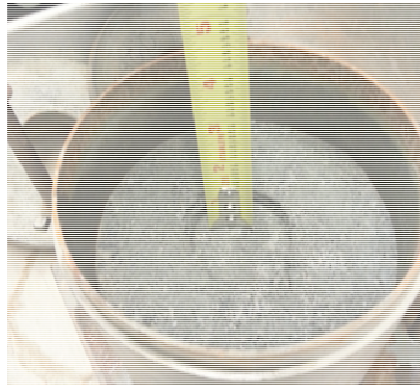
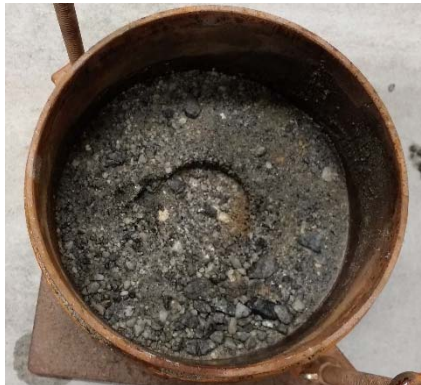
Figure 9: Selected pictures of CBR tested specimens

specimens, which is probably, in part a result of dislodgement of surrounding finer particles over the course of the wet-dry cycles.

(a) Sample being soaked

(b) C0 specimen

(c) C1 specimen

(d) C4 specimen

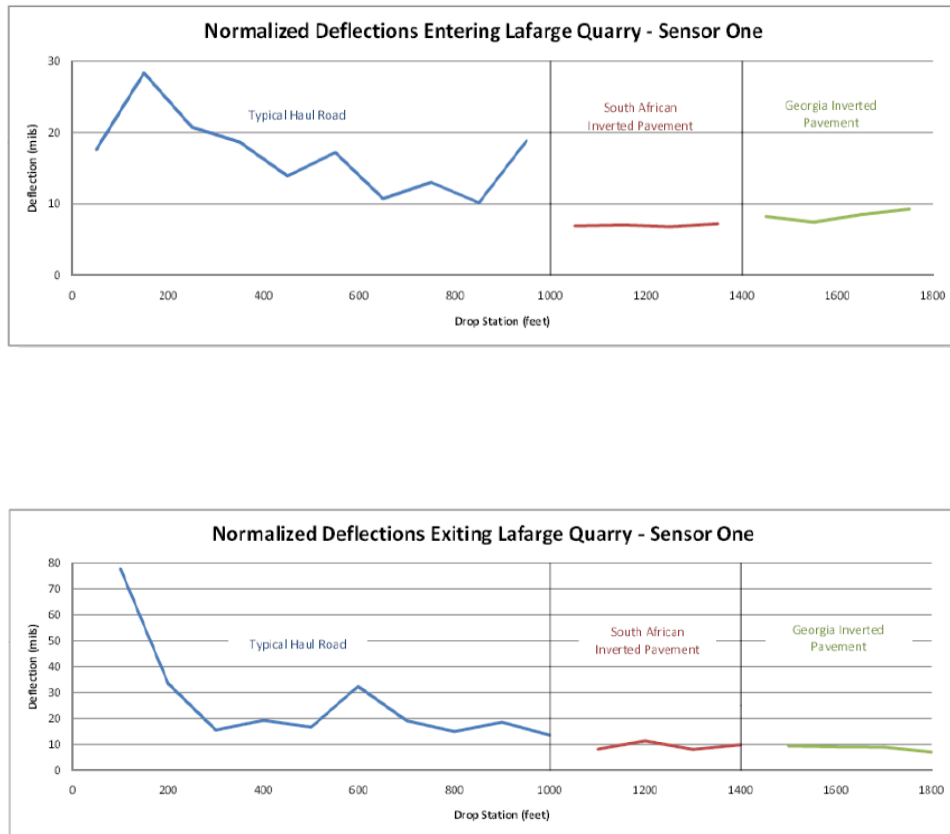
Figure 10. FWD Test Deflections conducted in Nov 2007 (after Lewis et al., 2012)

Figure 10 shows that FWD test deflection readings along the test section. Higher deflections were noted towards the entrance between Sta. 0 and Sta. 300, while the South African and Georgia pavements showed very low deflections, indicative of stiff pavement layers.

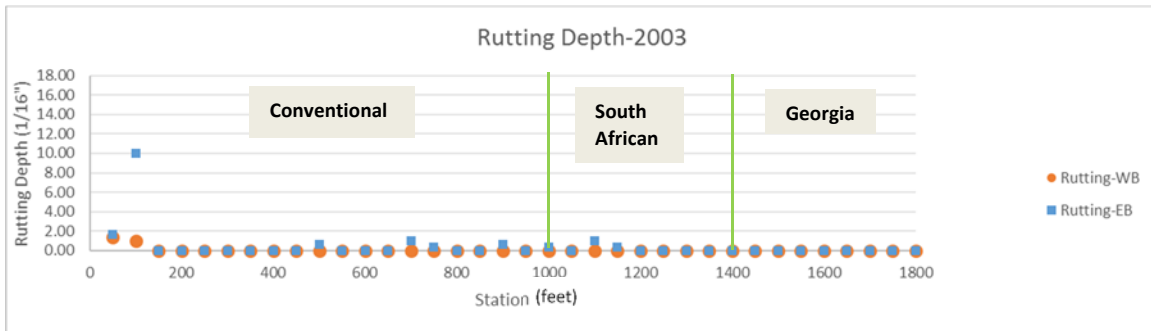
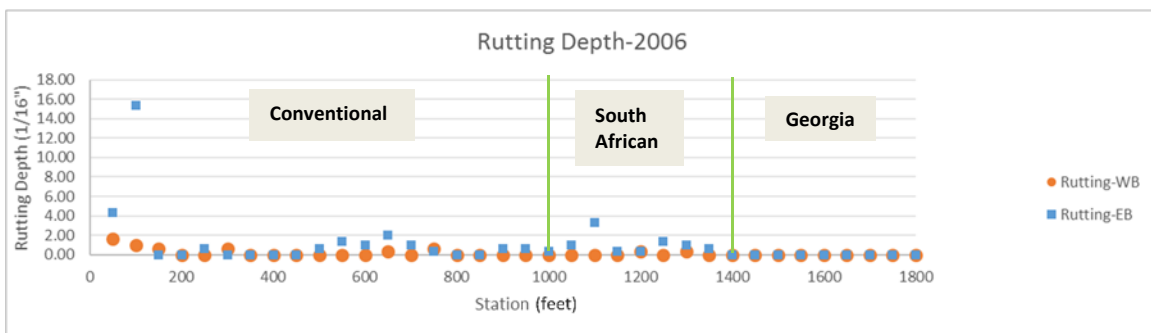
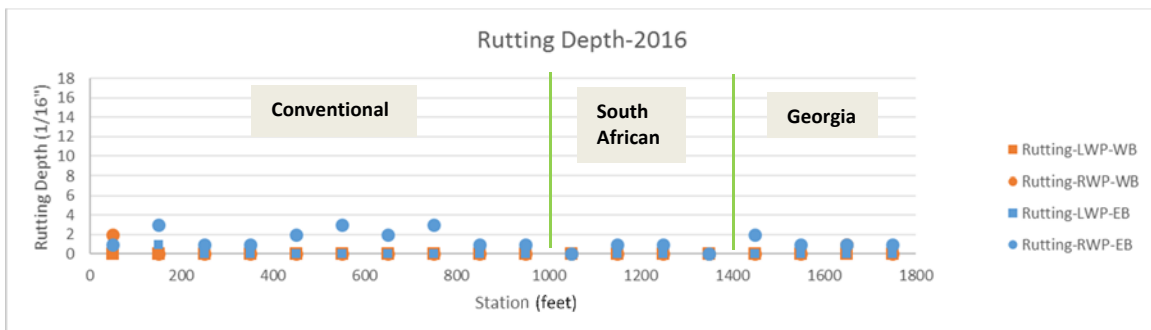
Figure 11. Rutting measurements in 2003

Figure 12. Rutting measurements in 2006

Figure 13. Rutting measurements in 2016

Figure 11, 12 and 13 present rutting depth measurements obtained in 2003, 2006 and 2016 respectively. The section between Sta. 0 and Sta. 300 near the highway intersection indicated high rutting behavior in the 2003 and 2006 data and consequently is understood to have undergone repairs at some stage prior to the 2016 measurements, which explains the lower readings in the 2016 study at that location. Meanwhile, the rest of the conventional pavement section seems to indicate gradual rutting increases and thus deterioration. The South African and Georgia sections are performing remarkably well after 16 years of operation. Based on the 2016 data, there may be slightly lesser rutting in the South African IBP than the Georgia IBP section, but additional measurements with the

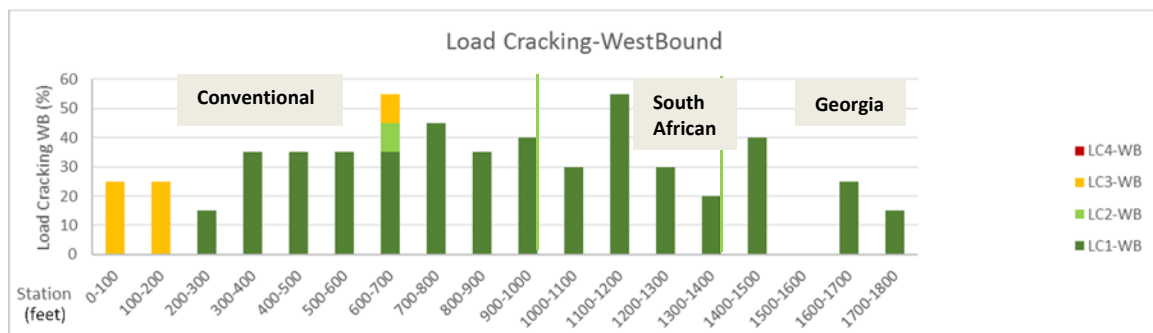
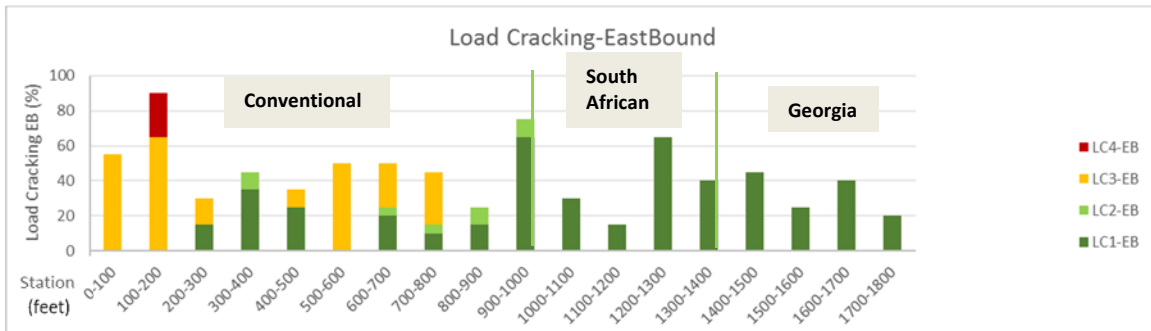
Figure 14. Load Cracking measurements in the Westbound lane (2016 measurements)

Figure 15. Load Cracking measurements in the Eastbound lane (2016 measurements)

15 show Load cracking in the eastbound direction being noticeably greater in severity (levels 3 and 4) than the westbound lane, likely due to the greater stresses from loaded haul-trucks coming out of the quarry. The South African section indicates slightly better resistance to load cracking in the eastbound lane (Figure 15), while both, South African and Georgia IBP sections are clearly performing better than the conventional section in both lanes. Similarly, Figure 16 shows Block cracking being slightly severe in the conventional section where FWD deflections were the greatest, while the South African and Georgia IBP sections performed comparably better.

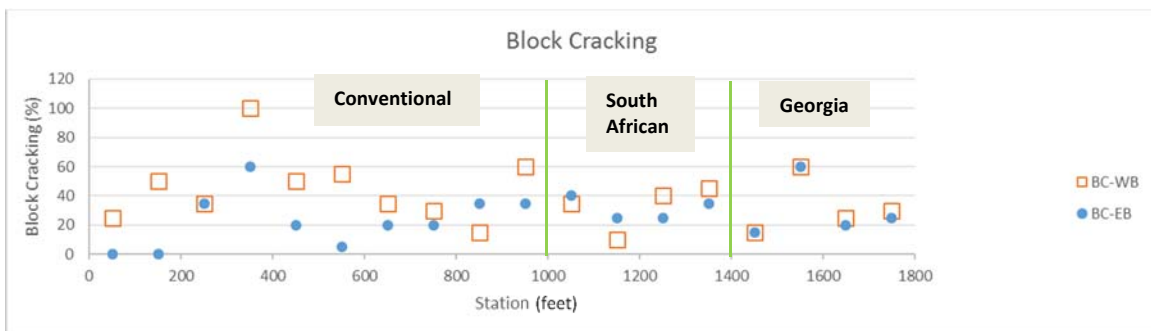
Figure 16. Block Cracking measurements (2016 measurements)

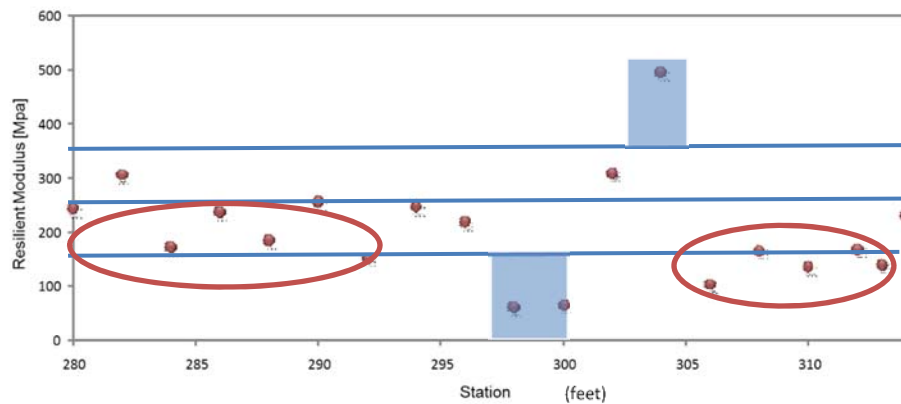
Figure 17. Resilient Modulus estimated from DCP penetration rate

Based on an extensive field and laboratory study conducted at the LaGrange Bypass test section, Cortes (2010) estimated the mean M_r to be 250 MPa with a standard deviation of 100 MPa. The resilient modulus was measured at various stations along the test section as shown in Figure 17 below, where Sta. 280+00 and Sta. 314+00 represent the extent of the Inverted Base pavement (IBP) section. The mean and one-standard deviation lines are also presented in Figure 17. From the graph, the major outliers are observed to be between Sta. 298+00 and Sta. 300+00 (weak subgrade) and between Sta. 303+00 and Sta. 305+00 (strong subgrade).

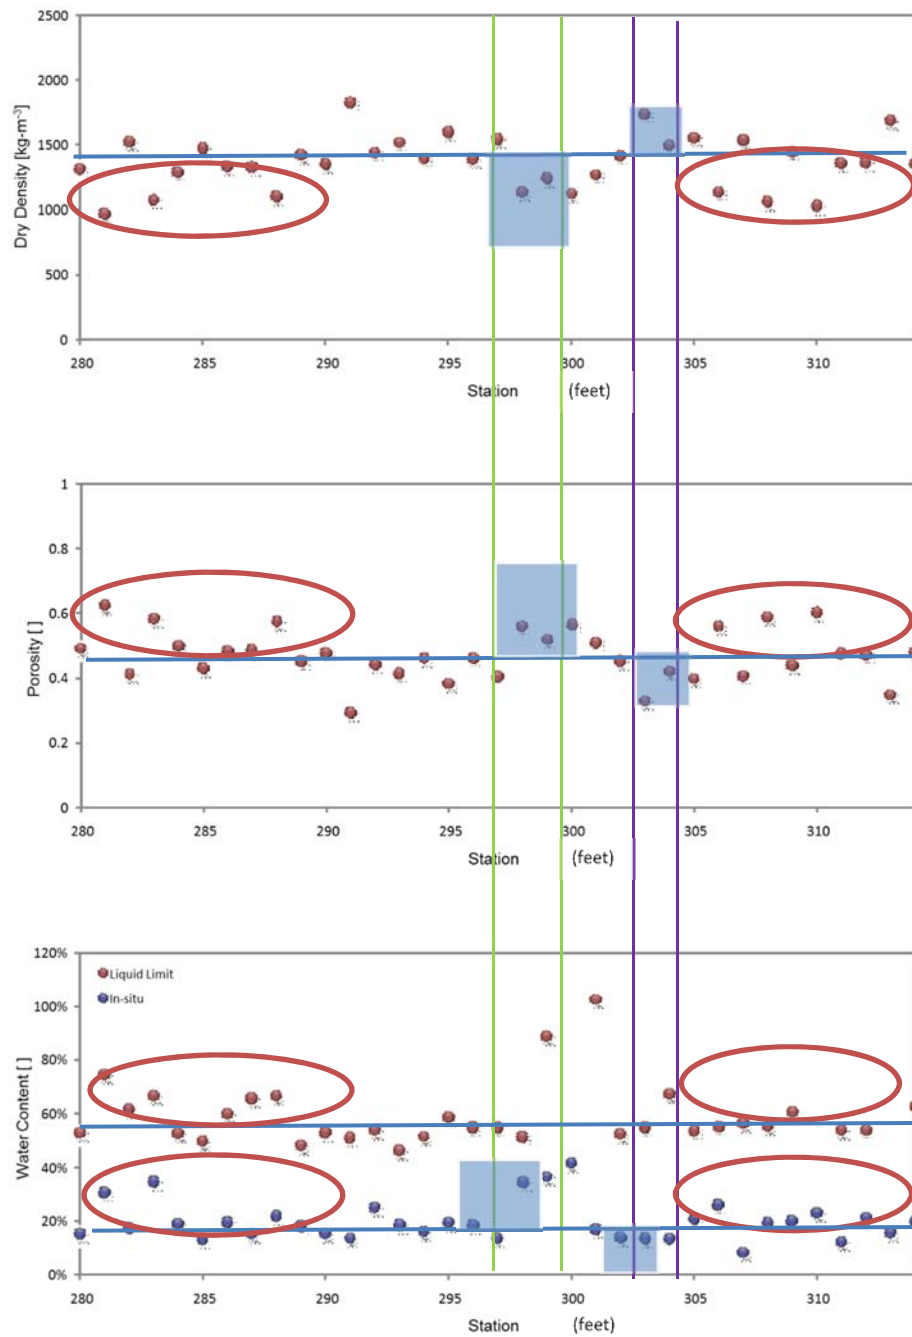
Figure 18. Soil properties measured along the pavement test section

Since in-situ moisture, density and porosity are some of the critical soil properties that affect resilient modulus and the quality of the subgrade material, Figure 18 presents plots of these properties along the test section (Cortes, 2010). There appears to be a correlation in the above-mentioned sections of pavement, i.e. Sta. 298+00 and Sta. 300+00 (weak subgrade) and Sta. 303+00 to Sta. 305+00 between resilient modulus and dry density (direct correlation), porosity (inverse correlation) and water content (inverse correlation). This confirms the merit of the resilient modulus values derived from dynamic cone penetrometer tests.

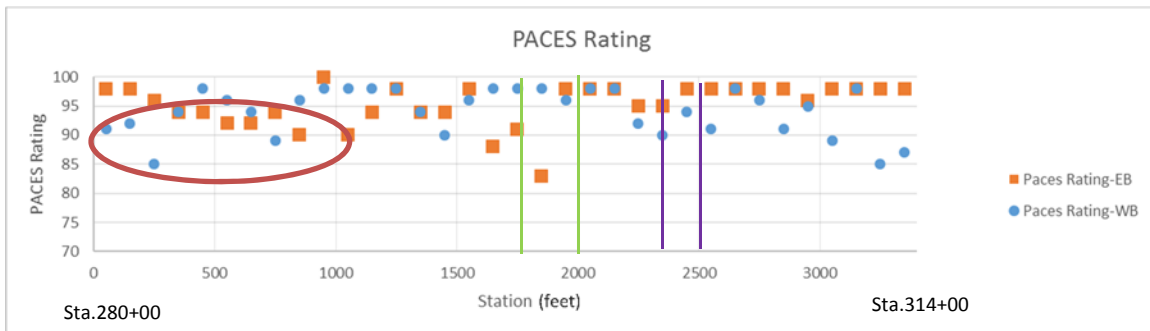
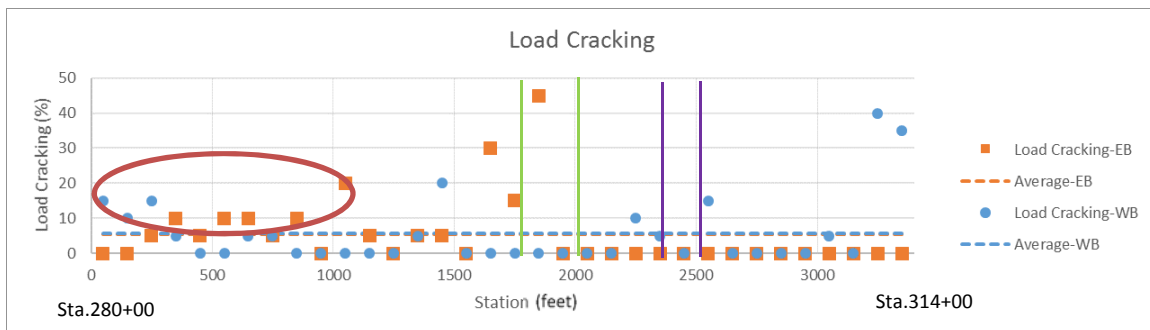
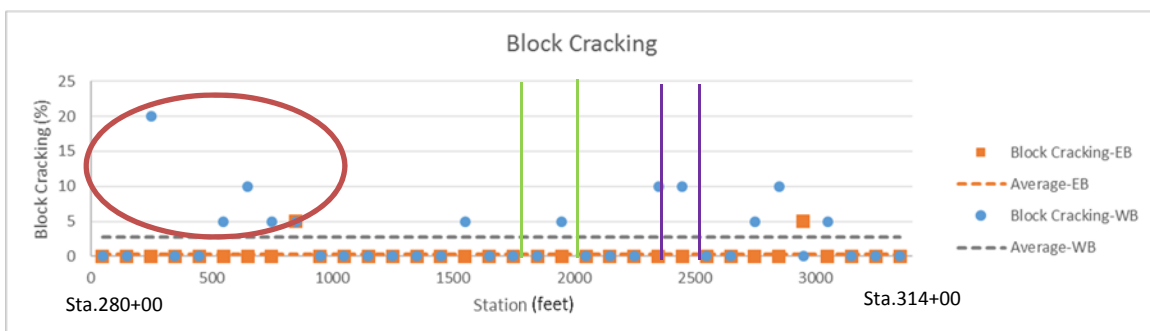
Figure 19. PACES Rating showing sections of interest (2016 measurements)

Figure 20. Load Cracking showing sections of interest (2016 measurements)

Figure 21. Block Cracking showing sections of interest (2016 measurements)

higher water content values (Figures 17 and 18), and likely, as a consequence, lower PACES ratings and relatively high load and block cracking as seen in Figures 19 to 21.

While the graphs do not indicate a definitive correlation at this stage between soil properties and observed behavior, they do indicate a possible dependency and identifies areas-of-interest to be closely monitored in the future as the pavement continues in use.

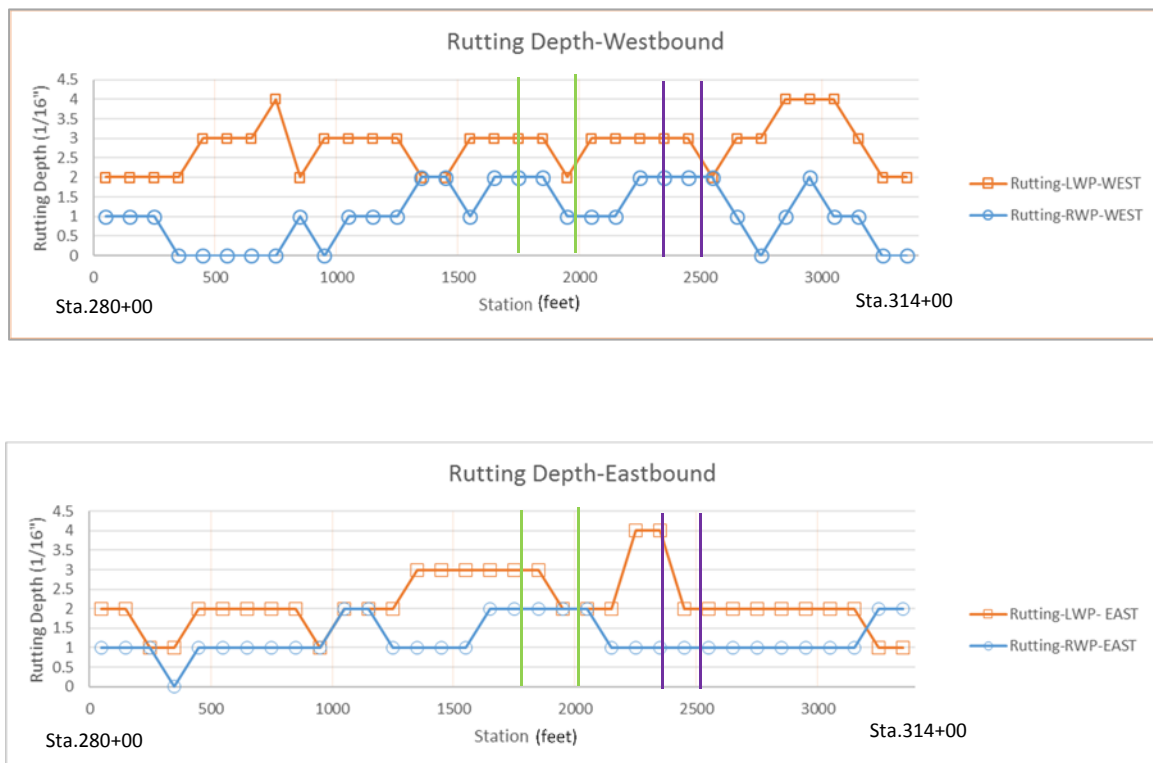
Figure 22. Rutting depth measurements made in 2016

Figure 22 presents the rutting depths as measured in the 2016 study conducted using laser scanning technology. Considering ruts have a larger areal footprint than other modes of distress, they tend to develop over prolonged deterioration in a pavement zone and the current 7-year operation cycle for this test section does not indicate any stand-out trends.

While there is not a clear trend in rutting behavior along the pavement section, the left wheel path (near the center-line of the road) in both directions shows greater rutting than the right wheel path. Additional field distress measurements after an additional period of service life are recommended to enable performance to be monitored.

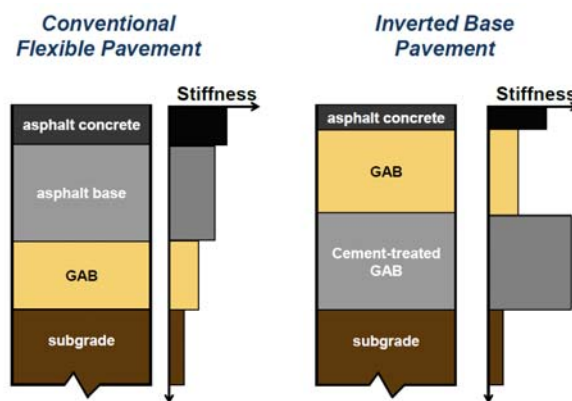
Figure 23: Comparison between conventional and inverted base pavement systems [Papadopoulos, 2014]

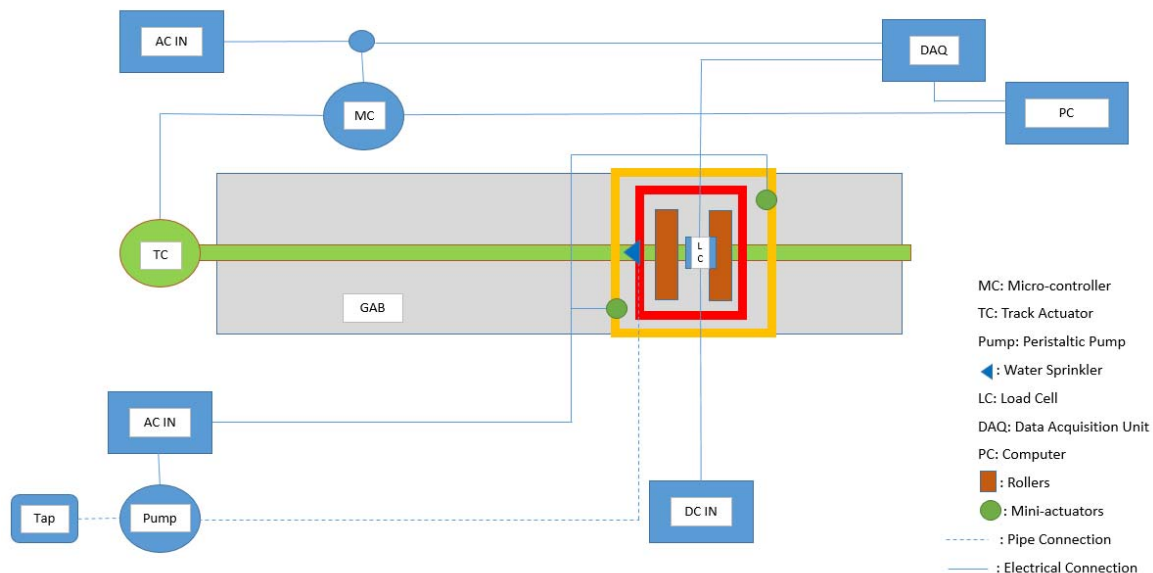
Figure 25: Schematic showing various components involved in testing process

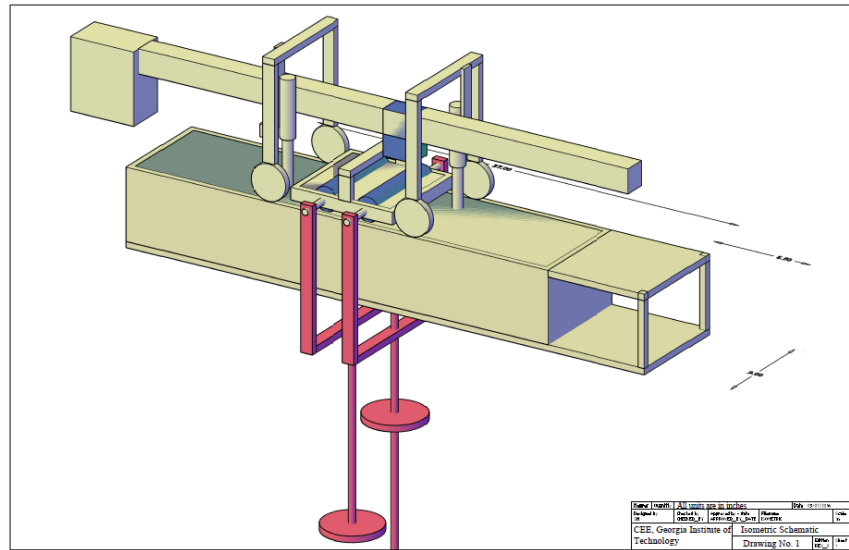
Figure 26: CAD rendering showing concept-design of slushing setup

Figures 26 and 27 show some additional schematics and photos of the device.

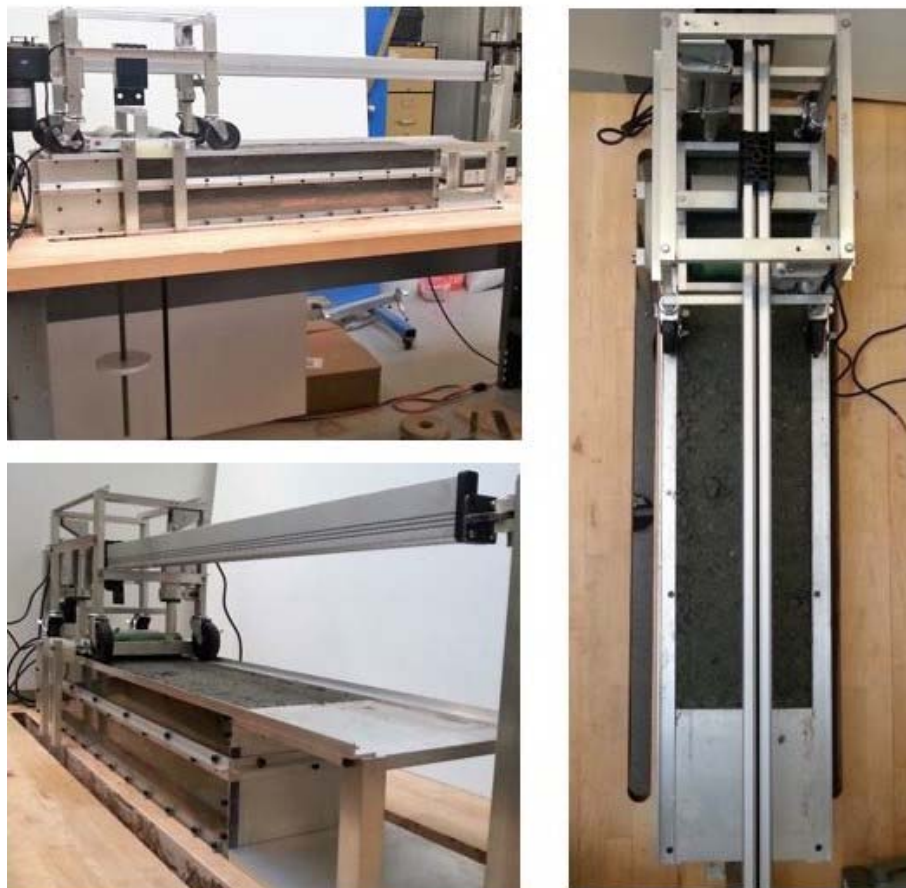
Figure 27: Photographs of slushing device

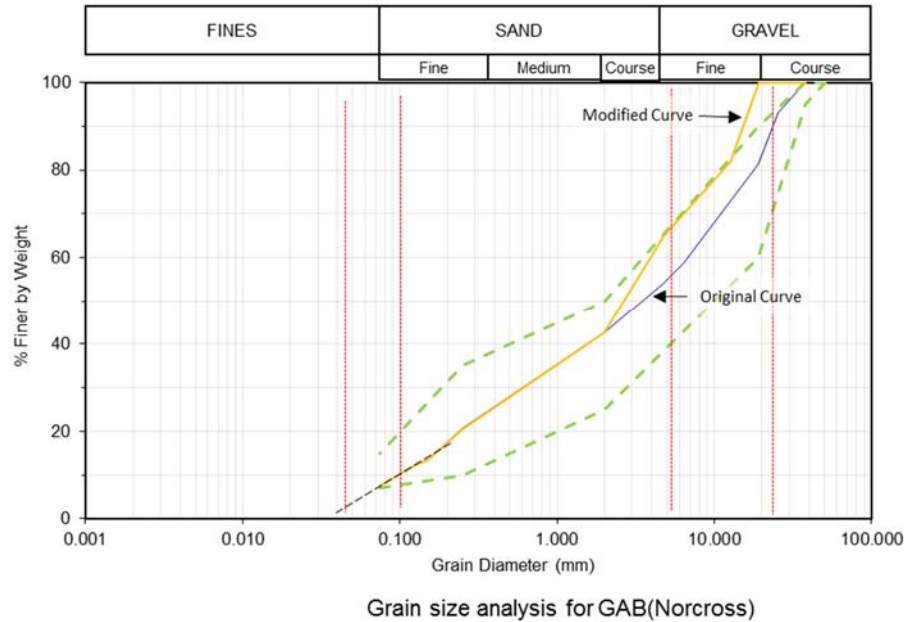
Figure 28: Grain size distribution curve for GAB material used in slushing test

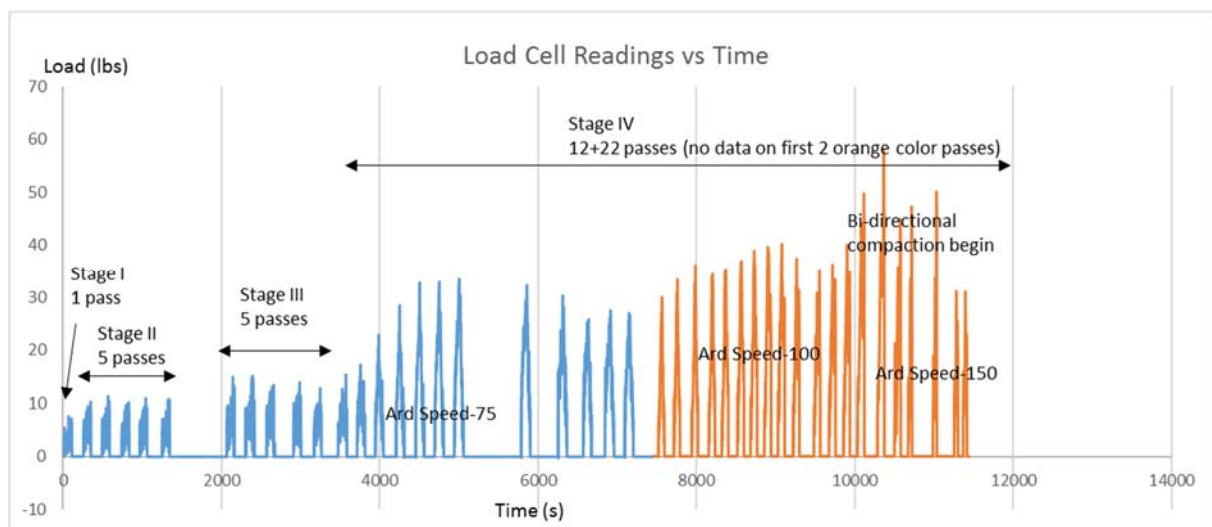
Figure 29: Horizontal load-cell readings for all cycles of compaction

Another interesting observation, which should be closely monitored for future tests is the bell-shaped load curve, with the load reading dropping in the second half of the slushing stage. This is noticed in Stage IV at all three speeds.

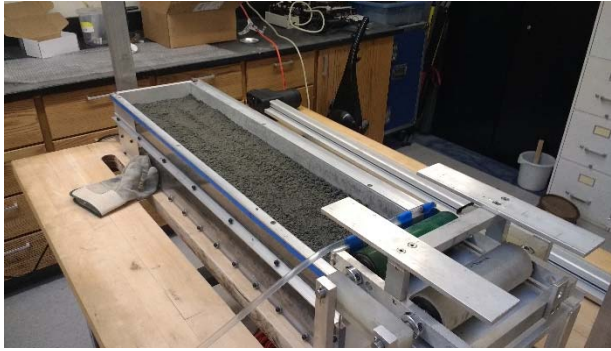
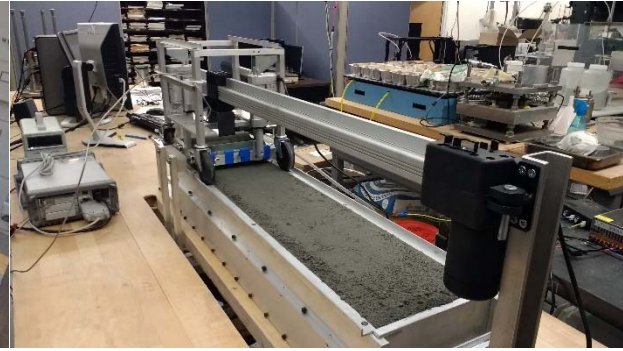
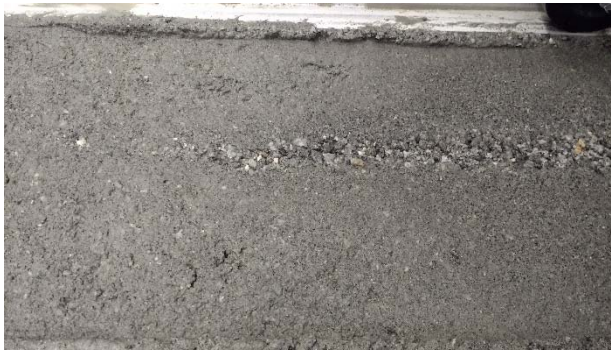
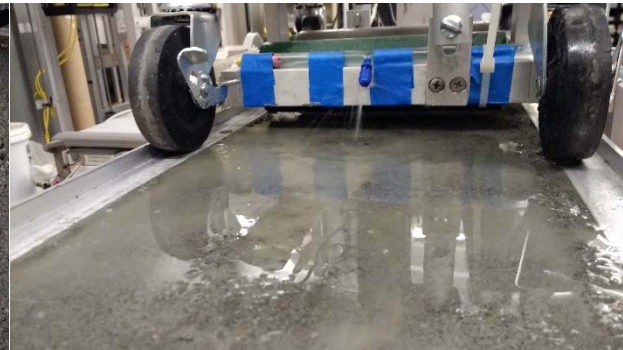
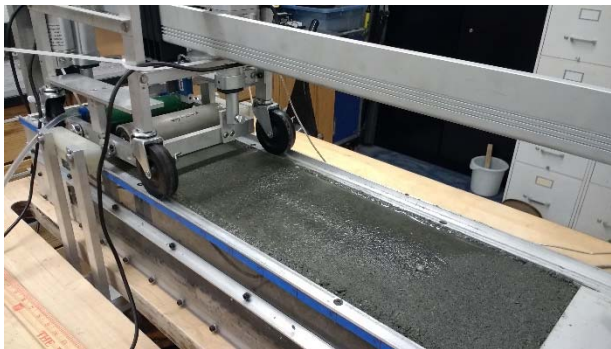
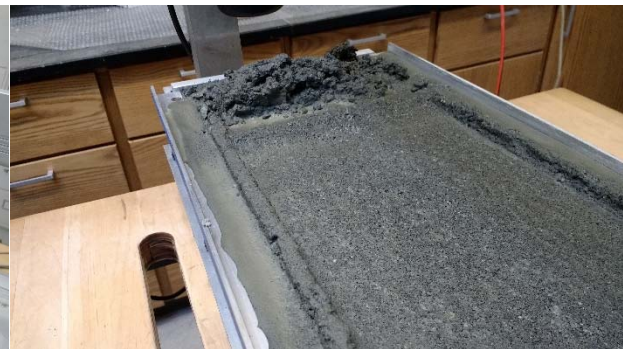
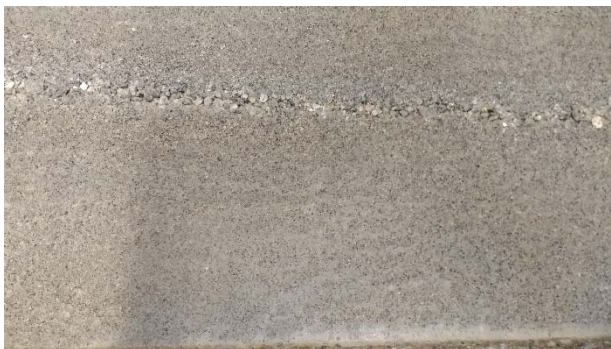
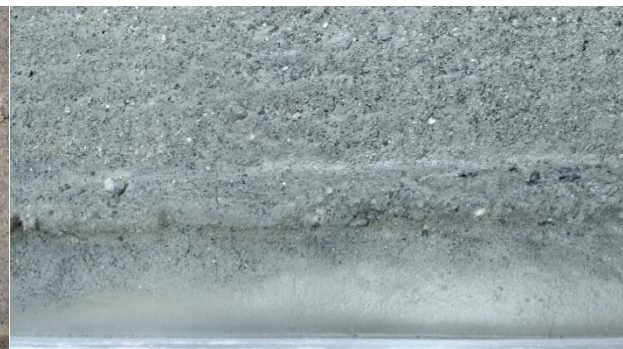
(a) GAB placement and manual compaction

(b) Commencement of stage I compaction

(c) GAB surface pre-slushing

(d) Slushing stage underway

(e) Slushing stage in progress

(f) Fines being ejected to sides of roller

(g) GAB surface after slushing

(h) GAB surface after slushing

Some photographs from the test are shown below in Figure 30. It should be mentioned that while air bubbles and fine particles were ejected at all across the surface, the water carrying these ejected particles was subsequently pushed to the side of the box by the following pass of the rollers. Therefore, the photos below indicate greater accumulation of fine particles along the edges of the box, as seen in Figure 30(f), (g) and (h).

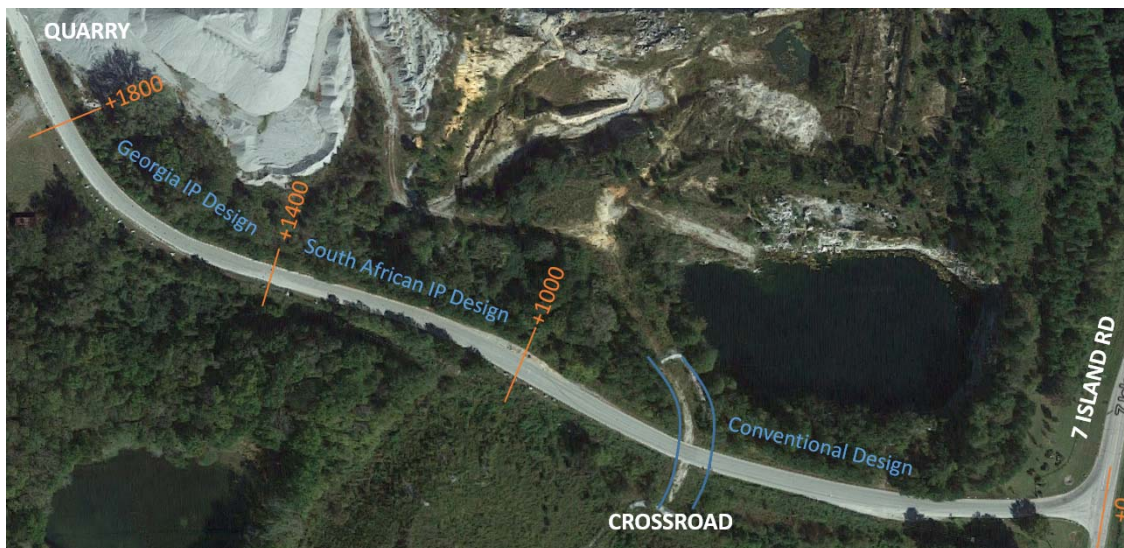
Figure 2. Layout for three test sections.

Both the inverted pavement test sections (SAIP and GAIP) were constructed with 8 in. of a cement-treated base, a 6-in. layer of GAB, and a thin, 3-in. layer of HMA on the top, the only difference being the incorporation of the “slushing” technique for the SAIP section. Slushing increases the stiffness of the GAB layer by reducing the volume of voids between the aggregate particles.

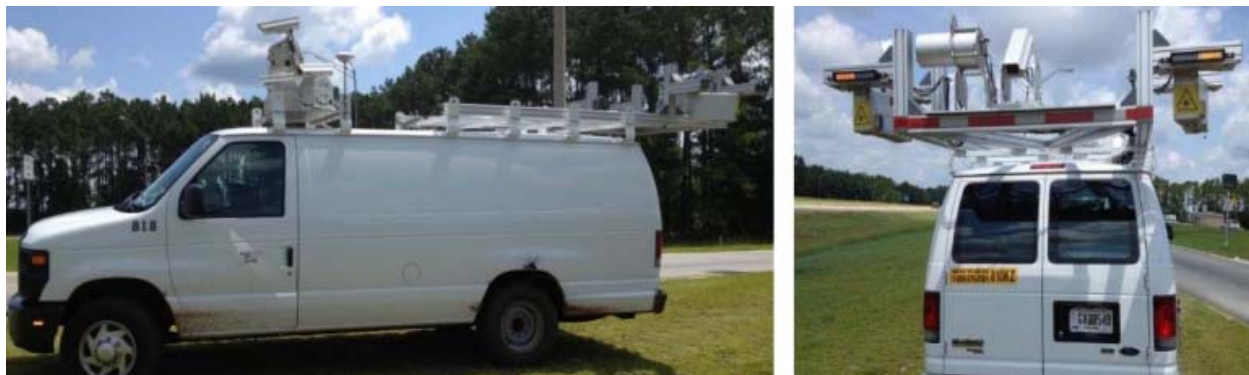
Figure 4. Georgia Tech Sensing Vehicle.

The Georgia Tech sensing vehicle, as shown in Figure 4, was driven at approximately 25 mph in both directions to collect the data at 5-meter intervals with each video log image corresponding to a single laser file. To facilitate better coverage of the access road, two runs of data were collected, and the run with better coverage of the marked lane was processed and analyzed.

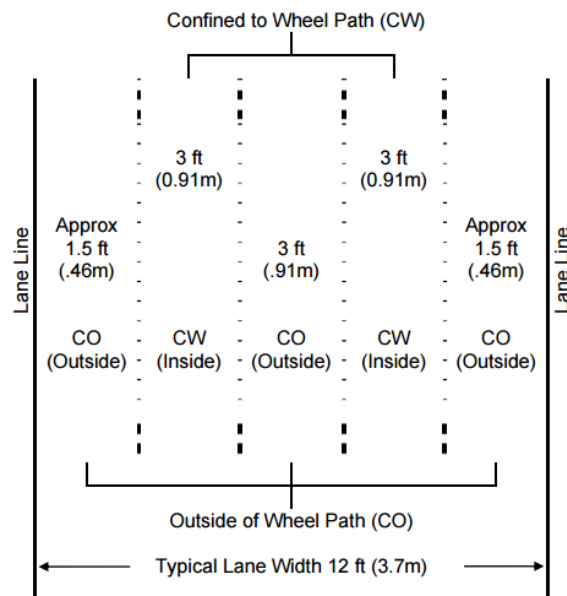
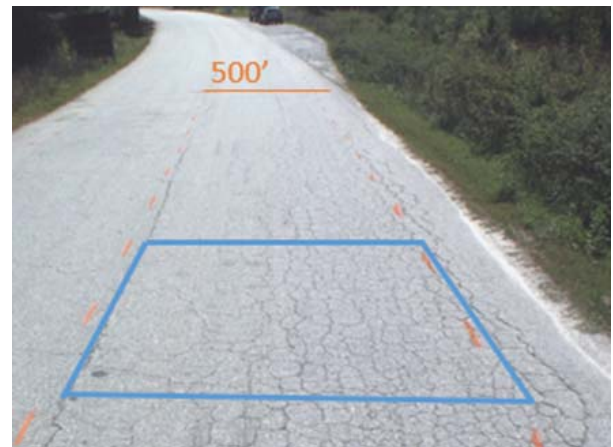
(a) Defined wheel path location (FDOT, 2015) (b) Need for adjusting wheel path locations

true surface condition. Rutting was computed at approximately every 1 ft. and the 60th percentile rutting was reported for every 100 ft in each wheel path. The 60th percentile was chosen as the representative value because it appears to best reflect the manual PACES surveys conducted by GDOT. After reviewing and recording distresses on each 5-m interval, the information was then aggregated for each 100-ft segment, which is the sample unit length in PACES. Load cracking, block/transverse cracking, and rutting were the only distresses present on the test sections. A PACES rating was computed for each 100-ft segment based on the distresses. Tables 1 and 2 summarize the rating and distresses derived from the sensing data for each 100-ft segment of the inbound and outbound lane.

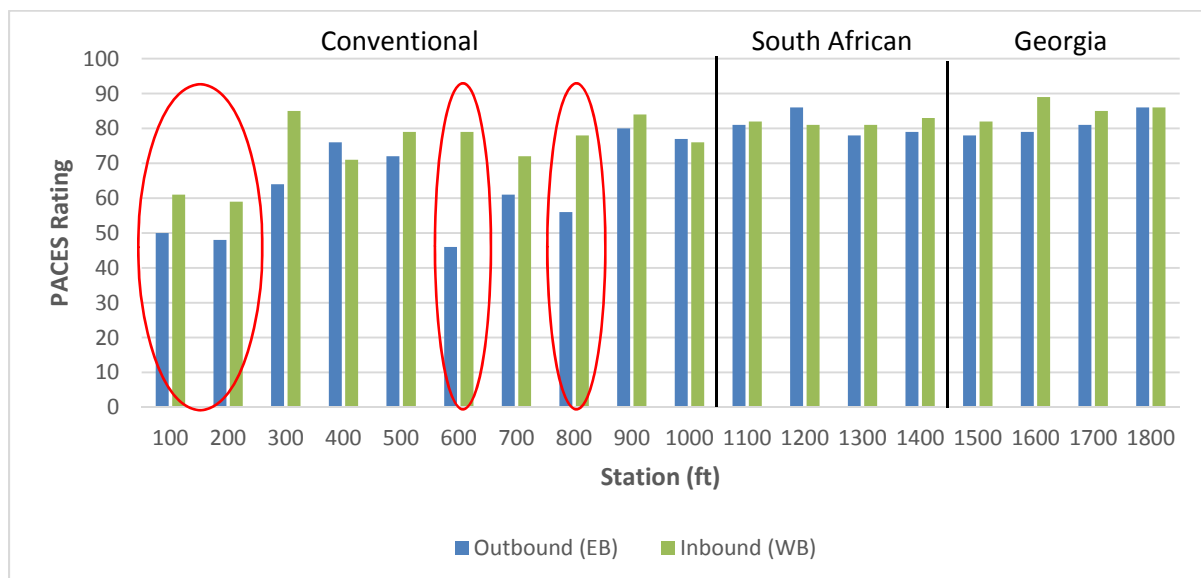
Figure 6. PACES rating in inbound and outbound lane.
