**LONG-TERM PERFORMANCE OF GRANULAR
BASES INCLUDING THE EFFECT OF WET-DRY
CYCLES ON INVERTED BASE PAVEMENT
PERFORMANCE**

GDOT Research Project No. 15-10

Final Report

Georgia Institute of Technology

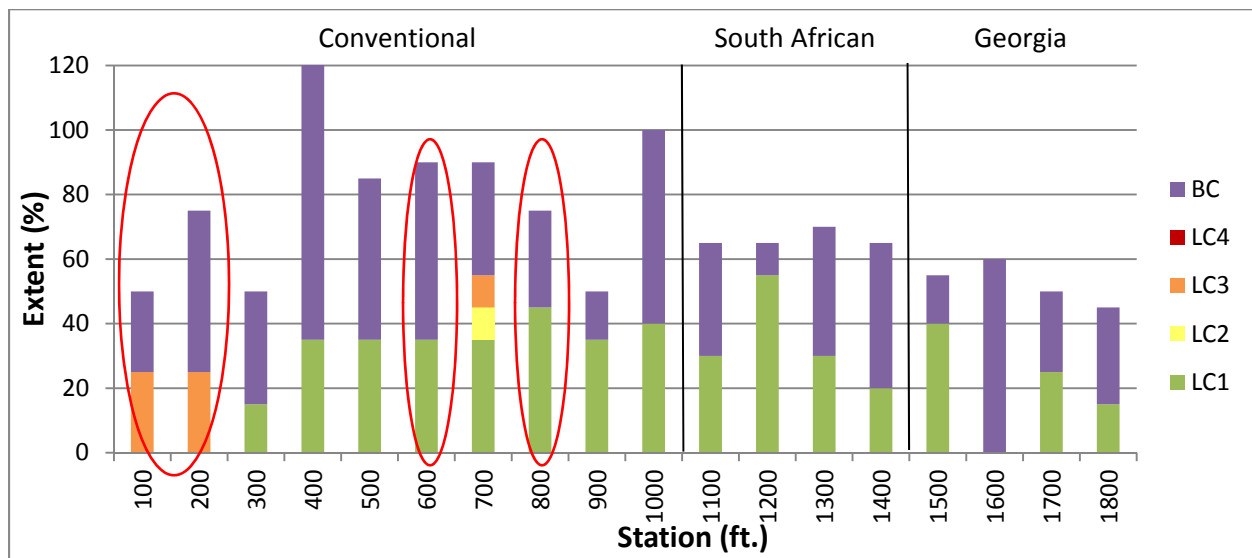
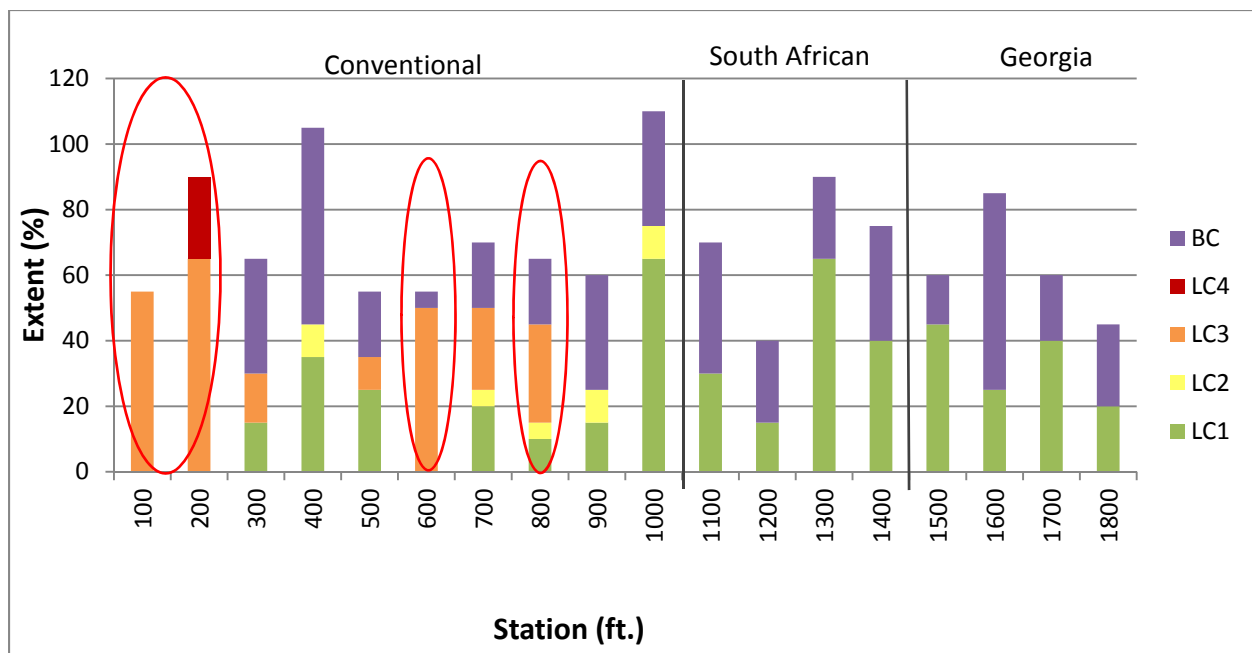
Figure 7. Distresses in inbound and outbound lane.

(a) Inbound lane.

(b) Outbound lane

load cracking and block cracking. Figures 7 and 8 show the extent of load cracking and block cracking for each 100-ft segment. It is noted that the total load cracking (Levels 1-4) should not exceed 100%; block cracking is recorded separately with only the predominant severity level and should not exceed 100% as well. Severe load cracking (Levels 3 and 4) was observed on the two segments close to the entrance, as shown in Figures 7(a) and 7(b). This is due to the trucks' deceleration and acceleration when approaching the entrance. Truck braking and idling has a significant negative impact on pavement surface condition. Unlike typical load cracking residing only in the wheel paths, the load cracking in these two segments cover the entire lane, as shown in Figure 8. This suggests that loading has been applied across the entire lane and is likely the result of trucks not traveling directly in the lane marked. The distresses on these two segments do not represent the pavement condition under normal traffic patterns; thus, these two segments were excluded from further analysis. In addition, the PACES rating for the segments (between marks +500 ft.~+600 ft. and +700 ft.~+800 ft.) near a roadside parking space and the crossroad, is noticeably lower in the outbound direction. Severe cracking was observed before the roadside parking space and the crossroad, as shown in Figure 9. This may be the result of this section's experiencing more slowly moving loaded trucks due to that cross traffic. While severe cracking was observed mostly on the outbound direction between segments +500 ft.~+600 ft. and +700 ft.~+800 ft., this stretch in both directions (inbound and outbound) was excluded from further analysis.

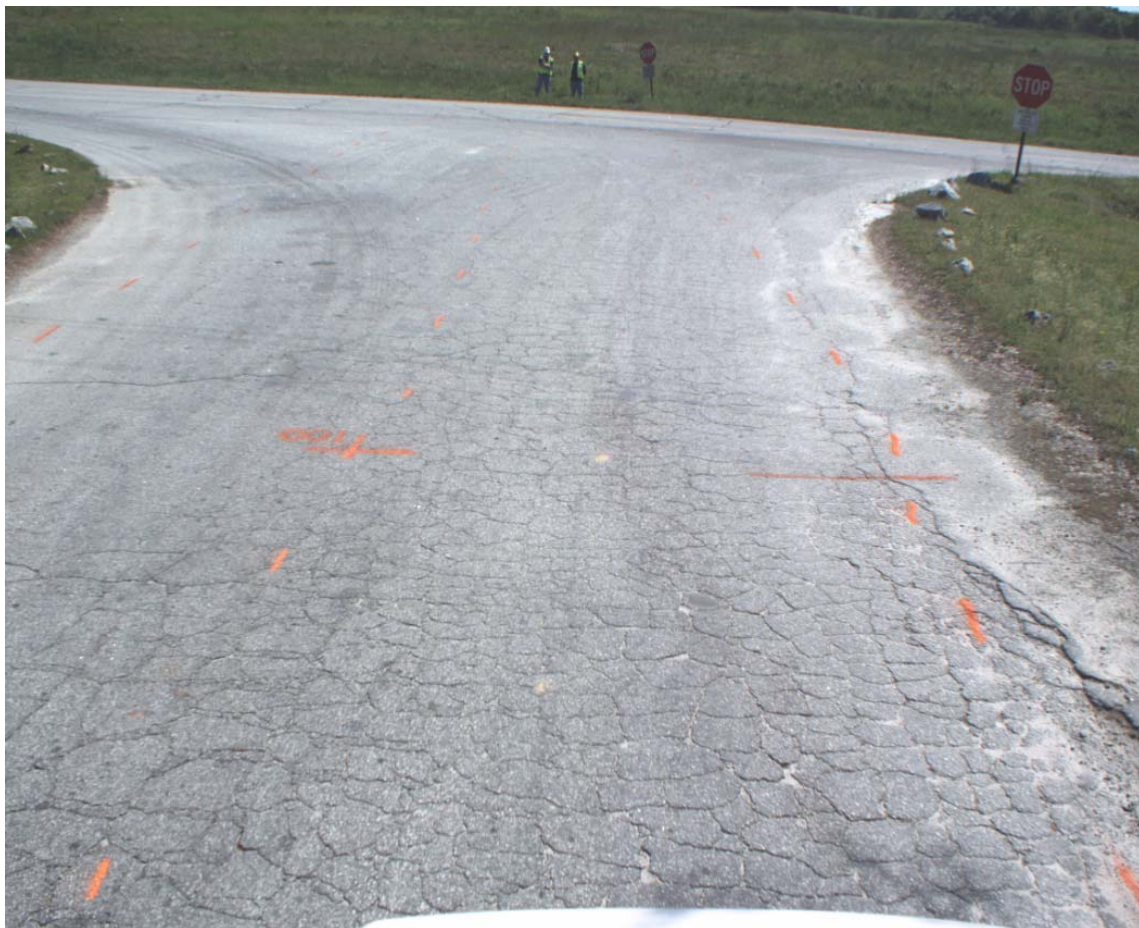
Figure 8. Distresses near station +100 ft.

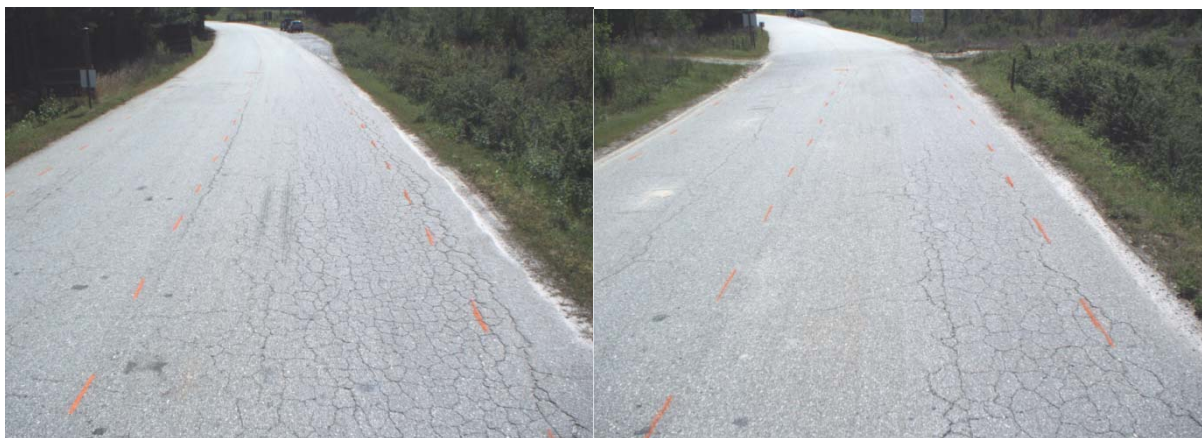
Figure 9. Severe load cracking near roadside parking space and the cross road.

(a) Cracking near the roadside parking

(b) Cracking near the cross road

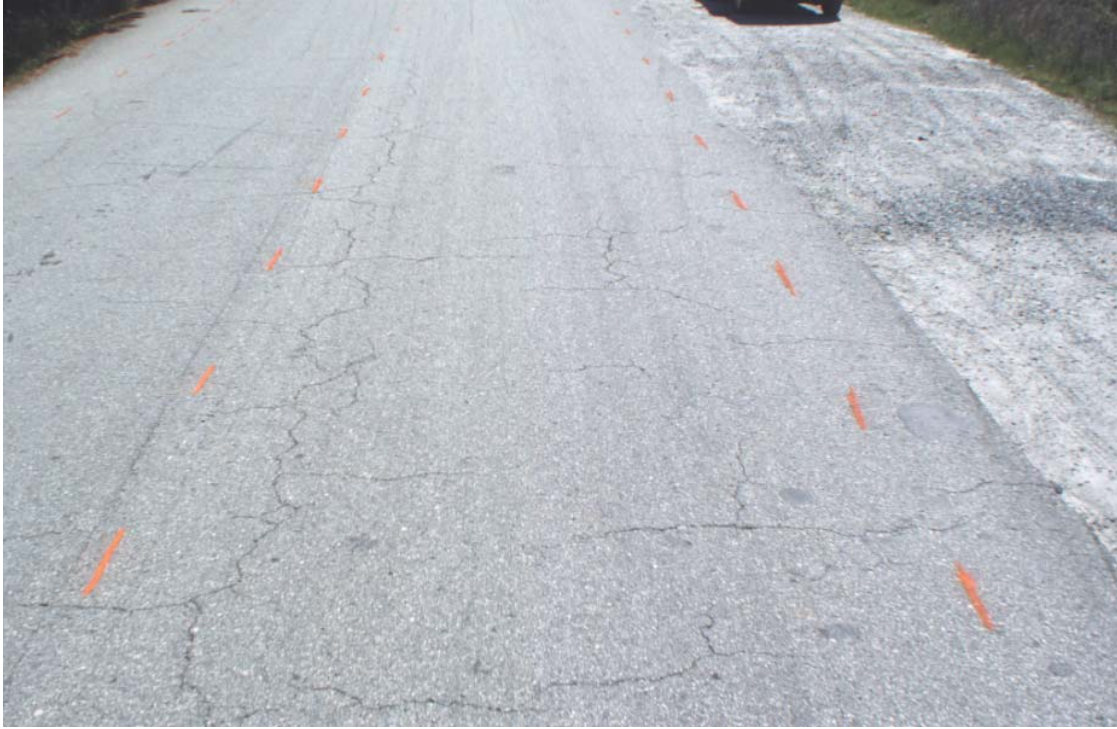
Figure 10. Example of typical distresses on the conventional section with less severe cracking.

The conventional section had diverse conditions with the ratings ranging from 61 to 85. The pavement condition in the outbound lane was significantly worse than the one in the inbound lane. The average rating in the inbound and outbound lane was 77.8 and 71.7, respectively. These low ratings can be attributed to high levels of load cracking. In addition to Level 1, Level 2 and 3 load cracking was observed in some locations in the outbound lane. It is noted the load cracking can be attributed to the poor drainage or loss of edge support. In addition to load cracking, which has the most significant impact on the PACES rating for this section, Level 1 block/transverse cracking was also observed on all segments in both directions. Figures 10 and 11 show typical distresses in the conventional section with less severe load cracking and with significant high-level load cracking, respectively. Rutting was observed in the outbound lane only. The right wheel path had a rutting of 1/16 in. to 2/16 in., and the left wheel paths had no rutting measured, which means the rutting is less than (1/16" or 1.5 mm).

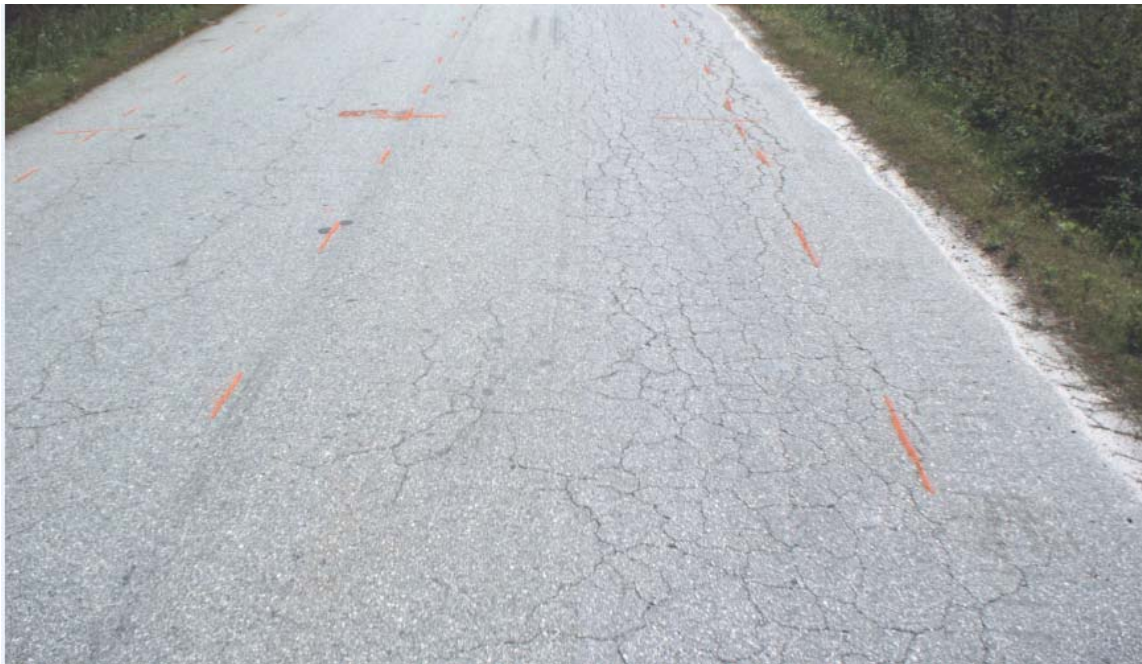
Figure 11. Example of typical distresses on the conventional section with severe load cracking.

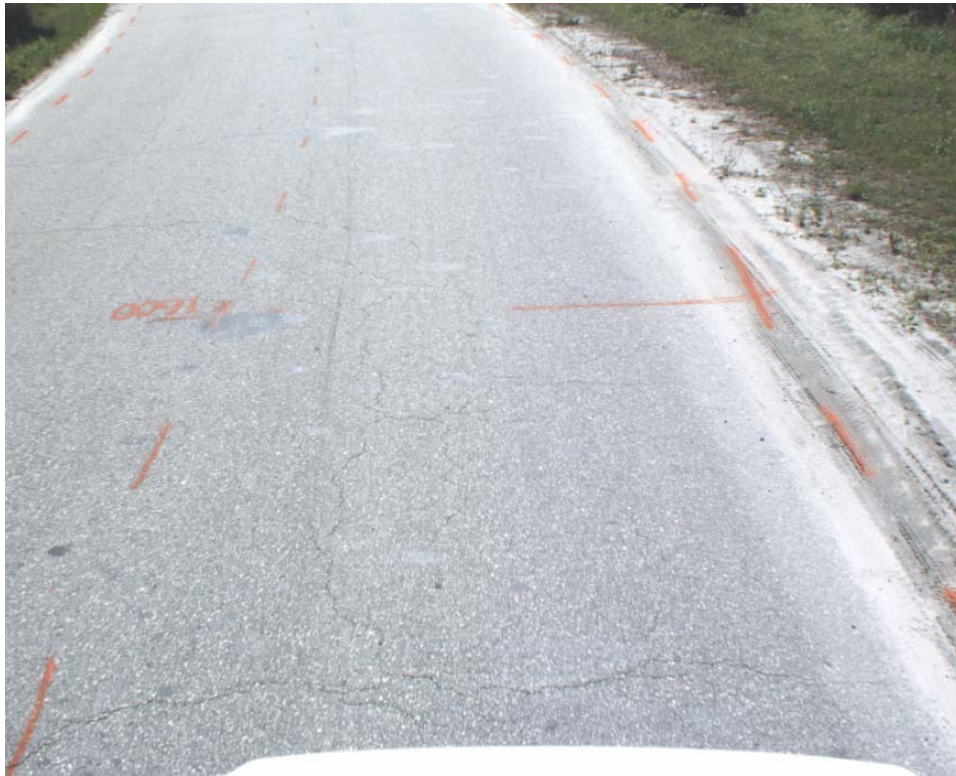
Figure 13. Example of typical distresses on the Georgia Inverted Pavement Section

inbound lane reported limited rutting. Figure 13 shows an example of the typical distresses on the Georgia section.

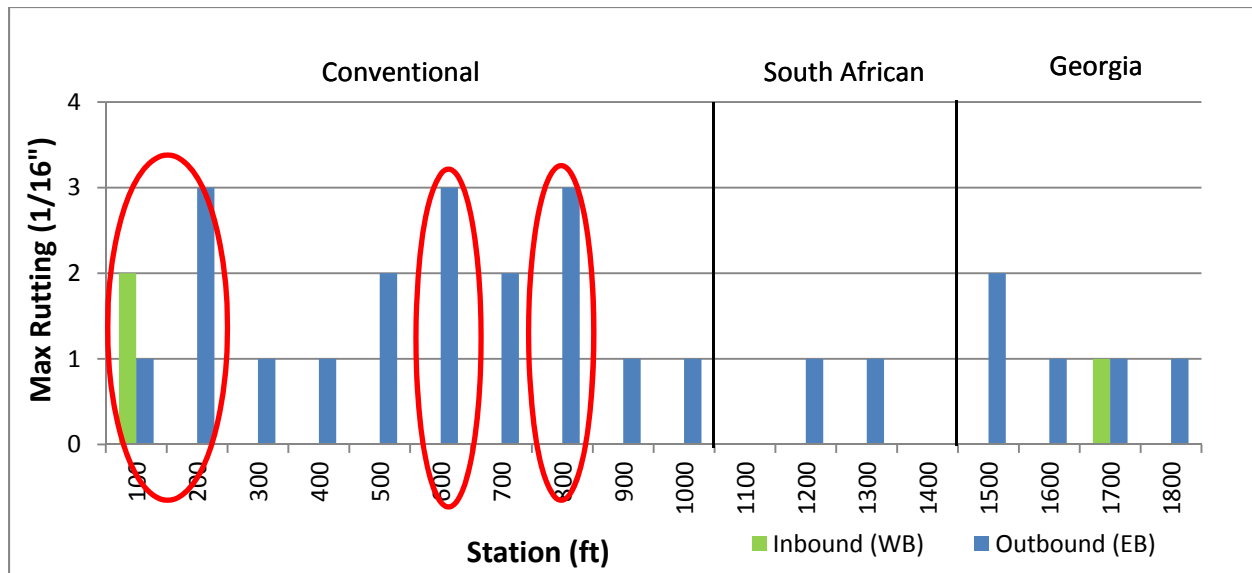
Figure 14. Max rutting for every 100-ft segments.

Figure 14 shows rutting reported on each 100-ft segment. In general, rutting was observed mainly in the outbound lane because of the trucks' heavy loads; very limited rutting was observed in the inbound lane. The segments highlighted in red circle are the ones excluded from the conventional section. Two segments (marked at +1100 ft.~+1200 ft. and +1200 ft.~+1300 ft.) in South African section had a rutting of 1/16 in. Compared to the Georgia section, the South African section had less rutting. This may imply the slushing could increase the stiffness of GAB. Further investigation, such as with a Falling Weight Deflectometer, is needed to verify the stiffness.

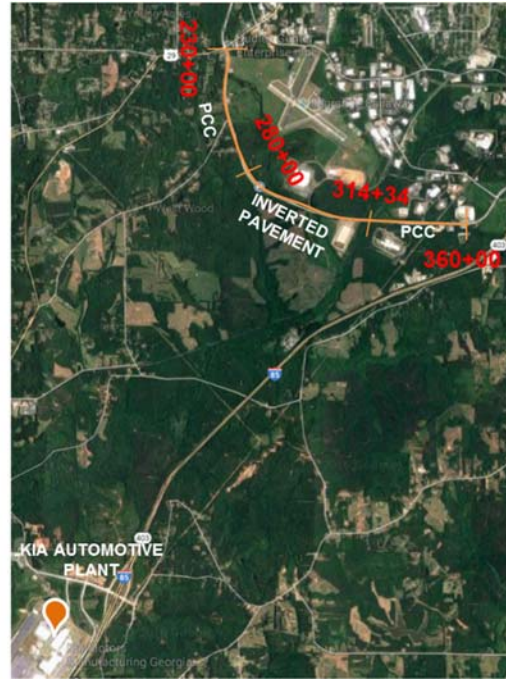
Figure 1. Inverted pavement test section in LaGrange, GA

(b) Test Section Location

Pegasus Parkway is a two-lane road located near the LaGrange Callaway Airport in Troup County, as shown in Figure 1a. It is an industrial parkway intended to serve the growing car manufacturing industry in Southwest Georgia. The test section is approximately 3,400-feet long between the 280+00 and 314+00 mark, as shown in Figure 1b. Jointed plain concrete pavement (JPCP) was constructed at both ends of the test section. Figure 2 shows the pavement structures for the IP test section and the PCC section. These pavement structures were designed based on the 1972 AASHTO interim pavement design guide. They were designed to sustain approximately 4.78 million trucks in a 20-year design life, which was estimated based on an

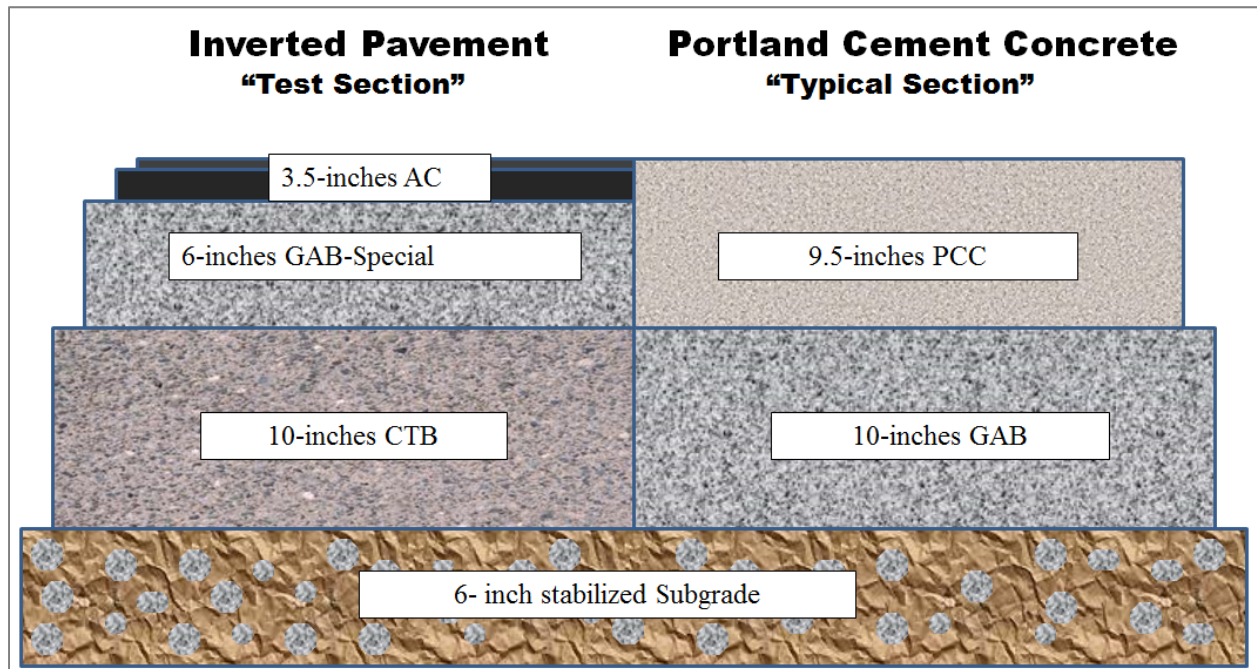
Figure 2. Pavement structures for IP test section and PCC section

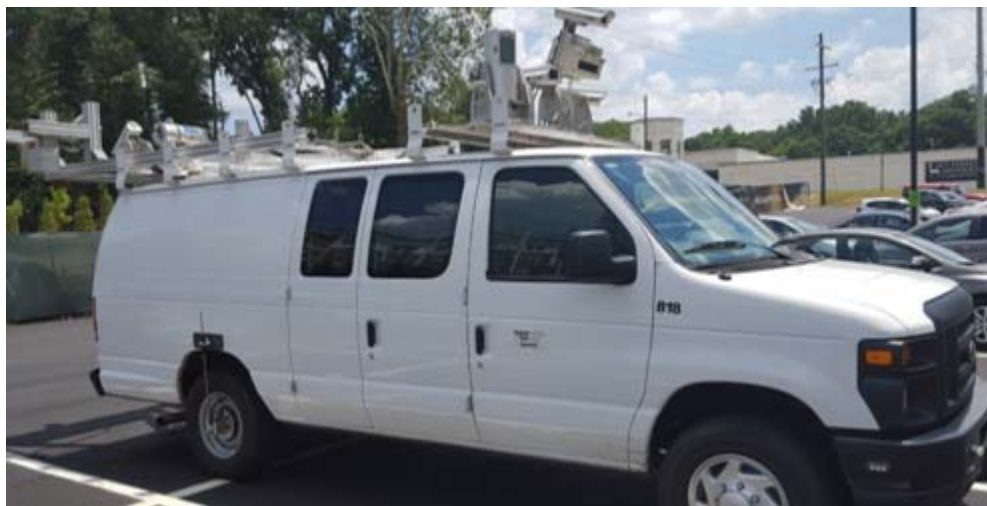
Figure 4. Georgia Tech sensing van (GTSV)

Georgia Tech's sensing vehicle, equipped with a laser crack measurement system (LCMS), GEO3D cameras, GPS, an IMU (inertial measurement system), and a DMI (distance measuring instrument), was used for collecting 3D pavement data, 2D images, and GPS data for extracting pavement distresses based on PACES (GDOT, 1993) standards. Data collection was performed on June 30, 2016, on the outside lanes (both Eastbound and Westbound) of the test section. Prior to data collection, Dr. James Frost's research team marked the test section every 100-ft for use in a PACES survey. A diagram of the marking scheme is shown in Figure 3. A total of thirty-four, 100-ft segments were marked on the pavement. The Westbound (WB) transition point for the IP section will be referred to as the 0+00-ft mark, and the Eastbound (EB) transition point from IP to JPCP will be referred to as the 34+00-ft mark. The Georgia Tech sensing vehicle (see Figure 4), followed by a GDOT traffic control crew, was driven at approximately 30 mph on the outside lane to collect 3D pavement data, video log images, GPS data, etc. The 3D pavement data was collected at a resolution of 5-mm, 1-mm, and 0.5-mm for the x (driving direction), y (transverse direction), and z (depth) directions, respectively, with a full-lane width coverage (i.e., 12 ft). To facilitate better coverage of the access road, two runs of data were collected, and the run with less lateral movement (i.e., better coverage of the marked lane) was processed and analyzed.

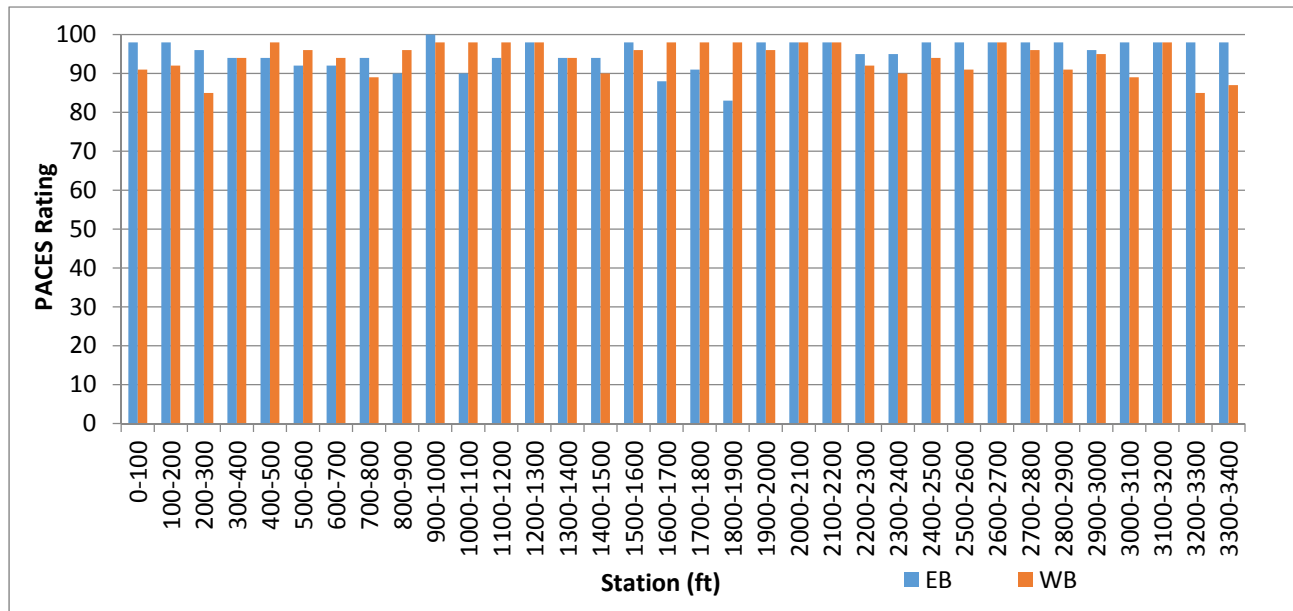
Figure 5. PACES rating in the EB and WB

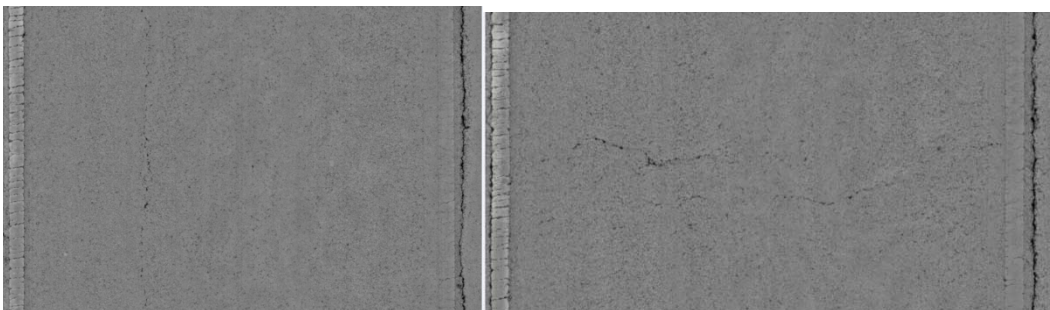
Figure 6. Examples of load cracking and block cracking observed on the test section

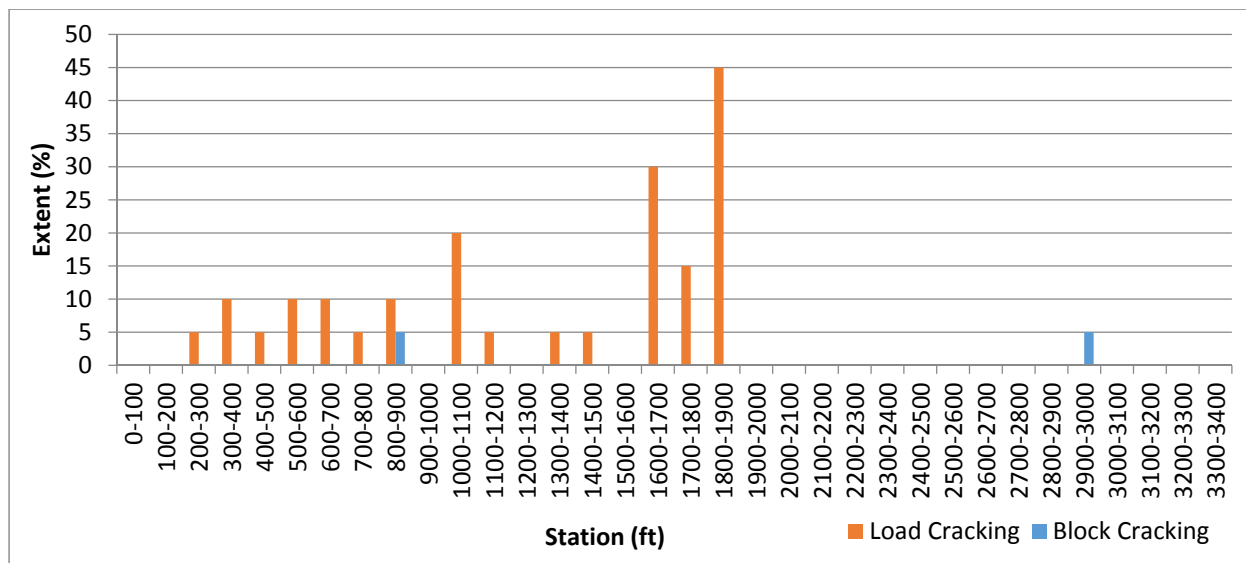
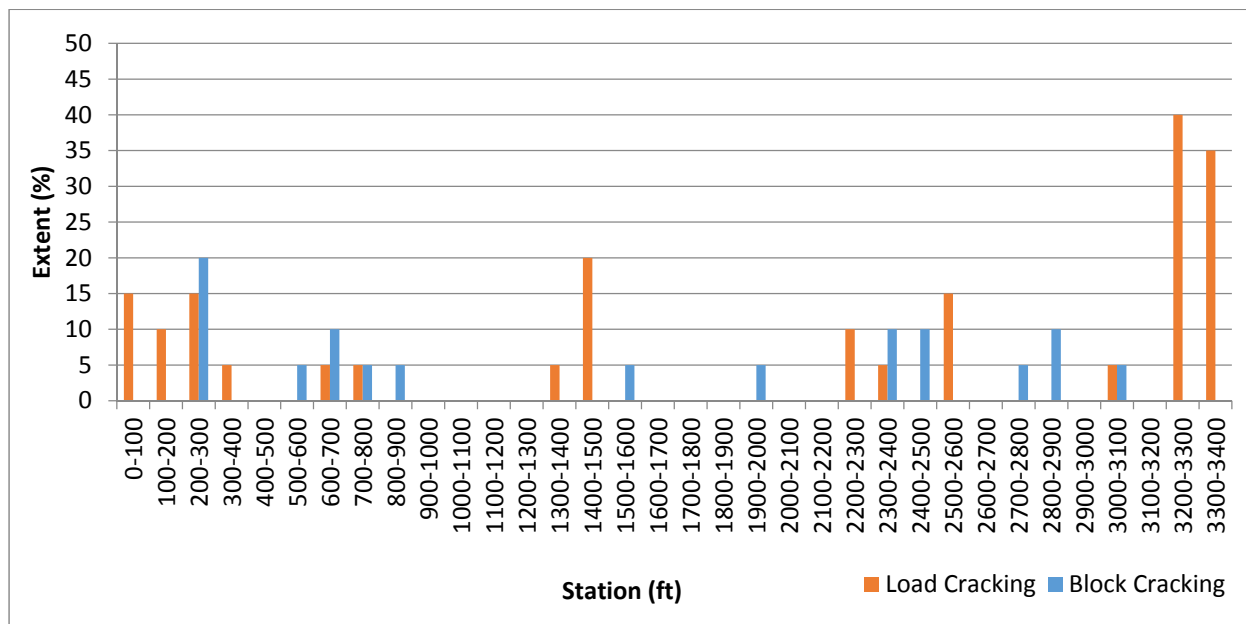
(a) Cracking in the EB

(b) Cracking in the WB

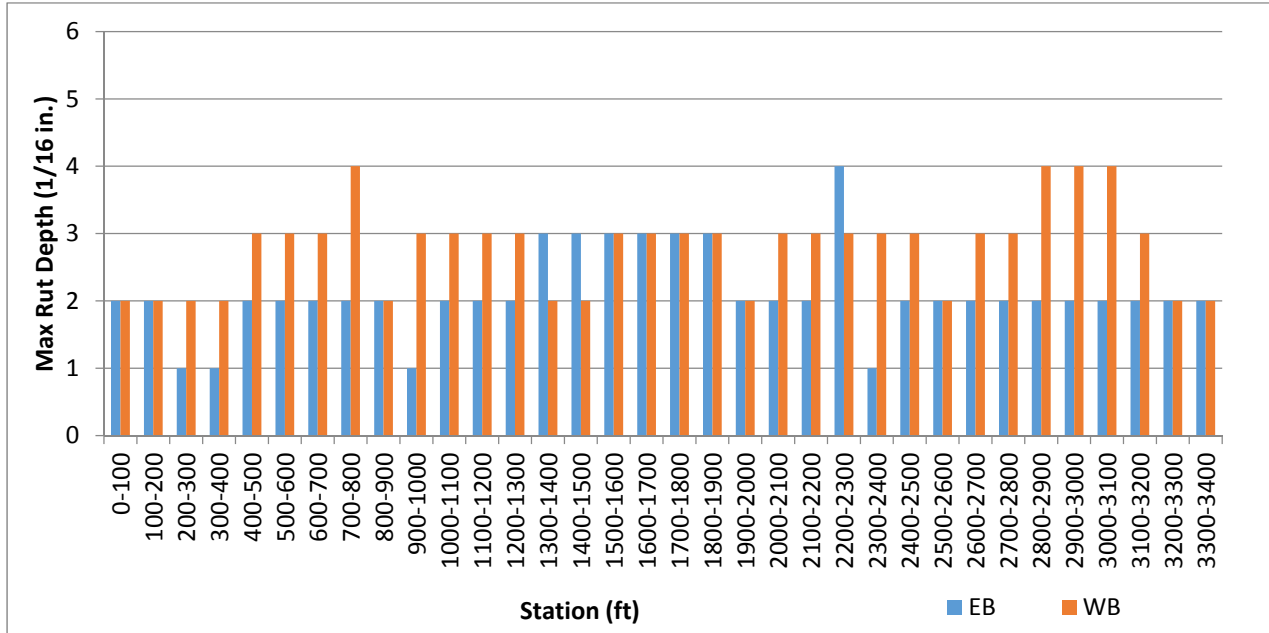
Figure 8. Maximum rutting in the EB and WB

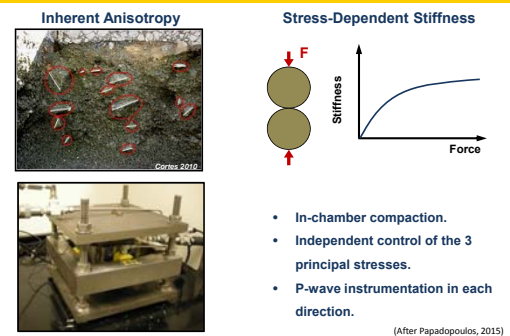
Phase III: stress ratio has small influence on the small-strain stiffness as long as the material is away from failure.

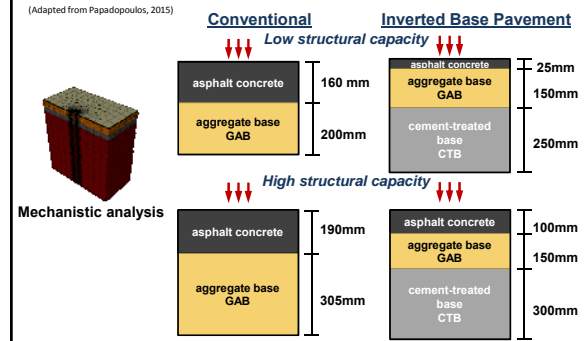
Phase III: aggregate base stiffness in IBPs is high due to the confinement provided by the CTB.
