March 2009
OR09.019

Remote Health Monitoring for Asset Management

Prepared by Missouri
University and Missouri
Department of Transportation

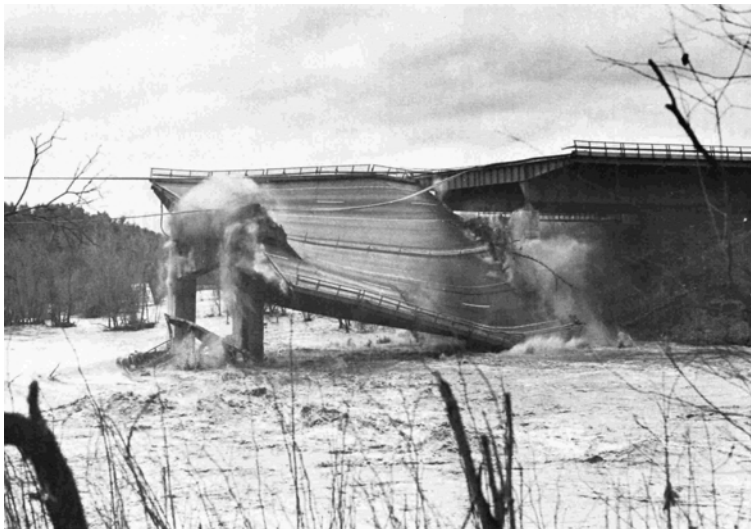
Figure 2.1. Photograph of the Skoharie Creek Bridge collapse, 1987.

The collapse of the Skoharie Creek Bridge in 1987 (shown in Figure 2.1) introduced a new era of concern regarding the structural stability of highway bridges and the stability of the substructure systems supporting them. The tragic collapse and others that have followed have focused attention on the need for dependable methods of monitoring the structural stability of highway structures. Bridge scour that results in a loss of structural stability is the most common reason for the collapse of highway bridges, and innovative, cost-effective monitoring methods are urgently needed. Presently there are more than 26,000 bridges in the U.S. identified as scour critical [1, 2]. More than 3,700 bridges were damaged by scour during the period of 1985 to 1995[2].

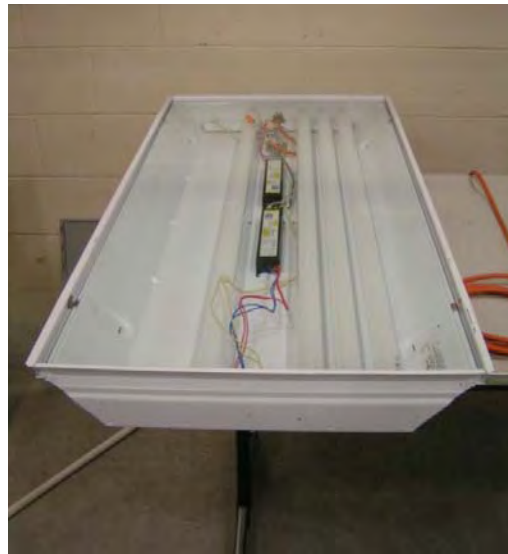
Figure 3.4 shows the setup used for exposing the circuit boards to UV light. Four fluorescent UV lights were used to maximize the amount of UV light along the entire length of the circuit boards. The large (24 in. long) circuit boards that were required for this project exceeded the size of the exposure beds that were available, and as such a new exposure bed needed to be developed. The exposure bed consisted of a common, 48" fluorescent light fixture with a custom-made tempered glass lens. Testing was conducted to determine the optimum exposure times for properly exposing the board such that they could be etched to produce a clear pattern of conductive lines on the surface of the board. Several different commercially available ultraviolet lamps were tested to determine the appropriate wavelength of light to effectively expose the board to generate sharp, clear lines through the etching process.

Figure 3.4. Setup for exposing circuit boards.

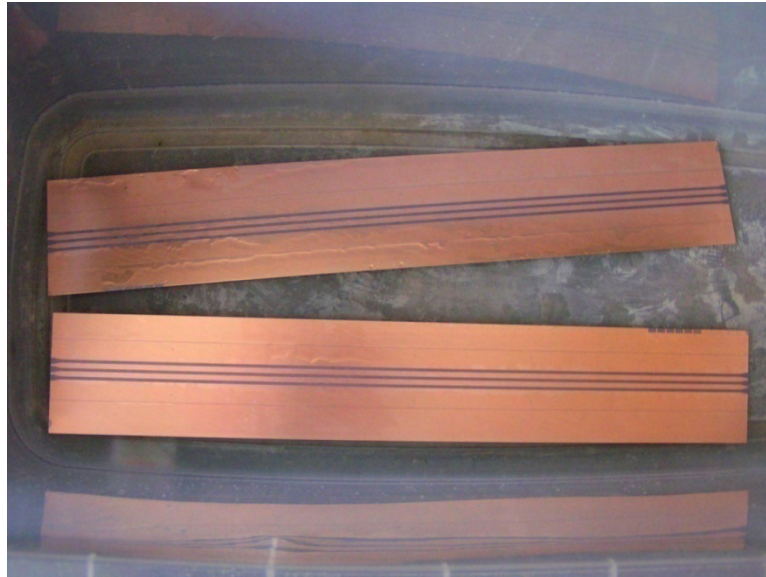
Figure 3.6. Exposed boards in the chemical bath.

The circuit board was then exposed to UV light. A study was conducted utilizing sample board materials to determine the effective exposure time for the board materials. As a result of this study, the boards were exposed for two minutes and then placed immediately into an acid bath to minimize the amount of ambient light exposure. The exposed board material is shown in Figure 3.6. This Figure shows the purple film that will protect the copper trunk lines during etching processes, leaving only the three conductive strips necessary to provide trunk lines for attaching the sensors. The copper that is visible in Figure 3.6 is removed during the etching process.

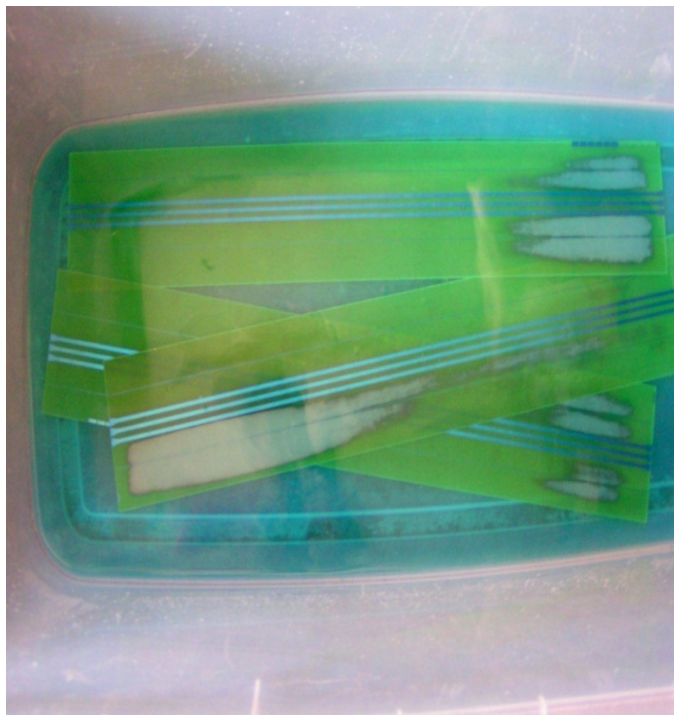
Figure 3.7 shows the excess copper being removed by the acid solution but leaving the lines that are protected by the hardened film. Once all the unwanted copper is removed the boards are washed to remove the acid. This manufacturing process was developed through an iterative procedure that improved the consistency of the process and ensured that the copper trunk lines remaining on the board had clear edges to improve long term reliability.

Figure 3.7. Excess copper being removed from the printed circuit boards.

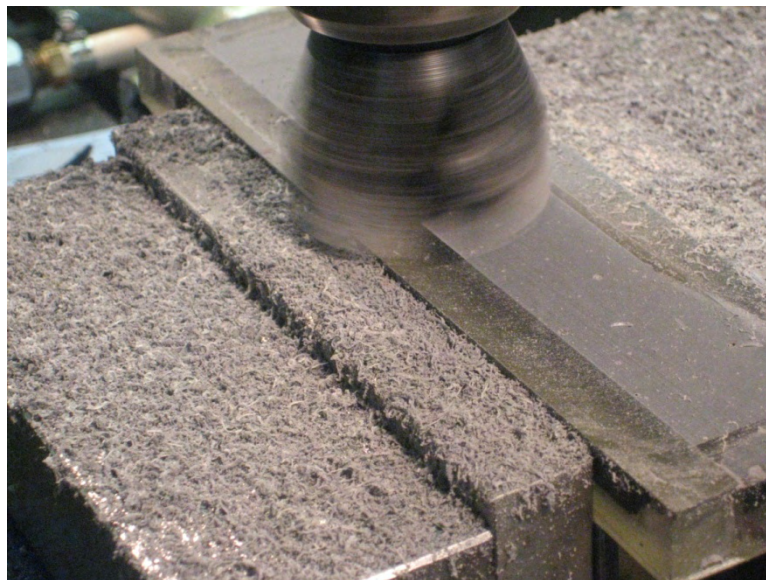
Figure 3.9. Photograph of the milling operation to level epoxy.

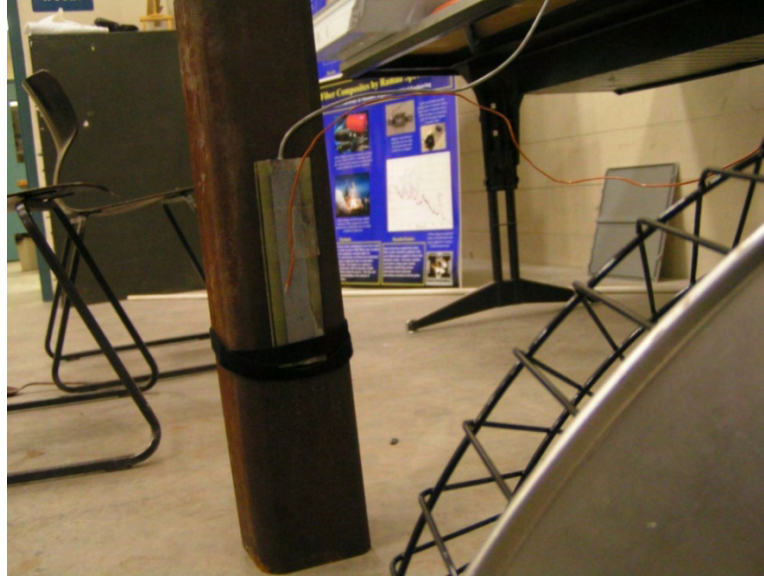
Figure 3.10. Small sensor array test setup.

For the preliminary testing, a small Labview program was developed that read two temperature sensors and controlled the infrared heater. In this Labview program, the unique serial number of each attached sensor is read and shown on the bottom of the panel on the display, along with the temperature reading from the sensor. The results of constructing this prototype array indicated several ways to improve the manufacturing process, as well as confirming several positive design aspects. It was found through testing that the epoxy allowed for rapid conduction of heat to the sensor, such that there was only a small difference in the output of a thermocouple and the output of the sensor array. It also showed that the selected epoxy was machinable such that the sensor modules could be machined once the epoxy was set. The epoxy is expected to play a key role in protecting the sensors and wiring from the surrounding environment.

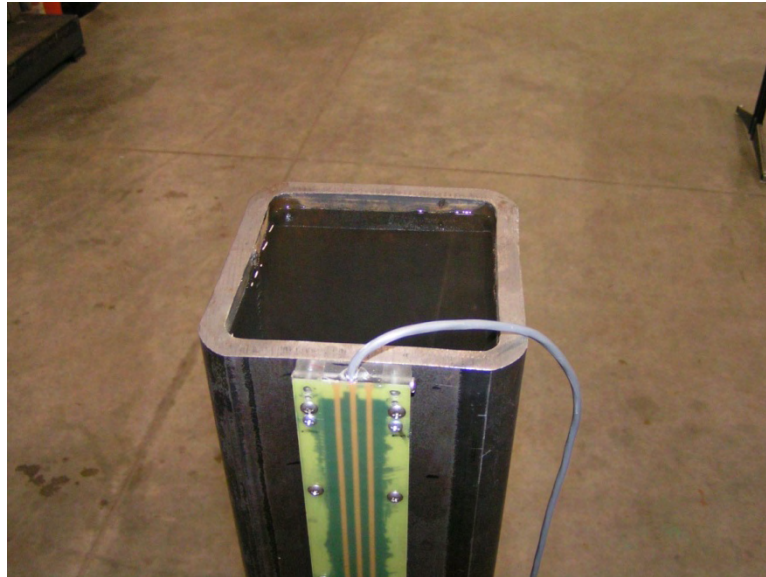
A closer photograph of the test pile is shown in Figure 4.3. The outside of the 16-sensor array can be seen. The three copper trunk lines are visible through the back of the circuit board, along with the black epoxy. The gray 3-conductor wire attaches all of the sensors to the serial port of the test computer through an adapter. Also, the water that fills the inside of the pile can be seen. The combination of water and sand/soil within the test pile was expected to allow for thermal gradient changes such as would be expected in the field.

Figure 4.3. Image of sensor array and water filled test pile.

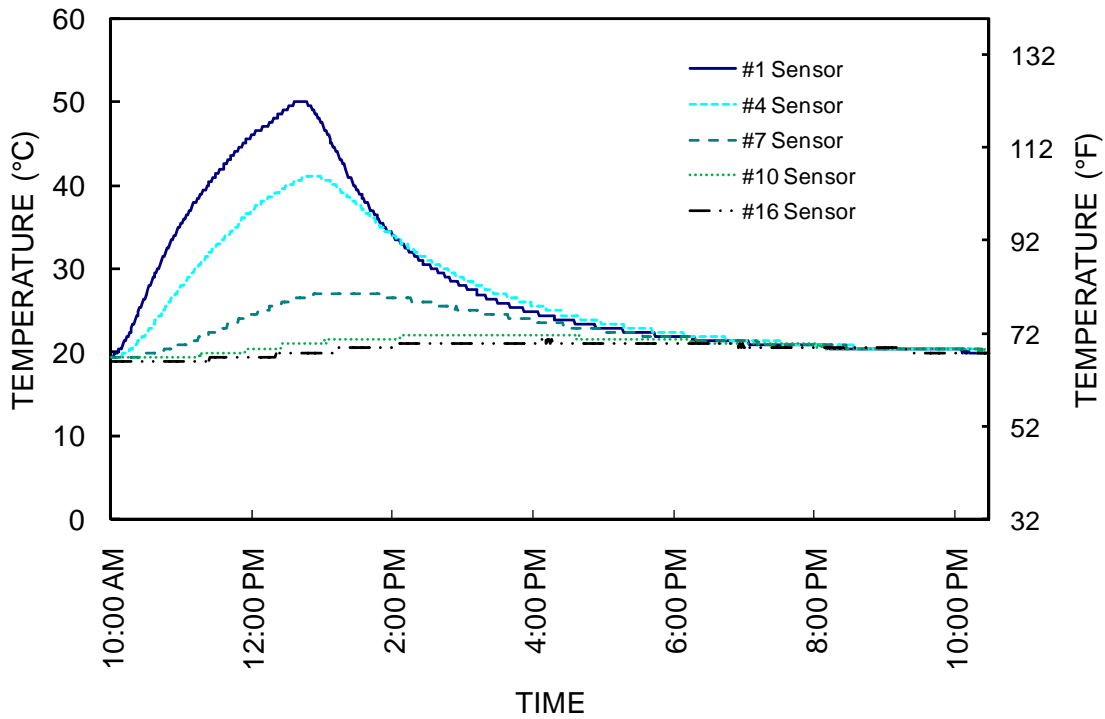
The testing of the 48 in. sensor array demonstrated the effectiveness of the new measurement technology. Figure 4.5 shows the results of one test where the pile started at room temperature and was heated. When the sensors nearest the heater reached 50 degrees Celsius the heater was turned off. From the start of the test to the peak temperature took about three hours, and from there back to equilibrium took about seven hours. The eighth sensor, which was the last sensor on the first circuit board, was the furthest away from the heat source that registered a significant differential from the adjacent sensor. The test illustrated that the gradient measured along the pile was detected by the sensors in their complete array configuration, and the data was successfully stored for later processing. The test also illustrated that the sensor array responded in a timely manner to impressed thermal changes.

Figure 4.5. Sensor array measurement during heating to 50°C and cooling.

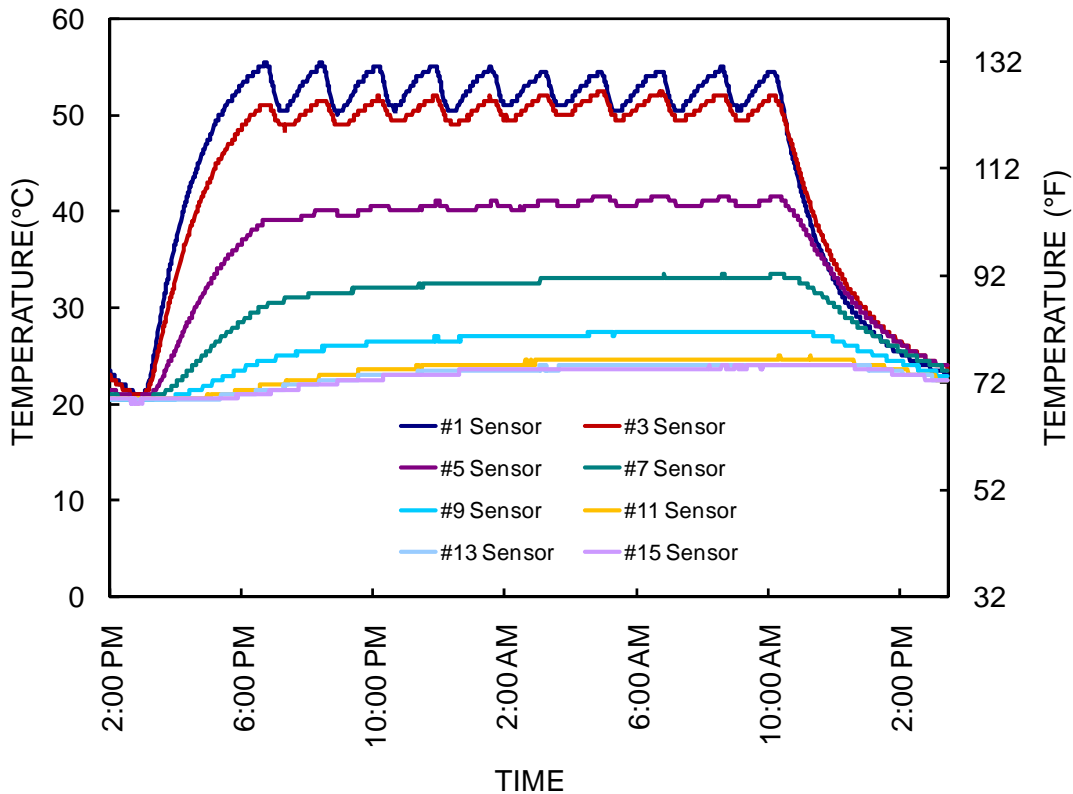
Figure 4.6 shows temperature measurements for a test where the target temperature of 55 °C was established for the heaters and this target temperature is maintained for about 18 hours. During this test, it took about the same amount of time for the pile to heat and cool as in the initial test, and the ninth and tenth sensors registered a significant differential from adjacent sensors. This was due to the longer time period of the test. The figure illustrates that sensor 1 responded rapidly to the application of heat from the ceramic heaters mounted on the test pile. The control system for these ceramic heaters turned the heaters on and off as a result of temperature measurements received from sensor 2. As a result of thermal inertia of the steel pile filled with soil and water, there is a delay in the response of the system to applied heat. This delay manifests in the variations in the temperature measurements (cycles) in time shown in the Figure.

Figure 4.6. Sensor array output during 1-day, 55 degree Celsius test.

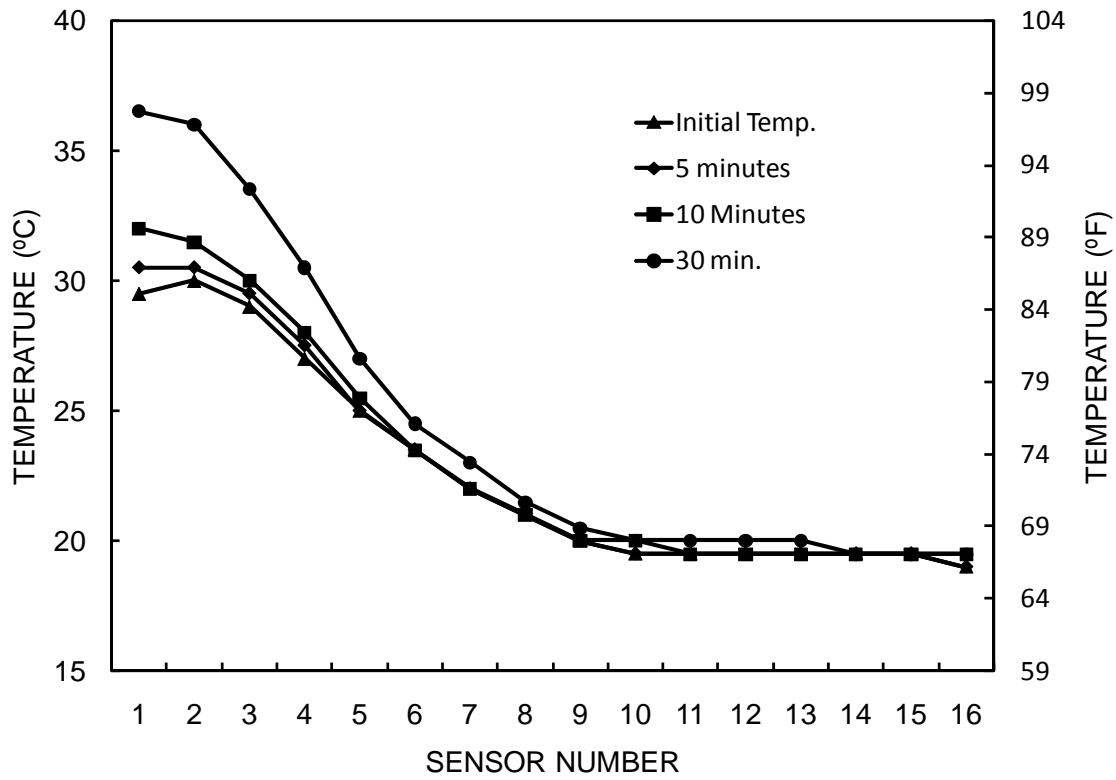
It is useful to examine data from the test pile as the thermal profile along the pile. Figure 4.7 shows the thermal output of the sensors along the length of the pile, starting with sensor 1 located nearest the heaters and ending with sensor 16, which is the furthest sensor from the heaters located at the top of the pile. The vertical axis is temperature. The figure shows the development of the thermal gradient in the pile as heat is applied by the ceramic heaters. Individual scans of the sensor array at times of 5, 10 and 30 minutes after a change in the control temperature for the heaters is shown. As shown in the figure, the sensors nearest the heaters respond to applied heat, and a thermal gradient is developed in the pile as intended. Sensors farthest from the pile do not respond to the applied heat. The change in temperature during the test for each sensor can be observed in the figure, for example the output of sensor 1 changes significantly in the final 20 minutes of the test. Graphing data as the gradient or profile along the length of the pile is expected to improve the ability to identify where the soil/water interface exists and how this interface changes over time.

Figure 4.7. Temperature gradient in the test pile during heating.

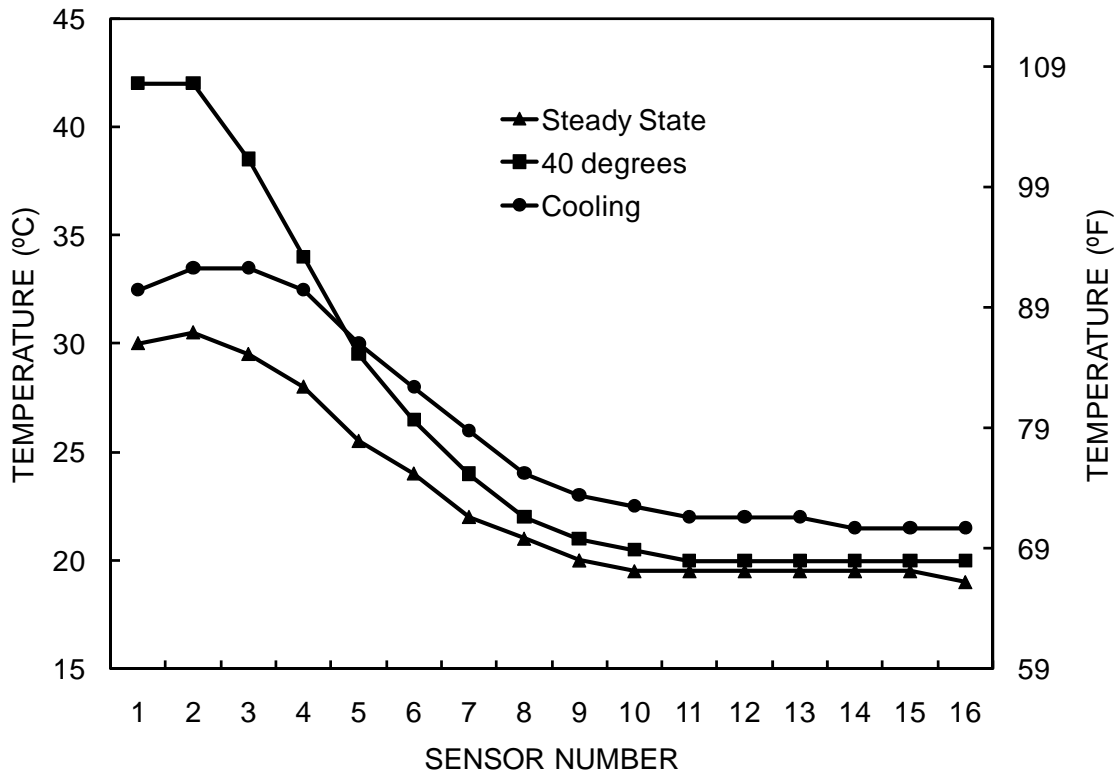
Figure 4.8 shows the thermal gradient along the length of the pile for three conditions. The steady-state condition is the thermal gradient in the pile after a test temperature of 30 °C has been established and maintained for several days. This is an established, steady thermal gradient along the length of the pile. The test temperature was then raised to 40 °C, resulting in the increased thermal gradient along the length of the pile as expected. The test temperature was subsequently adjusted to 20 °C. During the cooling of the pile, the thermal gradient is reduced as sensors respond to the pile reaching toward thermal equilibrium. This is illustrated by the increased temperatures of sensors 5-16, as the thermal wave resulting from the increased test temperature propagates through the pile. This testing illustrated that the sensor array was sensitive to changing thermal conditions and was capable of determining the thermal profile along the test pile under a variety of thermal conditions.

Figure 4.8. Temperature gradient in the test pile during heating and cooling.

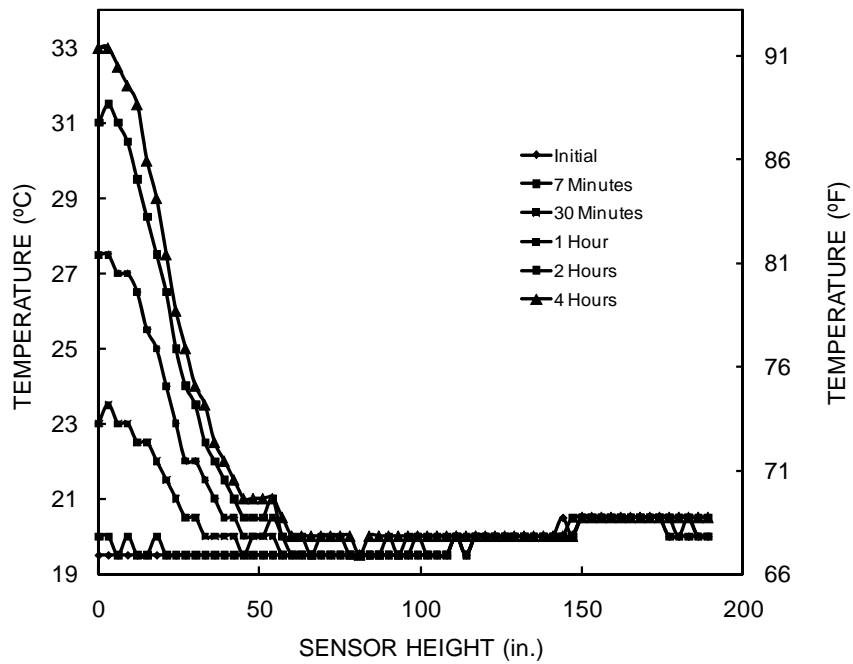
Figure 5.5. Sensor array output during heating test.

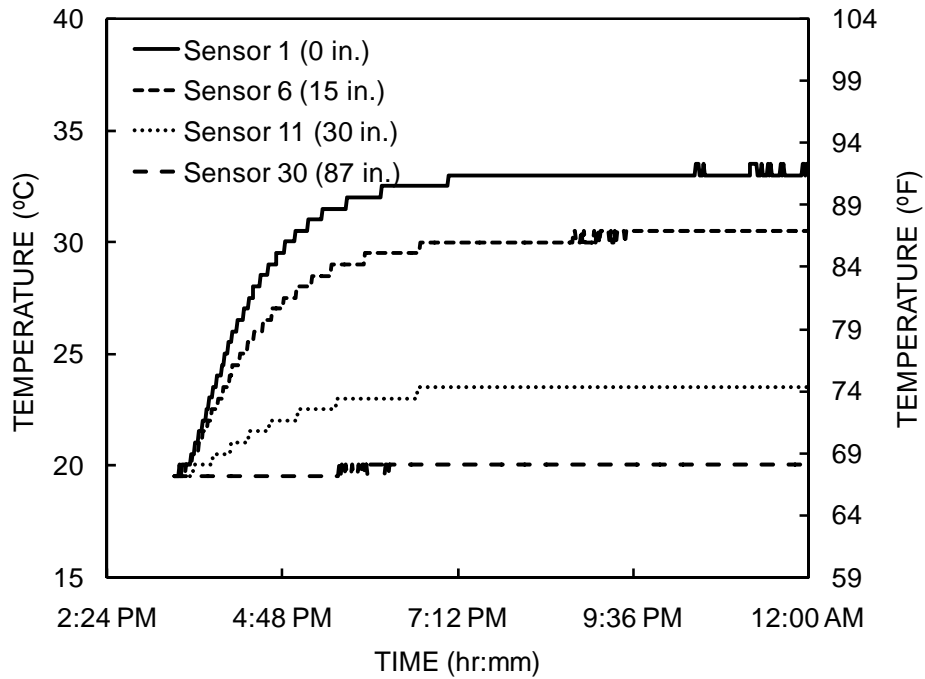
Figure 5.6 shows the performance of sensors 1, 6, 11 and 30 during the test. As shown in the figure, when the test is initiated (the heating lamp is turned on) the sensor responds to the external heat application and measures the heating of the sensor array up to a maximum temperature of 33.0 °C approximately 4 hrs later. The temperature distribution along the length of the pile measured by the remaining sensors in the array was expected to show a thermal gradient as the distance from the heat source to the individual sensor increased. Figure 5.6 shows that a sensor located 87 inches from the heat source (sensor 30) showed no reaction to the application of heat at the end of the pile, while sensor 6 (15 in. from the heat source) and sensor 11 (30 in. from the heat source) responded to the application of heat in an expected manner, increasing less rapidly over the course of the testing.

Figure 5.6. Response of sensor 1, 6, 11, and 30 to applied heat from an infrared heater at location 1.

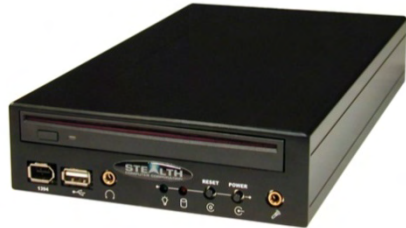
Figure 5.12. Photograph of Stealth computer used for data acquisition from temperature sensors.

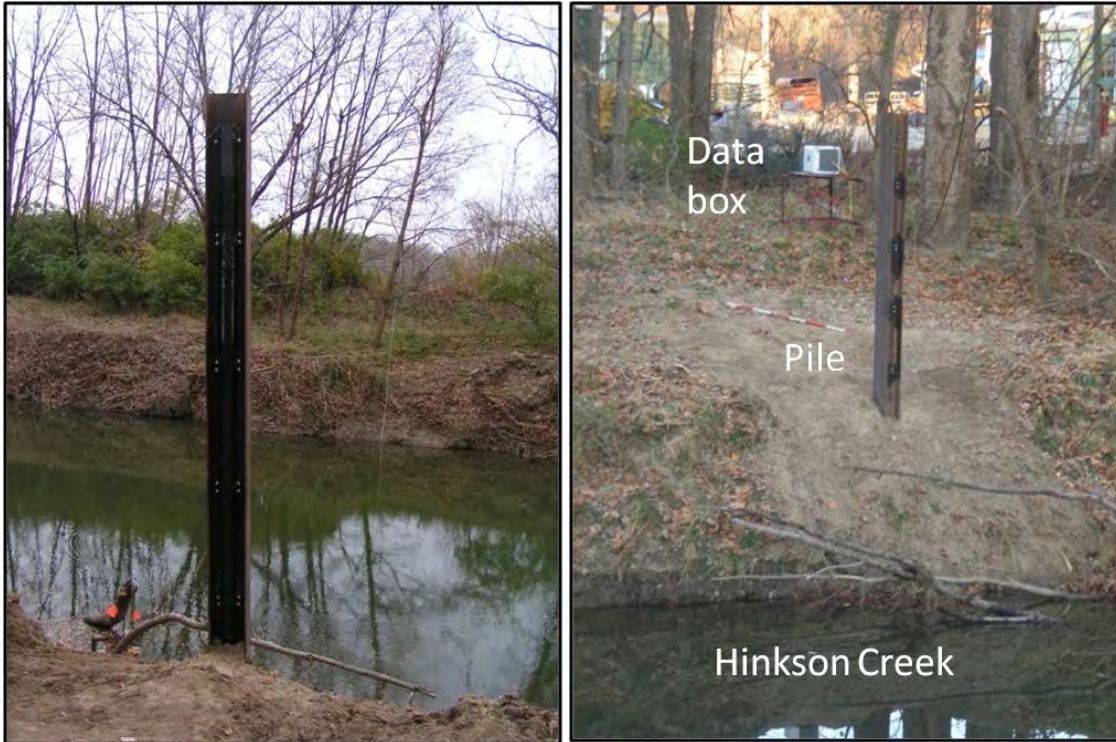
The pile was driven to refusal at this location. Approximately 18 in. of loose soil was placed around the top of the pile to level the bank and extend the portion of the test pile installed in the soil. This area of the creek is expected to flood regularly during high water events because the creek has steep, narrow banks, such that high water will occur with modest amounts of rainfall. The test pile was connected to the computer in the data box, and data stored on site as well as at a server on the MU campus.

Figure 5.13. Photograph of the test pile installation at Hinkson Creek.

5.13, a portion of the pile is installed in sound soil, and the rest of the pile is exposed to ambient air conditions. This represents an installation scheme along a normally dry bank of a river that is only submerged during flood conditions.

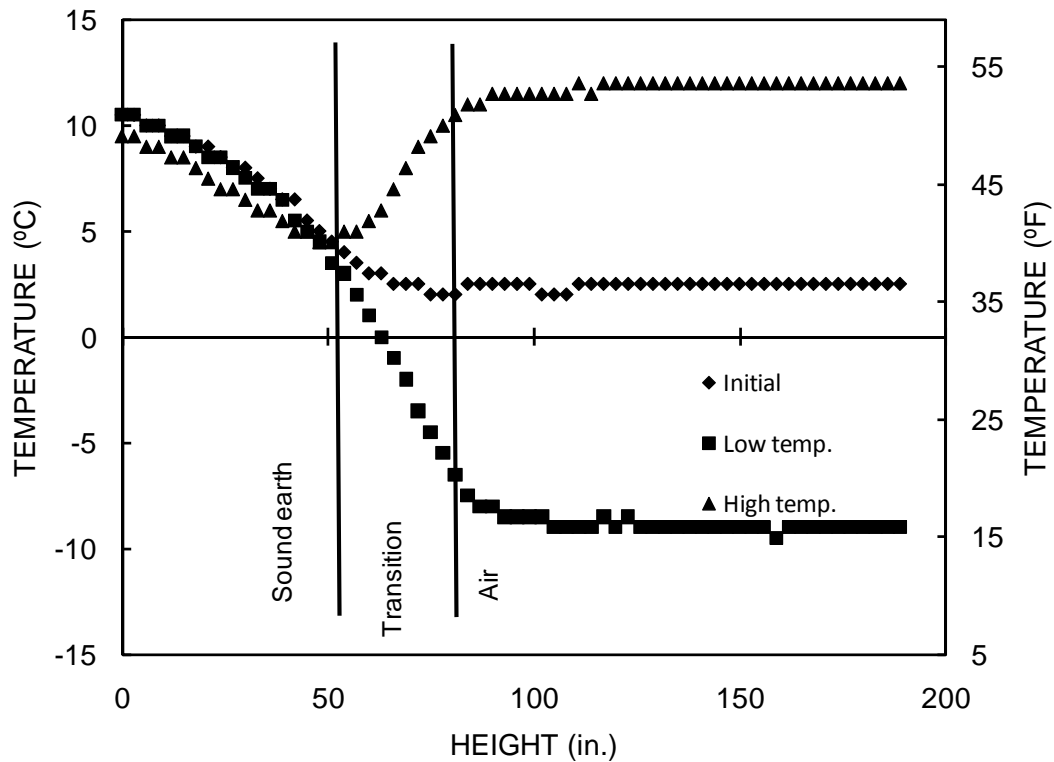
several days. Temperatures increase slightly into the sound soil, as the pile is not driven very deep due to the bedrock present at the site.

Figure 5.14. Temperature profile along the test pile for high, low and initial air temperatures.

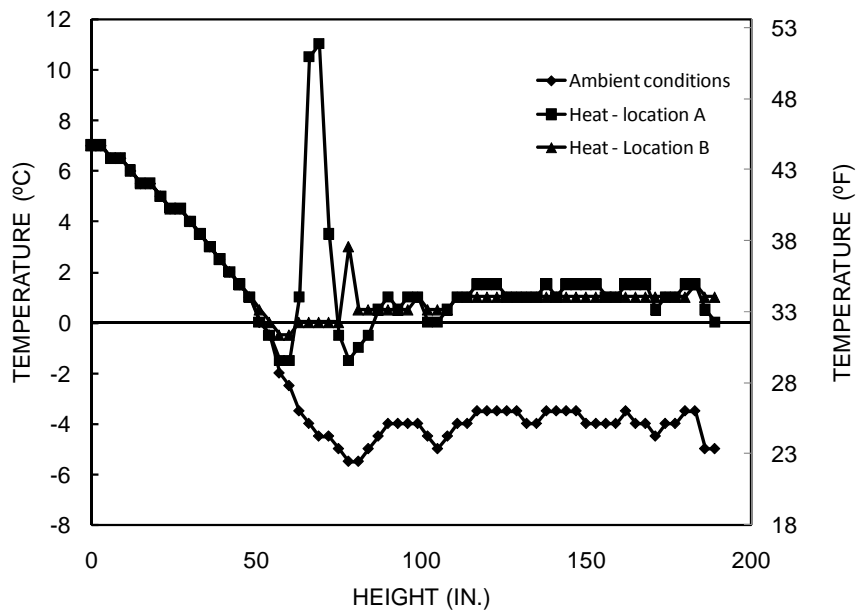
To further investigate the location of the air/soil interface on the installed pile, the pile was locally heated with a torch at the air/soil interface. The pile is installed along an inclined bank, such that the air/soil interface is different on opposing sides of the pile as shown in Figure 5.15. Heat was applied to the pile at the downhill location (location A) to heat the pile locally, such that the sensor that responded to the applied heat could be identified. The distribution of heat along the length of the pile is shown in Figure 5.15. Heat was also applied, though for a shorter time, to the up-hill side of the pile (location B), directly heating the armor channel holding the sensor. A smaller amount of heat was applied at location B to avoid damaging the epoxy in which the sensors are embedded. The spike in temperatures at location A and B can be clearly seen in the pile profile in Figure 5.15. The data indicated that sensor 24, located at a height of 69 in., was closest to applied heat at location A. At location B, sensor 27, at height of 78 in along the pile, was closest to the applied heat.

Figure 5.15. Schematic diagram of test pile showing locations where heat was applied (top) and resulting temperature measurements along sensor array.
