Proposed Testing of Concrete Sealers

Kentucky Transportation Center Technical Assistance Report — KTC-TA-17-04/KHIT2017-6-1F DOI: http://dx.doi.org/10.13023/KTC.TA.2017.04

Technical Assistance Report KTC-TA-17-04/KHIT2017-6-1F

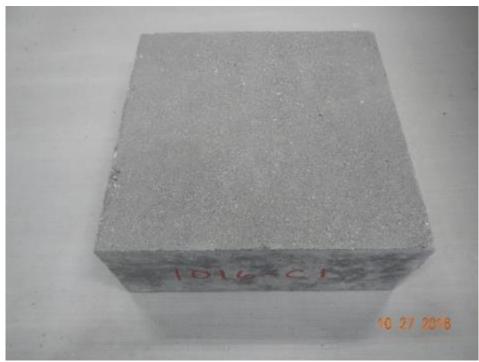
Figure 1 ICRI CSP3 Surface Preparation

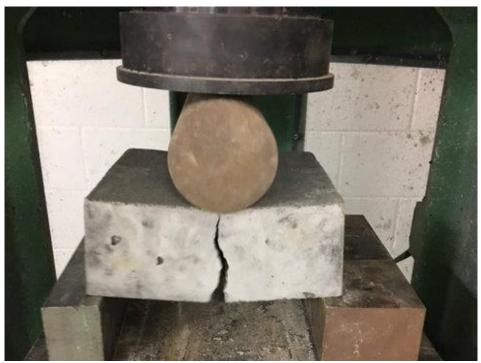
In order to test the healer/sealers, it was necessary to simulate a bridge deck crack. To accomplish this, eight specimens were scored across the bottom face to a depth of approximately $\frac{1}{2}$ inch. Using the compression tester the specimens were broken in half (Figure 2). The cracked specimens were then "re-assembled" by applying a small bead of silicon to the outer edges of the fractured surfaces at the sides of the specimen. A copper wire (approximately 0.017" diameter) was embedded in the silicon to act as a spacer (Figure 3). Clamps were fashioned using 2x4 lumber and 5/16" all-thread rods (Figure 4). By applying 15 ft. lbs. of torque to the clamps, the wire was compressed to approximately 0.016". The average crack width as measured by a Germann Crack Scope was 0.0164" (Figure 5).

Figure 2 Breaking specimen for Healer/Sealer Testing

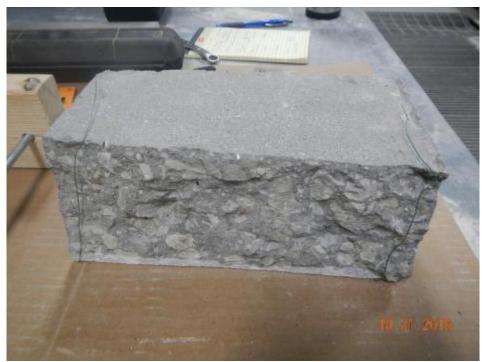
Figure 3 Fractured Surface with Wire Spacer

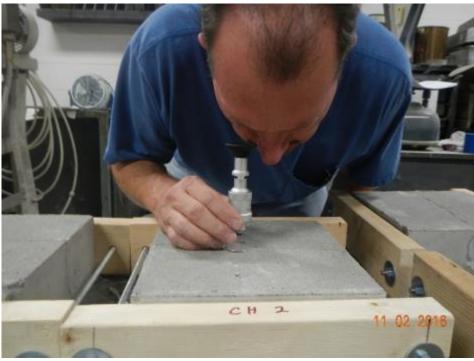
Figure 5 Crack Measurement Using Germann Crack Scope

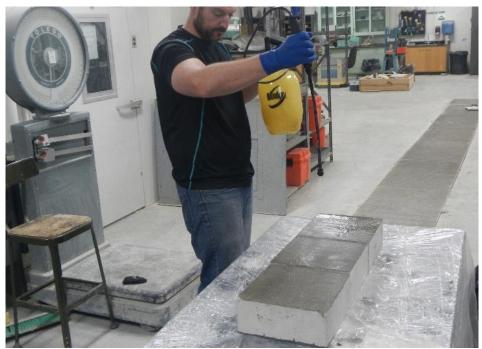
Sealer was applied with a low pressure Hudson sprayer in a single pass allowing material to flood the surface (Figure 6). After approximately five minutes, allowing time for material to saturate the surface, a brush was used to even out the material. This application method was performed in accordance with the product data sheet, which stated a usage of 100 to 150 ft² per gallon, however when applying to the small specimens there was considerable run off and therefore no attempt was made to calculate usage.

Figure 6 Application of Penetrating Sealer

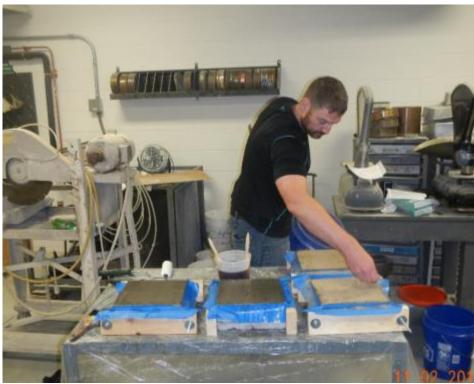
This healer/sealer was applied by brush in a manner to saturate the entire surface. To allow maximum penetration the material was pooled over the intentional crack for approximately five minutes, then excess was removed by brushing. Sand was broadcast, to refusal, over the entire test surface (Figure 7). The application method described in the product data sheet was adhered to as closely as possible. The recommended usage was 65 to 80 ft² per gallon when applying to broom finished concrete, however when applying to the small specimens there was considerable run off and no attempt was made to calculate usage. Considerable material also ran through the intentional crack.

Figure 7 Broadcasting Sand on Healer/Sealer

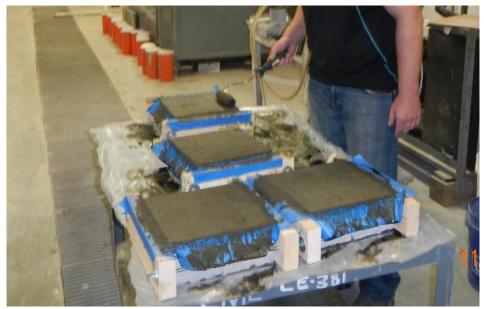
Figure 8 Back-rolling Healer/Sealer Specimens After Application of Sand

This healer/sealer was applied by brush in a manner to saturate the entire surface. The PDS stated to maintain 15 mils but due to the low viscosity, 3-5 mils was all that could be achieved using the roller method. Switching to the brush method allowed a build-up of 8-10 mils. The recommended usage was stated to be 100 to 150 ft² per gallon, however when applying to small specimens there is considerable run off and no attempt was made to calculate usage. Material also ran freely through the intentional crack. Sand was to be broadcast at 1 lb. per yd² then back rolled with additional material (Figure 8). Total test area was 4 ft² and approximately 1/8 lb. of sand was broadcast. When back-rolling, due to the tackiness of the material, there was a considerable amount of sand removed.

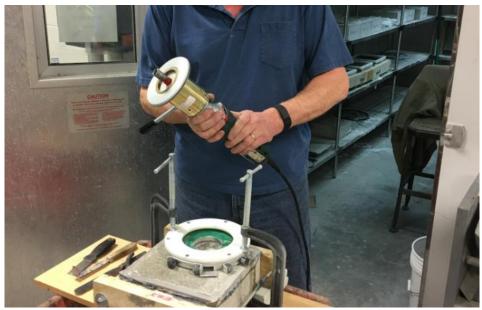
Using the Germann Profile Grinder (Figure 10), the top 2 mm (0.078") were removed and discarded to eliminate any residual surface contamination. From that point, concrete dust was collected at 4 mm (0.157") intervals down to 26 mm (1.02") (Figure 11). Samples from the baseline specimen had previously been collected and tested to establish a baseline chloride content. Since the healer/sealer material ran through the crack during application it was necessary to seal the bottom of the specimen to prevent the salt solution from running out. Therefore, additional dust samples were collected from the fractured surface of the healer/sealer specimens. These samples were collected by drilling 0.125" to 0.375" into the fractured surface, parallel to and approximately 1.5" to 2.0" below the ponded surface (Figure 12). All samples were oven dried for 24 hours at 110°C and sieved using a number 50 sieve. The Germann Rapid Chloride Test (RCT) (Figure 13) was used to determine chloride content. From each sample collected, 1.5 grams were weighed out and put into test vials of extraction solution. To allow for 100% extraction the samples were allowed to "soak" for approximately three days prior to testing. The average chloride content at each level for each of the products as well as the baseline and control specimens can be seen in Table 2 and Chart 1. Specimens SA 1 and CH 4 were ponded with plain water instead of the salt solution in an effort to determine any effect the salt may have on the other tests. The chloride content of SA1 and CH4 (0.016% and 0.010%) were relatively the same as the baseline samples and were not included in the results in Table 2 and Chart 1. All other tests were performed utilizing the ponding specimens after the ponding was complete.

Figure 10 Germann Profile Grinder

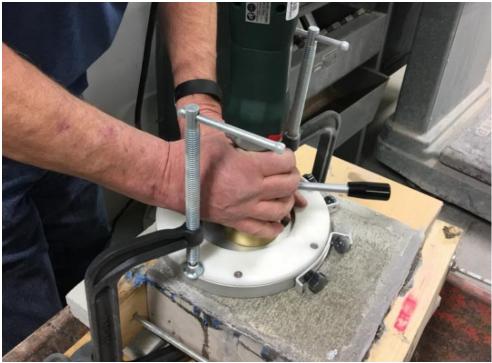
Figure 11 Germann Profile Grinder

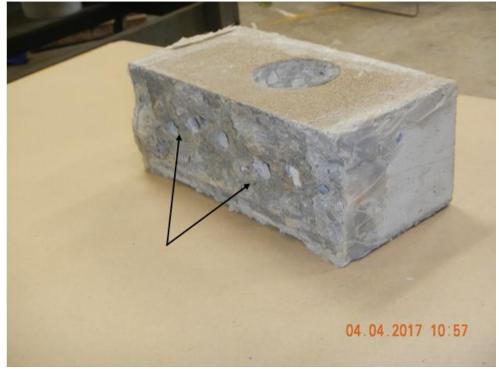
Figure 12 Fractured Surface (Arrows Indicate Sample Collection Area)

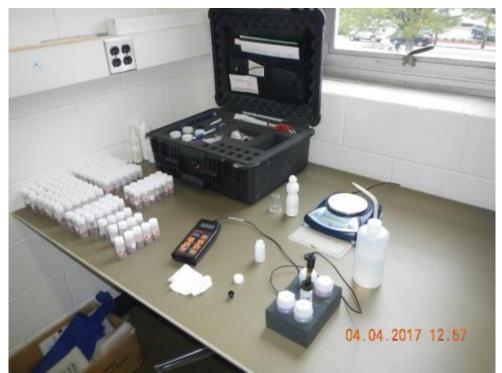
Figure 13 Germann Rapid Chloride Test (RCT)

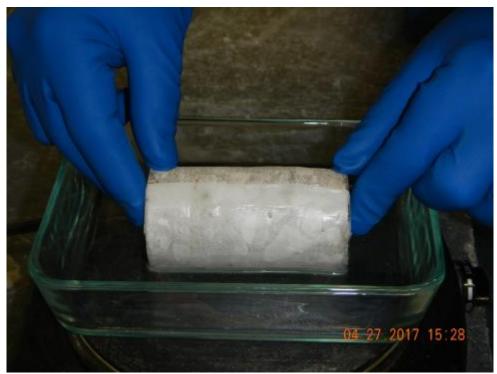
Figure 14 Application of Paraffin with Ends Taped

A 2.0" x 4.0" (diameter x length) core was extracted from each ponding block for absorption testing. The cores were prepared and tested in accordance with ASTM D6489 "Standard Test Method for Determining the Water Absorption of Hardened concrete With a Water Repellant Coating". The cores were oven dried at 75°C +/- 5°C (167°F +/- 9°F) for 24 hours then weighed at two hour intervals until a change of less than 0.2% was observed. After cooling to room temperature they were re-weighed and this weight was recorded as the initial weight. To assure the sides of the cores were waterproof, paraffin was melted at approximately 80°C (176°F) and applied by rolling the core in the wax (Figure 14). The depth of the wax was maintained at approximately 0.125" to 0.250". To prevent was from adhering to the ends of the core, duct tape had been applied and was removed before testing. Removal of the tape fractured the seal between the sides of the core and the treated surface, therefore in an effort to re-seal this area each core was further treated by dipping, at a shallow angle, into the paraffin to coat only the extreme edge of the test surface (Figure 15). Each core was re-weighed and placed, treated surface down, into 2.5 inches of D.I. water. At 24 and 48 hours the cores were removed, excess water wiped off, and re-weighed. The results can be seen in Table 3 and Chart 2.

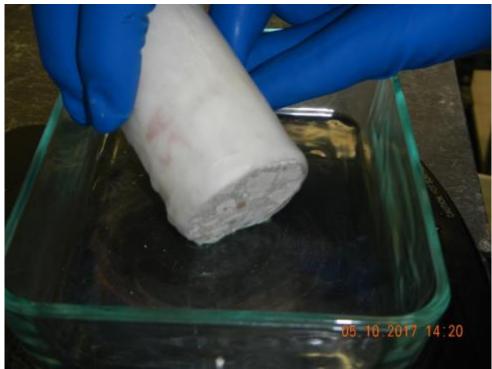
Figure 15 Application of Paraffin to Edges

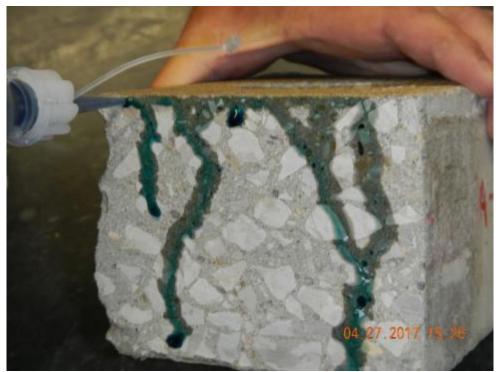
KTC-SOP-24 "Depth of Penetration of Concrete Sealer" (Appendix 3) was used to determine depth of sealer penetration. This SOP was developed for the NTPEP program and was adapted for this study. The test required cutting a cross section of the specimen, drying, and applying a water soluble dye to the cut surface at the interface of the sealing material (Figure 16). The dye should penetrate the concrete and be visible in the area below the point at which the sealer has penetrated. This area was viewed and measured using a Germann Crack Scope with 25x magnification. Penetration was detected with the two penetrating sealers (Table 4), however no penetration was observed with the healer/sealers other than into small crevices. Ambient lighting as well as a black light was utilized in examining these specimens.

Figure 16 Dye Application for Depth of Penetration Testing
