# **ESTABLISHING PROCEDURES AND GUIDELINES FOR PEDESTRIAN TREATMENTS AT UNCONTROLLED LOCATIONS**

Research Report No. FHWA-ICT-17-016

A report of the findings of  
**ICT PROJECT R27-167**  
**Establishing Procedures and Guidelines for Pedestrian  
Treatments at Uncontrolled Locations**

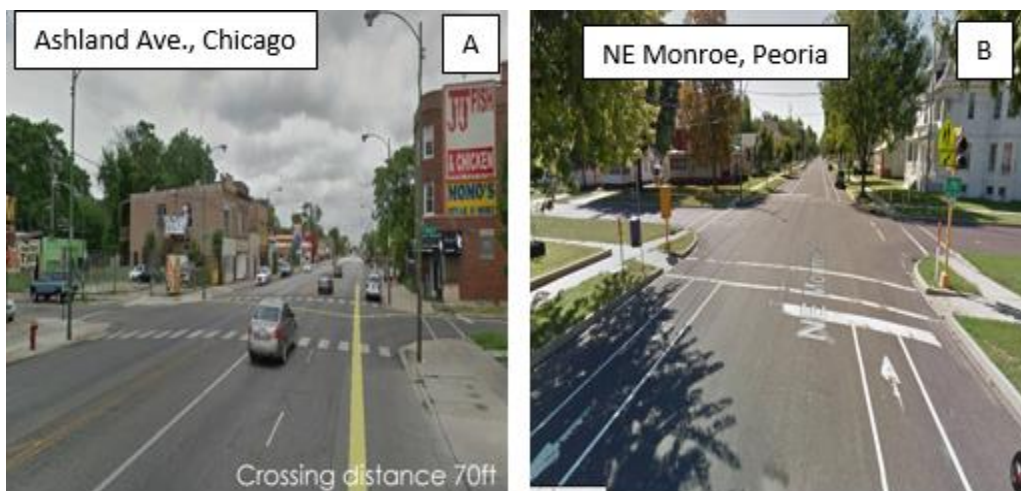
Two major cases of lengthy crossings were observed that may have contributed to unsafe pedestrian conditions. These include locations with multiple-lane crossings (more than three lanes) without a refuge island and locations with on-street parking and bicycle lanes on both sides of the roadway. Both cases increase the exposure time of pedestrians to traffic (Figure 30).

**Figure 30. (a) Wide crossing distance with no median; (b) parking lane increasing the crossing distance.**

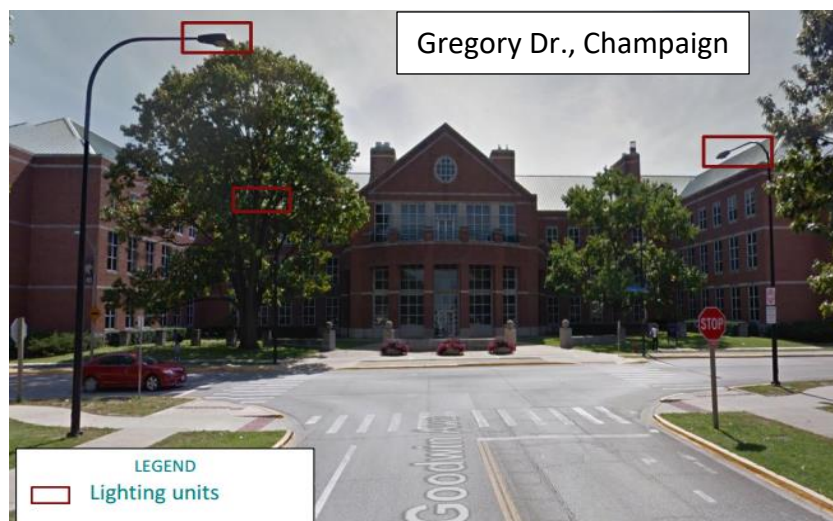
Figure 32), bad weather conditions, or noncontrasting clothing. Safety is further compromised when motorists do not expect pedestrians to be crossing. For example, an unexpected pedestrian crossing could occur at undesignated crossing points, at night, or during severe weather conditions.

**Figure 32. Example of inadequate street-lighting location.**

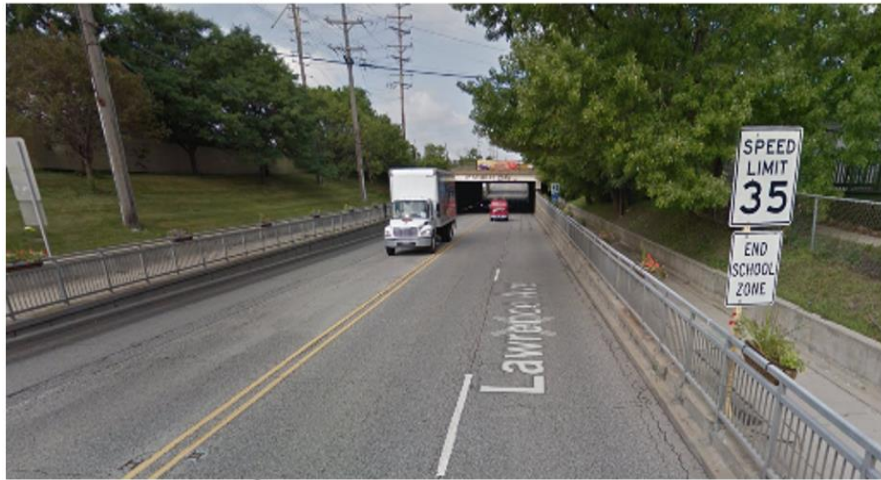
- To prohibit pedestrians from crossing roads with high speed limits or more than four lanes, pedestrian channelization is recommended. In addition, pedestrian channelization can be used to prohibit jaywalking between two adjacent crosswalks. Figure 42 shows an example of pedestrian channelization in Cook County, Illinois, that guides pedestrians to adjacent crosswalks.

**Figure 42. Example of pedestrian channelization, Cook County, Illinois.**

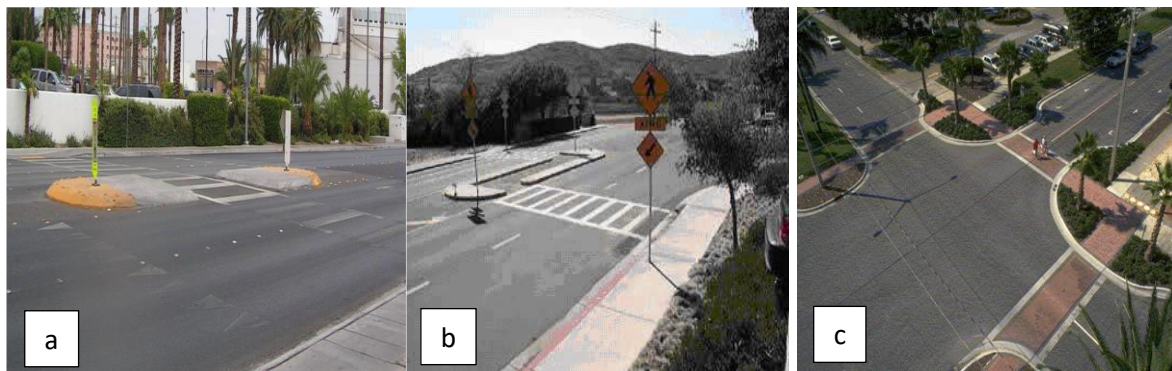
can ensure that pedestrians face oncoming traffic. A curb extension is effective to reduce the pedestrian's exposure to traffic and reduce the crossing distance. Another safety benefit of a bulb-out is that pedestrian-crossing signs placed there are more visible, as compared to those placed on the roadsides. A road diet is a traffic-calming measure to reduce speed through reducing the number of travel lanes or narrowing the travel lanes.

**Figure 51. (a) Raised median (Pulugurtha et al. 2012); (b) split pedestrian crossover (VDOT, 2004); and (c) curb extension (Turner and Carlson, 2000).**

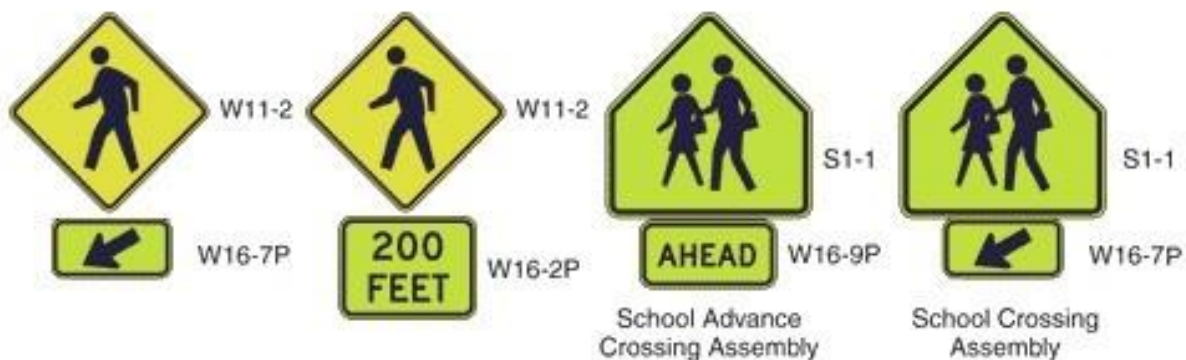
**Figure A- 1. Pedestrian crossing and warning signs (FHWA, 2009).**

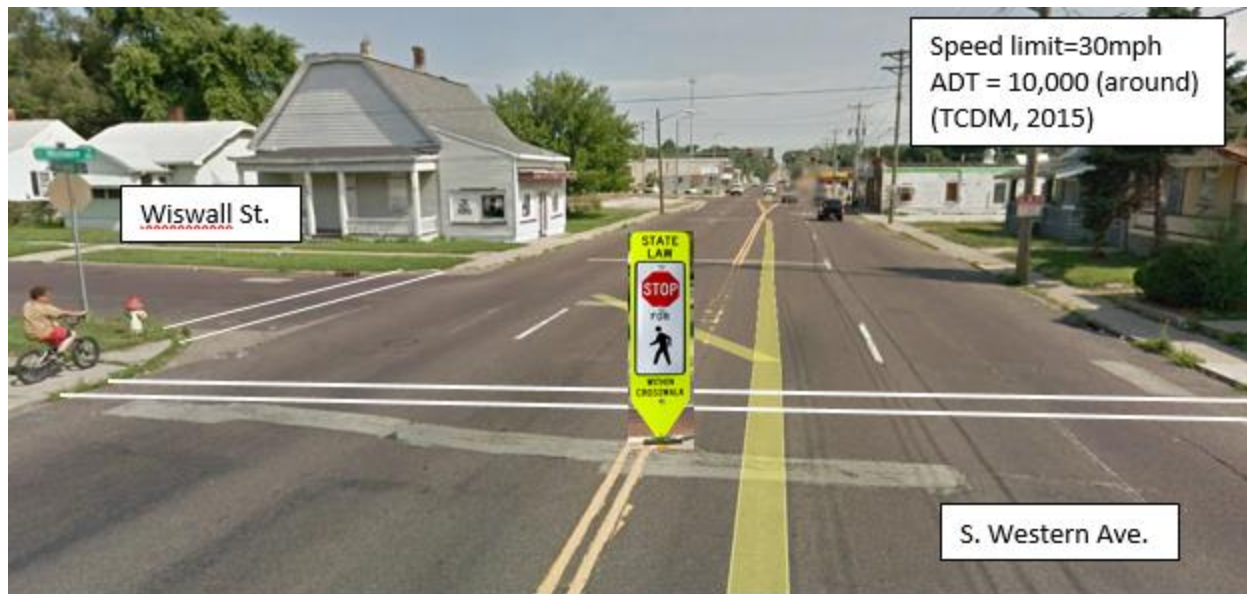
**Figure E-19. Proposed crosswalk and other improvements at the intersection of W. Wiswall St. with S Western Ave.**

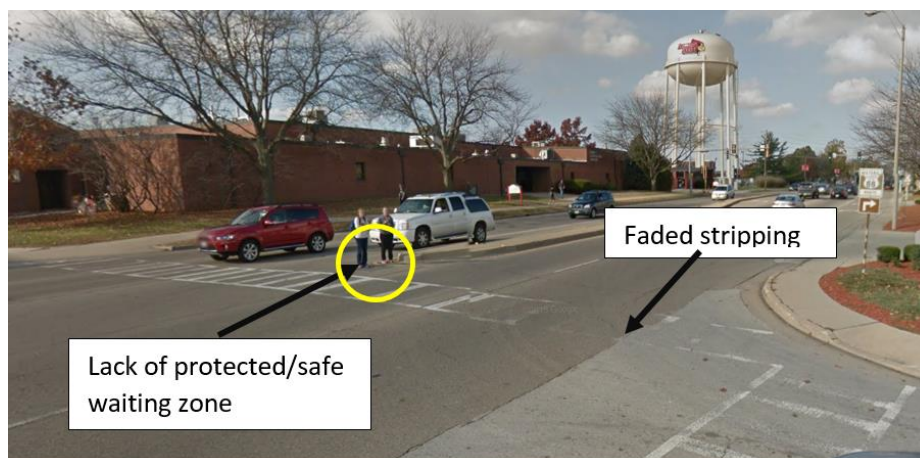
**Figure E-33. Faded marking and lack of refuge island at US Business 51 and W. Locust St.**

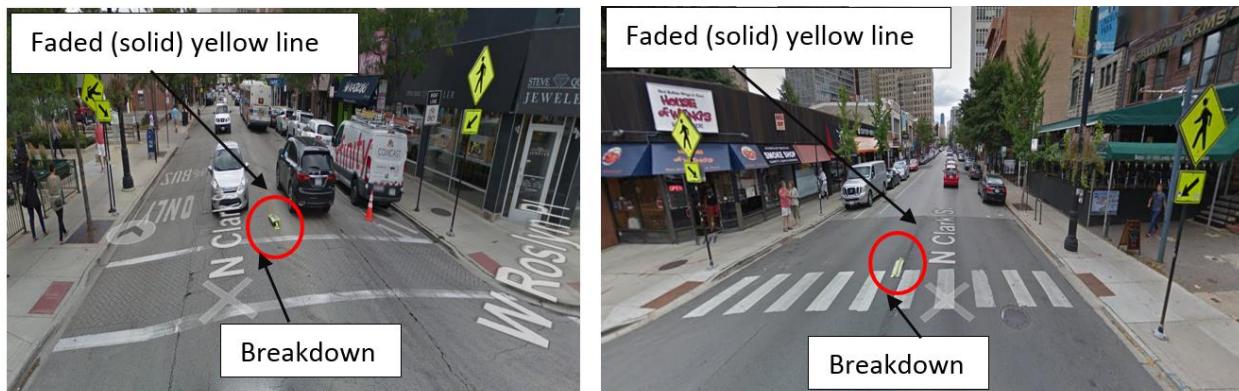
**Figure E-56. Breakdown of In-street crossing sign along N. Clark St.**

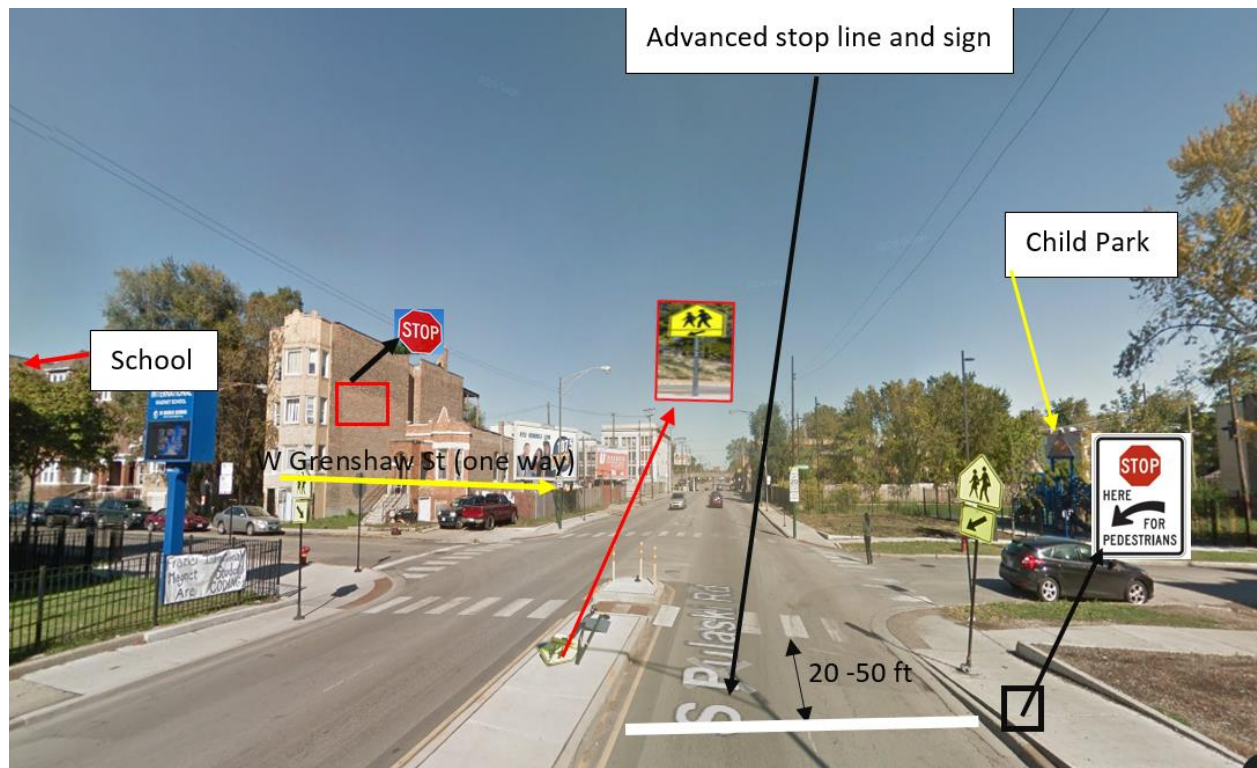
**Figure E-71. Refuge island with warning sign and advanced stop line (four lane roads).**

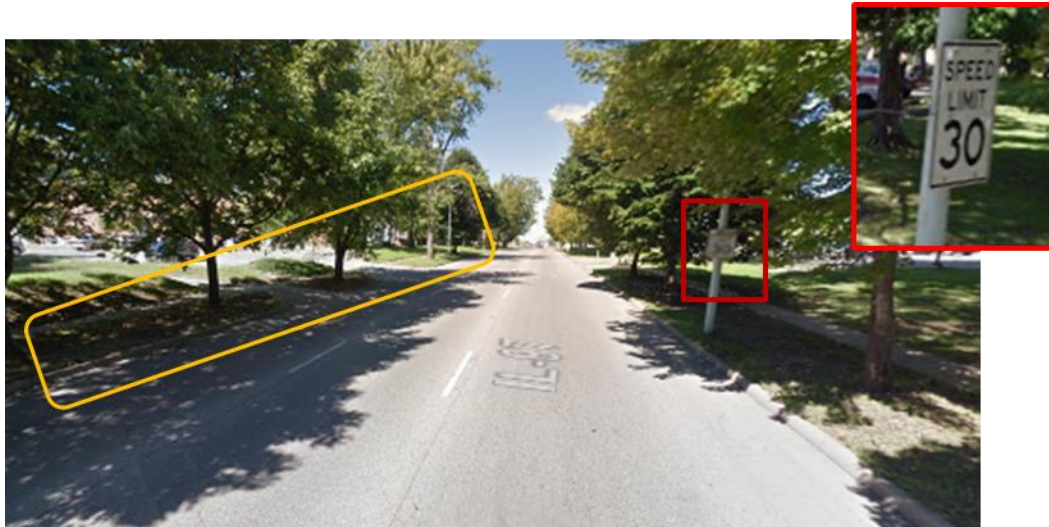
**Figure E-100. Trees cover speed limit sing and crosswalk at W. Jefferson St., residential area.**

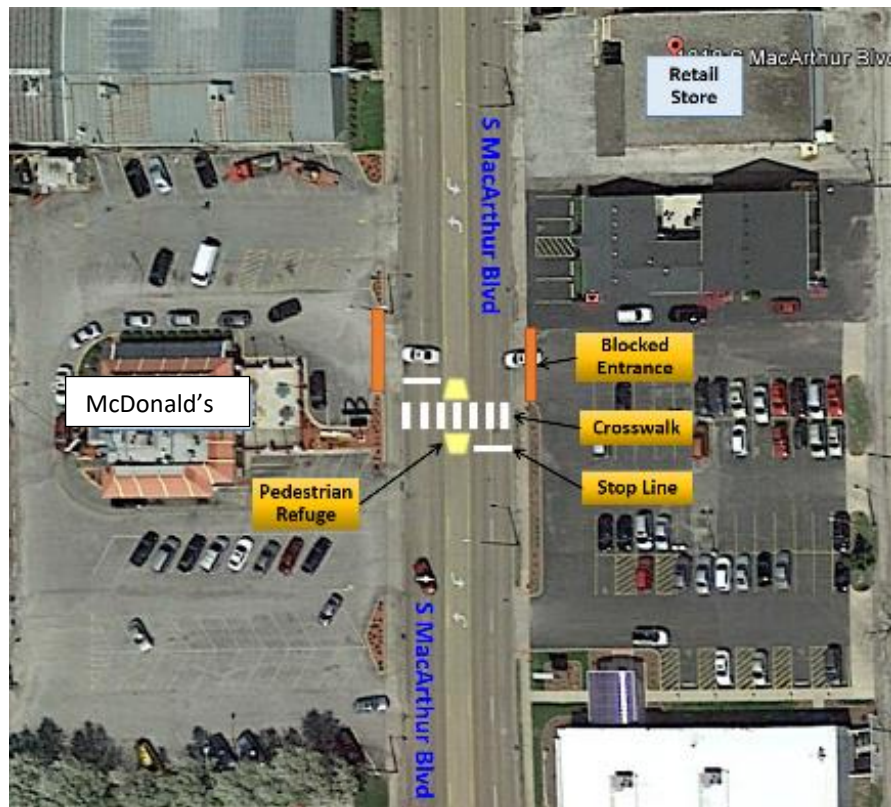
**Figure E-105. Recommended mid-term treatment, installing crosswalk along S. MacArthur Blvd.**

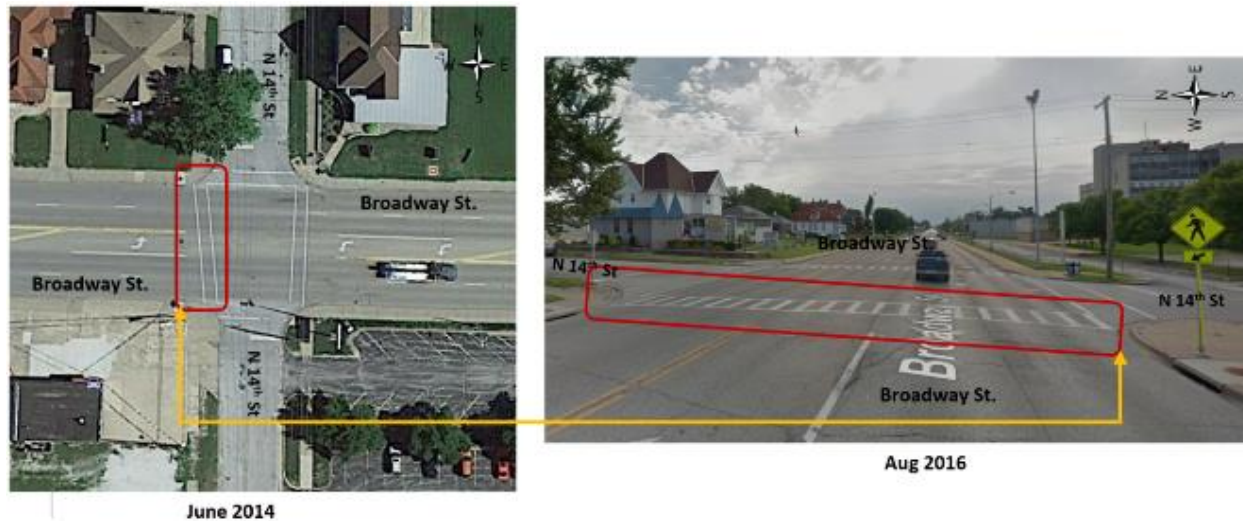
**Figure E-112. The type of crosswalk striping across Broadway St. (in 2014 and 2016).**
