TESTING NEW TECHNOLOGY TO RESTRICT WILDLIFE ACCESS TO HIGHWAYS: PHASE 1

Utah Department of Transportation
Research Division and Region Four

Utah State University
Department of Wildland Resources
Utah Transportation Center

Final Report
August 2017

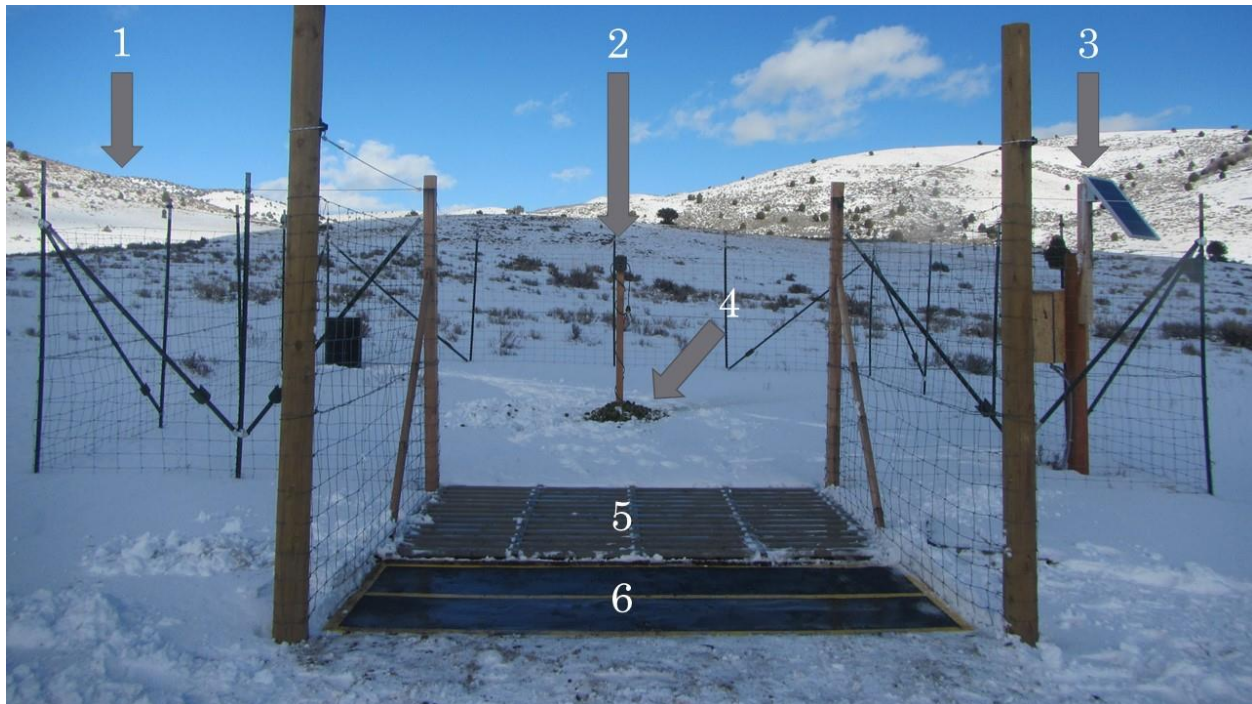
Figure 2. Front View of a 30 by 30 Feet (10 × 10 m) Wildlife Enclosure Used to Test Efficacy Cattle Guards Augmented with Either 9 feet by 4 feet (3 × 1.2 m), Pictured, or 9 feet by 3 feet (3 × 0.9 m) Electrified Pavement as a Wildlife Deterrent Barrier at Hardware Ranch Wildlife Management Area, Utah.

Symbols added to indicate enclosure elements: 1 = 7.5 feet high woven wire fencing, 2 = motion activated camera (Reconyx PC800), 3 = solar panel, 4 = alfalfa feed bait, 5 = simulated cattle guard, and 6 = electrified pavement device, outside panel is negative.

The electrified pavement device (Lampman Wildlife Services, Ontario, Canada) augmented the simulated cattle guards with two different widths. Both pavements were 10-foot long (3 m) and were either 3-foot (0.9 m) or 4-foot wide (1.2 m) (dimension traversed by an animal entering the enclosure). The electrified material was contained by a rectangular plastic board form filled with a black conductive material impregnated with a matrix of stainless steel bits that delivered an electrical potential to the entire surface of the pavement-like segment. An additional yellow plastic board installed lengthwise in the center of the form partitioned it into two sections, with the outermost board charged negative, and the board next to the cattle guard charged positive, Figure 2. The negatively and positively charged surfaces created a difference of electric potential between the two surfaces meant to deliver a high-voltage (9.9 kV), short duration ($< 3/10,000$ second) shock to animals in simultaneous contact with both surfaces. The

electric pavement was powered by a Stafix X3™ 3-Joule solar-powered energizer (Tru-Test Limited), which delivered a maximum output voltage of 11.4-kilovolts to the conductive segments at approximately 1.5-second intervals. A 40-watt solar panel, solar charge controller, and 12-volt deep-cycle battery were placed within each enclosure and provided continuous power to the system.

The Reconyx Model PC800 motion activated camera was installed on a post 6 feet (1.8 m) high and at the center of each enclosure and positioned to record wildlife approaches and behavioral reactions. Camera settings were programmed for 5 to 10 consecutive photographs rapid fire each time the camera was triggered, with no down time between triggers.

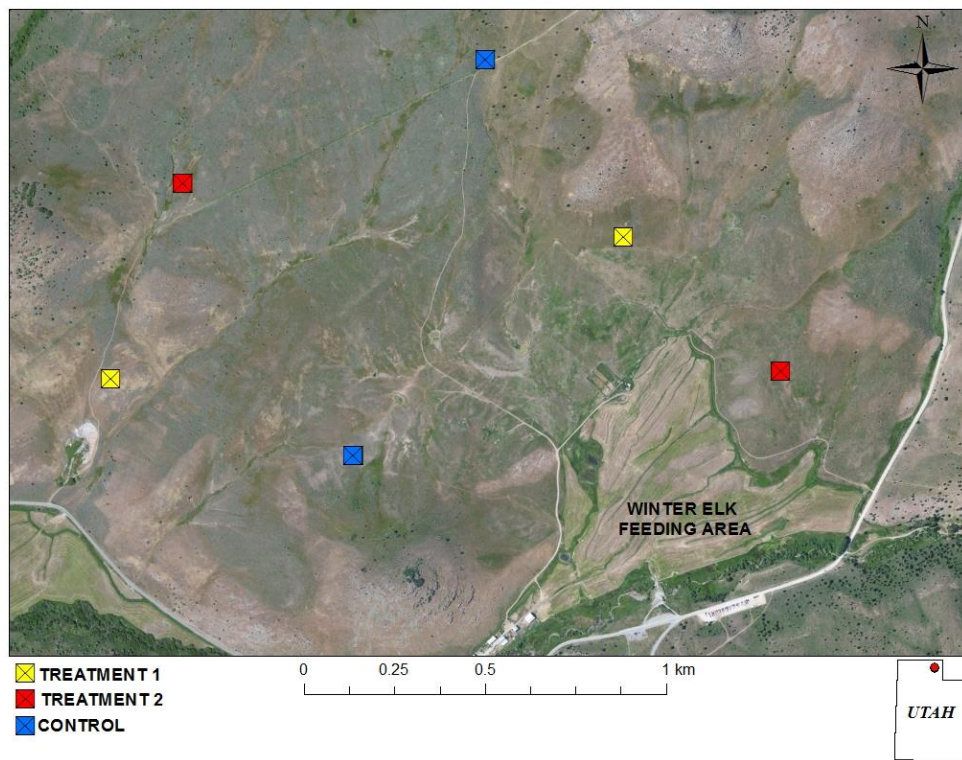
Figure 3. Wildlife Exclosures, Hardware Ranch, Wildlife Management Area, Utah.
Figure taken from Flower 2016.

Spacing between exclosures was maximized to reduce interdependence of deer and elk visitation and behavior among the exclosures. Average spacing of exclosures at Hardware was 0.7 miles (1.1 km). The minimum and maximum distance between two exclosures was 0.4 and 1.1 miles (0.6 km and 1.8 km), respectively. All exclosures were located at similar elevations and within comparable habitat. We used a randomized complete block design and partitioned the six experimental units into two separate experimental blocks. Treatment 1 was the 3 foot-wide (.9 m) pavement, Treatment 2 was the 4 foot-wide (1.2 m) pavement, and the control was fitted with just a single cattle guard (Figure 3). Further details are presented in Flower (2016).

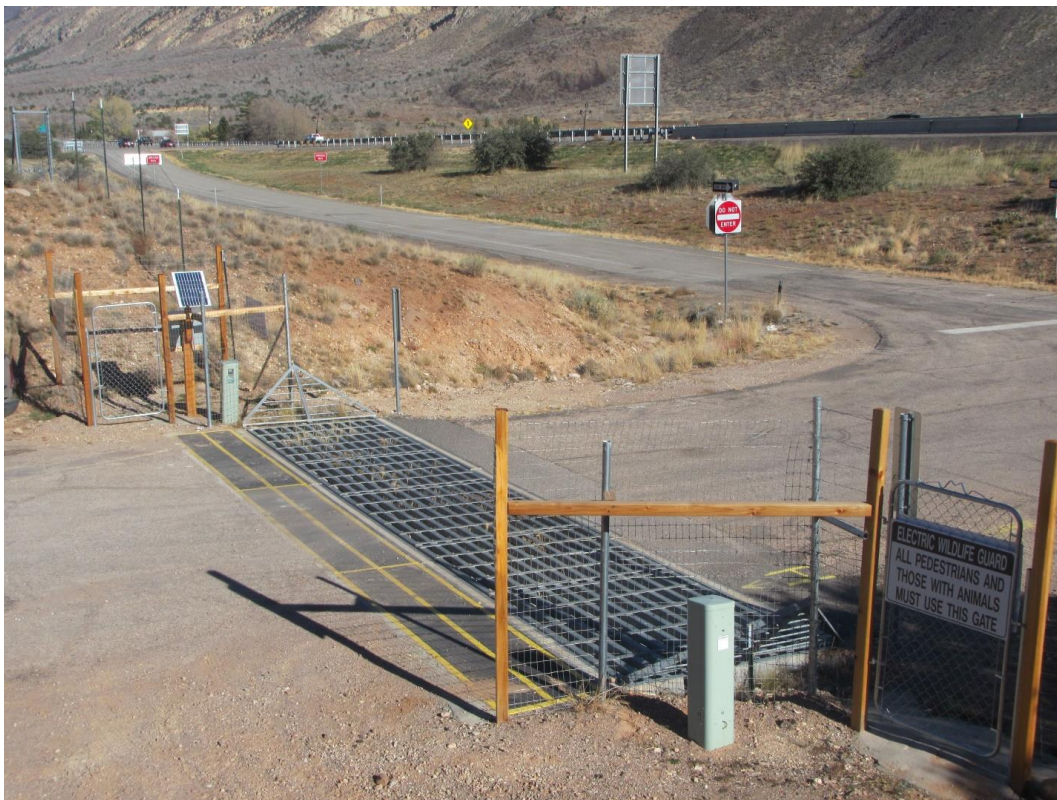
Figure 4. Cattle Guard Augmented with Electric Pavement 3 x 36 feet at West Access Road to I-15 at Exit 31, Near Pintura, Utah.

10,000. However, unlike the electric potential at electric pavements at Hardware, there was no electrical potential between the negative surface of the outside panel of the deterrent and the asphalt surface of the road, and only negligible potential (0.3 kV) between the positive surface of the deterrent and the surface of the road. To deter theft, components were located inside a steel box within an adjacent locked fenced area. A warning sign was installed advising pedestrians to use an adjacent gate in the fence (Figure 4. Cattle Guard Augmented with Electric Pavement 3 x 36 feet at West Access Road to I-15 at Exit 31, Near Pintura, Utah.

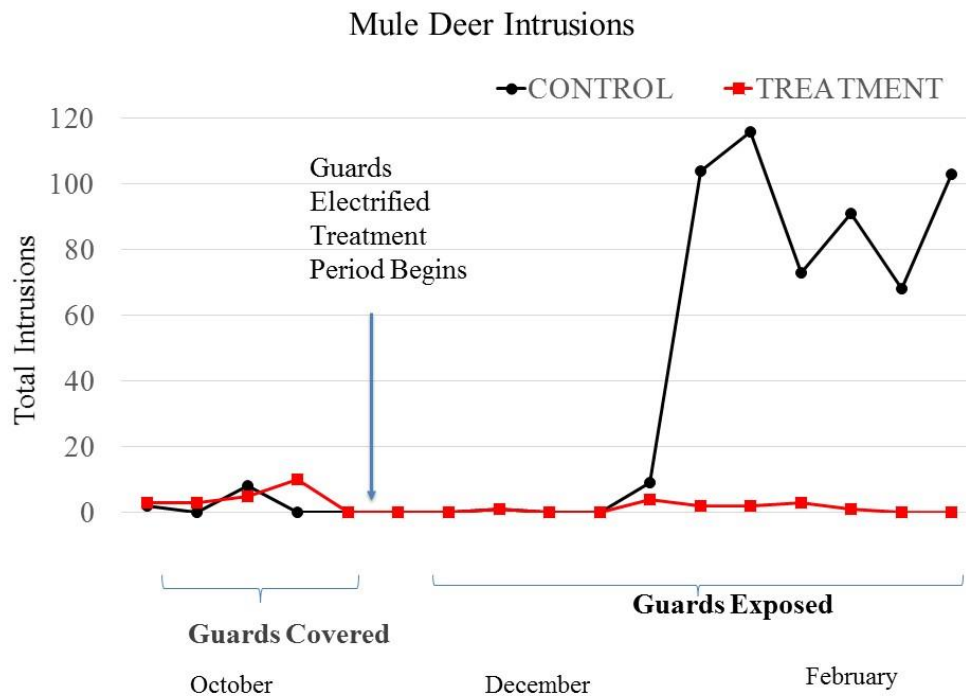
Figure 8. Weekly Mule Deer Breaches into Exclosures during Study.
Figure adapted from Flower, 2016.

eliminated across all sites until week 12, the end of 2014 and the start of 2015 and the beginning of winter, when intrusions increased dramatically at the control sites only (Figure 8). During the electric pavement treatment period, mule deer breached the electric pavement and single cattle guard sites 16 times, while mule deer breached the single cattle guard control sites 967 times.

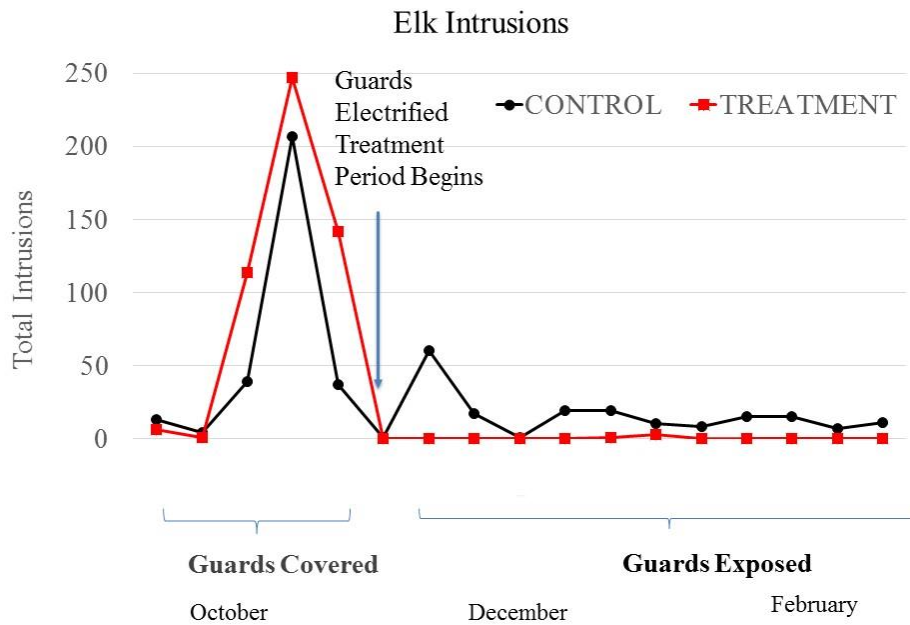
Figure 9. Elk Breaches into Exclosures during Study.
Figure adapted from Flower, 2016.

Elk appeared to be bold in using the exclosures during pre-treatment, and highly deterred once electricity was turned on in week six. Unlike mule deer, elk regularly entered baited feeding exclosures during the five-week pre-treatment period, with intrusions peaking in week 4 (Figure 9). When the deterrents were exposed in the treatment period, weekly elk intrusions were virtually eliminated at treated sites for the duration of the 17-week treatment period. However, elk intrusions at control sites occurred in nearly every week of the treatment period (Figure 9). During the treatment period, 200 elk intrusions were recorded into control sites compared with six, at treated sites.

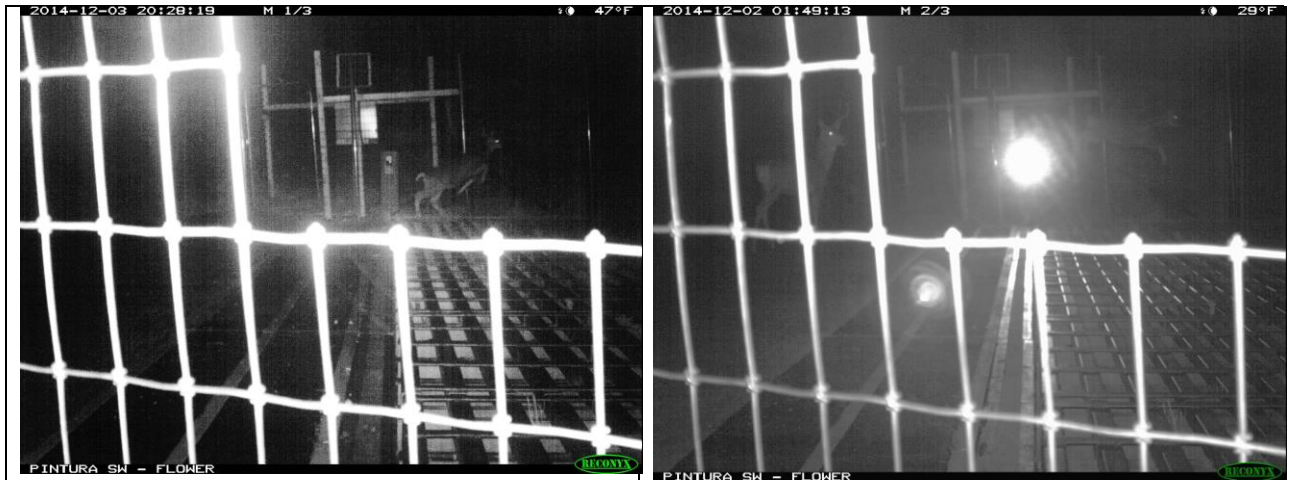
Figure 10. Mule Deer Used the Gap in Fencing Along North Side of Electric Pavement to Move to Road Right-of-Way at I-15, Pintura, Utah.

During pre-electric treatment of the west cattle guard, the east single cattle guard (the control site), was 62 percent effective in deterring the 74 individual mule deer movements. The west-cattle guard was monitored 2.5 months prior to the installation of the electric pavement on the guard. During that time, twice mule deer approached and were repelled. After the electricity was turned on at the west cattle guard, the east cattle guard was 49 percent effective at deterring the 61 mule deer movements. At the west cattle guard and electric pavement, monitoring from June 2014 to March 2015, 85 individual mule deer movements were documented near the pavement. Two types of behavior were eliminated from the final results at this west guard and electric pavement: animals breaching the electric pavement on the north edge where there was an eight-inch (20 cm) gap in the fencing (Figure 10), and inconclusive results. The electric pavement was then evaluated based on 36 individual mule deer movements. Thirteen times mule deer breached the pavement and guard, and 23 times they were repelled, for an overall effectiveness of 64 percent, see Figures 10 through 12, and Table 2.

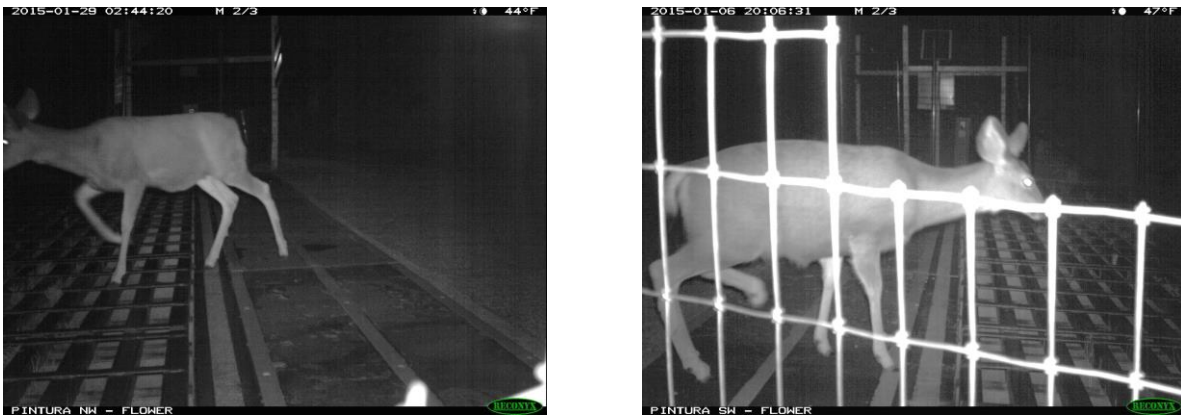
Figure 13. Two Examples of Mule Deer Does Walking Across I-15 Pintura Electric Pavement.

Mule deer jumped and walked across the electric pavement (Figures 13 through 16, below). It appeared in photos that often the mule deer felt or sensed the electricity, based on sudden jumping up or rearing up behaviors. The four figures below help to evaluate how the electric pavement and asphalt in front of the pavement may have worked.

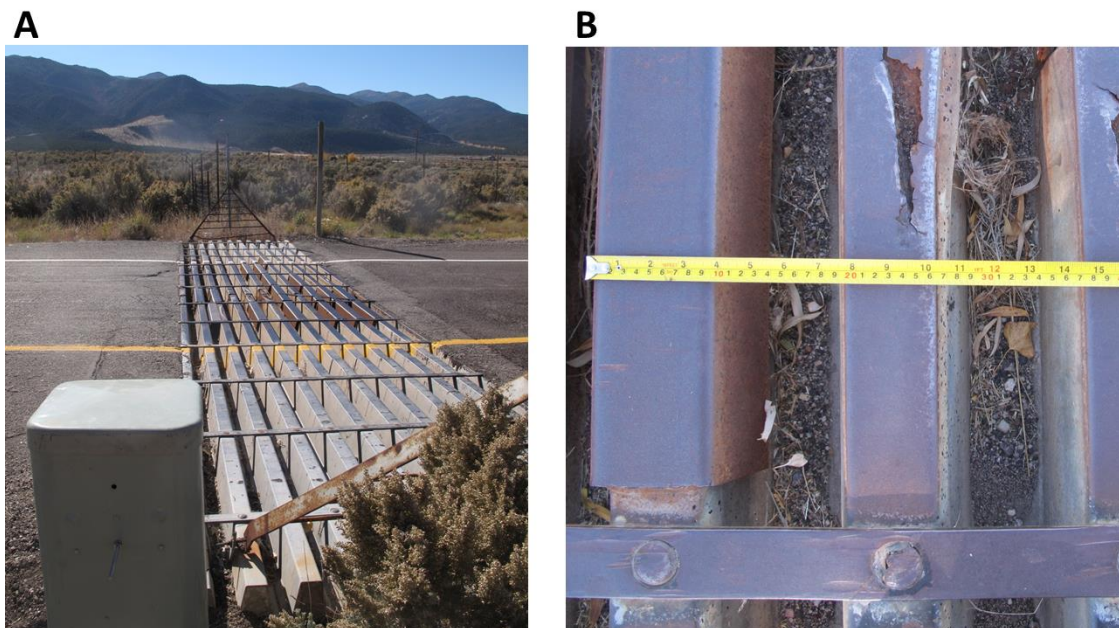
Figure 18. Cattle Guard (6.2 feet by 31.8 feet, 1.9 m \times 9.7 m) With No Excavation Pits, (A) and Close View of Cattle Guard Rails (B), on an access road to Interstate 15, MP 71, Near Summit, Utah.

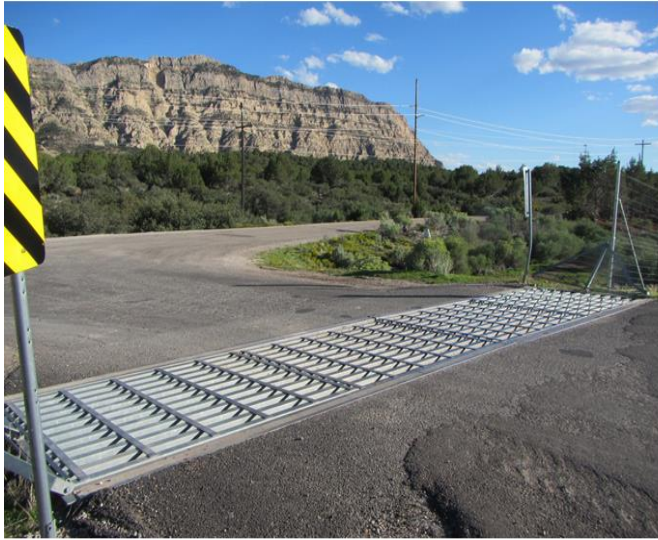
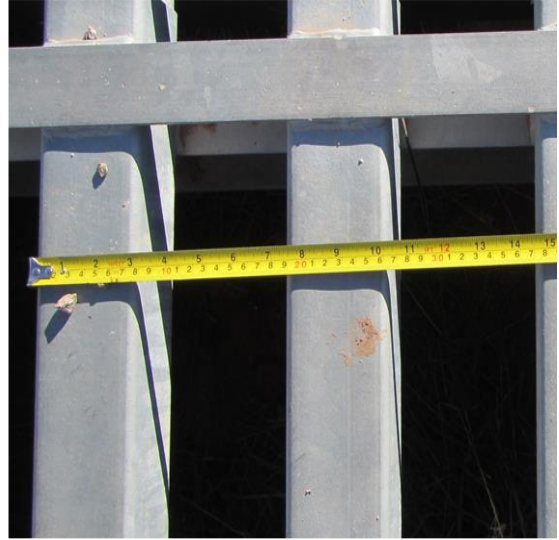
Figure 19. Standard Cattle Guard, 6.9 feet x 36 feet (2.1 m × 11 m), over Excavation Pit (A), and Close View of Cattle Guard Rails (B) on an Access Road to Interstate 15, MP 31, Near Pintura, UT.
Taken from Flower 2016.

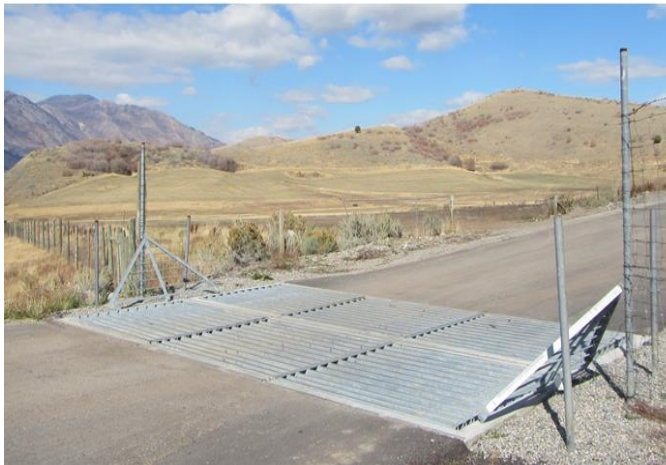
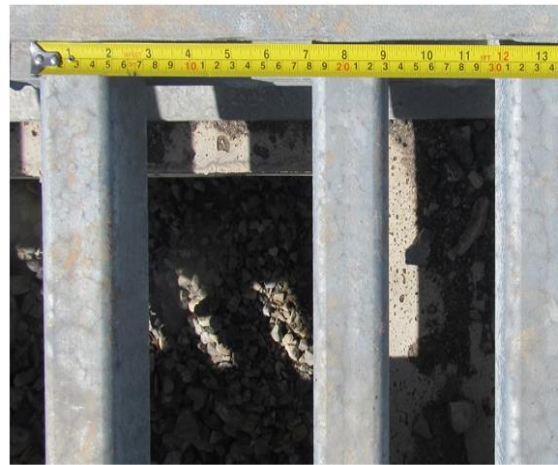
Figure 20. Double Cattle Guard (15 feet by 33 feet, 4.6 m × 7 m) Suspended over Excavation Pit (A), and Close View of Cattle Guard Rails (B), on an Access Road to U.S. Highway 91, MP 11, North of Mantua, Utah.
Taken from Flower 2016.

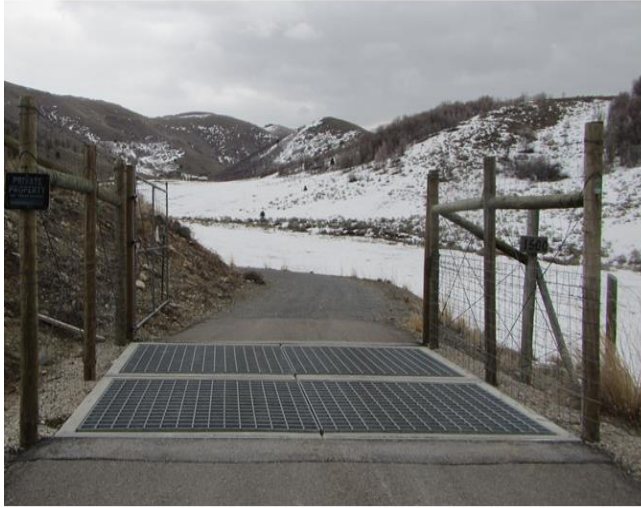
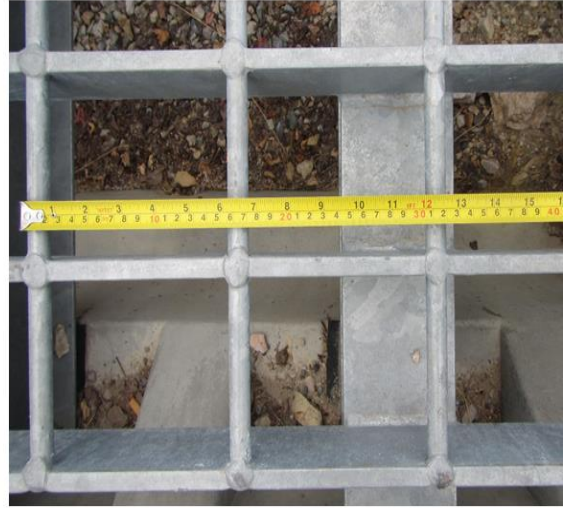
Figure 21. Wildlife Guard (16 by 16 feet, 4.9 m × 4.9 m) Suspended Over Excavation Pit (A), and Close View of Steel Grating (B) on an Access Road to U.S. Highway 91, MP 6, near Mantua, Utah.
Taken from Flower 2016.

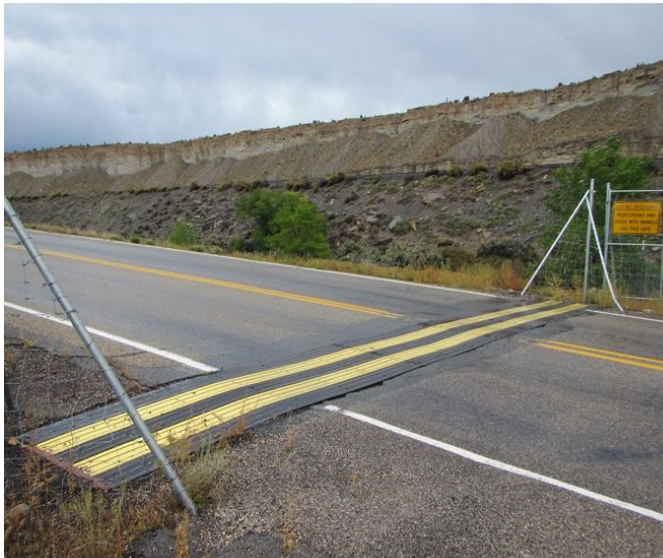
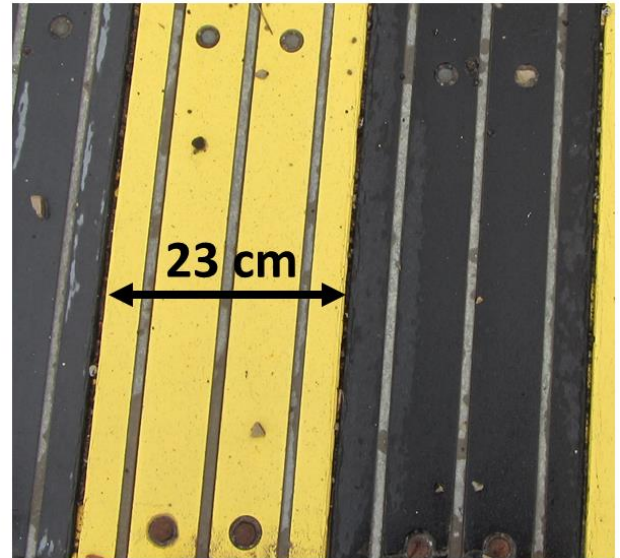
Figure 22. Electrified Mat (4 feet by 36 feet, 1.2 m × 11 m, A) and Close View of Composite Planks with Embedded Metal Electrodes (B), on an Access Road to U.S. Highway 6, MP 236, Near Helper, Utah.

This research found the electric mats to be ineffective. Like Siepel et al. (2013), this study found two electrified mats deployed along US 6 to be poor barriers to mule deer

movement. The two electrified mats monitored were confirmed operational during monitoring and in use according to the manufacturer recommended pulse-rate settings (1.5-seconds between electrical pulses). Although Seamans and Helon (2008) found strong effectiveness of electrified mats under experimental conditions using feed bait as a reward, this study's results corroborate those from Siepel et al. (2013) and suggest limited effectiveness of electrified mats in a real-world setting along a road with over 10,000 AADT.

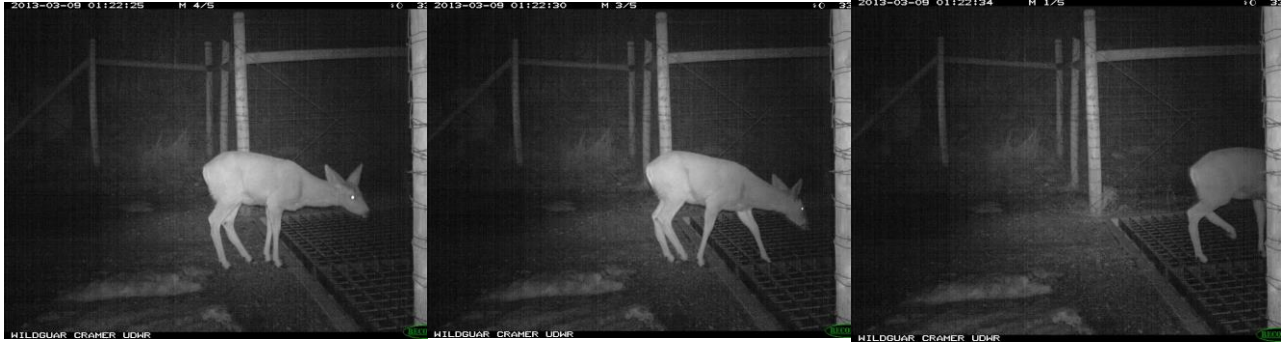
Figure 24. Mule Deer Breached US 91 Wildlife Guard by Walking on the Cross Bars and Support Beams.

Mule deer methods of breaching barriers occurred by the animals jumping over, walking across, or by moving along the edge of the barrier, where adjacent wildlife exclusion fencing formed a junction with the barrier (Figures 24-27). Walking across barriers was the most common method of breaching barriers, with 264 individual mule deer breaches recorded with this method. Most deer that breached double cattle guards and electrified mats walked across them (52 percent and 98 percent, respectively). The second most common method to breach barriers was through jumping over the barrier (n=232). Eighty percent of all recorded jumps by individuals occurred at the single cattle guards without excavation pits. Much less common were where individuals walked along the edge of barriers (n=43) or method of breaching was inconclusive (n=42). However, nearly 25 percent of recorded deer breaches at standard cattle guards occurred at the barrier edge, where guard apron wings were common (triangular metal structures installed at the margins of cattle guards). Similarly, most mule deer that breached wildlife guards (52 percent) crossed at the barrier edge, often on a narrow concrete frame exposed between the steel grid and the adjacent wildlife fencing, see Table 5.

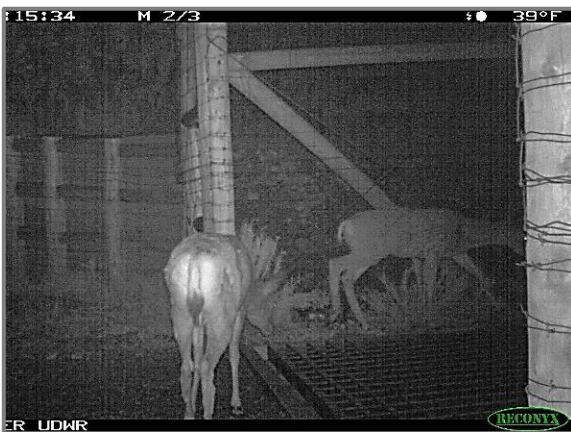
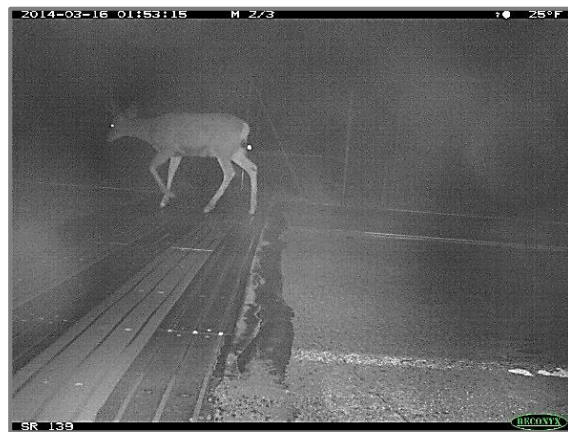
Figure 26. Mule Deer Walked Along Edge of Wildlife Guard on US 91, Left, and Walked Across Top of Electric Mats near US 6, Right.
