Report No. UT-17.16

TESTING NEW TECHNOLOGY TO RESTRICT WILDLIFE ACCESS TO HIGHWAYS: PHASE 2

Final Report

August 2017

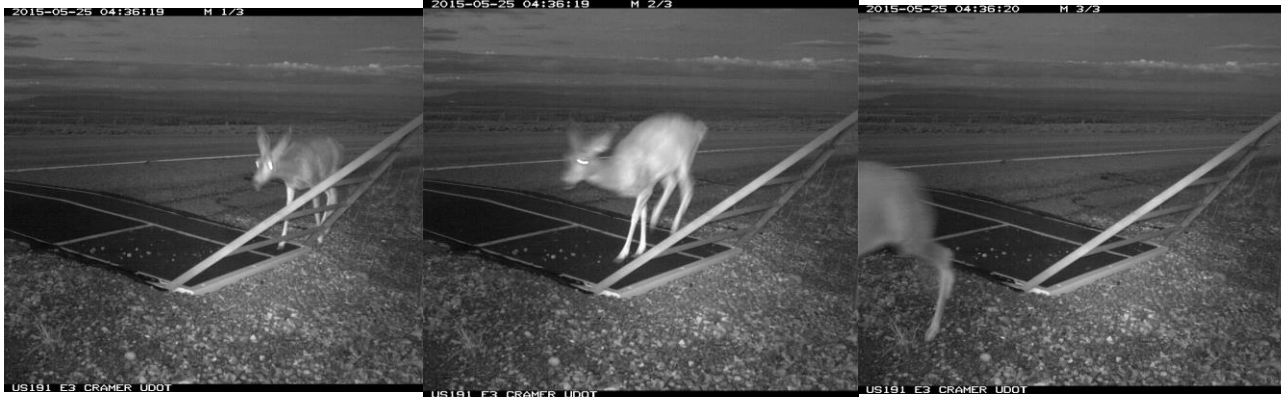
Figure 2. Mule Deer Breach Movement at US 191 Electric Pavement.

Photos revealed that mule deer often jumped over the three-foot wide (0.9 m) electric pavement in front of the single cattle guard on I-15, and the six-foot wide (1.8 m) pavement in US 191. If mule deer perceive they can avoid shock by jumping, they will continue to try to breach such installations. If they land on wider strips of electric pavement with these jumps, they may turn and repel. Future electric pavement installations will need to explore deployment with wider widths. There is also the potential to alternate electrically charged strips of pavement with asphalt over a wider area that may deter the animals.

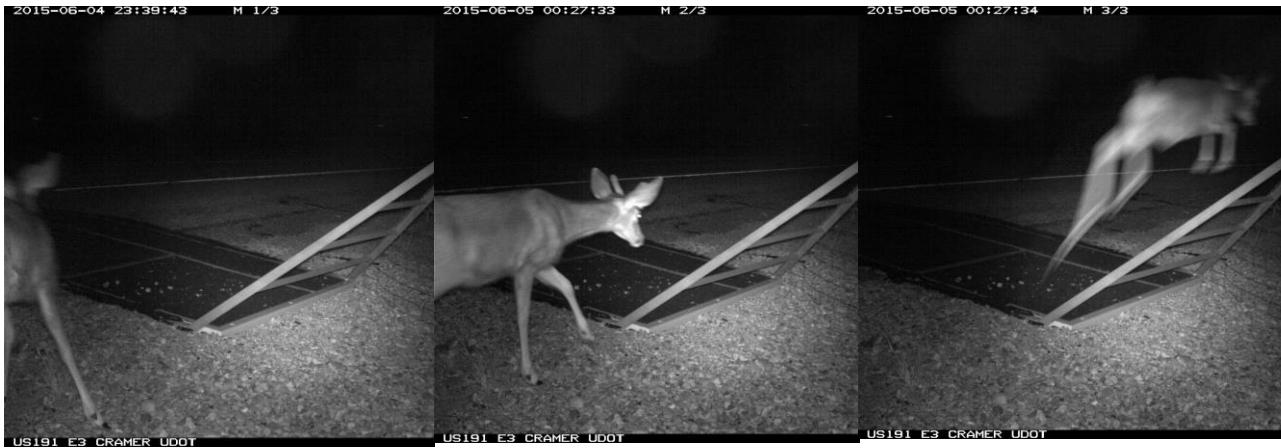
Figure 3. Mule Deer Escape Movement at US 191 Electric Pavement.

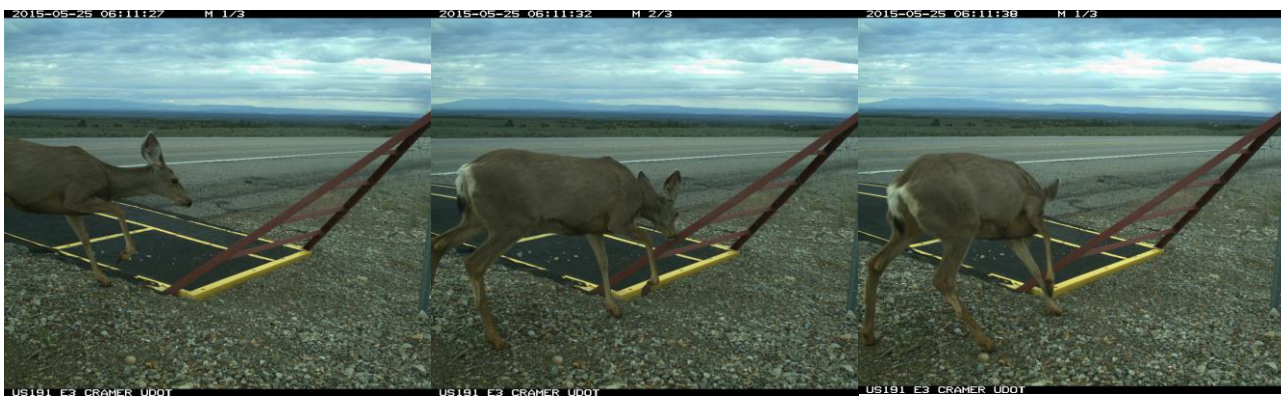
Figure 4. Mule Deer Escape Repellency at US 191 Electric Pavement

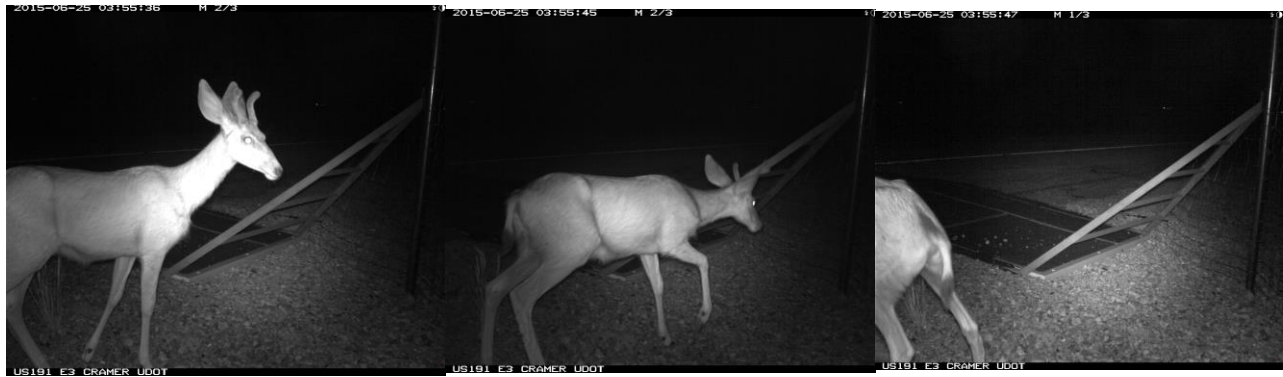
Figure 5. Mule Deer Escape Repellency at Electric Pavement US 191.

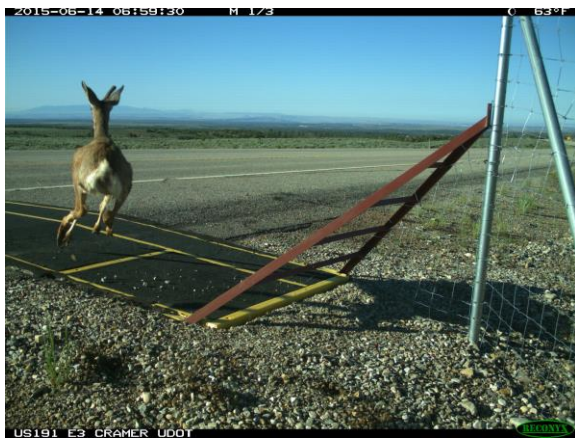
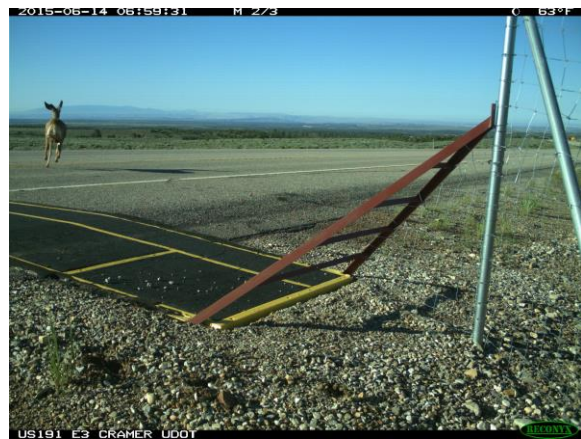
Figure 6. Mule Deer Escape Movement at US 191 Electric Pavement.

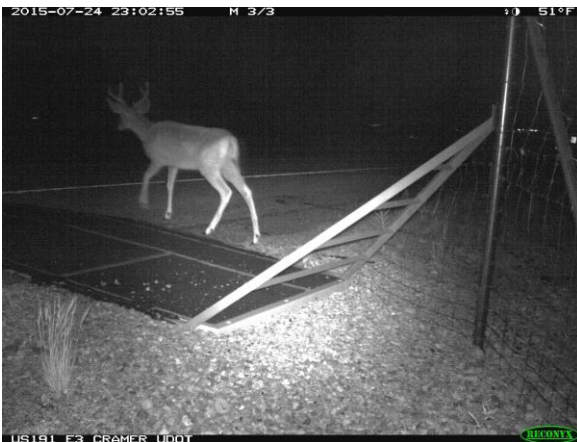
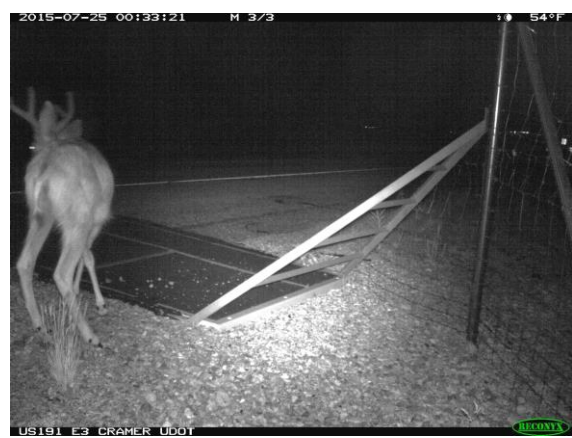
Figure 7. Left, Mule Deer Parallel Movement; Right, Mule Deer Escape Repellency Movement at US 191 Electric Pavement.

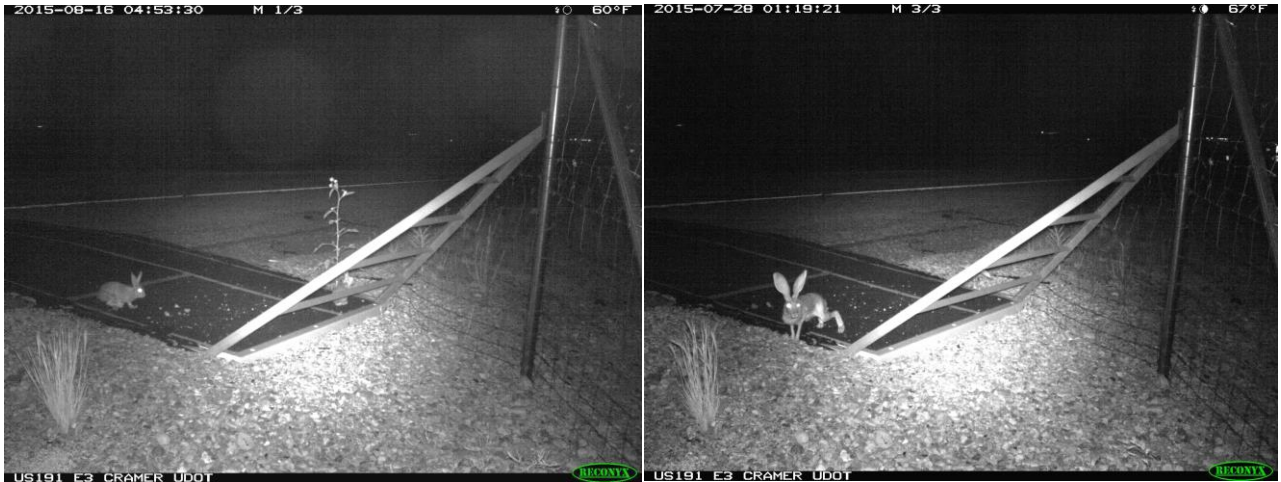
Figure 8. Examples of Rabbits Interacting with Electric Pavement on US 191.

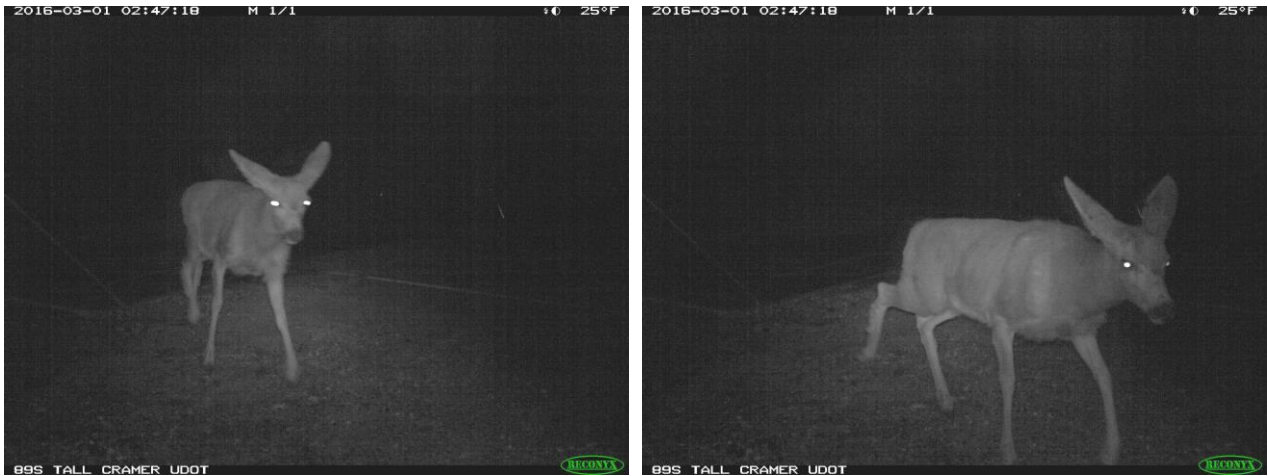
Figure 9. Mule Deer Escape Movement at US 89 Electric Pavement.

There was only one interactive mule deer movement photographed at the US 89 electric pavement, and it originated from inside the fenced area. Because of this, a percent effective calculation is not applicable, and escape rate and overall impermeability calculations do not have any real meaning. Thus, we cannot say how these rates compare to the established performance measure of 87 to 94 percent effective for wildlife guards and double cattle guards. The nine percent ratio of deer at the electric pavement to deer at the fence ends is similar to the 12 percent ratio at US 191. Both values demonstrate that deer were not trying to enter the fenced area in large numbers. These values do not indicate that barriers at fence ends are not important, but that they may not be important in these two locations. Future studies could determine if this trend is true for other locations.

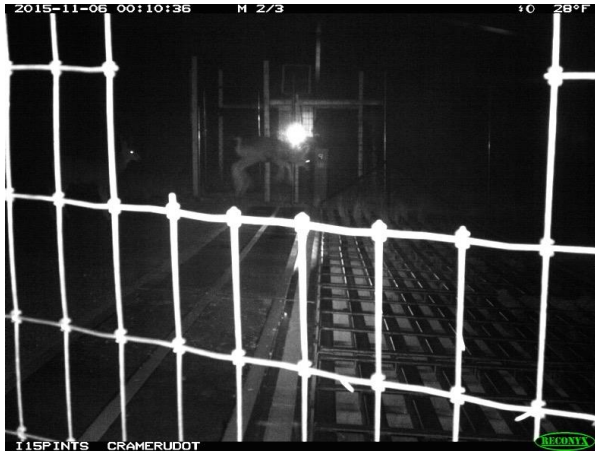
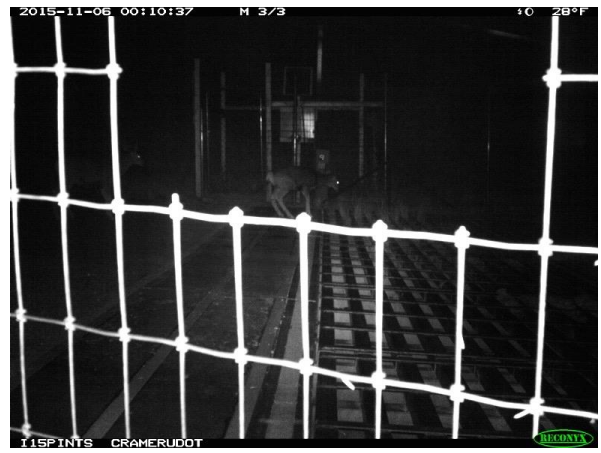
Figure 10. Mule Deer Fawn and Doe Repellency Movements at I-15 Cattle Guard and Electric Pavement.

Sample photos from the I-15 Exit 31 installation of electric pavement with a single cattle guard are presented in chronological order in Figures 10 through 18 below to assist the reader in evaluating how the deer interacted with the electric pavement.

Analysis of mule deer behaviors in the photos allowed researchers to evaluate how animals perceived and reacted to electric current. When a mule deer had hooves on the asphalt and the first electric pavement panel, which was negatively charged, most mule deer appeared not to react to the pavement. This agrees with the lack of measured electrical potential between the asphalt and the first panel of electric pavement found in Phase 1. When deer placed their hooves on both the outside negatively-charged surface and the positively-charged surface, animals appeared to react to the current. Some mule deer appeared to jump forward, some bucked their rear legs up as they moved forward, while others turned around. Overall, most animals were in a forward motion when they received electric stimulus and had a tendency to continue in the direction they were headed, toward the inside of the fenced area. Other mule deer appeared to detect something about the electric pavement without stepping on it, and repelled.

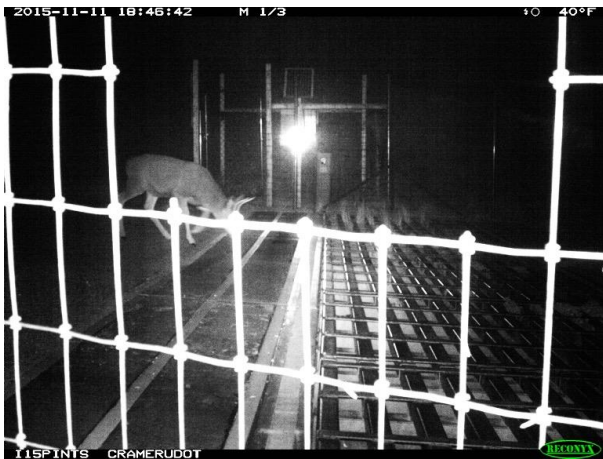
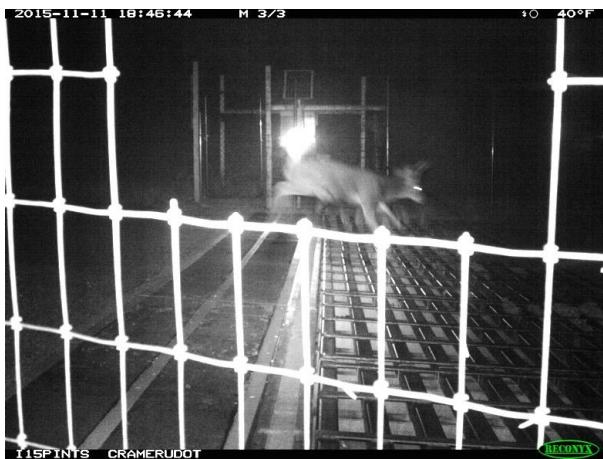
Figure 11. Mule Deer Breach of I-15 Electric Pavement and Single Cattle Guard.

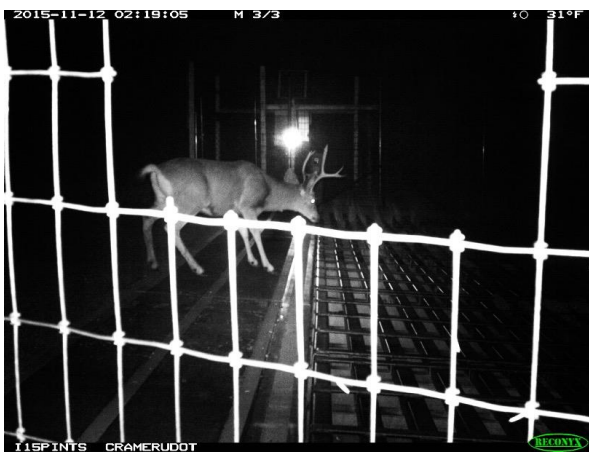
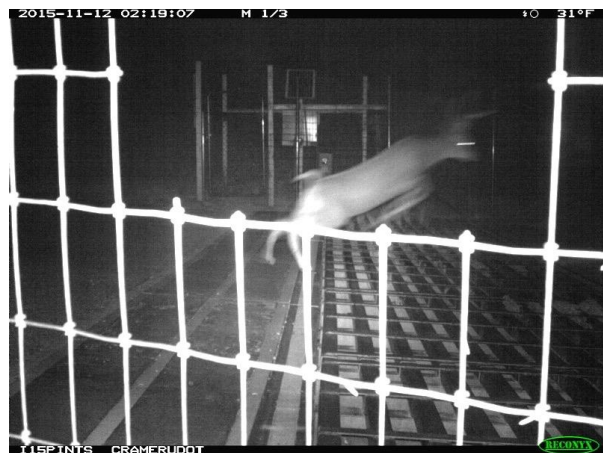
Figure 12. Mule Deer Breach of I-15 Electric Pavement and Single Cattle Guard

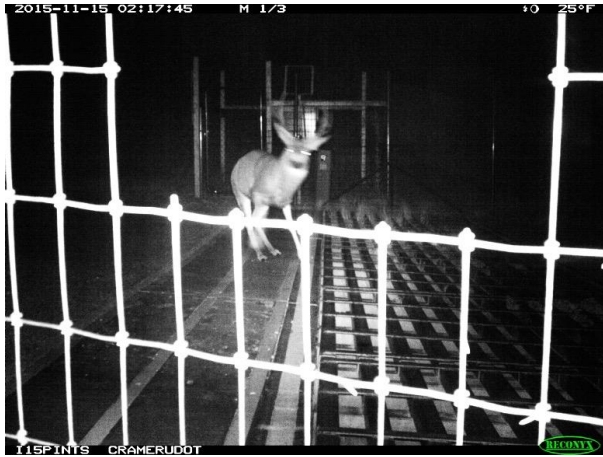
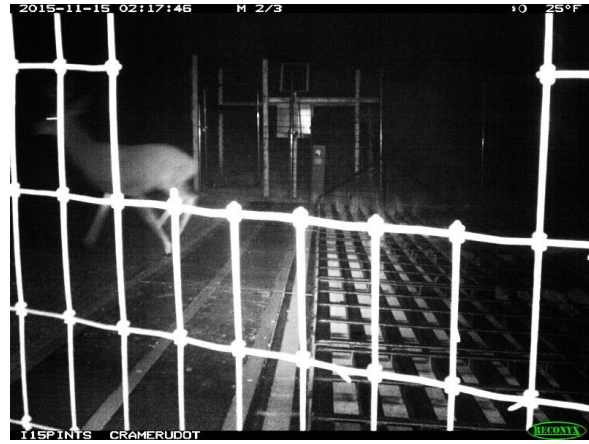
Figure 13. Mule Deer Repellency Movement at I-15 Electric Pavement and Cattle Guard.

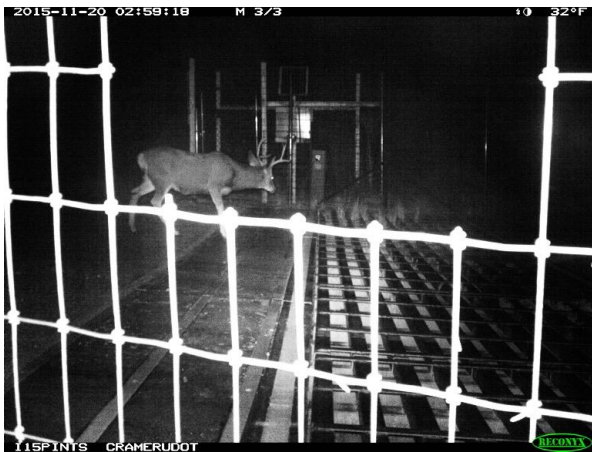
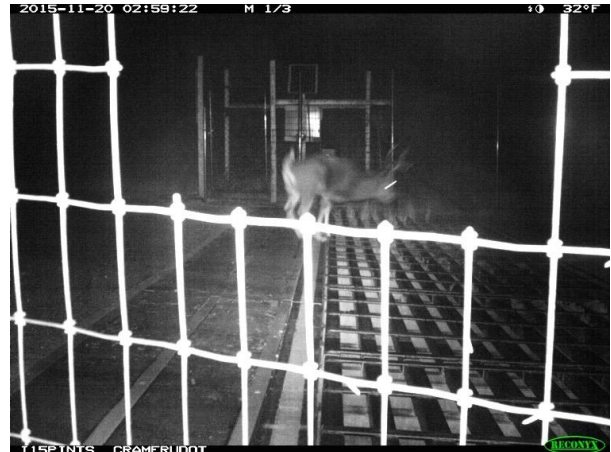
Figure 14. Mule Deer Breach Movement at I-15 Electric Pavement and Cattle Guard.

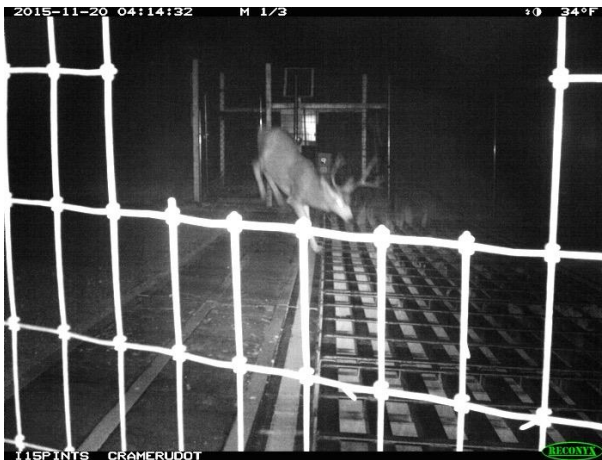
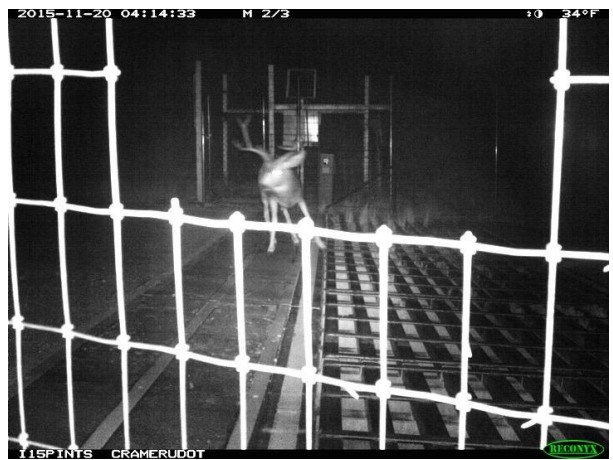
Figure 15. Mule Deer Repellency Movement at I-15 Electric Pavement and Cattle Guard.

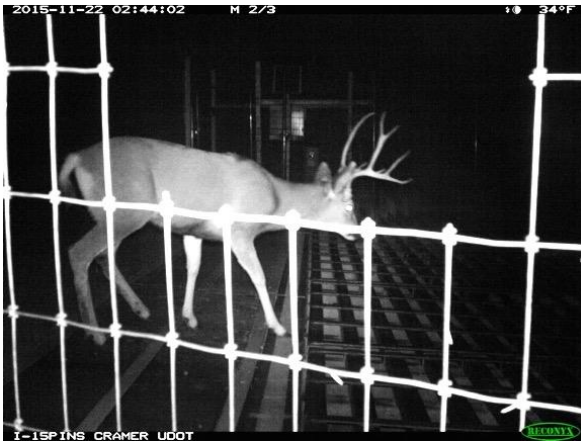
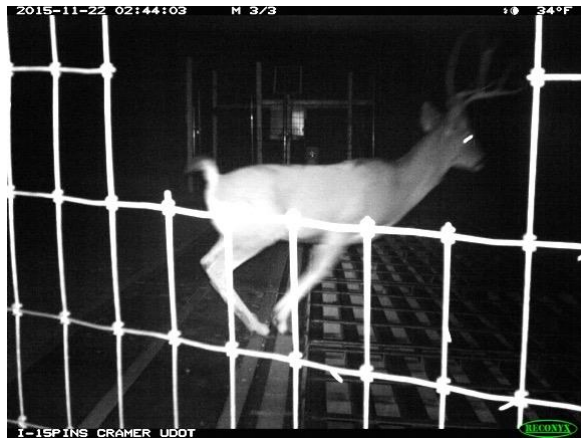
Figure 16. Mule Deer Breach Movement at I-15 Electric Pavement and Cattle Guard.

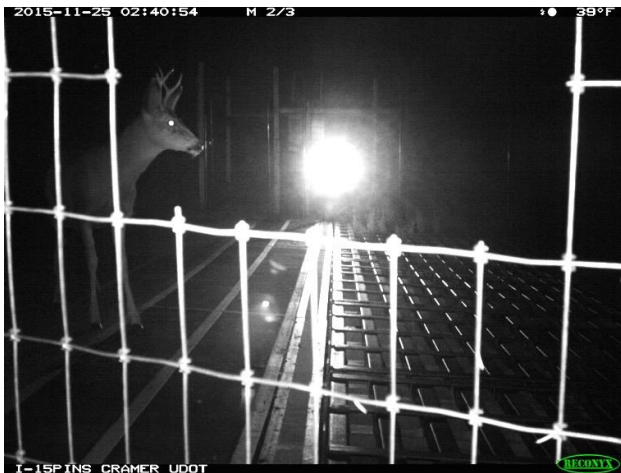
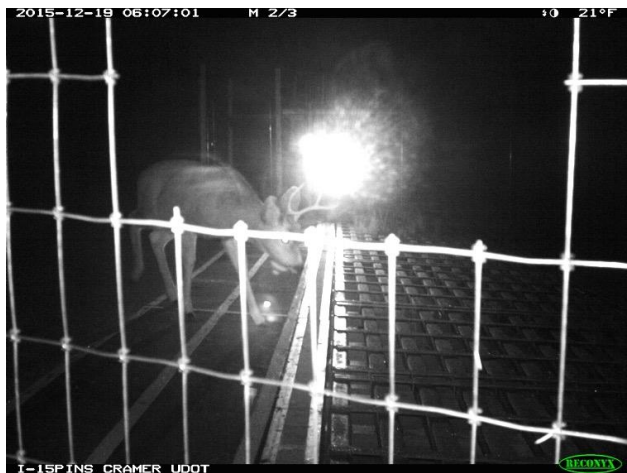
Figure 17. Left Mule Deer Repellency Movement; Right, Mule Deer Breached I-15 Electric Pavement and Cattle Guard.

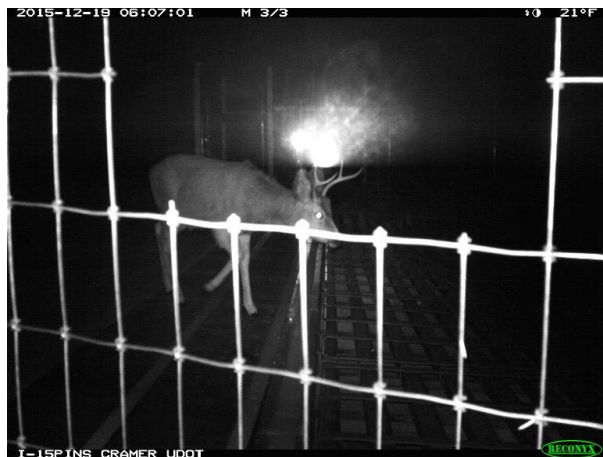
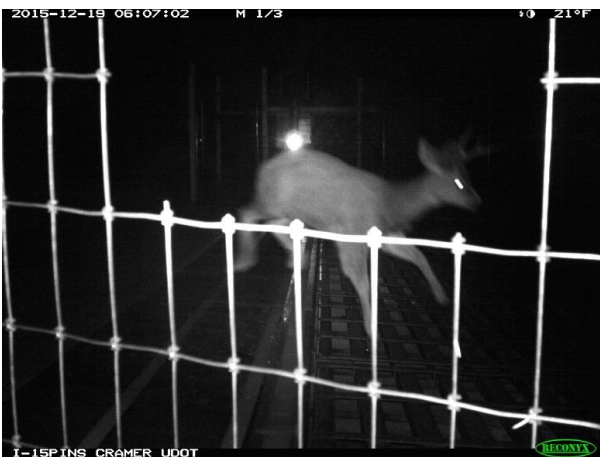
Figure 18. Mule Deer Breach Movement at I-15 Electric Pavement and Cattle Guard.
