Slope Stabilization Using Recycled Plastic Pins Phase III

FINAL REPORT

RI98-007D

by
J. Erik Loehr, Ph.D.
Assistant Professor of Civil Engineering
and
John J. Bowders, Ph.D., P.E.
Professor of Civil Engineering

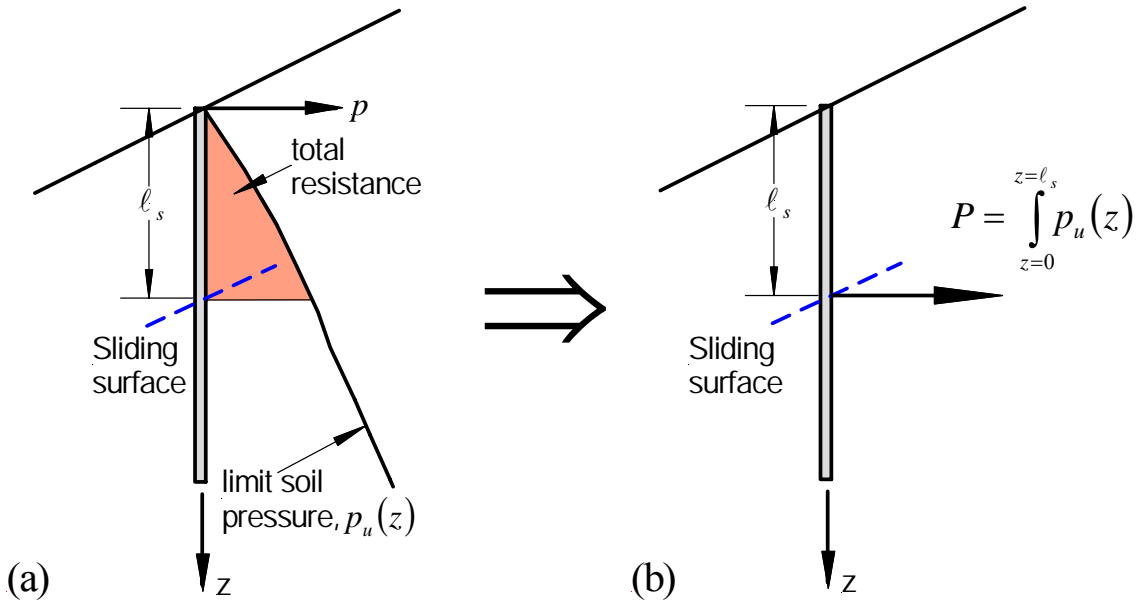
Figure 2.6 Schematic illustrating calculation of limit resistance force: (a) limit soil pressure and (b) equivalent lateral resistance force

in Figure 2.7. A limit resistance curve describing the magnitude of the limit lateral resistance as a function of position along the reinforcing member for Failure Mode 1 is shown in Figure 2.8.

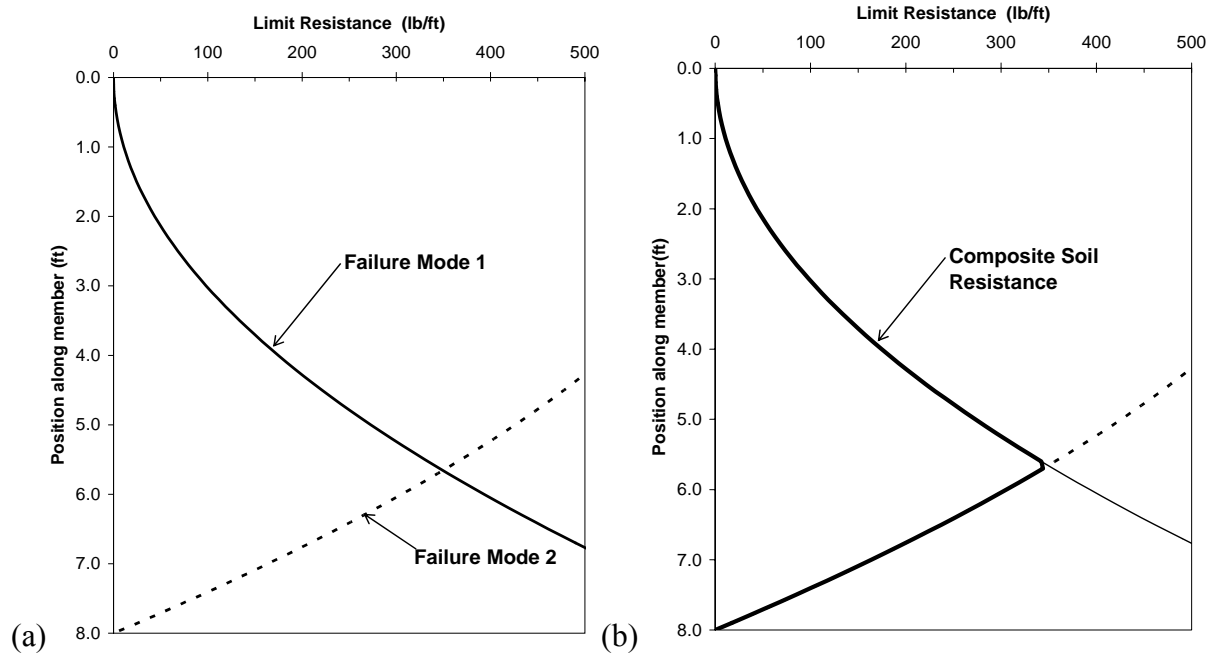
Figure 2.11 Determination of composite resistance based on failure of the soil: (a) Limit resistance curves of Failure Modes 1 and 2 and (b) composite limit resistance curve of Failure Modes 1 and 2.

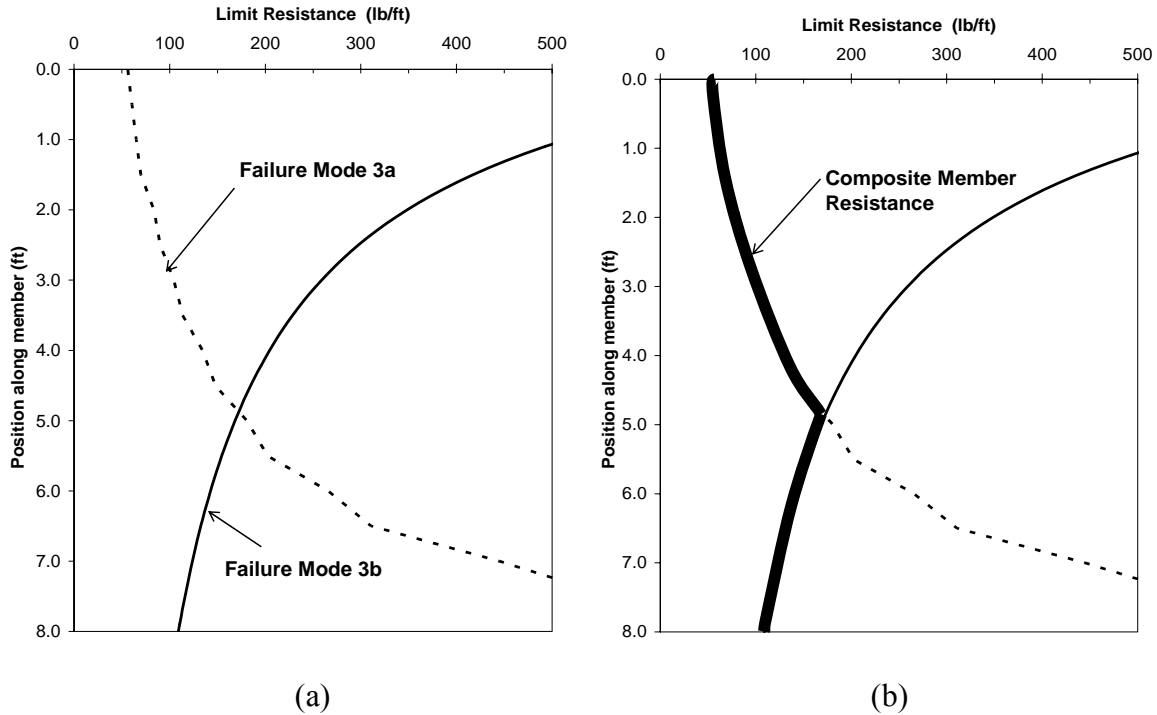
Figure 2.17 Limit resistance for structural failure of member in bending: (a) limit resistance of Failure Modes 3a and 3b and (b) composite member resistance

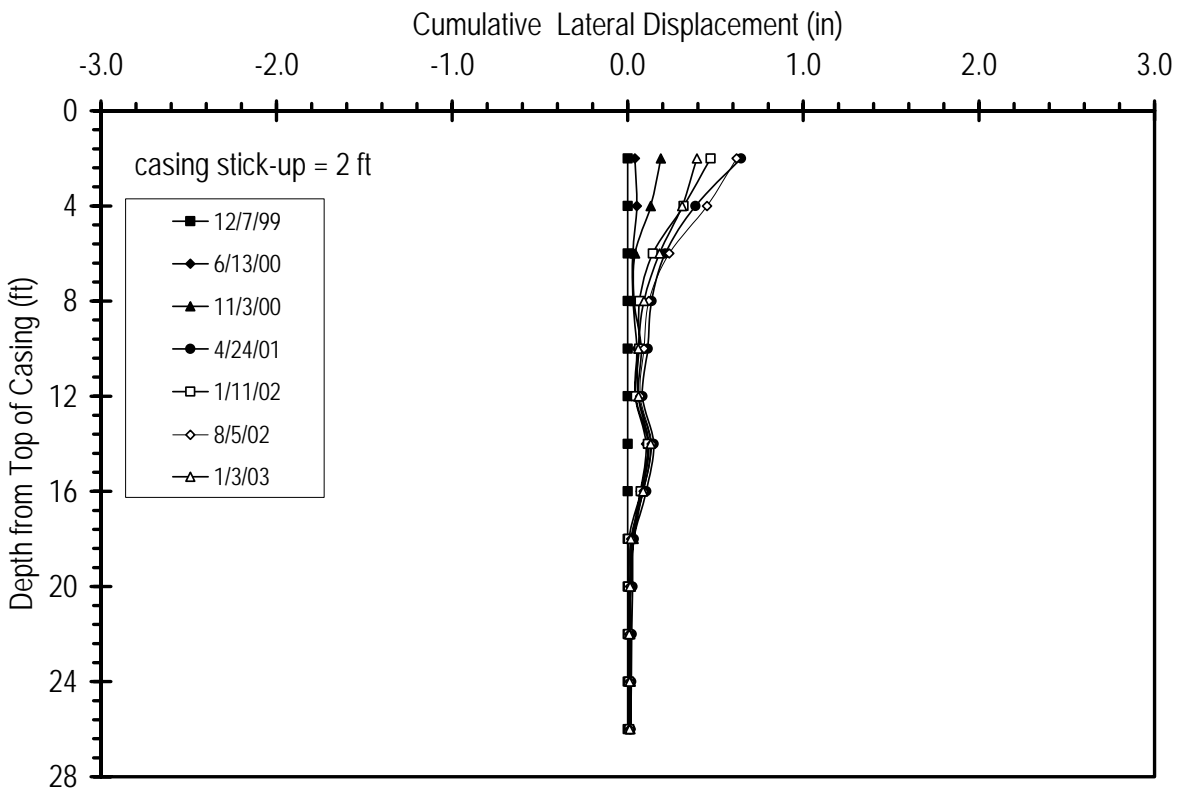
Figure 6.12 Lateral deflection profile for inclinometer I-2 in slide area S1 at I70-Emma site.

Figure 6.12 shows the lateral deflection profile determined from inclinometer I-2 in slide area S1 at the I70-Emma site. Other inclinometers showed generally similar profiles. However, some problems were experienced with some inclinometers indicating significant “up-slope” movements at depth. These “movements” are attributed to movement of the casing within the borehole as a result of inadequate backfilling of the casings rather than actual movements in the slope. As a result of these problems, inclinometer measurements have been somewhat scattered over time. As shown in the figure, movements have generally been greatest near the ground surface with continuously decreasing movements with depth. This trend was consistent among the remaining inclinometers, although the magnitudes of the overall movements varied somewhat.

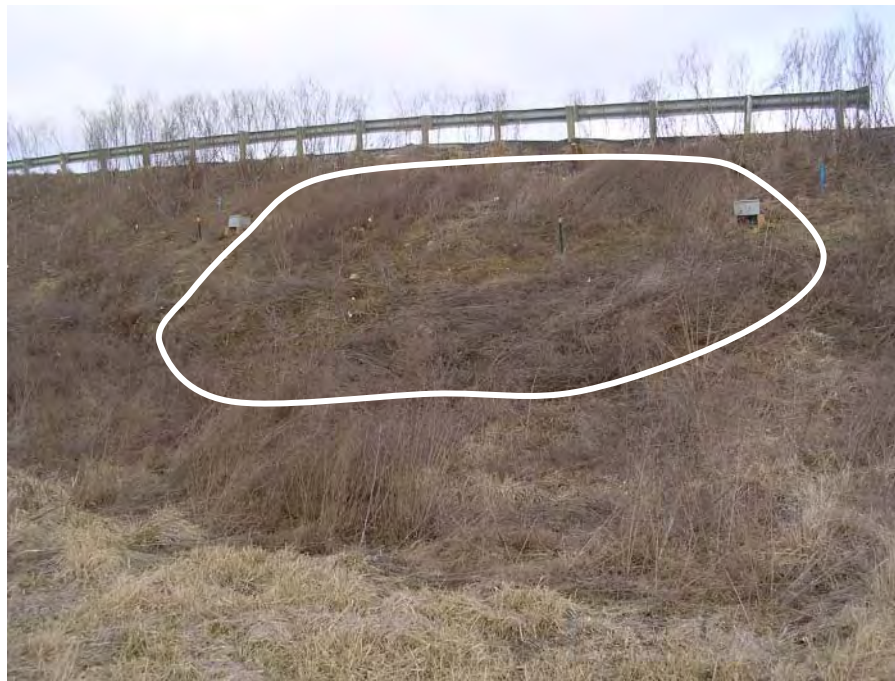
Figure 6.23 Observed failure in slide area S3 at I70-Emma site on January 27, 2005.

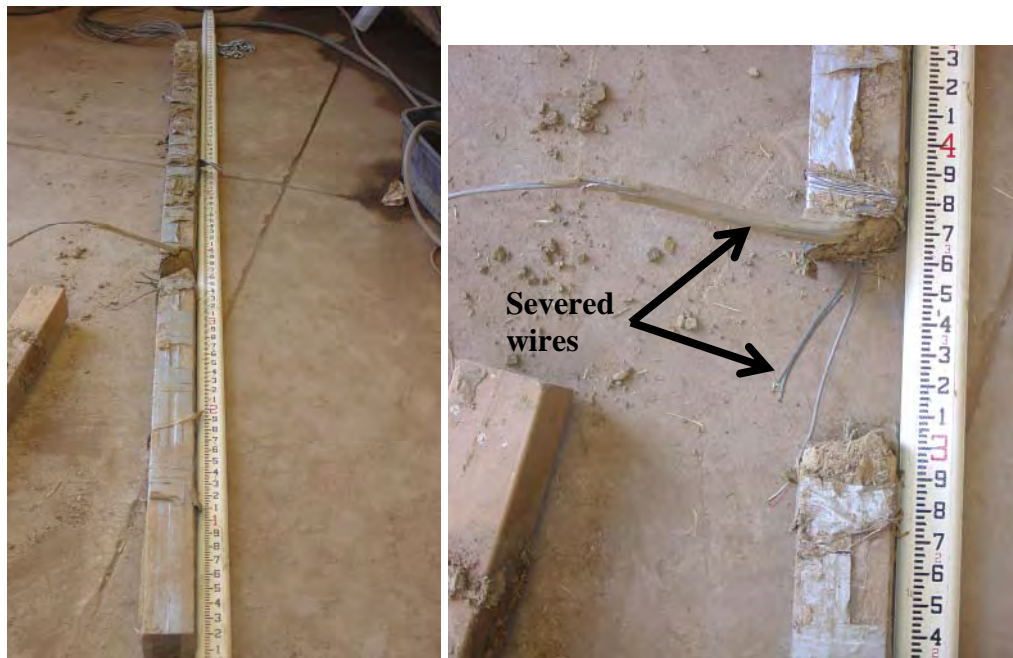
Figure 6.30 Photographs of member IM-18 after excavation: (a) complete member and (b) close up of the failure surface.

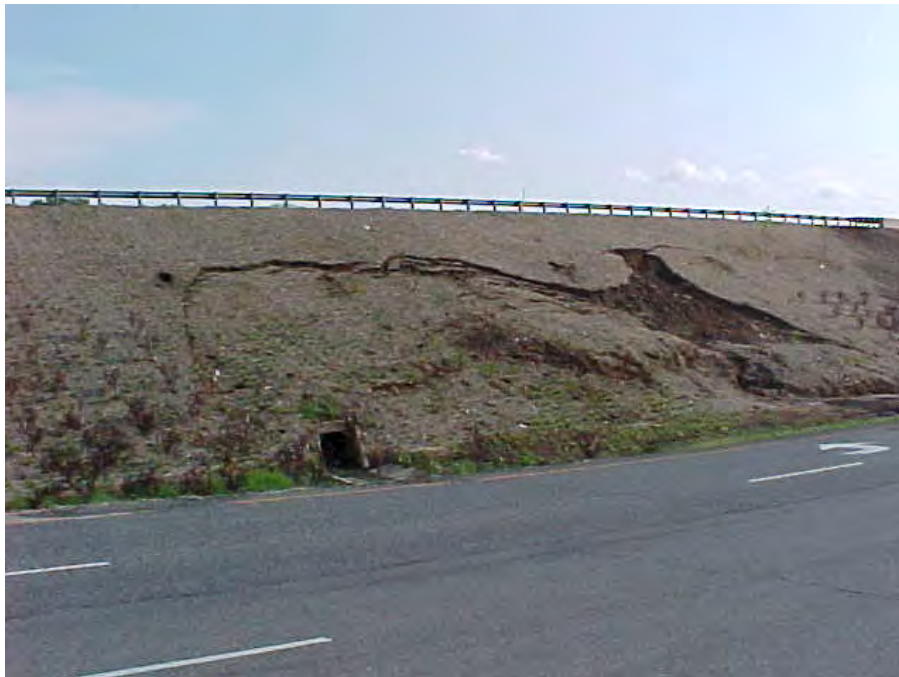
Figure 7.2 Photograph of most recent slide at I435-Wornall Road test site, June 20, 2001.

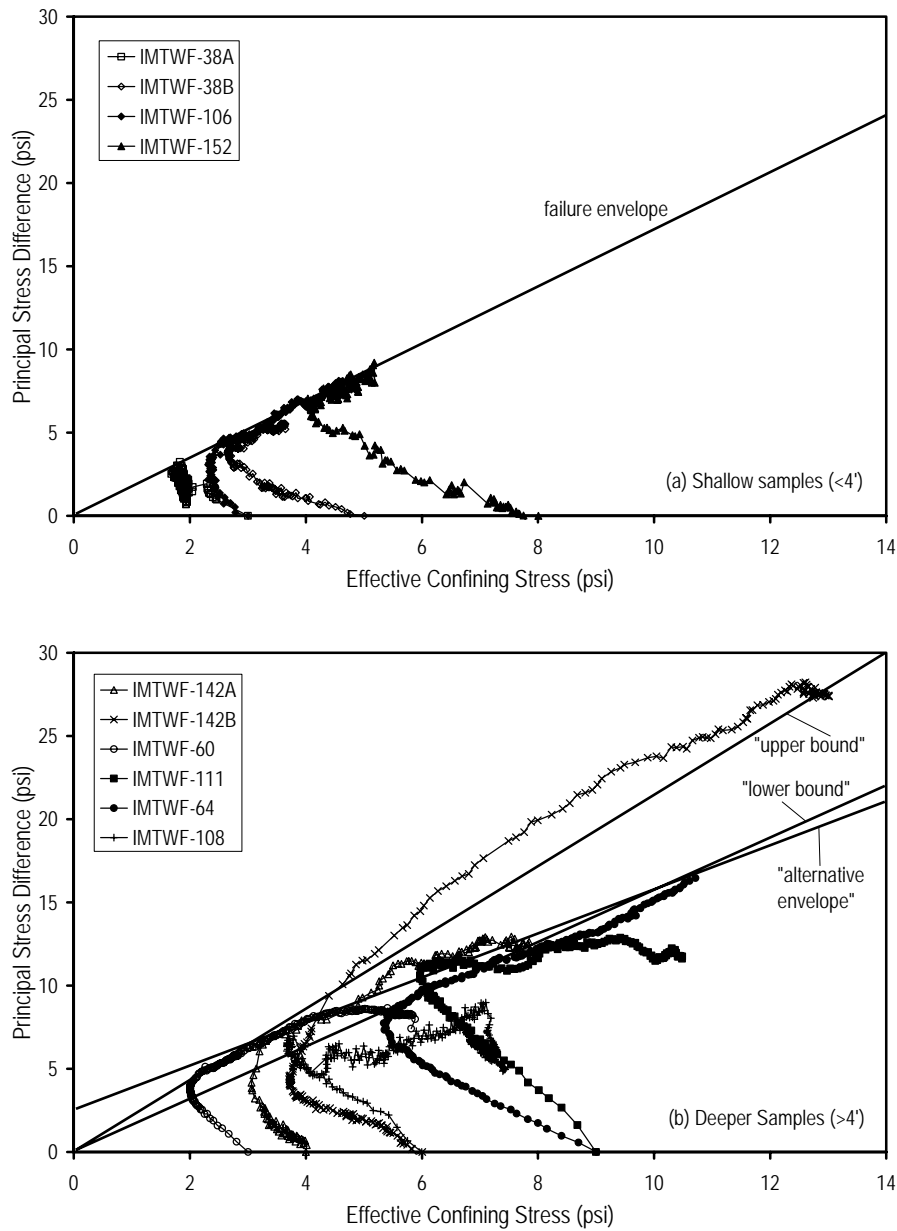
Figure 7.3 Summary of triaxial test results for specimens from I435-Wornall Road site: (a) shallow samples and (b) deeper samples.

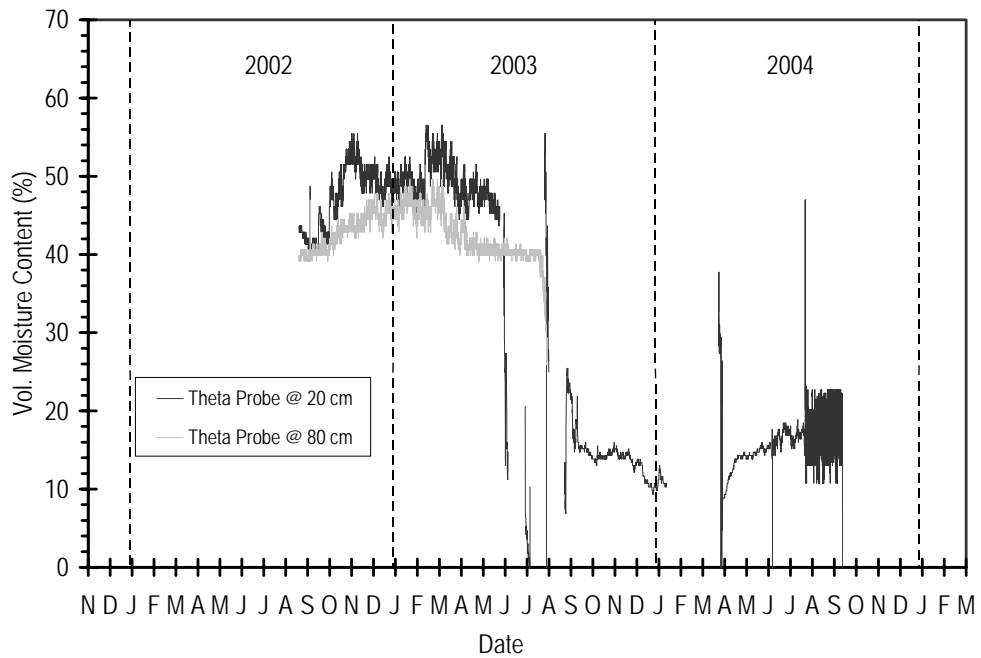
Figure 7.14 Volumetric water content from I435-Wornall Road test site.

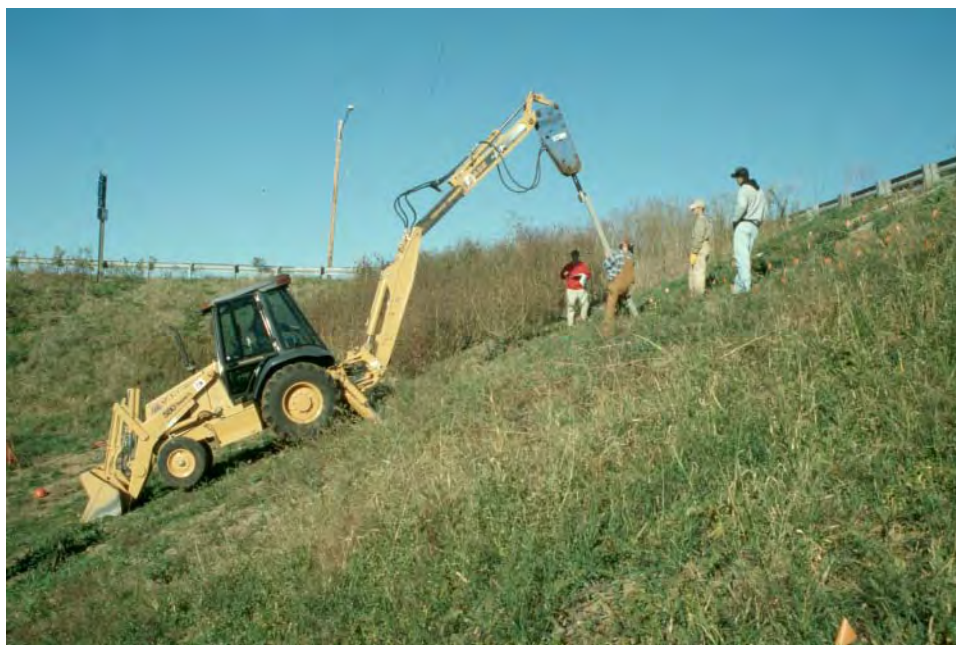
Figure 10.1 Backhoe mounted hammer used for initial installation attempts at the I70-Emma test site during Phase I.

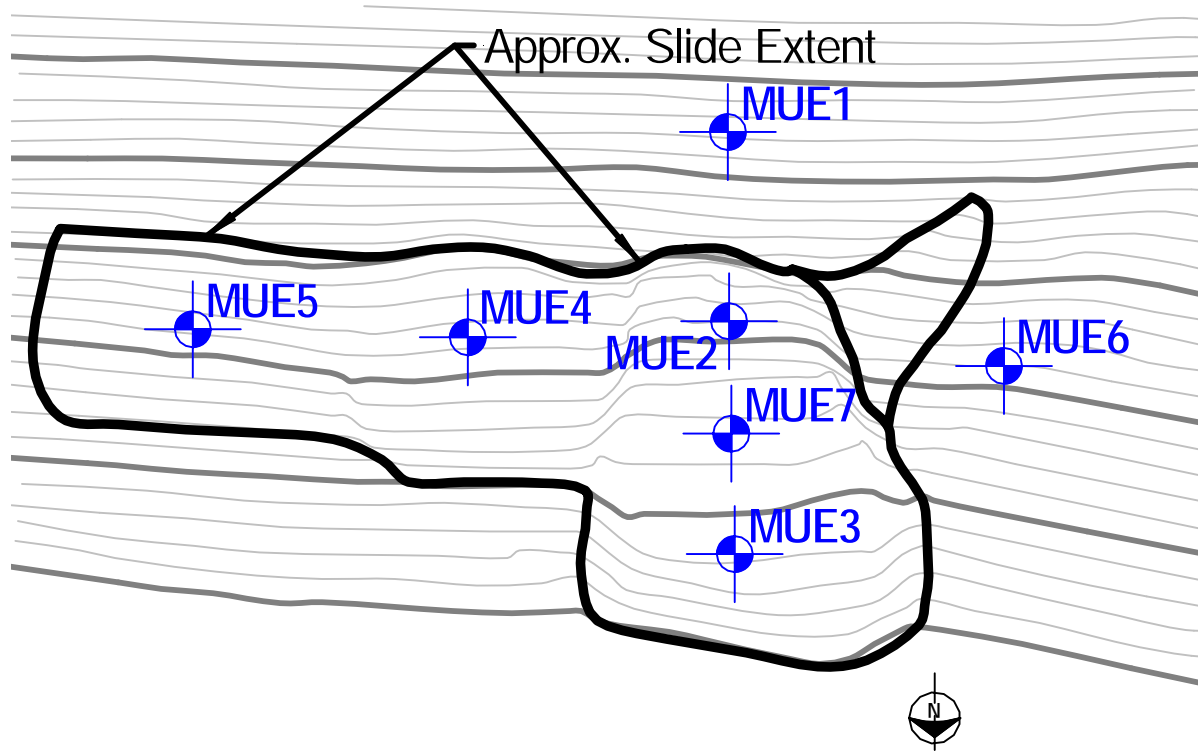
Figure B.1 Plan view of I435-Wornall Road site showing approximate boring locations.

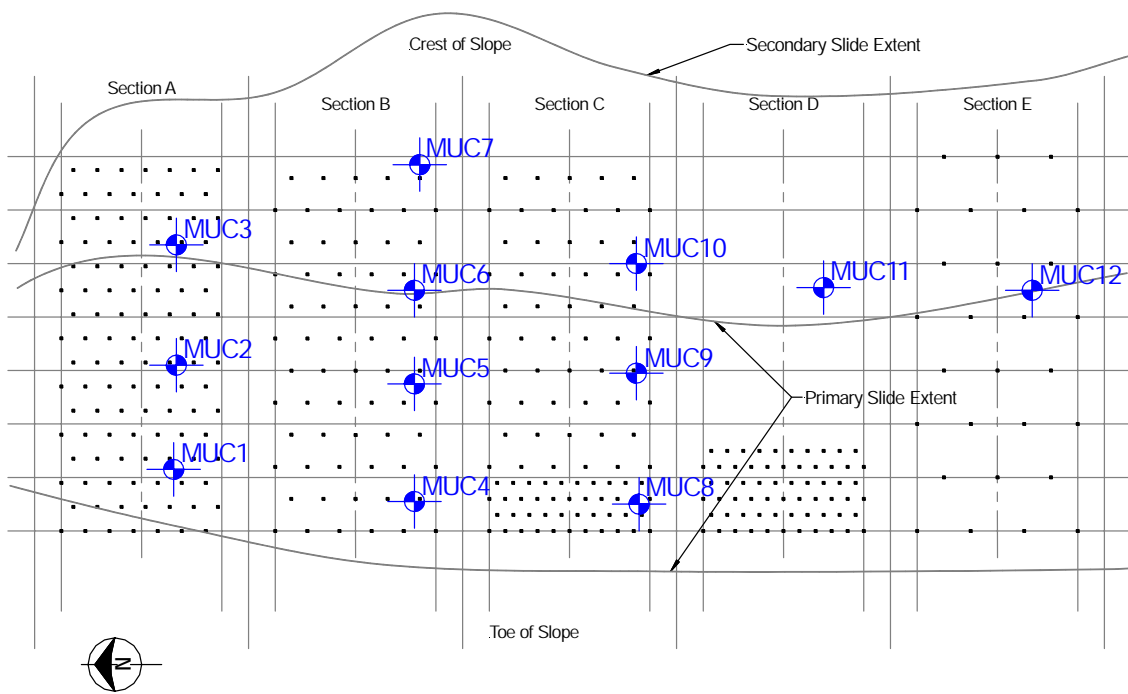
Figure D.1 Plan view of US54-Fulton site showing approximate boring locations.
