## **Route 139 Rehabilitation: Pulaski Skyway Contract 2**

FINAL REPORT  
June 2017

1. Report No. FHWA-NJ-2017-012		2. Government Accession No.		3. Recipient's Catalog No.	
4. Title and Subtitle Route 139 Rehabilitation: Pulaski Skyway Contract 2				5. Report Date June 2017

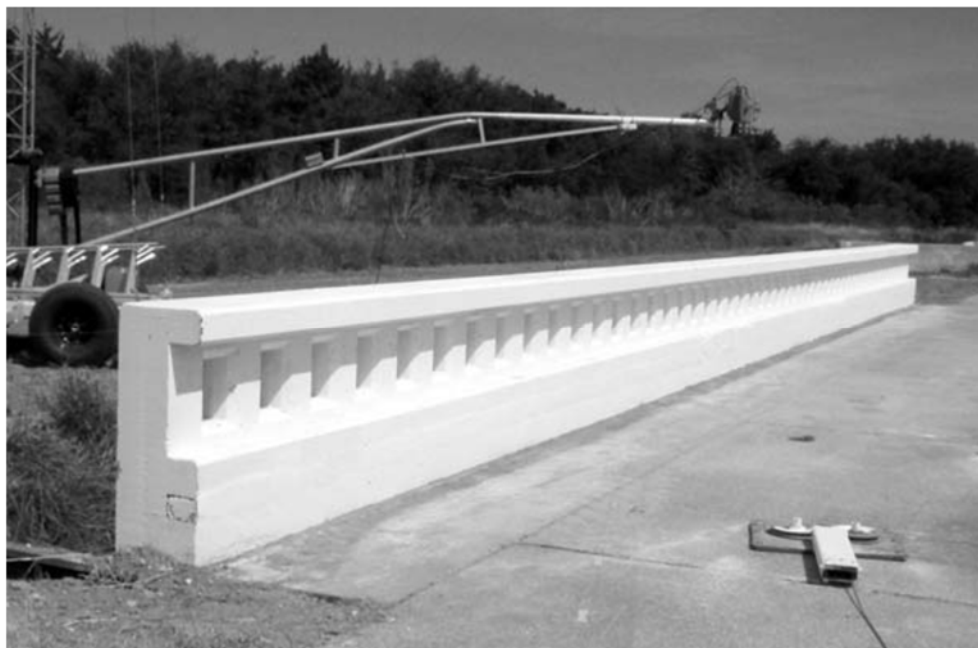
Figure 10. Texas F411 bridge rail <sup>(24)</sup>

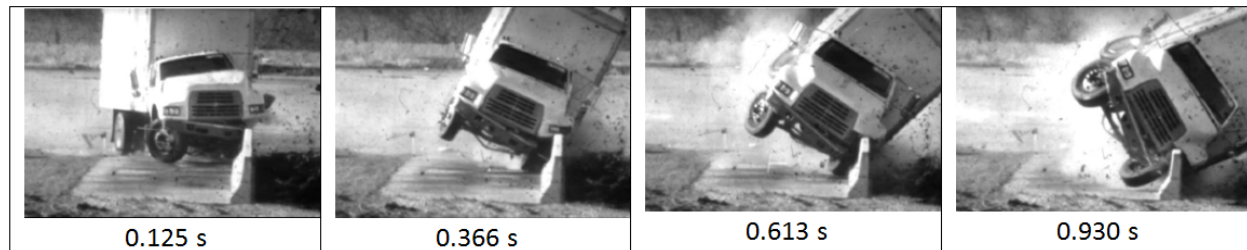
Figure 11. Test photos for failed MASH 4-12 test for 32 in barrier

Bullard et al. (2011) performed a MASH 4-12 test with a 32 in NJ barrier. This was previously tested under NCHRP Report 350 TL-4 conditions and passed marginally, but when tested again under the more severe MASH TL-4 conditions, the single unit truck rolled over that same barrier and failed.<sup>(17)</sup> Figure 11 shows the failed MASH 4-12 test of the 32 in high Jersey barrier.

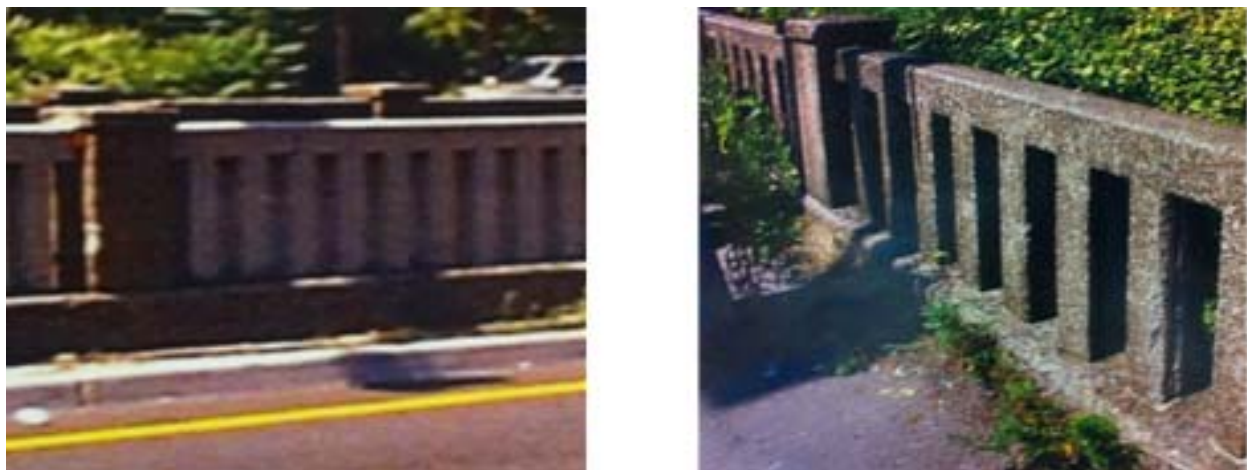
Figure 13. Existing open-faced balustrade on Route 139/Hoboken Viaduct

The Rt. 139/Hoboken Viaduct located in Jersey City Hudson County was constructed in 1932 as part of the Rt. 1/1&9 Historic Corridor with an open concrete balustrade along the length of the roadway. Figure 13 shows photos of existing balustrade on Rt. 139/Hoboken Viaduct. The original design features an open-faced balustrade with column to opening ratio of 1:1, approximately. NJDOT developed the preliminary design with only slight changes from original design (Figure 14(a)). The HPO approved the new concrete balustrade design but the new designed balustrade must also be shown to meet current crash test criteria of MASH TL-4.

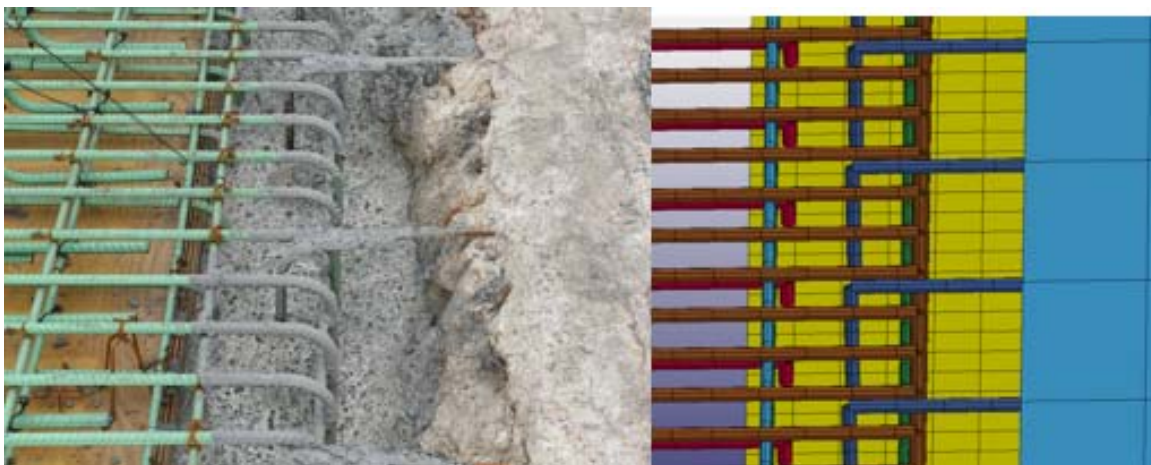
Figure 37. Filled wall portion of barrier setup (TTI) and FEM representation

Figure 36 shows the deck bars. Because the rigid block concrete is preexisting, the deck bars are bent and developed in the wall portion of the setup. The bottom deck bars are placed at 8-in, and the top deck bars are placed at 4-in. They are placed at 4-in because in the barrier specifications, there is a 5-ft bar alternating with the regular deck reinforcement to provide additional strength to the connection with the deck. All of the longitudinal #4 bars are tied to the deck bars. After this part of the rebar assembly is finished, the vertical wall portion is then poured. This is shown in Figure 37.

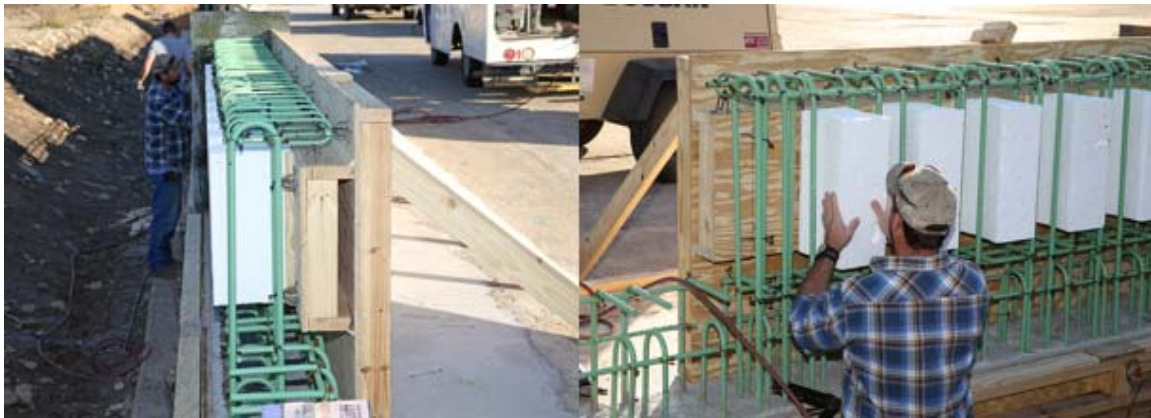
Figure 40. Vertical bars and top rail reinforcement secured to formwork (TTI)

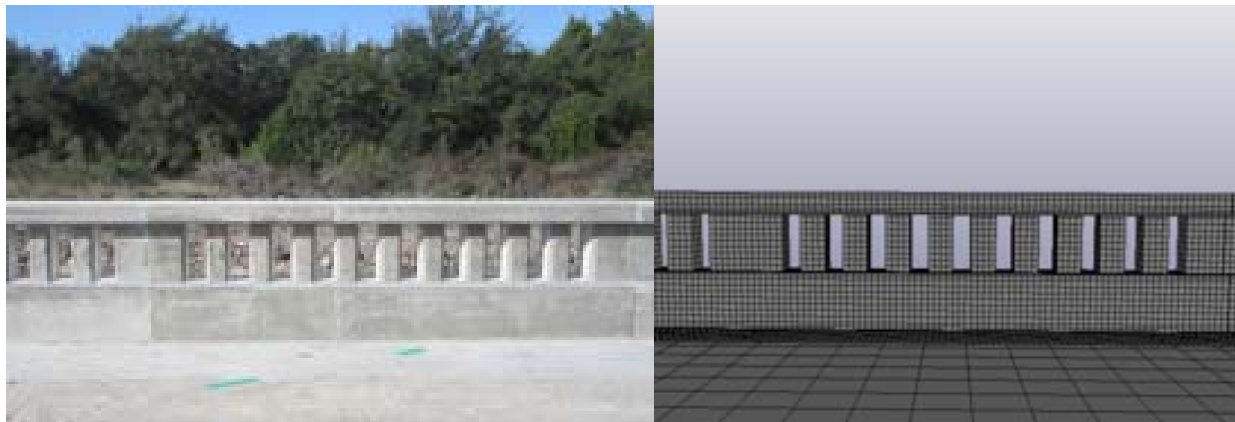
Figure 41. Fully constructed barrier (TTI) and FEM representation

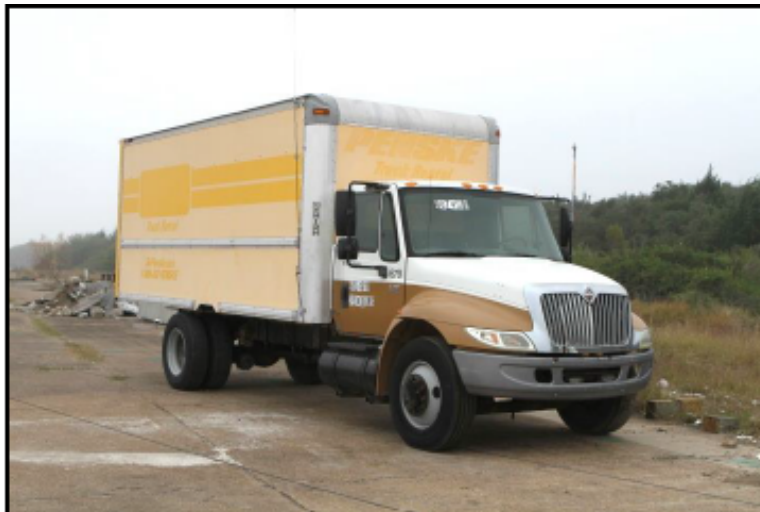
Figure 45. 10000S single unit truck tested (TTI)

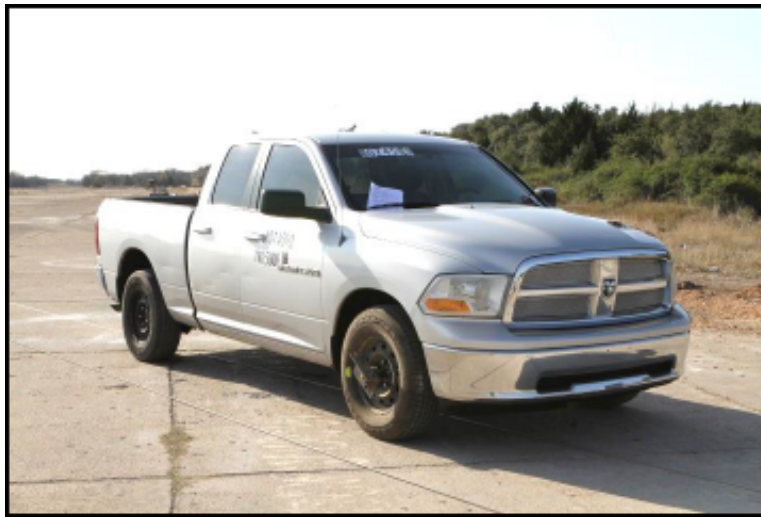
Figure 46. 2270P pickup truck tested (TTI)

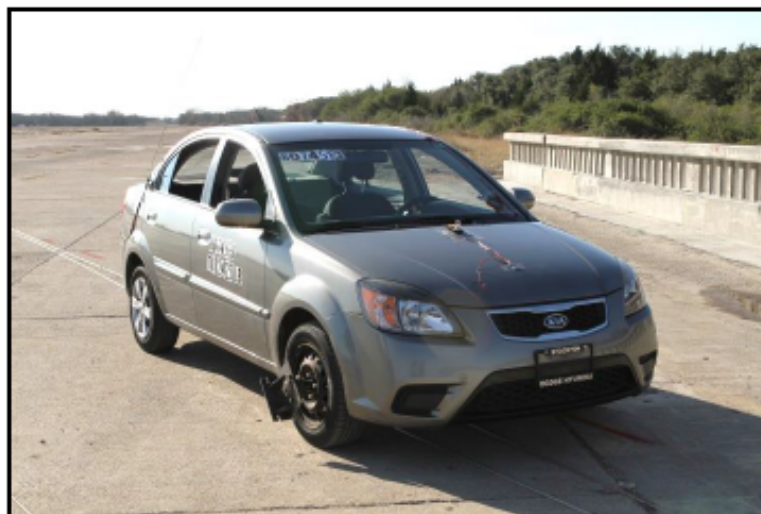
Figure 47. 1100C small passenger car tested (TTI)

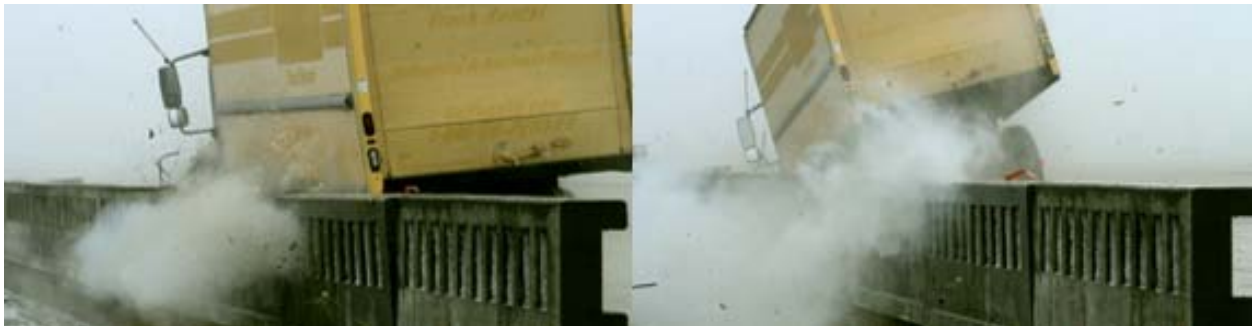
Figure 49. Maximum barrier deflection and permanent damage.

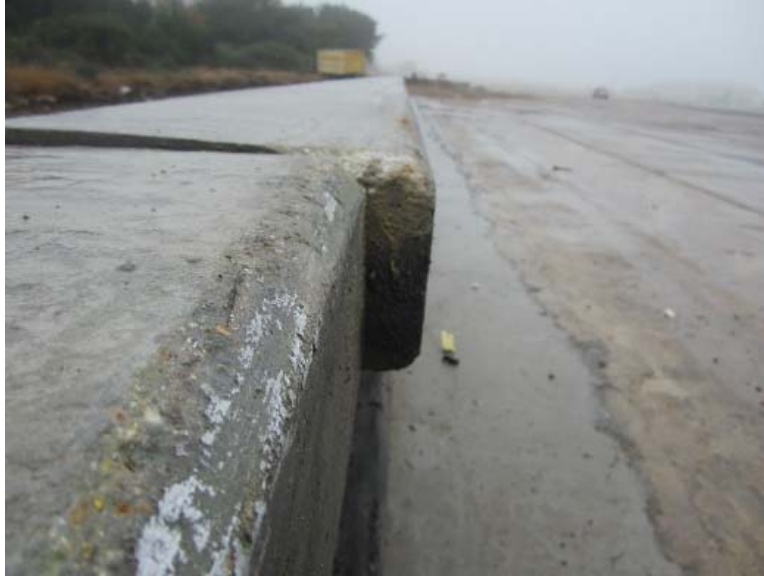
Figure 50. Permanent deflection of barrier after single unit truck test.

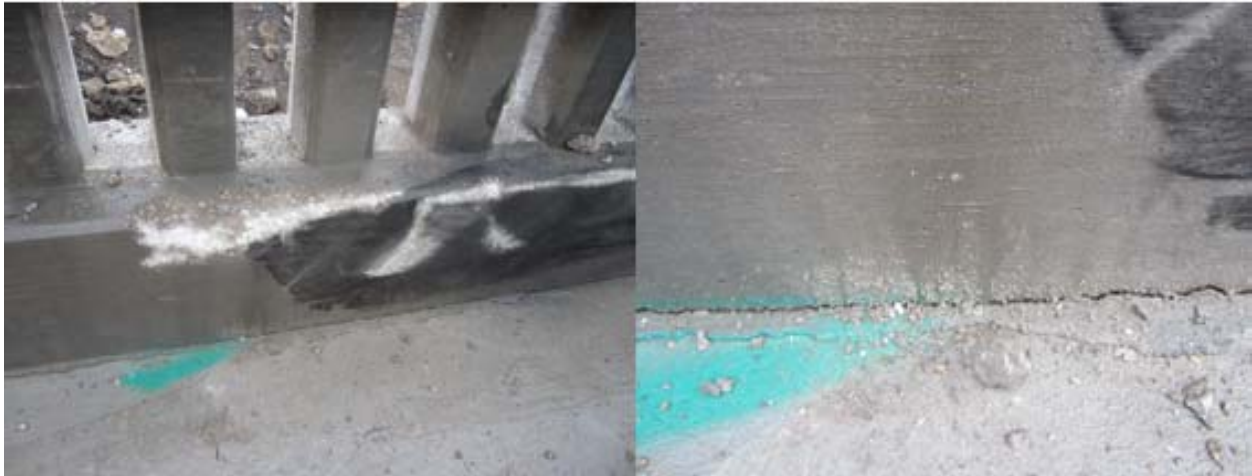
Figure 51. Barrier damage and crack at deck-barrier interface.

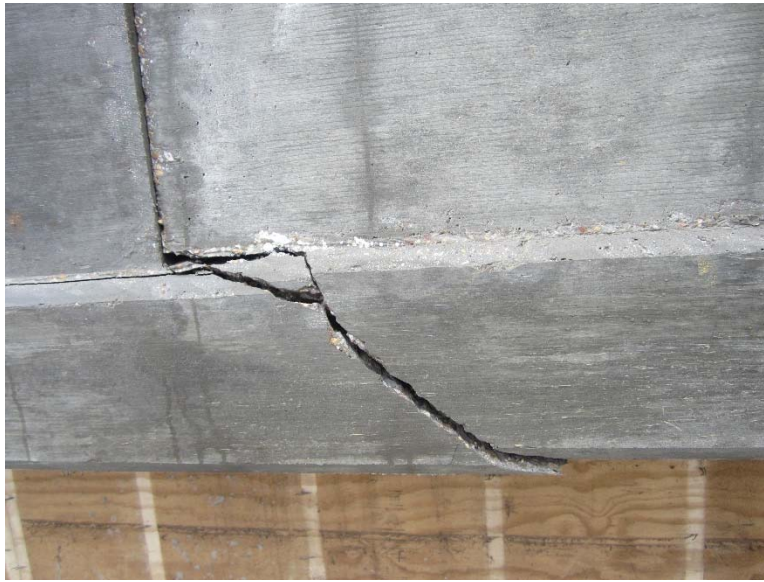
Figure 52. Crack in deck on non-impact side of barrier.

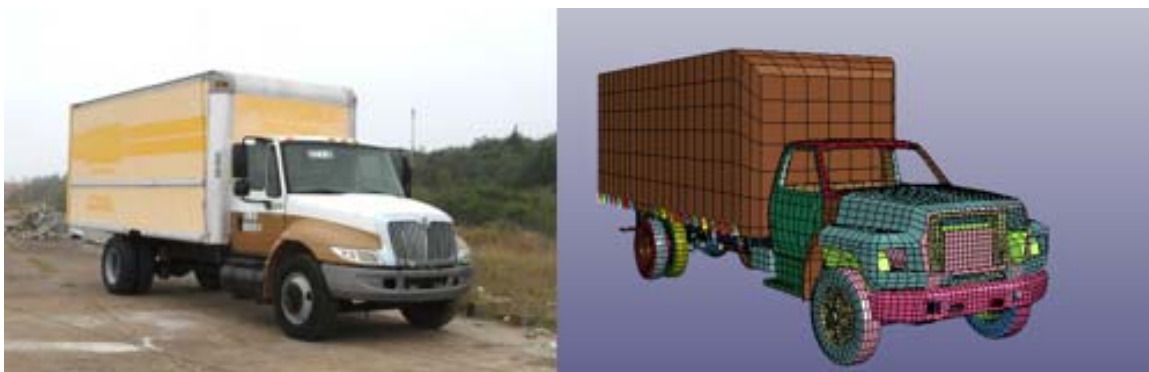
Figure 56. 10000S single unit truck and FEM representation

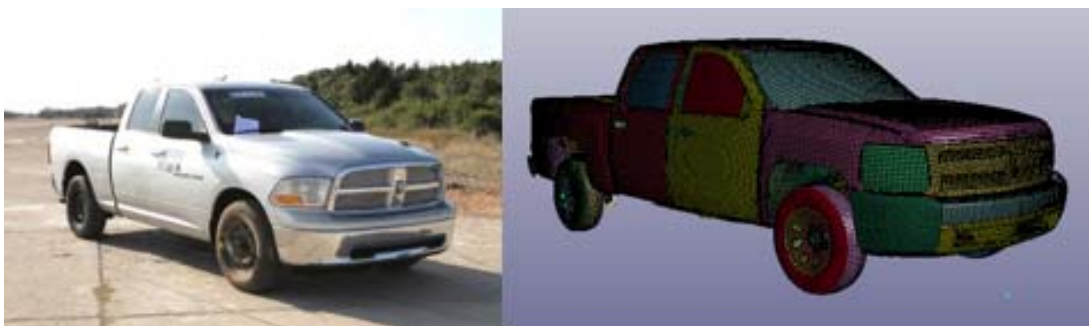
Figure 60. 2270P vehicle used and Chevy Silverado modeled
