# Bridge Maintenance Program for the City of Columbia, Missouri

**Final Report**  
**September 2017**

City of Columbia, Missouri  
Midwest Transportation Center  
U.S. Department of Transportation  
Office of the Assistant Secretary for  
Research and Technology

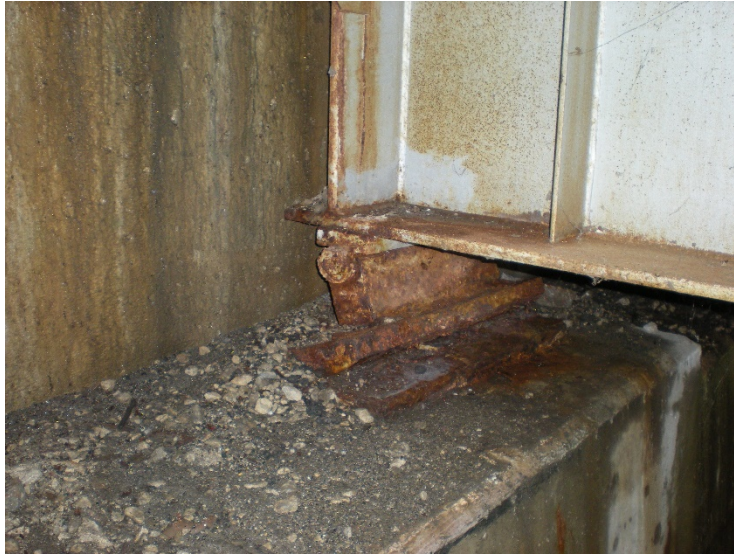
**Figure 3. Debris accumulated in the beam seat area as a result of a failed joint/seal in the deck above the bearing**

Debris accumulation in the beam seat area is particularly prevalent where deck joints are failing and can result in a significant increase in the rate of deterioration. Figure 3 shows an example of debris collected in the beam seat area as a result of a failed deck joint, which is allowing debris from the deck surface to accumulate on the beam seat.

High water events can also deposit debris in the beam seat area. Periodic cleaning of the beam seat area may not be required in areas where joints and seals are performing adequately if the bridge is not subject to periodic high water. When joints and seals are damaged, frequent cleaning of the bearing/beam seat area is necessary to clear debris and remove chlorides that typically drain from the bridge deck through the failed seal and directly onto the bridge bearings. Repair or replacement of joint seals and failing joints can reduce the need for cleaning.

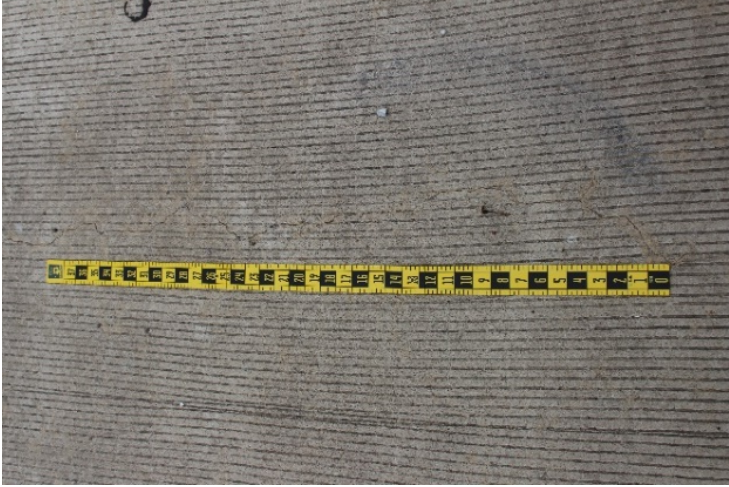
| Bridge No. | Actions Required |
|---|---|
| 930038 | <p>Bridge deck has extensive, long cracks. These cracks should be sealed.</p> |

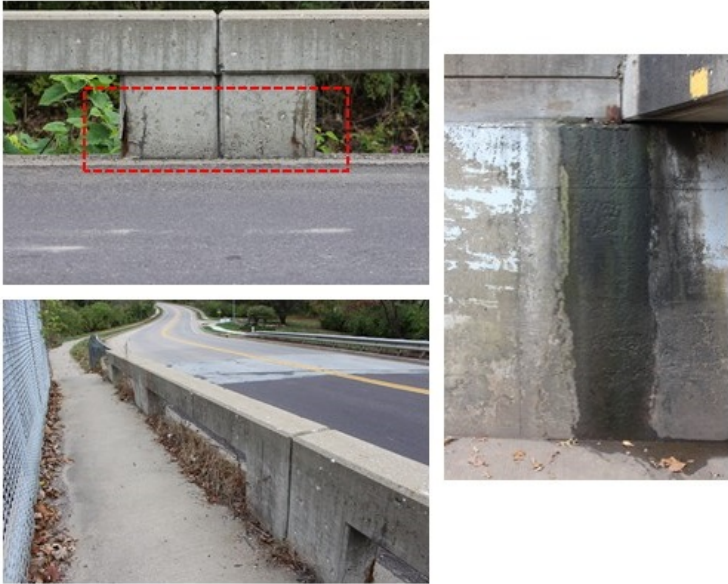
| Bridge No. | Actions Required |
|---|---|
| 930019 | <p>Debris accumulated on sidewalks is causing corrosion of the railing and spalling. Clean the debris accumulated in both sidewalks of the bridge. Correct drainage issue at abutment.</p> |

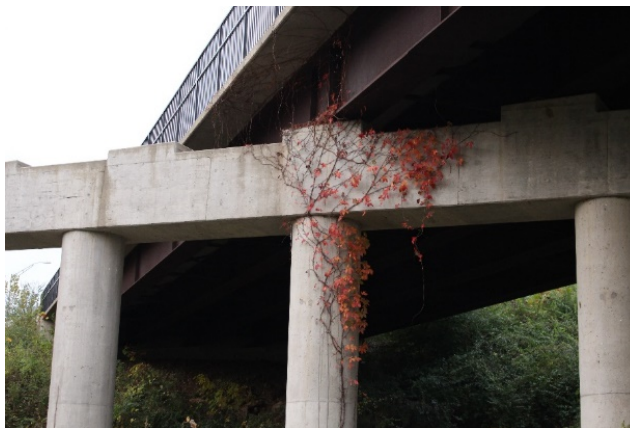
930034

Remove the vegetation that has climbed on the bridge.

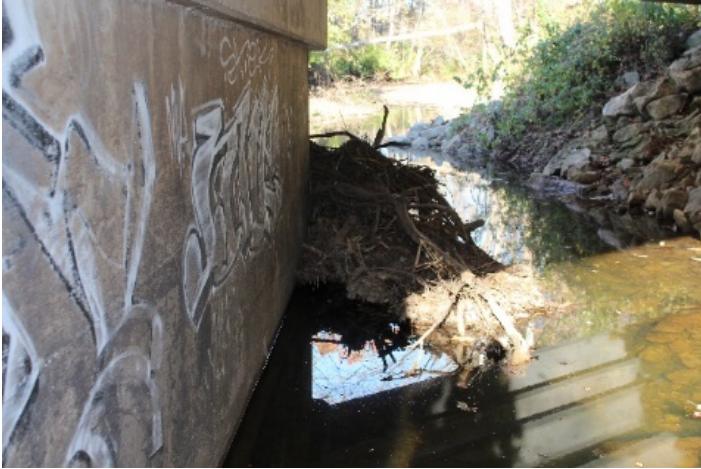
| Bridge No. | Actions Required |
|---|---|
| 930018 | <p>Remove and clean debris accumulated in the approach slabs. Remove the trees and branches stacked in pier wall on the upstream.</p> |

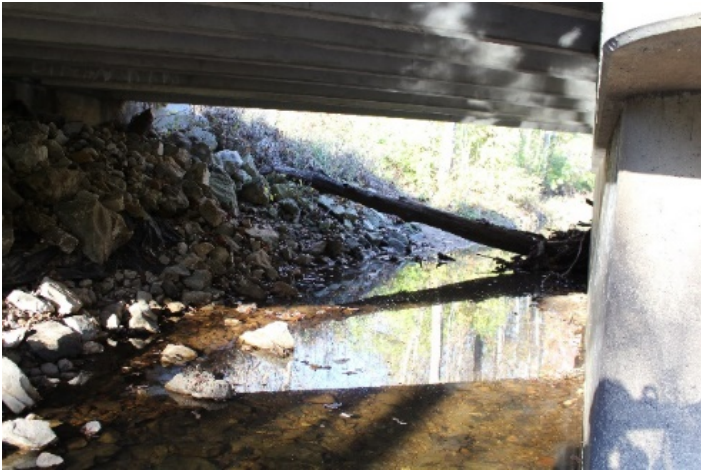
| Bridge No. | Actions Required |
|---|---|
| 930024 | <p>Fix the damaged expansion joint on one side of the bridge. Remove the trees and branches stacked in the pier wall on the upstream.</p> |

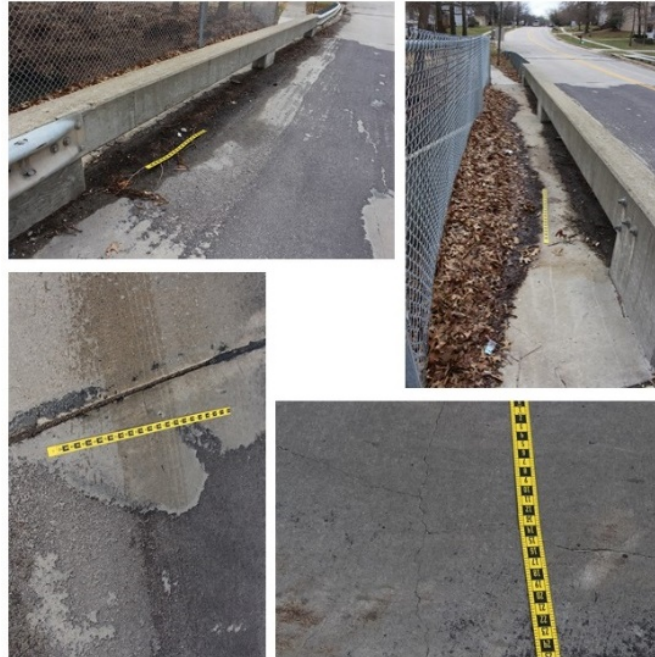
930021

Remove and clean the accumulated debris from sidewalk and bridge deck. The cracks should be sealed and the damaged pourable seal should be fixed.

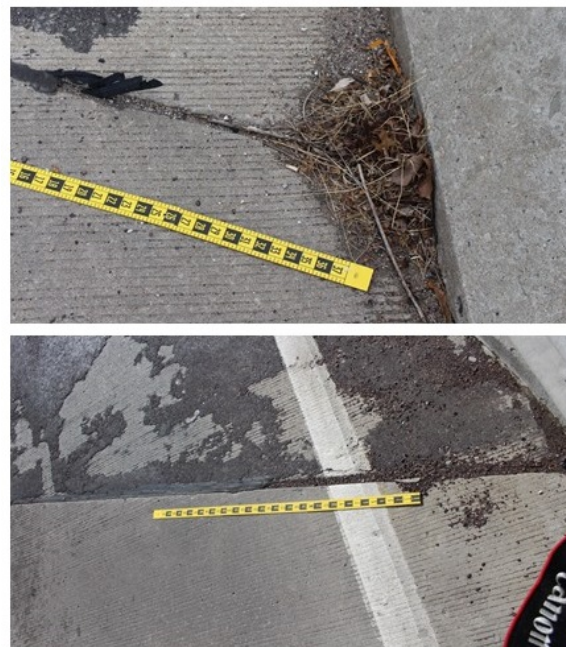
930017

Clean the accumulated debris from the deck. Fix the damaged pourable joint seal.

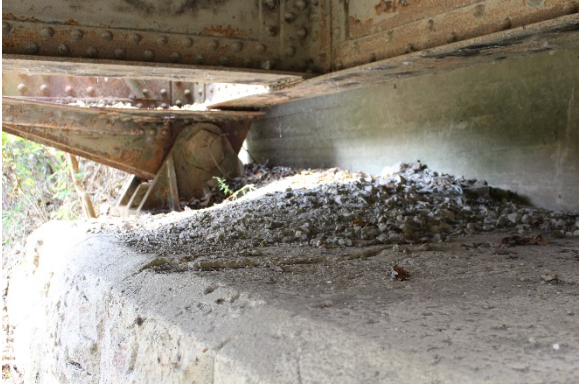
| | Question | Image of Typical Condition |
|---|---|---|
| 7 | Is there any debris accumulated on the beam seat or on other substructure elements?<br>Y/N<br>Notes | A close-up photograph of a bridge's beam seat. A large, irregular pile of debris, including leaves, twigs, and small stones, is accumulated on the concrete surface directly beneath the steel beam. The steel beam itself shows signs of rust and wear. |

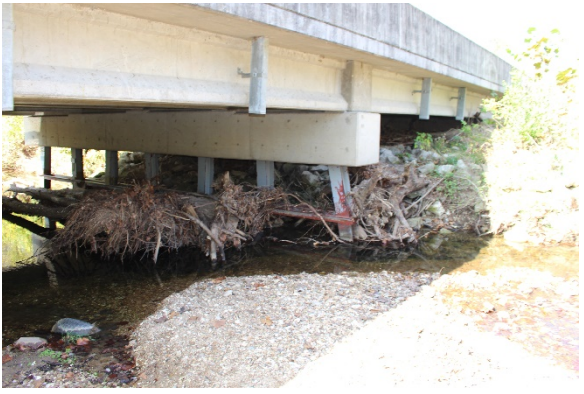
| | Question | Image of Typical Condition |
|---|---|---|
| 8 | Is there debris collected in the waterway that would affect the flow of water?<br>Y/N<br>Notes | A photograph showing the underside of a concrete bridge. A large pile of debris, including branches, leaves, and other organic matter, is collected in the waterway beneath the bridge, potentially obstructing water flow. The surrounding area is grassy and appears to be a natural waterway. |

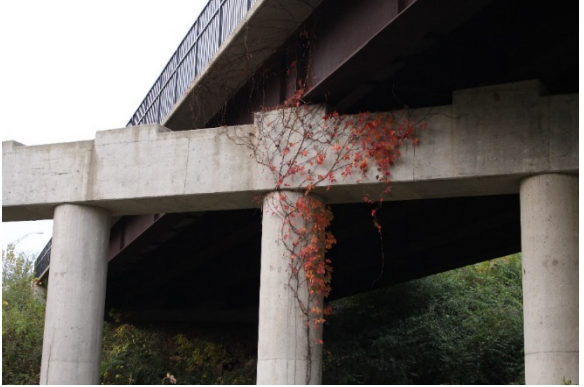
| | Question | Image of Typical Condition |
|---|---|---|
| 9 | Is there vegetation growing onto the superstructure/substructure?<br>Y/N<br>Notes | A photograph of a concrete bridge substructure. A vine with bright red leaves is growing up the side of a concrete pier, illustrating vegetation growing onto the substructure. |
