**Construction, Instrumentation, and Testing of Fast-Setting
Hydraulic Cement Concrete in Palmdale, California**

CALIFORNIA DEPARTMENT OF TRANSPORTATION

Jeffery R. Roesler, Clark W. Scheffy, Abdikarim. Ali, and David Bush

April 2000

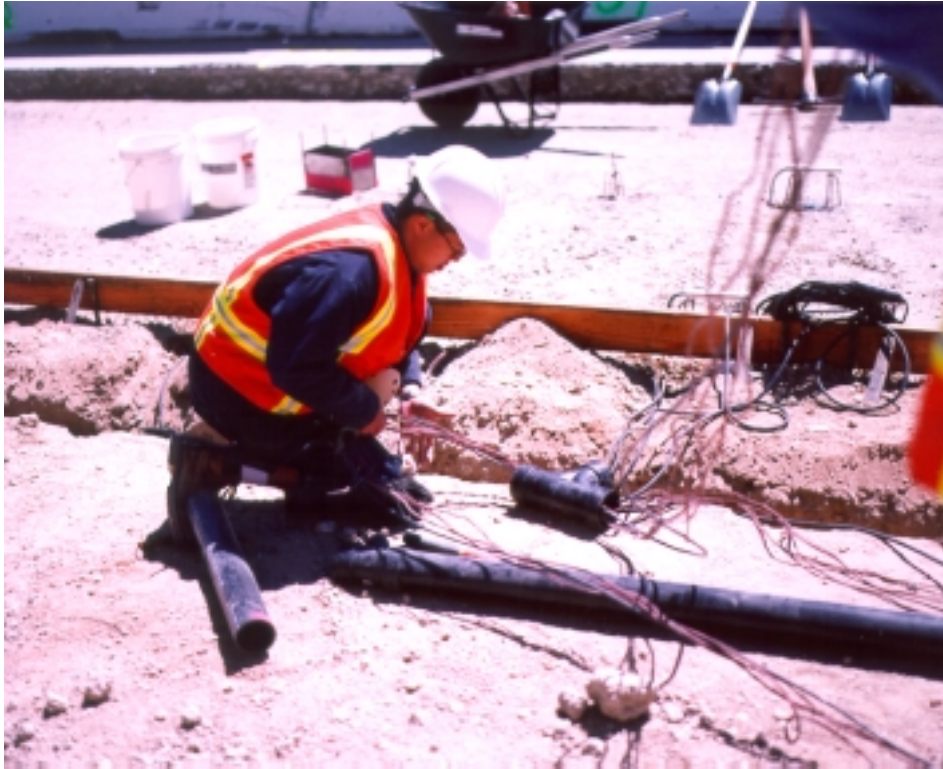
Figure 6.1. South Tangent Instrument Wiring and Piping Laid in Aggregate Base.

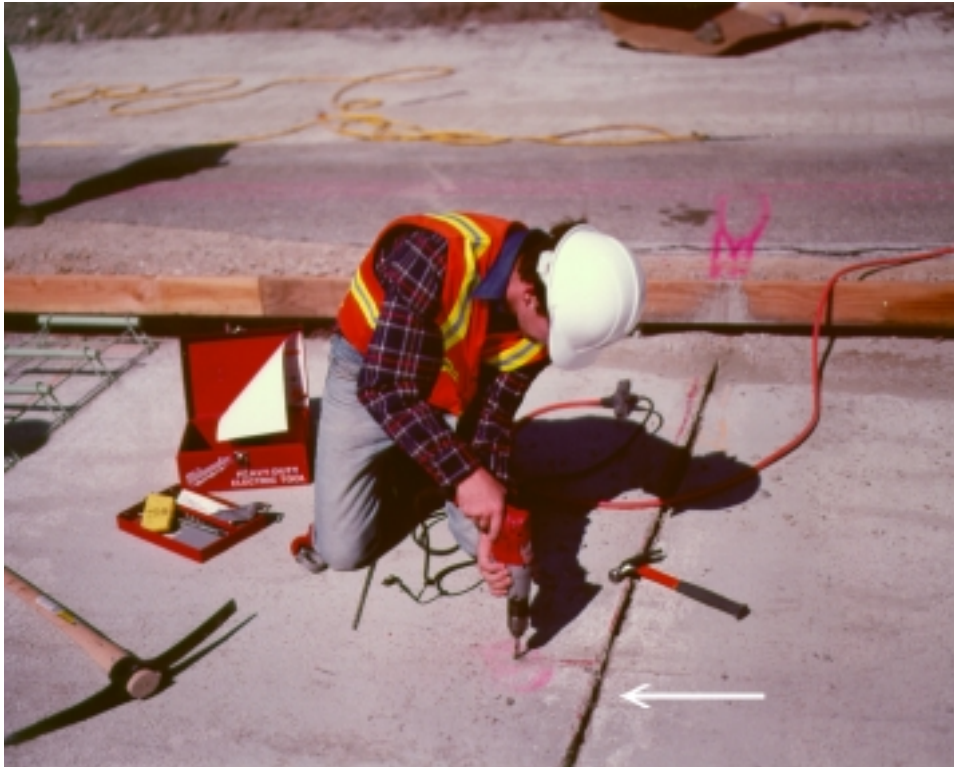
Figure 6.2. Grooves cut in North Tangent CTB for Instrument Leads.

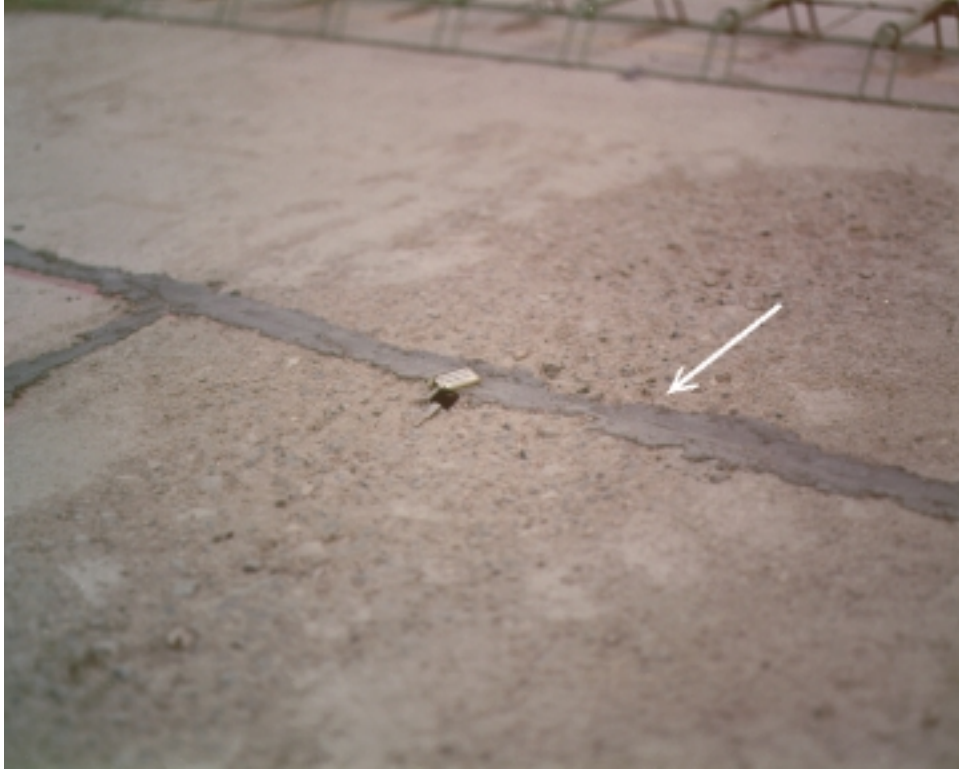
Figure 6.3. Backfilled Instrumentation Lead Channel on North Tangent CTB.

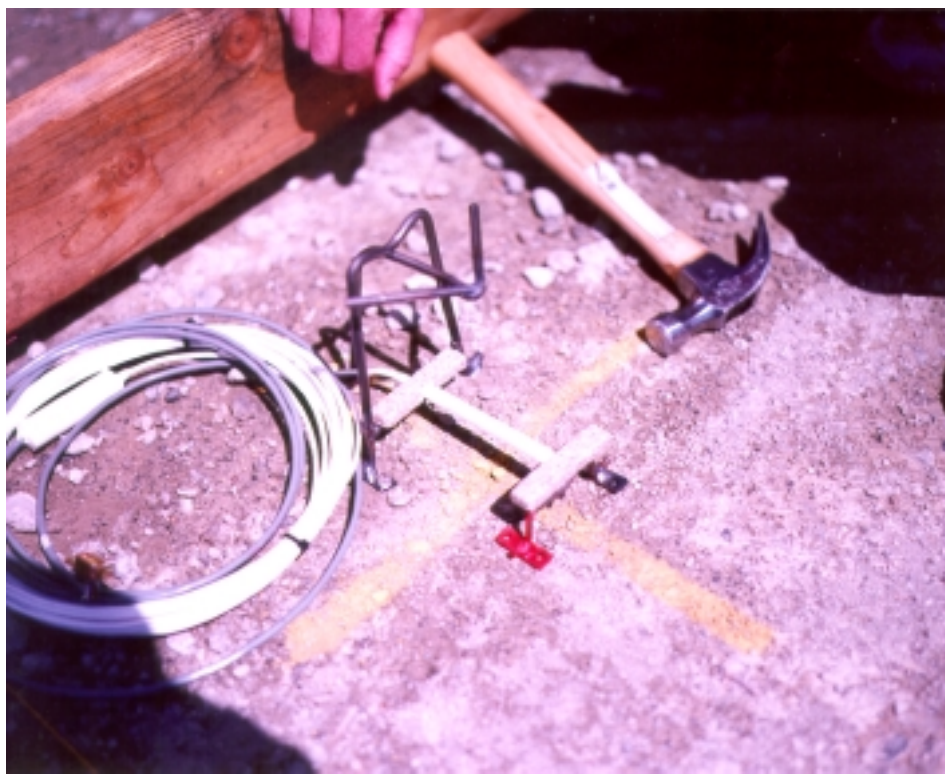
Figure 6.5. Steel Frames for Collocation of Dynatest PAST-2PCC (shown) and Tokyo-Sokki PMR-60-6L (not shown).

All strain gages were placed and properly oriented on the base material with small steel frames, as shown in Figures 6.4 and 6.5. Each instrument was attached to its steel frame using a plastic zip tie. Each instrument was attached firmly enough so that it wouldn't become dislodged

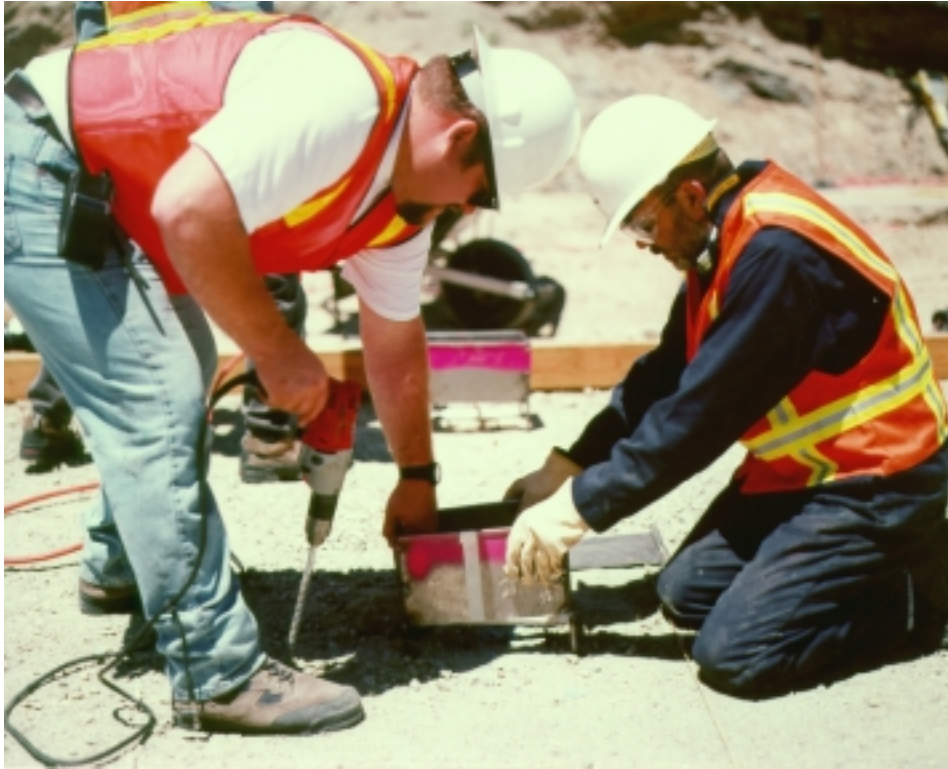
Figure 6.6. Steel Instrument Box Being Installed on South Tangent.

As shown in Figures 6.6 and 6.7, four-part sheet metal boxes with five-centimeter spikes at each corner were placed around all gages except for thermocouples. The sheet metal boxes prevented the flow of concrete from pushing any gages out of their intended location and orientation during paving. The spikes were driven into the base material to further stabilize the boxes. These boxes were then marked with “turkey tails” or wire flags affixed with duct tape so that they would be easily visible to the paving crew, as shown in Figure 6.8.

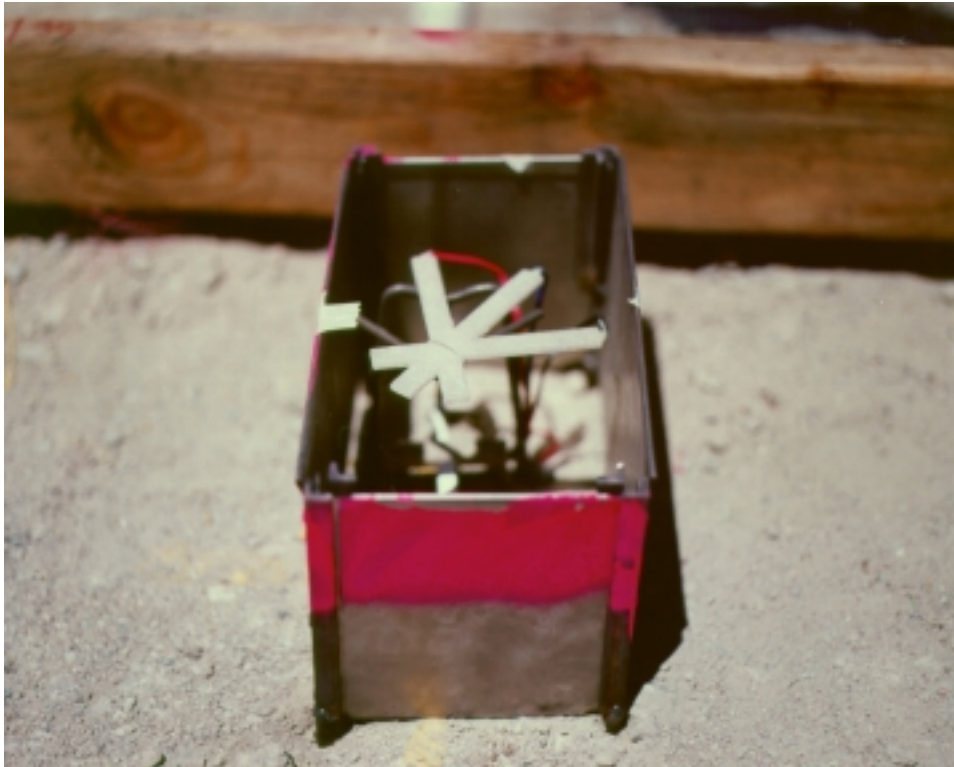
Figure 6.7. Steel Instrument Box Protecting Strain Gages on South Tangent.

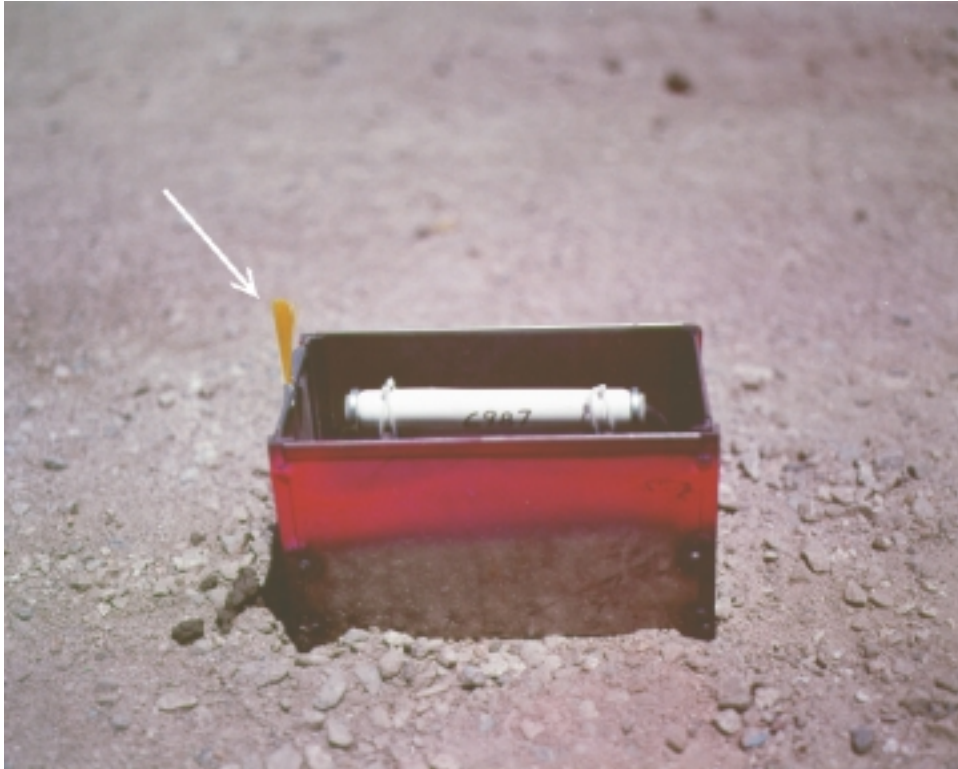
Figure 6.8. Instrument Box with Turkey Tail Attached.

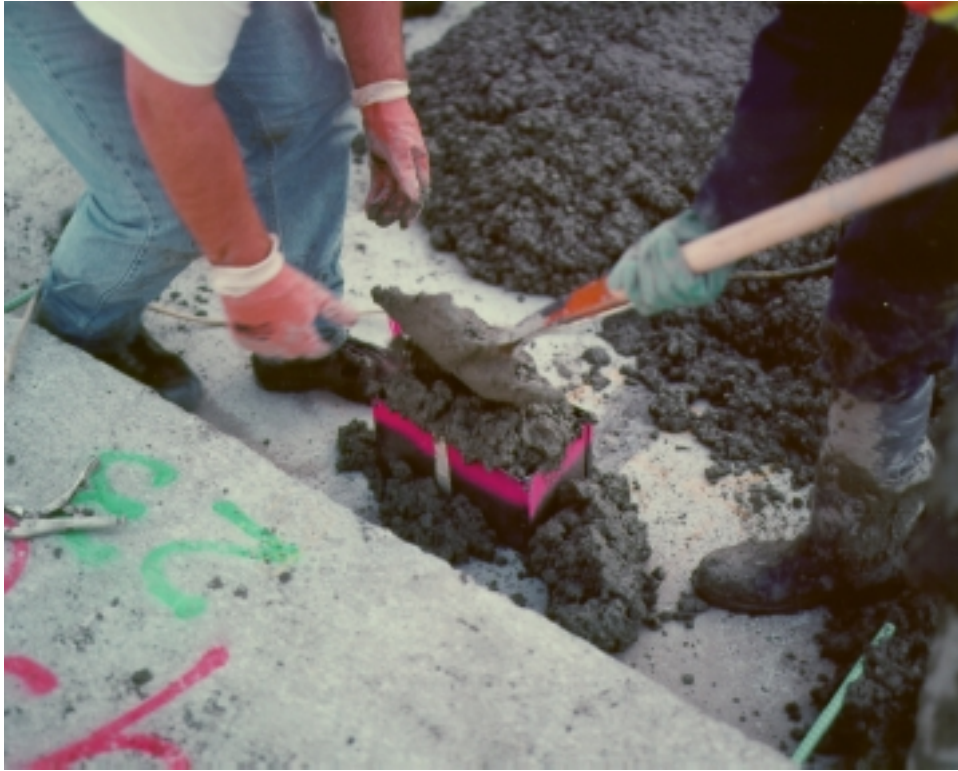
Figure 6.9. Instrument Box Being Filled by Shovel, North Tangent.

When the concrete neared one of the instruments in its box, UCB personnel shoveled concrete into the box, as shown in Figure 6.9. Coffman Specialties personnel consolidated the mix inside the sheet metal box by vibrating all four sides of the box, as shown in Figure 6.10. The Coffman Specialties crew then ran a screed over the concrete surface. Both the wire flags

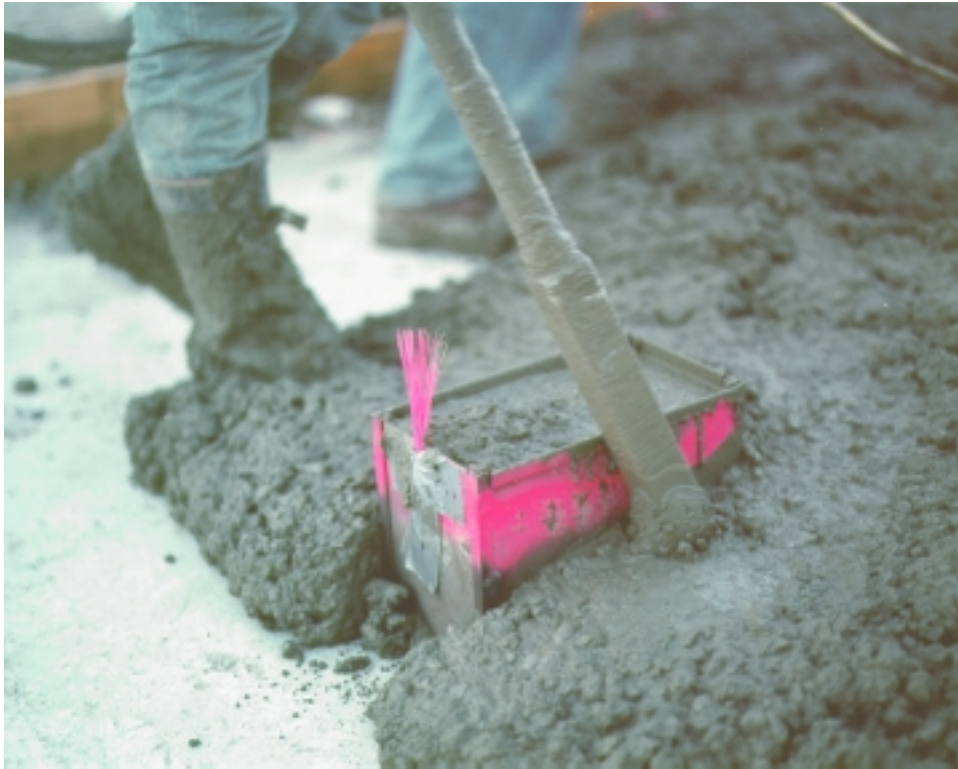
Figure 6.10. Vibrator Being Applied to Instrument Box to Consolidate Concrete.

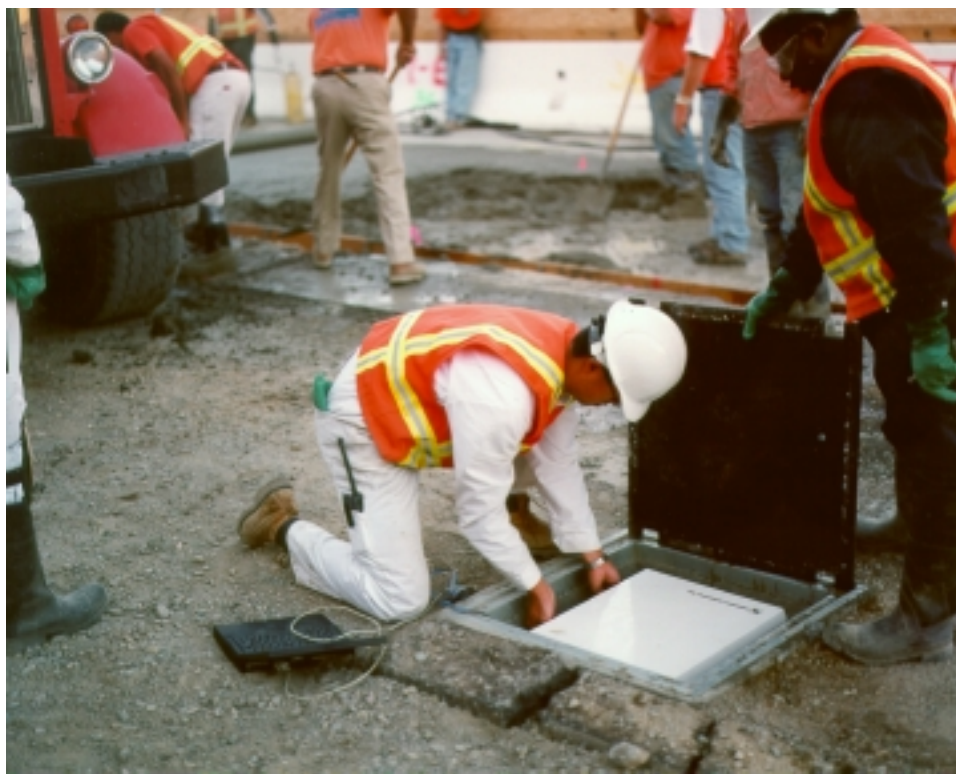
Figure 6.14. CR10X Acquisition System Being Placed on North Tangent.

The core of the online data acquisition system is the CR10X system manufactured by Campbell Scientific. Four such units were installed at the Palmdale test site: one on the South Tangent and three on the North Tangent. A schematic of the online data acquisition system is presented in Figure 6.13. The CR10X boxes were placed approximately 4 meters from the edge of the pavement. Each CR10X box was placed in the ground and surrounded by a concrete containment box with a steel cover. This was done to prevent damage to the CR10X during construction.

The CR10X systems consist of a CR10X data logger, one AM 416 relay multiplexer, two AM 25 Thermocouple multiplexers, one ASTEC DC/DC converter, one external 12 volt power supply, three signal conditioners, and an alkaline battery pack, all of which are enclosed in a fiberglass box. The system is used to continuously monitor and record data from thermocouples, LVDTs, MDDs, and environmental strain gages embedded in the test sections. The stored data can then be downloaded to a PC. Figure 6.14 shows the CR10X. The following sections detail all instrumentation placed during Palmdale construction.

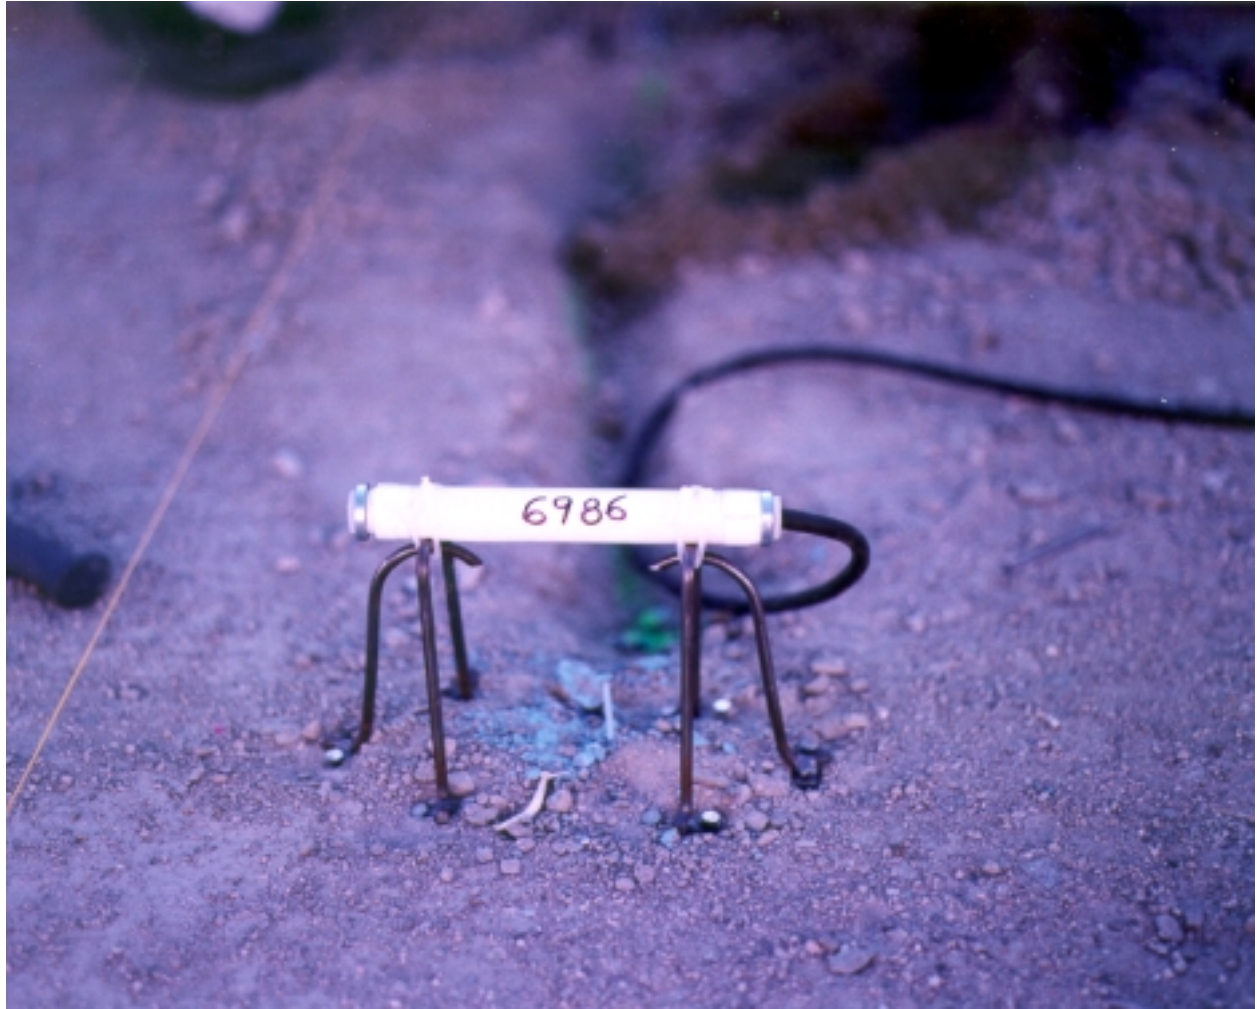
Figure 6.23. Carlson A-8 Strain Meter prior to Placement of Concrete, South Tangent.

The environmental strain gages used were the Carlson A-8 strain meter, manufactured by RST Instruments, Inc. Shown in Figures 6.15 and 6.23, the instrument is tubular in construction and contains two coils of highly elastic steel wire. One coil increases in length and electrical resistance when strained, while the other decreases in length when unloaded or compressed. The gages were placed in the concrete pavement at various critical locations near the surface and bottom of the pavement to measure strains caused by length changes in the pavement due to thermal changes and curing. The Carlson A-8 gages are monitored continuously by the online data acquisition system. A total of 24 Carlson A-8 gages have been embedded in the Palmdale test sections. Appendix A shows the locations of the Carlson A-8 gages on the Palmdale test sections.

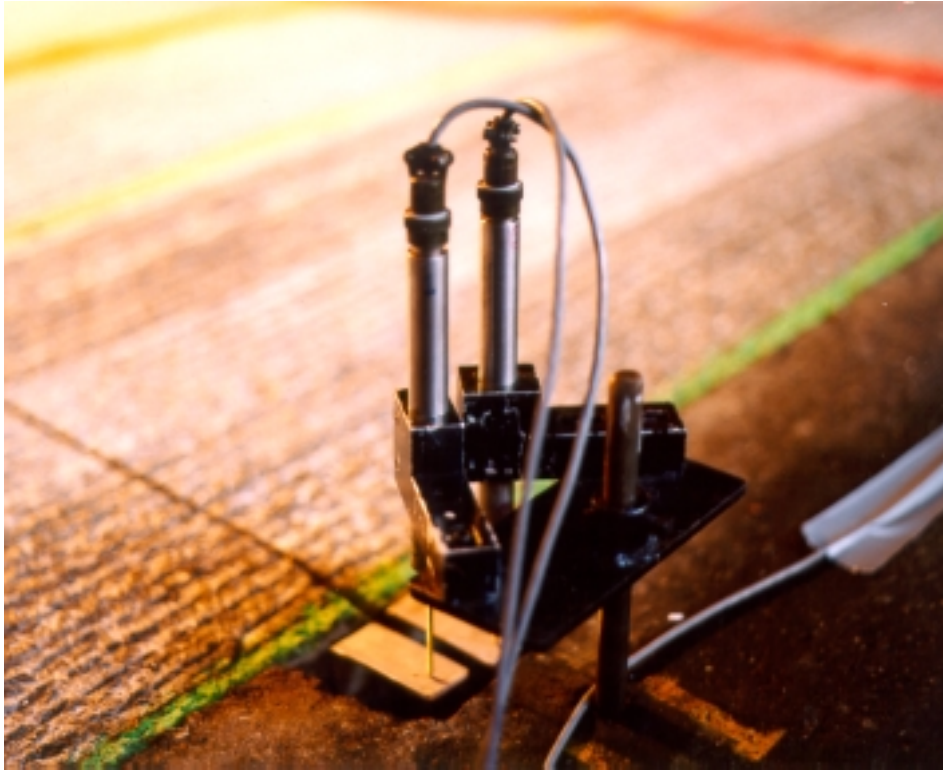
Figure 6.24. Joint Displacement Measuring Device (JDMD) on South Tangent. (*Edge Displacement Measuring Device is essentially identical except that it is placed in the middle of the slab instead of at the joint.*)

The JDMDs, manufactured by the UCB Pavement Research Center, are used to measure vertical and horizontal joint displacement under dynamic loads and temperature changes. For environmental changes, the JDMDs can be used in two separate configurations. The first device can measure the relative vertical and horizontal displacement across a joint. Each device consists of one Linear Variable Displacement Transducer (LVDT) for vertical displacement and one LVDT for horizontal displacement, as shown in Figure 6.24. Section 7C on the North Tangent

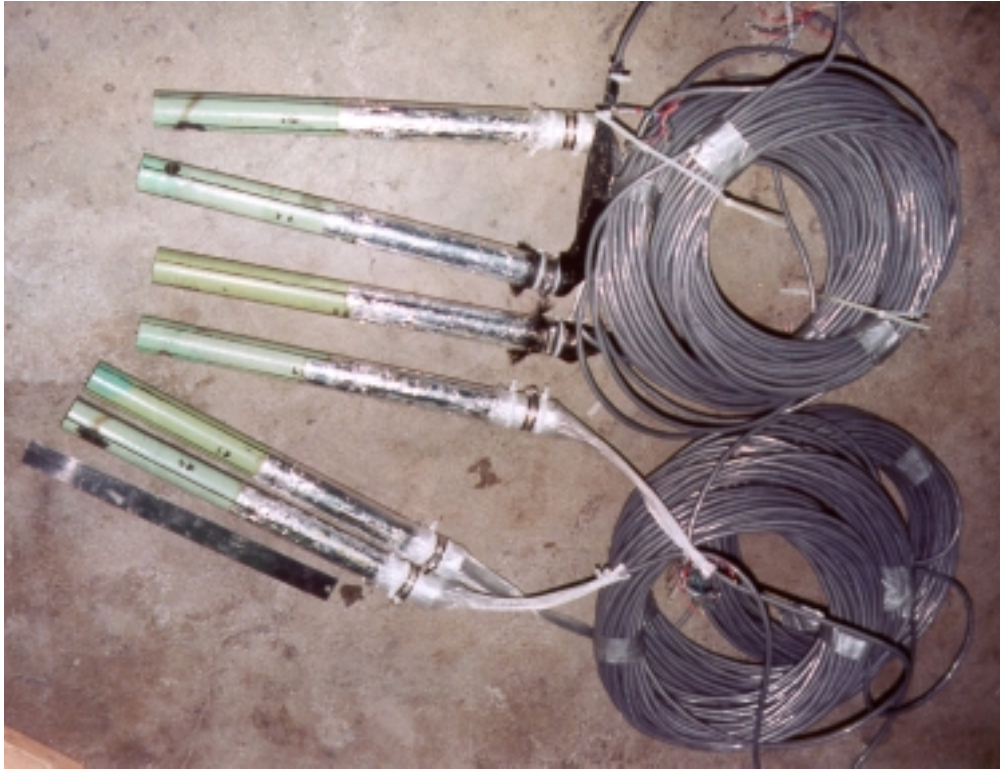
Figure 6.25. Individual Instrumented Dowel Bars Prior to being Welded to Dowel Bar Cage.

The instrumented dowels are 38 mm diameter by 450 mm long steel bars, spot welded to a frame to ensure the dowels were oriented properly in the slab. The dowels were spaced 300 mm center to center and 150 mm from the slab edge. Each instrumented dowel had two axial strain gages to measure bending strain and one strain gage rosette to measure bending and shear strain. Figure 6.25 shows the placement of the strain gages on the individual dowels prior to welding them into the dowel frame. Figures 6.26 and 6.27 show which dowels have strain gages

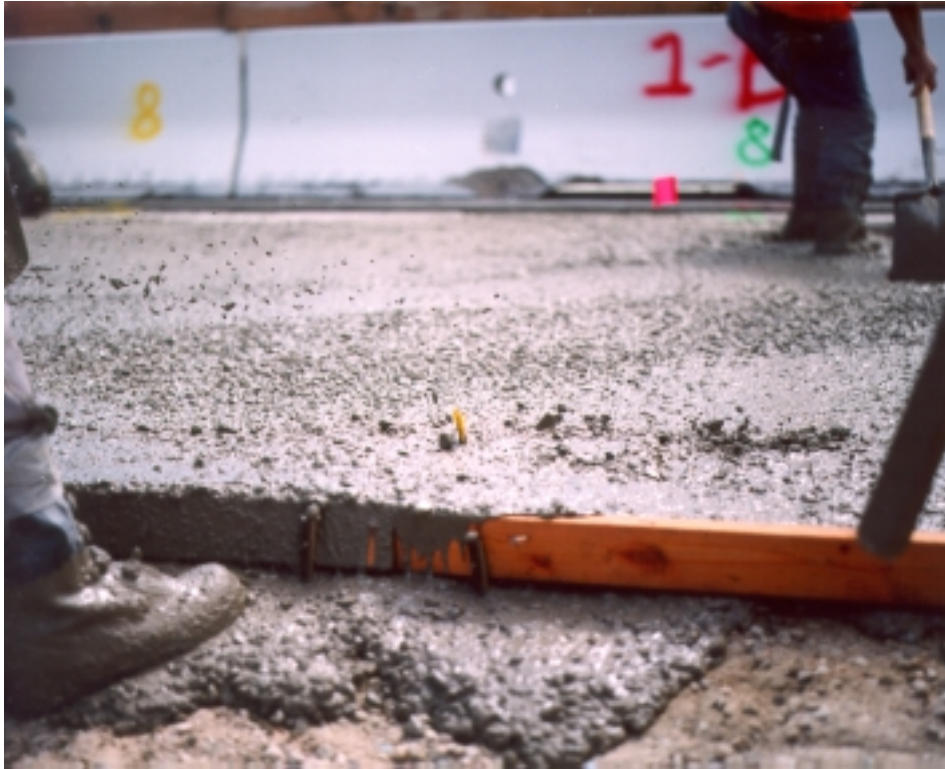
Figure 8.1. Wet Mix with Bleed Water on South Tangent.

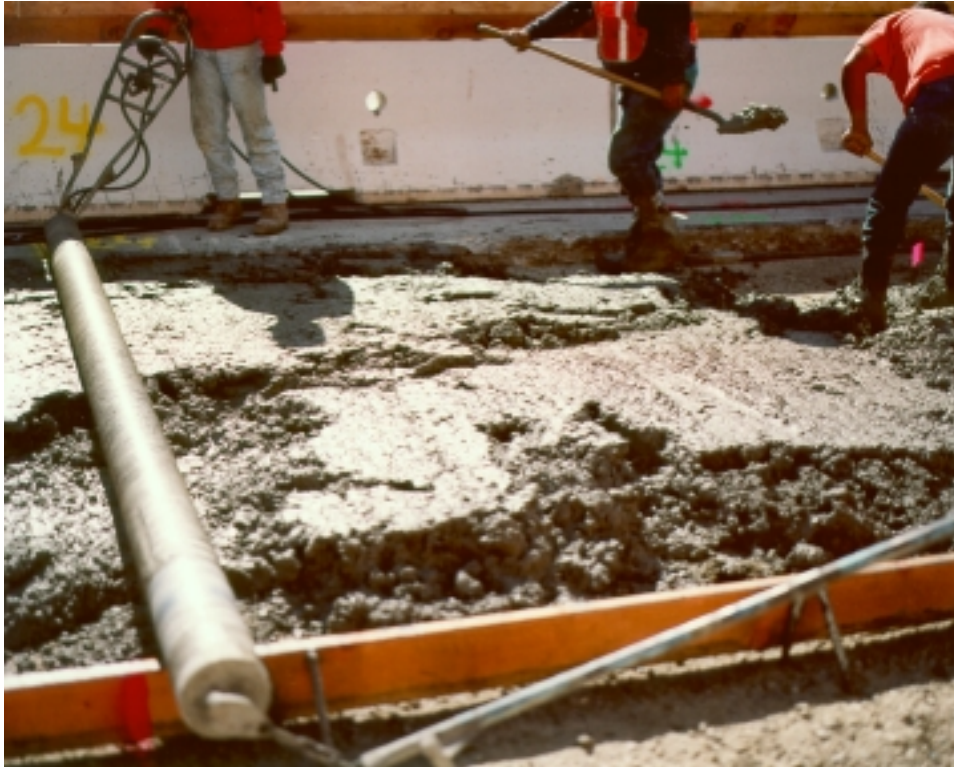
Figure 8.2. Unworkable Mix on South Tangent.

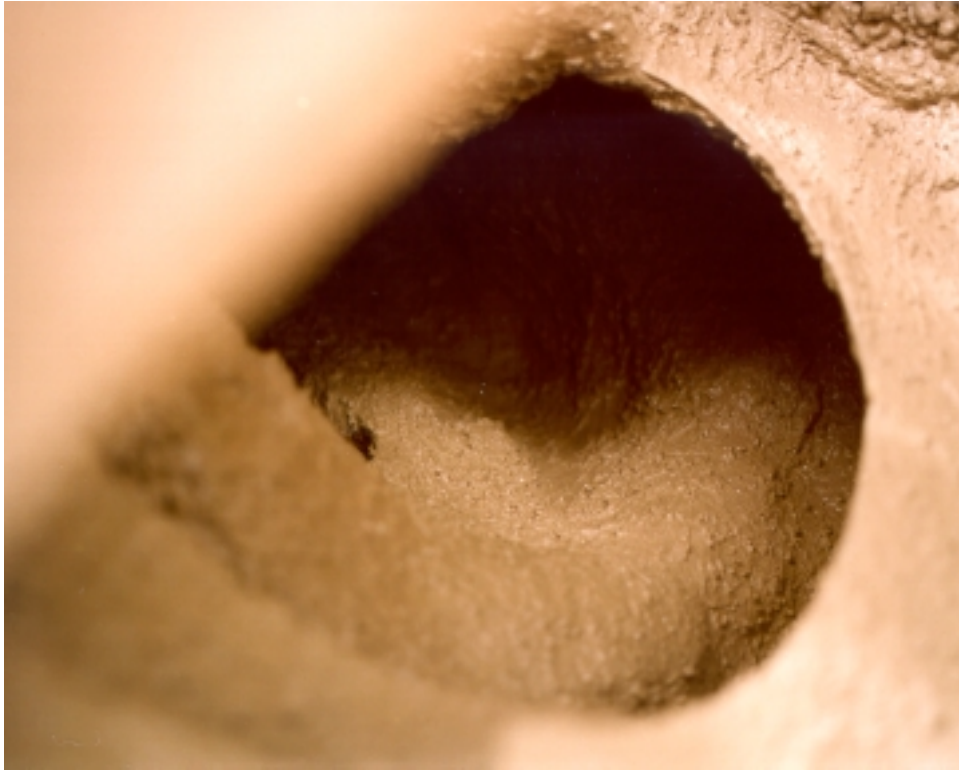
Figure 8.3. Clogged Fins inside Ready Mix Truck, North Tangent.

It was also observed that almost every night after paving, the contractor crew spent time chipping hardened concrete out of the ready mix truck drums.

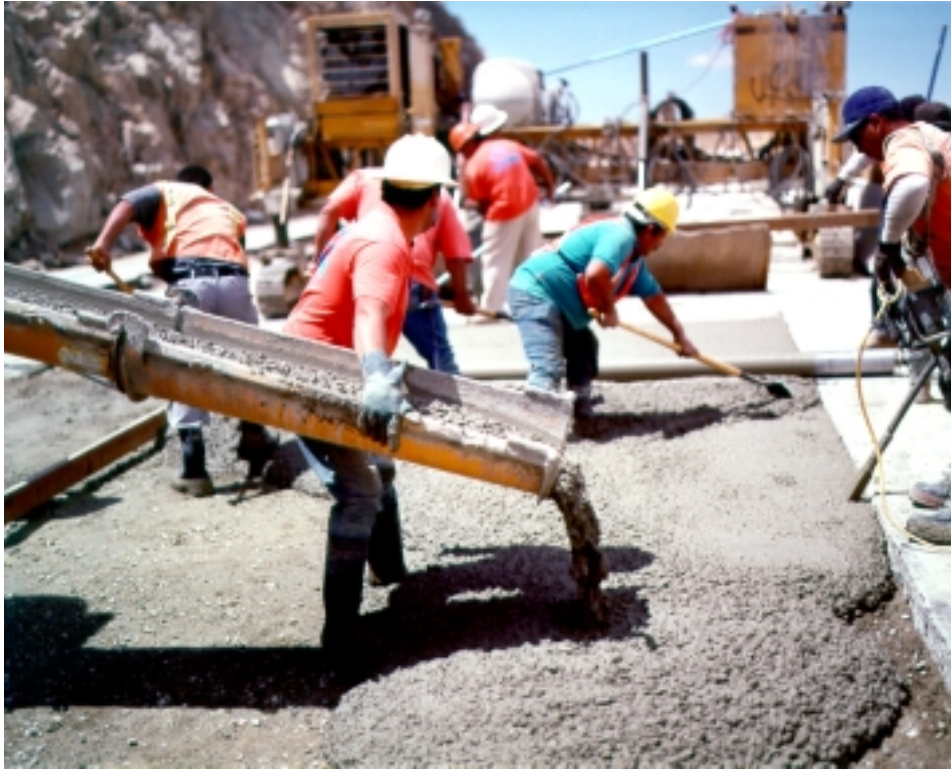
Figure 8.4. Good Mix Quality and Finish, South Tangent.

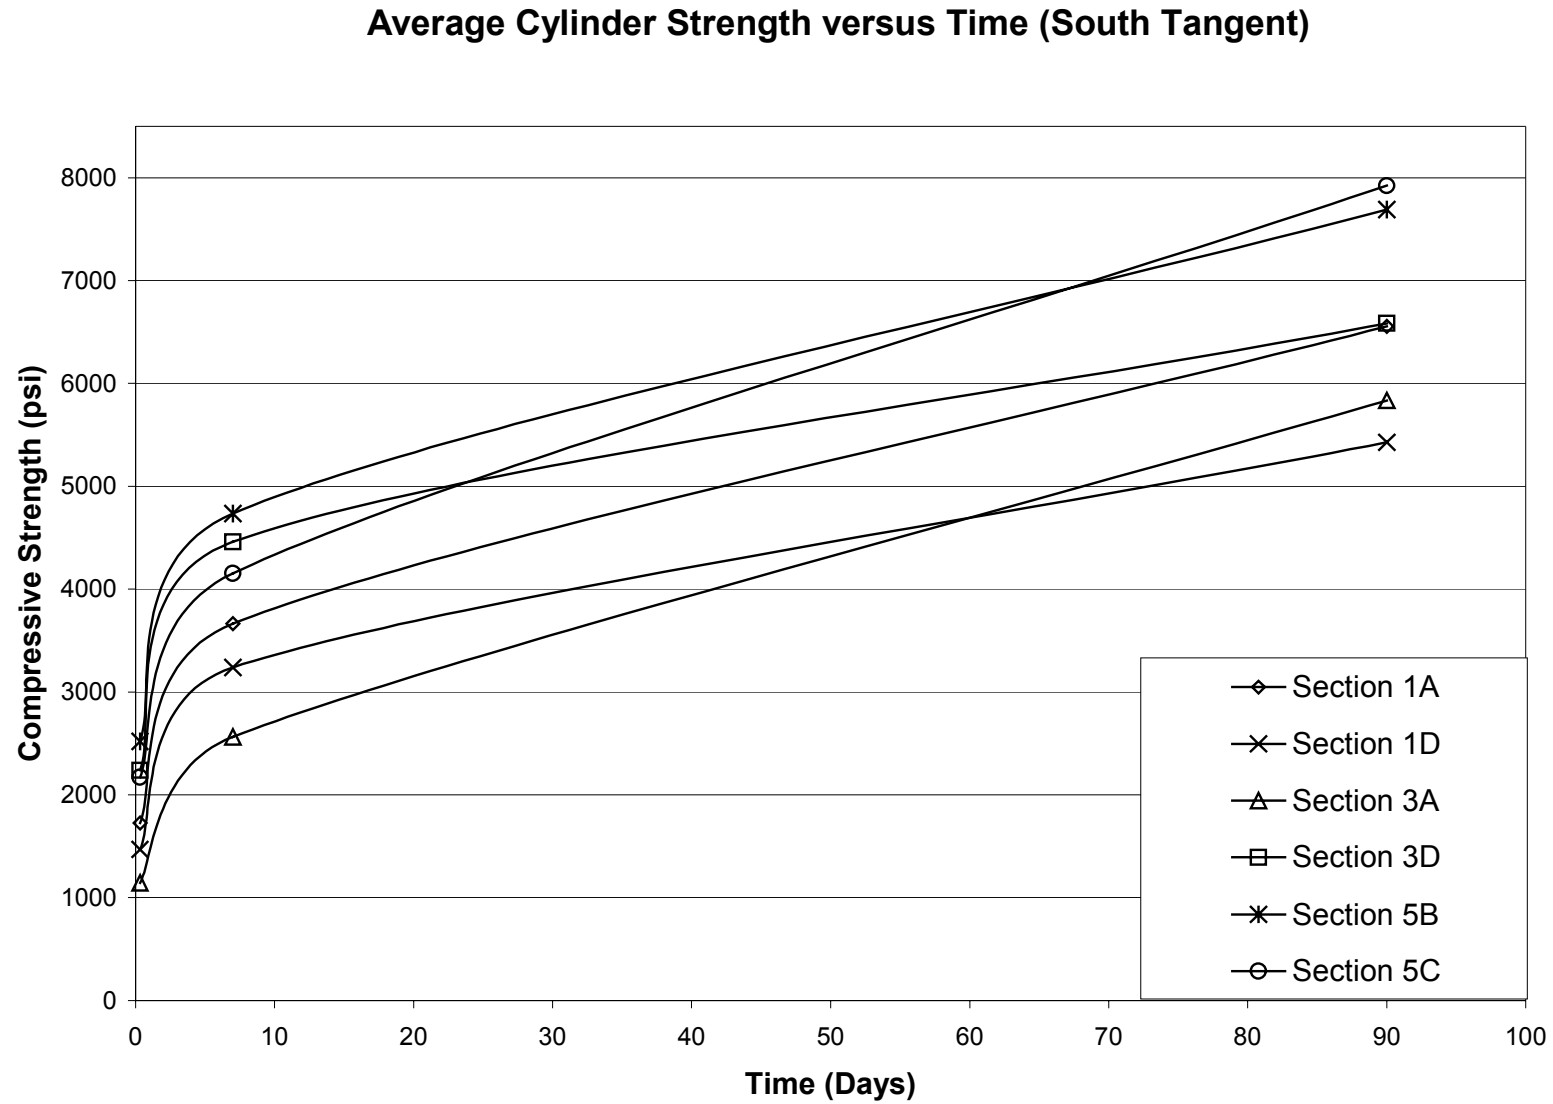
Figure 9.4. Average Cylinder Compressive Strength versus Time (South Tangent).

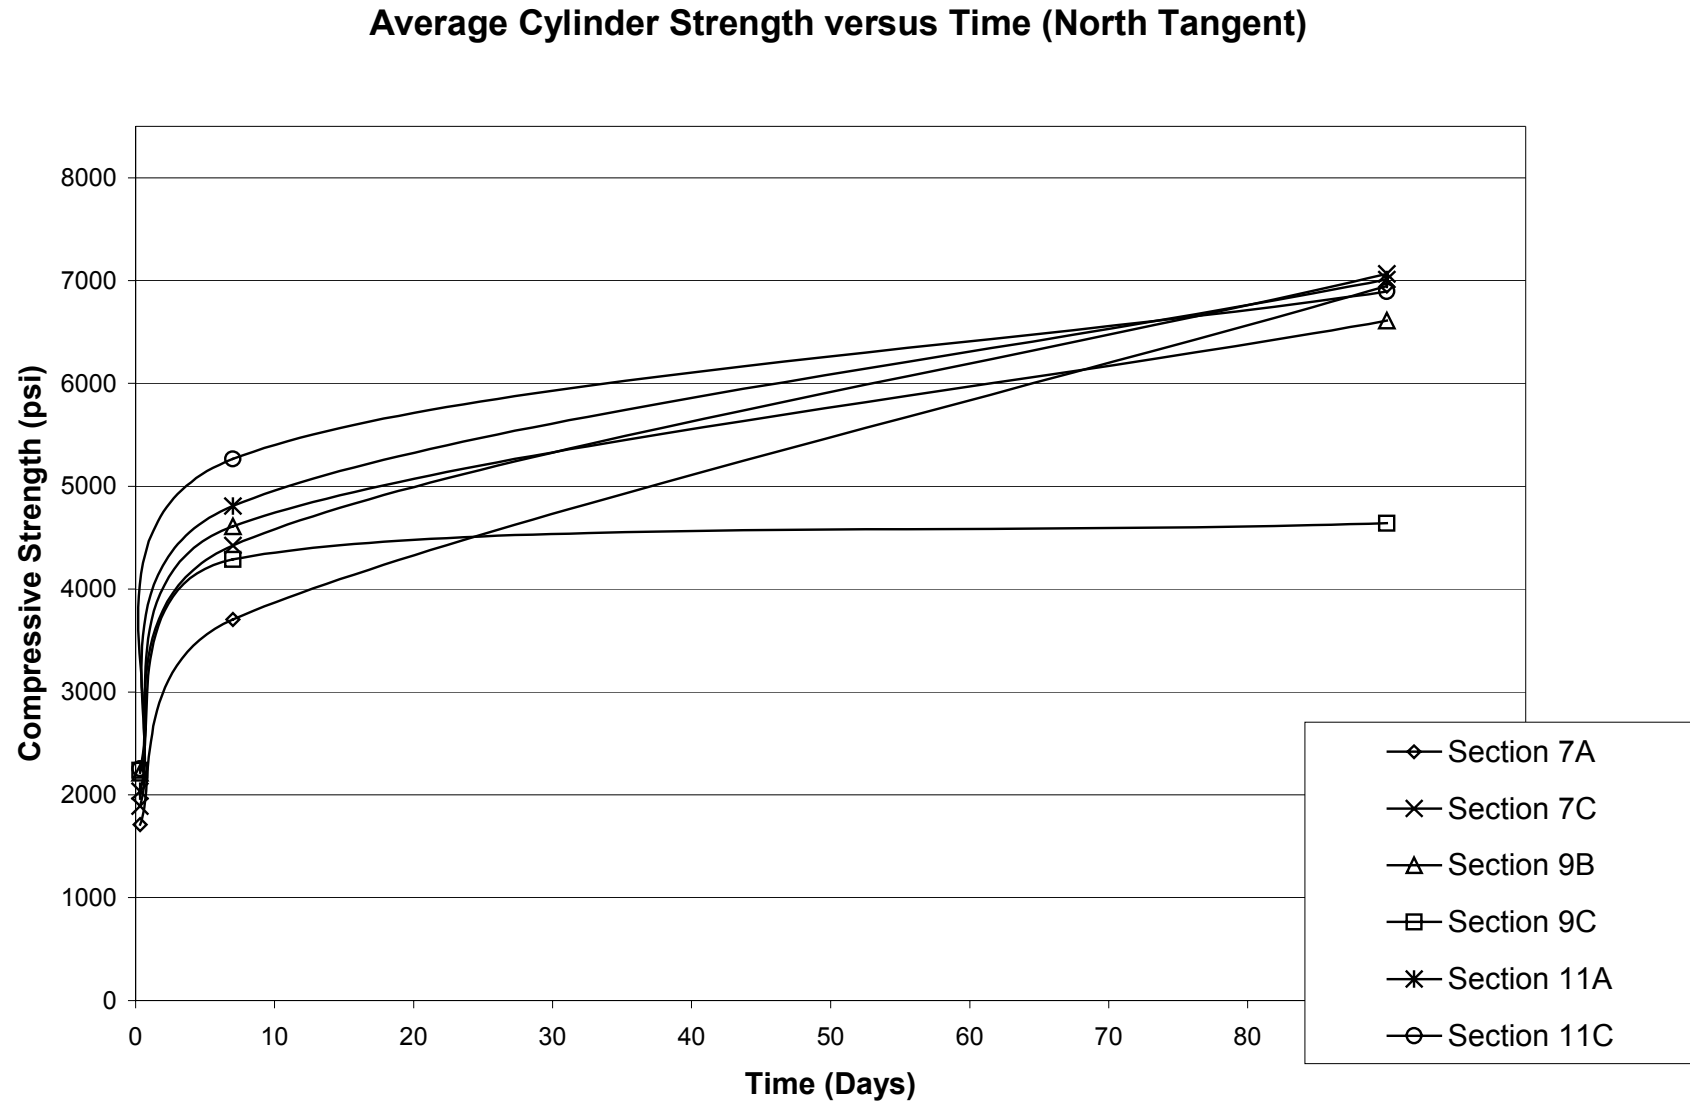
Figure 9.5. Average Cylinder Compressive Strength versus Time (North Tangent).

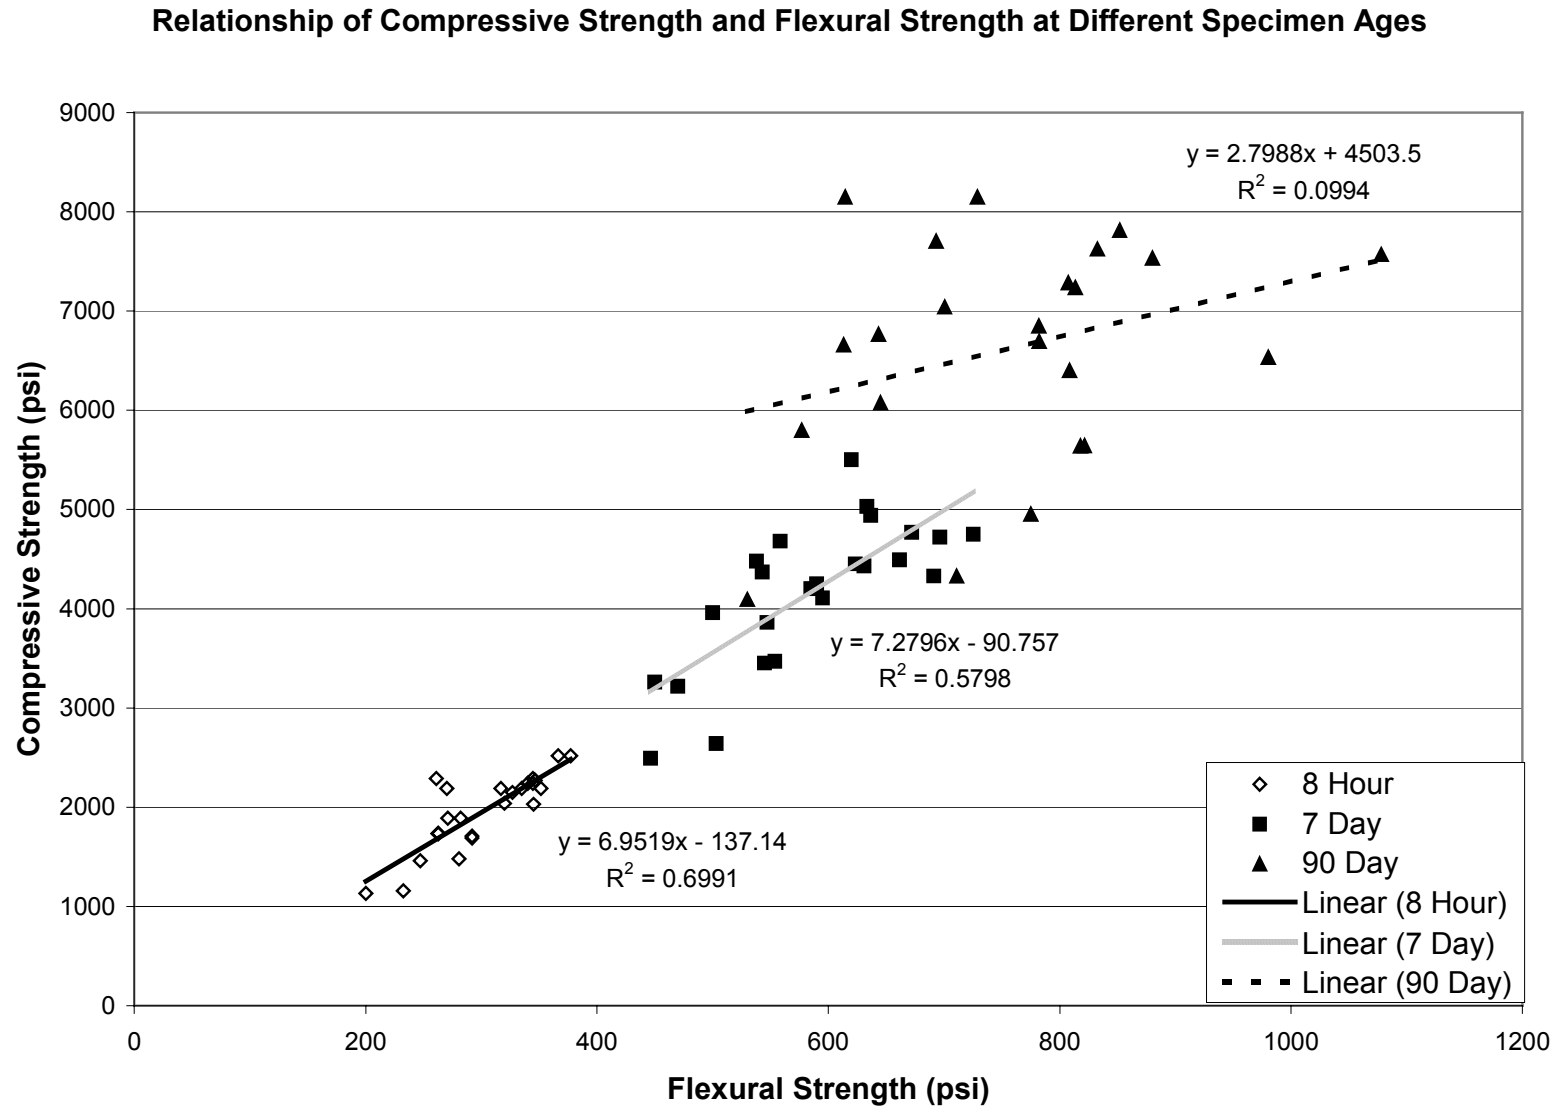
Figure 9.8. Relationship of Compressive Strength and Flexural Strength at Different Specimen Ages.

In order to identify where the most scatter exists in the data, a plot of beam (flexural) and cylinder (compressive) strength at each specimen age was made. Figure 9.8 shows that the scatter for the tests at 8 hours and 7 days is much less than for the tests at 90 days. At 90 days, there appears to be little correlation between flexural and compressive strength. Further laboratory testing needs to be completed to verify or dismiss the trend observed for the tests at 90 days.

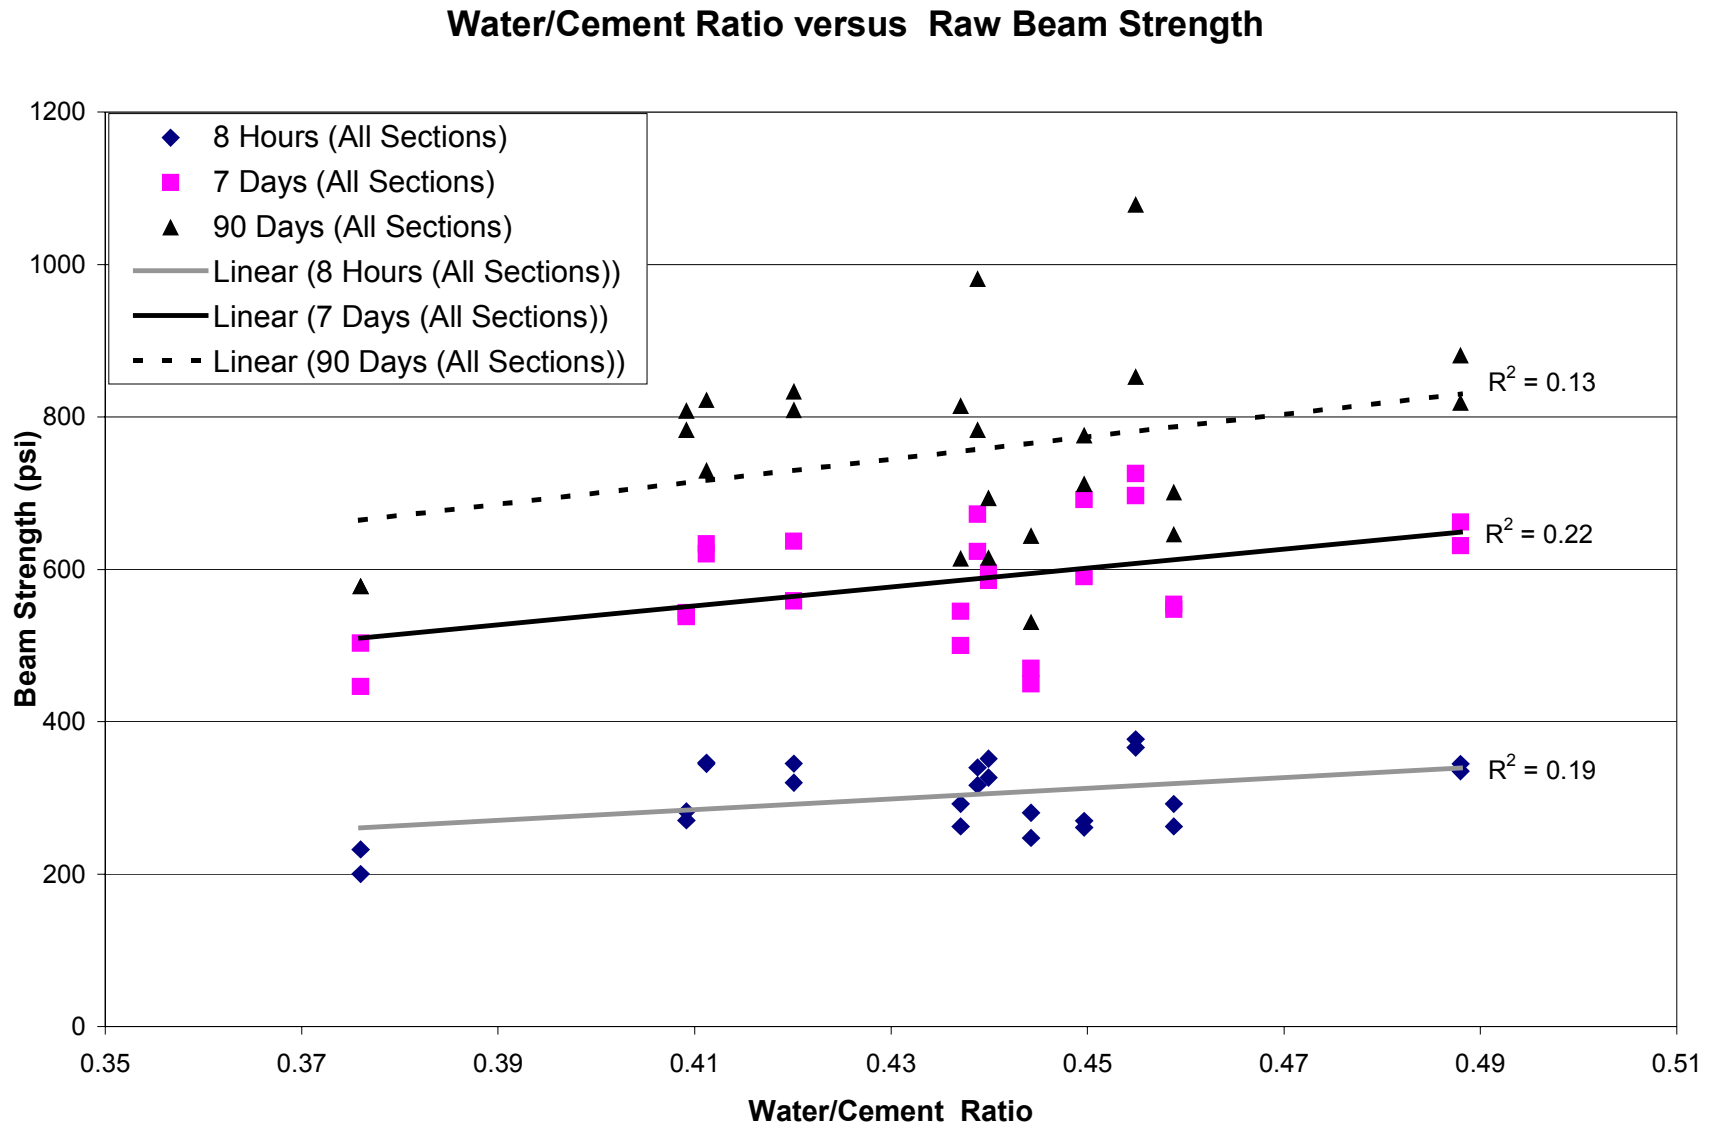
Figure 9.9. Water-to-Cement Ratio versus Beam Strength at 8 hours, 7 days, and 90 days.
