**Construction, Instrumentation, and Testing of Fast-Setting
Hydraulic Cement Concrete in Palmdale, California**

CALIFORNIA DEPARTMENT OF TRANSPORTATION

Jeffery R. Roesler, Clark W. Scheffy, Abdikarim. Ali, and David Bush

April 2000

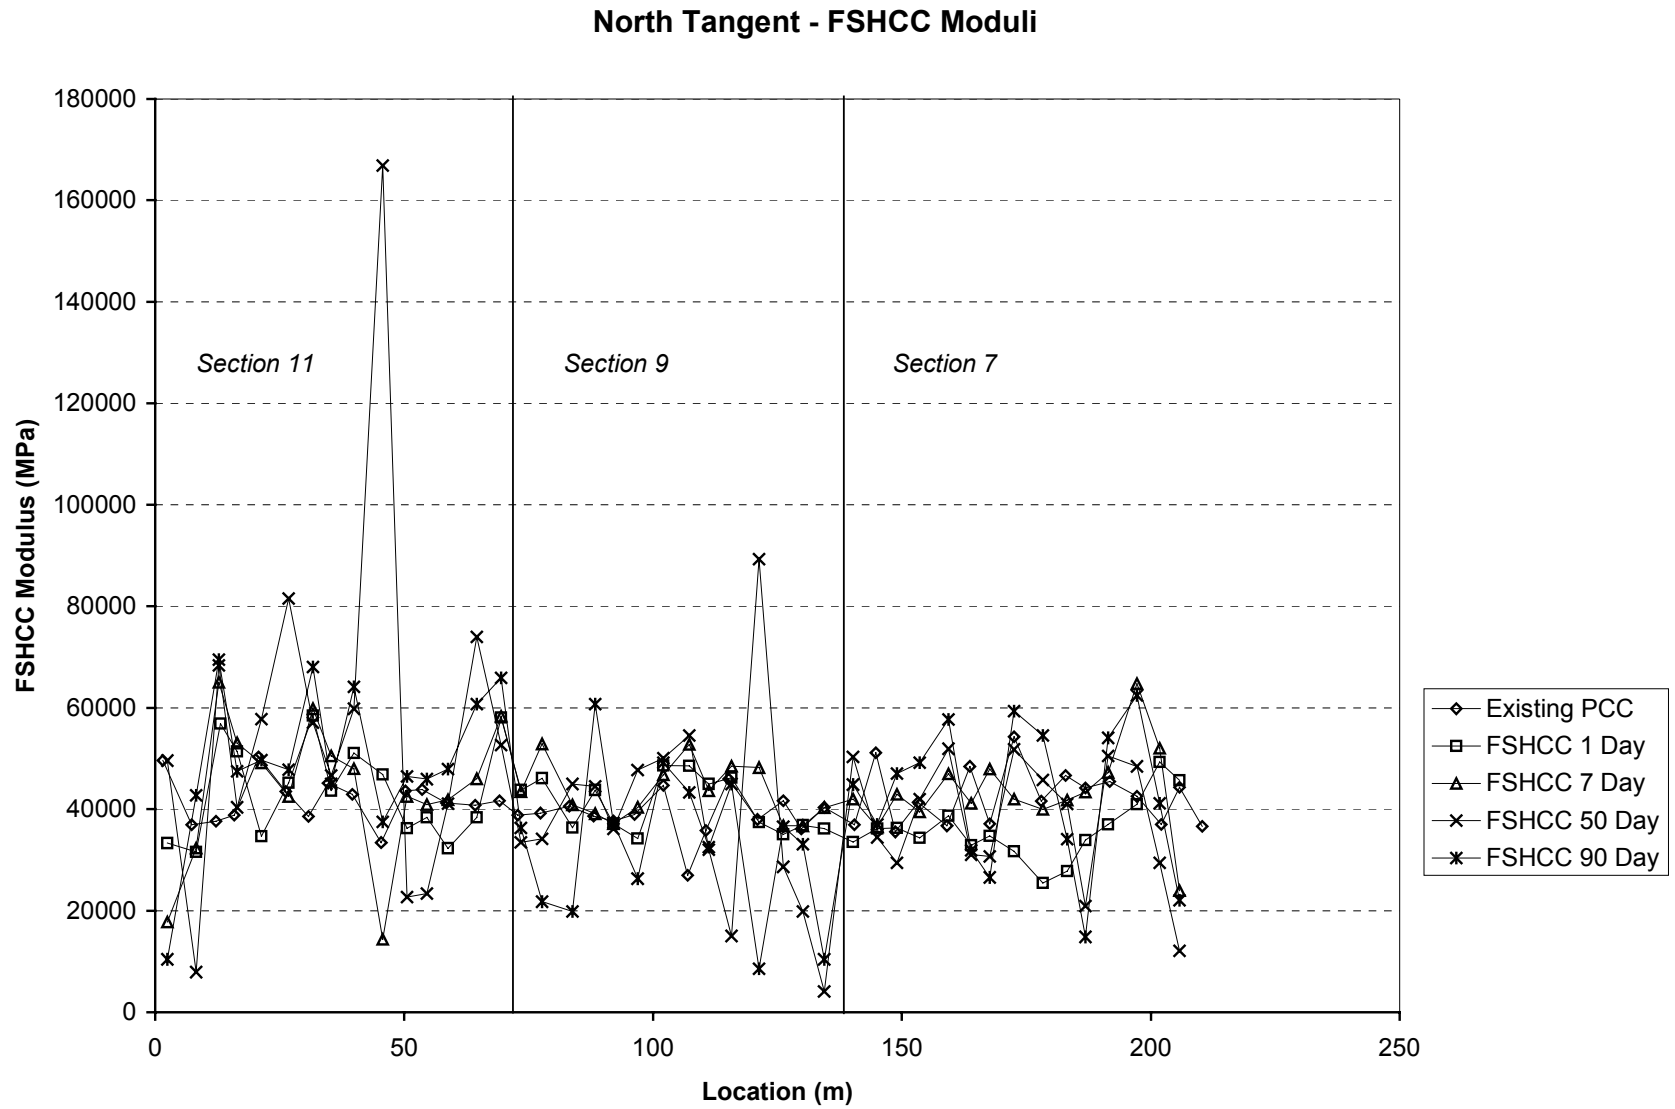
Figure 9.13. Surface Moduli (Backcalculated) for North Tangent.

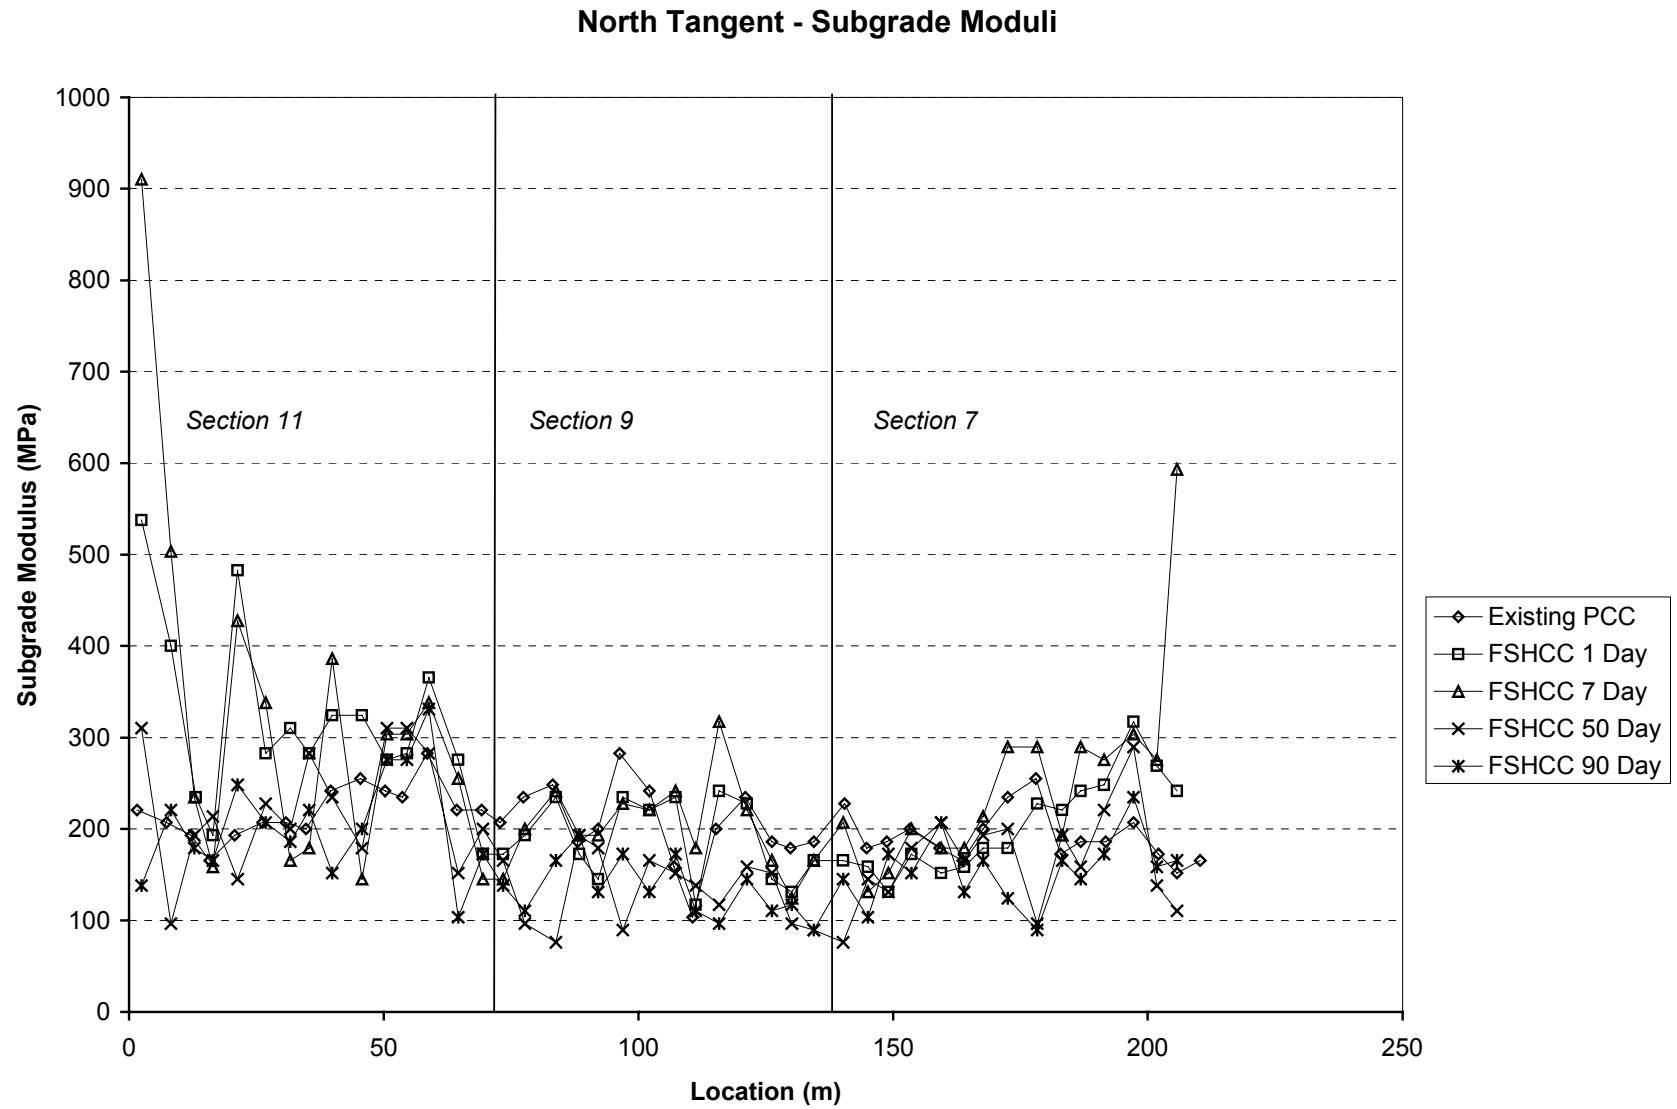
Figure 9.14. Subgrade Moduli (Backcalculated), North Tangent.

Estimated subgrade moduli do not appear to reflect the trend of increasing variability with time shown by deflections, which is consistent with the expected response. However, there does generally appear to be a trend of decreased subgrade modulus over time, which would explain the increasing deflection observed with time. The most common cause of subgrade modulus variation with time is considered to be variation in moisture content. The observed trend would typically be expected to result from increasing moisture content, which does not appear reasonable for the time period over which the deflections were measured. Another possibility involves stress sensitivity of the subgrade, which would be expected to correlate with any trends observed in the surface (FSHCC) modulus, (i.e. as FSHCC modulus increased, stress

induced on subgrade decreased for a given HWD load). Finally, the decrease in subgrade moduli could be an indication of micro- or macro-cracks occurring in the concrete surface layer.

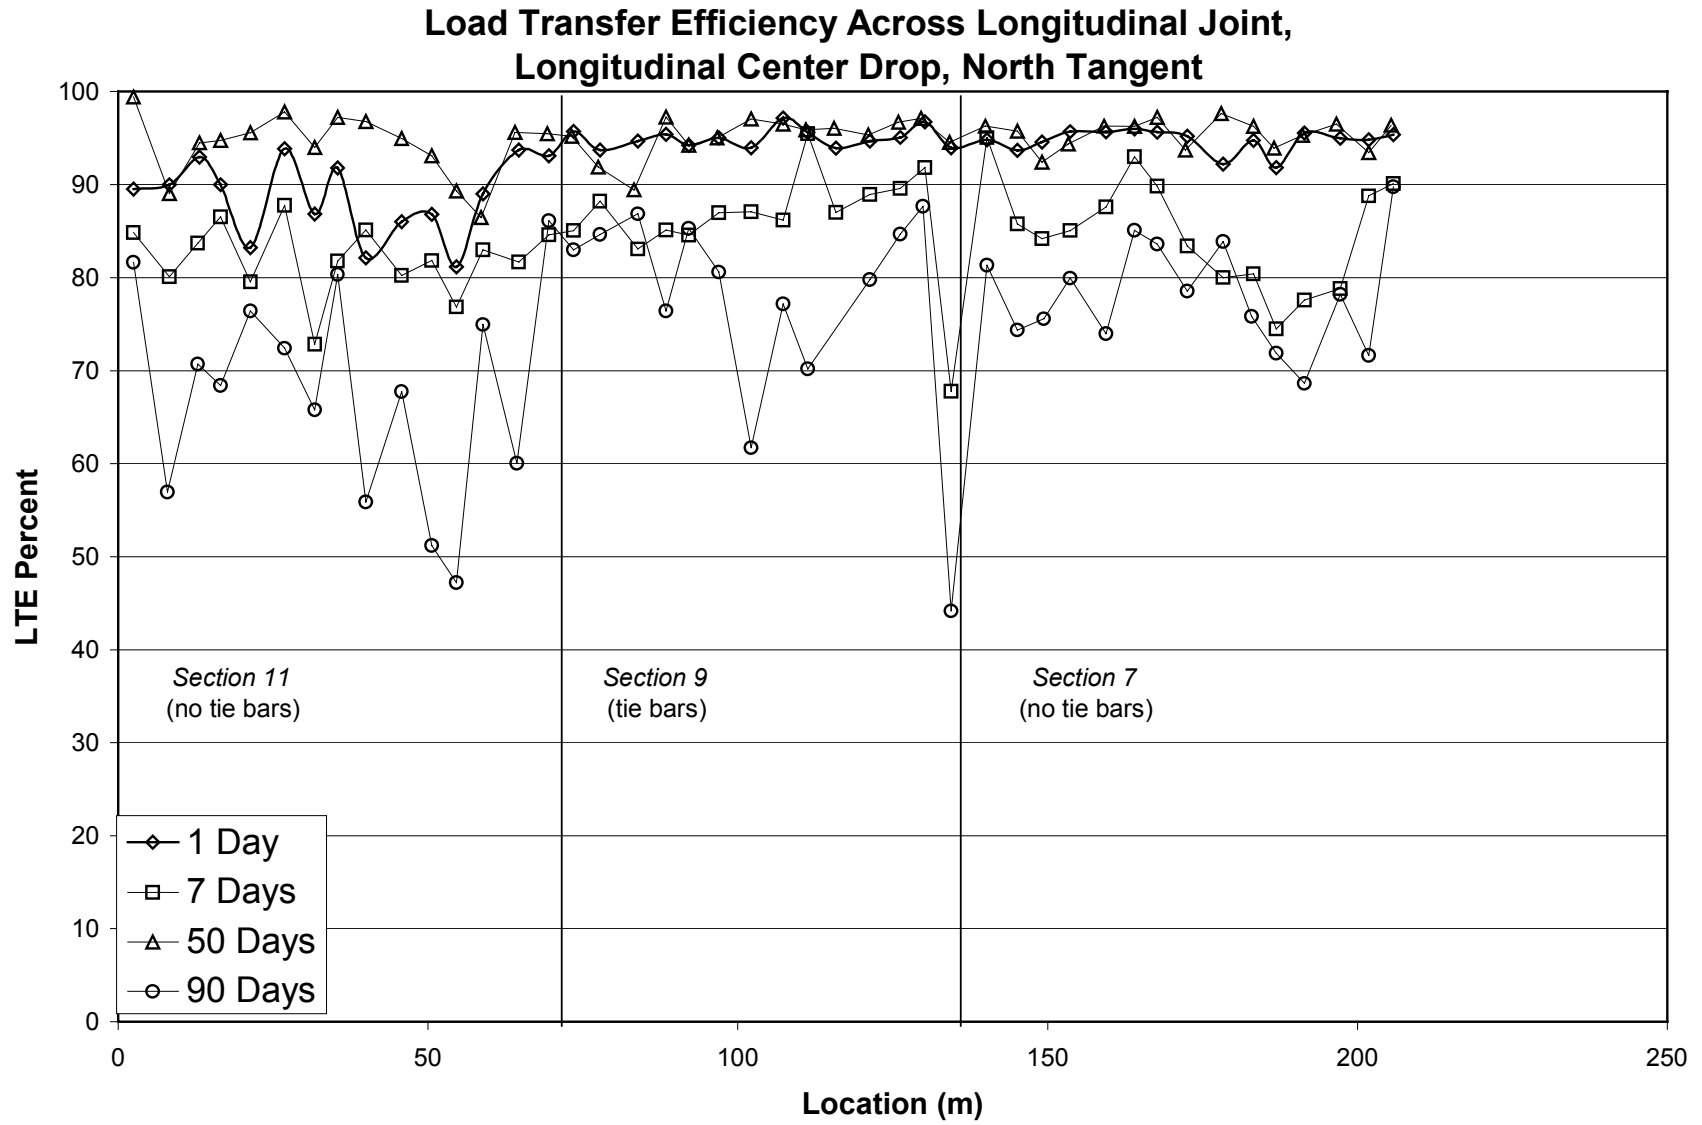
Figure 9.17. Longitudinal Joint Load Transfer Efficiency, Longitudinal Center Drop, North Tangent.

The decrease of the L.T.E. across the longitudinal joints over time, as shown in Figures 9.17 and 9.18, was probably due to the drying shrinkage of the concrete. This shrinkage resulted

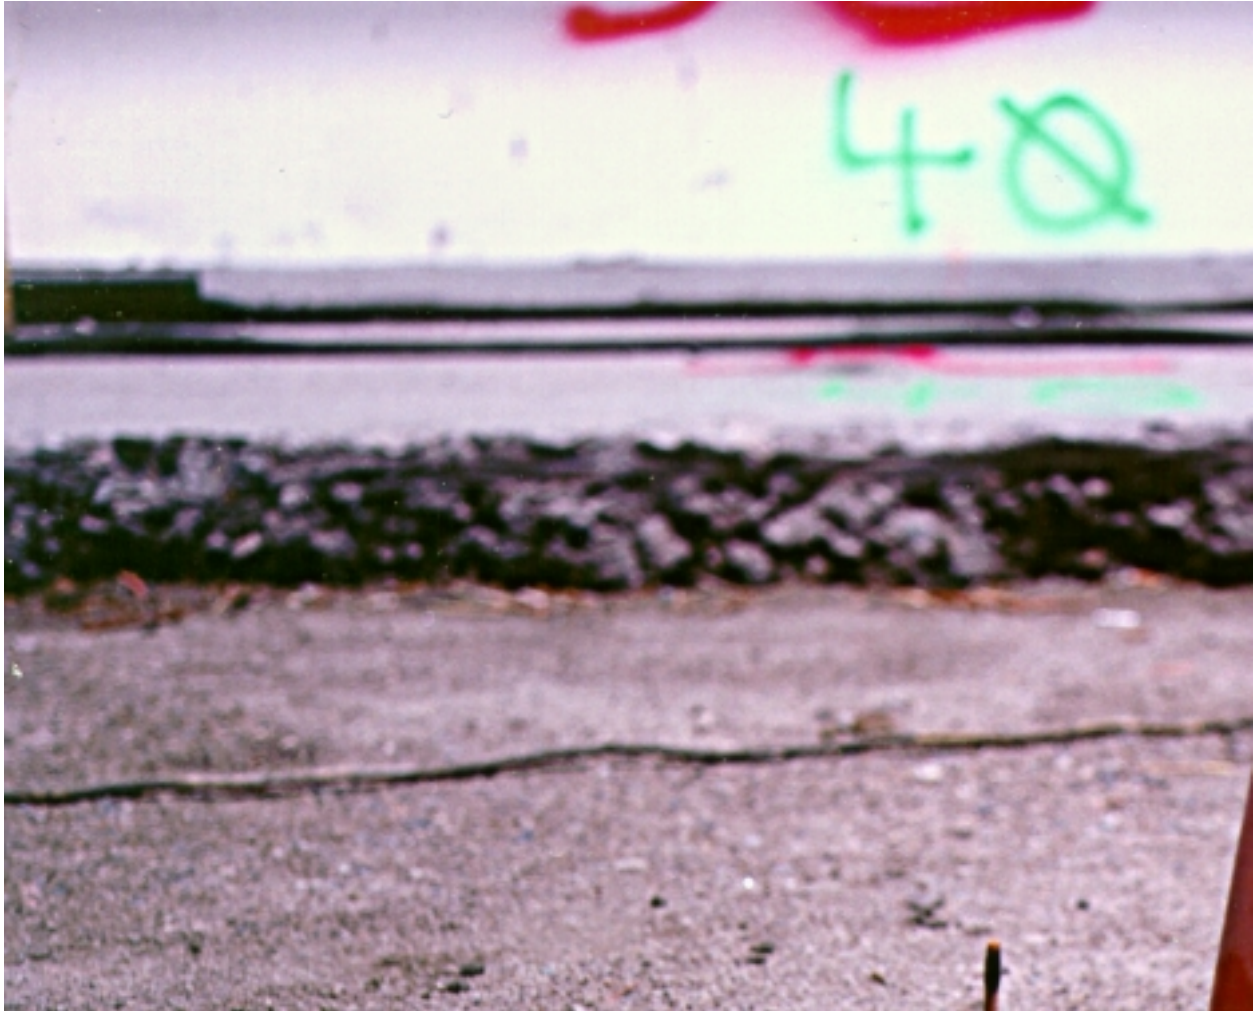
Figure 9.19. Detail photo of Rough Longitudinal Surface of Existing PCC Slabs, South Tangent.
