Reliability of Visual Inspection for Highway Bridges, Volume I: Final Report

FHWA-RD-01-020

JUNE 2001

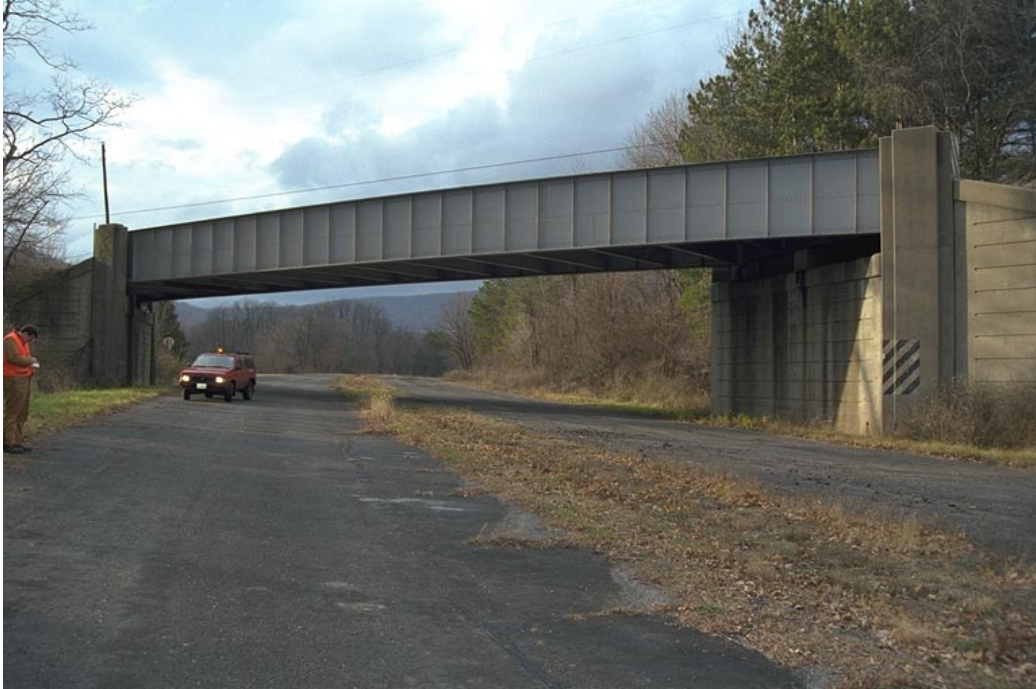
a. Elevation view of Bridge B521.

The north abutment shows general water staining, with numerous 25-mm spalls at form tie locations. The remaining portions of the substructure exhibit similar conditions and are, in general, in fair condition. Appendix D in Volume II further summarizes the overall condition of Bridge B521. Note that the Condition Ratings given in Appendix D will be referred to as the Reference Condition Ratings in subsequent sections.

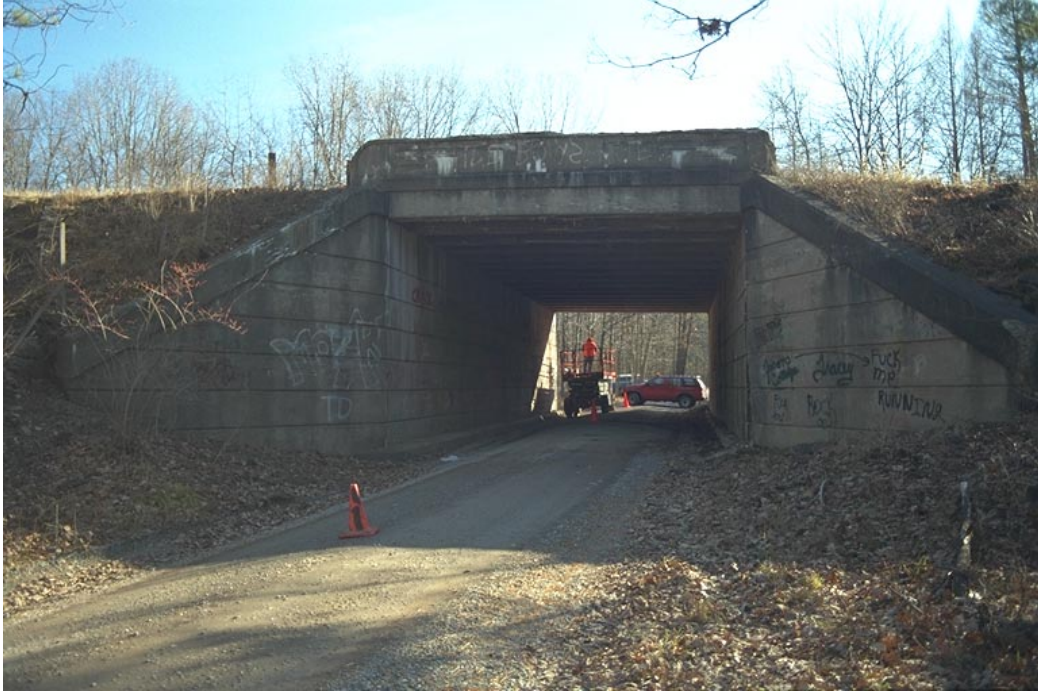
a. Elevation of Bridge B101A.

The substructure has experienced deterioration from water infiltration and soil movement. A significant horizontal crack is located just above mid-height along the length of one abutment.

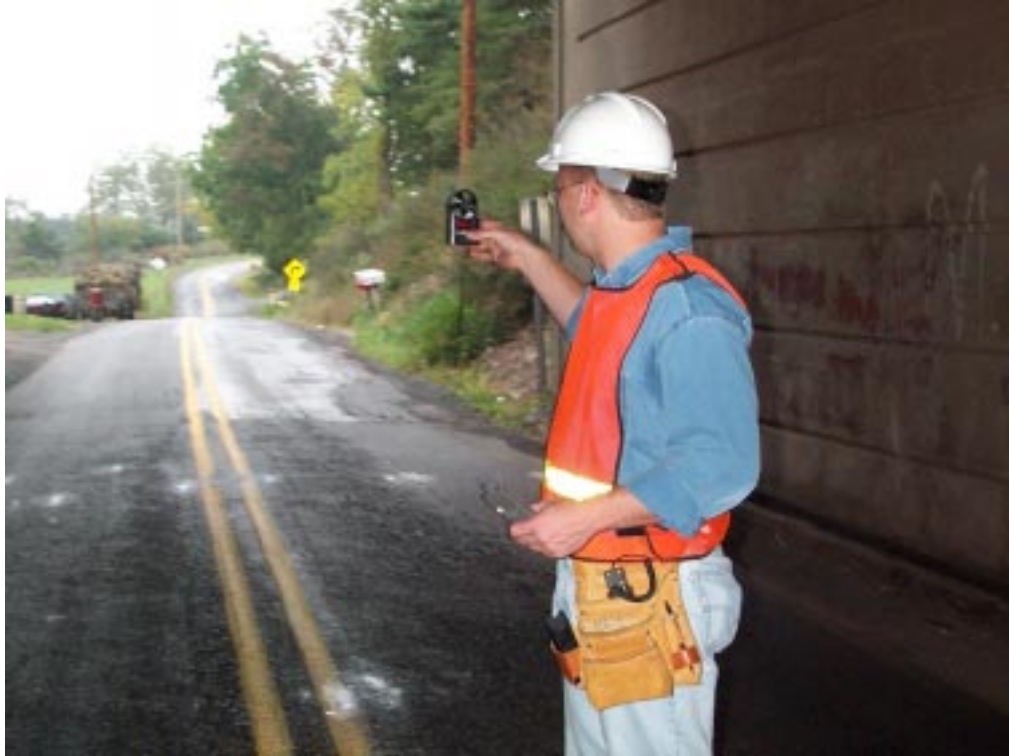
All measurements were made using standard equipment, with data recorded on the Palm IIIx via forms presented in Appendix J in Volume II. The measurements were made at consistent locations for each inspection specimen. To supplement these direct environmental measurements, qualitative assessments of the general weather conditions were also made and recorded on the forms in Appendix J. Figure 23 illustrates an observer measuring the environmental conditions.

Figure 23. Observer measuring the environmental conditions.

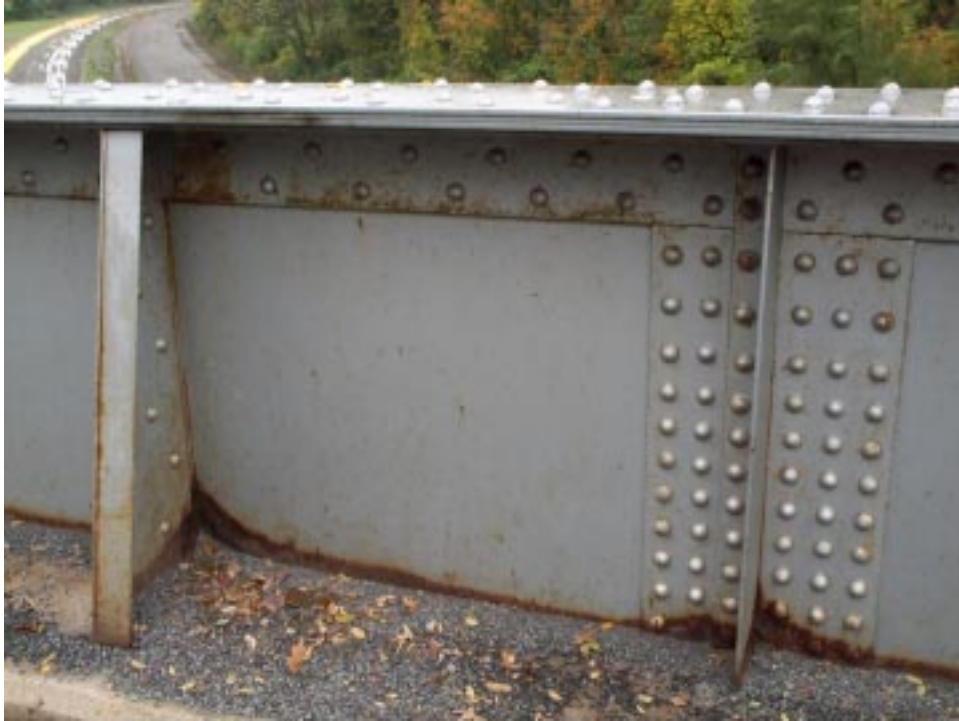
Figure 107. Deterioration described by Note A3 – Minor to moderate corrosion of stringer web at deck interface.

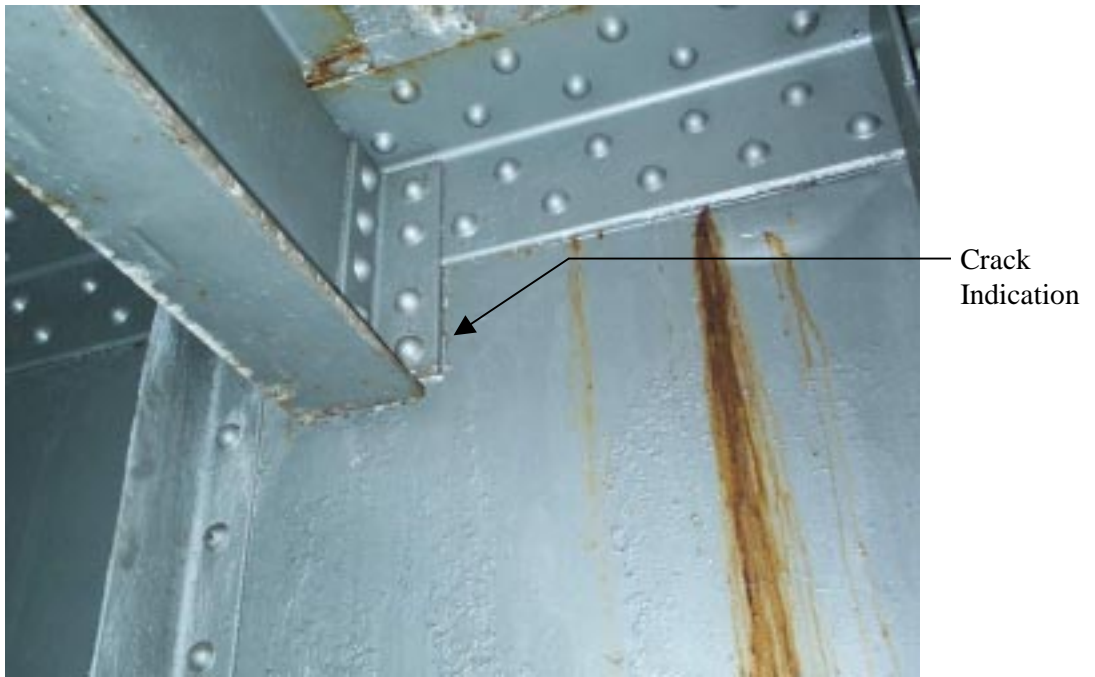
a. General location of implanted defect.

b. Close-up of defect.

Figure 131. Crack indication at the root of a tack weld.

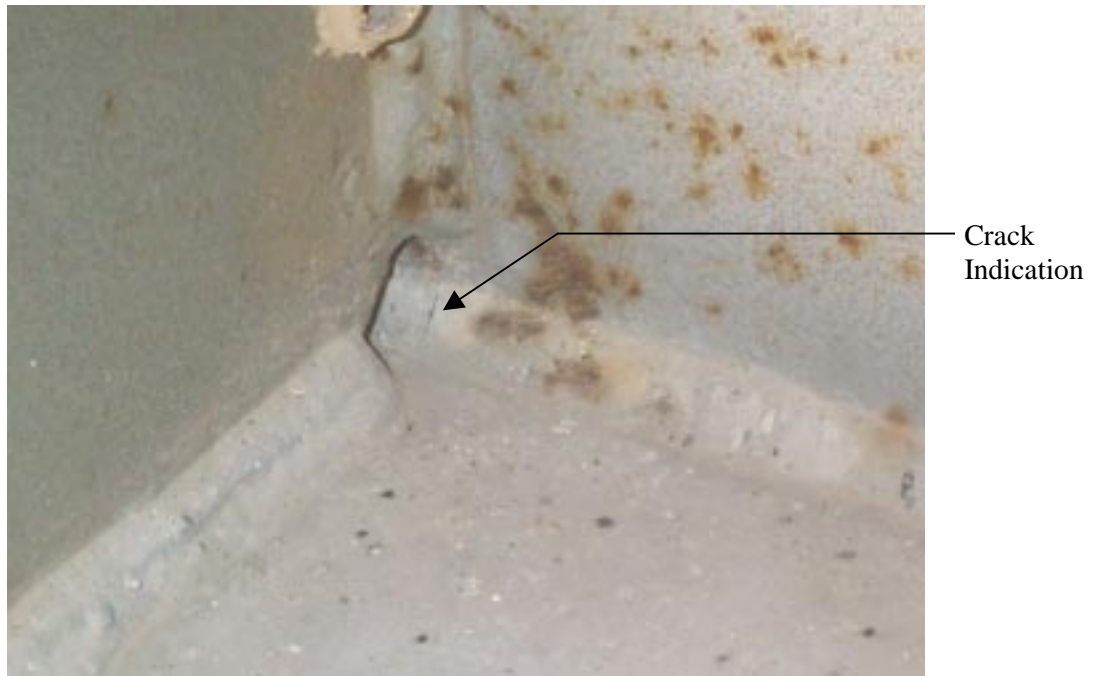
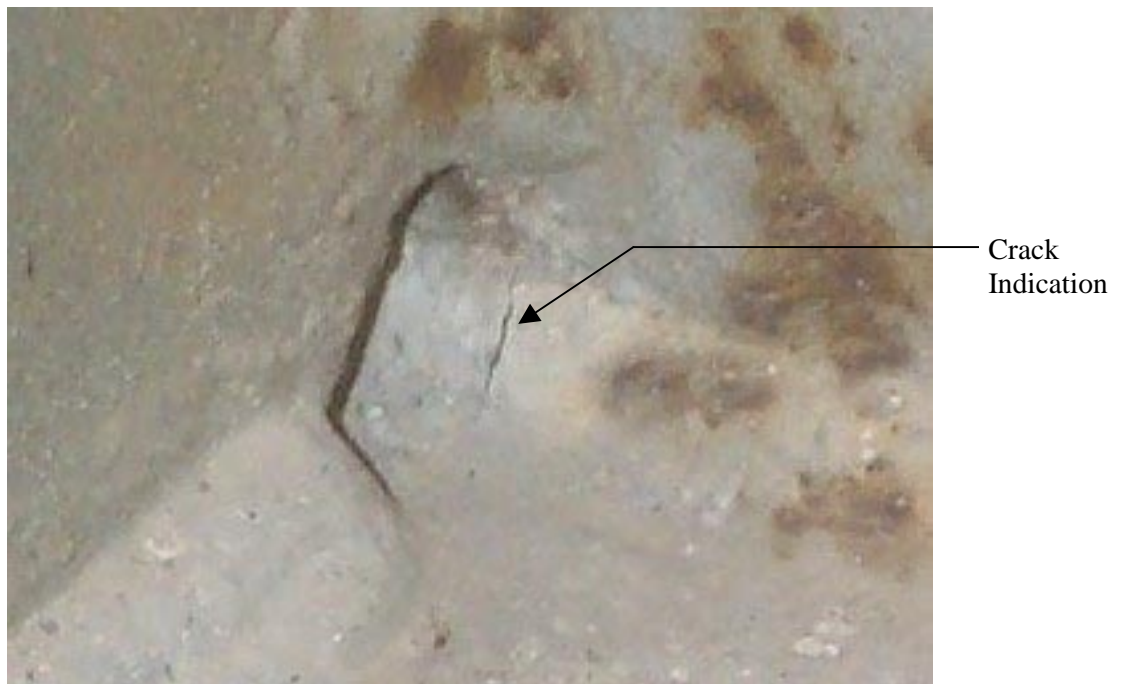
a. Web-to-flange connection.

Figure 142. Weld crack indication W2 near the base of a vertical stiffener.
