SD95-23-X

Evaluation of Geosynthetics in Asphalt Overlays of Jointed Concrete Pavements

**Study SD95-23
Executive Summary**

June 2000

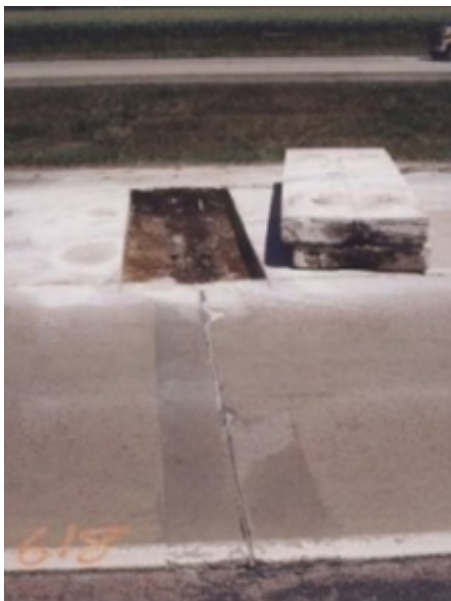
Figure 1 Joint 618 following the removing of the four-foot section and prior to the insertion of the steel bars and concrete.

Step 1 The joints that received maximum rehabilitation had four-foot sections that were cut down to the base aggregate and removed. Nine steel bars were then tied into the remaining bars and concrete was laid over them.

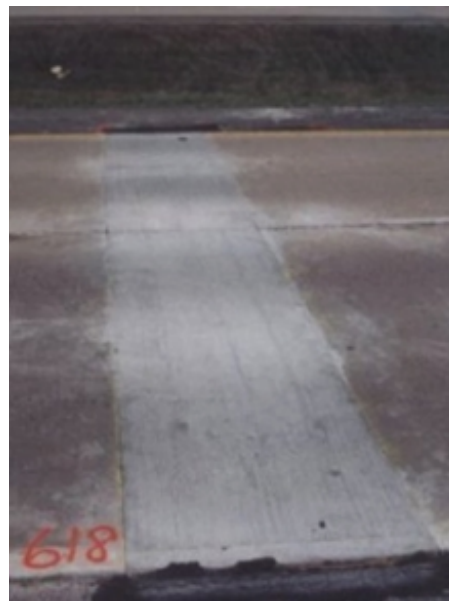
Figure 2 Joint 618 after maximum rehabilitation and prior to the asphalt overlay.

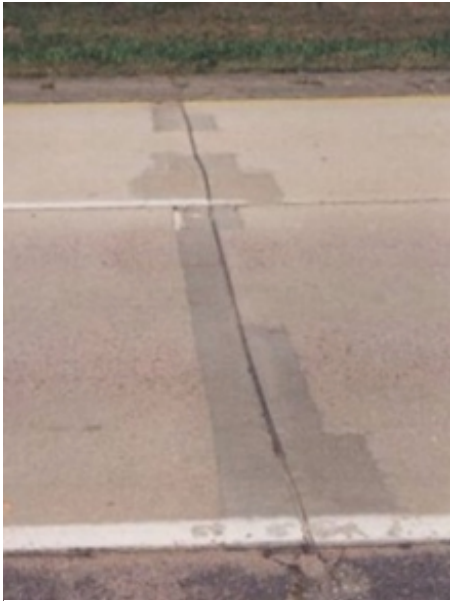
Figure 3 Joint 685 before minimum rehabilitation.

Step 2 The joints that received minimum rehabilitation were brushed off and small holes were repaired. Prior to this, a partial depth repair was performed in 1979 and no additional repair was done since.

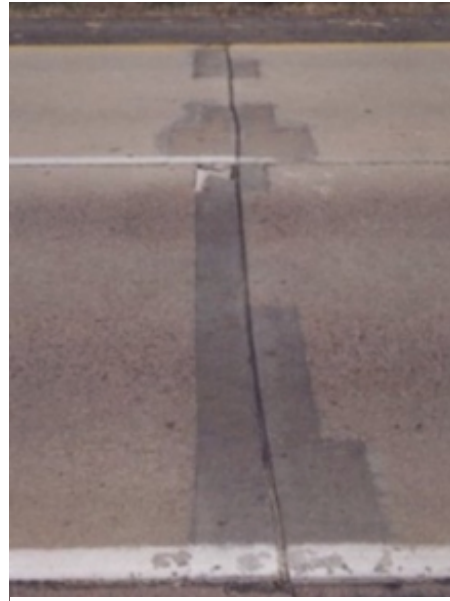
Figure 4 Joint 685 after minimum rehabilitation and prior to the asphalt overlay.

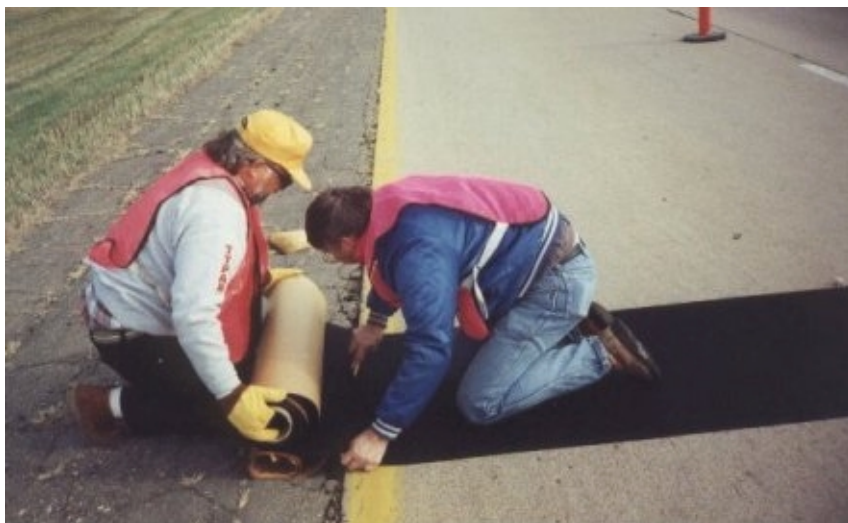
Figure 5 Supplier-Personnel and Gill Hedman (Office of Materials and Surfacing) installing Linq Tac-711N.

Step 3 Following the rehabilitations, the geosynthetic fabrics were placed over the joint before receiving the asphalt overlay.

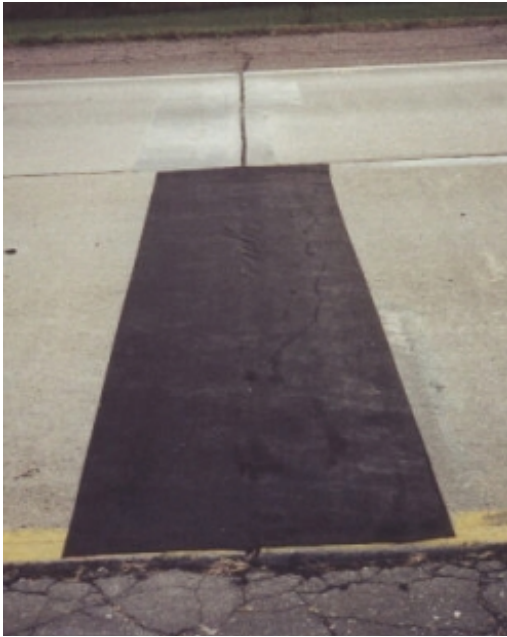
Figure 6 Linq Tac-711N installed and ready for the asphalt overlay.

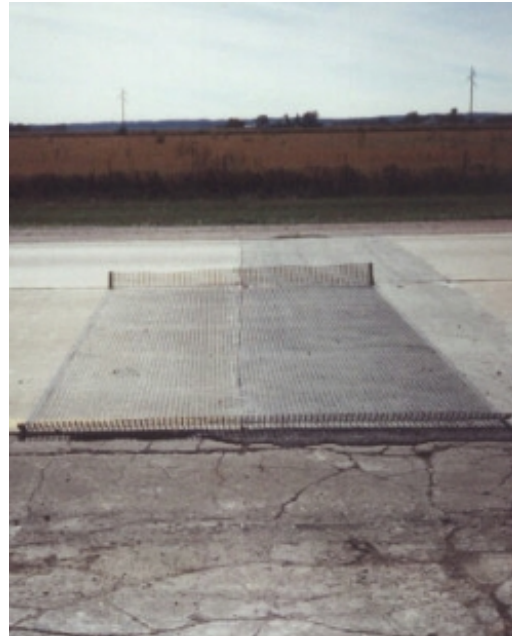
Figure 7 Strata Grid-200 installed and ready for the asphalt overlay.

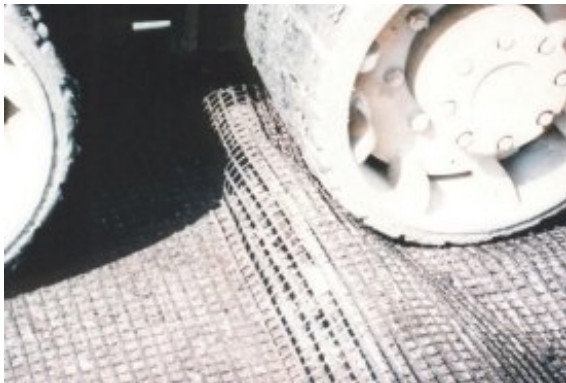
Figure 8 Strata Grid-200 bubbling under the tires of a truck.

Step 4 Once the fabrics were laid, the asphalt overlay began. Trucks were run over the fabrics and in some cases caused bubbling in the Strata Grid-200 so a thin layer of spread was placed on the fabric to avoid pulling and stretching from tack on the tires. No problems occurred when the Linq Tac-711N was being installed.

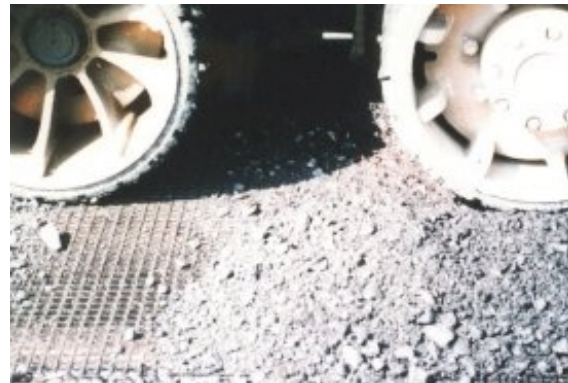
Figure 9 A thin layer of spread used to avoid pulling and stretching from the tires.

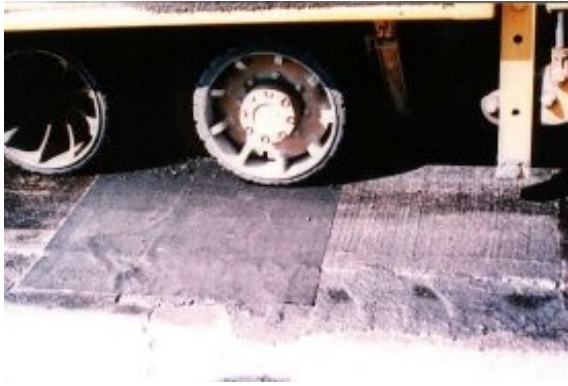
Figure 10 Linq Tac-711N under construction with no pulling or shoving.

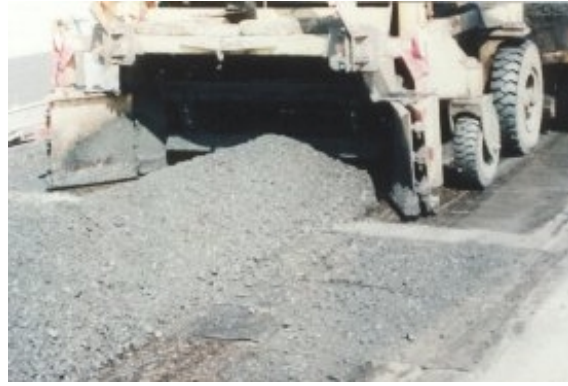
Figure 11 The pickup machines were kept raised to prevent damage to the fabric.

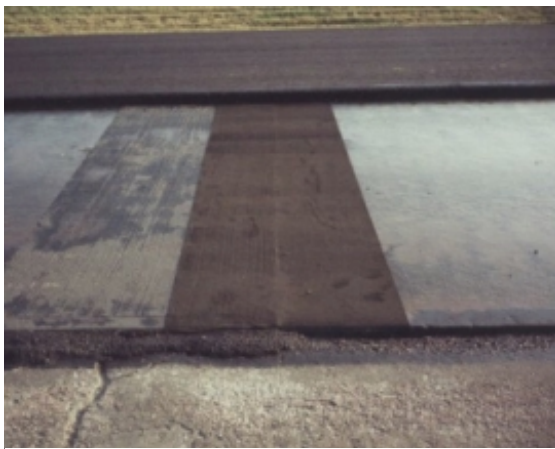
Figure 12 Linq Tac-711N with passing lane overlaid with asphalt.

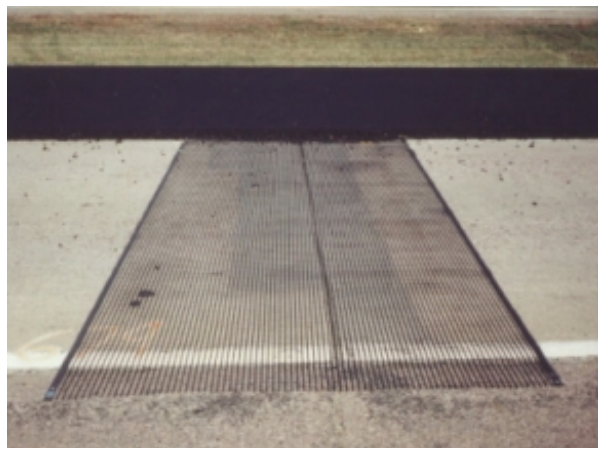
Figure 13 Strata Grid-200 with passing lane overlaid with asphalt.

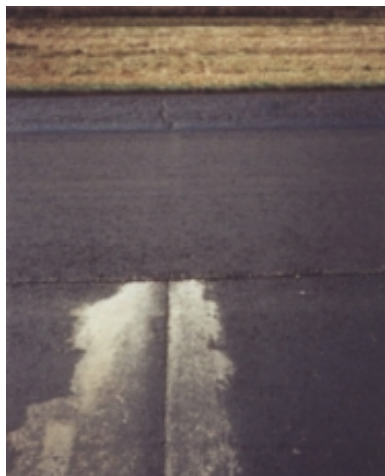
Figure 14 Joint sawed after asphalt overlay.

Step 5 After the asphalt overlay, joints were either sawed and sealed or left unsawed.

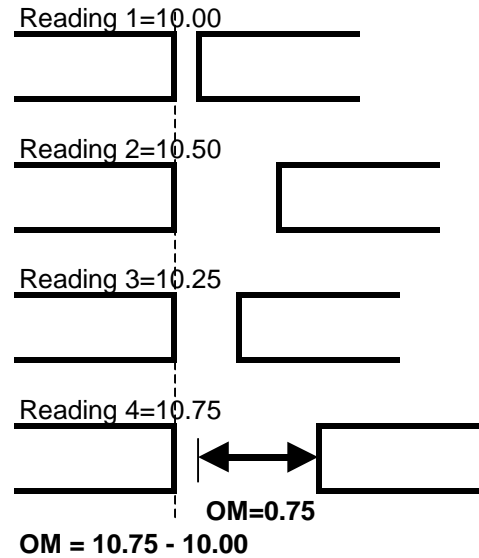
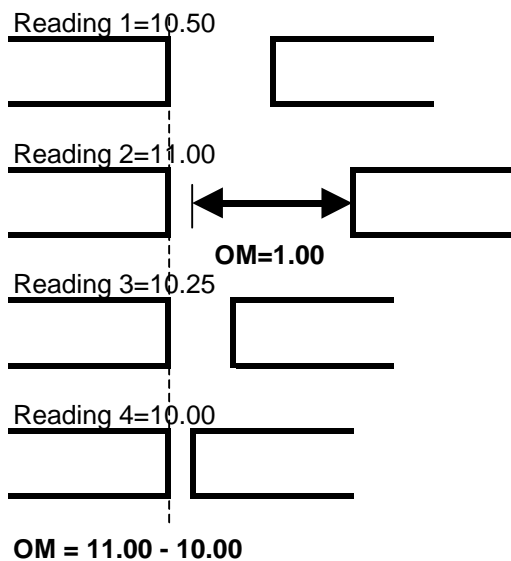
Figure 15 Observed Movement

observed movement is noted in the table for each segment. Below is a diagram of four joints that show how the observed movement was found.

Observed Movement= Widest Joint Width - Narrowest Joint Width

OM = Observed Movement

The “Observed Movement” in Table 2 was the difference between the widest joint width and the narrowest joint width. The average, minimum, and maximum amount of

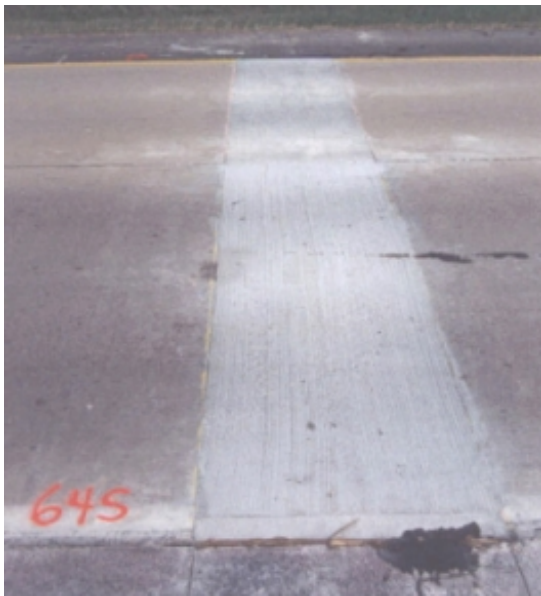
Figure 16 Joint 645 contains Strata Grid-200, with maximum rehabilitation and an unsawed joint prior to the asphalt overlay.

Segment 4, joints 645-654, had Strata Grid-200 for a geosynthetic fabric, maximum rehabilitation, and unsawed joints. Five additional cracks surfaced in the driving lane although no cracks appeared in the passing lane. The average observed movement as determined by the pin measurements for the driving lane was 0.14 inches and 0.18 inches for the passing lane. The minimum and maximum observed movement for the driving lane was 0.09 inches and 0.31 inches. The minimum and maximum readings for the passing lane were 0.06 inches and 0.38 inches.

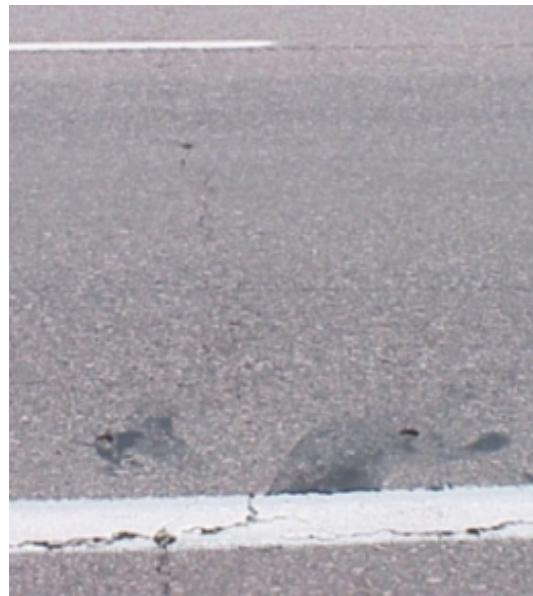
Figure 17 Joint 645 with crack reflecting through the asphalt overlay where the joint is.

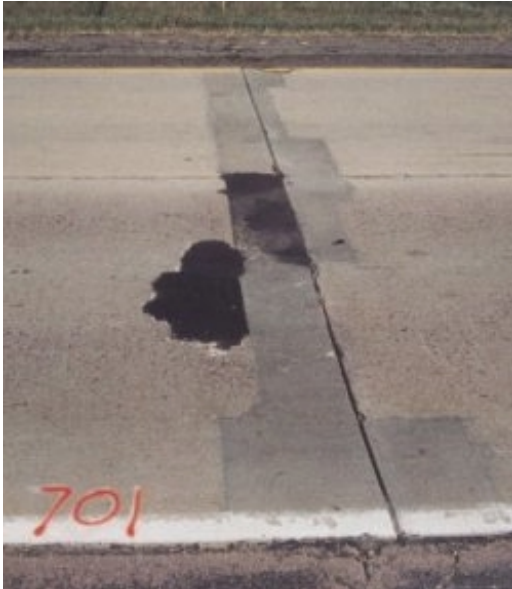
Figure 18 Joint 701 with no fabric, an unsawed joint, and minimum rehabilitation prior to the asphalt overlay.

Segment 9, joints 695-704, had no fabric, minimum rehabilitation, and unsawed joints. There were two cracks in the driving lane and none in the passing lane. The average observed movement as determined by the pin measurements for the driving lane was 0.19 inches and 0.27 inches for the passing lane. The minimum and maximum observed movement for the driving lane was 0.09 inches and 0.41 inches. The minimum and maximum readings for the passing lane were 0.13 inches and 0.94 inches.

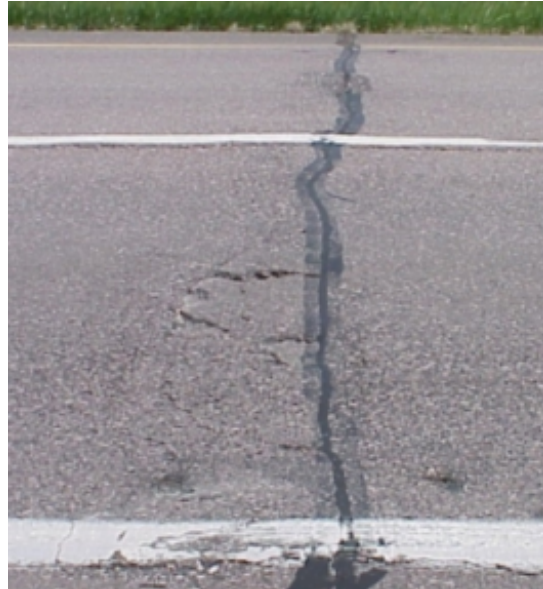
Figure 19 Joint 701 with buckling of the concrete causing cracks to reflect through the asphalt overlay. (Only minimum rehabilitation joint that showed buckling problems in the entire test section.)

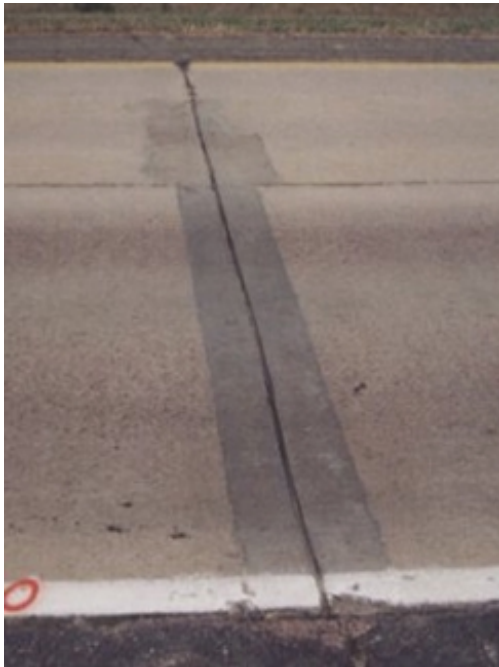
Figure 20 Joint 730 with no fabric, minimum rehabilitation, and a sawed joint prior to the asphalt overlay. (note the partial depth repair that was completed in 1979)

Segment 12, joints 725-734, had no fabric material, minimum rehabilitation, and sawed joints. There was one crack in the driving lane and none in the passing lane. The average

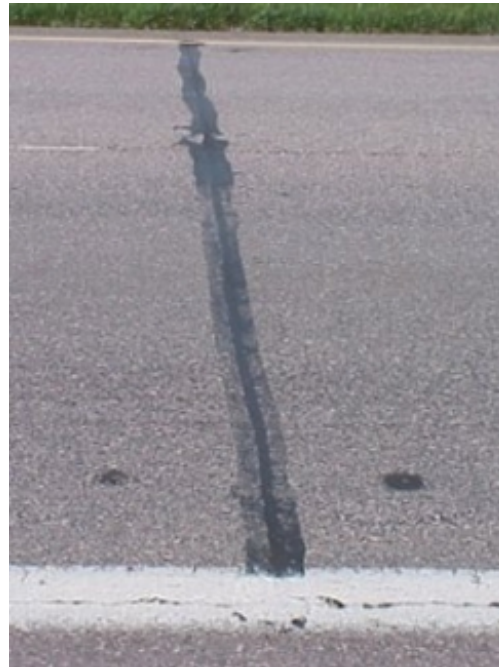
Figure 21 Joint 730 showing no problems with the joint. (More typical performance of minimum rehabilitation)
