**SIMPLIFIED IMPACT TESTING OF TRAFFIC BARRIER SYSTEMS**

***(Phase 1)***

Richard M. Gutkowski, Ph.D., P.E.  
and  
Derek J. Winkler  
Department of Civil Engineering  
Colorado State University  
Fort Collins, Colorado 80523

June 2003

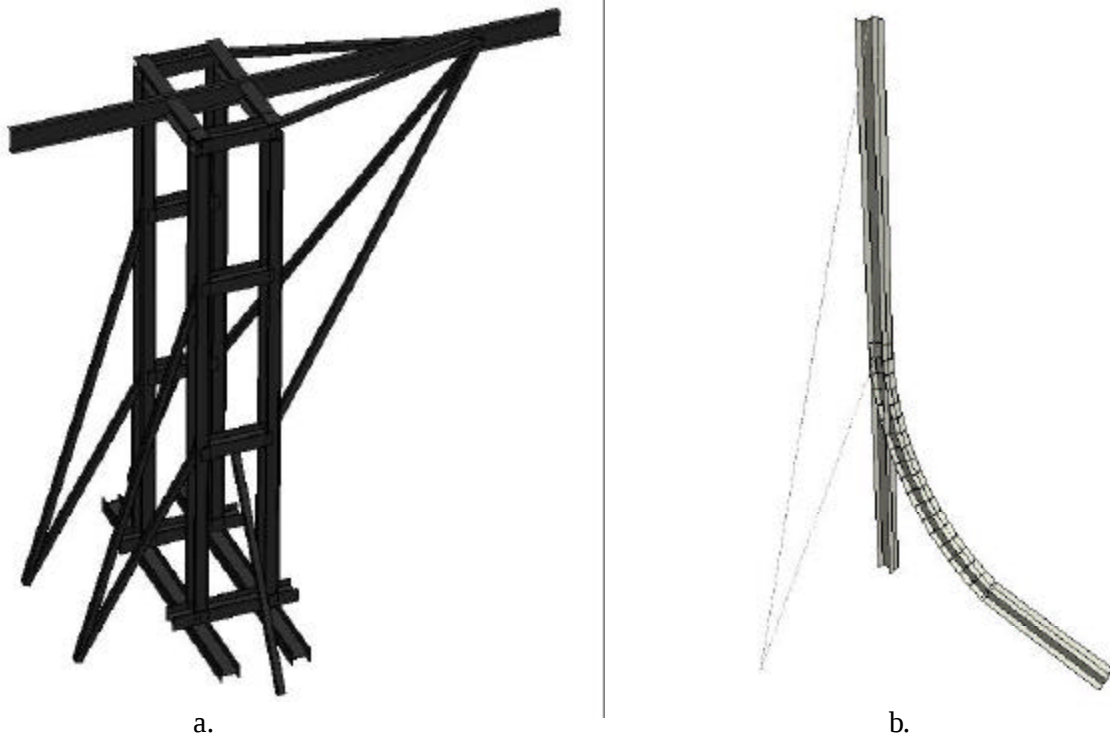
Figure 3.1: a. Conceptual modification to load frame for pendulum testing. b. Conceptual design of tower and rail structure.

The first of these options was to develop a pendulum-type test similar to that used previously for guardrail testing. To limit encroachment on other laboratory activities, it was necessary to modify one of the load frames in the laboratory to accommodate the pendulum, rather than attaching the pendulum to the large load frame as done previously, or attaching the pendulum to the building's roof structure. The latter alternative would not only have usurped most of the laboratory space, but would have required safety analyses for approval. The conceptual design for the pendulum frame is shown in Figure 3.1a. Advantages of the pendulum approach included its independence of weather conditions, its easily controlled impact speed, and the ability to achieve a relatively horizontal alignment of the mass at the instant of impact, as typically is encountered with an impacting vehicle. Unfortunately, the mass would of course swing unrealistically into and out of the horizontal plane before and after impact, and the velocity of the mass was limited by the height of the structure to which it was to be mounted.

The second option considered was to mount the concrete block to a tall vertical rail that curved to the horizontal alignment at the bottom, again utilizing the acceleration of gravity to generate impact speed (Figure 3.1b). This option was dismissed because the funds needed for the material and fabrication costs associated with the tower structure were not available. Also unfavorable was the difficulty anticipated with safely controlling travel of the concrete block beyond the end of the rail.

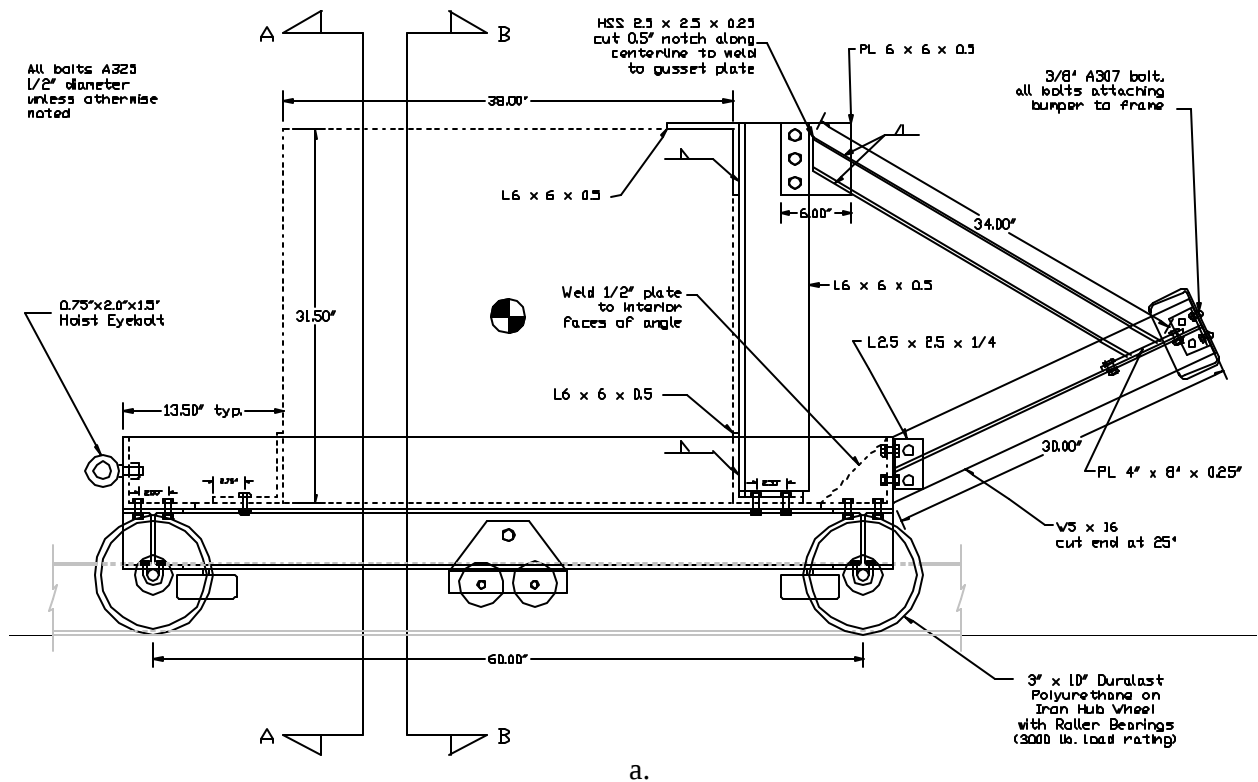
Figure 3.5: a. Side elevation, test vehicle design. b. Cart, as built, with concrete block in upper left corner.

In keeping with the need for minimal cost, the test vehicle frame was constructed entirely of readily available steel angles, channels, wide flange sections, and hollow tubes, as shown in Figures 3.5 and 3.6. Bolted connections were used for most of the frame to ensure that any parts damaged during a test could be quickly and inexpensively removed and replaced. The primary load-bearing portion of the frame consisted of half-inch plate angles, with six-inch legs to provide restraint to the concrete block.

This frame was then mounted to wide-flange sections, to which one-inch axles and inexpensive, 10-inch iron-hub wheels with roller bearings were mounted. The use of 10-inch wheels then dictated dimensions of the guide rail and the wide-flange members that connected the main vehicle frame to the axles. Use of larger wheels, had they been available at reasonable cost, would have dictated using a taller, more expensive wide-flange section for the guide rail than the W6 x 12 that was used.

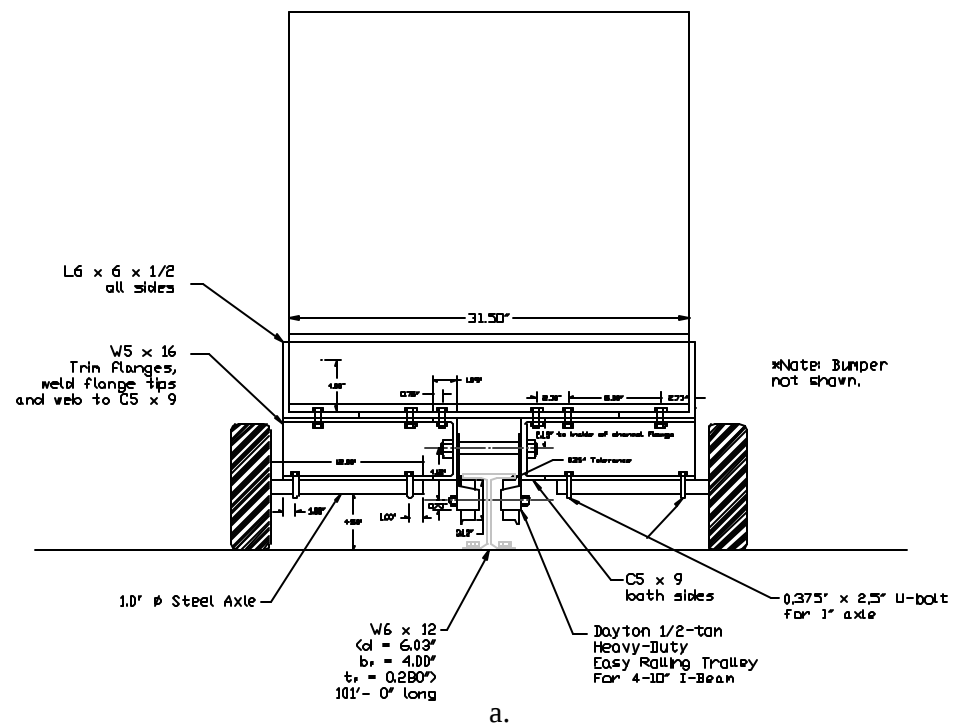
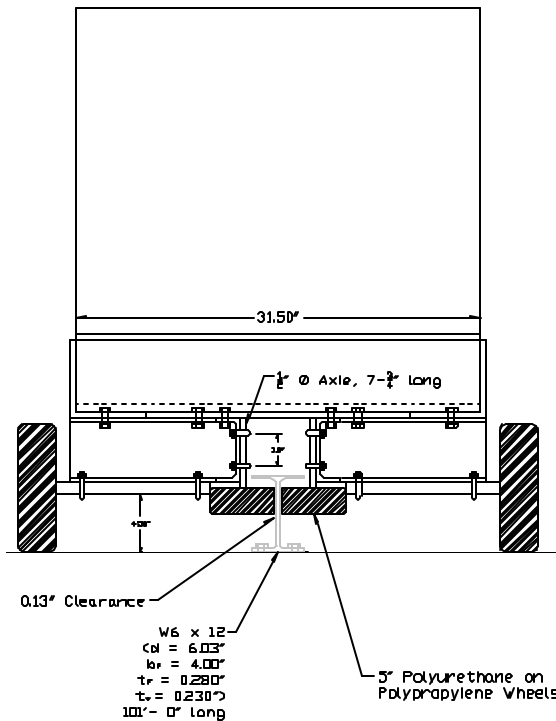
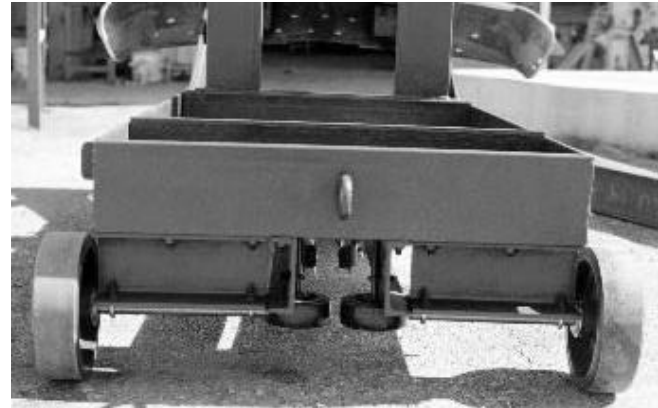
Figure 3.6: a. Section A-A, showing the trolley. b. Section B-B, showing the lateral restraint wheels. c. Rear view of the test vehicle, as fabricated, showing the lateral restraint wheels and the trolley.

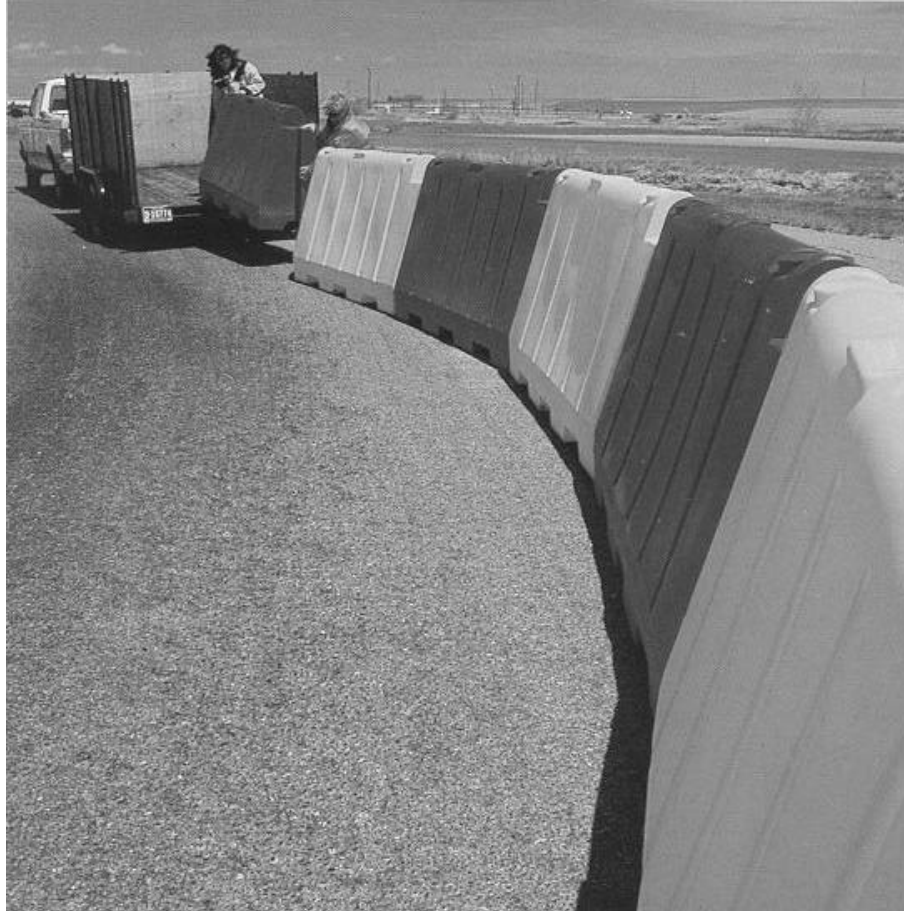
Figure 3.11: Assembly of an interconnected line of barrier specimens in the field.

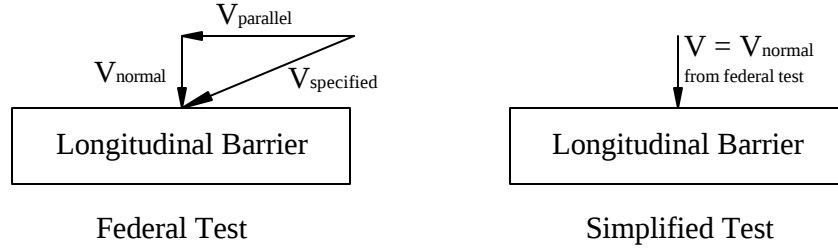
Figure 3.12: Use of the normal component of the federal test's specified velocity.

The simplified test was configured for an impact angle of 90 degrees, as opposed to the 25-degree impact angle specified in the federal standard. However, since the impact severity as given by equation 2.1 is computed using the normal component of the velocity vector, the impact severity specified for a given test level can still be achieved with the simplified test's 90-degree impact angle by using the normal component of the specified velocity, as shown in Figure 3.12.

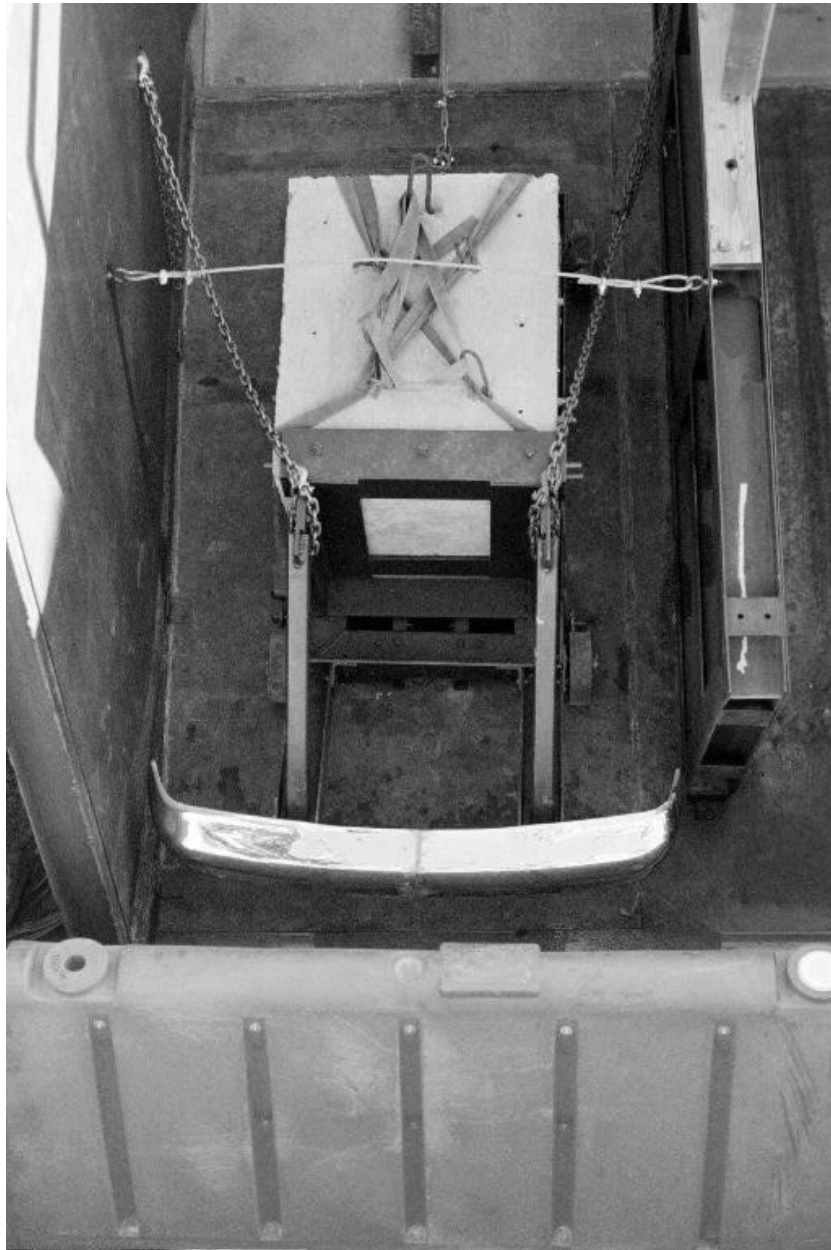
Figure 4.3: Surrogate test vehicle loaded with the concrete block and chained to the flume to permit safe barrier placement. Also visible are the safety cable, tiedown straps, and the end of the guide rail.

To ensure safety for the individuals who were to position test specimens at the base of the flume, the loaded surrogate test vehicle was hoisted partway onto the flume incline and chained in place, as shown in Figure 4.3. Three interconnected barriers were then positioned according to the design test configuration, as shown in Figure 4.4. The right barrier was positioned with approximately 3.5 feet of its width protruding through the gate in the north flume base wall, to permit a direct impact of the test vehicle on the center barrier. In an attempt to provide similar translational restraint to the left barrier as imparted by the concrete gate to the right barrier, a fourth barrier was placed six inches behind the left barrier. Once positioned properly, the barriers were filled to capacity with water, and were photographed in their initial position. After all personnel were clear of the flume base, the test vehicle was hoisted onto the guide rail and then to the 3.53-meter height necessary for development of the 67.6-kilojoule impact severity for test level 2. The test vehicle is shown in Figure 4.5 in its initial position.

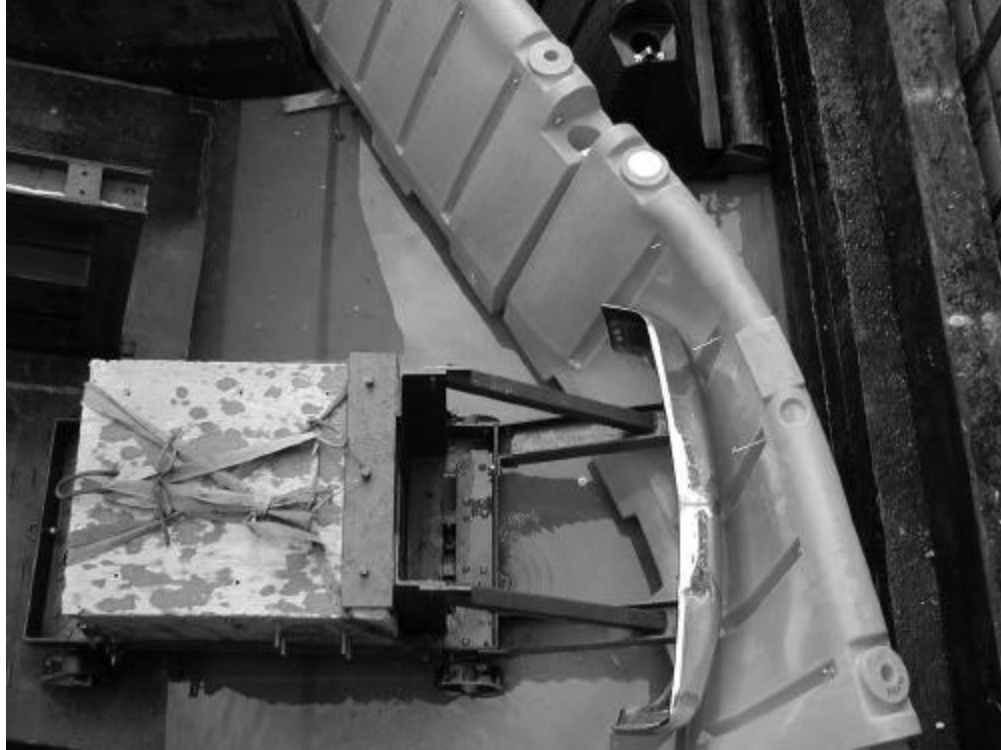
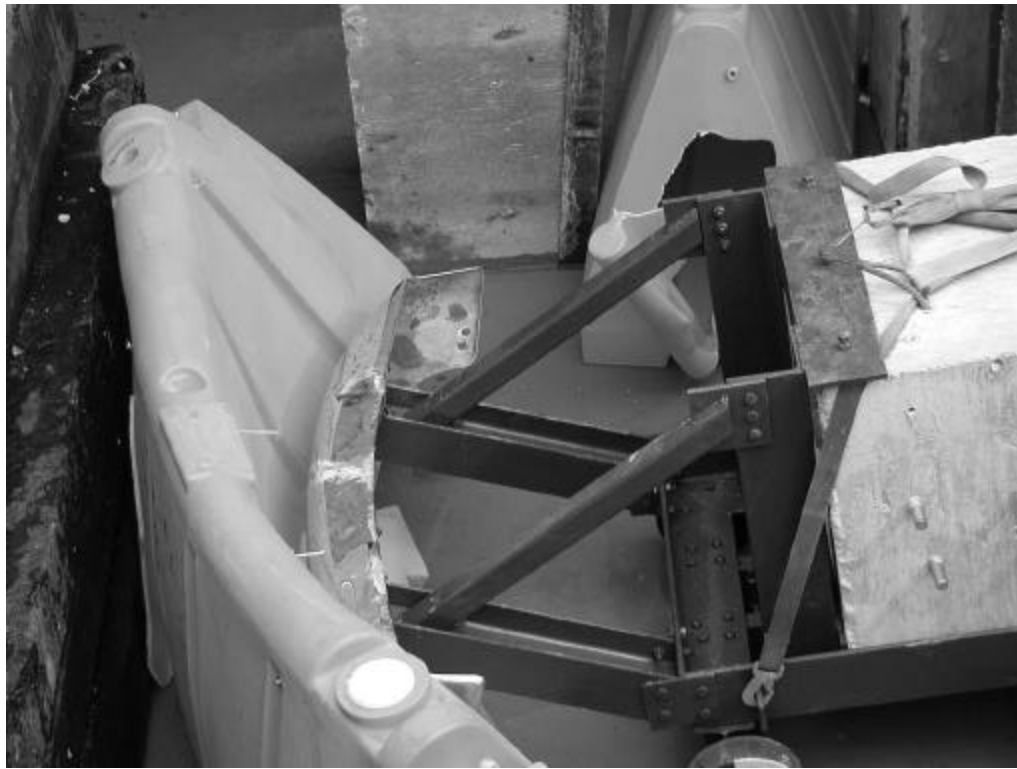
Figure 4.7: Deflected position of test specimens and final position of the test vehicle following the first test. a. Overhead view. b. North view, showing tearing of the right barrier's connector bar.

The first test was successful in many respects, as it effectively illustrated the mode of the barrier specimen's structural response and features of the test configuration that were in need of improvement. In accordance with NCHRP reporting procedures, several frames from the contact phase of the impact were extracted from high-speed photography, and are presented in Figure 4.6a and b. Photographs of the barrier specimens and the surrogate test vehicle in their final positions after impact are shown in Figure 4.7.
